# **2023** FACILITY CONDITION SURVEY

Spokane Community College

SURVEY CONDUCTED BY:  
Steve Lewandowski  
State Board for Community  
and Technical Colleges

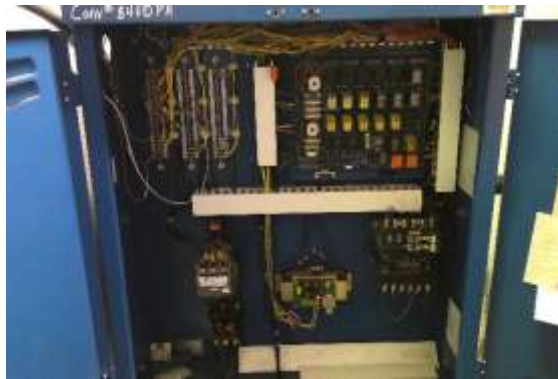
Estimated average life expectancy (years) : 30
Scoring priority category 1 : System Use (score = 15)
Category 1 percentage : 70 %
Scoring priority category 2 : Facility Use/ Civil Rights Violation (score = 20)
Category 2 percentage : 30 %
Project construction estimate (MACC): \$150,000
Total project estimate (including soft costs): \$208,000
Additional points based on building condition: 2
Deficiency score : $2.5 \times ((15 \times 70\%) + (20 \times 30\%)) + 2 = 43.3$

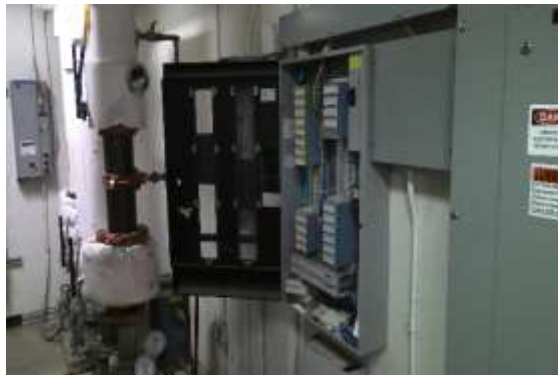
**Deficiency F02**

Category 1 percentage : 70 %
Scoring priority category 2 : High Repair/Repl. Cost (scoring weight=12)
Category 2 percentage : 30 %
Project construction estimate (MACC): \$55,000
Total project estimate (including soft costs): \$76,000
Additional points based on building condition: 1
Deficiency score : $4 \times ((15 \times 70\%) + (12 \times 30\%)) + 1 = 57.4$

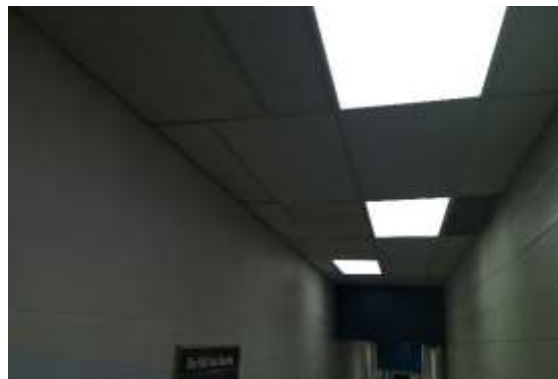
**Deficiency F03**

Recommended funding schedule : Fund in Next Biennium (scoring weight=2.5)
Estimated remaining life (years) : 5
Estimated average life expectancy (years) : 25
Scoring priority category 1 : System Use (scoring weight=15)
Category 1 percentage : 60 %
Scoring priority category 2 : High Operating Cost (scoring weight=10)
Category 2 percentage : 40 %
Project construction estimate (MACC): \$111,000
Total project estimate (including soft costs): \$154,000
Additional points based on building condition: 2
Deficiency score : $2.5 \times ((15 \times 60\%) + (10 \times 40\%)) + 2 = 34.5$

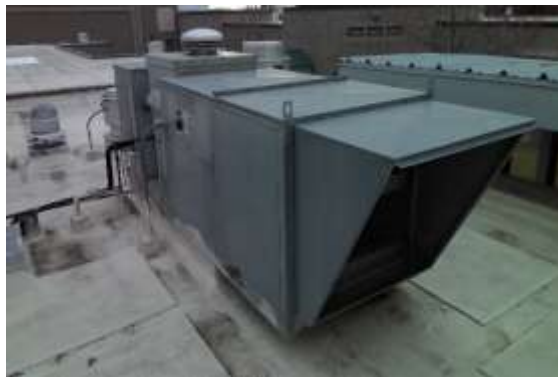
**Deficiency F04**

Estimated remaining life (years) : 5
Estimated average life expectancy (years) : 20
Scoring priority category 1 : System Use (scoring weight=15)
Category 1 percentage : 70 %
Scoring priority category 2 : High Repair/Repl. Cost (scoring weight=12)
Category 2 percentage : 30 %
Project construction estimate (MACC): \$51,000
Total project estimate (including soft costs): \$70,000
Additional points based on building condition: 1
Deficiency score : $2.5 \times ((15 \times 70\%) + (12 \times 30\%)) + 1 = 36.3$

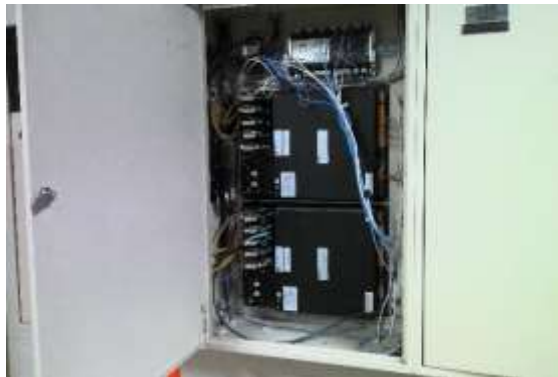
**Deficiency F05**

Recommended funding schedule : Fund in Next Biennium (scoring weight=2.5)
Estimated remaining life (years) : 7
Estimated average life expectancy (years) : 30
Scoring priority category 1 : High Operating Cost (scoring weight=10)
Category 1 percentage : 50 %
Scoring priority category 2 : High Repair/Repl. Cost (scoring weight=12)
Category 2 percentage : 50 %
Project construction estimate (MACC): \$444,000
Total project estimate (including soft costs): \$617,000
Additional points based on building condition: 0
Deficiency score : $2.5 \times ((10 \times 50\%) + (12 \times 50\%)) + 0 = 27.5$

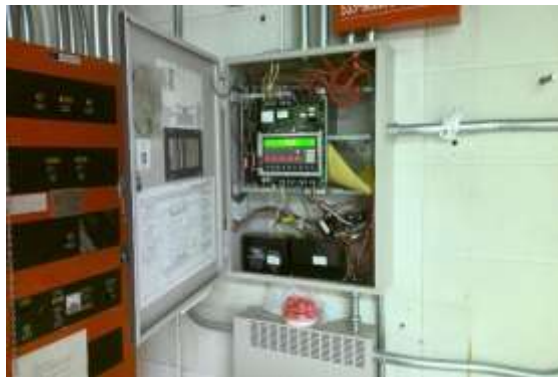
**Deficiency F06**

Estimated remaining life (years) : 3
Estimated average life expectancy (years) : 20
Scoring priority category 1 : System Use (scoring weight=15)
Category 1 percentage : 70 %
Scoring priority category 2 : Health/Safety (scoring weight=25)
Category 2 percentage : 30 %
Project construction estimate (MACC): \$57,000
Total project estimate (including soft costs): \$79,000
Additional points based on building condition: 0
Deficiency score : $4 \times ((15 \times 70\%) + (25 \times 30\%)) + 0 = 72$

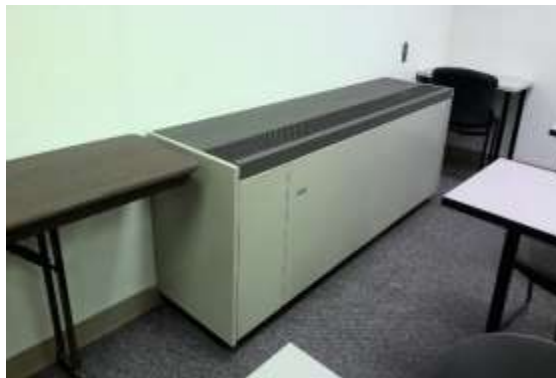
**Deficiency F07**

Category 2 percentage : 20 %
Project construction estimate (MACC): \$40,000
Total project estimate (including soft costs): \$55,000
Additional points based on building condition: 2
Deficiency score : $4 \times ((12 \times 80\%) + (15 \times 20\%)) + 2 = 52.4$

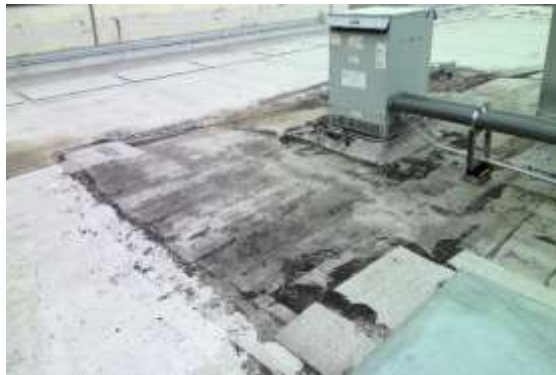
**Deficiency R01**

Scoring priority category 1 : System Use (scoring weight=15)
Category 1 percentage : 100 %
Scoring priority category 2 : Quality of Use (scoring weight=5)
Category 2 percentage : 0 %
Project construction estimate (MACC): \$158,000
Total project estimate (including soft costs): \$219,000
Additional points based on building condition: 2
Deficiency score : $4 \times (15 \times 100\%) + 2 = 62$

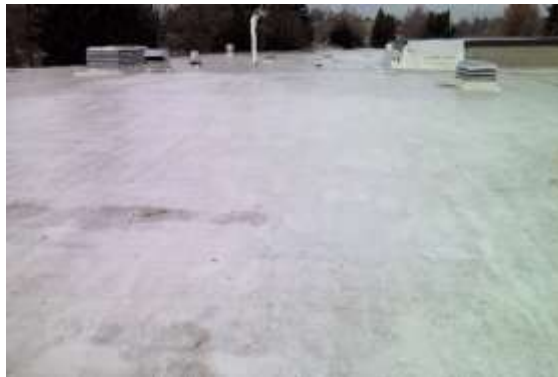
**Deficiency R02**

Scoring priority category 1 : System Use (scoring weight=15)
Category 1 percentage : 60 %
Scoring priority category 2 : High Repair/Repl. Cost (scoring weight=12)
Category 2 percentage : 40 %
Project construction estimate (MACC): \$249,000
Total project estimate (including soft costs): \$346,000
Additional points based on building condition: 1
Deficiency score : $4 \times ((15 \times 60\%) + (12 \times 40\%)) + 1 = 56.2$

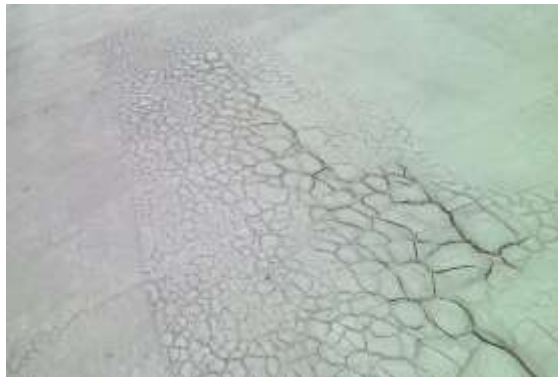
**Deficiency R03**

Scoring priority category 1 : High Repair/Repl. Cost (scoring weight=12)
Category 1 percentage : 60 %
Scoring priority category 2 : System Use (scoring weight=15)
Category 2 percentage : 40 %
Project construction estimate (MACC): \$320,000
Total project estimate (including soft costs): \$444,000
Additional points based on building condition: 1
Deficiency score : $2.5 \times ((12 \times 60\%) + (15 \times 40\%)) + 1 = 34$

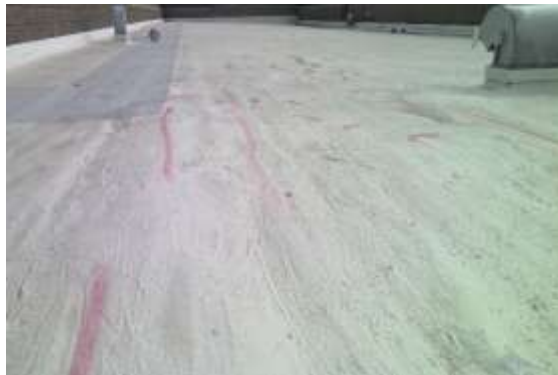
**Deficiency R04**

Scoring priority category 1 : High Repair/Repl. Cost (scoring weight=12)
Category 1 percentage : 60 %
Scoring priority category 2 : System Use (scoring weight=15)
Category 2 percentage : 40 %
Project construction estimate (MACC): \$196,000
Total project estimate (including soft costs): \$272,000
Additional points based on building condition: 5
Deficiency score : $4 \times ((12 \times 60\%) + (15 \times 40\%)) + 5 = 57.8$

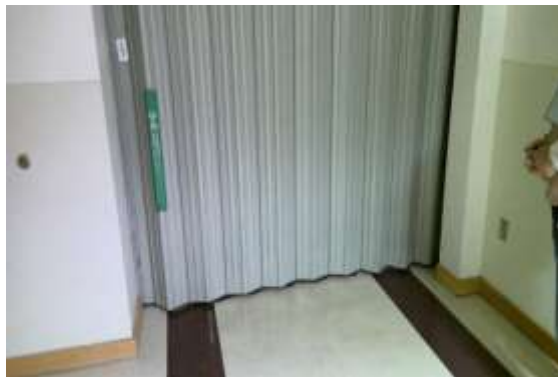
**Deficiency F08**

Estimated remaining life (years) : 3
Estimated average life expectancy (years) : 25
Scoring priority category 1 : System Use (scoring weight=15)
Category 1 percentage : 60 %
Scoring priority category 2 : Health/Safety (scoring weight=25)
Category 2 percentage : 40 %
Project construction estimate (MACC): \$105,000
Total project estimate (including soft costs): \$146,000
Additional points based on building condition: 2
Deficiency score : $4 \times ((15 \times 60\%) + (25 \times 40\%)) + 2 = 78$

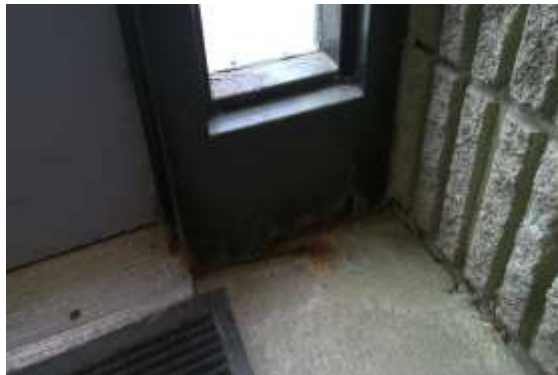
**Deficiency F09**

Estimated average life expectancy (years) : 30
Scoring priority category 1 : High Repair/Repl. Cost (scoring weight=12)
Category 1 percentage : 100 %
Scoring priority category 2 : None
Category 2 percentage : 0 %
Project construction estimate (MACC): \$30,000
Total project estimate (including soft costs): \$41,000
Additional points based on building condition: 2
Deficiency score : $4 \times (12 \times 100\%) + 2 = 50$

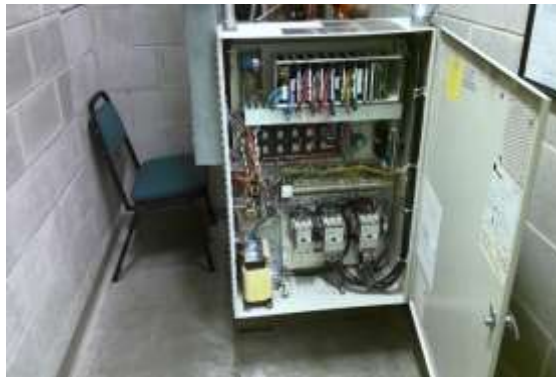
**Deficiency F10**

Recommended funding schedule : Fund in Next Biennium (scoring weight=2.5)
Estimated remaining life (years) : 5
Estimated average life expectancy (years) : 40
Scoring priority category 1 : System Use (scoring weight=15)
Category 1 percentage : 70 %
Scoring priority category 2 : Facility Use/ Civil Rights Violation (scoring weight=20)
Category 2 percentage : 30 %
Project construction estimate (MACC): \$150,000
Total project estimate (including soft costs): \$208,000
Additional points based on building condition: 1
Deficiency score : $2.5 \times ((15 \times 70\%) + (20 \times 30\%)) + 1 = 42.3$

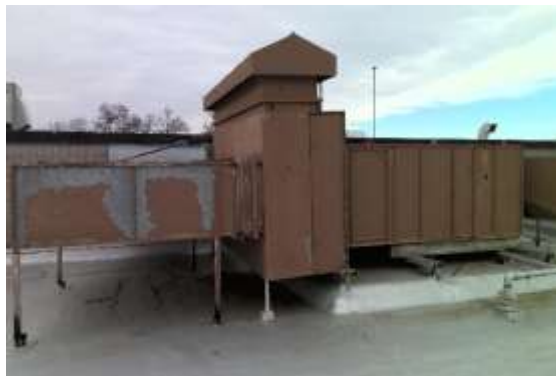
**Deficiency F11**

Category 2 percentage : 0 %
Project construction estimate (MACC): \$222,000
Total project estimate (including soft costs): \$308,000
Additional points based on building condition: 5
Deficiency score : $4 \times (15 \times 100\%) + 5 = 65$

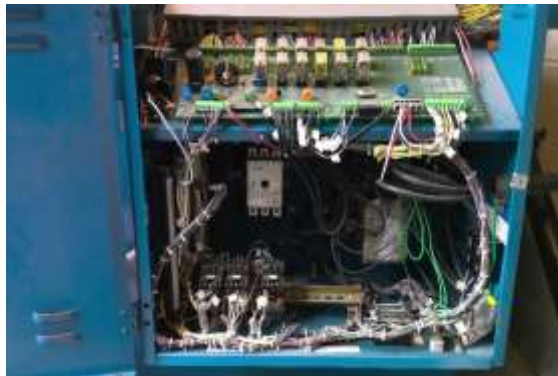
**Deficiency F12**

Recommended funding schedule : Deferred Backlog (scoring weight=1)
Estimated remaining life (years) : 5
Estimated average life expectancy (years) : 40
Scoring priority category 1 : High Repair/Repl. Cost (scoring weight=12)
Category 1 percentage : 70 %
Scoring priority category 2 : System Use (scoring weight=15)
Category 2 percentage : 30 %
Project construction estimate (MACC): \$150,000
Total project estimate (including soft costs): \$208,000
Additional points based on building condition: 5
Deficiency score : $1 \times ((12 \times 70\%) + (15 \times 30\%)) + 5 = 17.9$

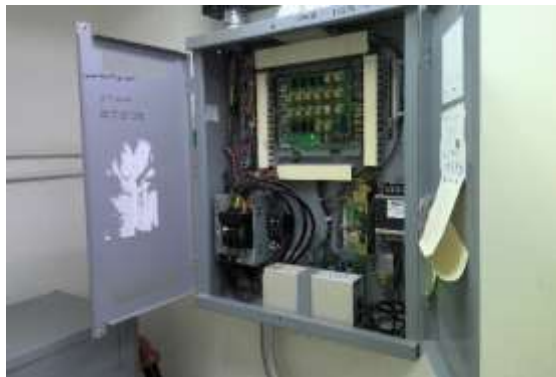
**Deficiency F13**

Estimated average life expectancy (years) : 40
Scoring priority category 1 : System Use (scoring weight=15)
Category 1 percentage : 70 %
Scoring priority category 2 : Facility Use/ Civil Rights Violation (scoring weight=20)
Category 2 percentage : 30 %
Project construction estimate (MACC): \$150,000
Total project estimate (including soft costs): \$208,000
Additional points based on building condition: 1
Deficiency score : $4 \times ((15 \times 70\%) + (20 \times 30\%)) + 1 = 67$
