2023 FACILITY CONDITION SURVEY

Spokane Falls Community
College

SURVEY CONDUCTED BY:
Steve Lewandowski
State Board for Community
and Technical Colleges

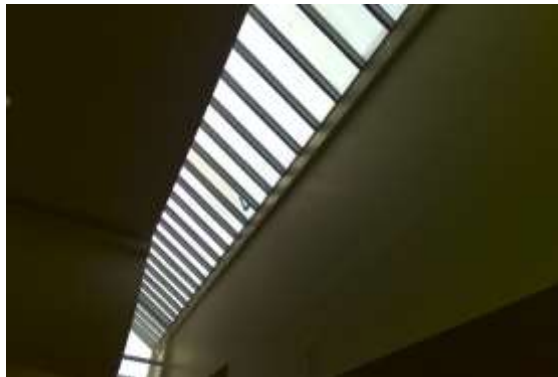
The skylight is leaking. The glazing seals have failed causing moisture to enter between panels. The failed glazing should be replaced.

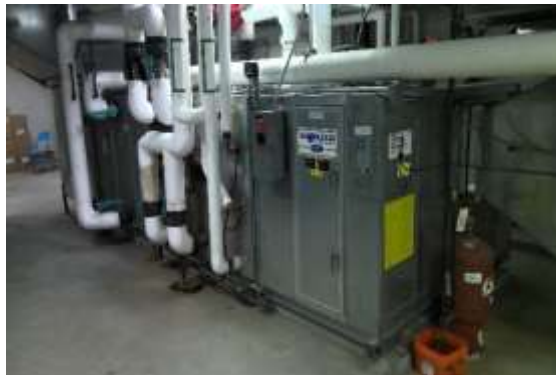
Deficiency F02

The penthouse make-up air handler unit has required recent repairs, but still functions as designed. The unit is nearing the end of its useful life. The units should be monitored for future replacement.

Scoring priority category 1 : System Use (scoring weight=15)
Category 1 percentage : 80 %
Scoring priority category 2 : High Repair/Repl. Cost (scoring weight=12)
Category 2 percentage : 20 %
Project construction estimate (MACC): \$299,000
Total project estimate (including soft costs): \$420,000
Additional points based on building condition: 1
Deficiency score : $1 \times ((15 \times 80\%) + (12 \times 20\%)) + 1 = 15.4$

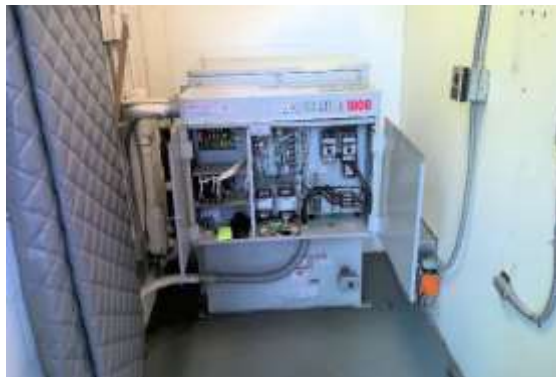
Deficiency F03

The college is concerned about the age and ability to maintain the function of elevator Car 1. The elevator had normal function during the survey and prior records indicated typical repair frequency. The elevator repair and maintenance contractor indicated that parts are difficult to obtain and maintenance has become more difficult. The college staff indicated that the building no longer had any instructional use and was periodically only used for administrative meetings. The meetings only occur in the upper level and the elevator would not be required for any building use. The elevator should continue to be monitored for future need and repair.

Recommended funding schedule : Fund in Next Biennium (scoring weight=2.5)
Estimated remaining life (years) : (No Data)
Scoring priority category 1 : System Use (scoring weight=15)
Category 1 percentage : 90 %
Scoring priority category 2 : Facility Use/ Civil Rights Violation (scoring weight=20)
Category 2 percentage : 10 %
Project construction estimate (MACC): \$220,000
Total project estimate (including soft costs): \$309,000
Additional points based on building condition: 2
Deficiency score : $2.5 \times ((15 \times 90\%) + (20 \times 10\%)) + 2 = 40.8$

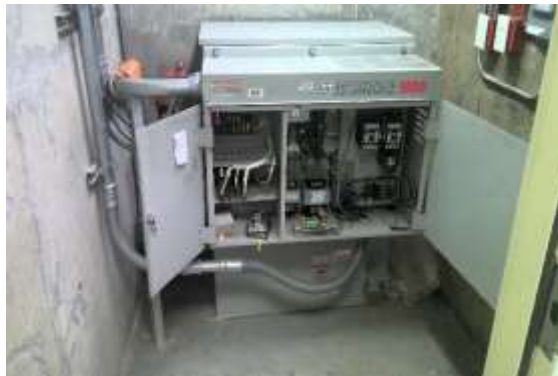
Deficiency F04

The elevator still functions as designed, however, the controls supporting the elevator are no longer well supported by the elevator repair and maintenance contractor. Parts may be difficult to obtain, which may slow down repairs. The controls should be upgraded in the future to ensure reliable operation of the elevator, however, based on the age of components, the elevator should still function appropriate for several years. The elevator should continue to be monitored for repairs.

Recommended funding schedule : Fund in Next Biennium (scoring weight=2.5)
Estimated remaining life (years) : 7
Estimated average life expectancy (years) : 30
Scoring priority category 1 : High Repair/Repl. Cost (scoring weight=12)
Category 1 percentage : 80 %
Scoring priority category 2 : Facility Use/ Civil Rights Violation (scoring weight=20)
Category 2 percentage : 20 %
Project construction estimate (MACC): \$150,000
Total project estimate (including soft costs): \$210,000
Additional points based on building condition: 0
Deficiency score : $2.5 \times ((12 \times 80\%) + (20 \times 20\%)) + 0 = 34$

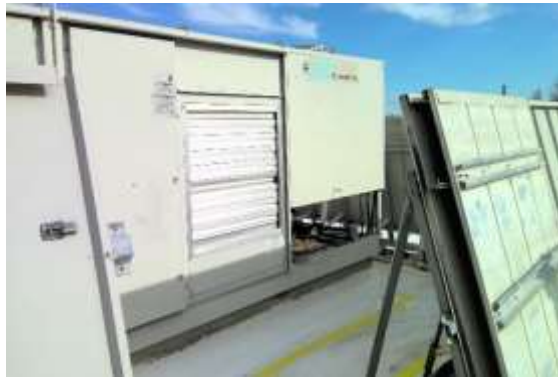
Deficiency F05

The three (3) multi-zone units on the roof continue to require repairs to sustain operation. New parts are difficult to procure due to age and lack of support for units. Heat exchangers have been repaired but efforts not 100% effective as it is difficult to access and requires specialized service. Replacement of the heat exchanger is costly as it is integral to the entire unit. The units have a design flaw, typical of this model, that makes them susceptible to failure. All units should be replaced. (Estimate based on study produced by ESCO contractor). The unit in the worst condition should be replaced. The other two units should continue to be monitored for repair or replacement.

Recommended funding schedule : Immediate (scoring weight=4)
Estimated remaining life (years) : 3
Estimated average life expectancy (years) : 20
Scoring priority category 1 : System Use (scoring weight=15)
Category 1 percentage : 100 %
Scoring priority category 2 : None
Category 2 percentage : 0 %
Project construction estimate (MACC): \$400,000
Total project estimate (including soft costs): \$562,000
Additional points based on building condition: 2
Deficiency score : $4 \times (15 \times 100\%) + 2 = 62$

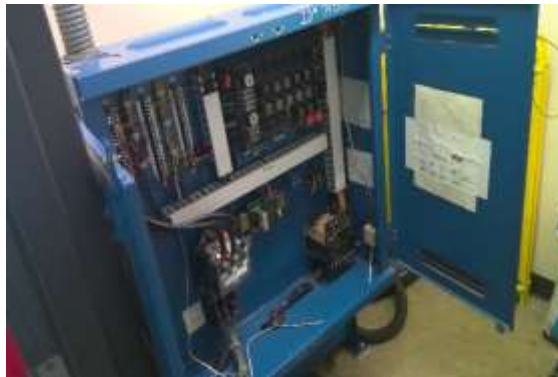
Deficiency F06

The elevator still functions as designed, however, the controls supporting elevator 1 are no longer supported by the elevator repair and maintenance contractor. Any control component failure may cause significant delays in use, which would violate Civil Rights laws (accessibility). The restricted level of repair support was verified by the vendor. The controls should be upgraded to ensure reliable operation of the elevator.

Recommended funding schedule : Immediate (scoring weight=4)
Estimated remaining life (years) : 5
Estimated average life expectancy (years) : 40
Scoring priority category 1 : System Use (scoring weight=15)
Category 1 percentage : 70 %
Scoring priority category 2 : Facility Use/ Civil Rights Violation (scoring weight=20)
Category 2 percentage : 30 %
Project construction estimate (MACC): \$150,000
Total project estimate (including soft costs): \$210,000
Additional points based on building condition: 1
Deficiency score : $4 \times ((15 \times 70\%) + (20 \times 30\%)) + 1 = 67$

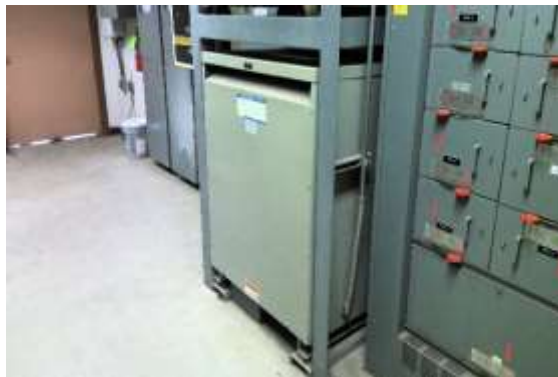
Deficiency F07

The college believes that the building transformer T1 is beyond its expected life. The unit still functioned as designed and most similar transformers in the system have experienced a much longer life. The unit should continue to be monitored for replacement in the future.

Estimated remaining life (years) : 5
Estimated average life expectancy (years) : 30
Scoring priority category 1 : High Repair/Repl. Cost (scoring weight=12)
Category 1 percentage : 100 %
Scoring priority category 2 : None
Category 2 percentage : 0 %
Project construction estimate (MACC): \$25,000
Total project estimate (including soft costs): \$35,000
Additional points based on building condition: 1
Deficiency score : $2.5 \times (12 \times 100\%) + 1 = 31$

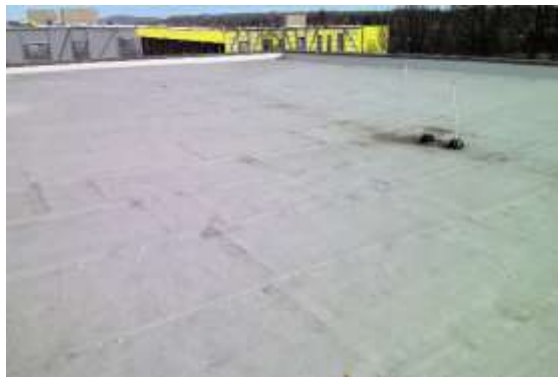
Deficiency R01

The renewal coating on the main upper section of built-up roof is starting to bubble in some areas. The coating still adequately protects the roofing and may still be under warranty. This upper roof should continue to be monitored and repaired or replaced in the future.

Estimated remaining life (years) : 5
Estimated average life expectancy (years) : 20
Scoring priority category 1 : High Repair/Repl. Cost (scoring weight=12)
Category 1 percentage : 70 %
Scoring priority category 2 : System Use (scoring weight=15)
Category 2 percentage : 30 %
Project construction estimate (MACC): \$782,000
Total project estimate (including soft costs): \$1,099,000
Additional points based on building condition: 1
Deficiency score : $2.5 \times ((12 \times 70\%) + (15 \times 30\%)) + 1 = 33.3$

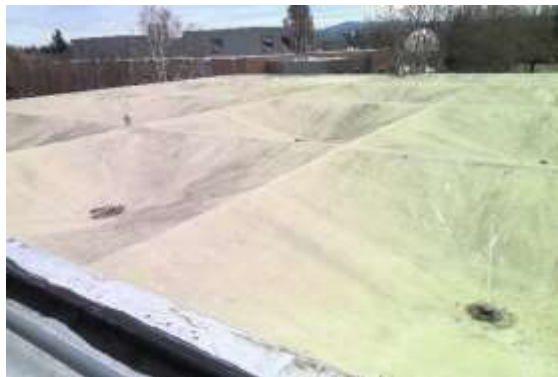
Deficiency R02

The college is concerned about the age of the roof. There are visual signs of degradation and recent repairs, however, the roof did not have active leaks. The roofing should continue to be monitored for repairs and future re-conditioning.

Estimated average life expectancy (years) : 25
Scoring priority category 1 : High Repair/Repl. Cost (scoring weight=12)
Category 1 percentage : 70 %
Scoring priority category 2 : System Use (scoring weight=15)
Category 2 percentage : 30 %
Project construction estimate (MACC): \$211,000
Total project estimate (including soft costs): \$296,000
Additional points based on building condition: 1
Deficiency score : $2.5 \times ((12 \times 70\%) + (15 \times 30\%)) + 1 = 33.3$

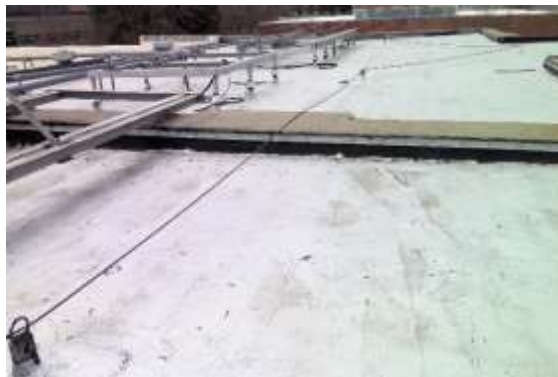
Deficiency R03

The roofing exhibits signs of blistering and degradation. There are also sections of failed cap flashing and areas of wet insulation, based on a prior roof inspection. The roofing should be re-conditioned to extend its useful life.

Scoring priority category 1 : System Use (scoring weight=15)
Category 1 percentage : 70 %
Scoring priority category 2 : High Repair/Repl. Cost (scoring weight=12)
Category 2 percentage : 30 %
Project construction estimate (MACC): \$254,000
Total project estimate (including soft costs): \$357,000
Additional points based on building condition: 1
Deficiency score : $4 \times ((15 \times 70\%) + (12 \times 30\%)) + 1 = 57.4$

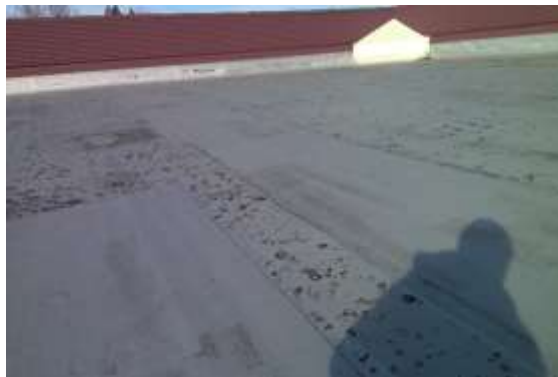
Deficiency R04

The built-up roofing and reflective coating has deteriorated. The roof has not experienced leaks and prior scans did not indicate that the roof insulation has become saturated. The roof should continue to be monitored for repairs to extend its useful life.

Estimated average life expectancy (years) : 25
Scoring priority category 1 : System Use (scoring weight=15)
Category 1 percentage : 100 %
Scoring priority category 2 : None
Category 2 percentage : 0 %
Project construction estimate (MACC): \$164,000
Total project estimate (including soft costs): \$230,000
Additional points based on building condition: 0
Deficiency score : $2.5 \times (15 \times 100\%) + 0 = 37.5$

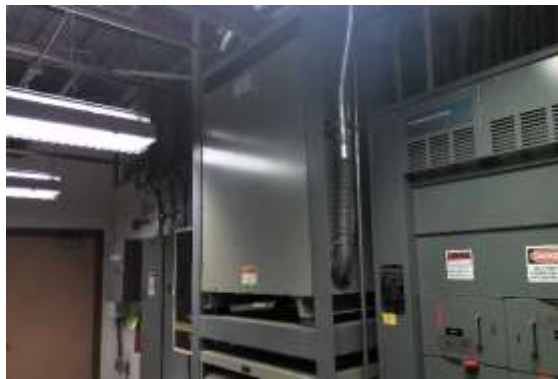
Deficiency F08

.The college believes that the building transformer T2 is beyond its expected life. The unit still functioned as designed and most similar transformers in the system have experienced a much longer life. The unit should continue to be monitored for replacement in the future.

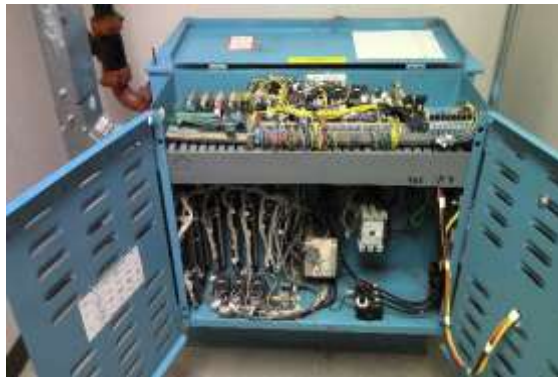
Deficiency F09

The college is concerned about the age of the elevator control equipment. Typically, most elevator controls use can be extended up to 45 years through regular maintenance and repairs, even when parts become more difficult to obtain. These controls are 29 years old and should continue to be repaired and monitored for future replacement.

Recommended funding schedule : Deferred Backlog (scoring weight=1)
Estimated remaining life (years) : 5
Estimated average life expectancy (years) : 40
Scoring priority category 1 : System Use (scoring weight=15)
Category 1 percentage : 80 %
Scoring priority category 2 : Facility Use/ Civil Rights Violation (scoring weight=20)
Category 2 percentage : 20 %
Project construction estimate (MACC): \$150,000
Total project estimate (including soft costs): \$210,000
Additional points based on building condition: 1
Deficiency score : $1 \times ((15 \times 80\%) + (20 \times 20\%)) + 1 = 17$

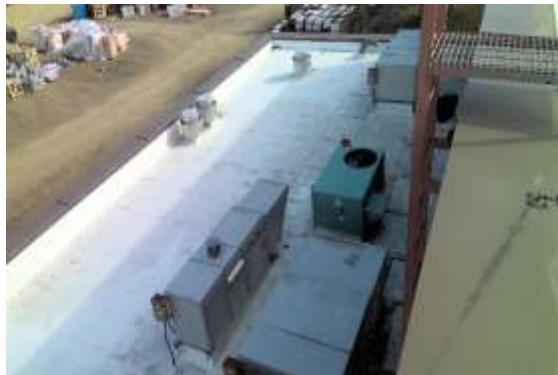
Deficiency F10

Category 1 percentage : 50 %
Scoring priority category 2 : High Repair/Repl. Cost (scoring weight=12)
Category 2 percentage : 50 %
Project construction estimate (MACC): \$222,000
Total project estimate (including soft costs): \$312,000
Additional points based on building condition: 1
Deficiency score : $4 \times ((15 \times 50\%) + (12 \times 50\%)) + 1 = 55$

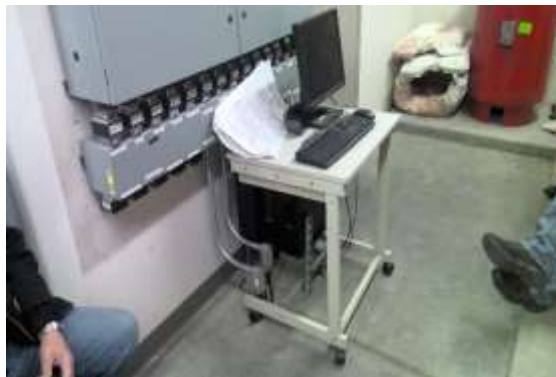
Deficiency F11

Estimated remaining life (years) : 5
Estimated average life expectancy (years) : 15
Scoring priority category 1 : System Use (scoring weight=15)
Category 1 percentage : 80 %
Scoring priority category 2 : Facility Use/ Civil Rights Violation (scoring weight=20)
Category 2 percentage : 20 %
Project construction estimate (MACC): \$150,000
Total project estimate (including soft costs): \$210,000
Additional points based on building condition: 0
Deficiency score : $2.5 \times ((15 \times 80\%) + (20 \times 20\%)) + 0 = 40$

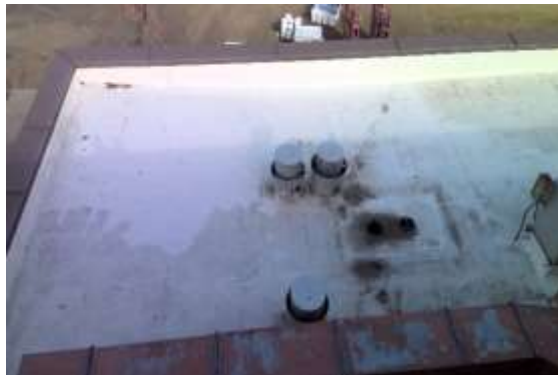
Deficiency R05

Scoring priority category 1 : System Use (scoring weight=15)
Category 1 percentage : 70 %
Scoring priority category 2 : High Repair/Repl. Cost (scoring weight=12)
Category 2 percentage : 30 %
Project construction estimate (MACC): \$520,000
Total project estimate (including soft costs): \$731,000
Additional points based on building condition: 1
Deficiency score : $2.5 \times ((15 \times 70\%) + (12 \times 30\%)) + 1 = 36.3$

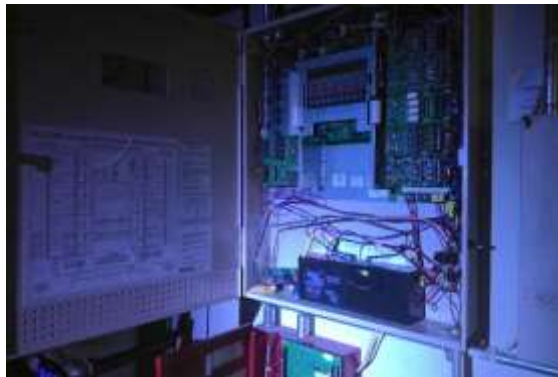
Deficiency F12

Recommended funding schedule : Immediate (scoring weight=4)
Estimated remaining life (years) : 3
Estimated average life expectancy (years) : 20
Scoring priority category 1 : Health/Safety (scoring weight=25)
Category 1 percentage : 100 %
Scoring priority category 2 : None
Category 2 percentage : 0 %
Project construction estimate (MACC): \$57,000
Total project estimate (including soft costs): \$80,000
Additional points based on building condition: 0
Deficiency score : $4 \times (25 \times 100\%) + 0 = 100$

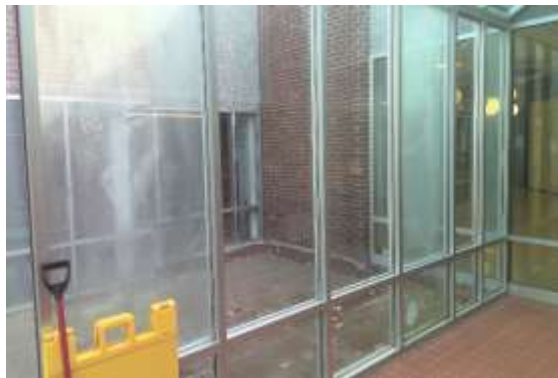
Deficiency F13

Category 2 percentage : 20 %
Project construction estimate (MACC): \$22,000
Total project estimate (including soft costs): \$30,000
Additional points based on building condition: 2
Deficiency score : $4 \times ((15 \times 80\%) + (12 \times 20\%)) + 2 = 59.6$

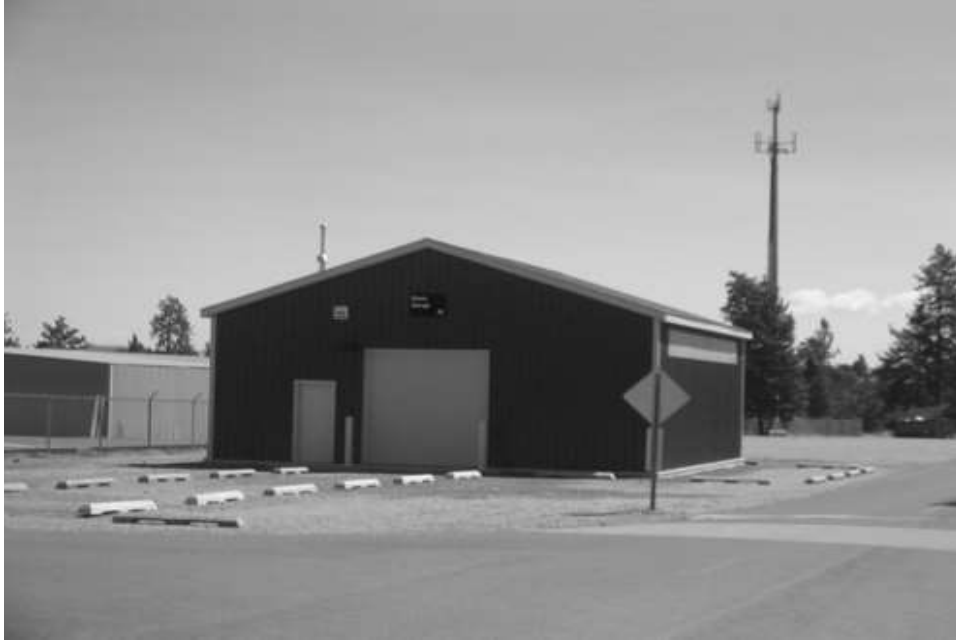
Drama Storage Building (172-26) STATE UFI: A01135 Main Campus (172A)
AREA: 1,440 SF BUILT: 2005 REMODELED: No PREDOMINANT USE: Storage
CONSTRUCTION TYPE: Light CRV/SF: \$198 REPLACEMENT VALUE: \$285,120

Primary Systems			
COMPONENT:	Structure	RATING: 1 x WEIGHT: 8.8 = SCORE: 8.8	
No signs of settlement or cracking, no abrupt vertical changes Columns, bearing walls and roof structure appears sound/free of defects			
COMMENTS:	Metal framing; concrete slab		
COMPONENT:	Exterior Closure	RATING: 1 x WEIGHT: 8.8 = SCORE: 8.8	
Weatherproof, tight, well-maintained exterior walls, doors, windows/finishes			
COMMENTS:	Metal wall panels		
COMPONENT:	Roofing	RATING: 1 x WEIGHT: 11.1 = SCORE: 11.1	
Flashing and penetrations appear sound and membrane appears water- tight; drainage is positive and there are overflow scuppers			
COMMENTS:	Standing seam metal roof

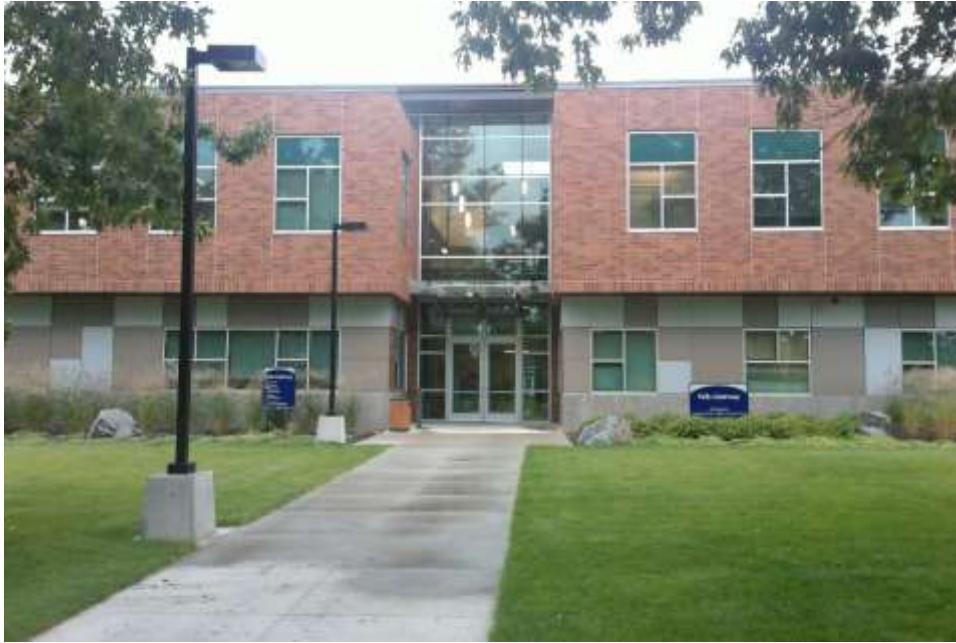
Falls Gateway (172-30) STATE UFI: A12985 Main Campus (172A)
AREA: 47,497 SF BUILT: 2013 REMODELED: No PREDOMINANT USE: Classroom
CONSTRUCTION TYPE: No data CRV/SF: \$356 REPLACEMENT VALUE: \$16,908,932

Primary Systems			
COMPONENT:	Structure	RATING: 2 x WEIGHT: 8 =	SCORE: 16
Minor cracks evident in a small portion of the structure			
COMMENTS:	No data		
COMPONENT:	Exterior Closure	RATING: 1 x WEIGHT: 8 =	SCORE: 8
Weatherproof, tight, well-maintained exterior walls, doors, windows/finishes			
COMMENTS:	No data		
COMPONENT:	Roofing	RATING: 1 x WEIGHT: 10 =	SCORE: 10
Flashing and penetrations appear sound and membrane appears water- tight; drainage is positive and there are overflow scuppers			
COMMENTS:	No data

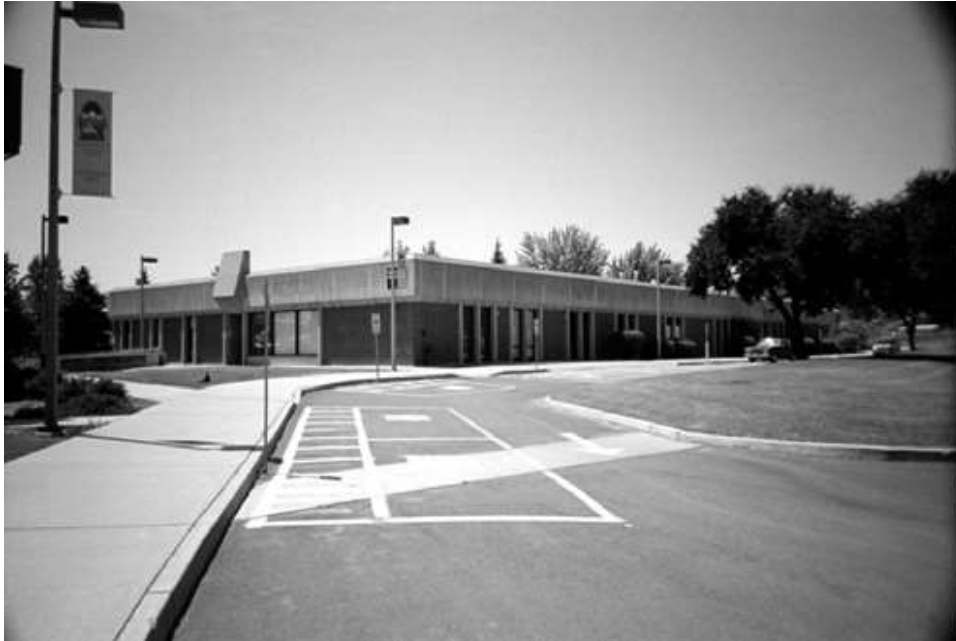
Human Services (172-16) STATE UFI: A08600 Main Campus (172A)
AREA: 34,270 SF BUILT: 1975 REMODELED: 2016 PREDOMINANT USE: Vocational Arts
CONSTRUCTION TYPE: Medium CRV/SF: \$395 REPLACEMENT VALUE: \$13,536,650

Primary Systems			
COMPONENT:	Structure	RATING: 1 x WEIGHT: 8.3 = SCORE: 8.3	
No signs of settlement or cracking, no abrupt vertical changes Columns, bearing walls and roof structure appears sound/free of defects			
COMMENTS:	Brick and concrete; steel		
COMPONENT:	Exterior Closure	RATING: 1 x WEIGHT: 8.3 = SCORE: 8.3	
Weatherproof, tight, well-maintained exterior walls, doors, windows/finishes			
COMMENTS:	Brick facing; concrete columns; plaster fascia		
COMPONENT:	Roofing	RATING: 3 x WEIGHT: 10.4 = SCORE: 31.3	
Some deterioration is evident in membrane and flashings; maintenance or minor repair is needed			
COMMENTS:	BUR; Parapet needs new caulking or metal cap; new UV coating in 2002

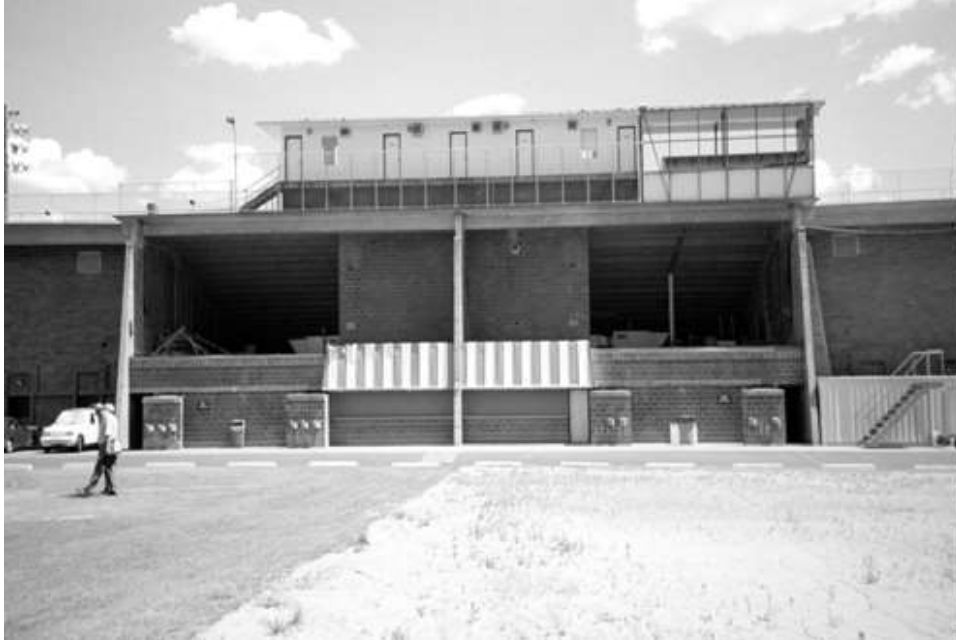
P.E. Annex (172-13) STATE UFI: A01742 Main Campus (172A)
AREA: 18,687 SF BUILT: 1970 REMODELED: 2013 PREDOMINANT USE: PE Programs
CONSTRUCTION TYPE: Medium CRV/SF: \$349 REPLACEMENT VALUE: \$6,521,763

Primary Systems			
COMPONENT:	Structure	RATING: 3 x WEIGHT: 8.7 = SCORE: 26.1	
Some cracking evident but does not likely affect structural integrity; Visible defects apparent but are non-structural			
COMMENTS:	CMU/Concrete; random cracking throughout		
COMPONENT:	Exterior Closure	RATING: 3 x WEIGHT: 8.7 = SCORE: 26.1	
Sound and weatherproof but with some physical deterioration evident			
COMMENTS:	CMU walls		
COMPONENT:	Roofing	RATING: 5 x WEIGHT: 10.9 = SCORE: 54.5	
Leaking and deterioration is to point where new roof is required			
COMMENTS:	Concrete bleachers form roof of structure; extensive joint leaks and cracking

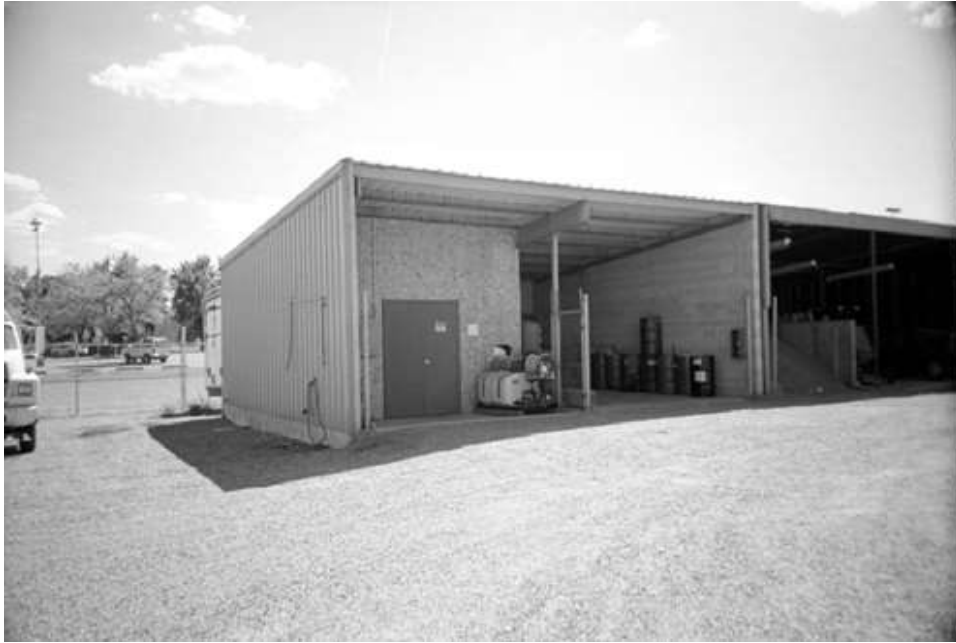
Pesticide Storage Shed (172-23) STATE UFI: A06123 Main Campus (172A)
 AREA: 400 SF BUILT: 2000 REMODELED: No PREDOMINANT USE: Storage
 CONSTRUCTION TYPE: Light CRV/SF: \$198 REPLACEMENT VALUE: \$79,200

Primary Systems			
COMPONENT:	Structure	RATING: 1 x WEIGHT: 8.7 =	SCORE: 8.7
No signs of settlement or cracking, no abrupt vertical changes Columns, bearing walls and roof structure appears sound/free of defects			
COMMENTS:	Metal frame		
COMPONENT:	Exterior Closure	RATING: 3 x WEIGHT: 8.7 =	SCORE: 26.1
Sound and weatherproof but with some physical deterioration evident			
COMMENTS:	Unfinished strand board		
COMPONENT:	Roofing	RATING: 1 x WEIGHT: 10.9 =	SCORE: 10.9
Flashing and penetrations appear sound and membrane appears water- tight; drainage is positive and there are overflow scuppers			
COMMENTS:	Metal roof

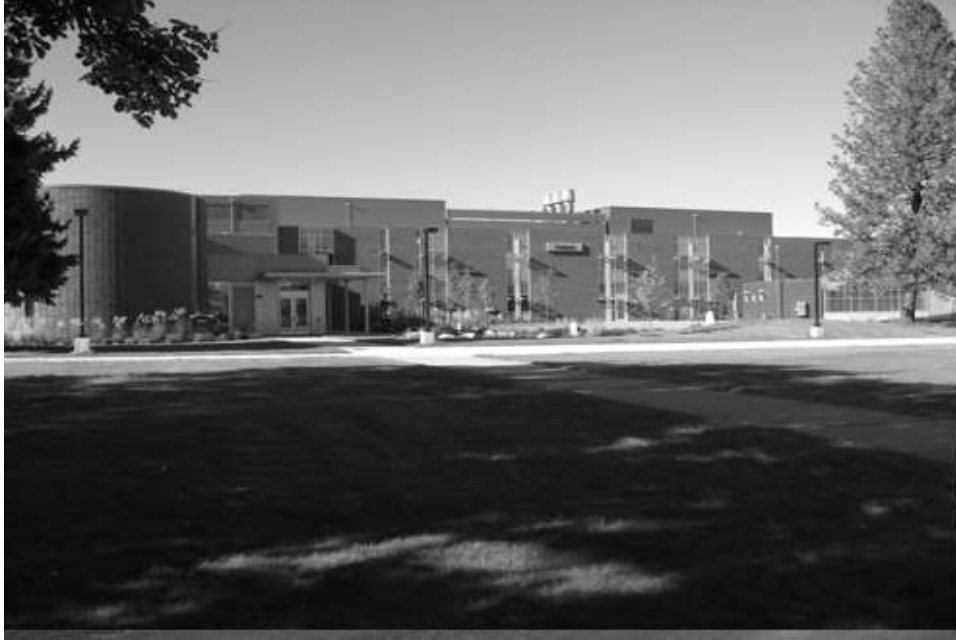
Science (172-28) STATE UFI: A10555 Main Campus (172A)
AREA: 70,823 SF BUILT: 2011 REMODELED: No PREDOMINANT USE: Science Lab.
CONSTRUCTION TYPE: Heavy CRV/SF: \$494 REPLACEMENT VALUE: \$34,986,562

Primary Systems			
COMPONENT:	Structure	RATING: 1 x WEIGHT: 8 =	SCORE: 8
No signs of settlement or cracking, no abrupt vertical changes Columns, bearing walls and roof structure appears sound/free of defects			
COMMENTS:	Structural steel; concrete; polished concrete block		
COMPONENT:	Exterior Closure	RATING: 1 x WEIGHT: 8 =	SCORE: 8
Weatherproof, tight, well-maintained exterior walls, doors, windows/finishes			
COMMENTS:	Brick; polished concrete block; metal architectural panels		
COMPONENT:	Roofing	RATING: 1 x WEIGHT: 10 =	SCORE: 10
Flashing and penetrations appear sound and membrane appears water- tight; drainage is positive and there are overflow scuppers			
COMMENTS:	Single-ply TPO membrane

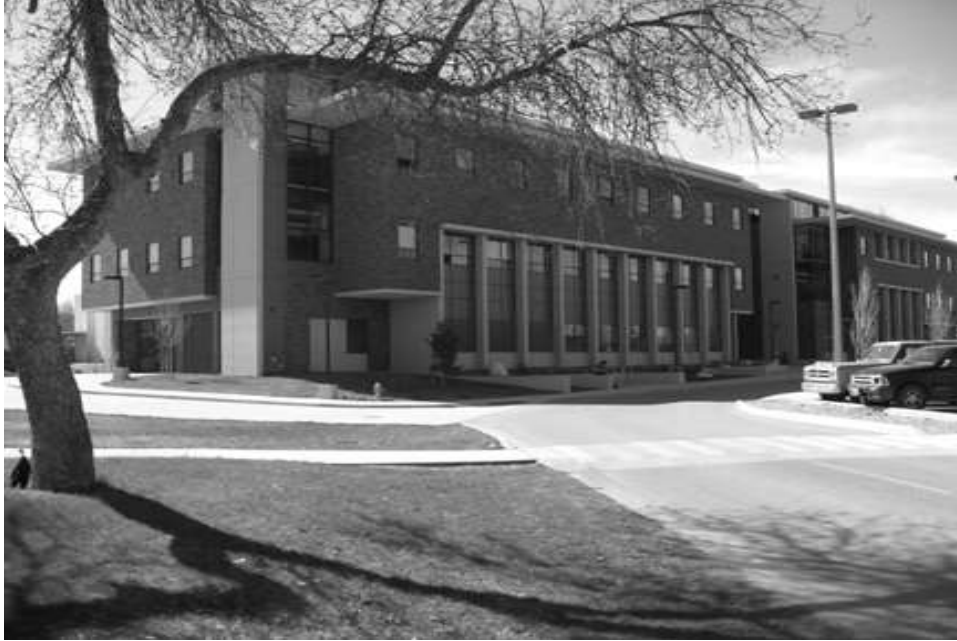
Sn-W'Ey'-Mn (172-24) STATE UFI: A06297 Main Campus (172A)
AREA: 70,533 SF BUILT: 2007 REMODELED: No PREDOMINANT USE: General Classroom
CONSTRUCTION TYPE: Heavy CRV/SF: \$376 REPLACEMENT VALUE: \$26,520,408

Primary Systems			
COMPONENT:	Structure	RATING: 1 x WEIGHT: 8 =	SCORE: 8
No signs of settlement or cracking, no abrupt vertical changes Columns, bearing walls and roof structure appears sound/free of defects			
COMMENTS:	Structural steel; cast concrete		
COMPONENT:	Exterior Closure	RATING: 1 x WEIGHT: 8 =	SCORE: 8
Weatherproof, tight, well-maintained exterior walls, doors, windows/finishes			
COMMENTS:	Corrugated metal panels; cast concrete; brick		
COMPONENT:	Roofing	RATING: 1 x WEIGHT: 10 =	SCORE: 10
Flashing and penetrations appear sound and membrane appears water- tight; drainage is positive and there are overflow scuppers			
COMMENTS:	Single-ply TPO membrane

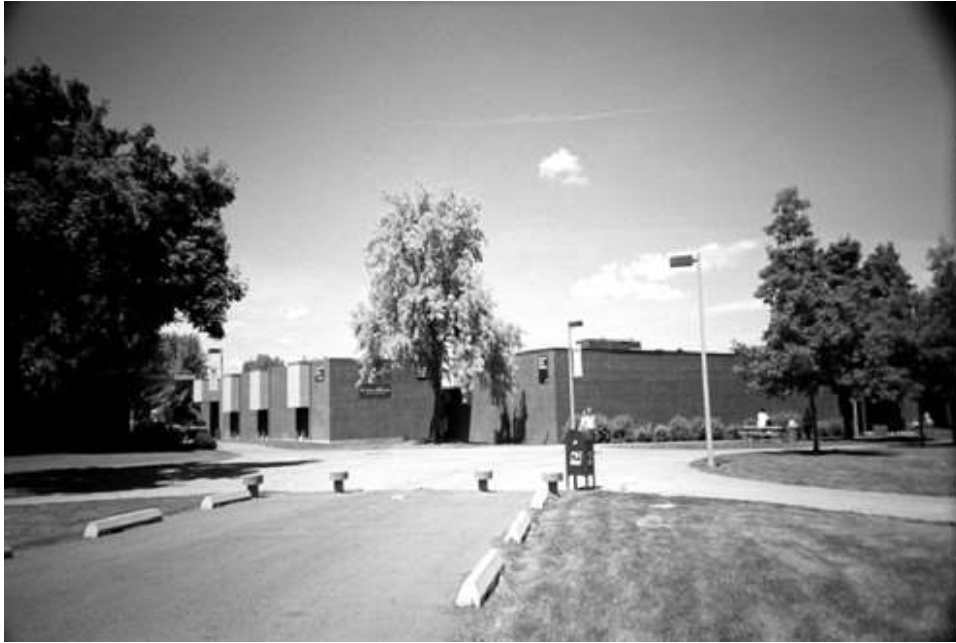
Student Union Building (172-17) STATE UFI: A02310 Main Campus (172A)
AREA: 78,295 SF BUILT: 1976 REMODELED: 2016 PREDOMINANT USE: Student Center
CONSTRUCTION TYPE: Heavy CRV/SF: \$391 REPLACEMENT VALUE: \$30,613,345

Primary Systems			
COMPONENT:	Structure	RATING: 1 x WEIGHT: 8 =	SCORE: 8
No signs of settlement or cracking, no abrupt vertical changes Columns, bearing walls and roof structure appears sound/free of defects			
COMMENTS:	Brick and concrete		
COMPONENT:	Exterior Closure	RATING: 1 x WEIGHT: 8 =	SCORE: 8
Weatherproof, tight, well-maintained exterior walls, doors, windows/finishes			
COMMENTS:	Brick exterior		
COMPONENT:	Roofing	RATING: 2 x WEIGHT: 10 =	SCORE: 20
Majority of roofing and flashing appear sound, but a small portion of roofing shows deterioration where maintenance or minor repair needed			
COMMENTS:	BUR; newer roof on main building area; new UV coat on remainder

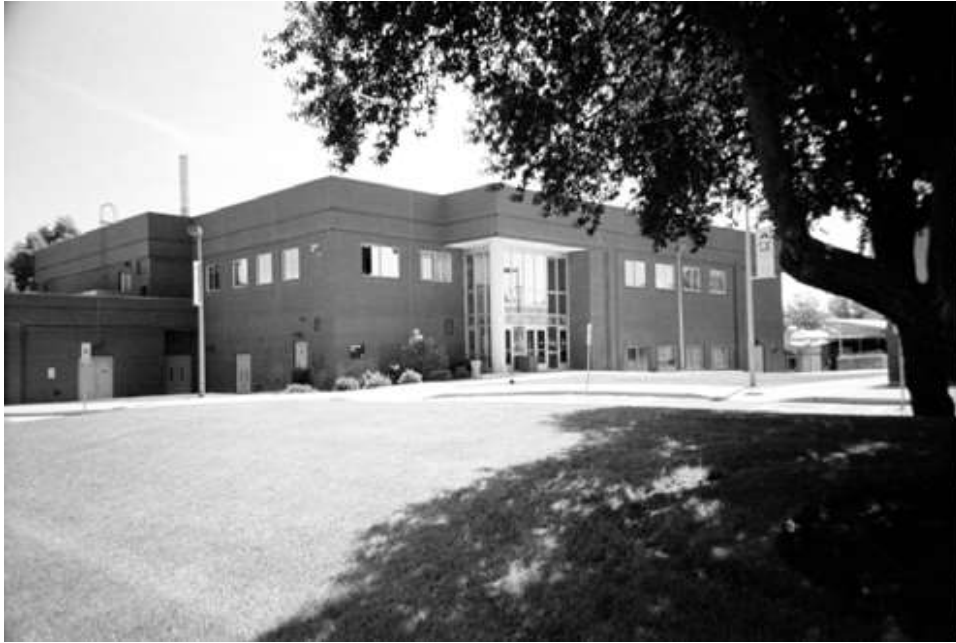
Technical Arts (172-19) STATE UFI: A03711 Main Campus (172A)
AREA: 41,457 SF BUILT: 1994 REMODELED: No PREDOMINANT USE: Vocational Arts
CONSTRUCTION TYPE: Heavy CRV/SF: \$395 REPLACEMENT VALUE: \$16,375,515

Primary Systems			
COMPONENT:	Structure	RATING: 1 x WEIGHT: 8.4 =	SCORE: 8.4
No signs of settlement or cracking, no abrupt vertical changes Columns, bearing walls and roof structure appears sound/free of defects			
COMMENTS:	Concrete and steel		
COMPONENT:	Exterior Closure	RATING: 1 x WEIGHT: 8.4 =	SCORE: 8.4
Weatherproof, tight, well-maintained exterior walls, doors, windows/finishes			
COMMENTS:	Brick exterior		
COMPONENT:	Roofing	RATING: 2 x WEIGHT: 10.5 =	SCORE: 21
Majority of roofing and flashing appear sound, but a small portion of roofing shows deterioration where maintenance or minor repair needed			
COMMENTS:	BUR in good condition; new UV coat applied in 2012

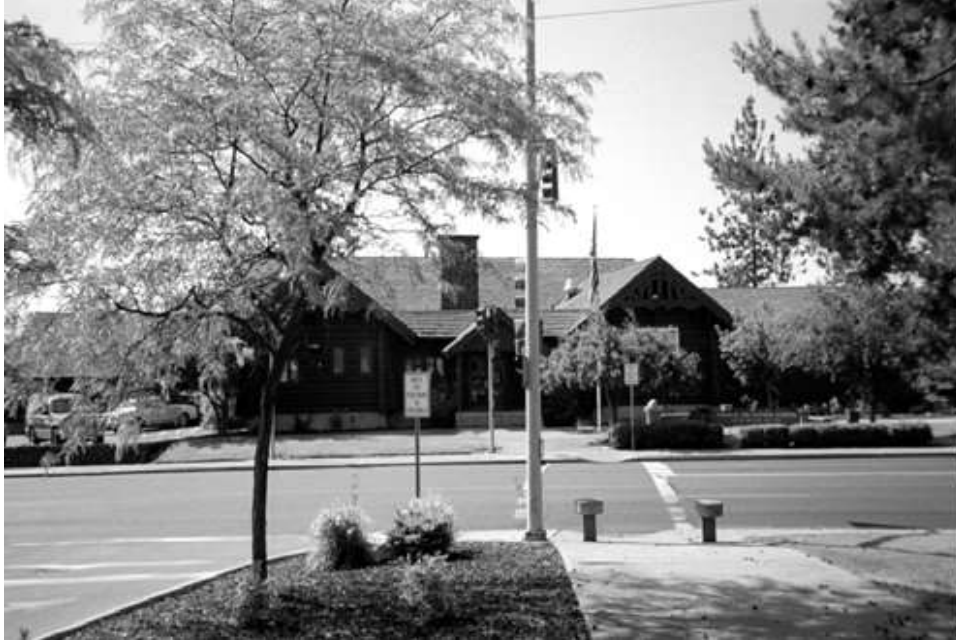
Lodge (172-9) STATE UFI: A01909 Main Campus (172A)
AREA: 19,080 SF BUILT: 1943 REMODELED: 2005 PREDOMINANT USE: General Classroom
CONSTRUCTION TYPE: Light CRV/SF: \$376 REPLACEMENT VALUE: \$7,174,080

Primary Systems			
COMPONENT:	Structure	RATING: 1 x WEIGHT: 8 =	SCORE: 8
No signs of settlement or cracking, no abrupt vertical changes Columns, bearing walls and roof structure appears sound/free of defects			
COMMENTS:	Wood frame; concrete; logs		
COMPONENT:	Exterior Closure	RATING: 1 x WEIGHT: 8 =	SCORE: 8
Weatherproof, tight, well-maintained exterior walls, doors, windows/finishes			
COMMENTS:	Log walls; concrete; wood siding		
COMPONENT:	Roofing	RATING: 1 x WEIGHT: 10 =	SCORE: 10
Flashing and penetrations appear sound and membrane appears water- tight; drainage is positive and there are overflow scuppers			
COMMENTS:	New roof installed in 2006 - vinyl/cement shakes

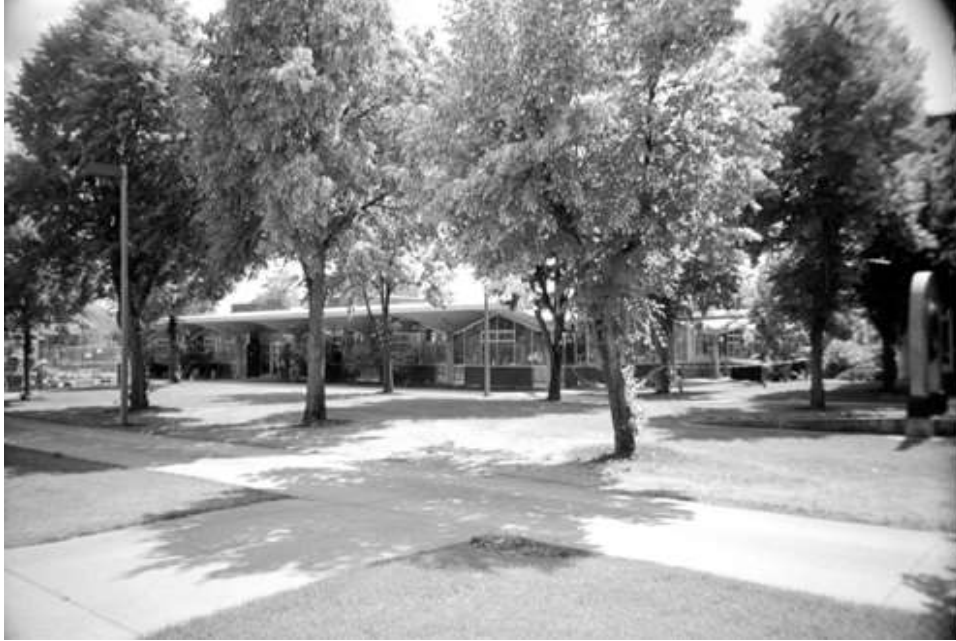
Primary Systems			
COMPONENT:	Structure	RATING: 3 x WEIGHT: 8.3 =	SCORE: 25
Some cracking evident but does not likely affect structural integrity; Visible defects apparent but are non-structural			
COMMENTS:	Concrete column; concrete; steel; brick; some structural concerns		
COMPONENT:	Exterior Closure	RATING: 3 x WEIGHT: 8.3 =	SCORE: 25
Sound and weatherproof but with some physical deterioration evident			
COMMENTS:	Brick and CMU; window walls; stucco/plaster; energy inefficient closure		
COMPONENT:	Roofing	RATING: 3 x WEIGHT: 10.4 =	SCORE: 31.3
Some deterioration is evident in membrane and flashings; maintenance or minor repair is needed			
COMMENTS:	Foam roof; repaired/replaced in 2004, but high maintenance; standing seam metal; recoat 2016

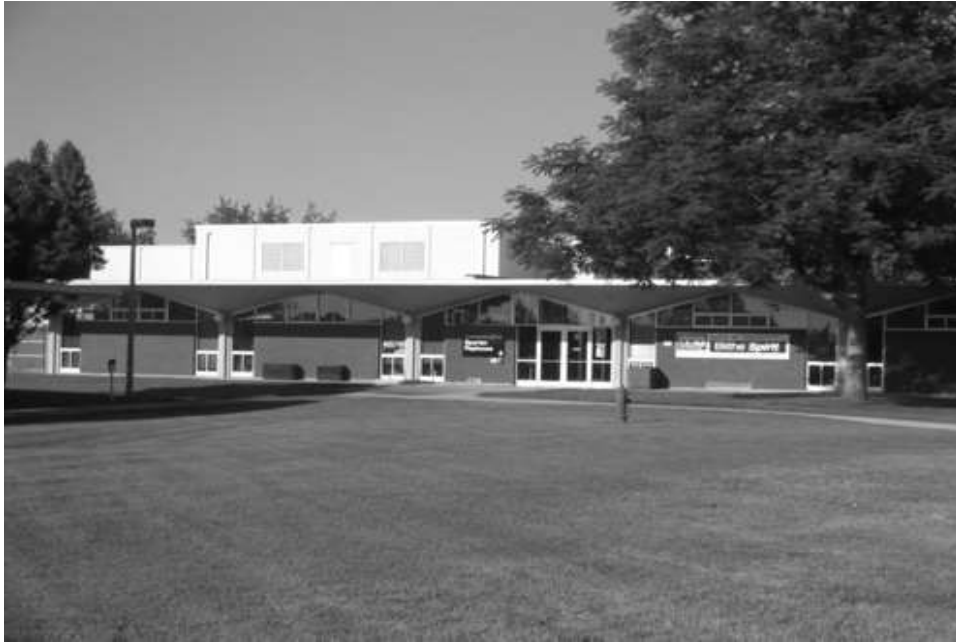
Primary Systems			
COMPONENT:	Structure	RATING: 3 x WEIGHT: 8.3 =	SCORE: 25
Some cracking evident but does not likely affect structural integrity; Visible defects apparent but are non-structural			
COMMENTS:	Concrete columns and roof; concrete; CMU; steel		
COMPONENT:	Exterior Closure	RATING: 3 x WEIGHT: 8.3 =	SCORE: 25
Sound and weatherproof but with some physical deterioration evident			
COMMENTS:	Brick; CMU; window walls; stucco/plaster		
COMPONENT:	Roofing	RATING: 2 x WEIGHT: 10.4 =	SCORE: 20.9
Majority of roofing and flashing appear sound, but a small portion of roofing shows deterioration where maintenance or minor repair needed			
COMMENTS:	Foam hyperbolic roof; high maintenance; TPO single-ply; mineral capsheet BUR; BUR w UV coat

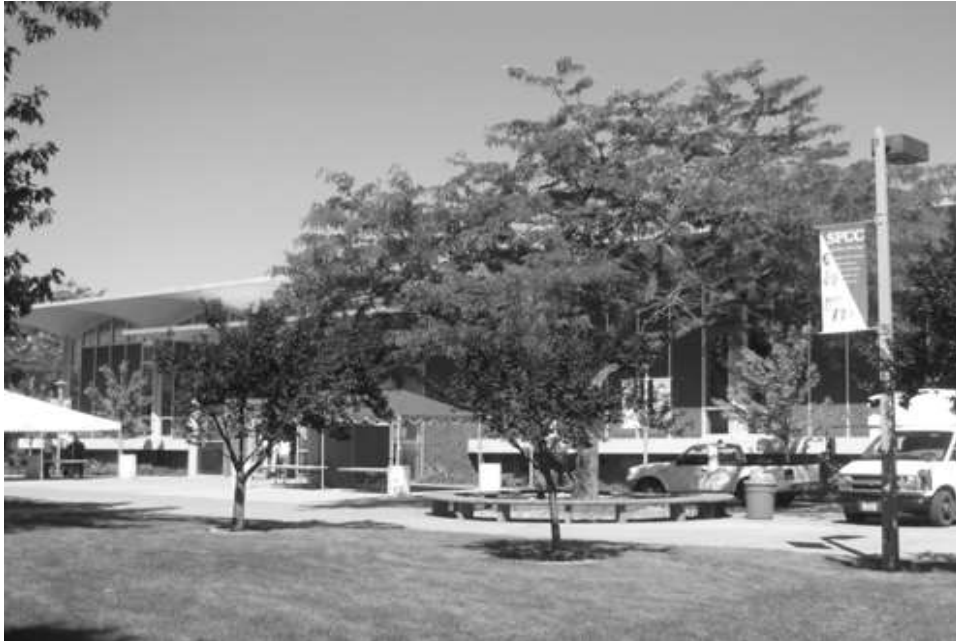
Primary Systems			
COMPONENT:	Structure	RATING: 1 x WEIGHT: 8 =	SCORE: 8
No signs of settlement or cracking, no abrupt vertical changes Columns, bearing walls and roof structure appears sound/free of defects			
COMMENTS:	Concrete column and beam; concrete roof		
COMPONENT:	Exterior Closure	RATING: 1 x WEIGHT: 8 =	SCORE: 8
Weatherproof, tight, well-maintained exterior walls, doors, windows/finishes			
COMMENTS:	Brick and concrete; window walls and CMU		
COMPONENT:	Roofing	RATING: 3 x WEIGHT: 10 =	SCORE: 30
Some deterioration is evident in membrane and flashings; maintenance or minor repair is needed			
COMMENTS:	Foam roof on portion and built-up roof w UV coat on rest; minor UV coat wear

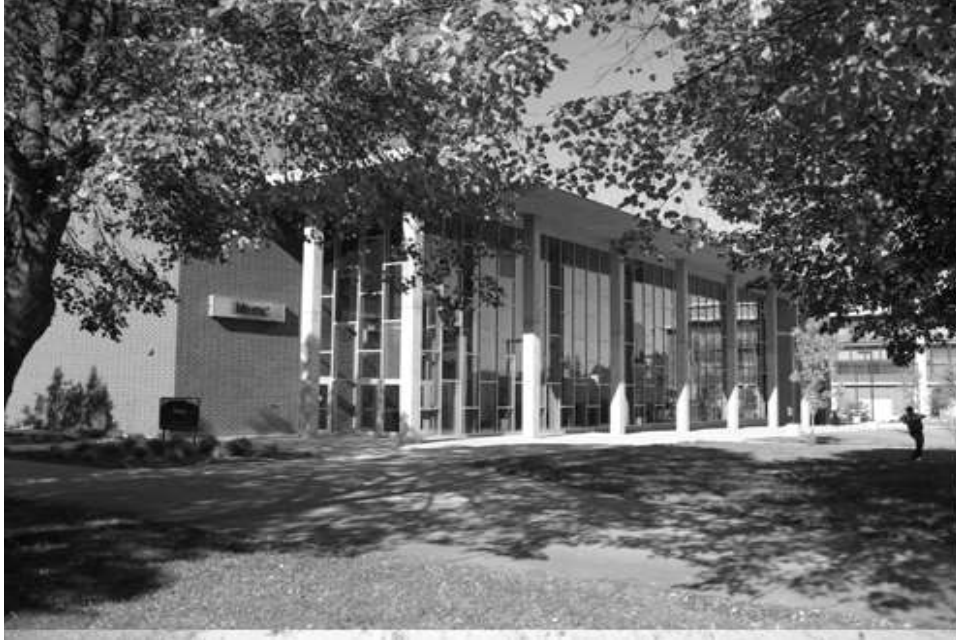
Primary Systems			
COMPONENT:	Structure	RATING: 1 x WEIGHT: 8 =	SCORE: 8
No signs of settlement or cracking, no abrupt vertical changes Columns, bearing walls and roof structure appears sound/free of defects			
COMMENTS:	Cement columns; concrete, steel and brick		
COMPONENT:	Exterior Closure	RATING: 1 x WEIGHT: 8 =	SCORE: 8
Weatherproof, tight, well-maintained exterior walls, doors, windows/finishes			
COMMENTS:	Brick and aluminum window walls		
COMPONENT:	Roofing	RATING: 2 x WEIGHT: 10 =	SCORE: 20
Majority of roofing and flashing appear sound, but a small portion of roofing shows deterioration where maintenance or minor repair needed			
COMMENTS:	Single-ply TPO membrane; BUR w capsheet; BUR w UV coating-worn; skylight

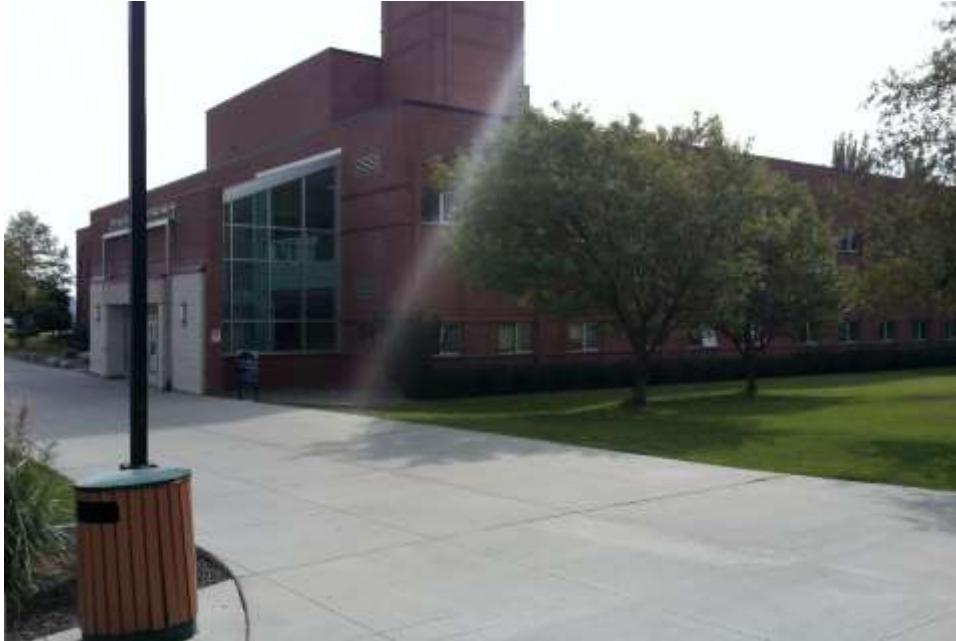
Primary Systems			
COMPONENT:	Structure	RATING: 1 x WEIGHT: 8 =	SCORE: 8
No signs of settlement or cracking, no abrupt vertical changes Columns, bearing walls and roof structure appears sound/free of defects			
COMMENTS:	Steel frame		
COMPONENT:	Exterior Closure	RATING: 1 x WEIGHT: 8 =	SCORE: 8
Weatherproof, tight, well-maintained exterior walls, doors, windows/finishes			
COMMENTS:	Brick		
COMPONENT:	Roofing	RATING: 1 x WEIGHT: 10 =	SCORE: 10
Flashing and penetrations appear sound and membrane appears water- tight; drainage is positive and there are overflow scuppers			
COMMENTS:	New single-ply TPO membrane installed in 2008

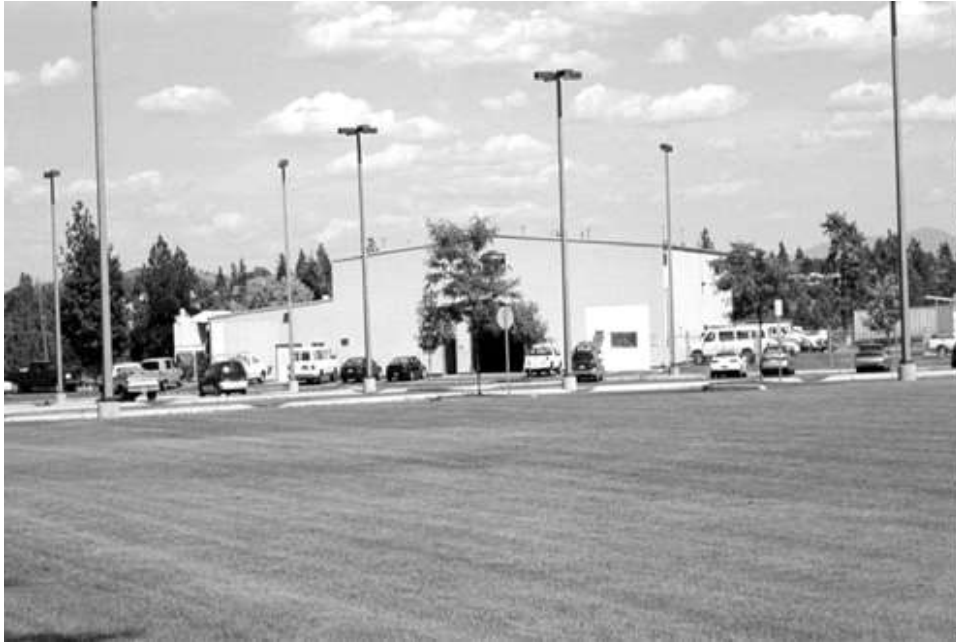
Primary Systems			
COMPONENT:	Structure	RATING: 2 x WEIGHT: 8.3 =	SCORE: 16.7
Minor cracks evident in a small portion of the structure			
COMMENTS:	Wood framed; concrete slab has numerous cracks		
COMPONENT:	Exterior Closure	RATING: 2 x WEIGHT: 8.3 =	SCORE: 16.7
Weatherproof exterior, but finish appears poorly maintained			
COMMENTS:	Metal wall panels		
COMPONENT:	Roofing	RATING: 1 x WEIGHT: 10.4 =	SCORE: 10.4
Flashing and penetrations appear sound and membrane appears water- tight; drainage is positive and there are overflow scuppers			
COMMENTS:	New metal coated roof in 2002

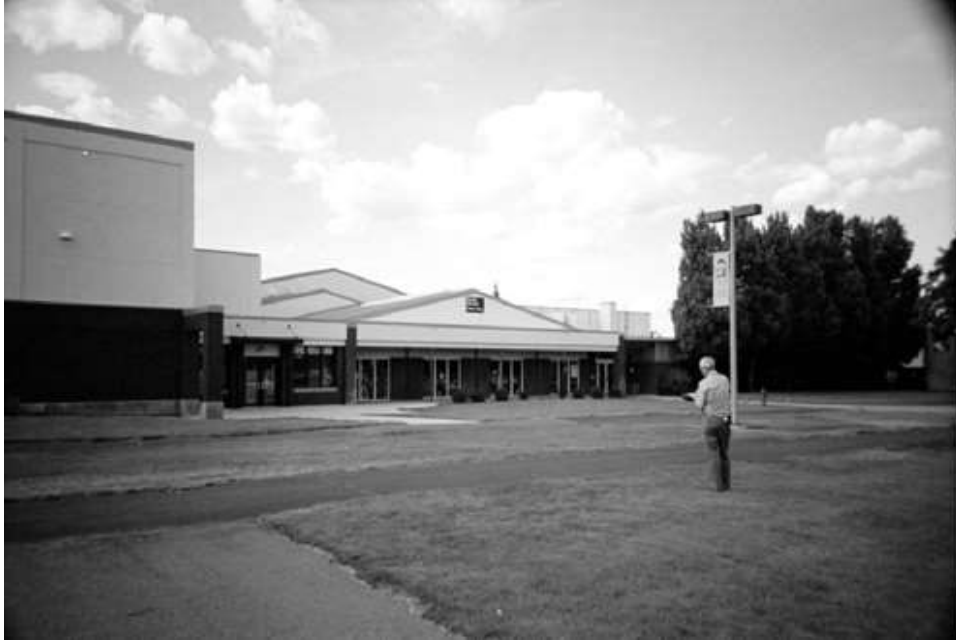
Primary Systems			
COMPONENT:	Structure	RATING: 1 x WEIGHT: 8 =	SCORE: 8
No signs of settlement or cracking, no abrupt vertical changes Columns, bearing walls and roof structure appears sound/free of defects			
COMMENTS:			
COMPONENT:	Exterior Closure	RATING: 1 x WEIGHT: 8 =	SCORE: 8
Weatherproof, tight, well-maintained exterior walls, doors, windows/finishes			
COMMENTS:			
COMPONENT:	Roofing	RATING: 2 x WEIGHT: 10 =	SCORE: 20
Majority of roofing and flashing appear sound, but a small portion of roofing shows deterioration where maintenance or minor repair needed			
COMMENTS:	Foam with single-ply surface, metal

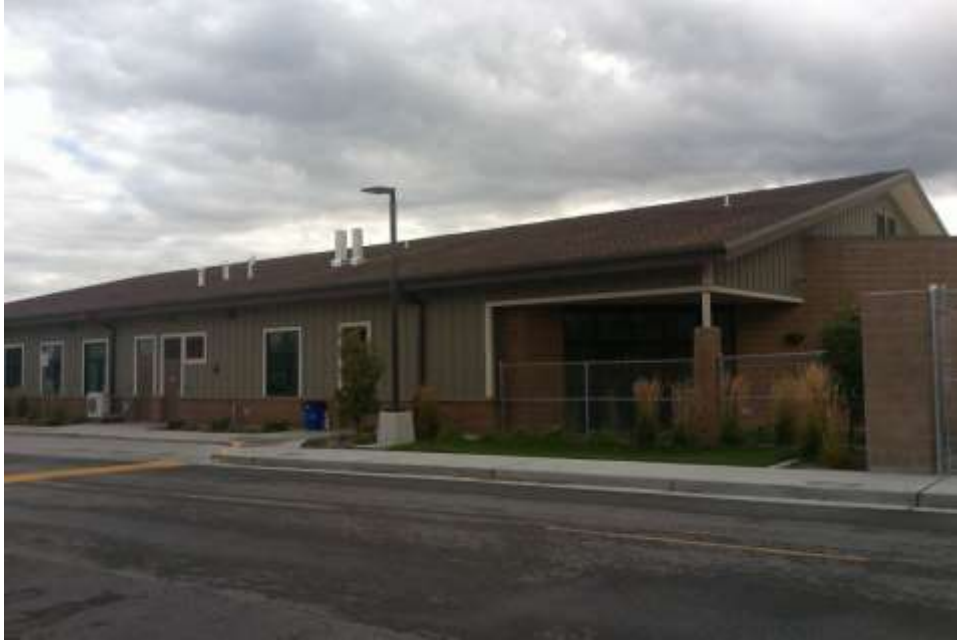
Primary Systems			
COMPONENT:	Structure	RATING: 1 x WEIGHT: 8.4 =	SCORE: 8.4
No signs of settlement or cracking, no abrupt vertical changes Columns, bearing walls and roof structure appears sound/free of defects			
COMMENTS:	No data		
COMPONENT:	Exterior Closure	RATING: 1 x WEIGHT: 8.4 =	SCORE: 8.4
Weatherproof, tight, well-maintained exterior walls, doors, windows/finishes			
COMMENTS:	No data		
COMPONENT:	Roofing	RATING: 1 x WEIGHT: 10.5 =	SCORE: 10.5
Flashing and penetrations appear sound and membrane appears water- tight; drainage is positive and there are overflow scuppers			
COMMENTS:	No data
