2023 FACILITY CONDITION SURVEY

Spokane Falls Community
College

SURVEY CONDUCTED BY:
Steve Lewandowski
State Board for Community
and Technical Colleges

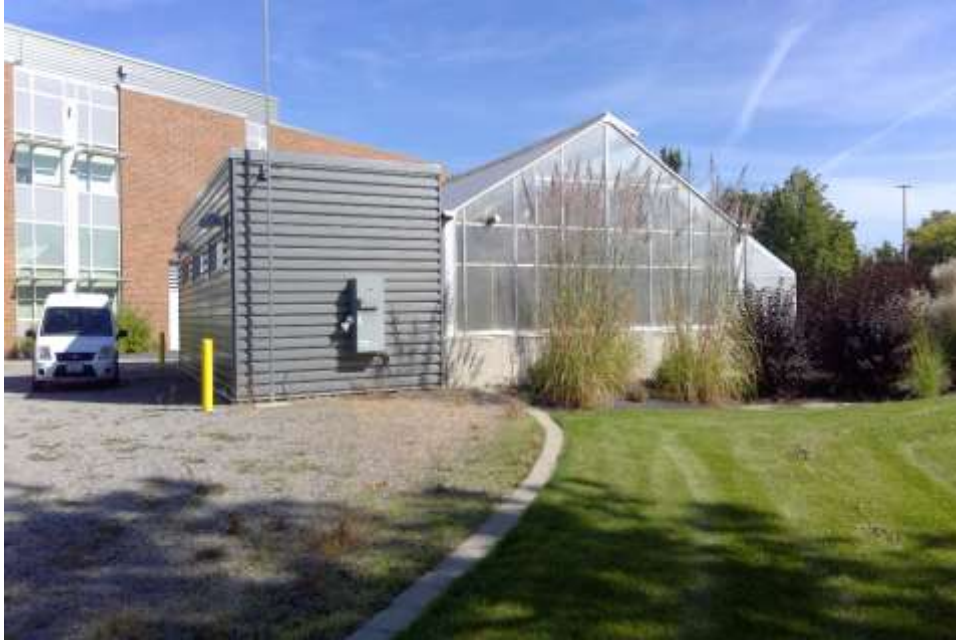
Primary Systems			
COMPONENT:	Structure	RATING: 1 x WEIGHT: 10.2 =	SCORE: 10.2
No signs of settlement or cracking, no abrupt vertical changes Columns, bearing walls and roof structure appears sound/free of defects			
COMMENTS:	No data		
COMPONENT:	Exterior Closure	RATING: 1 x WEIGHT: 10.2 =	SCORE: 10.2
Weatherproof, tight, well-maintained exterior walls, doors, windows/finishes			
COMMENTS:	No data		
COMPONENT:	Roofing	RATING: 1 x WEIGHT: 12.7 =	SCORE: 12.7
Flashing and penetrations appear sound and membrane appears water- tight; drainage is positive and there are overflow scuppers			
COMMENTS:	No data

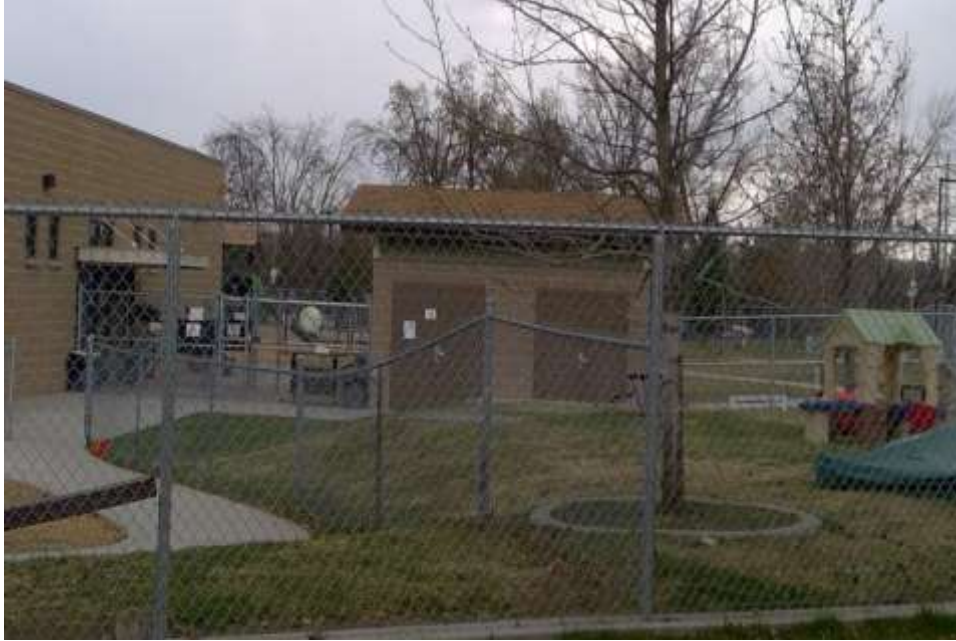
Primary Systems			
COMPONENT:	Structure	RATING: 1 x WEIGHT: 10.5 =	SCORE: 10.5
No signs of settlement or cracking, no abrupt vertical changes Columns, bearing walls and roof structure appears sound/free of defects			
COMMENTS:	No data		
COMPONENT:	Exterior Closure	RATING: 1 x WEIGHT: 10.5 =	SCORE: 10.5
Weatherproof, tight, well-maintained exterior walls, doors, windows/finishes			
COMMENTS:	No data		
COMPONENT:	Roofing	RATING: 1 x WEIGHT: 13.2 =	SCORE: 13.2
Flashing and penetrations appear sound and membrane appears water- tight; drainage is positive and there are overflow scuppers			
COMMENTS:	No data
