2023 FACILITY CONDITION SURVEY

Walla Walla Community
College

SURVEY CONDUCTED BY:
Steve Lewandowski
State Board for Community
and Technical Colleges

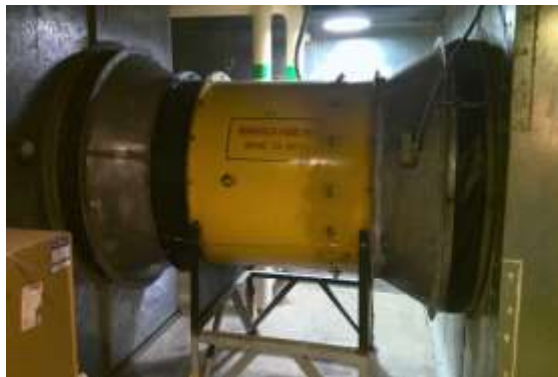
The air handlers have degraded. The structure has air leaks. The dampers still function, but leak. The controls are pneumatic and have become unreliable. Air handler 4 is in the worst condition and should be reconditioned to extend their useful life.

Estimated average life expectancy (years) : 40
Scoring priority category 1 : System Use (score = 15)
Category 1 percentage : 60 %
Scoring priority category 2 : High Repair/Repl. Cost (score = 12)
Category 2 percentage : 40 %
Project construction estimate (MACC): \$600,000
Total project estimate (including soft costs): \$842,000
Additional points based on building condition: 2
Deficiency score : $4 \times ((15 \times 60\%) + (12 \times 40\%)) + 2 = 57.2$

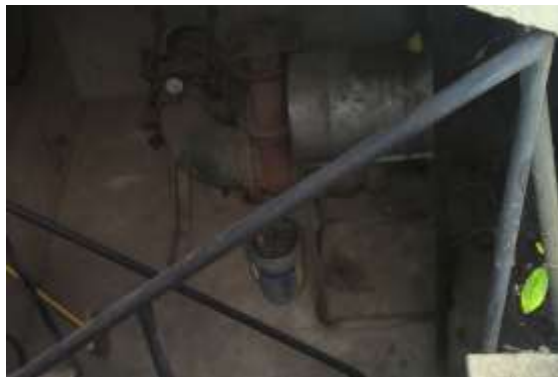
Deficiency F03

The college is concerned about the age of the well pump. The pump is used to circulate cool water that is used for the building mechanical system. The college is mainly concerned about the pump head at the bottom of the well since it has not been seen for roughly 50 years. The pump motor that is mounted at the surface has been repaired and still functions as designed. This is integral to the cooling system. The pump head should be replaced due to its age to ensure that the system remains functional. The college is concerned about the short term fix that does not meet the city's request to replace the well.

Recommended funding schedule : Immediate (scoring weight=4)
Estimated remaining life (years) : 3
Estimated average life expectancy (years) : 40
Scoring priority category 1 : System Use (scoring weight=15)
Category 1 percentage : 100 %
Scoring priority category 2 : None
Category 2 percentage : 0 %
Project construction estimate (MACC): \$250,000
Total project estimate (including soft costs): \$351,000
Additional points based on building condition: 2
Deficiency score : $4 \times (15 \times 100\%) + 2 = 62$

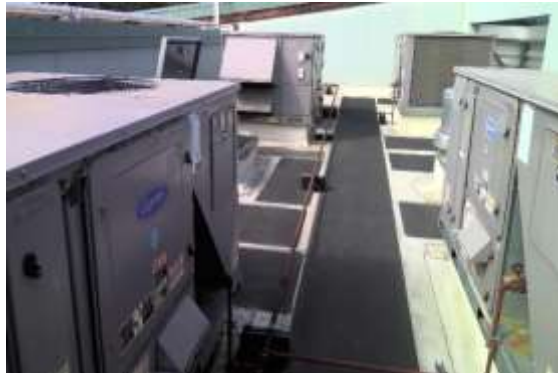
Deficiency F04

The college has been required to repair these units more frequently and were concerned about their reliability. The units still function as designed. Three units in the worst condition should be replaced.

Scoring priority category 1 : High Repair/Repl. Cost (scoring weight=12)
Category 1 percentage : 50 %
Scoring priority category 2 : System Use (scoring weight=15)
Category 2 percentage : 50 %
Project construction estimate (MACC): \$90,000
Total project estimate (including soft costs): \$126,000
Additional points based on building condition: 0
Deficiency score : $4 \times ((12 \times 50\%) + (15 \times 50\%)) + 0 = 54$

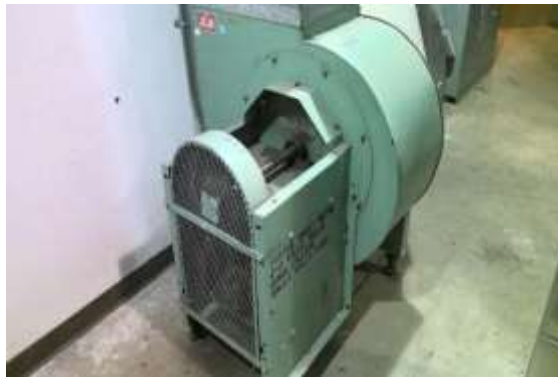
Deficiency F05

The exhaust fans have degraded and require frequent repairs. All of the units were functioning during the site visit. These units should continue to be monitored for replacement.

Scoring priority category 1 : High Operating Cost (scoring weight=10)
Category 1 percentage : 70 %
Scoring priority category 2 : High Repair/Repl. Cost (scoring weight=12)
Category 2 percentage : 30 %
Project construction estimate (MACC): \$42,000
Total project estimate (including soft costs): \$59,000
Additional points based on building condition: 0
Deficiency score : $2.5 \times ((10 \times 70\%) + (12 \times 30\%)) + 0 = 26.5$

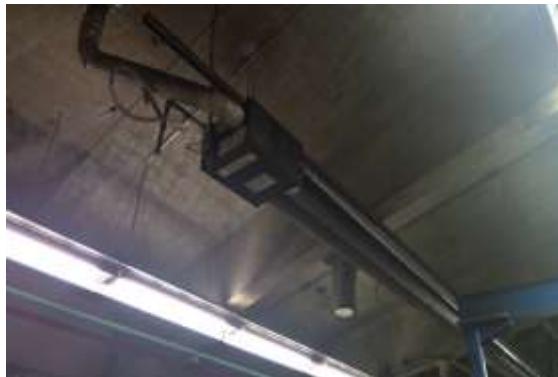
Deficiency F06

The college is concerned about the age of some shop heaters in the agricultural, facilities and trades buildings. There are eight infrared heaters and eleven ceiling-hung units. The parts are becoming hard to find and repairs are becoming more frequent. The heaters still function as designed and can still be repaired, if required. The heaters should be monitored for future replacement.

Recommended funding schedule : Fund in Next Biennium (scoring weight=2.5)
Estimated remaining life (years) : 5
Estimated average life expectancy (years) : 25
Scoring priority category 1 : High Repair/Repl. Cost (scoring weight=12)
Category 1 percentage : 100 %
Scoring priority category 2 : None
Category 2 percentage : 0 %
Project construction estimate (MACC): \$125,000
Total project estimate (including soft costs): \$175,000
Additional points based on building condition: 0
Deficiency score : $2.5 \times (12 \times 100\%) + 0 = 30$

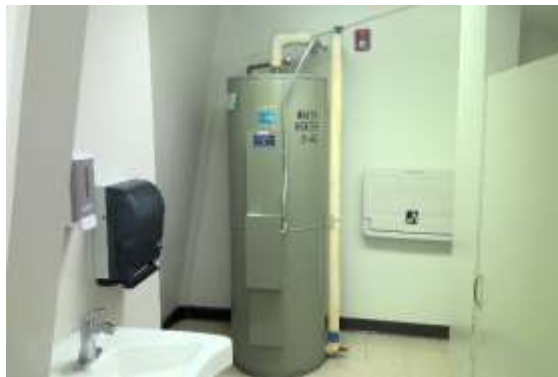
Deficiency F07

The college is concerned about the age of some of the buildings water heaters. The water heaters are primarily located in the agricultural and technology buildings. They are still functioning, but have exceeded their expected life. The water heaters should be replaced.

Estimated remaining life (years) : 5
Estimated average life expectancy (years) : 25
Scoring priority category 1 : System Use (scoring weight=15)
Category 1 percentage : 100 %
Scoring priority category 2 : None
Category 2 percentage : 0 %
Project construction estimate (MACC): \$32,000
Total project estimate (including soft costs): \$44,000
Additional points based on building condition: 0
Deficiency score : $2.5 \times (15 \times 100\%) + 0 = 37.5$

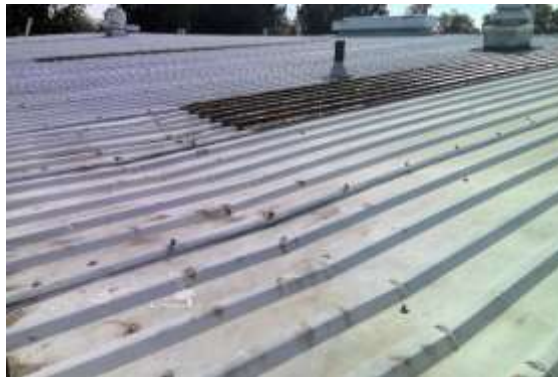
Deficiency R01

Numerous leaks due to age and wear, original to the building. The roof fasteners should be replaced to extend the life of the roofing.

Category 1 percentage : 70 %
Scoring priority category 2 : System Use (scoring weight=15)
Category 2 percentage : 30 %
Project construction estimate (MACC): \$27,000
Total project estimate (including soft costs): \$37,000
Additional points based on building condition: 2
Deficiency score : $4 \times ((12 \times 70\%) + (15 \times 30\%)) + 2 = 53.6$

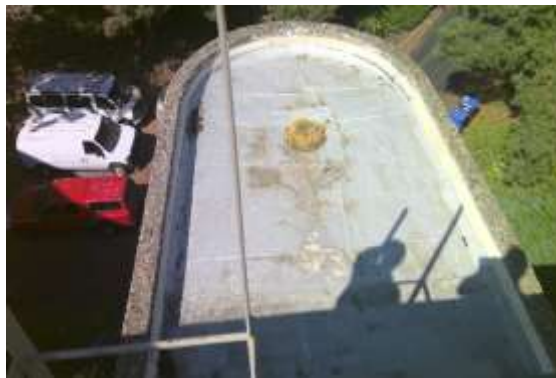
Deficiency R02

Three areas over the exterior stairwells roof leak.

Category 2 percentage : 20 %
Project construction estimate (MACC): \$45,000
Total project estimate (including soft costs): \$63,000
Additional points based on building condition: 2
Deficiency score : $2.5 \times ((12 \times 80\%) + (5 \times 20\%)) + 2 = 28.5$

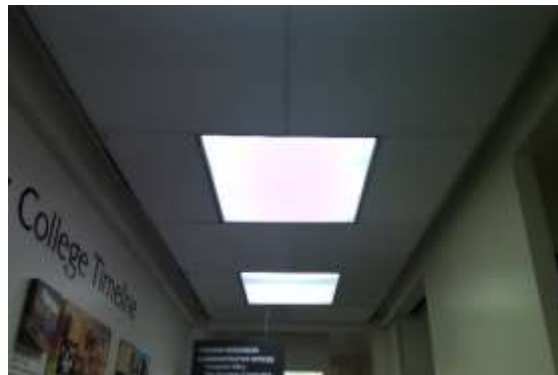
Deficiency F08

The college believes that the 4x4 light fixtures have degraded. The college indicated that many of the lens covers have failed, but the staff could not locate a failed lens during the survey. Parts are no longer available. Each light allows air flow from the mechanical system to flow through it. The ductwork must be modified at each light to allow the air to flow adjacent to the light replacement. The fixtures appeared to be in working condition during the survey and should continue to be monitored for replacement. It may be best to replace these fixtures as part of a minor improvement or major capital project since they are still in working condition.

Recommended funding schedule : Deferred Backlog (scoring weight=1)
Estimated remaining life (years) : 7
Estimated average life expectancy (years) : 30
Scoring priority category 1 : High Repair/Repl. Cost (scoring weight=12)
Category 1 percentage : 60 %
Scoring priority category 2 : System Use (scoring weight=15)
Category 2 percentage : 40 %
Project construction estimate (MACC): \$160,000
Total project estimate (including soft costs): \$224,000
Additional points based on building condition: 2
Deficiency score : $1 \times ((12 \times 60\%) + (15 \times 40\%)) + 2 = 15.2$

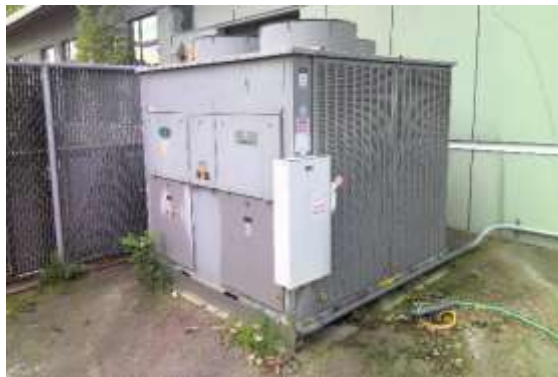
Deficiency F09

The college indicated that the condensing unit has required an increased need for repairs due to premature failures. One compressor and interface control board have been replaced. The unit leaks refrigerant and should be replaced.

Estimated average life expectancy (years) : 20
Scoring priority category 1 : High Repair/Repl. Cost (scoring weight=12)
Category 1 percentage : 70 %
Scoring priority category 2 : System Use (scoring weight=15)
Category 2 percentage : 30 %
Project construction estimate (MACC): \$175,000
Total project estimate (including soft costs): \$245,000
Additional points based on building condition: 0
Deficiency score : $4 \times ((12 \times 70\%) + (15 \times 30\%)) + 0 = 51.6$

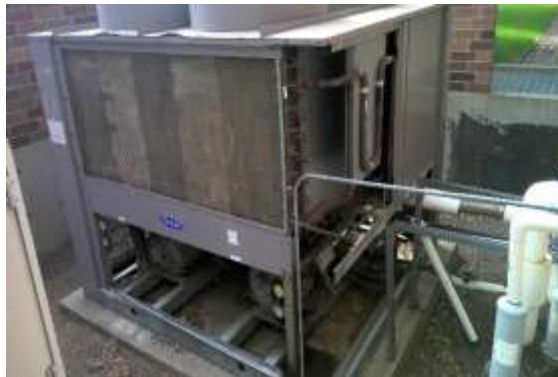
Deficiency F10

Condensing unit for AHU 1 at nursing has a leak in the coils Repairs are becoming more frequent.

Category 1 percentage : 50 %
Scoring priority category 2 : System Use (scoring weight=15)
Category 2 percentage : 50 %
Project construction estimate (MACC): \$150,000
Total project estimate (including soft costs): \$210,000
Additional points based on building condition: 0
Deficiency score : $2.5 \times ((12 \times 50\%) + (15 \times 50\%)) + 0 = 33.8$

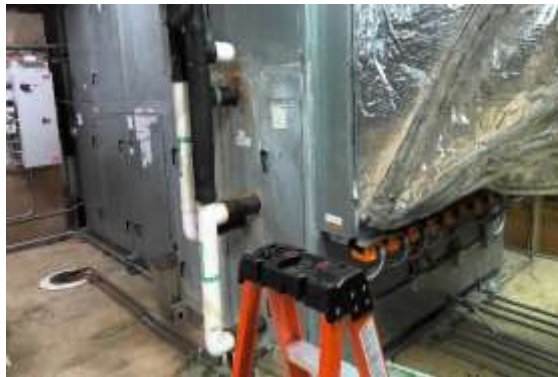
Deficiency F12

Air Handler actuators have continued to fail. Shives and pullies are wearing out. The unit should be reconditioned.

Category 1 percentage : 70 %
Scoring priority category 2 : System Use (scoring weight=15)
Category 2 percentage : 30 %
Project construction estimate (MACC): \$160,000
Total project estimate (including soft costs): \$224,000
Additional points based on building condition: 0
Deficiency score : $4 \times ((12 \times 70\%) + (15 \times 30\%)) + 0 = 51.6$

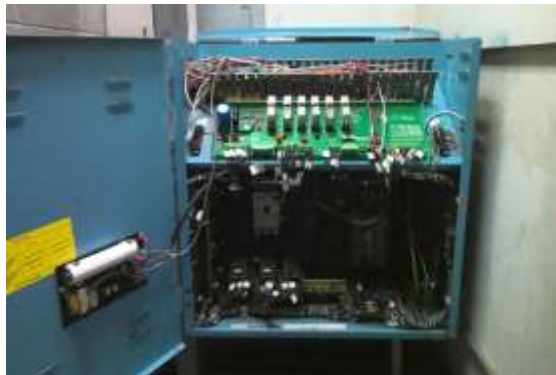
Deficiency F13

The elevator controls are no longer repairable. A letter from the vendor states that controls are no longer available. The Controls should be replaced.

Category 1 percentage : 70 %
Scoring priority category 2 : Facility Use/ Civil Rights Violation (scoring weight=20)
Category 2 percentage : 30 %
Project construction estimate (MACC): \$145,000
Total project estimate (including soft costs): \$203,000
Additional points based on building condition: 1
Deficiency score : $4 \times ((15 \times 70\%) + (20 \times 30\%)) + 1 = 67$

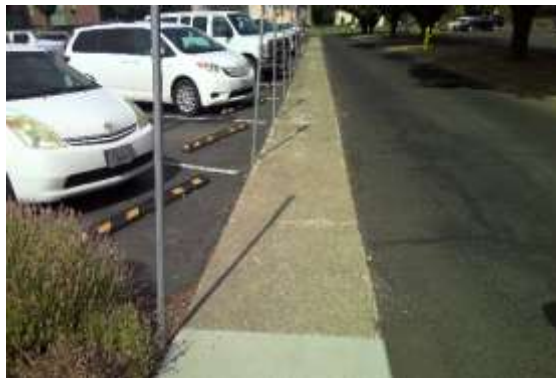
Deficiency S01

Repair failed and degraded concrete adjacent to bus turnaround.

Category 2 percentage : 20 %
Project construction estimate (MACC): \$30,000
Total project estimate (including soft costs): \$42,000
Additional points based on building condition: 0
Deficiency score : $4 \times ((12 \times 80\%) + (20 \times 20\%)) + 0 = 54.4$
