2023 FACILITY CONDITION SURVEY

Wenatchee Valley College

SURVEY CONDUCTED BY:
Steve Lewandowski
State Board for Community
and Technical Colleges

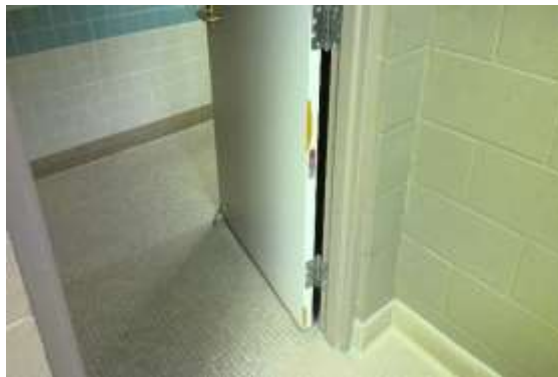
Estimated average life expectancy (years) : 20
Scoring priority category 1 : High Repair/Repl. Cost (score = 12)
Category 1 percentage : 90 %
Scoring priority category 2 : Quality of Use (score = 5)
Category 2 percentage : 10 %
Project construction estimate (MACC): \$20,000
Total project estimate (including soft costs): \$28,000
Additional points based on building condition: 0
Deficiency score : $4 \times ((12 \times 90\%) + (5 \times 10\%)) + 0 = 45.2$

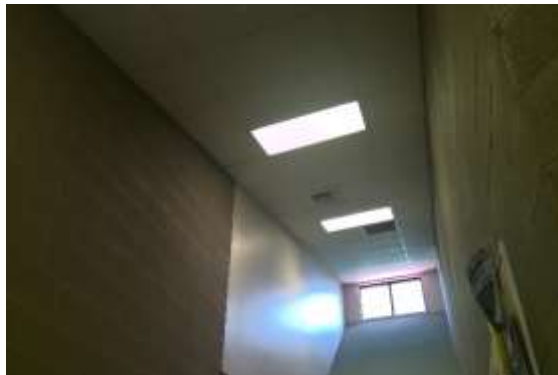
Deficiency F02

Scoring priority category 1 : High Repair/Repl. Cost (scoring weight=12)
Category 1 percentage : 50 %
Scoring priority category 2 : Quality of Use (scoring weight=5)
Category 2 percentage : 50 %
Project construction estimate (MACC): \$60,000
Total project estimate (including soft costs): \$84,000
Additional points based on building condition: 1
Deficiency score : $1 \times ((12 \times 50\%) + (5 \times 50\%)) + 1 = 9.5$

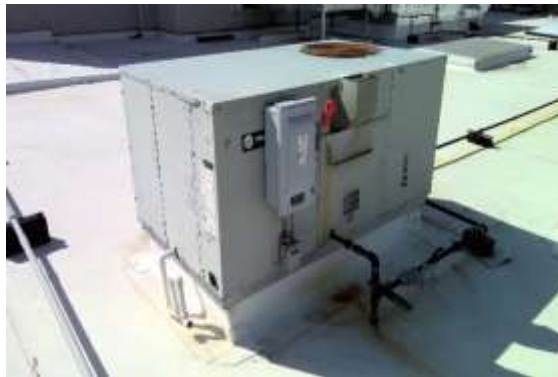
Deficiency F03

Scoring priority category 2 : High Repair/Repl. Cost (scoring weight=12)
Category 2 percentage : 50 %
Project construction estimate (MACC): \$30,000
Total project estimate (including soft costs): \$42,000
Additional points based on building condition: 5
Deficiency score : $4 \times ((15 \times 50\%) + (12 \times 50\%)) + 5 = 59$

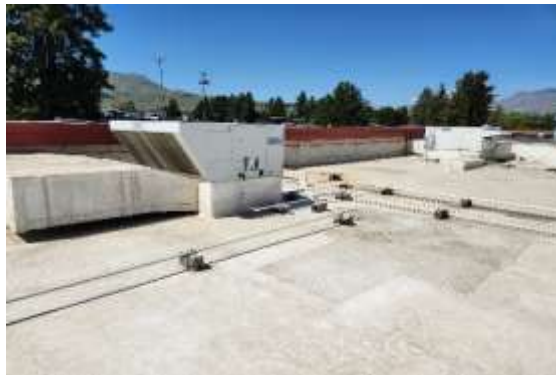
Deficiency F04

Category 1 percentage : 70 %
Scoring priority category 2 : High Repair/Repl. Cost (scoring weight=12)
Category 2 percentage : 30 %
Project construction estimate (MACC): \$130,000
Total project estimate (including soft costs): \$182,000
Additional points based on building condition: 1
Deficiency score : $4 \times ((15 \times 70\%) + (12 \times 30\%)) + 1 = 57.4$

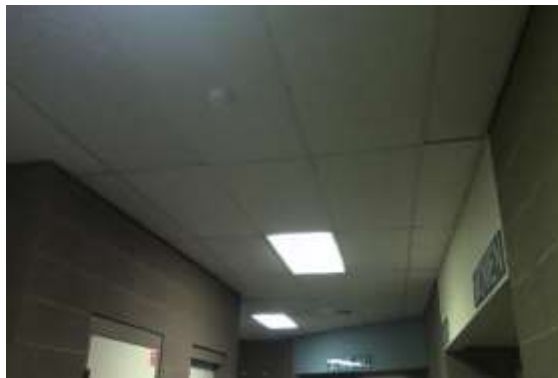
Deficiency F05

Category 2 percentage : 40 %
Project construction estimate (MACC): \$20,000
Total project estimate (including soft costs): \$28,000
Additional points based on building condition: 1
Deficiency score : $4 \times ((15 \times 60\%) + (12 \times 40\%)) + 1 = 56.2$

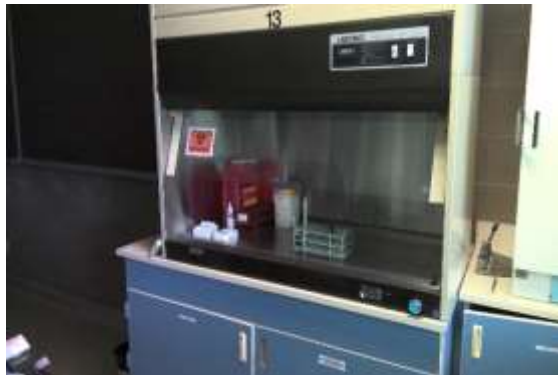
Deficiency F06

Category 1 percentage : 50 %
Scoring priority category 2 : Quality of Use (scoring weight=5)
Category 2 percentage : 50 %
Project construction estimate (MACC): \$45,000
Total project estimate (including soft costs): \$63,000
Additional points based on building condition: 1
Deficiency score : $1 \times ((12 \times 50\%) + (5 \times 50\%)) + 1 = 9.5$

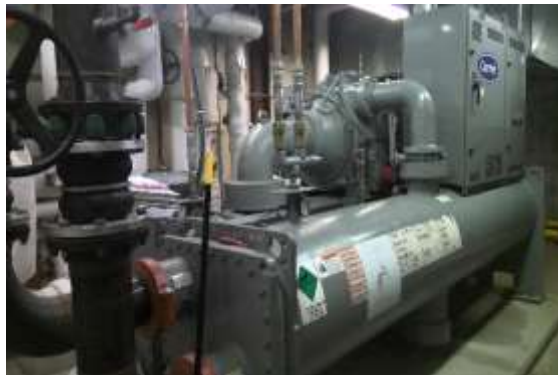
Deficiency F07

Scoring priority category 2 : None
Category 2 percentage : 0 %
Project construction estimate (MACC): \$45,000
Total project estimate (including soft costs): \$63,000
Additional points based on building condition: 0
Deficiency score : $2.5 \times (15 \times 100\%) + 0 = 37.5$

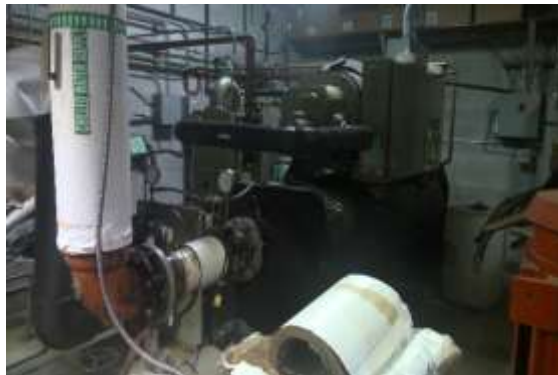
Deficiency F08

Scoring priority category 2 : High Repair/Repl. Cost (scoring weight=12)
Category 2 percentage : 30 %
Project construction estimate (MACC): \$65,000
Total project estimate (including soft costs): \$91,000
Additional points based on building condition: 5
Deficiency score : $4 \times ((15 \times 70\%) + (12 \times 30\%)) + 5 = 61.4$

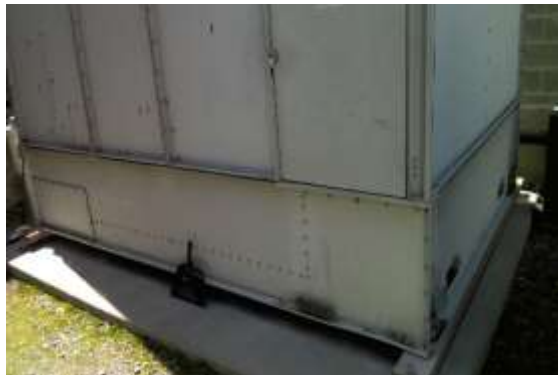
Deficiency F09

Category 1 percentage : 100 %
Scoring priority category 2 : None
Category 2 percentage : 0 %
Project construction estimate (MACC): \$22,000
Total project estimate (including soft costs): \$30,000
Additional points based on building condition: 0
Deficiency score : $1 \times (15 \times 100\%) + 0 = 15$

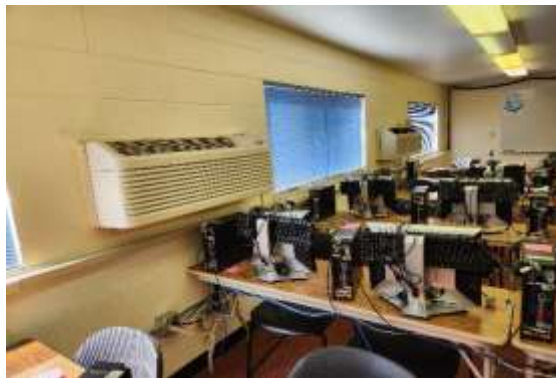
Deficiency F10

Project construction estimate (MACC): \$20,000
Total project estimate (including soft costs): \$28,000
Additional points based on building condition: 5
Deficiency score : $4 \times (15 \times 100\%) + 5 = 65$

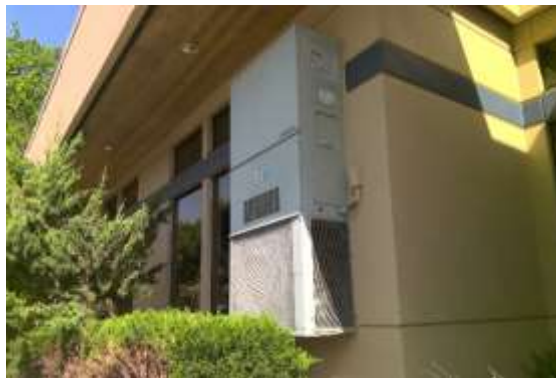
Deficiency F11

Category 2 percentage : 40 %
Project construction estimate (MACC): \$20,000
Total project estimate (including soft costs): \$28,000
Additional points based on building condition: 1
Deficiency score : $4 \times ((15 \times 60\%) + (12 \times 40\%)) + 1 = 56.2$

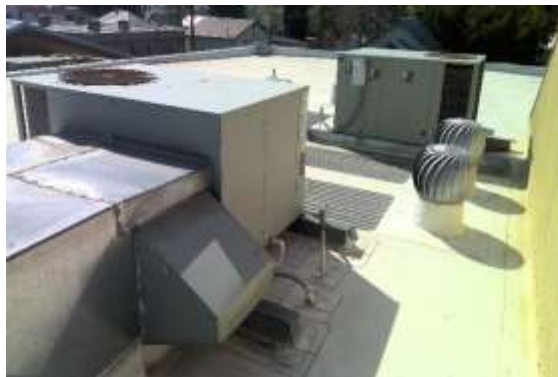
Deficiency F12

Estimated average life expectancy (years) : 20
Scoring priority category 1 : System Use (scoring weight=15)
Category 1 percentage : 90 %
Scoring priority category 2 : High Repair/Repl. Cost (scoring weight=12)
Category 2 percentage : 10 %
Project construction estimate (MACC): \$60,000
Total project estimate (including soft costs): \$84,000
Additional points based on building condition: 1
Deficiency score : $4 \times ((15 \times 90\%) + (12 \times 10\%)) + 1 = 59.8$

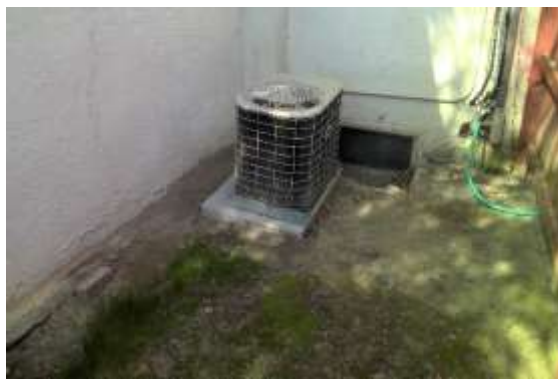
Deficiency F13

Recommended funding schedule : Immediate (scoring weight=4)
Estimated remaining life (years) : 3
Estimated average life expectancy (years) : 20
Scoring priority category 1 : High Repair/Repl. Cost (scoring weight=12)
Category 1 percentage : 80 %
Scoring priority category 2 : System Use (scoring weight=15)
Category 2 percentage : 20 %
Project construction estimate (MACC): \$20,000
Total project estimate (including soft costs): \$28,000
Additional points based on building condition: 0
Deficiency score : Needs study

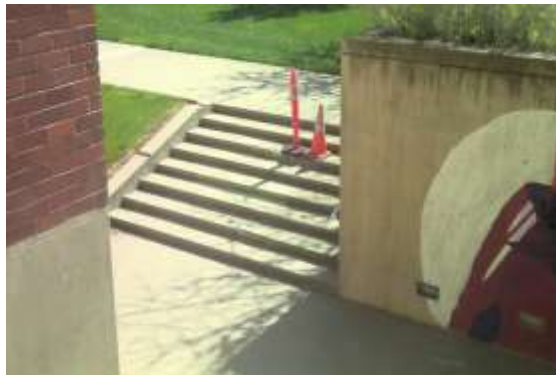
Deficiency S01

Scoring priority category 2 : Health/Safety (scoring weight=25)
Category 2 percentage : 20 %
Project construction estimate (MACC): \$110,000
Total project estimate (including soft costs): \$154,000
Additional points based on building condition: 0
Deficiency score : $4 \times ((12 \times 80\%) + (25 \times 20\%)) + 0 = 58.4$

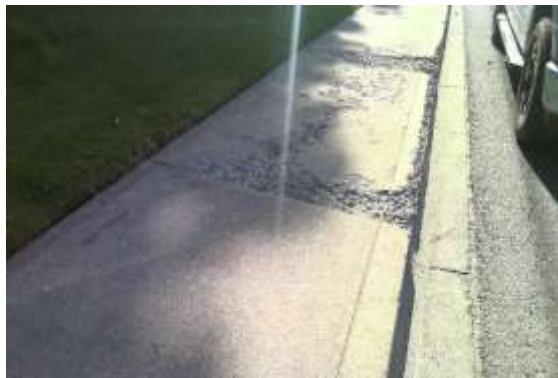
Deficiency S02

Scoring priority category 2 : Facility Use/ Civil Rights Violation (scoring weight=20)
Category 2 percentage : 20 %
Project construction estimate (MACC): \$25,000
Total project estimate (including soft costs): \$35,000
Additional points based on building condition: 0
Deficiency score : $4 \times ((12 \times 80\%) + (20 \times 20\%)) + 0 = 54.4$

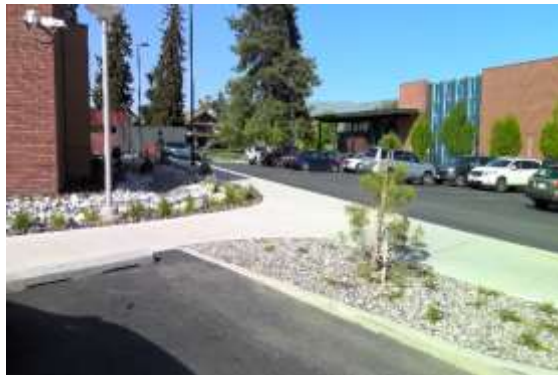
Deficiency S03

Scoring priority category 2 : None
Category 2 percentage : 0 %
Project construction estimate (MACC): \$30,000
Total project estimate (including soft costs): \$42,000
Additional points based on building condition: 0
Deficiency score : $4 \times (15 \times 100\%) + 0 = 60$

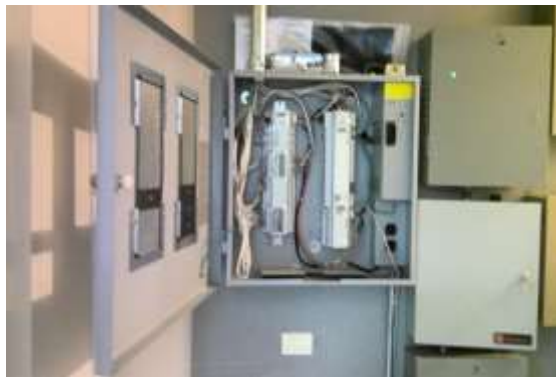
Deficiency F14

Estimated remaining life (years) : 3
Estimated average life expectancy (years) : 20
Scoring priority category 1 : High Repair/Repl. Cost (scoring weight=12)
Category 1 percentage : 50 %
Scoring priority category 2 : System Use (scoring weight=15)
Category 2 percentage : 50 %
Project construction estimate (MACC): \$60,000
Total project estimate (including soft costs): \$84,000
Additional points based on building condition: 0
Deficiency score : Needs study

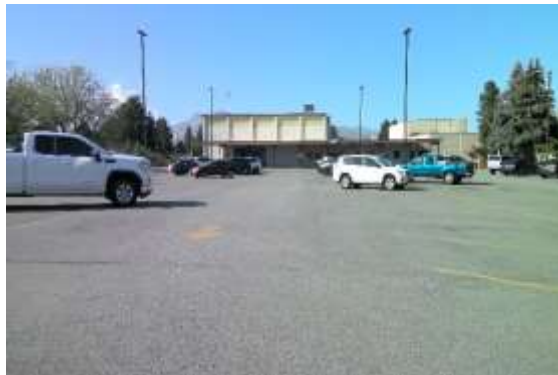
Deficiency S04

Category 1 percentage : 90 %
Scoring priority category 2 : High Repair/Repl. Cost (scoring weight=12)
Category 2 percentage : 10 %
Project construction estimate (MACC): \$80,000
Total project estimate (including soft costs): \$112,000
Additional points based on building condition: 0
Deficiency score : $4 \times ((15 \times 90\%) + (12 \times 10\%)) + 0 = 58.8$

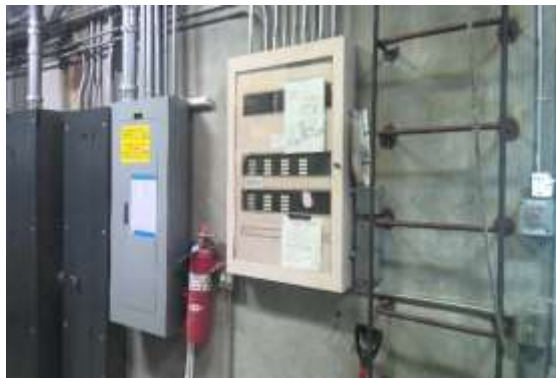
Deficiency F15

Category 2 percentage : 30 %
Project construction estimate (MACC): \$20,000
Total project estimate (including soft costs): \$28,000
Additional points based on building condition: 5
Deficiency score : $4 \times ((15 \times 70\%) + (25 \times 30\%)) + 5 = 77$

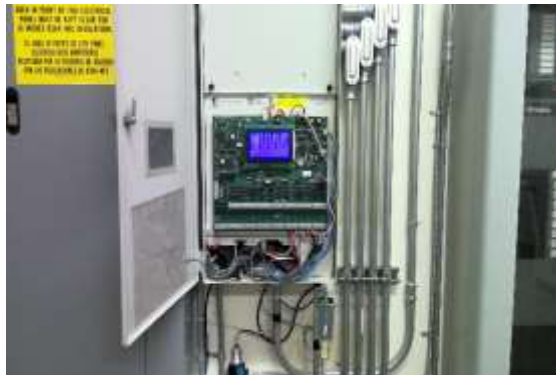
Deficiency F16

Estimated average life expectancy (years) : 20
Scoring priority category 1 : System Use (scoring weight=15)
Category 1 percentage : 70 %
Scoring priority category 2 : High Repair/Repl. Cost (scoring weight=12)
Category 2 percentage : 30 %
Project construction estimate (MACC): \$40,000
Total project estimate (including soft costs): \$56,000
Additional points based on building condition: 0
Deficiency score : Needs study
