# **2023** FACILITY CONDITION SURVEY

Whatcom Community College

SURVEY CONDUCTED BY:  
Steve Lewandowski  
State Board for Community  
and Technical Colleges

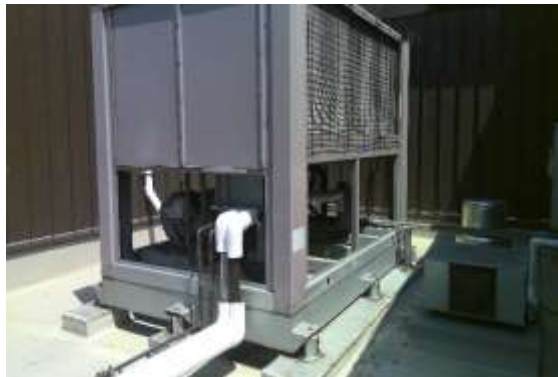
**Deficiency F01**

The college was concerned about electrical issues due to equipment vibration. The staff indicated that there were fan reliability issues as well as refrigerant leaks, however, the unit appeared to be in fairly good condition. College staff also indicate that the coils have started leaking. The unit cooling coils should be replaced to extend the life of the unit.

| Deficiency score : $4 \times ((15 \times 70\%) + (12 \times 30\%)) + 1 = 57.4$ |

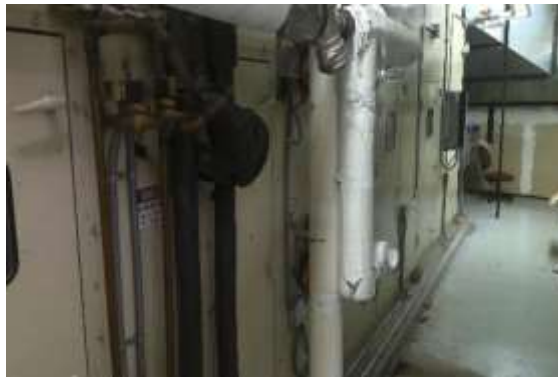
**Deficiency F02**

The college is concerned about the age of the air handler. Staff indicated that there are reoccurring issues with refrigerant leaks and replacement parts are becoming more difficult to find. The unit appeared to be in good condition, but required maintenance. The unit should continue to be monitored for repair or replacement.

| Deficiency score : $2.5 \times ((15 \times 80\%) + (10 \times 20\%)) + 1 = 36$ |

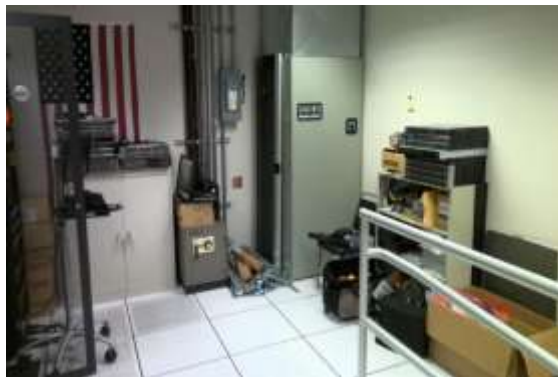
**Deficiency F03**

One of the HVAC units serving the main server room is near the end of its useful life. The adjacent lead-lag unit has already been replaced. The remaining unit should be replace to ensure proper cooling is not disrupted.

| Deficiency score : $4 \times (15 \times 100\%) + 1 = 61$ |

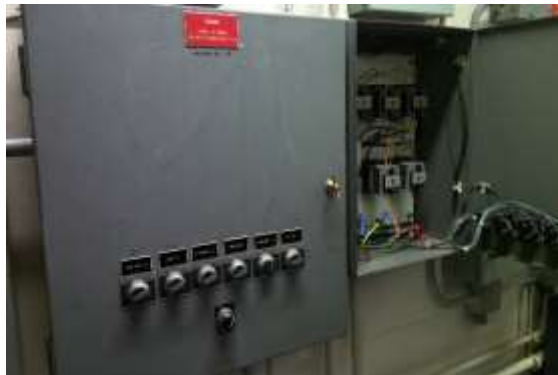
**Deficiency F04**

The lighting Control panel is failing and is no longer supported by the manufacturer. The panel should be replaced and the 480V system components should be reconditioned.

| Deficiency score : $4 \times ((12 \times 80\%) + (15 \times 20\%)) + 1 = 51.4$ |

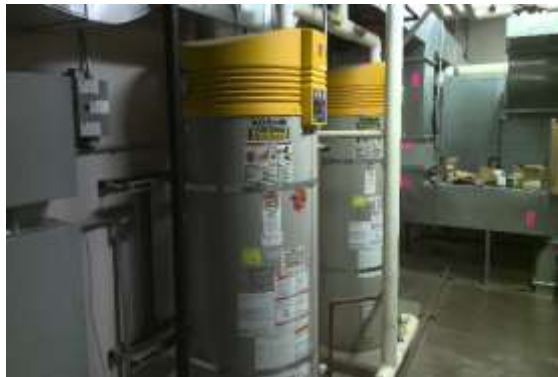
**Deficiency F05**

The hot water heaters have become less reliable and have started to show signs of degradation. The water heaters should be replaced.

| Deficiency score : $4 \times (15 \times 100\%) + 0 = 60$ |

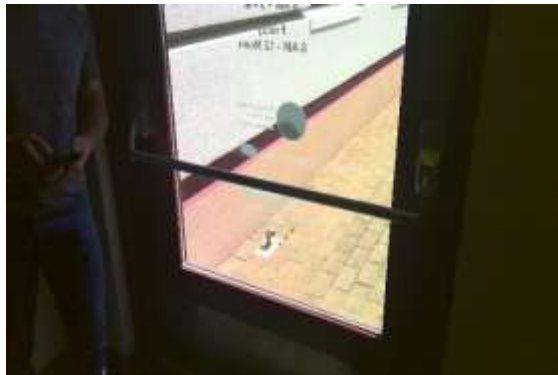
**Deficiency F07**

The door crash bar hardware has become unreliable. The vendor no longer can repair components. The door hardware should be replaced.

| Deficiency score : $4 \times ((15 \times 80\%) + (25 \times 20\%)) + 1 = 69$ |

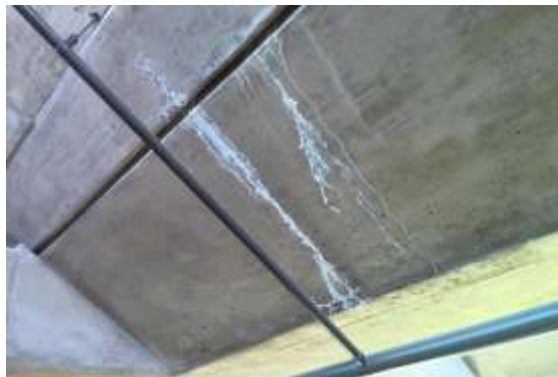
**Deficiency R01**

The roof has begun to leak, but the source of the leaks is unclear. A drone inspection did not identify degraded areas. The roofing requires some spot repairs and regular maintenance to stop water from infiltrating the roofing. The roofing should continue to be monitored for future repair or replacement.

| Deficiency score : $2.5 \times ((12 \times 70\%) + (15 \times 30\%)) + 0 = 32.3$ |

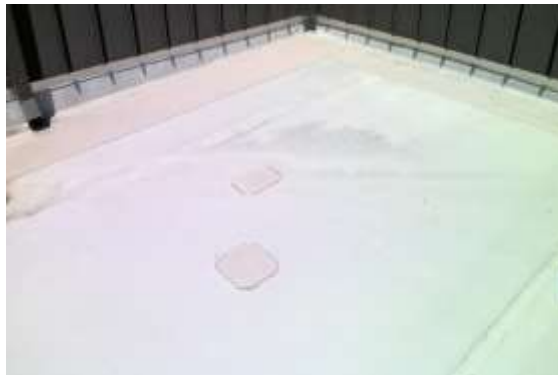
**Deficiency R02**

The roofing has degraded. The college has repaired several leaks and there are areas where the surface has severely degraded. The roofing should be reconditioned to extend its useful life.

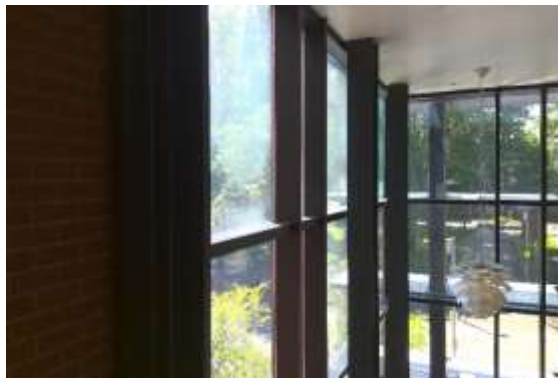
**Deficiency F08**

Multiple glazing units located in LDC, HNR, KUL have failed and should be replaced.

| Deficiency score : $4 \times (15 \times 100\%) + 0 = 60$ |

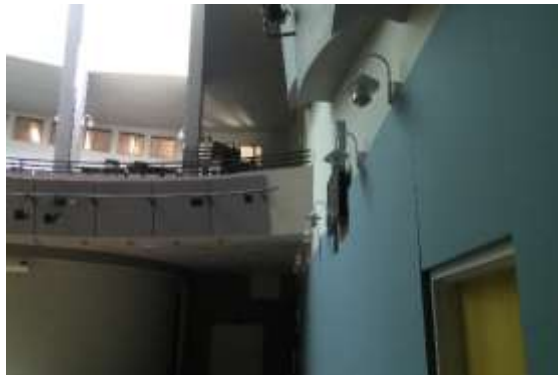
**Deficiency F09**

The majority of the dimmable wall light fixtures have failed. These fixtures are no longer supported by the vendor and parts are no longer available. The fixtures should be replaced.

| Deficiency score : $4 \times (15 \times 100\%) + 1 = 61$ |

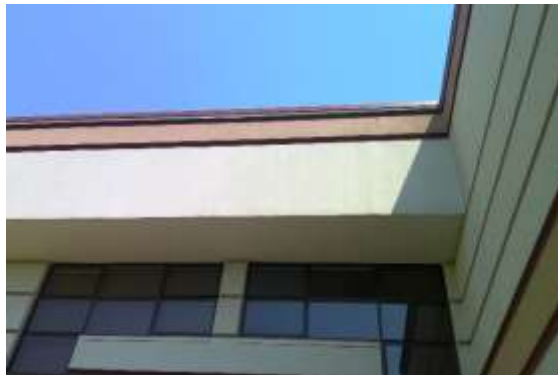
**Deficiency F10**

The upper section of dryvit had degraded and cracked. The finish system should be repaired and re-surfaced to extend the life of the insulation envelope system.

| Deficiency score : $4 \times (15 \times 100\%) + 1 = 61$ |

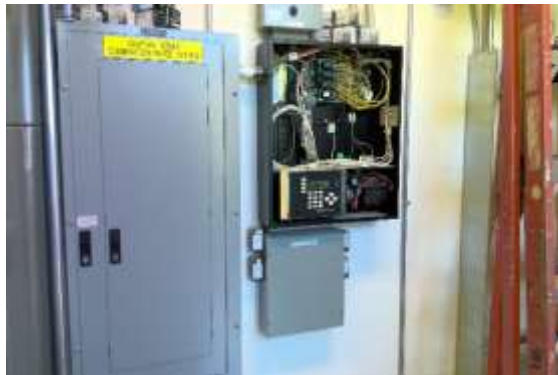
**Deficiency F11**

The lighting control panel is failing and is no longer supported by manufacturer. The control panel should be replaced to restore function to the lighting system.

| Deficiency score : $4 \times ((12 \times 70\%) + (15 \times 30\%)) + 0 = 51.6$ |

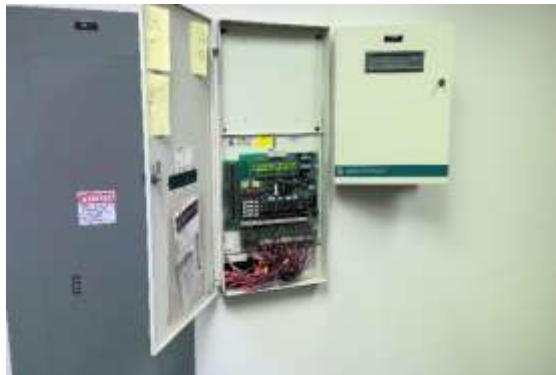
**Deficiency F12**

The lighting control panel is failing and is no longer supported by manufacturer. The control panel should be replaced to restore function to the lighting system.

| Deficiency score : $4 \times (15 \times 100\%) + 1 = 61$ |

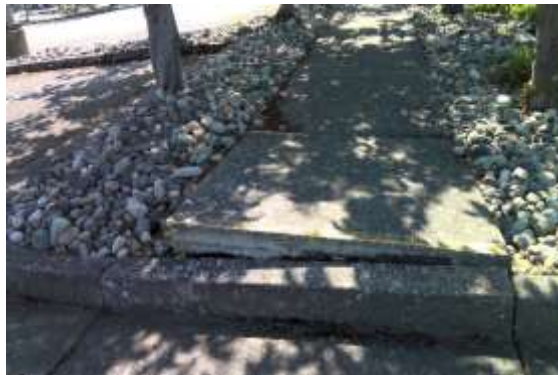
**Deficiency S01**

There are several areas of pedestrian access paths that have failed due to tree root growth. These sections of path surface and curbing should be replaced.

| Deficiency score : $4 \times ((12 \times 70\%) + (25 \times 30\%)) + 0 = 63.6$ |

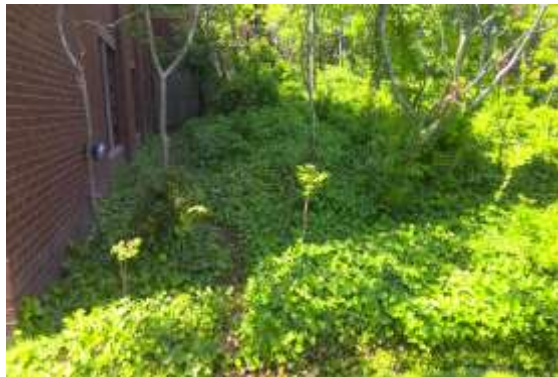
**Deficiency S02**

A section of cast iron sewer line has consistently become blocked. The line has little slope. The line needs to be cleaned out every two years. The pipe interior surface has degraded and causes material to build up easily. The section of pipe should be re-lined to provide a smooth interior surface and extend the useful life of the pipe.

| Deficiency score : $4 \times ((15 \times 80\%) + (20 \times 20\%)) + 0 = 64$ |

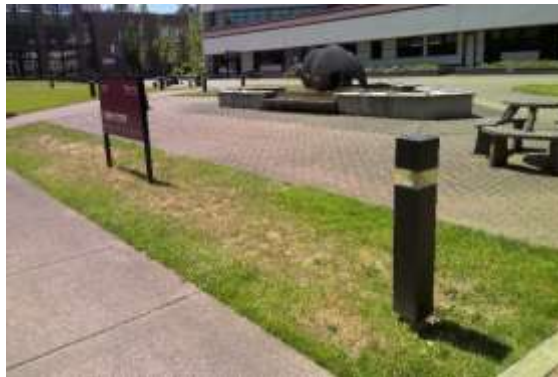
**Deficiency S03**

Eight of the twenty pedestrian light bollards have failed. Part are no longer available to repair the bollards. The bollards should be replaced.

| Deficiency score : $4 \times ((15 \times 80\%) + (10 \times 20\%)) + 0 = 56$ |

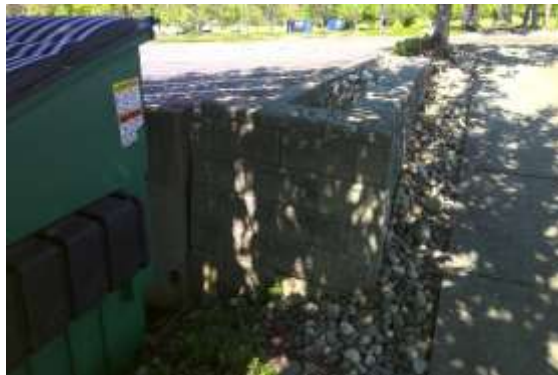
**Deficiency S05**

The retaining wall has started to lean. The failed retaining wall should be repaired to return it to the original function.

| Deficiency score : $4 \times (15 \times 100\%) + 0 = 60$ |
