# 2021 FACILITY CONDITION SURVEY

Centralia College

SURVEY CONDUCTED BY:  
Steve Lewandowski  
State Board for Community  
and Technical Colleges

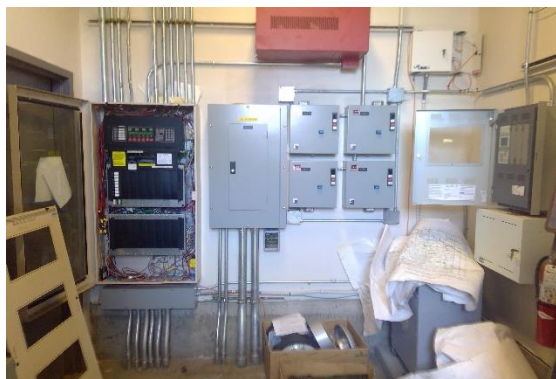
### **Deficiency F01**

Many buildings have an older generation of fire alarm panels that the college thinks are no longer supported by the vendor. These older panels have had difficulty communicating with the head-end monitoring system. If documentation describing the lack of support is provided by the college then these panels should be replaced.

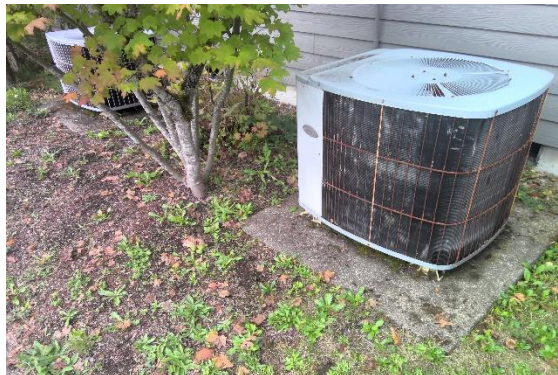
**Deficiency F02**

The heat pumps have degraded. The college has been required to replace various components to maintain use of the units. The heat pumps are at the end of their useful life and should be replaced.

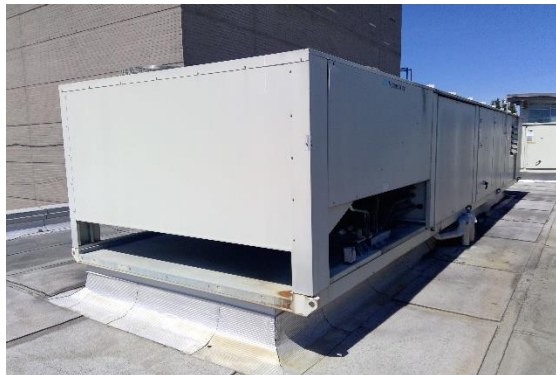
**Deficiency F03**

One of the mammoth HVAC units has several compressors that have failed. The unit should be repaired to regain full function.

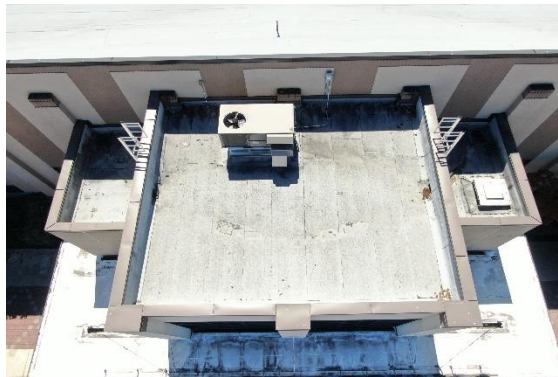
**Deficiency R01**

The north and south sections of roofing have degraded. There are areas of blistering surfaces and cracking. These sections of roofing should be repaired and reconditioned to extend its useful life.

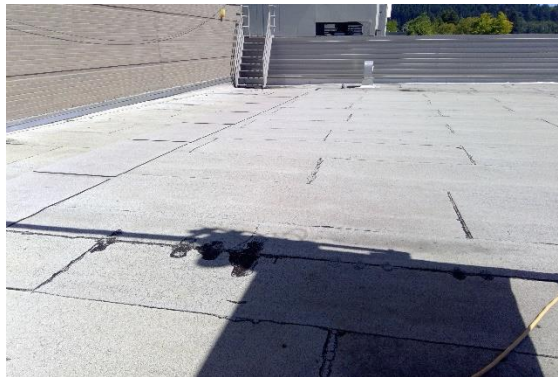
**Deficiency R02**

The roofing has degraded. There are areas of the roofing that has bubbles and cracking. The roof should be repaired and reconditioned to extend its useful life.
