# 2021 FACILITY CONDITION SURVEY

Clark College

SURVEY CONDUCTED BY:  
Steve Lewandowski  
State Board for Community  
and Technical Colleges

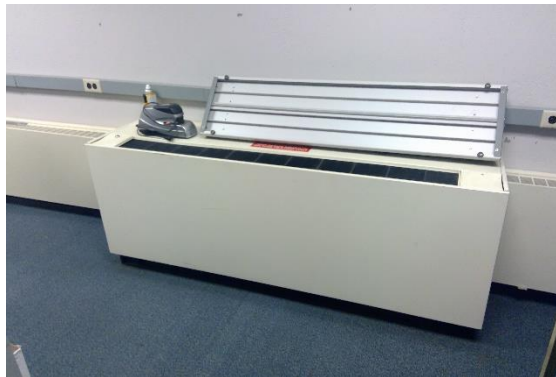
| Additional points based on building condition: 2 |
| Deficiency score : $2.5 \times ((10 \times 70\%) + (15 \times 30\%)) + 2 = 30.8$ |

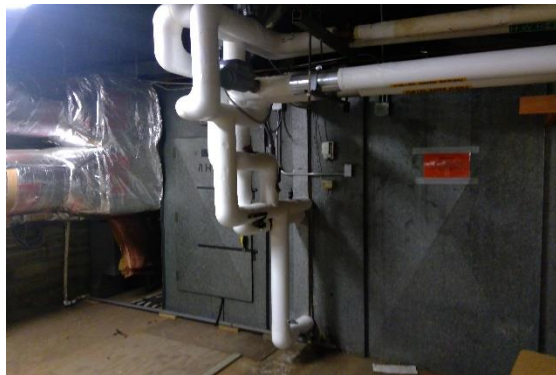
| Additional points based on building condition: 2 |
| Deficiency score : $1 \times ((10 \times 70\%) + (15 \times 30\%)) + 2 = 13.5$ |

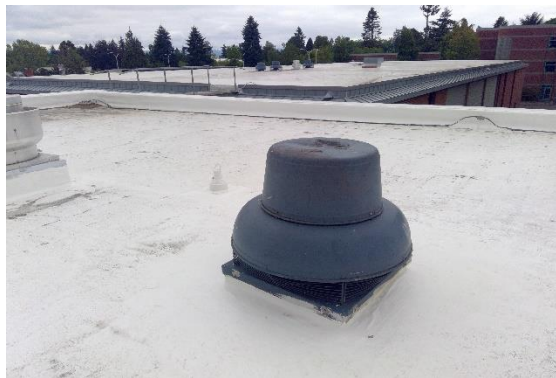
**Deficiency F09**

The exhaust fans no longer function and should be replaced.

| Additional points based on building condition: 2 |
| Deficiency score : $4 \times ((12 \times 60\%) + (15 \times 40\%)) + 2 = 54.8$ |

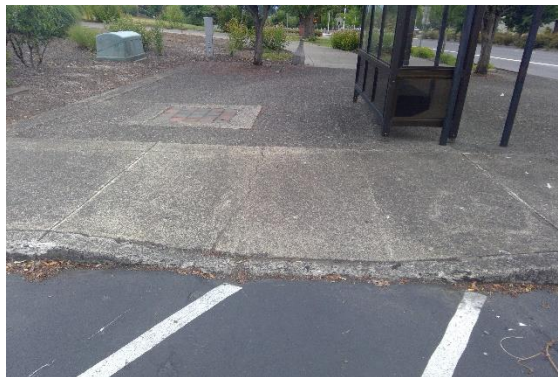
**Deficiency S01**

| Additional points based on building condition: 0 |
| Deficiency score : $4 \times (20 \times 100\%) + 0 = 80$ |

Deficiency S01: Replace sidewalks at the Main Campus (140A). Project cost estimate = \$60,000

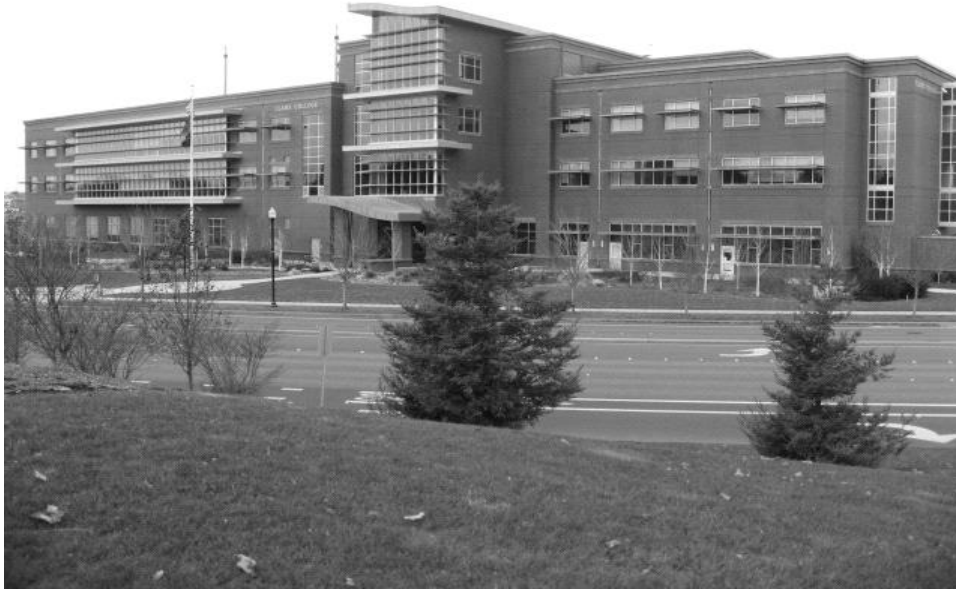
Clark College @ Ctc (140-CTC)      STATE UFI: A08429      Satellite Campus (140D)  
AREA: 69,928 SF      BUILT: 2009      REMODELED: No      PREDOMINANT USE: General Classroom  
CONSTRUCTION TYPE: Heavy      CRV/SF: \$474      REPLACEMENT VALUE: \$33,145,872

| Primary Systems | | | |
|---|---|---|---|
| No signs of settlement or cracking, no abrupt vertical changes Columns, bearing walls and roof structure appears sound/free of defects | | | |
| Majority of roofing and flashing appear sound, but a small portion of roofing shows deterioration where maintenance or minor repair needed | | | |

| Secondary Systems | | | |
|---|---|---|--|
| | Nice appearance, smooth transitions, level subfloors, no cracks/separating | | |
| | Maintainable surfaces in good condition | | |
| | Maintainable surfaces in good condition; good alignment and appearance | | |

| Service Systems | | | |
|---|---|---|--|
| | Fixtures and piping appear to be in good condition; no evidence of leaks | | |
| | Equipment in fair condition; minor deterioration; controls require troubleshooting; office areas have A/C; hazardous areas are ventilated | | |

| Safety Systems | | | |
|---|---|---|--|
| | Locally monitored detection; alarm and strobes present; sprinklers in high hazard areas | | |

| Quality Standards | | | |
|---|---|---|--|
| | Life expectancy is >20 years; minor system deterioration | | |

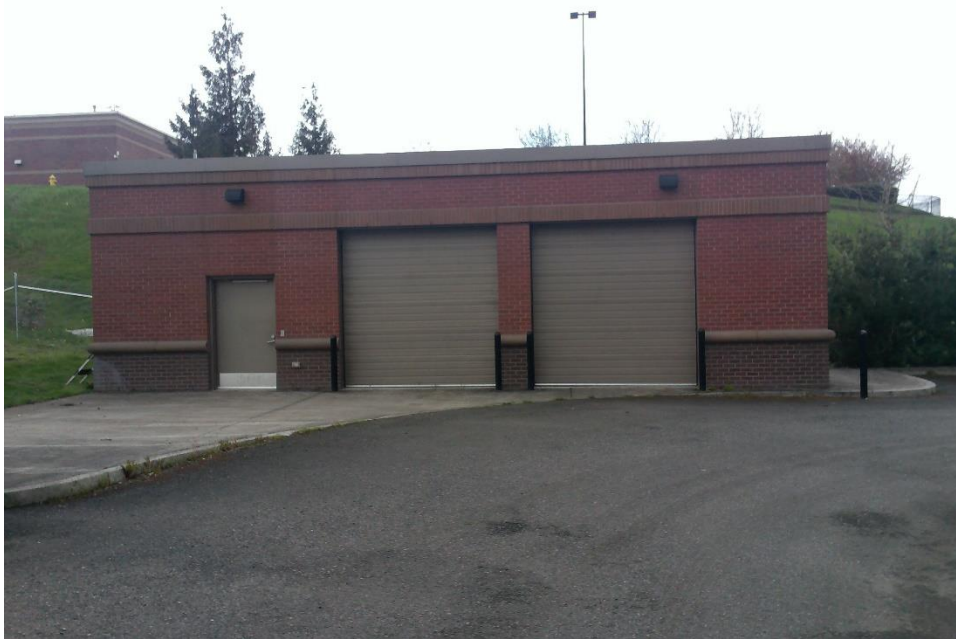
Ctc Storage Building (140-CSB)      STATE UFI: A21462      Satellite Campus (140D)  
AREA: 675 SF      BUILT: 2015      REMODELED: No      PREDOMINANT USE: Storage  
CONSTRUCTION TYPE: No data      CRV/SF: \$222      REPLACEMENT VALUE: \$149,850

| Primary Systems | | | |
|---|---|---|---|
| No signs of settlement or cracking, no abrupt vertical changes Columns, bearing walls and roof structure appears sound/free of defects | | | |

| Secondary Systems | | | |
|---|---|---|---|
| | Nice appearance, smooth transitions, level subfloors, no cracks/separating | | |
| | Maintainable surfaces in good condition | | |

| Safety Systems | | | |
|---|---|---|---|
| | Locally monitored detection; alarm and strobes present; sprinklers in high hazard areas | | |

| Quality Standards | | | |
|---|---|---|---|
| | Life expectancy is >20 years; minor system deterioration | | |

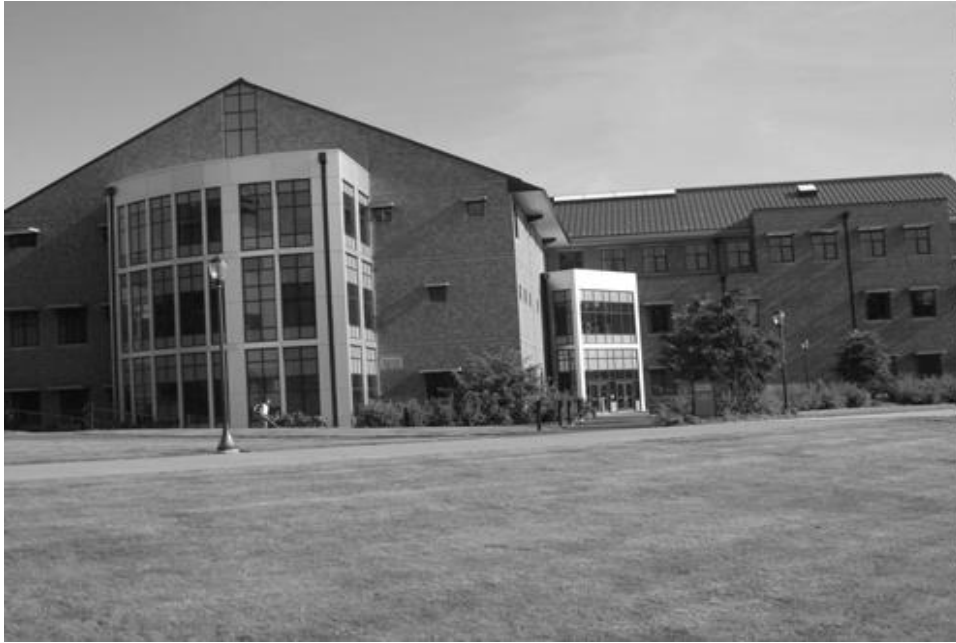
Clark College @ Wsuv (140-CCW)      STATE UFI: A04241      Wsu-V Campus (140C)  
AREA: 63,050 SF      BUILT: 2005      REMODELED: No      PREDOMINANT USE: Multi-Use  
CONSTRUCTION TYPE: Heavy      CRV/SF: \$469      REPLACEMENT VALUE: \$29,570,450

| Primary Systems | | | |
|---|---|---|--|
| No signs of settlement or cracking, no abrupt vertical changes Columns, bearing walls and roof structure appears sound/free of defects | | | |
| COMMENTS: | Standing seam metal and PVC single-ply; Kalwall skylights; good condition | | |

| Secondary Systems | | | |
|---|---|---|---|
| Some wear is evident; maintenance needed | | | |
| COMMENTS: | Linoleum; carpet-surface wear; concrete; ceramic tile | | |
| Maintainable surfaces in good condition | | | |
| Maintainable surfaces in good condition; good alignment and appearance | | | |

| Service Systems | | | |
|---|---|---|---|
| Fixtures and piping appear to be in good condition; no evidence of leaks | | | |
| Equipment in fair condition; minor deterioration; controls require troubleshooting; office areas have A/C; hazardous areas are ventilated | | | |

| Safety Systems | | | |
|---|---|---|---|
| Locally monitored detection; alarm and strobes present; sprinklers in high hazard areas | | | |

| Quality Standards | | | |
|---|---|---|---|
| Life expectancy is >20 years; minor system deterioration | | | |
