# 2021 FACILITY CONDITION SURVEY

Columbia Basin College

SURVEY CONDUCTED BY:  
Steve Lewandowski  
State Board for Community  
and Technical Colleges

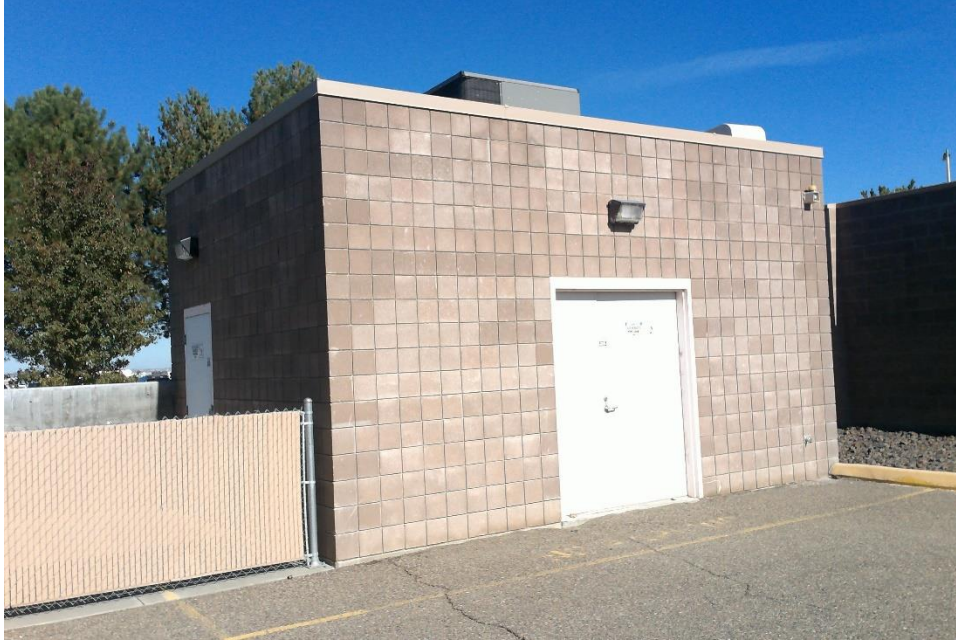
Chemical Bunker (190-0)      STATE UFI: A10317      Main Campus (190A)  
AREA: 270 SF      BUILT: 1995      REMODELED: No      PREDOMINANT USE: Storage  
CONSTRUCTION TYPE: No data      CRV/SF: \$144      REPLACEMENT VALUE: \$38,880

| Primary Systems | | | |
|---|---|---|---|
| No signs of settlement or cracking, no abrupt vertical changes Columns, bearing walls and roof structure appears sound/free of defects | | | |

| Secondary Systems | | | |
|---|---|---|---|
| | Nice appearance, smooth transitions, level subfloors, no cracks/separating | | |

| Service Systems | | | |
|---|---|---|---|
| | Fixtures and piping appear to be in good condition; no evidence of leaks | | |
| | Equipment in good condition; easily controlled; serves all required spaces; All necessary spaces are adequately ventilated; A/C provided | | |

| Safety Systems | | | |
|---|---|---|---|
| | Locally monitored detection; alarm and strobes present; sprinklers in high hazard areas | | |

| Quality Standards | | | |
|---|---|---|---|
| | Life expectancy is >20 years; minor system deterioration | | |

CONDITION: Adequate

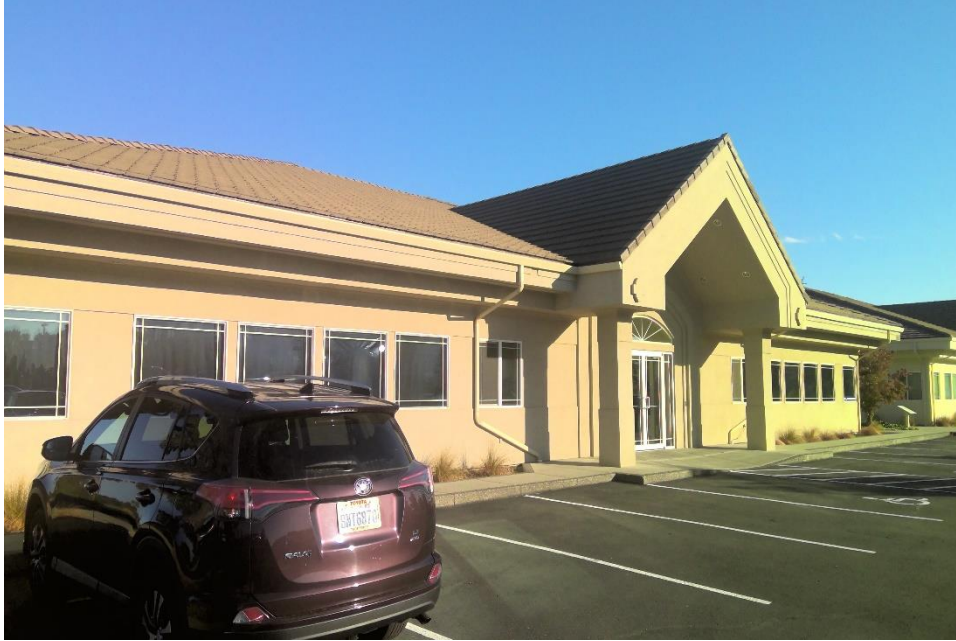
Andrews Office Complex (190-AOC)      STATE UFI: A25708      Main Campus (190A)  
AREA: 10,705 SF      BUILT: 2002      REMODELED: No      PREDOMINANT USE: Office  
CONSTRUCTION TYPE: No data      CRV/SF: \$300      REPLACEMENT VALUE: \$3,211,500

| Primary Systems | | | |
|---|---|---|--|
| No signs of settlement or cracking, no abrupt vertical changes Columns, bearing walls and roof structure appears sound/free of defects | | | |

| Secondary Systems | | | |
|---|---|---|---|
| | Some wear is evident; maintenance needed | | |
| | Maintainable surfaces in good condition | | |
| | Maintainable surfaces in good condition; good alignment and appearance | | |
| | Fairly modern door surfaces and hardware with minor deterioration; good working order | | |

| Service Systems | | | |
|---|---|---|---|
| | Fixtures and piping appear to be in good condition; no evidence of leaks | | |
| | Equipment in good condition; easily controlled; serves all required spaces; All necessary spaces are adequately ventilated; A/C provided | | |

| Safety Systems | | | |
|---|---|---|--|
| | Locally monitored detection; alarm present, but missing visual component or sprinklers | | |

| Quality Standards | | | |
|---|---|---|--|
| | Life expectancy is >20 years; minor system deterioration | | |

CONDITION: Adequate

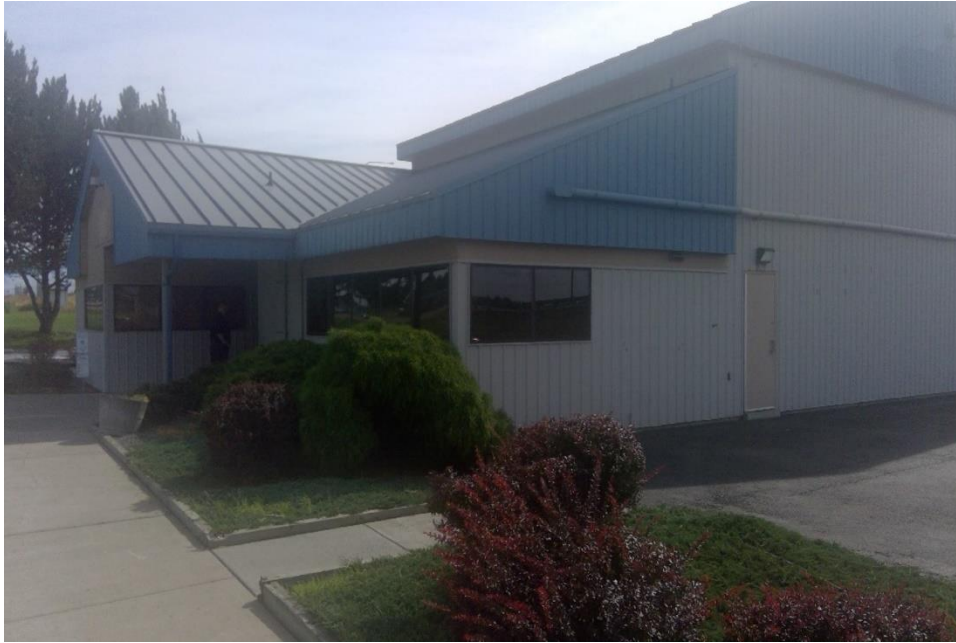
Fitness And Wellness Annex (190-FIT)      STATE UFI: A25431      Main Campus (190A)  
AREA: 5,400 SF      BUILT: 1989      REMODELED: No      PREDOMINANT USE: Multi-Use  
CONSTRUCTION TYPE: No data      CRV/SF: \$380      REPLACEMENT VALUE: \$2,052,000

| Primary Systems | | | |
|---|---|---|---|
| No signs of settlement or cracking, no abrupt vertical changes Columns, bearing walls and roof structure appears sound/free of defects | | | |
| Sound and weatherproof but with some deterioration evident | | | |
| Majority of roofing and flashing appear sound, but a small portion of roofing shows deterioration where maintenance or minor repair needed | | | |

| Secondary Systems | | | |
|---|---|---|--|
| | Some wear is evident; maintenance needed | | |
| | Aging surfaces in fair condition and good alignment | | |
| | Fairly modern door surfaces and hardware with minor deterioration; good working order | | |

| Service Systems | | | |
|---|---|---|--|
| | Equipment in fair condition; minor deterioration; controls require troubleshooting; office areas have A/C; hazardous areas are ventilated | | |
| | Adequate service and distribution capacity for current/future needs; some deterioration evident | | |

| Safety Systems | | | |
|---|---|---|--|
| | Locally monitored detection; alarm and strobes present; sprinklers in high hazard areas | | |

| Quality Standards | | | |
|---|---|---|--|
| | Life expectancy is roughly 10-15 years; moderate system deterioration | | |

TOTAL SCORE = 288      PREVIOUS BIENNIUM SCORE = 248  
CONDITION: Needs Improvement/Additional Maintenance

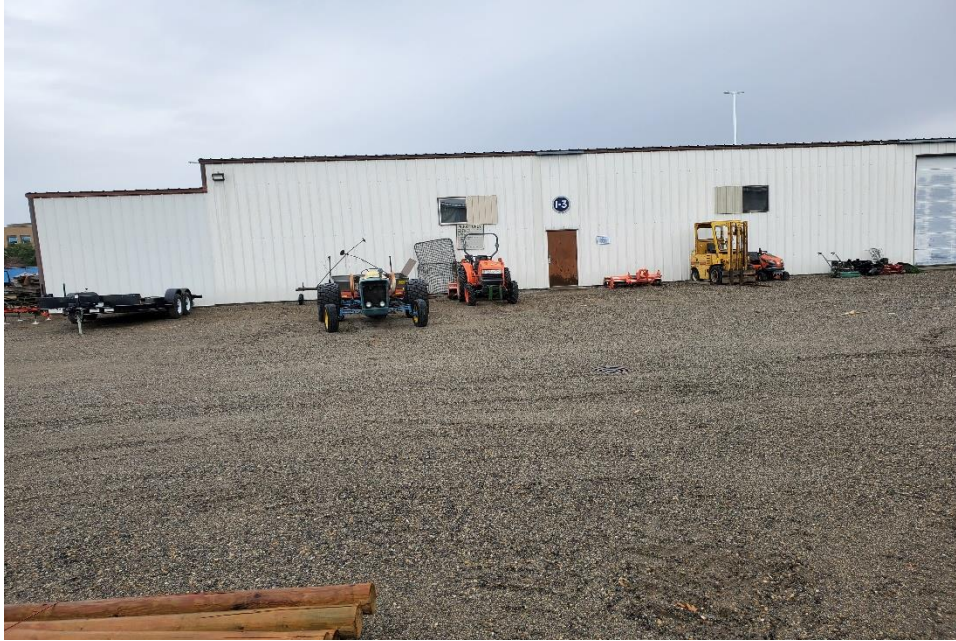
Industrial Building 3 (190-013)      STATE UFI: A09769      Main Campus (190A)  
AREA: 6,343 SF      BUILT: 1983      REMODELED: No      PREDOMINANT USE: General Classroom  
CONSTRUCTION TYPE: Medium      CRV/SF: \$234      REPLACEMENT VALUE: \$1,484,262

| Primary Systems | | | |
|---|---|---|--|
| No signs of settlement or cracking, no abrupt vertical changes Columns, bearing walls and roof structure appears sound/free of defects | | | |
| Sound and weatherproof but with some deterioration evident | | | |
| Some deterioration is evident in membrane and flashings; maintenance or minor repair is needed | | | |

| Secondary Systems | | | |
|---|---|---|---|
| | Some wear and minor imperfections are evident; beginning deterioration | | |
| | Maintainable surfaces in good condition; good alignment and appearance | | |

| Service Systems | | | |
|---|---|---|---|
| | Fixtures and piping appear to be in good condition; no evidence of leaks | | |
| | System generally adequate; some deterioration; needs balancing; Offices areas have A/C; hazardous areas are ventilated | | |
| | Generally adequate work area illumination; some areas with unsafe levels of illumination or inadequate outlets | | |

| Safety Systems | | | |
|---|---|---|---|
| | Generally meets codes for vintage of construction; minor health or accessibility violations exist | | |
| | Some of the modifications not well thought out or constructed; inadequate HVAC and electrical service provided | | |

| Quality Standards | | | |
|---|---|---|---|
| | Life expectancy is 5-10 years; moderate to significant system deterioration | | |

CONDITION: Needs Improvement/Renovation

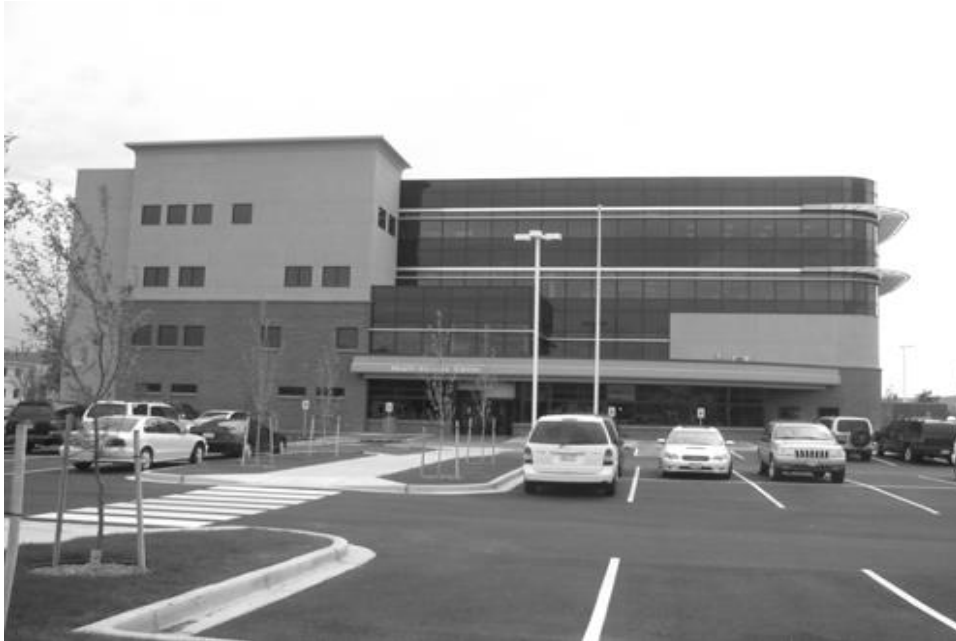
Health Science Center (190-00RS)      STATE UFI: A09278      Richland Campus (190B)  
 AREA: 67,010 SF      BUILT: 2004      REMODELED: 2013      PREDOMINANT USE: Vocational Arts  
 CONSTRUCTION TYPE: Medium      CRV/SF: \$379      REPLACEMENT VALUE: \$25,396,790

| Primary Systems | | | |
|---|---|---|---|
| No signs of settlement or cracking, no abrupt vertical changes Columns, bearing walls and roof structure appears sound/free of defects | | | |
| Majority of roofing and flashing appear sound, but a small portion of roofing shows deterioration where maintenance or minor repair needed | | | |
