# 2021 FACILITY CONDITION SURVEY

Pierce College Puyallup

SURVEY CONDUCTED BY:  
Steve Lewandowski  
State Board for Community  
and Technical Colleges

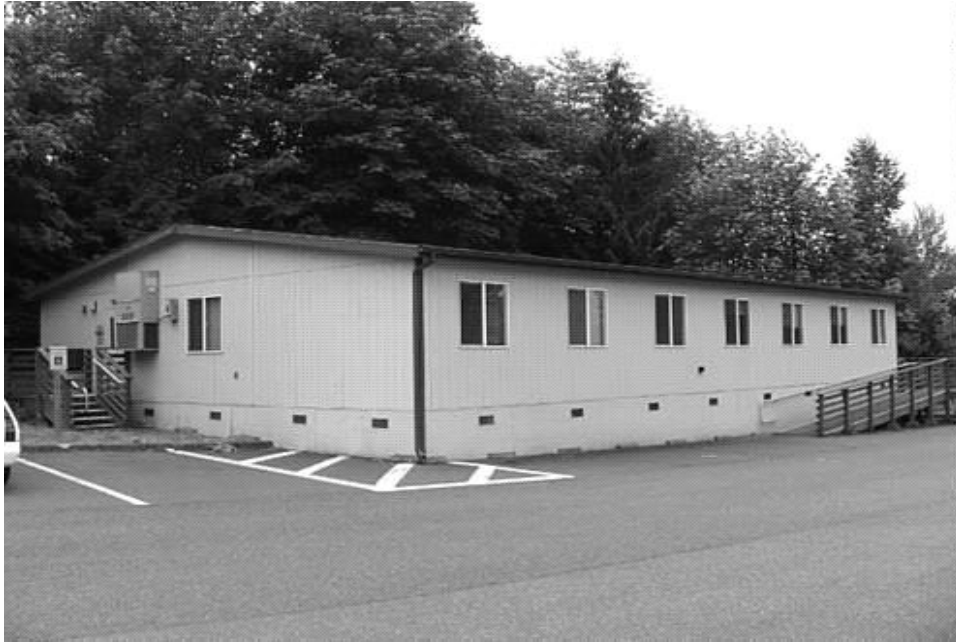
Puyallup Faculty Center (112-PC4)      STATE UFI: A02612      Puyallup Campus (112B)  
AREA: 2,688 SF      BUILT: 0      REMODELED: No      PREDOMINANT USE: Faculty Office  
CONSTRUCTION TYPE: Temporary      CRV/SF: \$190      REPLACEMENT VALUE: \$510,720

| Primary Systems | | | |
|---|---|---|---|
| COMPONENT: | Structure | RATING: 5 x WEIGHT: 8.8 = | SCORE: 44.2 |
