2021 FACILITY CONDITION SURVEY

Spokane Falls Community
College

SURVEY CONDUCTED BY:
Steve Lewandowski
State Board for Community
and Technical Colleges

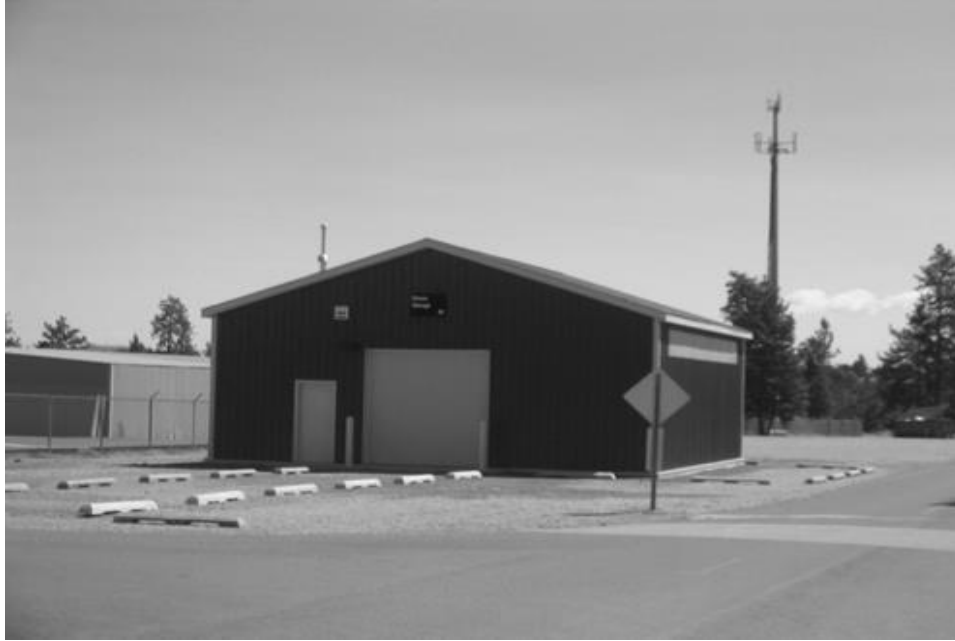
Drama Storage Building (172-26) STATE UF1: A01135 Main Campus (172A)
AREA: 1,440 SF BUILT: 2005 REMODELED: No PREDOMINANT USE: Storage
CONSTRUCTION TYPE: Light CRV/SF: \$190 REPLACEMENT VALUE: \$273,600

Primary Systems			
COMPONENT:	Structure	RATING: 1 x WEIGHT: 8.8 =	SCORE: 8.8
No signs of settlement or cracking, no abrupt vertical changes Columns, bearing walls and roof structure appears sound/free of defects			
COMMENTS:	Metal framing; concrete slab		
COMPONENT:	Exterior Closure	RATING: 1 x WEIGHT: 8.8 =	SCORE: 8.8
Weatherproof, tight, well-maintained exterior walls, doors, windows/finishes			
COMMENTS:	Metal wall panels		
COMPONENT:	Roofing	RATING: 1 x WEIGHT: 11.1 =	SCORE: 11.1
Flashing and penetrations appear sound and membrane appears water- tight; drainage is positive and there are overflow scuppers			
COMMENTS:	Standing seam metal roof

Secondary Systems			
COMPONENT:	Floor Finishes	RATING: 1 x WEIGHT: 6.6 =	SCORE: 6.6
Nice appearance, smooth transitions, level subfloors, no cracks/separating			
COMMENTS:	Concrete		
COMPONENT:	Wall Finishes	RATING: 1 x WEIGHT: 6.6 =	SCORE: 6.6
Maintainable surfaces in good condition			
COMMENTS:	Plywood; OSB		
COMPONENT:	Ceiling Finishes	RATING: 1 x WEIGHT: 6.6 =	SCORE: 6.6
Maintainable surfaces in good condition; good alignment and appearance			
COMMENTS:	Metal roof panels		
COMPONENT:	Doors & Hardware	RATING: 1 x WEIGHT: 6.6 =	SCORE: 6.6
Appropriate hardware, closers, panic devices; in good working order			
COMMENTS:	HM doors and frames; metal overhead door

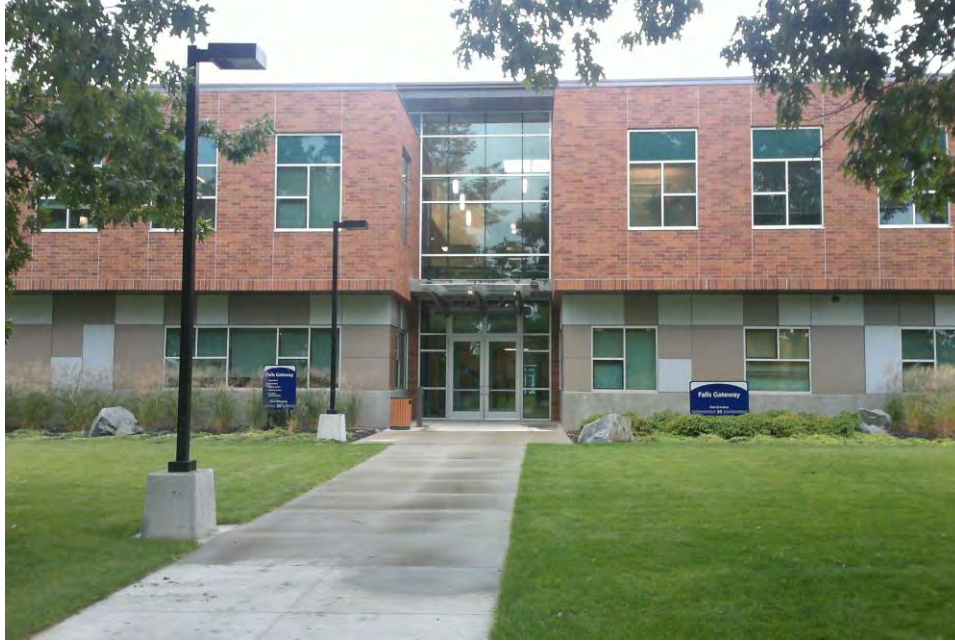
Falls Gateway (172-30) STATE UFI: A12985 Main Campus (172A)
AREA: 47,497 SF BUILT: 2013 REMODELED: No PREDOMINANT USE: Classroom
CONSTRUCTION TYPE: No data CRV/SF: \$342 REPLACEMENT VALUE: \$16,243,974

Primary Systems			
COMPONENT:	Structure	RATING: 1 x WEIGHT: 8 =	SCORE: 8
No signs of settlement or cracking, no abrupt vertical changes Columns, bearing walls and roof structure appears sound/free of defects			
COMMENTS:	No data		
COMPONENT:	Exterior Closure	RATING: 1 x WEIGHT: 8 =	SCORE: 8
Weatherproof, tight, well-maintained exterior walls, doors, windows/finishes			
COMMENTS:	No data		
COMPONENT:	Roofing	RATING: 1 x WEIGHT: 10 =	SCORE: 10
Flashing and penetrations appear sound and membrane appears water- tight; drainage is positive and there are overflow scuppers			
COMMENTS:	No data

Secondary Systems			
COMPONENT:	Floor Finishes	RATING: 1 x WEIGHT: 6 =	SCORE: 6
	Nice appearance, smooth transitions, level subfloors, no cracks/separating		
COMMENTS:	No data		
COMPONENT:	Wall Finishes	RATING: 1 x WEIGHT: 6 =	SCORE: 6
	Maintainable surfaces in good condition		
COMMENTS:	No data		
COMPONENT:	Ceiling Finishes	RATING: 1 x WEIGHT: 6 =	SCORE: 6
	Maintainable surfaces in good condition; good alignment and appearance		
COMMENTS:	No data		
COMPONENT:	Doors & Hardware	RATING: 1 x WEIGHT: 6 =	SCORE: 6
	Appropriate hardware, closers, panic devices; in good working order		
COMMENTS:	No data

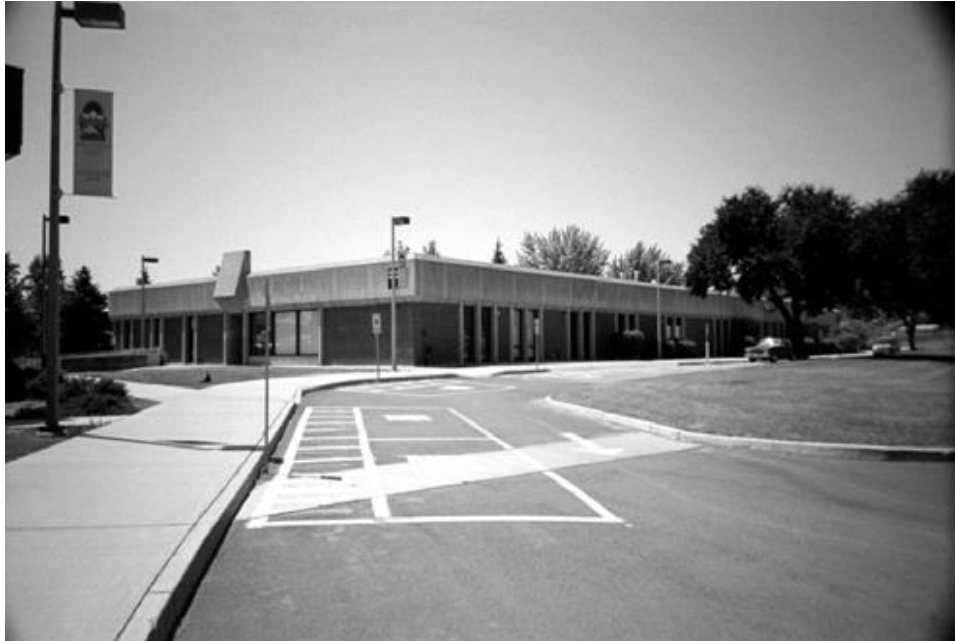
Human Services (172-16) STATE UFI: A08600 Main Campus (172A)
AREA: 34,270 SF BUILT: 1975 REMODELED: 2016 PREDOMINANT USE: Vocational Arts
CONSTRUCTION TYPE: Medium CRV/SF: \$379 REPLACEMENT VALUE: \$12,988,330

Primary Systems			
COMPONENT:	Structure	RATING: 1 x WEIGHT: 8.3 =	SCORE: 8.3
No signs of settlement or cracking, no abrupt vertical changes Columns, bearing walls and roof structure appears sound/free of defects			
COMMENTS:	Brick and concrete; steel		
COMPONENT:	Exterior Closure	RATING: 1 x WEIGHT: 8.3 =	SCORE: 8.3
Weatherproof, tight, well-maintained exterior walls, doors, windows/finishes			
COMMENTS:	Brick facing; concrete columns; plaster fascia		
COMPONENT:	Roofing	RATING: 3 x WEIGHT: 10.4 =	SCORE: 31.3
Some deterioration is evident in membrane and flashings; maintenance or minor repair is needed			
COMMENTS:	BUR; Parapet needs new caulking or metal cap; new UV coating in 2002

Secondary Systems			
COMPONENT:	Floor Finishes	RATING: 2 x WEIGHT: 6.3 =	SCORE: 12.5
Some wear is evident; maintenance needed			
COMMENTS:	Terrazzo; vinyl tile; carpet; some wear on carpet		
COMPONENT:	Wall Finishes	RATING: 1 x WEIGHT: 6.3 =	SCORE: 6.3
Maintainable surfaces in good condition			
COMMENTS:	Gypsum board and vinyl wall covering; ceramic tile		
COMPONENT:	Ceiling Finishes	RATING: 3 x WEIGHT: 6.3 =	SCORE: 18.8
Some wear and tear; Minor staining or deterioration			
COMMENTS:	Lay-in tile throughout; some need cleaning/tile replacement; odd sized tiles		
COMPONENT:	Doors & Hardware	RATING: 1 x WEIGHT: 6.3 =	SCORE: 6.3
Appropriate hardware, closers, panic devices; in good working order			
COMMENTS:	Interior and exterior HM doors and frames

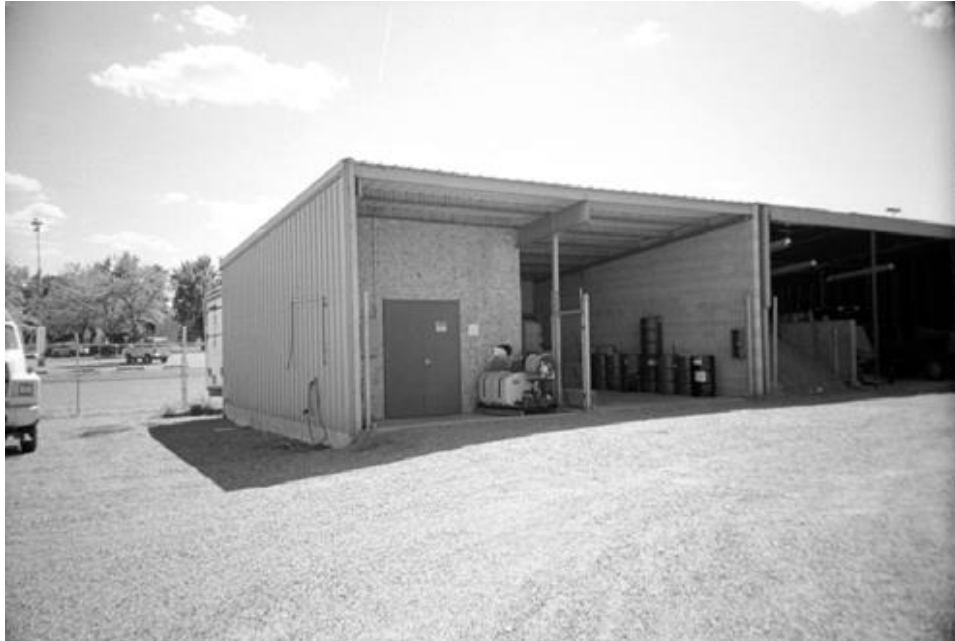
Pesticide Storage Shed (172-23) STATE UFI: A06123 Main Campus (172A)
AREA: 400 SF BUILT: 2000 REMODELED: No PREDOMINANT USE: Storage
CONSTRUCTION TYPE: Light CRV/SF: \$190 REPLACEMENT VALUE: \$76,000

Primary Systems			
COMPONENT:	Structure	RATING: 1 x WEIGHT: 8.7 =	SCORE: 8.7
No signs of settlement or cracking, no abrupt vertical changes Columns, bearing walls and roof structure appears sound/free of defects			
COMMENTS:	Metal frame		
COMPONENT:	Exterior Closure	RATING: 3 x WEIGHT: 8.7 =	SCORE: 26.1
Sound and weatherproof but with some deterioration evident			
COMMENTS:	Unfinished strand board		
COMPONENT:	Roofing	RATING: 1 x WEIGHT: 10.9 =	SCORE: 10.9
Flashing and penetrations appear sound and membrane appears water- tight; drainage is positive and there are overflow scuppers			
COMMENTS:	Metal roof

Secondary Systems			
COMPONENT:	Floor Finishes	RATING: 1 x WEIGHT: 6.5 = SCORE: 6.5	
	Nice appearance, smooth transitions, level subfloors, no cracks/separating		
COMMENTS:	Concrete		
COMPONENT:	Wall Finishes	RATING: 1 x WEIGHT: 6.5 = SCORE: 6.5	
	Maintainable surfaces in good condition		
COMMENTS:	Plastic wall panels		
COMPONENT:	Ceiling Finishes	RATING: 1 x WEIGHT: 6.5 = SCORE: 6.5	
	Maintainable surfaces in good condition; good alignment and appearance		
COMMENTS:	No ceiling; insulated under roof deck		
COMPONENT:	Doors & Hardware	RATING: 1 x WEIGHT: 6.5 = SCORE: 6.5	
	Appropriate hardware, closers, panic devices; in good working order		
COMMENTS:	Metal doors

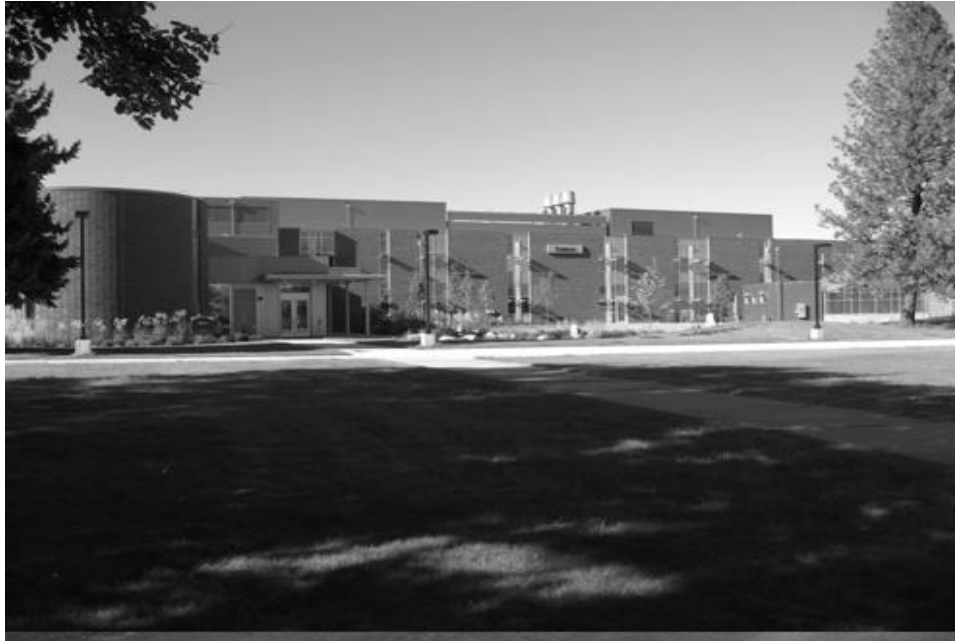
Science (172-28) STATE UFI: A10555 Main Campus (172A)
AREA: 70,823 SF BUILT: 2011 REMODELED: No PREDOMINANT USE: Science Lab.
CONSTRUCTION TYPE: Heavy CRV/SF: \$474 REPLACEMENT VALUE: \$33,570,102

Primary Systems			
COMPONENT:	Structure	RATING: 1 x WEIGHT: 8 =	SCORE: 8
No signs of settlement or cracking, no abrupt vertical changes Columns, bearing walls and roof structure appears sound/free of defects			
COMMENTS:	Structural steel; concrete; polished concrete block		
COMPONENT:	Exterior Closure	RATING: 1 x WEIGHT: 8 =	SCORE: 8
Weatherproof, tight, well-maintained exterior walls, doors, windows/finishes			
COMMENTS:	Brick; polished concrete block; metal architectural panels		
COMPONENT:	Roofing	RATING: 1 x WEIGHT: 10 =	SCORE: 10
Flashing and penetrations appear sound and membrane appears water- tight; drainage is positive and there are overflow scuppers			
COMMENTS:	Single-ply TPO membrane

Secondary Systems			
COMPONENT:	Floor Finishes	RATING: 1 x WEIGHT: 6 = SCORE: 6	
	Nice appearance, smooth transitions, level subfloors, no cracks/separating		
COMMENTS:	Terrazzo; ceramic tile; carpet tile; sheet vinyl; coated concrete		
COMPONENT:	Wall Finishes	RATING: 1 x WEIGHT: 6 = SCORE: 6	
	Maintainable surfaces in good condition		
COMMENTS:	Concrete; Gypsum board; fiberboard scuff panels; ceramic tile; CMU		
COMPONENT:	Ceiling Finishes	RATING: 1 x WEIGHT: 6 = SCORE: 6	
	Maintainable surfaces in good condition; good alignment and appearance		
COMMENTS:	Deck pan; lay-in tile; Gypsum board; concrete		
COMPONENT:	Doors & Hardware	RATING: 1 x WEIGHT: 6 = SCORE: 6	
	Appropriate hardware, closers, panic devices; in good working order		
COMMENTS:	Interior wood doors w HM frames-most w glazing; exterior aluminum doors/frames and HM doors/frames

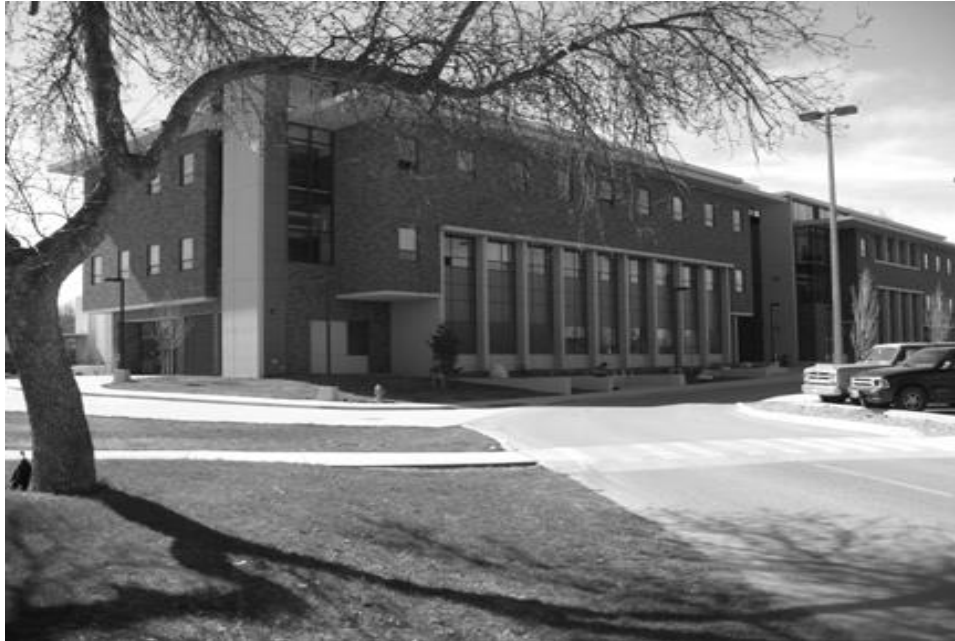
Sn-W'Ey'-Mn (172-24) STATE UFI: A06297 Main Campus (172A)
AREA: 70,533 SF BUILT: 2007 REMODELED: No PREDOMINANT USE: General Classroom
CONSTRUCTION TYPE: Heavy CRV/SF: \$361 REPLACEMENT VALUE: \$25,462,413

Primary Systems			
COMPONENT:	Structure	RATING: 1 x WEIGHT: 8 =	SCORE: 8
No signs of settlement or cracking, no abrupt vertical changes Columns, bearing walls and roof structure appears sound/free of defects			
COMMENTS:	Structural steel; cast concrete		
COMPONENT:	Exterior Closure	RATING: 1 x WEIGHT: 8 =	SCORE: 8
Weatherproof, tight, well-maintained exterior walls, doors, windows/finishes			
COMMENTS:	Corrugated metal panels; cast concrete; brick		
COMPONENT:	Roofing	RATING: 1 x WEIGHT: 10 =	SCORE: 10
Flashing and penetrations appear sound and membrane appears water- tight; drainage is positive and there are overflow scuppers			
COMMENTS:	Single-ply TPO membrane

Secondary Systems			
COMPONENT:	Floor Finishes	RATING: 1 x WEIGHT: 6 = SCORE: 6	
	Nice appearance, smooth transitions, level subfloors, no cracks/separating		
COMMENTS:	Terrazzo; carpet tile; linoleum; vinyl tile; ceramic tile		
COMPONENT:	Wall Finishes	RATING: 1 x WEIGHT: 6 = SCORE: 6	
	Maintainable surfaces in good condition		
COMMENTS:	Vinyl panels; gypsum board; ceramic tile; cast concrete; brick; window walls		
COMPONENT:	Ceiling Finishes	RATING: 1 x WEIGHT: 6 = SCORE: 6	
	Maintainable surfaces in good condition; good alignment and appearance		
COMMENTS:	Lay-ins; gypsum board		
COMPONENT:	Doors & Hardware	RATING: 1 x WEIGHT: 6 = SCORE: 6	
	Appropriate hardware, closers, panic devices; in good working order		
COMMENTS:	Exterior aluminum glazed doors/frames; interior bamboo doors/HM frames

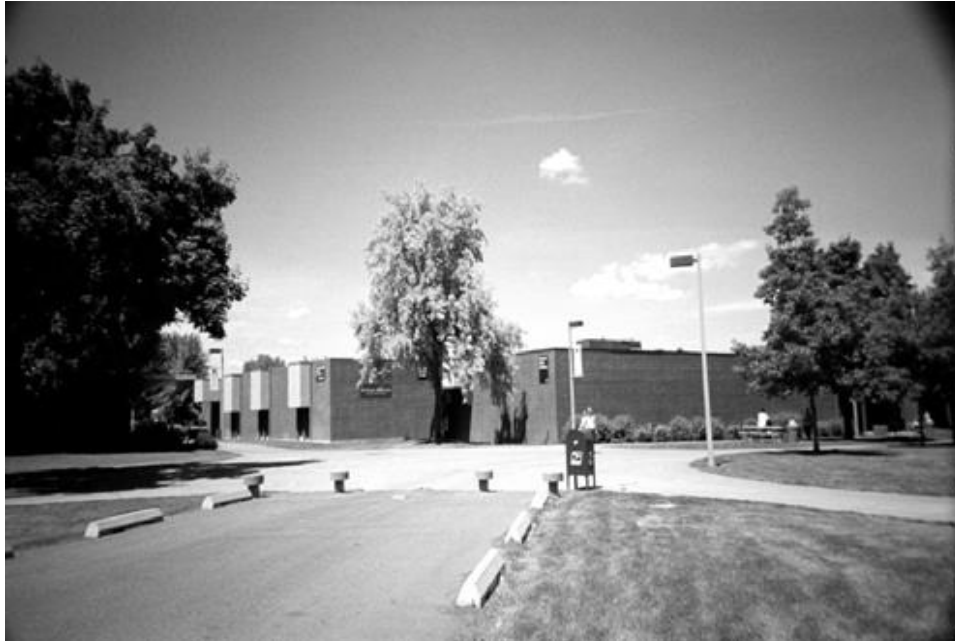
Student Union Building (172-17) STATE UFI: A02310 Main Campus (172A)
AREA: 78,295 SF BUILT: 1976 REMODELED: 2016 PREDOMINANT USE: Student Center
CONSTRUCTION TYPE: Heavy CRV/SF: \$376 REPLACEMENT VALUE: \$29,438,920

Primary Systems			
COMPONENT:	Structure	RATING: 1 x WEIGHT: 8 =	SCORE: 8
No signs of settlement or cracking, no abrupt vertical changes Columns, bearing walls and roof structure appears sound/free of defects			
COMMENTS:	Brick and concrete		
COMPONENT:	Exterior Closure	RATING: 1 x WEIGHT: 8 =	SCORE: 8
Weatherproof, tight, well-maintained exterior walls, doors, windows/finishes			
COMMENTS:	Brick exterior		
COMPONENT:	Roofing	RATING: 3 x WEIGHT: 10 =	SCORE: 30
Some deterioration is evident in membrane and flashings; maintenance or minor repair is needed			
COMMENTS:	BUR; newer roof on main building area; new UV coat on remainder

Secondary Systems			
COMPONENT:	Floor Finishes	RATING: 2 x WEIGHT: 6 = SCORE: 12	
	Some wear is evident; maintenance needed		
COMMENTS:	Vinyl tile; carpet; terrazzo; carpet tile; concrete; laminate; ceramic tile		
COMPONENT:	Wall Finishes	RATING: 1 x WEIGHT: 6 = SCORE: 6	
	Maintainable surfaces in good condition		
COMMENTS:	Gypsum board; vinyl wall covering; ceramic tile		
COMPONENT:	Ceiling Finishes	RATING: 3 x WEIGHT: 6 = SCORE: 18	
	Some wear and tear; Minor staining or deterioration		
COMMENTS:	Lay-in tile, primarily 24"x60"; Gypsum board; concealed spline tile		
COMPONENT:	Doors & Hardware	RATING: 3 x WEIGHT: 6 = SCORE: 18	
	Functional but dated		
COMMENTS:	Interior wood and HM doors/HM frames' exterior aluminum doors/frames and steel doors/frames

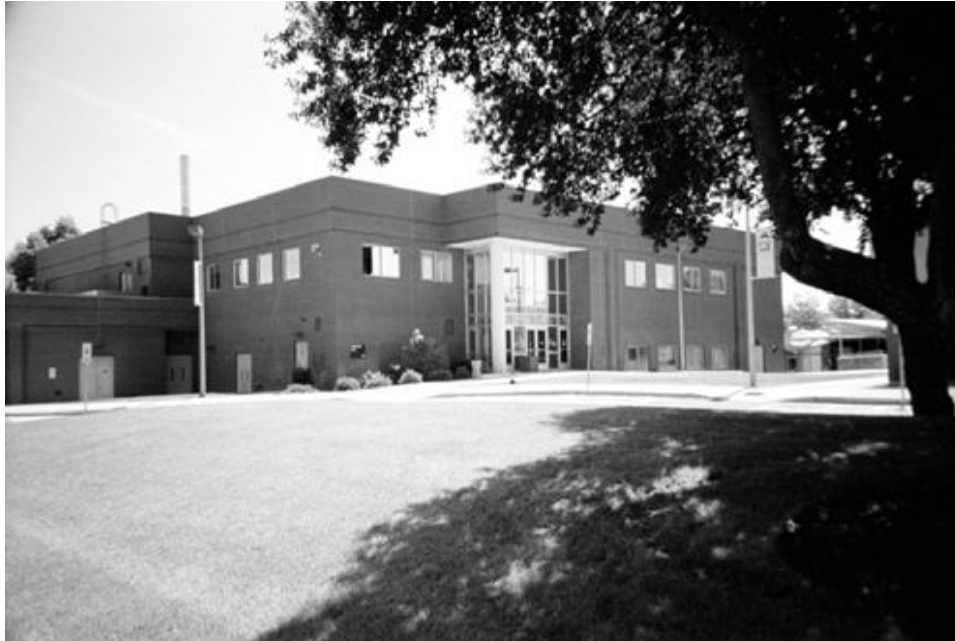
Technical Arts (172-19) STATE UFI: A03711 Main Campus (172A)
AREA: 41,457 SF BUILT: 1994 REMODELED: No PREDOMINANT USE: Vocational Arts
CONSTRUCTION TYPE: Heavy CRV/SF: \$379 REPLACEMENT VALUE: \$15,712,203

Primary Systems			
COMPONENT:	Structure	RATING: 1 x WEIGHT: 8 =	SCORE: 8
No signs of settlement or cracking, no abrupt vertical changes Columns, bearing walls and roof structure appears sound/free of defects			
COMMENTS:	Concrete and steel		
COMPONENT:	Exterior Closure	RATING: 1 x WEIGHT: 8 =	SCORE: 8
Weatherproof, tight, well-maintained exterior walls, doors, windows/finishes			
COMMENTS:	Brick exterior		
COMPONENT:	Roofing	RATING: 2 x WEIGHT: 10 =	SCORE: 20
Majority of roofing and flashing appear sound, but a small portion of roofing shows deterioration where maintenance or minor repair needed			
COMMENTS:	BUR in good condition; new UV coat applied in 2008

Secondary Systems				
COMPONENT:	Floor Finishes	RATING: 2	x WEIGHT: 6	= SCORE: 12
	Some wear is evident; maintenance needed			
COMMENTS:	Vinyl tile and carpet; ceramic tile			
COMPONENT:	Wall Finishes	RATING: 2	x WEIGHT: 6	= SCORE: 12
	Maintainable surfaces, minor maintenance is required in some areas			
COMMENTS:	Gypsum board; vinyl wall covering-random seam lifting throughout; ceramic tile			
COMPONENT:	Ceiling Finishes	RATING: 1	x WEIGHT: 6	= SCORE: 6
	Maintainable surfaces in good condition; good alignment and appearance			
COMMENTS:	Gypsum board; stained ceiling panels in several areas of 2nd floor			
COMPONENT:	Doors & Hardware	RATING: 1	x WEIGHT: 6	= SCORE: 6
	Appropriate hardware, closers, panic devices; in good working order			
COMMENTS:	Interior laminate doors w HM frames; exterior aluminum doors/frames and HM doors/frames

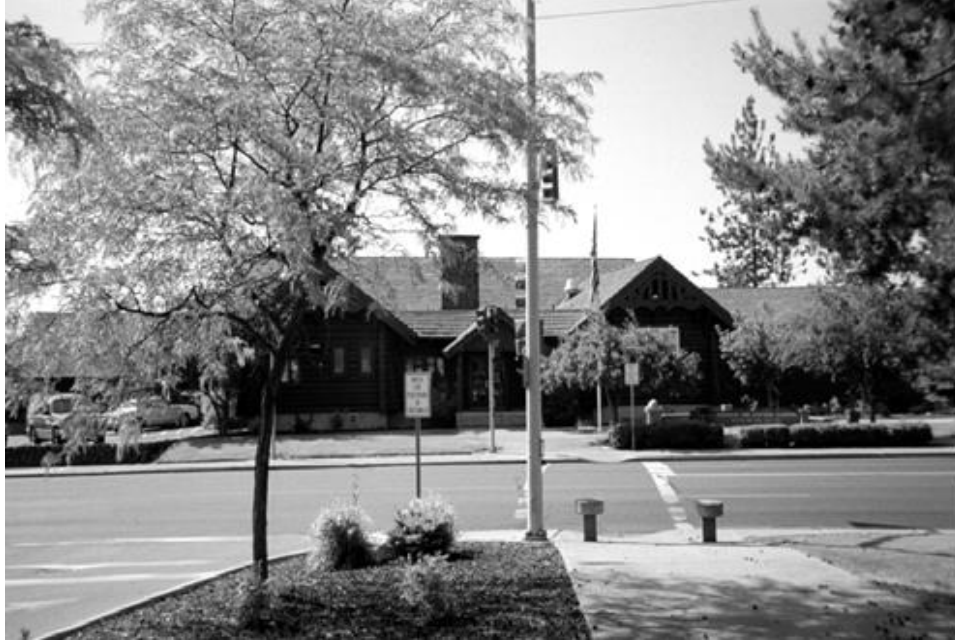
Lodge (172-9) STATE UFI: A01909 Main Campus (172A)
 AREA: 19,080 SF BUILT: 1943 REMODELED: 2005 PREDOMINANT USE: General Classroom
 CONSTRUCTION TYPE: Light CRV/SF: \$361 REPLACEMENT VALUE: \$6,887,880

Primary Systems			
COMPONENT:	Structure	RATING: 1 x WEIGHT: 8 =	SCORE: 8
No signs of settlement or cracking, no abrupt vertical changes Columns, bearing walls and roof structure appears sound/free of defects			
COMMENTS:	Wood frame; concrete; logs		
COMPONENT:	Exterior Closure	RATING: 1 x WEIGHT: 8 =	SCORE: 8
Weatherproof, tight, well-maintained exterior walls, doors, windows/finishes			
COMMENTS:	Log walls; concrete; wood siding		
COMPONENT:	Roofing	RATING: 4 x WEIGHT: 10 =	SCORE: 40
General deterioration and some leaks are evident; resurfacing or partial repair is needed			
COMMENTS:	New roof installed in 2006 - vinyl/cement shakes

Secondary Systems			
COMPONENT:	Floor Finishes	RATING: 3 x WEIGHT: 6 = SCORE: 18	
	Some wear and minor imperfections are evident; beginning deterioration		
COMMENTS:	Vinyl tile and carpet; ceramic tile; wood floors refinished in 06		
COMPONENT:	Wall Finishes	RATING: 1 x WEIGHT: 6 = SCORE: 6	
	Maintainable surfaces in good condition		
COMMENTS:	Wood and Gypsum board; ceramic tile		
COMPONENT:	Ceiling Finishes	RATING: 3 x WEIGHT: 6 = SCORE: 18	
	Some wear and tear; Minor staining or deterioration		
COMMENTS:	Wood and Gypsum board; acoustical tile-sagging in areas		
COMPONENT:	Doors & Hardware	RATING: 3 x WEIGHT: 6 = SCORE: 18	
	Functional but dated		
COMMENTS:	Interior and exterior wood doors/frames

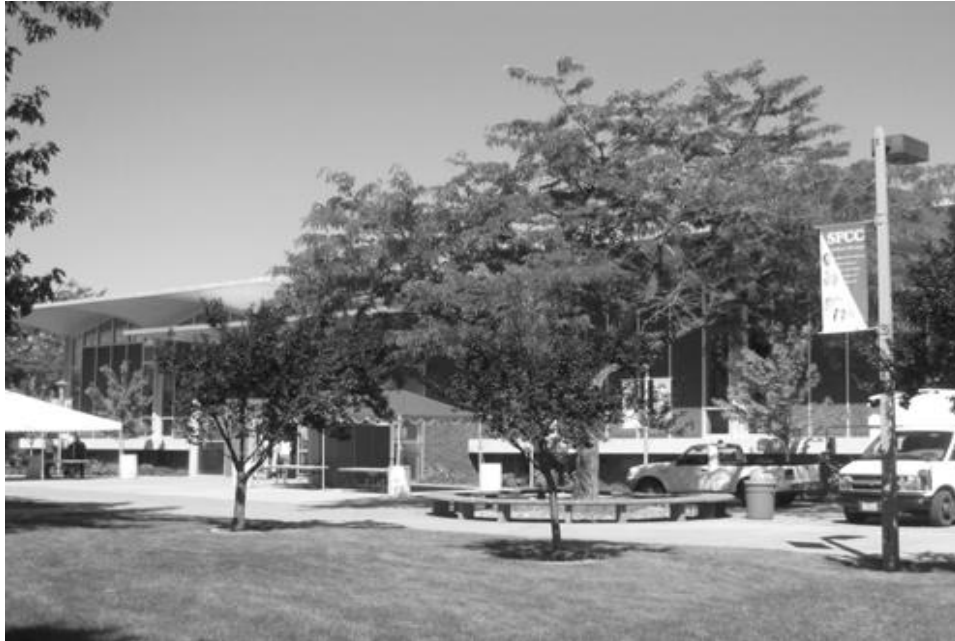
Library (172-2) STATE UFI: A09692 Main Campus (172A)
 AREA: 48,074 SF BUILT: 1965 REMODELED: 2003 PREDOMINANT USE: Library
 CONSTRUCTION TYPE: Heavy CRV/SF: \$361 REPLACEMENT VALUE: \$17,354,714

Primary Systems			
COMPONENT:	Structure	RATING: 1 x WEIGHT: 8 =	SCORE: 8
No signs of settlement or cracking, no abrupt vertical changes Columns, bearing walls and roof structure appears sound/free of defects			
COMMENTS:	Concrete column and beam; concrete roof		
COMPONENT:	Exterior Closure	RATING: 1 x WEIGHT: 8 =	SCORE: 8
Weatherproof, tight, well-maintained exterior walls, doors, windows/finishes			
COMMENTS:	Brick and concrete; window walls and CMU		
COMPONENT:	Roofing	RATING: 2 x WEIGHT: 10 =	SCORE: 20
Majority of roofing and flashing appear sound, but a small portion of roofing shows deterioration where maintenance or minor repair needed			
COMMENTS:	Foam roof on portion and built-up roof w UV coat on rest; minor UV coat wear

Secondary Systems			
COMPONENT:	Floor Finishes	RATING: 3 x WEIGHT: 6 = SCORE: 18	
	Some wear and minor imperfections are evident; beginning deterioration		
COMMENTS:	Random carpet wear in basement; vinyl tile; sheet vinyl; ceramic tile		
COMPONENT:	Wall Finishes	RATING: 1 x WEIGHT: 6 = SCORE: 6	
	Maintainable surfaces in good condition		
COMMENTS:	CMU; gypsum board; ceramic tile		
COMPONENT:	Ceiling Finishes	RATING: 1 x WEIGHT: 6 = SCORE: 6	
	Maintainable surfaces in good condition; good alignment and appearance		
COMMENTS:	Concrete; lay-in ceiling tiles		
COMPONENT:	Doors & Hardware	RATING: 3 x WEIGHT: 6 = SCORE: 18	
	Functional but dated		
COMMENTS:	Interior wood/laminate doors w HM frames-damaged in basement; aluminum exterior doors/frames

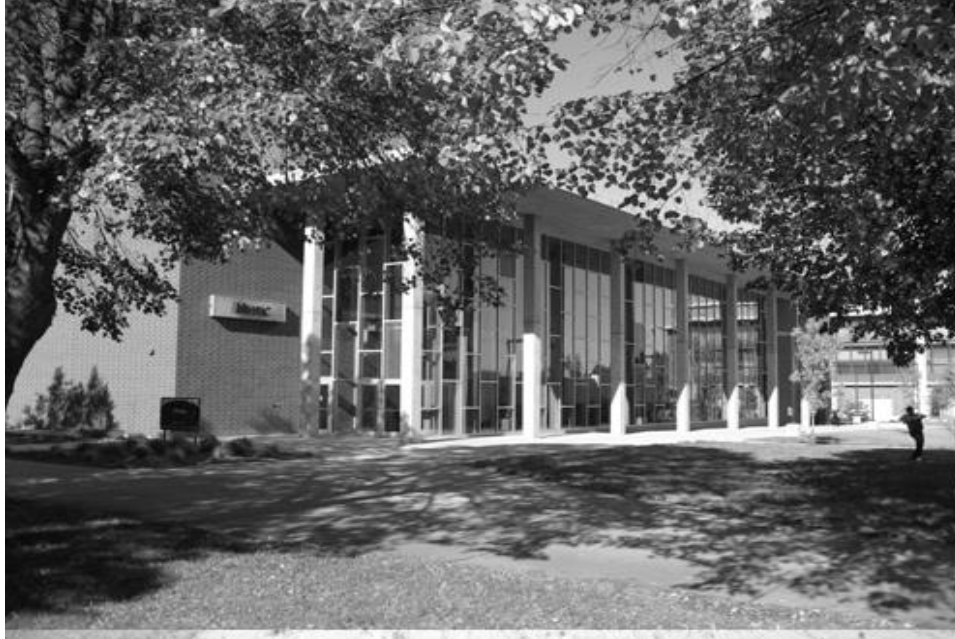
Music (172-15) STATE UFI: A01914 Main Campus (172A)
 AREA: 50,571 SF BUILT: 1971 REMODELED: 2010 PREDOMINANT USE: Performing Arts
 CONSTRUCTION TYPE: Heavy CRV/SF: \$404 REPLACEMENT VALUE: \$20,430,684

Primary Systems			
COMPONENT:	Structure	RATING: 1 x WEIGHT: 8 =	SCORE: 8
No signs of settlement or cracking, no abrupt vertical changes Columns, bearing walls and roof structure appears sound/free of defects			
COMMENTS:	Cement columns; concrete, steel and brick		
COMPONENT:	Exterior Closure	RATING: 1 x WEIGHT: 8 =	SCORE: 8
Weatherproof, tight, well-maintained exterior walls, doors, windows/finishes			
COMMENTS:	Brick and aluminum window walls		
COMPONENT:	Roofing	RATING: 1 x WEIGHT: 10 =	SCORE: 10
Flashing and penetrations appear sound and membrane appears water- tight; drainage is positive and there are overflow scuppers			
COMMENTS:	Single-ply TPO membrane; BUR w capsheet; BUR w UV coating-worn; skylight

Secondary Systems			
COMPONENT:	Floor Finishes	RATING: 1 x WEIGHT: 6 = SCORE: 6	
	Nice appearance, smooth transitions, level subfloors, no cracks/separating		
COMMENTS:	Ceramic tile; carpet tile; resilient tile		
COMPONENT:	Wall Finishes	RATING: 1 x WEIGHT: 6 = SCORE: 6	
	Maintainable surfaces in good condition		
COMMENTS:	Bamboo panels; Gypsum board; fiberboard soffit panels; ceramic tile; CMU		
COMPONENT:	Ceiling Finishes	RATING: 1 x WEIGHT: 6 = SCORE: 6	
	Maintainable surfaces in good condition; good alignment and appearance		
COMMENTS:	Bamboo strip; lay-in panel; Gypsum board		
COMPONENT:	Doors & Hardware	RATING: 1 x WEIGHT: 6 = SCORE: 6	
	Appropriate hardware, closers, panic devices; in good working order		
COMMENTS:	Interior bamboo wood /steel doors w HM frames; exterior aluminum doors/frames

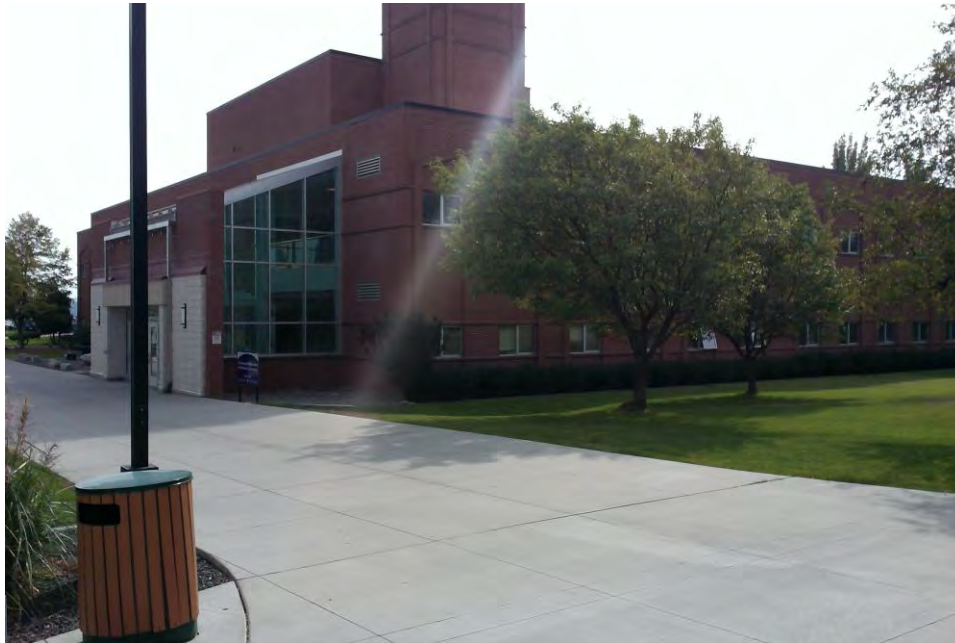
Computing, Mathematics And Tech. (172-18) STATE UFI: A01955 Main Campus (172A)
AREA: 49,802 SF BUILT: 1990 REMODELED: 2010 PREDOMINANT USE: Computer Lab.
CONSTRUCTION TYPE: Heavy CRV/SF: \$469 REPLACEMENT VALUE: \$23,357,138

Primary Systems			
COMPONENT:	Structure	RATING: 1 x WEIGHT: 8 =	SCORE: 8
No signs of settlement or cracking, no abrupt vertical changes Columns, bearing walls and roof structure appears sound/free of defects			
COMMENTS:	Steel frame		
COMPONENT:	Exterior Closure	RATING: 1 x WEIGHT: 8 =	SCORE: 8
Weatherproof, tight, well-maintained exterior walls, doors, windows/finishes			
COMMENTS:	Brick		
COMPONENT:	Roofing	RATING: 1 x WEIGHT: 10 =	SCORE: 10
Flashing and penetrations appear sound and membrane appears water- tight; drainage is positive and there are overflow scuppers			
COMMENTS:	New single-ply TPO membrane installed in 2008

Secondary Systems			
COMPONENT:	Floor Finishes	RATING: 3 x WEIGHT: 6 =	SCORE: 18
	Some wear and minor imperfections are evident; beginning deterioration		
COMMENTS:	Terrazzo; ceramic tile; vinyl tile; carpet tile; carpet-worn in a number of areas		
COMPONENT:	Wall Finishes	RATING: 3 x WEIGHT: 6 =	SCORE: 18
	Aging surfaces but sound; some maintenance is required		
COMMENTS:	Gypsum board and ceramic tile; vinyl wall covering-stained in numerous areas		
COMPONENT:	Ceiling Finishes	RATING: 1 x WEIGHT: 6 =	SCORE: 6
	Maintainable surfaces in good condition; good alignment and appearance		
COMMENTS:	Lay-in tile; gypsum board		
COMPONENT:	Doors & Hardware	RATING: 1 x WEIGHT: 6 =	SCORE: 6
	Appropriate hardware, closers, panic devices; in good working order		
COMMENTS:	Interior laminate doors w HM frames; exterior aluminum doors/frames

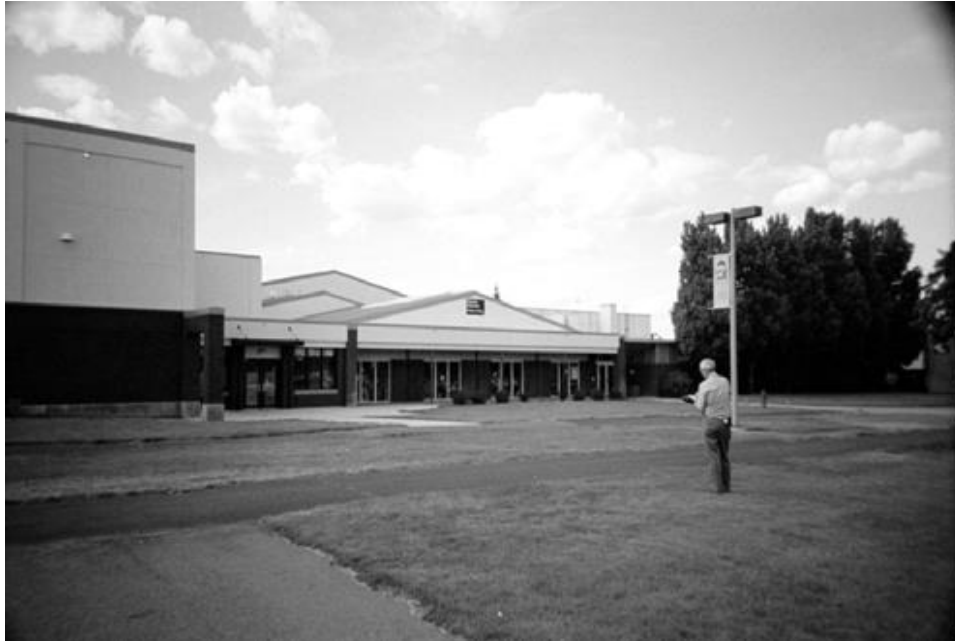
Gymnasium (172-7) STATE UFI: A05765 Main Campus (172A)
AREA: 69,999 SF BUILT: 1965 REMODELED: 2018 PREDOMINANT USE: Gymnasium
CONSTRUCTION TYPE: Heavy CRV/SF: \$335 REPLACEMENT VALUE: \$23,449,665

CONDITION: Needs Improvement/Additional Maintenance

Primary Systems			
COMPONENT:	Structure	RATING: 1 x WEIGHT: 8 =	SCORE: 8
No signs of settlement or cracking, no abrupt vertical changes Columns, bearing walls and roof structure appears sound/free of defects			
COMMENTS:			
COMPONENT:	Exterior Closure	RATING: 1 x WEIGHT: 8 =	SCORE: 8
Weatherproof, tight, well-maintained exterior walls, doors, windows/finishes			
COMMENTS:			
COMPONENT:	Roofing	RATING: 3 x WEIGHT: 10 =	SCORE: 30
Some deterioration is evident in membrane and flashings; maintenance or minor repair is needed			
COMMENTS:	Foam with single-ply surface, metal

Secondary Systems			
COMPONENT:	Floor Finishes	RATING: 3 x WEIGHT: 6 =	SCORE: 18
Some wear and minor imperfections are evident; beginning deterioration			
COMMENTS:	Vinyl tile; carpet; ceramic tile; wood floor		
COMPONENT:	Wall Finishes	RATING: 3 x WEIGHT: 6 =	SCORE: 18
Aging surfaces but sound; some maintenance is required			
COMMENTS:	CMU and painted Gypsum board; ceramic tile		
COMPONENT:	Ceiling Finishes	RATING: 1 x WEIGHT: 6 =	SCORE: 6
Maintainable surfaces in good condition; good alignment and appearance			
COMMENTS:	Exposed structure, Gypsum		
COMPONENT:	Doors & Hardware	RATING: 3 x WEIGHT: 6 =	SCORE: 18
Functional but dated			
COMMENTS:	Interior laminate and wood doors w HM frames; glazed aluminum exterior doors

Service Systems			
COMPONENT:	Elevators	RATING: 5 x WEIGHT: 6 =	SCORE: 30
No elevator access for upper floors			
COMMENTS:	No access to main gym		
COMPONENT:	Plumbing	RATING: 1 x WEIGHT: 8 =	SCORE: 8
Fixtures and piping appear to be in good condition; no evidence of leaks			
COMMENTS:	Copper, black iron and PVC piping; porcelain fixtures		
COMPONENT:	HVAC	RATING: 1 x WEIGHT: 8 =	SCORE: 8
Equipment in good condition; easily controlled; serves all required spaces; All necessary spaces are adequately ventilated; A/C provided			
COMMENTS:	Hot and chilled water to AHUs		
COMPONENT:	Electrical	RATING: 1 x WEIGHT: 8 =	SCORE: 8
Adequate service and distribution capacity for current/future needs			
COMMENTS:			
COMPONENT:	Lights/Power	RATING: 1 x WEIGHT: 8 =	SCORE: 8
Contemporary lighting with good work area illumination; ample outlets			
COMMENTS:	High bay fixtures

Quality Standards			
COMPONENT:	Maintenance	RATING: 1 x WEIGHT: 7 = SCORE: 7	
	Facility appears well maintained		
COMMENTS:			
COMPONENT:	Remaining Life	RATING: 3 x WEIGHT: 6 = SCORE: 18	
	Life expectancy is roughly 10-15 years; moderate system deterioration		
COMMENTS:			
COMPONENT:	Appearance	RATING: 3 x WEIGHT: 6 = SCORE: 18	
	Average construction; average interior and exterior appearance		
COMMENTS:

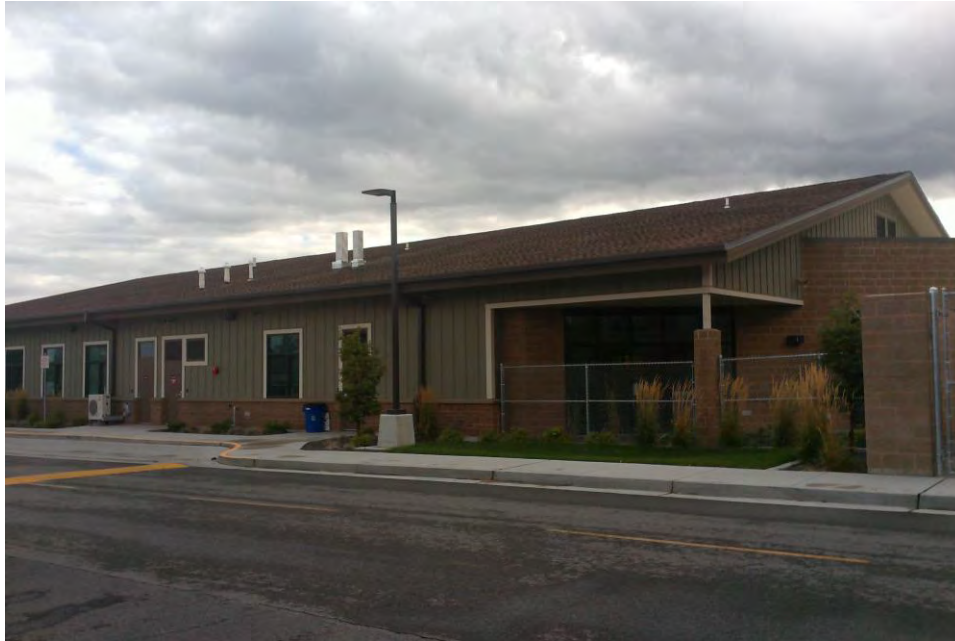
Early Learning Center (172-29) STATE UFI: A21041 Main Campus (172A)
AREA: 15,091 SF BUILT: 2013 REMODELED: No PREDOMINANT USE: Child Care
CONSTRUCTION TYPE: No data CRV/SF: \$348 REPLACEMENT VALUE: \$5,251,668

Primary Systems			
COMPONENT:	Structure	RATING: 1 x WEIGHT: 8.4 =	SCORE: 8.4
No signs of settlement or cracking, no abrupt vertical changes Columns, bearing walls and roof structure appears sound/free of defects			
COMMENTS:	No data		
COMPONENT:	Exterior Closure	RATING: 1 x WEIGHT: 8.4 =	SCORE: 8.4
Weatherproof, tight, well-maintained exterior walls, doors, windows/finishes			
COMMENTS:	No data		
COMPONENT:	Roofing	RATING: 1 x WEIGHT: 10.5 =	SCORE: 10.5
Flashing and penetrations appear sound and membrane appears water- tight; drainage is positive and there are overflow scuppers			
COMMENTS:	No data

Secondary Systems			
COMPONENT:	Floor Finishes	RATING: 1 x WEIGHT: 6.3 = SCORE: 6.3	
	Nice appearance, smooth transitions, level subfloors, no cracks/separating		
COMMENTS:	No data		
COMPONENT:	Wall Finishes	RATING: 1 x WEIGHT: 6.3 = SCORE: 6.3	
	Maintainable surfaces in good condition		
COMMENTS:	No data		
COMPONENT:	Ceiling Finishes	RATING: 1 x WEIGHT: 6.3 = SCORE: 6.3	
	Maintainable surfaces in good condition; good alignment and appearance		
COMMENTS:	No data		
COMPONENT:	Doors & Hardware	RATING: 1 x WEIGHT: 6.3 = SCORE: 6.3	
	Appropriate hardware, closers, panic devices; in good working order		
COMMENTS:	No data

Service Systems			
COMPONENT:	Elevators	RATING: No data	
	No data		
COMMENTS:	No data		
COMPONENT:	Plumbing	RATING: 1 x WEIGHT: 8.4 = SCORE: 8.4	
	Fixtures and piping appear to be in good condition; no evidence of leaks		
COMMENTS:	No data		
COMPONENT:	HVAC	RATING: 1 x WEIGHT: 8.4 = SCORE: 8.4	
	Equipment in good condition; easily controlled; serves all required spaces; All necessary spaces are adequately ventilated; A/C provided		
COMMENTS:	No data		
COMPONENT:	Electrical	RATING: 1 x WEIGHT: 8.4 = SCORE: 8.4	
	Adequate service and distribution capacity for current/future needs		
COMMENTS:	No data		
COMPONENT:	Lights/Power	RATING: 1 x WEIGHT: 8.4 = SCORE: 8.4	
	Contemporary lighting with good work area illumination; ample outlets		
COMMENTS:	No data

Safety Systems			
COMPONENT:	Life/Safety	RATING: 1 x WEIGHT: 10.5 =	SCORE: 10.5
	Appears to meet current codes		
COMMENTS:	No data		
COMPONENT:	Fire Safety	RATING: 1 x WEIGHT: 10.5 =	SCORE: 10.5
	Locally monitored detection; alarm and strobes present; sprinklers in high hazard areas		
COMMENTS:	No data		
COMPONENT:	Modifications	RATING: 0 x WEIGHT: 0 =	SCORE: 0
	No data		
COMMENTS:	No data

Quality Standards			
COMPONENT:	Maintenance	RATING: 1 x WEIGHT: 7.4 =	SCORE: 7.4
	Facility appears well maintained		
COMMENTS:	No data		
COMPONENT:	Remaining Life	RATING: 1 x WEIGHT: 6.3 =	SCORE: 6.3
	Life expectancy is >20 years; minor system deterioration		
COMMENTS:	No data		
COMPONENT:	Appearance	RATING: 1 x WEIGHT: 6.3 =	SCORE: 6.3
	Well-constructed building; generally attractive interior and exterior		
COMMENTS:	No data

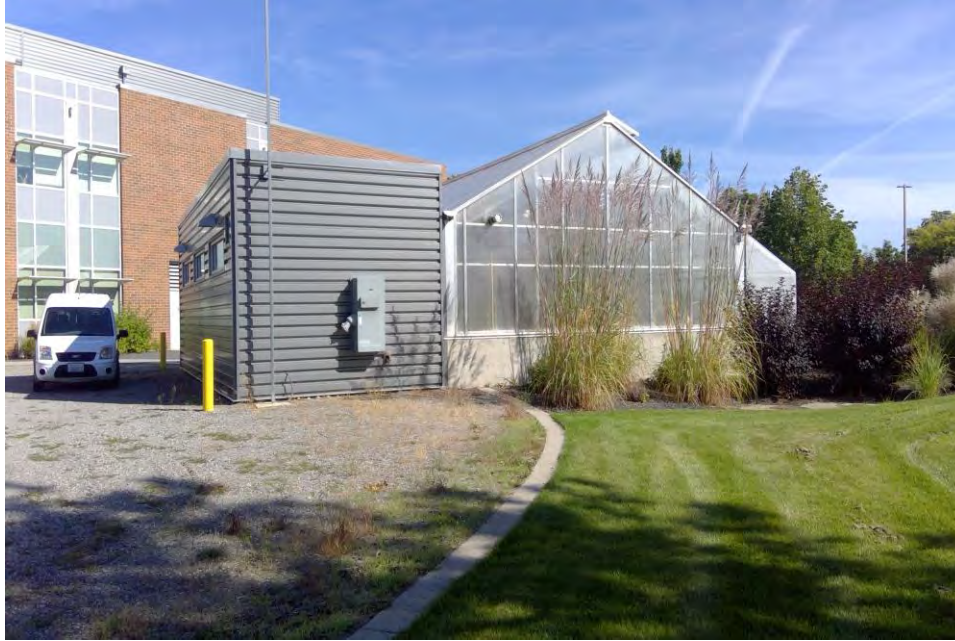
Science Greenhouse (172-28A) STATE UFI: A25179 Main Campus (172A)
AREA: 1,600 SF BUILT: 0 REMODELED: No PREDOMINANT USE: Greenhouse
CONSTRUCTION TYPE: No data CRV/SF: \$474 REPLACEMENT VALUE: \$758,400

Primary Systems			
COMPONENT:	Structure	RATING: 1 x WEIGHT: 10.2 =	SCORE: 10.2
No signs of settlement or cracking, no abrupt vertical changes Columns, bearing walls and roof structure appears sound/free of defects			
COMMENTS:	No data		
COMPONENT:	Exterior Closure	RATING: 1 x WEIGHT: 10.2 =	SCORE: 10.2
Weatherproof, tight, well-maintained exterior walls, doors, windows/finishes			
COMMENTS:	No data		
COMPONENT:	Roofing	RATING: 1 x WEIGHT: 12.7 =	SCORE: 12.7
Flashing and penetrations appear sound and membrane appears water- tight; drainage is positive and there are overflow scuppers			
COMMENTS:	No data

Secondary Systems			
COMPONENT:	Floor Finishes	RATING: 1 x WEIGHT: 7.6 =	SCORE: 7.6
	Nice appearance, smooth transitions, level subfloors, no cracks/separating		
COMMENTS:	No data		
COMPONENT:	Wall Finishes	RATING: 0 x WEIGHT: 0 =	SCORE: 0
	No data		
COMMENTS:	No data		
COMPONENT:	Ceiling Finishes	RATING: 0 x WEIGHT: 0 =	SCORE: 0
	No data		
COMMENTS:	No data		
COMPONENT:	Doors & Hardware	RATING: 1 x WEIGHT: 7.6 =	SCORE: 7.6
	Appropriate hardware, closers, panic devices; in good working order		
COMMENTS:	No data

Service Systems			
COMPONENT:	Elevators	RATING: 0 x WEIGHT: 0 =	SCORE: 0
	No data		
COMMENTS:	No data		
COMPONENT:	Plumbing	RATING: 1 x WEIGHT: 10.2 =	SCORE: 10.2
	Fixtures and piping appear to be in good condition; no evidence of leaks		
COMMENTS:	No data		
COMPONENT:	HVAC	RATING: 1 x WEIGHT: 10.2 =	SCORE: 10.2
	Equipment in good condition; easily controlled; serves all required spaces; All necessary spaces are adequately ventilated; A/C provided		
COMMENTS:	No data		
COMPONENT:	Electrical	RATING: 1 x WEIGHT: 10.2 =	SCORE: 10.2
	Adequate service and distribution capacity for current/future needs		
COMMENTS:	No data		
COMPONENT:	Lights/Power	RATING: 1 x WEIGHT: 10.2 =	SCORE: 10.2
	Contemporary lighting with good work area illumination; ample outlets		
COMMENTS:	No data

Safety Systems			
COMPONENT:	Life/Safety	RATING: 1 x WEIGHT: 12.7 =	SCORE: 12.7
	Appears to meet current codes		
COMMENTS:	No data		
COMPONENT:	Fire Safety	RATING: 2 x WEIGHT: 12.7 =	SCORE: 25.4
	Locally monitored detection; alarm present, but missing visual component or sprinklers		
COMMENTS:	No data		
COMPONENT:	Modifications	RATING: 0 x WEIGHT: 0 =	SCORE: 0
	No data		
COMMENTS:	No data

Quality Standards			
COMPONENT:	Maintenance	RATING: 2 x WEIGHT: 8.9 =	SCORE: 17.8
	Routine maintenance is required; impact is minor		
COMMENTS:	No data		
COMPONENT:	Remaining Life	RATING: 1 x WEIGHT: 7.6 =	SCORE: 7.6
	Life expectancy is >20 years; minor system deterioration		
COMMENTS:	No data		
COMPONENT:	Appearance	RATING: 1 x WEIGHT: 7.6 =	SCORE: 7.6
	Well-constructed building; generally attractive interior and exterior		
COMMENTS:	No data
