2021 FACILITY CONDITION SURVEY

Tacoma Community College

SURVEY CONDUCTED BY:
Steve Lewandowski
State Board for Community
and Technical Colleges

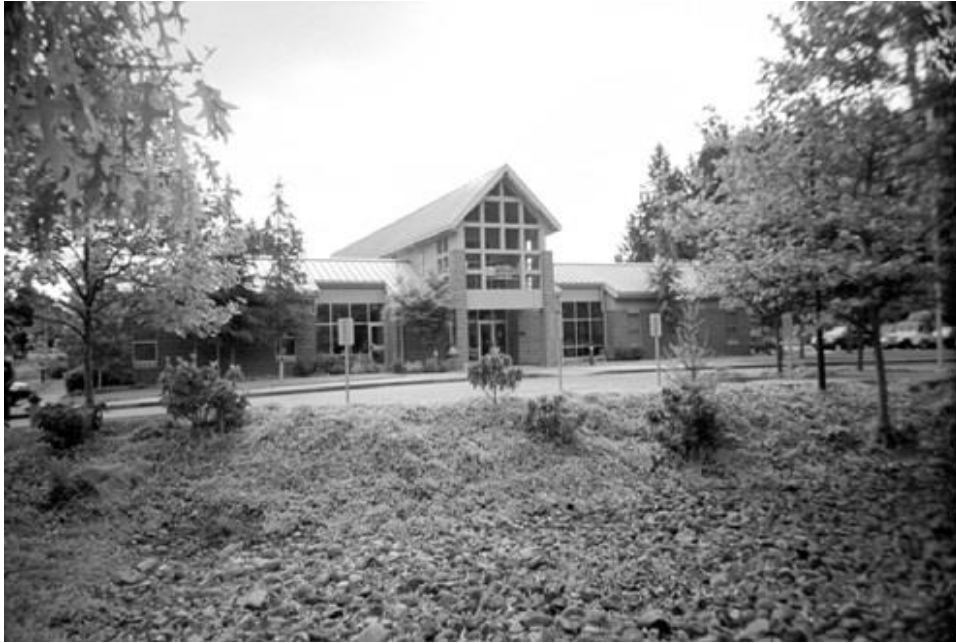
Gig Harbor/Peninsula Center (220-00D) STATE UFI: A01020 Gig Harbor Ctr (220C)
AREA: 13,000 SF BUILT: 1995 REMODELED: No PREDOMINANT USE: General Classroom
CONSTRUCTION TYPE: Medium CRV/SF: \$361 REPLACEMENT VALUE: \$4,693,000

Primary Systems			
COMPONENT:	Structure	RATING: 2 x WEIGHT: 8.3 =	SCORE: 16.7
Minor cracks evident in a small portion of the structure			
COMMENTS:	CMU and wood framing		
COMPONENT:	Exterior Closure	RATING: 1 x WEIGHT: 8.3 =	SCORE: 8.3
Weatherproof, tight, well-maintained exterior walls, doors, windows/finishes			
COMMENTS:	CMU and stucco		
COMPONENT:	Roofing	RATING: 2 x WEIGHT: 10.4 =	SCORE: 20.9
Majority of roofing and flashing appear sound, but a small portion of roofing shows deterioration where maintenance or minor repair needed			
COMMENTS:	Standing seam metal-2002

Secondary Systems			
COMPONENT:	Floor Finishes	RATING: 1 x WEIGHT: 6.3 =	SCORE: 6.3
	Nice appearance, smooth transitions, level subfloors, no cracks/separating		
COMMENTS:	Carpet-2010; vinyl tile; ceramic tile		
COMPONENT:	Wall Finishes	RATING: 2 x WEIGHT: 6.3 =	SCORE: 12.5
	Maintainable surfaces, minor maintenance is required in some areas		
COMMENTS:	Gypsum board; ceramic tile		
COMPONENT:	Ceiling Finishes	RATING: 1 x WEIGHT: 6.3 =	SCORE: 6.3
	Maintainable surfaces in good condition; good alignment and appearance		
COMMENTS:	Gypsum board and lay-in tile-water damage in spots		
COMPONENT:	Doors & Hardware	RATING: 2 x WEIGHT: 6.3 =	SCORE: 12.5
	Fairly modern door surfaces and hardware with minor deterioration; good working order		
COMMENTS:	Interior wood doors w HM frames; exterior aluminum doors/frames

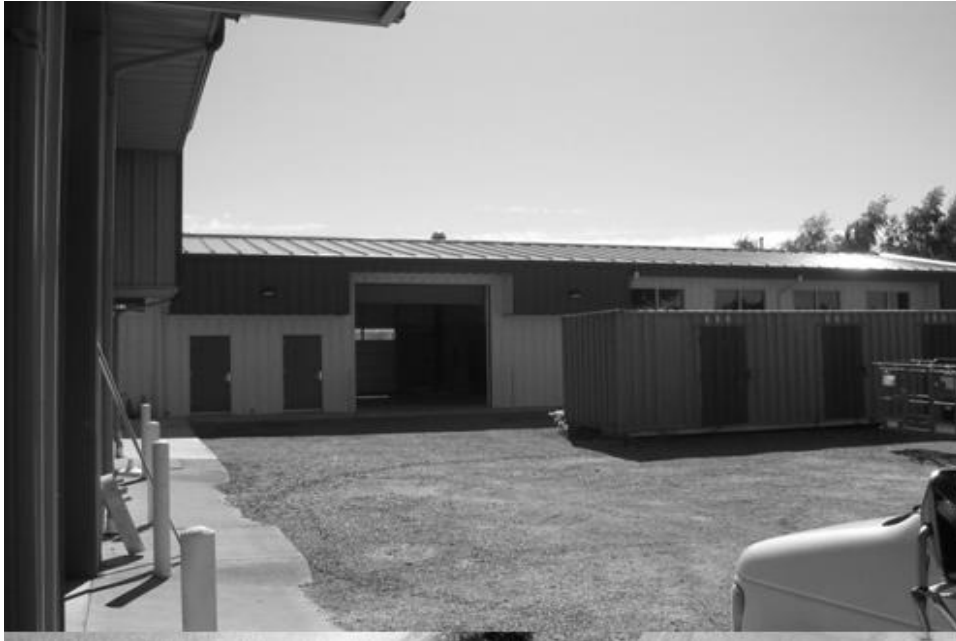
Carpenter/Grounds Shops (220-22) STATE UFI: A05344 Main Campus (220A)
AREA: 4,000 SF BUILT: 2007 REMODELED: No PREDOMINANT USE: Maintenance
CONSTRUCTION TYPE: Medium CRV/SF: \$222 REPLACEMENT VALUE: \$888,000

Primary Systems			
COMPONENT:	Structure	RATING: 1 x WEIGHT: 8.7 =	SCORE: 8.7
No signs of settlement or cracking, no abrupt vertical changes Columns, bearing walls and roof structure appears sound/free of defects			
COMMENTS:	Steel and aluminum framing; engineered building		
COMPONENT:	Exterior Closure	RATING: 1 x WEIGHT: 8.7 =	SCORE: 8.7
Weatherproof, tight, well-maintained exterior walls, doors, windows/finishes			
COMMENTS:	Metal wall panels		
COMPONENT:	Roofing	RATING: 1 x WEIGHT: 10.9 =	SCORE: 10.9
Flashing and penetrations appear sound and membrane appears water- tight; drainage is positive and there are overflow scuppers			
COMMENTS:	Metal roof panels

Secondary Systems			
COMPONENT:	Floor Finishes	RATING: 2 x WEIGHT: 6.5 =	SCORE: 13.1
	Some wear is evident; maintenance needed		
COMMENTS:	Concrete w epoxy overlay		
COMPONENT:	Wall Finishes	RATING: 2 x WEIGHT: 6.5 =	SCORE: 13.1
	Maintainable surfaces, minor maintenance is required in some areas		
COMMENTS:	Insulation; gypsum board		
COMPONENT:	Ceiling Finishes	RATING: 0 x WEIGHT: 0 =	SCORE: 0
	No data		
COMMENTS:	Insulation		
COMPONENT:	Doors & Hardware	RATING: 3 x WEIGHT: 6.5 =	SCORE: 19.6
	Functional but dated		
COMMENTS:	Interior/exterior HM doors/frames-surface wear; metal OH doors

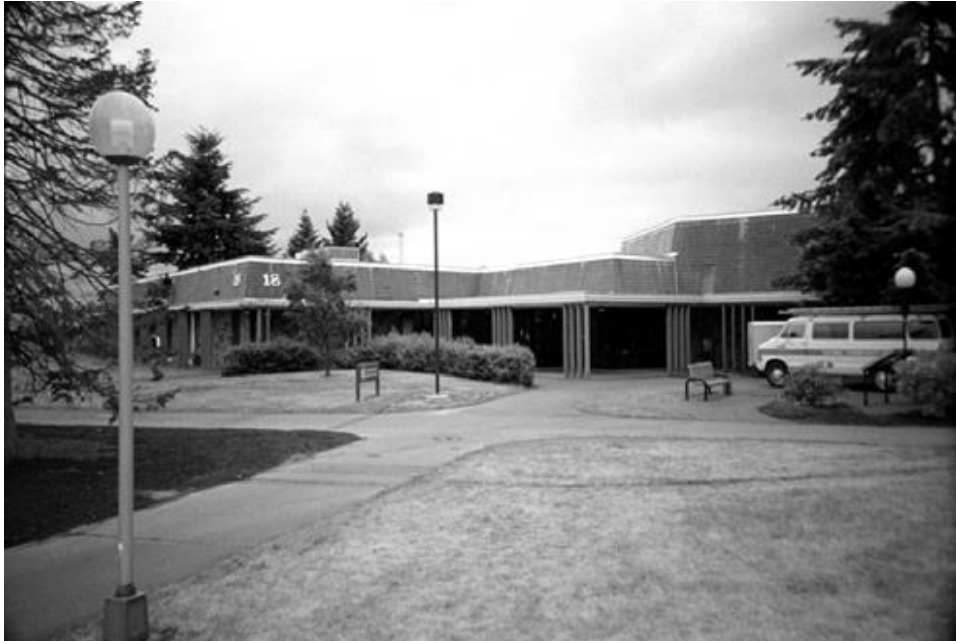
Cascade (220-14) STATE UFI: A00444 Main Campus (220A)
 AREA: 17,880 SF BUILT: 1965 REMODELED: No PREDOMINANT USE: Student Services
 CONSTRUCTION TYPE: Medium CRV/SF: \$323 REPLACEMENT VALUE: \$5,775,240

Primary Systems			
COMPONENT:	Structure	RATING: 3 x WEIGHT: 8.3 =	SCORE: 25
Some cracking evident but does not likely affect structural integrity; Visible defects apparent but are non-structural			
COMMENTS:	Concrete columns and tilt-up panels; wood framing		
COMPONENT:	Exterior Closure	RATING: 2 x WEIGHT: 8.3 =	SCORE: 16.7
Weatherproof exterior, but generally appears poorly maintained			
COMMENTS:	Concrete panels w embedded stone; plaster soffits; cement-asbestos mansard tiles		
COMPONENT:	Roofing	RATING: 4 x WEIGHT: 10.4 =	SCORE: 41.7
General deterioration and some leaks are evident; resurfacing or partial repair is needed			
COMMENTS:	Hypalon single-ply. Should be resurfaced.

Secondary Systems			
COMPONENT:	Floor Finishes	RATING: 2 x WEIGHT: 6.3 =	SCORE: 12.5
Some wear is evident; maintenance needed			
COMMENTS:	Carpet tile; carpet; ceramic tile		
COMPONENT:	Wall Finishes	RATING: 1 x WEIGHT: 6.3 =	SCORE: 6.3
Maintainable surfaces in good condition			
COMMENTS:	Gypsum board; ceramic tile		
COMPONENT:	Ceiling Finishes	RATING: 1 x WEIGHT: 6.3 =	SCORE: 6.3
Maintainable surfaces in good condition; good alignment and appearance			
COMMENTS:	Gypsum board and lay-in tile		
COMPONENT:	Doors & Hardware	RATING: 1 x WEIGHT: 6.3 =	SCORE: 6.3
Appropriate hardware, closers, panic devices; in good working order			
COMMENTS:	Interior laminate doors w HM frames; exterior aluminum doors/frames

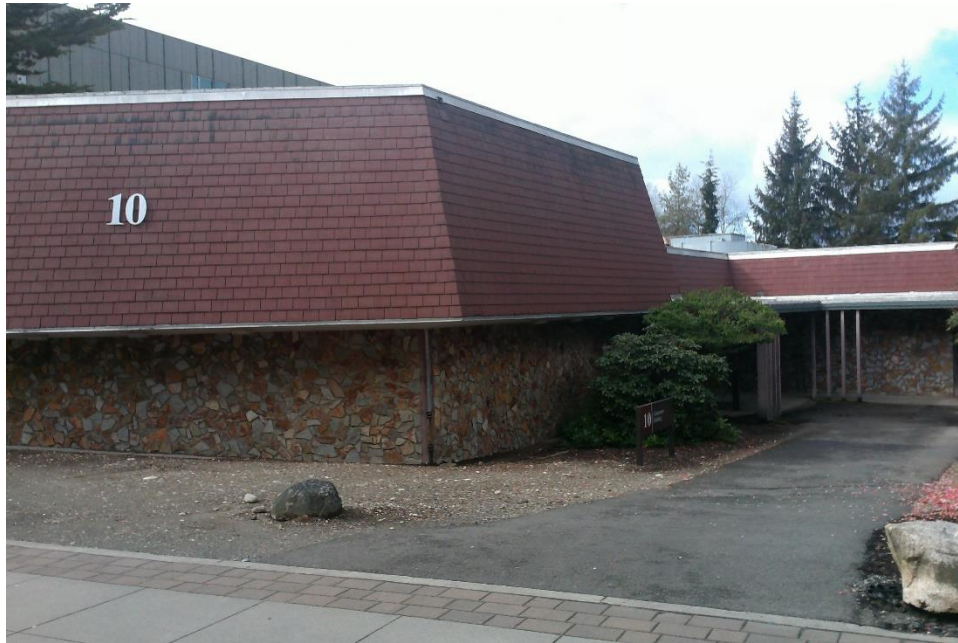
Chinook -North Section (220-10) STATE UFI: A00792 Main Campus (220A)
AREA: 13,718 SF BUILT: 1965 REMODELED: No PREDOMINANT USE: General Classroom
CONSTRUCTION TYPE: Medium CRV/SF: \$361 REPLACEMENT VALUE: \$4,952,198

Primary Systems			
COMPONENT:	Structure	RATING: 2 x WEIGHT: 8.3 =	SCORE: 16.7
Minor cracks evident in a small portion of the structure			
COMMENTS:	Concrete columns and tilt-up panels; wood framing		
COMPONENT:	Exterior Closure	RATING: 5 x WEIGHT: 8.3 =	SCORE: 41.7
Significant deterioration, leaking and air infiltration apparent			
COMMENTS:	Concrete panels w embedded stone; plaster soffits; cement-asbestos mansard tiles		
COMPONENT:	Roofing	RATING: 5 x WEIGHT: 10.4 =	SCORE: 52.1
Leaking and deterioration is to point where new roof is required			
COMMENTS:	Hypalon single-ply; canopy needs rear drains

Secondary Systems			
COMPONENT:	Floor Finishes	RATING: 3 x WEIGHT: 6.3 =	SCORE: 18.8
Some wear and minor imperfections are evident; beginning deterioration			
COMMENTS:	Carpet; carpet tile; ceramic tile		
COMPONENT:	Wall Finishes	RATING: 4 x WEIGHT: 6.3 =	SCORE: 25
Aging surfaces generally require maintenance; some areas require repair			
COMMENTS:	Gypsum board, concrete and ceramic tile		
COMPONENT:	Ceiling Finishes	RATING: 2 x WEIGHT: 6.3 =	SCORE: 12.5
Aging surfaces in fair condition and good alignment			
COMMENTS:	Gypsum board and lay-in tile		
COMPONENT:	Doors & Hardware	RATING: 3 x WEIGHT: 6.3 =	SCORE: 18.8
Functional but dated			
COMMENTS:	Interior/exterior HM doors/frames-surface wear

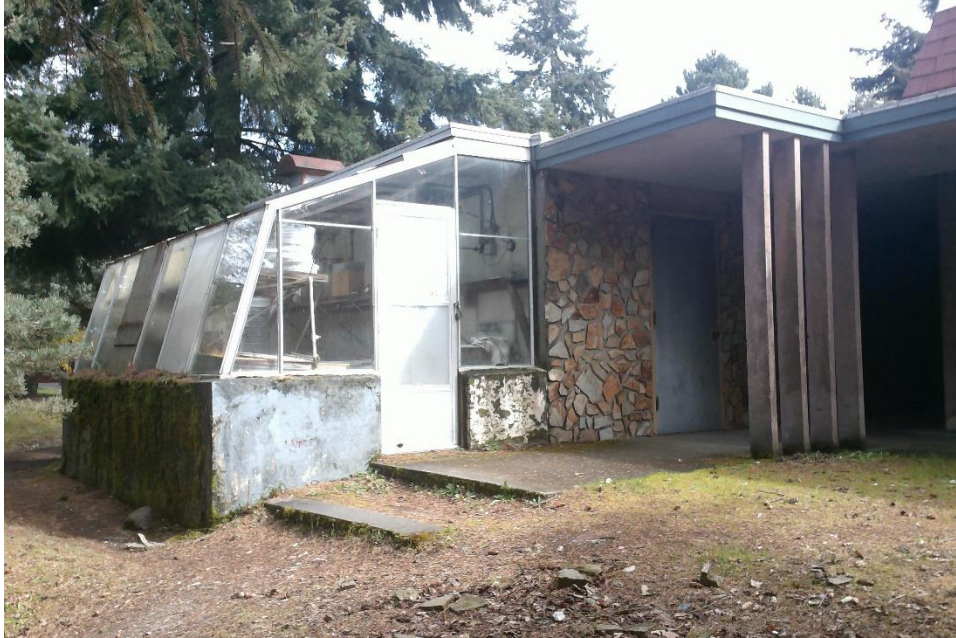
Chinook -Storage (220-10B) STATE UFI: A07263 Main Campus (220A)
AREA: 812 SF BUILT: 1965 REMODELED: No PREDOMINANT USE: Central Computer Or
Telecommunications
CONSTRUCTION TYPE: No data CRV/SF: \$240 REPLACEMENT VALUE: \$194,880

Primary Systems			
COMPONENT:	Structure	RATING: 3 x WEIGHT: 8 =	SCORE: 24
Some cracking evident but does not likely affect structural integrity; Visible defects apparent but are non-structural			
COMMENTS:	No data		
COMPONENT:	Exterior Closure	RATING: 5 x WEIGHT: 8 =	SCORE: 40
Significant deterioration, leaking and air infiltration apparent			
COMMENTS:	No data		
COMPONENT:	Roofing	RATING: 5 x WEIGHT: 10 =	SCORE: 50
Leaking and deterioration is to point where new roof is required			
COMMENTS:	No data

Secondary Systems		
COMPONENT:	Floor Finishes	RATING: 3 x WEIGHT: 6 = SCORE: 18
	Some wear and minor imperfections are evident; beginning deterioration	
COMMENTS:	No data	
COMPONENT:	Wall Finishes	RATING: 5 x WEIGHT: 6 = SCORE: 30
	Surfaces are deteriorated and require resurfacing or rebuilding	
COMMENTS:	No data	
COMPONENT:	Ceiling Finishes	RATING: 5 x WEIGHT: 6 = SCORE: 30
	Deteriorated, significant number of stained or sagging areas; inappropriate for occupancy	
COMMENTS:	No data	
COMPONENT:	Doors & Hardware	RATING: 3 x WEIGHT: 6 = SCORE: 18
	Functional but dated	
COMMENTS:	No data

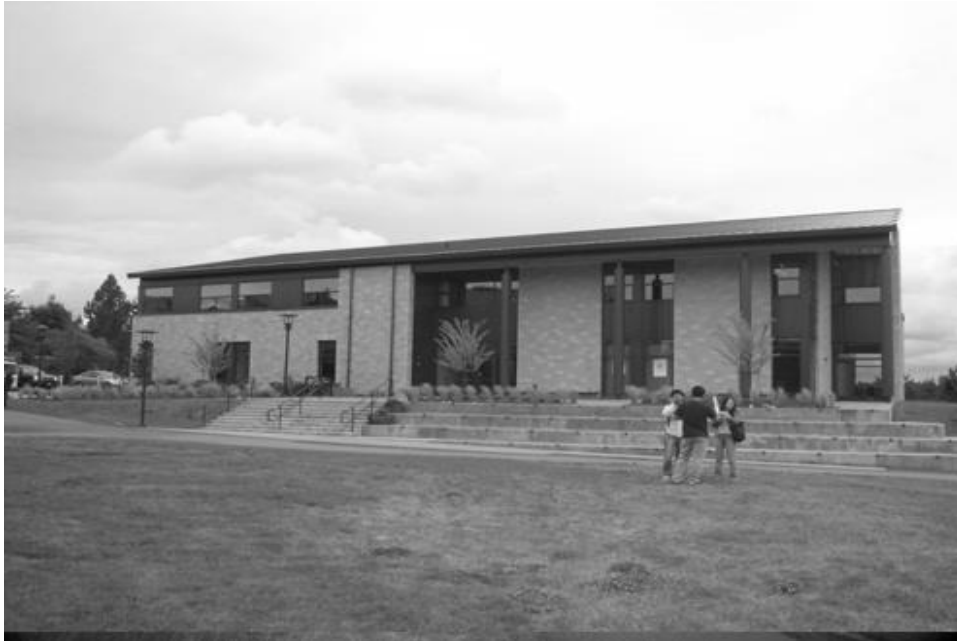
Classroom Administration (220-12) STATE UFI: A08709 Main Campus (220A)
AREA: 16,500 SF BUILT: 2004 REMODELED: No PREDOMINANT USE: General Classroom
CONSTRUCTION TYPE: Medium CRV/SF: \$361 REPLACEMENT VALUE: \$5,956,500

Primary Systems			
COMPONENT:	Structure	RATING: 1 x WEIGHT: 8 =	SCORE: 8
No signs of settlement or cracking, no abrupt vertical changes Columns, bearing walls and roof structure appears sound/free of defects			
COMMENTS:	Split-face and flat CMU; concrete; structural steel		
COMPONENT:	Exterior Closure	RATING: 1 x WEIGHT: 8 =	SCORE: 8
Weatherproof, tight, well-maintained exterior walls, doors, windows/finishes			
COMMENTS:	CMU; Metal panels; aluminum window walls		
COMPONENT:	Roofing	RATING: 1 x WEIGHT: 10 =	SCORE: 10
Flashing and penetrations appear sound and membrane appears water- tight; drainage is positive and there are overflow scuppers			
COMMENTS:	Standing seam metal roof

Secondary Systems			
COMPONENT:	Floor Finishes	RATING: 1 x WEIGHT: 6 =	SCORE: 6
	Nice appearance, smooth transitions, level subfloors, no cracks/separating		
COMMENTS:	Quarry and ceramic tile; vinyl tile; carpet		
COMPONENT:	Wall Finishes	RATING: 3 x WEIGHT: 6 =	SCORE: 18
	Aging surfaces but sound; some maintenance is required		
COMMENTS:	Gypsum board-damage and stains; wood panels; ceramic tile		
COMPONENT:	Ceiling Finishes	RATING: 1 x WEIGHT: 6 =	SCORE: 6
	Maintainable surfaces in good condition; good alignment and appearance		
COMMENTS:	Lay-in tile; gypsum board		
COMPONENT:	Doors & Hardware	RATING: 1 x WEIGHT: 6 =	SCORE: 6
	Appropriate hardware, closers, panic devices; in good working order		
COMMENTS:	Interior wood glazed doors w HM frames; sidelites; exterior aluminum glazed doors/frames

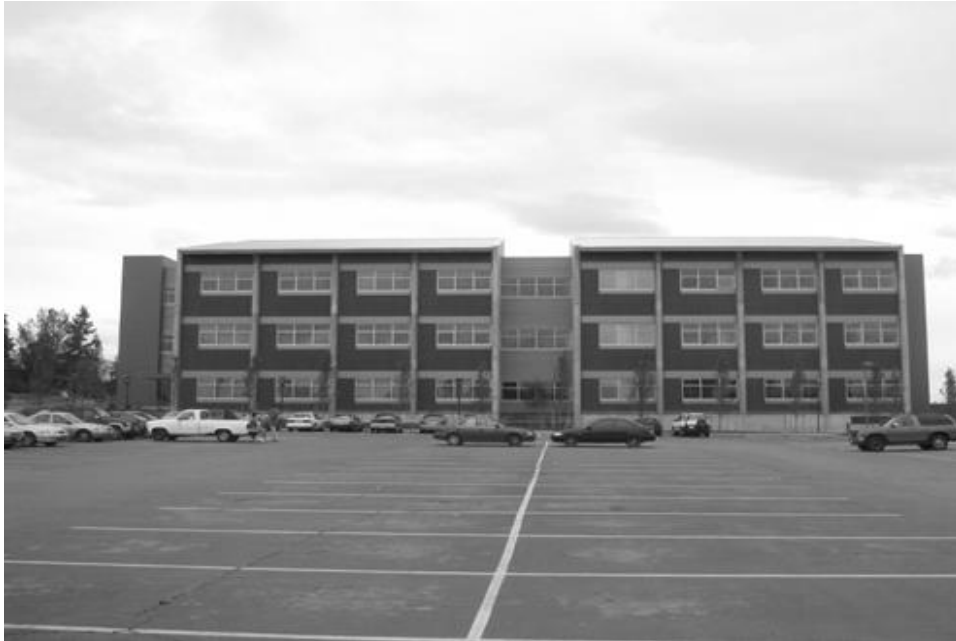
Info Tech Voc Center (220-16) STATE UFI: A01953 Main Campus (220A)
AREA: 56,516 SF BUILT: 2004 REMODELED: No PREDOMINANT USE: Computer Lab.
CONSTRUCTION TYPE: Heavy CRV/SF: \$361 REPLACEMENT VALUE: \$20,402,276

Primary Systems			
COMPONENT:	Structure	RATING: 1 x WEIGHT: 8 =	SCORE: 8
No signs of settlement or cracking, no abrupt vertical changes Columns, bearing walls and roof structure appears sound/free of defects			
COMMENTS:	Cast concrete and steel		
COMPONENT:	Exterior Closure	RATING: 1 x WEIGHT: 8 =	SCORE: 8
Weatherproof, tight, well-maintained exterior walls, doors, windows/finishes			
COMMENTS:	Cast concrete and metal wall panels		
COMPONENT:	Roofing	RATING: 1 x WEIGHT: 10 =	SCORE: 10
Flashing and penetrations appear sound and membrane appears water- tight; drainage is positive and there are overflow scuppers			
COMMENTS:	Standing seam metal roof; single-ply TPO

Secondary Systems			
COMPONENT:	Floor Finishes	RATING: 2 x WEIGHT: 6 =	SCORE: 12
Some wear is evident; maintenance needed			
COMMENTS:	Carpet tile-surface wear; clay and ceramic tile		
COMPONENT:	Wall Finishes	RATING: 1 x WEIGHT: 6 =	SCORE: 6
Maintainable surfaces in good condition			
COMMENTS:	Concrete; gypsum board; ceramic tile		
COMPONENT:	Ceiling Finishes	RATING: 1 x WEIGHT: 6 =	SCORE: 6
Maintainable surfaces in good condition; good alignment and appearance			
COMMENTS:	Concrete; gypsum board; lay-in tile		
COMPONENT:	Doors & Hardware	RATING: 1 x WEIGHT: 6 =	SCORE: 6
Appropriate hardware, closers, panic devices; in good working order			
COMMENTS:	Interior wood doors w HM frames; sidelites; exterior glazed aluminum doors/frames

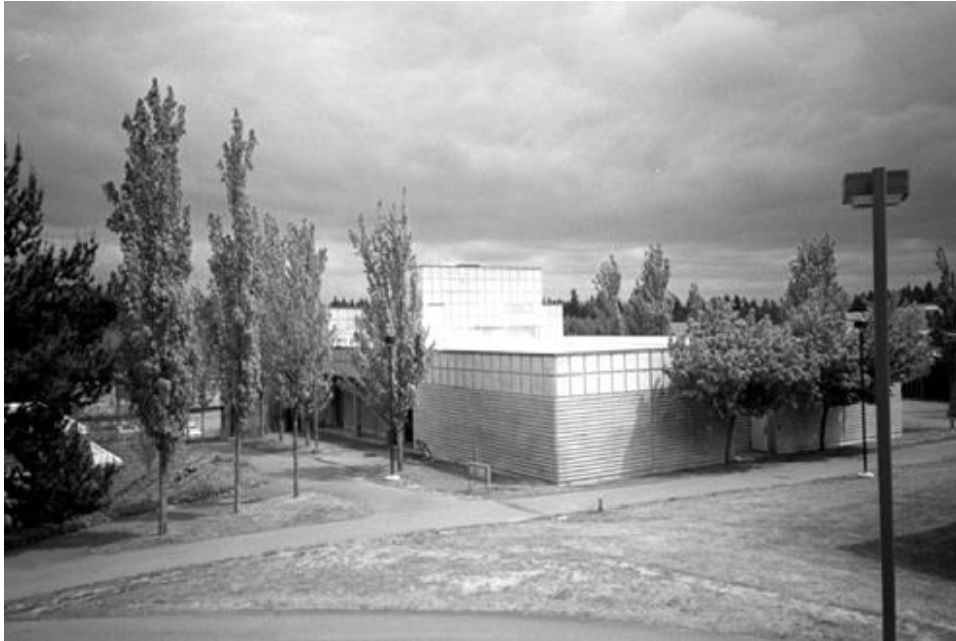
Information Systems - Adjunct Faculty Center (220-18) STATE UFI: A08337 Main Campus (220A)
AREA: 16,231 SF BUILT: 1989 REMODELED: No PREDOMINANT USE: Computer Lab.
CONSTRUCTION TYPE: Heavy CRV/SF: \$361 REPLACEMENT VALUE: \$5,859,391

Primary Systems			
COMPONENT:	Structure	RATING: 1 x WEIGHT: 8 =	SCORE: 8
No signs of settlement or cracking, no abrupt vertical changes Columns, bearing walls and roof structure appears sound/free of defects			
COMMENTS:	Cast concrete		
COMPONENT:	Exterior Closure	RATING: 2 x WEIGHT: 8 =	SCORE: 16
Weatherproof exterior, but generally appears poorly maintained			
COMMENTS:	Cast concrete; aluminum window walls		
COMPONENT:	Roofing	RATING: 4 x WEIGHT: 10 =	SCORE: 40
General deterioration and some leaks are evident; resurfacing or partial repair is needed			
COMMENTS:	Hypalon single-ply

Secondary Systems			
COMPONENT:	Floor Finishes	RATING: 2 x WEIGHT: 6 =	SCORE: 12
	Some wear is evident; maintenance needed		
COMMENTS:	Carpet; ceramic tile; vinyl tile; carpet tile		
COMPONENT:	Wall Finishes	RATING: 1 x WEIGHT: 6 =	SCORE: 6
	Maintainable surfaces in good condition		
COMMENTS:	Concrete and gypsum board		
COMPONENT:	Ceiling Finishes	RATING: 2 x WEIGHT: 6 =	SCORE: 12
	Aging surfaces in fair condition and good alignment		
COMMENTS:	Gypsum board and lay-in tile		
COMPONENT:	Doors & Hardware	RATING: 3 x WEIGHT: 6 =	SCORE: 18
	Functional but dated		
COMMENTS:	Interior HM doors/frames-surface wear; exterior aluminum doors/frames

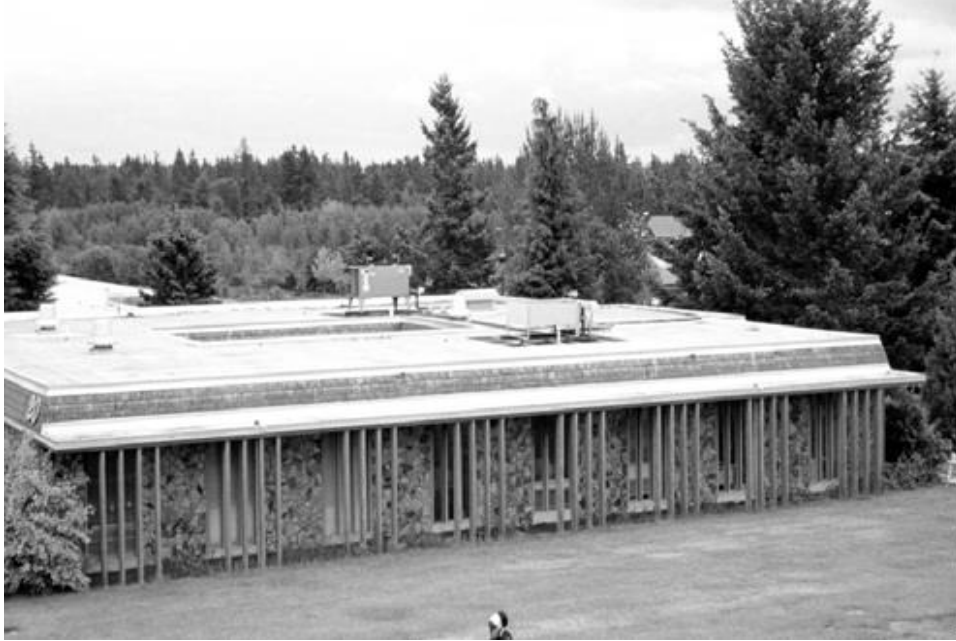
Madrona (220-F2) STATE UFI: A02211 Main Campus (220A)
 AREA: 5,179 SF BUILT: 1965 REMODELED: No PREDOMINANT USE: Faculty Office
 CONSTRUCTION TYPE: Medium CRV/SF: \$323 REPLACEMENT VALUE: \$1,672,817

Primary Systems			
COMPONENT:	Structure	RATING: 3 x WEIGHT: 8.8 =	SCORE: 26.3
Some cracking evident but does not likely affect structural integrity; Visible defects apparent but are non-structural			
COMMENTS:	Concrete columns and tilt-up panels; wood framing		
COMPONENT:	Exterior Closure	RATING: 2 x WEIGHT: 8.8 =	SCORE: 17.6
Weatherproof exterior, but generally appears poorly maintained			
COMMENTS:	Concrete panels w embedded stone; plaster soffits; cement-asbestos mansard tiles		
COMPONENT:	Roofing	RATING: 1 x WEIGHT: 11 =	SCORE: 11
Flashing and penetrations appear sound and membrane appears water- tight; drainage is positive and there are overflow scuppers			
COMMENTS:	Single ply 2017

Secondary Systems			
COMPONENT:	Floor Finishes	RATING: 1 x WEIGHT: 6.6 =	SCORE: 6.6
Nice appearance, smooth transitions, level subfloors, no cracks/separating			
COMMENTS:	Carpet; vinyl tile; ceramic tile		
COMPONENT:	Wall Finishes	RATING: 1 x WEIGHT: 6.6 =	SCORE: 6.6
Maintainable surfaces in good condition			
COMMENTS:	Gypsum board; Formica panels		
COMPONENT:	Ceiling Finishes	RATING: 1 x WEIGHT: 6.6 =	SCORE: 6.6
Maintainable surfaces in good condition; good alignment and appearance			
COMMENTS:	Gypsum board		
COMPONENT:	Doors & Hardware	RATING: 2 x WEIGHT: 6.6 =	SCORE: 13.2
Fairly modern door surfaces and hardware with minor deterioration; good working order			
COMMENTS:	Interior/exterior HM doors/frames-surface wear

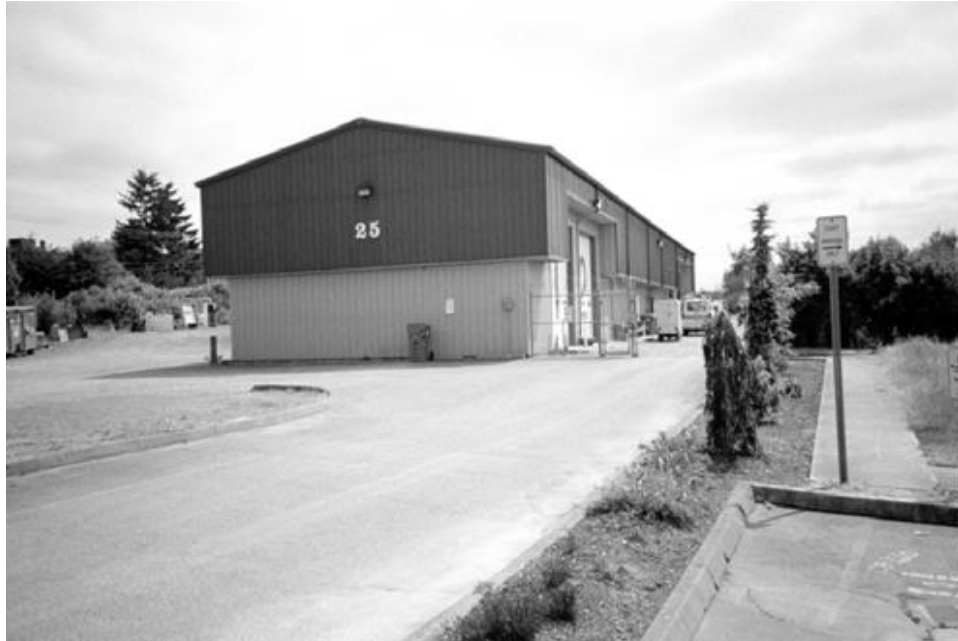
Maintenance Building (220-21) STATE UFI: A09893 Main Campus (220A)
AREA: 8,960 SF BUILT: 1987 REMODELED: No PREDOMINANT USE: Maintenance
CONSTRUCTION TYPE: Light CRV/SF: \$253 REPLACEMENT VALUE: \$2,266,880

Primary Systems			
COMPONENT:	Structure	RATING: 1 x WEIGHT: 8.3 =	SCORE: 8.3
No signs of settlement or cracking, no abrupt vertical changes Columns, bearing walls and roof structure appears sound/free of defects			
COMMENTS:	Steel frame engineered building		
COMPONENT:	Exterior Closure	RATING: 1 x WEIGHT: 8.3 =	SCORE: 8.3
Weatherproof, tight, well-maintained exterior walls, doors, windows/finishes			
COMMENTS:	Metal panels		
COMPONENT:	Roofing	RATING: 1 x WEIGHT: 10.4 =	SCORE: 10.4
Flashing and penetrations appear sound and membrane appears water- tight; drainage is positive and there are overflow scuppers			
COMMENTS:	Metal panels

Secondary Systems			
COMPONENT:	Floor Finishes	RATING: 2 x WEIGHT: 6.3 =	SCORE: 12.5
Some wear is evident; maintenance needed			
COMMENTS:	Concrete; vinyl tile-surface wear; sheet vinyl-surface wear; carpet tile		
COMPONENT:	Wall Finishes	RATING: 2 x WEIGHT: 6.3 =	SCORE: 12.5
Maintainable surfaces, minor maintenance is required in some areas			
COMMENTS:	Gypsum board and metal framing		
COMPONENT:	Ceiling Finishes	RATING: 2 x WEIGHT: 6.3 =	SCORE: 12.5
Aging surfaces in fair condition and good alignment			
COMMENTS:	Gypsum board and metal framing		
COMPONENT:	Doors & Hardware	RATING: 3 x WEIGHT: 6.3 =	SCORE: 18.8
Functional but dated			
COMMENTS:	Interior/exterior HM doors/frames-extensive surface wear; OH metal doors

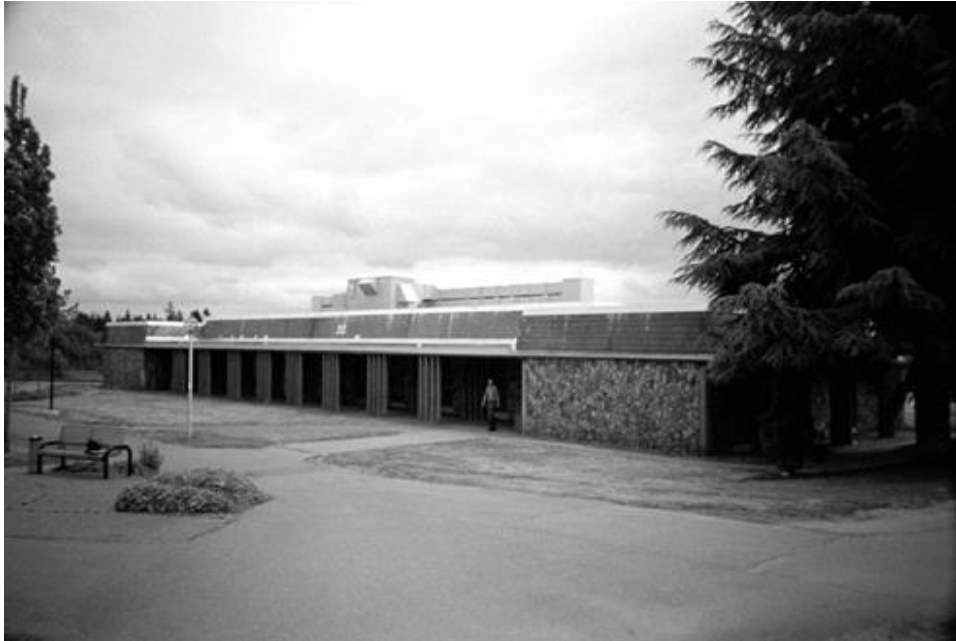
Meeker (220-17) STATE UFI: A04784 Main Campus (220A)
AREA: 9,553 SF BUILT: 1964 REMODELED: No PREDOMINANT USE: General Classroom
CONSTRUCTION TYPE: Medium CRV/SF: \$361 REPLACEMENT VALUE: \$3,448,633

Primary Systems			
COMPONENT:	Structure	RATING: 3 x WEIGHT: 8.3 =	SCORE: 25
Some cracking evident but does not likely affect structural integrity; Visible defects apparent but are non-structural			
COMMENTS:	Concrete columns and tilt-up panels; wood framing		
COMPONENT:	Exterior Closure	RATING: 3 x WEIGHT: 8.3 =	SCORE: 25
Sound and weatherproof but with some deterioration evident			
COMMENTS:	Concrete panels w embedded stone; plaster soffits; cement-asbestos mansard tiles		
COMPONENT:	Roofing	RATING: 3 x WEIGHT: 10.4 =	SCORE: 31.3
Some deterioration is evident in membrane and flashings; maintenance or minor repair is needed			
COMMENTS:	TPO single-ply membrane; front canopy requires drains at rear

Secondary Systems			
COMPONENT:	Floor Finishes	RATING: 1 x WEIGHT: 6.3 =	SCORE: 6.3
	Nice appearance, smooth transitions, level subfloors, no cracks/separating		
COMMENTS:	Carpet-mostly worn; vinyl and ceramic tile		
COMPONENT:	Wall Finishes	RATING: 2 x WEIGHT: 6.3 =	SCORE: 12.5
	Maintainable surfaces, minor maintenance is required in some areas		
COMMENTS:	Gypsum board and ceramic tile		
COMPONENT:	Ceiling Finishes	RATING: 3 x WEIGHT: 6.3 =	SCORE: 18.8
	Some wear and tear; Minor staining or deterioration		
COMMENTS:	Gypsum board and lay-in tile		
COMPONENT:	Doors & Hardware	RATING: 3 x WEIGHT: 6.3 =	SCORE: 18.8
	Functional but dated		
COMMENTS:	Interior/exterior HM doors/frames-surface wear and denting

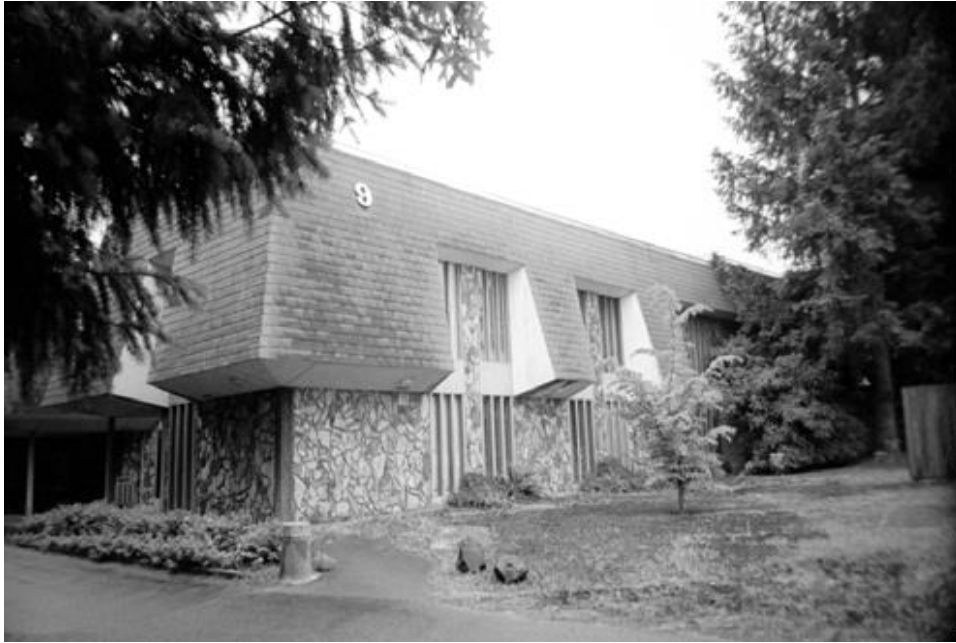
Mt Adams (220-F1) STATE UFI: A03517 Main Campus (220A)
AREA: 10,539 SF BUILT: 1970 REMODELED: No PREDOMINANT USE: Faculty Office
CONSTRUCTION TYPE: Medium CRV/SF: \$323 REPLACEMENT VALUE: \$3,404,097

Primary Systems			
COMPONENT:	Structure	RATING: 3 x WEIGHT: 8 =	SCORE: 24
Some cracking evident but does not likely affect structural integrity; Visible defects apparent but are non-structural			
COMMENTS:	Concrete columns and tilt-up panels; wood framing		
COMPONENT:	Exterior Closure	RATING: 3 x WEIGHT: 8 =	SCORE: 24
Sound and weatherproof but with some deterioration evident			
COMMENTS:	Concrete panels w embedded stone; plaster soffits; cement-asbestos mansard tiles		
COMPONENT:	Roofing	RATING: 3 x WEIGHT: 10 =	SCORE: 30
Some deterioration is evident in membrane and flashings; maintenance or minor repair is needed			
COMMENTS:	Hypalon single-ply membrane; membrane is beginning to deteriorate; needs restoration

Secondary Systems			
COMPONENT:	Floor Finishes	RATING: 1 x WEIGHT: 6 =	SCORE: 6
	Nice appearance, smooth transitions, level subfloors, no cracks/separating		
COMMENTS:	Carpet-new/old; carpet tile; ceramic tile		
COMPONENT:	Wall Finishes	RATING: 1 x WEIGHT: 6 =	SCORE: 6
	Maintainable surfaces in good condition		
COMMENTS:	Gypsum board; concrete; ceramic tile		
COMPONENT:	Ceiling Finishes	RATING: 3 x WEIGHT: 6 =	SCORE: 18
	Some wear and tear; Minor staining or deterioration		
COMMENTS:	Acoustical ceiling tile and gypsum board		
COMPONENT:	Doors & Hardware	RATING: 3 x WEIGHT: 6 =	SCORE: 18
	Functional but dated		
COMMENTS:	Interior/exterior HM doors/frames-surface wear

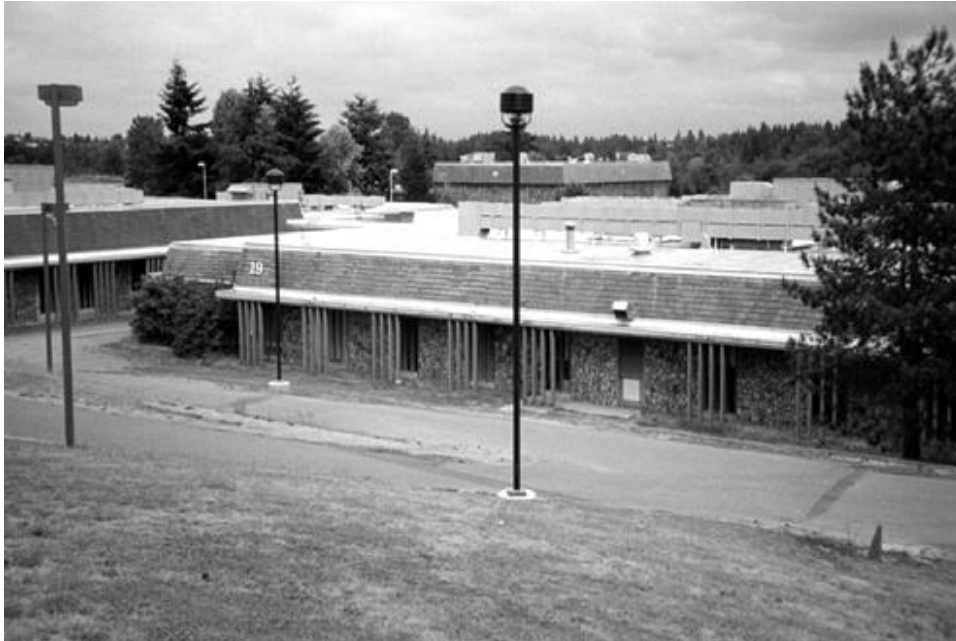
Mt Rainier (220-19)	STATE UFI: A05826	Main Campus (220A)
AREA: 36,649 SF	BUILT: 1975	REMODELED: No
CONSTRUCTION TYPE: Medium	CRV/SF: \$361	REPLACEMENT VALUE: \$13,230,289
PREDOMINANT USE: Vocational Arts

Primary Systems			
COMPONENT:	Structure	RATING: 3 x WEIGHT: 8 =	SCORE: 24
Some cracking evident but does not likely affect structural integrity; Visible defects apparent but are non-structural			
COMMENTS:	Concrete columns and tilt-up panels; wood framing		
COMPONENT:	Exterior Closure	RATING: 3 x WEIGHT: 8 =	SCORE: 24
Sound and weatherproof but with some deterioration evident			
COMMENTS:	Concrete panels w embedded stone; plaster soffits; cement-asbestos mansard tiles		
COMPONENT:	Roofing	RATING: 3 x WEIGHT: 10 =	SCORE: 30
Some deterioration is evident in membrane and flashings; maintenance or minor repair is needed			
COMMENTS:	Hypalon single-ply; deteriorated

Secondary Systems			
COMPONENT:	Floor Finishes	RATING: 2 x WEIGHT: 6 = SCORE: 12	
	Some wear is evident; maintenance needed		
COMMENTS:	Carpet-surface wear; vinyl tile; some VAT under carpet; carpet tile; ceramic tile		
COMPONENT:	Wall Finishes	RATING: 2 x WEIGHT: 6 = SCORE: 12	
	Maintainable surfaces, minor maintenance is required in some areas		
COMMENTS:	Gypsum board; ceramic tile; concrete		
COMPONENT:	Ceiling Finishes	RATING: 3 x WEIGHT: 6 = SCORE: 18	
	Some wear and tear; Minor staining or deterioration		
COMMENTS:	Lay-in tile-minor staining		
COMPONENT:	Doors & Hardware	RATING: 3 x WEIGHT: 6 = SCORE: 18	
	Functional but dated		
COMMENTS:	Interior/exterior HM doors/frames-surface wear

Service Systems			
COMPONENT:	Elevators	RATING: 5 x WEIGHT: 6 = SCORE: 30	
	No elevator access for upper floors		
COMMENTS:	Two story		
COMPONENT:	Plumbing	RATING: 3 x WEIGHT: 8 = SCORE: 24	
	Fixtures are functional but dated; some leaks; maintenance required		
COMMENTS:	Copper, galvanized and cast iron piping; porcelain fixtures		
COMPONENT:	HVAC	RATING: 2 x WEIGHT: 8 = SCORE: 16	
	Equipment in fair condition; minor deterioration; controls require troubleshooting; office areas have A/C; hazardous areas are ventilated		
COMMENTS:	Gas hot water boiler; chilled water from central plant; rooftop AHU w coils		
COMPONENT:	Electrical	RATING: 2 x WEIGHT: 8 = SCORE: 16	
	Adequate service and distribution capacity for current/future needs; some deterioration evident		
COMMENTS:	1200amp 480/277v; 400amp 480/277v; served by two separate transformers		
COMPONENT:	Lights/Power	RATING: 3 x WEIGHT: 8 = SCORE: 24	
	Adequate work area illumination; adequate outlets for current use

Quality Standards			
COMPONENT:	Maintenance	RATING: 3 x WEIGHT: 7 = SCORE: 21	
	Routine maintenance is required; deferred maintenance is evident; impact is minor to moderate		
COMMENTS:	Concrete canopy support columns have numerous spalls that need to be patched		
COMPONENT:	Remaining Life	RATING: 3 x WEIGHT: 6 = SCORE: 18	
	Life expectancy is roughly 10-15 years; moderate system deterioration		
COMMENTS:	Structurally adequate building; adequate size; good candidate for complete interior renovation		
COMPONENT:	Appearance	RATING: 3 x WEIGHT: 6 = SCORE: 18	
	Average construction; average interior and exterior appearance		
COMMENTS:	Exterior is very dated and unattractive

CONDITION: Needs Improvement/Renovation

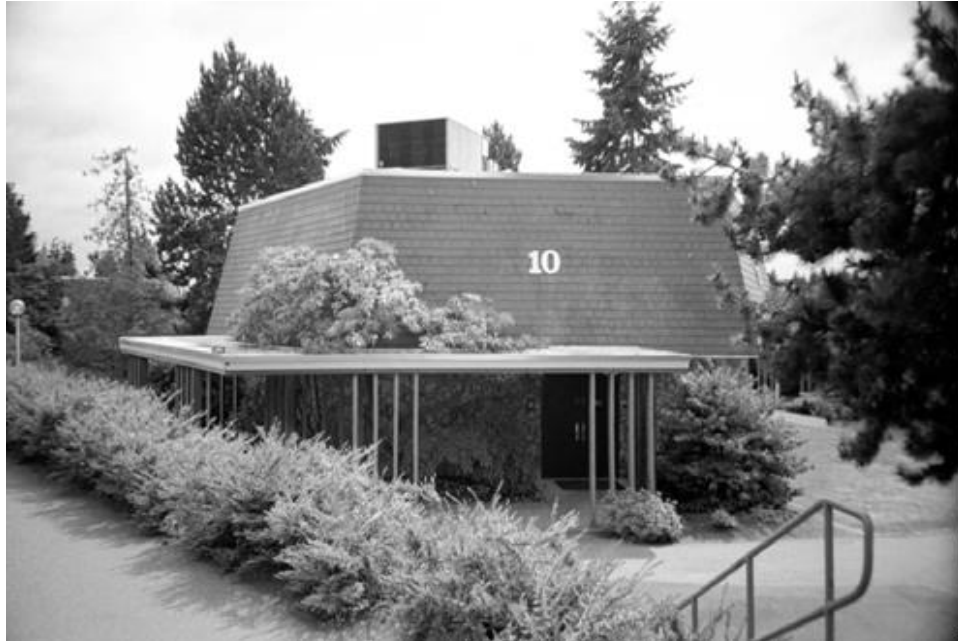
Mt Saint Helens (220-L1) STATE UFI: A08915 Main Campus (220A)
AREA: 2,194 SF BUILT: 1966 REMODELED: No PREDOMINANT USE: General Classroom
CONSTRUCTION TYPE: Medium CRV/SF: \$361 REPLACEMENT VALUE: \$792,034

Primary Systems			
COMPONENT:	Structure	RATING: 3 x WEIGHT: 8.7 =	SCORE: 26.1
Some cracking evident but does not likely affect structural integrity; Visible defects apparent but are non-structural			
COMMENTS:	Concrete columns and tilt-up panels; wood framing		
COMPONENT:	Exterior Closure	RATING: 3 x WEIGHT: 8.7 =	SCORE: 26.1
Sound and weatherproof but with some deterioration evident			
COMMENTS:	Concrete panels w embedded stone; plaster soffits; cement-asbestos mansard tiles		
COMPONENT:	Roofing	RATING: 4 x WEIGHT: 10.9 =	SCORE: 43.6
General deterioration and some leaks are evident; resurfacing or partial repair is needed			
COMMENTS:	Hypalon single-ply-1990; needs restoration

Secondary Systems			
COMPONENT:	Floor Finishes	RATING: 3 x WEIGHT: 6.5 =	SCORE: 19.6
Some wear and minor imperfections are evident; beginning deterioration			
COMMENTS:	Carpet throughout		
COMPONENT:	Wall Finishes	RATING: 1 x WEIGHT: 6.5 =	SCORE: 6.5
Maintainable surfaces in good condition			
COMMENTS:	Gypsum board; concrete		
COMPONENT:	Ceiling Finishes	RATING: 3 x WEIGHT: 6.5 =	SCORE: 19.6
Some wear and tear; Minor staining or deterioration			
COMMENTS:	Gypsum board and acoustical tile		
COMPONENT:	Doors & Hardware	RATING: 3 x WEIGHT: 6.5 =	SCORE: 19.6
Functional but dated			
COMMENTS:	Interior/exterior HM doors/frames-surface wear

Service Systems			
COMPONENT:	Elevators	RATING: 0 x WEIGHT: 0 =	SCORE: 0
No data			
COMMENTS:			
COMPONENT:	Plumbing	RATING: 1 x WEIGHT: 8.7 =	SCORE: 8.7
Fixtures and piping appear to be in good condition; no evidence of leaks			
COMMENTS:	Copper and cast iron piping; 1 sink		
COMPONENT:	HVAC	RATING: 1 x WEIGHT: 8.7 =	SCORE: 8.7
Equipment in good condition; easily controlled; serves all required spaces; All necessary spaces are adequately ventilated; A/C provided			
COMMENTS:	Rooftop packaged HVAC		
COMPONENT:	Electrical	RATING: 1 x WEIGHT: 8.7 =	SCORE: 8.7
Adequate service and distribution capacity for current/future needs			
COMMENTS:	225amp 480/277v		
COMPONENT:	Lights/Power	RATING: 1 x WEIGHT: 8.7 =	SCORE: 8.7
Contemporary lighting with good work area illumination; ample outlets			
COMMENTS:	Ceiling mount and recessed can fluorescent lighting

Quality Standards			
COMPONENT:	Maintenance	RATING: 3 x WEIGHT: 7.6 =	SCORE: 22.9
Routine maintenance is required; deferred maintenance is evident; impact is minor to moderate			
COMMENTS:	Concrete canopy support columns have numerous spalls that need to be patched		
COMPONENT:	Remaining Life	RATING: 5 x WEIGHT: 6.5 =	SCORE: 32.7
Life expectancy is <5 years; significant system deterioration			
COMMENTS:	Single classroom; no flexibility for instruction; inadequate for long-term		
COMPONENT:	Appearance	RATING: 3 x WEIGHT: 6.5 =	SCORE: 19.6
Average construction; average interior and exterior appearance			
COMMENTS:	Exterior is very dated and unattractive

CONDITION: Needs Improvement/Renovation

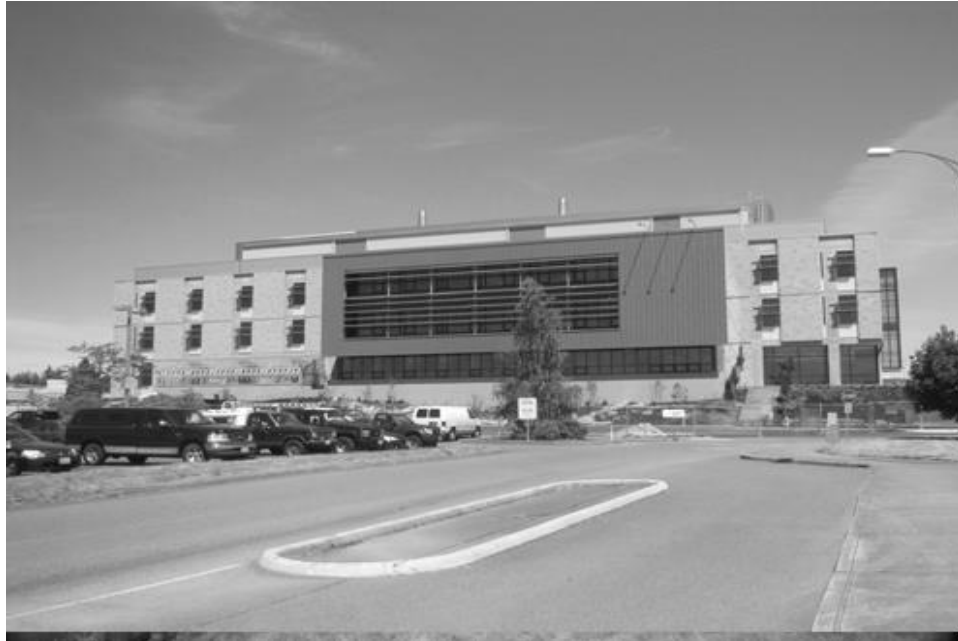
Pamela Transue Ctr. For Science & Engineering (220-15) STATE UFI: A02101 Main Campus (220A)
 AREA: 73,300 SF BUILT: 2007 REMODELED: No PREDOMINANT USE: Science Lab.
 CONSTRUCTION TYPE: Heavy CRV/SF: \$469 REPLACEMENT VALUE: \$34,377,700

Primary Systems			
COMPONENT:	Structure	RATING: 1 x WEIGHT: 8 = SCORE: 8	
No signs of settlement or cracking, no abrupt vertical changes Columns, bearing walls and roof structure appears sound/free of defects			
COMMENTS:	Steel frame and concrete		
COMPONENT:	Exterior Closure	RATING: 1 x WEIGHT: 8 = SCORE: 8	
Weatherproof, tight, well-maintained exterior walls, doors, windows/finishes			
COMMENTS:	Metal architectural panels; aluminum window walls; cement block; concrete		
COMPONENT:	Roofing	RATING: 1 x WEIGHT: 10 = SCORE: 10	
Flashing and penetrations appear sound and membrane appears water- tight; drainage is positive and there are overflow scuppers			
COMMENTS:	BUR w granulated cap sheet

Secondary Systems			
COMPONENT:	Floor Finishes	RATING: 2 x WEIGHT: 6 =	SCORE: 12
	Some wear is evident; maintenance needed		
COMMENTS:	Polished and unpolished concrete; carpet tiles; vinyl tile		
COMPONENT:	Wall Finishes	RATING: 1 x WEIGHT: 6 =	SCORE: 6
	Maintainable surfaces in good condition		
COMMENTS:	Gypsum board-plaster coat on some hall areas; ceramic tile; bare concrete		
COMPONENT:	Ceiling Finishes	RATING: 1 x WEIGHT: 6 =	SCORE: 6
	Maintainable surfaces in good condition; good alignment and appearance		
COMMENTS:	Lay-in tile; gypsum board; metal deck pan		
COMPONENT:	Doors & Hardware	RATING: 1 x WEIGHT: 6 =	SCORE: 6
	Appropriate hardware, closers, panic devices; in good working order		
COMMENTS:	Interior wood doors w HM frames; glass lites; exterior glazed aluminum doors/frames

Service Systems			
COMPONENT:	Elevators	RATING: 1 x WEIGHT: 6 =	SCORE: 6
	Appropriate and functional for occupancy and use		
COMMENTS:	5 stop		
COMPONENT:	Plumbing	RATING: 1 x WEIGHT: 8 =	SCORE: 8
	Fixtures and piping appear to be in good condition; no evidence of leaks		
COMMENTS:	Copper, steel, cast iron and PVC piping; porcelain and ss fixtures		
COMPONENT:	HVAC	RATING: 1 x WEIGHT: 8 =	SCORE: 8
	Equipment in good condition; easily controlled; serves all required spaces; All necessary spaces are adequately ventilated; A/C provided		
COMMENTS:	2 HW boilers; chiller; AHUs w VAV boxes; hot water radiant perimeter heat; heat recovery		
COMPONENT:	Electrical	RATING: 1 x WEIGHT: 8 =	SCORE: 8
	Adequate service and distribution capacity for current/future needs		
COMMENTS:	2000amp 480/277v		
COMPONENT:	Lights/Power	RATING: 1 x WEIGHT: 8 =	SCORE: 8
	Contemporary lighting with good work area illumination; ample outlets

Safety Systems			
COMPONENT:	Life/Safety	RATING: 1 x WEIGHT: 10 = SCORE: 10	
	Appears to meet current codes		
COMMENTS:			
COMPONENT:	Fire Safety	RATING: 1 x WEIGHT: 10 = SCORE: 10	
	Locally monitored detection; alarm and strobes present; sprinklers in high hazard areas		
COMMENTS:			
COMPONENT:	Modifications	RATING: 1 x WEIGHT: 7 = SCORE: 7	
	Modifications appear to be in compliance with codes and sound construction practices; HVAC/electrical service properly provided		
COMMENTS:	New building

Quality Standards			
COMPONENT:	Maintenance	RATING: 1 x WEIGHT: 7 = SCORE: 7	
	Facility appears well maintained		
COMMENTS:			
COMPONENT:	Remaining Life	RATING: 1 x WEIGHT: 6 = SCORE: 6	
	Life expectancy is >20 years; minor system deterioration		
COMMENTS:	Well-constructed; should have 40+ year life		
COMPONENT:	Appearance	RATING: 1 x WEIGHT: 6 = SCORE: 6	
	Well-constructed building; generally attractive interior and exterior		
COMMENTS:

CONDITION: Superior

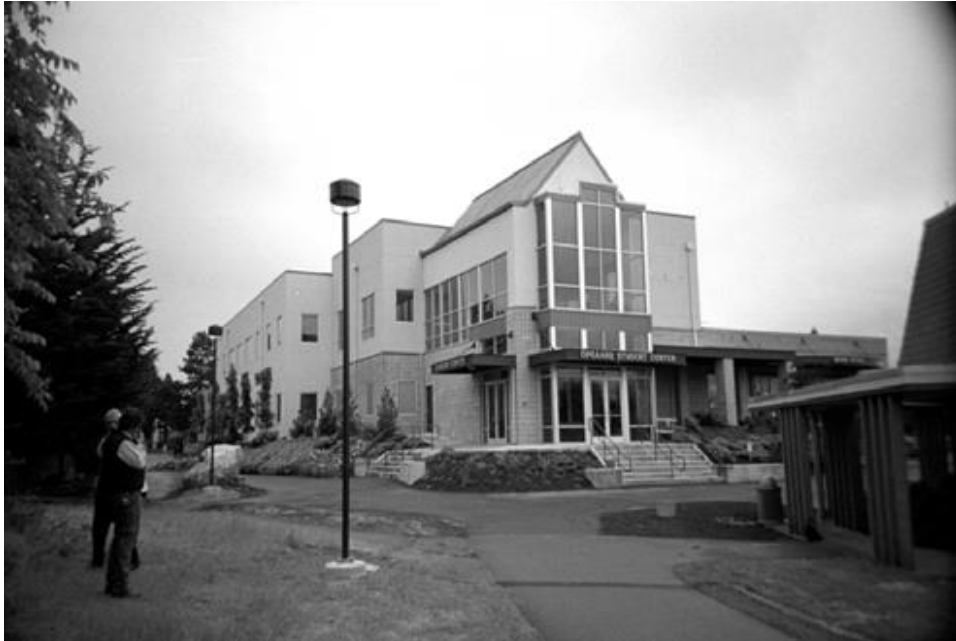
Tahoma - Opgaard Student Center (220-11) STATE UFI: A07930 Main Campus (220A)
 AREA: 40,810 SF BUILT: 1967 REMODELED: No PREDOMINANT USE: Student Center
 CONSTRUCTION TYPE: Medium CRV/SF: \$376 REPLACEMENT VALUE: \$15,344,560

Primary Systems			
COMPONENT:	Structure	RATING: 1 x WEIGHT: 8 =	SCORE: 8
No signs of settlement or cracking, no abrupt vertical changes Columns, bearing walls and roof structure appears sound/free of defects			
COMMENTS:	CMU and concrete		
COMPONENT:	Exterior Closure	RATING: 1 x WEIGHT: 8 =	SCORE: 8
Weatherproof, tight, well-maintained exterior walls, doors, windows/finishes			
COMMENTS:	CMU and metal panels; aluminum window walls		
COMPONENT:	Roofing	RATING: 2 x WEIGHT: 10 =	SCORE: 20
Majority of roofing and flashing appear sound, but a small portion of roofing shows deterioration where maintenance or minor repair needed			
COMMENTS:	BUR w mineral-surfaced cap sheet-2010; hypalon single-ply

Secondary Systems			
COMPONENT:	Floor Finishes	RATING: 2 x WEIGHT: 6 = SCORE: 12	
	Some wear is evident; maintenance needed		
COMMENTS:	Carpet-general surface wear; vinyl tile; ceramic and quarry tile; concrete		
COMPONENT:	Wall Finishes	RATING: 1 x WEIGHT: 6 = SCORE: 6	
	Maintainable surfaces in good condition		
COMMENTS:	Gypsum board; ceramic tile; plastic panels		
COMPONENT:	Ceiling Finishes	RATING: 2 x WEIGHT: 6 = SCORE: 12	
	Aging surfaces in fair condition and good alignment		
COMMENTS:	Gypsum board; lay-in tile		
COMPONENT:	Doors & Hardware	RATING: 3 x WEIGHT: 6 = SCORE: 18	
	Functional but dated		
COMMENTS:	Interior wood/HM doors w HM frames-surface wear; exterior aluminum and HM doors/frames-surface wear; storefront funded 21-23

Service Systems			
COMPONENT:	Elevators	RATING: 1 x WEIGHT: 6 = SCORE: 6	
	Appropriate and functional for occupancy and use		
COMMENTS:	2 stop for two story portion of building		
COMPONENT:	Plumbing	RATING: 2 x WEIGHT: 8 = SCORE: 16	
	Fixtures and piping are functional; finishes require maintenance		
COMMENTS:	Copper, cast iron, steel and PVC piping; vitreous fixtures		
COMPONENT:	HVAC	RATING: 3 x WEIGHT: 8 = SCORE: 24	
	System generally adequate; some deterioration; needs balancing; Offices areas have A/C; hazardous areas are ventilated		
COMMENTS:	2 HW boilers; chilled water from central plant; AHUs w VAV and fan coils		
COMPONENT:	Electrical	RATING: 1 x WEIGHT: 8 = SCORE: 8	
	Adequate service and distribution capacity for current/future needs		
COMMENTS:	1200amp 480/277v; 800amp 208/120v		
COMPONENT:	Lights/Power	RATING: 1 x WEIGHT: 8 = SCORE: 8	
	Contemporary lighting with good work area illumination; ample outlets

Safety Systems			
COMPONENT:	Life/Safety	RATING: 2 x WEIGHT: 10 = SCORE: 20	
	Most areas meet current codes; some areas meet codes for prior construction phases		
COMMENTS:			
COMPONENT:	Fire Safety	RATING: 1 x WEIGHT: 10 = SCORE: 10	
	Locally monitored detection; alarm and strobes present; sprinklers in high hazard areas		
COMMENTS:	New fire alarm panel in 2005; partially sprinklered		
COMPONENT:	Modifications	RATING: 1 x WEIGHT: 7 = SCORE: 7	
	Modifications appear to be in compliance with codes and sound construction practices; HVAC/electrical service properly provided		
COMMENTS:	Modifications appear properly constructed

Quality Standards			
COMPONENT:	Maintenance	RATING: 1 x WEIGHT: 7 = SCORE: 7	
	Facility appears well maintained		
COMMENTS:			
COMPONENT:	Remaining Life	RATING: 1 x WEIGHT: 6 = SCORE: 6	
	Life expectancy is >20 years; minor system deterioration		
COMMENTS:	Major additions in 1989, 1995 and 2001; major renovation of original wing in 2002		
COMPONENT:	Appearance	RATING: 1 x WEIGHT: 6 = SCORE: 6	
	Well-constructed building; generally attractive interior and exterior		
COMMENTS:

CONDITION: Adequate

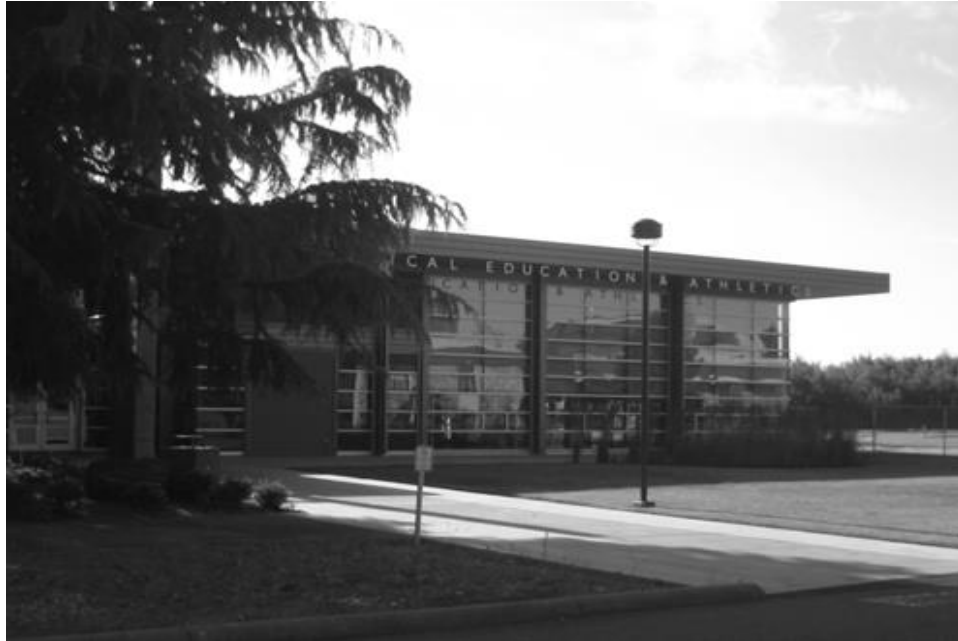
Titan (220-20) STATE UFI: A07300 Main Campus (220A)
 AREA: 25,140 SF BUILT: 1966 REMODELED: No PREDOMINANT USE: Gymnasium
 CONSTRUCTION TYPE: Medium CRV/SF: \$335 REPLACEMENT VALUE: \$8,421,900

Primary Systems			
COMPONENT:	Structure	RATING: 1 x WEIGHT: 8.3 =	SCORE: 8.3
No signs of settlement or cracking, no abrupt vertical changes Columns, bearing walls and roof structure appears sound/free of defects			
COMMENTS:	Concrete columns and tilt-up panels; wood framing		
COMPONENT:	Exterior Closure	RATING: 1 x WEIGHT: 8.3 =	SCORE: 8.3
Weatherproof, tight, well-maintained exterior walls, doors, windows/finishes			
COMMENTS:	Concrete panels w embedded stone; plaster soffits; cement-asbestos mansard tiles		
COMPONENT:	Roofing	RATING: 2 x WEIGHT: 10.4 =	SCORE: 20.9
Majority of roofing and flashing appear sound, but a small portion of roofing shows deterioration where maintenance or minor repair needed			
COMMENTS:	Hypalon single-ply; upper roof new in 02; lower roof is deteriorated

Secondary Systems			
COMPONENT:	Floor Finishes	RATING: 1 x WEIGHT: 6.3 =	SCORE: 6.3
Nice appearance, smooth transitions, level subfloors, no cracks/separating			
COMMENTS:	Carpet-surface wear; carpet tile; ceramic tile; hardwood-surface wear; vinyl tile; rubber mats		
COMPONENT:	Wall Finishes	RATING: 1 x WEIGHT: 6.3 =	SCORE: 6.3
Maintainable surfaces in good condition			
COMMENTS:	Gypsum board; ceramic tile		
COMPONENT:	Ceiling Finishes	RATING: 1 x WEIGHT: 6.3 =	SCORE: 6.3
Maintainable surfaces in good condition; good alignment and appearance			
COMMENTS:	Gypsum board; metal deck pan		
COMPONENT:	Doors & Hardware	RATING: 1 x WEIGHT: 6.3 =	SCORE: 6.3
Appropriate hardware, closers, panic devices; in good working order			
COMMENTS:	Interior/exterior HM doors/frames-surface wear

Service Systems			
COMPONENT:	Elevators	RATING: 0 x WEIGHT: 0 =	SCORE: 0
No data			
COMMENTS:			
COMPONENT:	Plumbing	RATING: 1 x WEIGHT: 8.3 =	SCORE: 8.3
Fixtures and piping appear to be in good condition; no evidence of leaks			
COMMENTS:	Copper, galvanized, PVC and cast iron piping; porcelain fixtures		
COMPONENT:	HVAC	RATING: 1 x WEIGHT: 8.3 =	SCORE: 8.3
Equipment in good condition; easily controlled; serves all required spaces; All necessary spaces are adequately ventilated; A/C provided			
COMMENTS:	HW boiler; AHUs; rooftop packaged HVAC units-4 deteriorated		
COMPONENT:	Electrical	RATING: 1 x WEIGHT: 8.3 =	SCORE: 8.3
Adequate service and distribution capacity for current/future needs			
COMMENTS:	1200amp 480/277v		
COMPONENT:	Lights/Power	RATING: 1 x WEIGHT: 8.3 =	SCORE: 8.3
Contemporary lighting with good work area illumination; ample outlets			
COMMENTS:	Lay-in, recessed can, suspended and ceiling mount fluorescent lighting

Safety Systems			
COMPONENT:	Life/Safety	RATING: 1 x WEIGHT: 10.4 = SCORE: 10.4	
	Appears to meet current codes		
COMMENTS:			
COMPONENT:	Fire Safety	RATING: 1 x WEIGHT: 10.4 = SCORE: 10.4	
	Locally monitored detection; alarm and strobes present; sprinklers in high hazard areas		
COMMENTS:	New fire alarm panel in 2011		
COMPONENT:	Modifications	RATING: 1 x WEIGHT: 7.3 = SCORE: 7.3	
	Modifications appear to be in compliance with codes and sound construction practices; HVAC/electrical service properly provided		
COMMENTS:	Modifications 2016

Quality Standards			
COMPONENT:	Maintenance	RATING: 1 x WEIGHT: 7.3 = SCORE: 7.3	
	Facility appears well maintained		
COMMENTS:	Concrete canopy support columns have numerous spalls that need to be patched		
COMPONENT:	Remaining Life	RATING: 1 x WEIGHT: 6.3 = SCORE: 6.3	
	Life expectancy is >20 years; minor system deterioration		
COMMENTS:	1998 exercise room addition; gym needs complete interior renovation to extend useful life		
COMPONENT:	Appearance	RATING: 1 x WEIGHT: 6.3 = SCORE: 6.3	
	Well-constructed building; generally attractive interior and exterior		
COMMENTS:	Exterior is very dated and unattractive, except for new addition

CONDITION: Superior

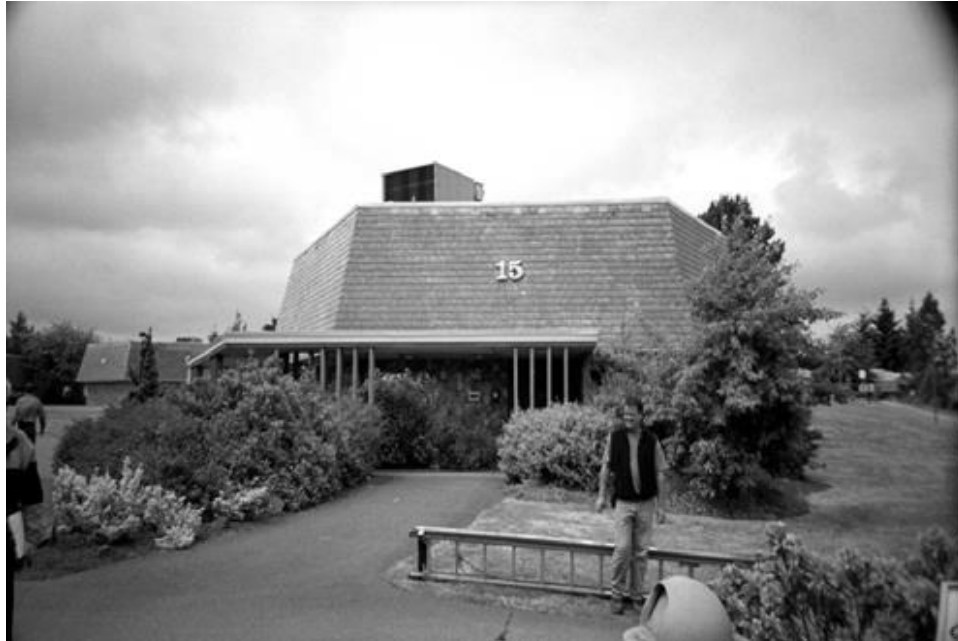
Vancouver (220-L2) STATE UFI: A08782 Main Campus (220A)
AREA: 2,194 SF BUILT: 1966 REMODELED: No PREDOMINANT USE: General Classroom
CONSTRUCTION TYPE: Medium CRV/SF: \$361 REPLACEMENT VALUE: \$792,034

Primary Systems			
COMPONENT:	Structure	RATING: 3 x WEIGHT: 8.7 = SCORE: 26.1	
Some cracking evident but does not likely affect structural integrity; Visible defects apparent but are non-structural			
COMMENTS:	Concrete columns and tilt-up panels; wood framing		
COMPONENT:	Exterior Closure	RATING: 3 x WEIGHT: 8.7 = SCORE: 26.1	
Sound and weatherproof but with some deterioration evident			
COMMENTS:	Concrete panels w embedded stone; plaster soffits; cement-asbestos mansard tiles		
COMPONENT:	Roofing	RATING: 5 x WEIGHT: 10.9 = SCORE: 54.5	
Leaking and deterioration is to point where new roof is required			
COMMENTS:	Hypalon single-ply-1990; needs restoration

Secondary Systems			
COMPONENT:	Floor Finishes	RATING: 1 x WEIGHT: 6.5 =	SCORE: 6.5
	Nice appearance, smooth transitions, level subfloors, no cracks/separating		
COMMENTS:	Carpet throughout		
COMPONENT:	Wall Finishes	RATING: 1 x WEIGHT: 6.5 =	SCORE: 6.5
	Maintainable surfaces in good condition		
COMMENTS:	Gypsum board; concrete		
COMPONENT:	Ceiling Finishes	RATING: 2 x WEIGHT: 6.5 =	SCORE: 13.1
	Aging surfaces in fair condition and good alignment		
COMMENTS:	Gypsum board and acoustical tile		
COMPONENT:	Doors & Hardware	RATING: 3 x WEIGHT: 6.5 =	SCORE: 19.6
	Functional but dated		
COMMENTS:	Interior/exterior HM doors/frames-surface wear

Service Systems			
COMPONENT:	Elevators	RATING: 0 x WEIGHT: 0 =	SCORE: 0
	No data		
COMMENTS:			
COMPONENT:	Plumbing	RATING: 1 x WEIGHT: 8.7 =	SCORE: 8.7
	Fixtures and piping appear to be in good condition; no evidence of leaks		
COMMENTS:	Copper and cast iron piping; 1 sink		
COMPONENT:	HVAC	RATING: 1 x WEIGHT: 8.7 =	SCORE: 8.7
	Equipment in good condition; easily controlled; serves all required spaces; All necessary spaces are adequately ventilated; A/C provided		
COMMENTS:	Rooftop packaged HVAC unit-failing		
COMPONENT:	Electrical	RATING: 1 x WEIGHT: 8.7 =	SCORE: 8.7
	Adequate service and distribution capacity for current/future needs		
COMMENTS:	225amp 480/277v		
COMPONENT:	Lights/Power	RATING: 1 x WEIGHT: 8.7 =	SCORE: 8.7
	Contemporary lighting with good work area illumination; ample outlets		
COMMENTS:	Ceiling mount and recessed can fluorescent lighting

Quality Standards			
COMPONENT:	Maintenance	RATING: 3 x WEIGHT: 7.6 = SCORE: 22.9	
	Routine maintenance is required; deferred maintenance is evident; impact is minor to moderate		
COMMENTS:	Concrete canopy support columns have numerous spalls that need to be patched		
COMPONENT:	Remaining Life	RATING: 5 x WEIGHT: 6.5 = SCORE: 32.7	
	Life expectancy is <5 years; significant system deterioration		
COMMENTS:	Single classroom; no flexibility for instruction; inadequate for long-term		
COMPONENT:	Appearance	RATING: 3 x WEIGHT: 6.5 = SCORE: 19.6	
	Average construction; average interior and exterior appearance		
COMMENTS:	Exterior is very dated and unattractive

CONDITION: Needs Improvement/Renovation
