2021 FACILITY CONDITION SURVEY

Tacoma Community College

SURVEY CONDUCTED BY:
Steve Lewandowski
State Board for Community
and Technical Colleges

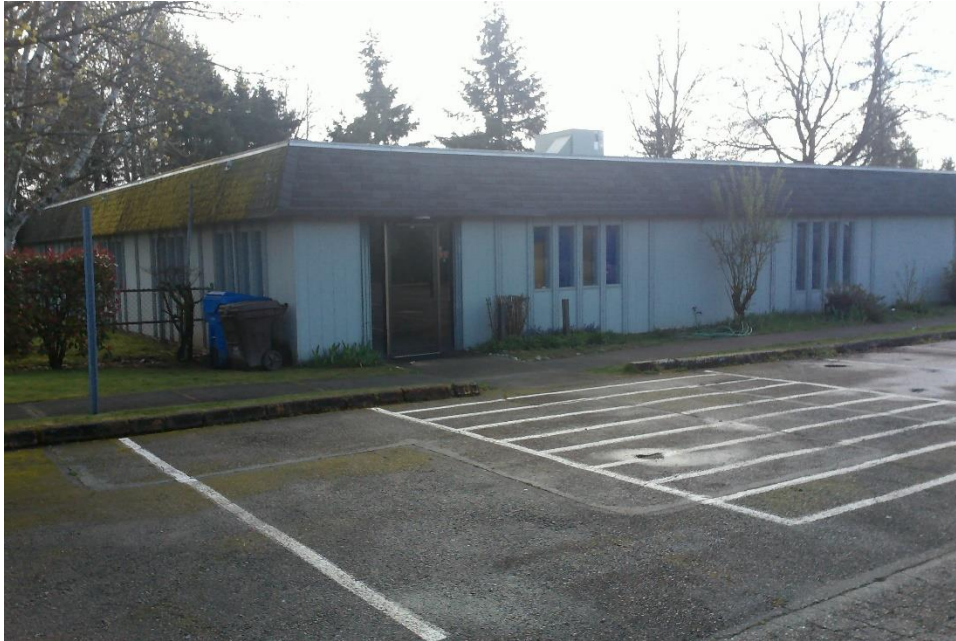
Warehouse-Storage-Surplus (220-WH) STATE UFI: A05762 Main Campus (220A)
AREA: 5,286 SF BUILT: 1981 REMODELED: No PREDOMINANT USE: Central Storage
CONSTRUCTION TYPE: No data CRV/SF: \$144 REPLACEMENT VALUE: \$761,184

Primary Systems			
COMPONENT:	Structure	RATING: 3 x WEIGHT: 8 =	SCORE: 24
Some cracking evident but does not likely affect structural integrity; Visible defects apparent but are non-structural			
COMMENTS:	No data		
COMPONENT:	Exterior Closure	RATING: 2 x WEIGHT: 8 =	SCORE: 16
Weatherproof exterior, but generally appears poorly maintained			
COMMENTS:	No data		
COMPONENT:	Roofing	RATING: 1 x WEIGHT: 10 =	SCORE: 10
Flashing and penetrations appear sound and membrane appears water- tight; drainage is positive and there are overflow scuppers			
COMMENTS:	single ply 2018

Secondary Systems		
COMPONENT:	Floor Finishes	RATING: 4 x WEIGHT: 6 = SCORE: 24
	General deterioration evident; one-third to one-half of flooring exhibits extensive deterioration	
COMMENTS:	No data	
COMPONENT:	Wall Finishes	RATING: 4 x WEIGHT: 6 = SCORE: 24
	Aging surfaces generally require maintenance; some areas require repair	
COMMENTS:	No data	
COMPONENT:	Ceiling Finishes	RATING: 5 x WEIGHT: 6 = SCORE: 30
	Deteriorated, significant number of stained or sagging areas; inappropriate for occupancy	
COMMENTS:	No data	
COMPONENT:	Doors & Hardware	RATING: 3 x WEIGHT: 6 = SCORE: 18
	Functional but dated	
COMMENTS:	No data

Service Systems		
COMPONENT:	Elevators	RATING: No data
	No data	
COMMENTS:	No data	
COMPONENT:	Plumbing	RATING: 4 x WEIGHT: 8 = SCORE: 32
	General deterioration of most fixtures and pipes; moderate number of leaks and blockage areas; need repairs	
COMMENTS:	No data	
COMPONENT:	HVAC	RATING: 3 x WEIGHT: 8 = SCORE: 24
	System generally adequate; some deterioration; needs balancing; Offices areas have A/C; hazardous areas are ventilated	
COMMENTS:	No data	
COMPONENT:	Electrical	RATING: 1 x WEIGHT: 8 = SCORE: 8
	Adequate service and distribution capacity for current/future needs	
COMMENTS:	No data	
COMPONENT:	Lights/Power	RATING: 4 x WEIGHT: 8 = SCORE: 32
	Generally adequate work area illumination; some areas with unsafe levels of illumination or inadequate outlets	
COMMENTS:	No data

Safety Systems			
COMPONENT:	Life/Safety	RATING: 3 x WEIGHT: 10 = SCORE: 30	
	Generally meets codes for vintage of construction		
COMMENTS:	No data		
COMPONENT:	Fire Safety	RATING: 2 x WEIGHT: 10 = SCORE: 20	
	Locally monitored detection; alarm present, but missing visual component or sprinklers		
COMMENTS:	No data		
COMPONENT:	Modifications	RATING: 3 x WEIGHT: 7 = SCORE: 21	
	Some modifications lack code compliance; HVAC service not fully considered during renovation		
COMMENTS:	No data

Quality Standards			
COMPONENT:	Maintenance	RATING: 5 x WEIGHT: 7 = SCORE: 35	
	General deterioration is evident; lack of adequate maintenance is evident; impact is moderate to severe		
COMMENTS:	No data		
COMPONENT:	Remaining Life	RATING: 3 x WEIGHT: 6 = SCORE: 18	
	Life expectancy is roughly 10-15 years; moderate system deterioration		
COMMENTS:	No data		
COMPONENT:	Appearance	RATING: 5 x WEIGHT: 6 = SCORE: 30	
	Poor to average construction; very unattractive exterior and interior spaces		
COMMENTS:	No data

Heat Loss			
COMPONENT:	Insulation	RATING: 4 x WEIGHT: 6 = SCORE: 24	
	Insulation present in some areas or systems, but missing in other areas or systems		
COMMENTS:	No data		
COMPONENT:	Glazing	RATING: 2 x WEIGHT: 6 = SCORE: 12	
	Mix of double glazed windows; some with aluminum/metal frames and some that minimize conductivity		
COMMENTS:	No data

CONDITION: Needs Improvement/Renovation

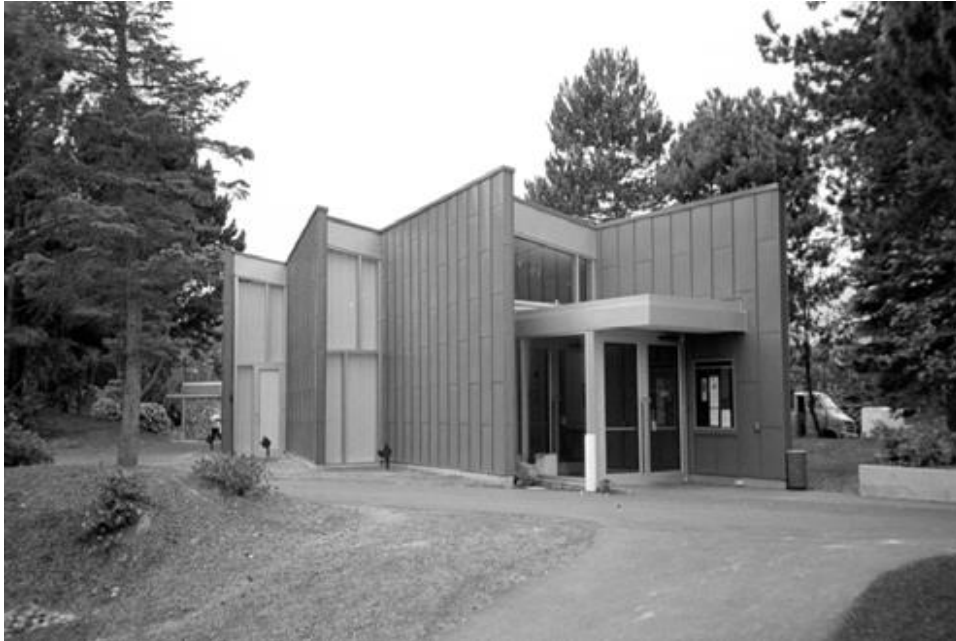
Art Gallery (220-4) STATE UFI: A01072 Main Campus (220A)
AREA: 2,080 SF BUILT: 2003 REMODELED: No PREDOMINANT USE: Visual Arts
CONSTRUCTION TYPE: Light CRV/SF: \$361 REPLACEMENT VALUE: \$750,880

Primary Systems			
COMPONENT:	Structure	RATING: 1 x WEIGHT: 8.3 =	SCORE: 8.3
No signs of settlement or cracking, no abrupt vertical changes Columns, bearing walls and roof structure appears sound/free of defects			
COMMENTS:	Stick framing with concrete slab and wood roof deck/joists		
COMPONENT:	Exterior Closure	RATING: 1 x WEIGHT: 8.3 =	SCORE: 8.3
Weatherproof, tight, well-maintained exterior walls, doors, windows/finishes			
COMMENTS:	Standing seam metal panels		
COMPONENT:	Roofing	RATING: 1 x WEIGHT: 10.4 =	SCORE: 10.4
Flashing and penetrations appear sound and membrane appears water- tight; drainage is positive and there are overflow scuppers			
COMMENTS:	Standing seam metal roof

Secondary Systems			
COMPONENT:	Floor Finishes	RATING: 1 x WEIGHT: 6.3 =	SCORE: 6.3
	Nice appearance, smooth transitions, level subfloors, no cracks/separating		
COMMENTS:	Concrete with ground/polished surface		
COMPONENT:	Wall Finishes	RATING: 1 x WEIGHT: 6.3 =	SCORE: 6.3
	Maintainable surfaces in good condition		
COMMENTS:	Gypsum board; ceramic tile		
COMPONENT:	Ceiling Finishes	RATING: 1 x WEIGHT: 6.3 =	SCORE: 6.3
	Maintainable surfaces in good condition; good alignment and appearance		
COMMENTS:	Gypsum board; lay-in tile		
COMPONENT:	Doors & Hardware	RATING: 1 x WEIGHT: 6.3 =	SCORE: 6.3
	Appropriate hardware, closers, panic devices; in good working order		
COMMENTS:	Interior/exterior aluminum/HM doors/frames

Service Systems			
COMPONENT:	Elevators	RATING: 0 x WEIGHT: 0 =	SCORE: 0
	No data		
COMMENTS:			
COMPONENT:	Plumbing	RATING: 1 x WEIGHT: 8.3 =	SCORE: 8.3
	Fixtures and piping appear to be in good condition; no evidence of leaks		
COMMENTS:	Copper, steel and cast iron piping		
COMPONENT:	HVAC	RATING: 1 x WEIGHT: 8.3 =	SCORE: 8.3
	Equipment in good condition; easily controlled; serves all required spaces; All necessary spaces are adequately ventilated; A/C provided		
COMMENTS:	Split system heat pump		
COMPONENT:	Electrical	RATING: 1 x WEIGHT: 8.3 =	SCORE: 8.3
	Adequate service and distribution capacity for current/future needs		
COMMENTS:	400amp 240/120v		
COMPONENT:	Lights/Power	RATING: 1 x WEIGHT: 8.3 =	SCORE: 8.3
	Contemporary lighting with good work area illumination; ample outlets		
COMMENTS:	Hanging, recessed can and track fluorescent lighting

Safety Systems			
COMPONENT:	Life/Safety	RATING: 1 x WEIGHT: 10.4 = SCORE: 10.4	
	Appears to meet current codes		
COMMENTS:			
COMPONENT:	Fire Safety	RATING: 1 x WEIGHT: 10.4 = SCORE: 10.4	
	Locally monitored detection; alarm and strobes present; sprinklers in high hazard areas		
COMMENTS:	New fire alarm panel in 2011		
COMPONENT:	Modifications	RATING: 1 x WEIGHT: 7.3 = SCORE: 7.3	
	Modifications appear to be in compliance with codes and sound construction practices; HVAC/electrical service properly provided		
COMMENTS:	No modifications apparent

Quality Standards			
COMPONENT:	Maintenance	RATING: 1 x WEIGHT: 7.3 = SCORE: 7.3	
	Facility appears well maintained		
COMMENTS:			
COMPONENT:	Remaining Life	RATING: 1 x WEIGHT: 6.3 = SCORE: 6.3	
	Life expectancy is >20 years; minor system deterioration		
COMMENTS:			
COMPONENT:	Appearance	RATING: 2 x WEIGHT: 6.3 = SCORE: 12.5	
	Well-constructed building; average interior and exterior appearance		
COMMENTS:	Building won a design award, but only average looking

CONDITION: Superior

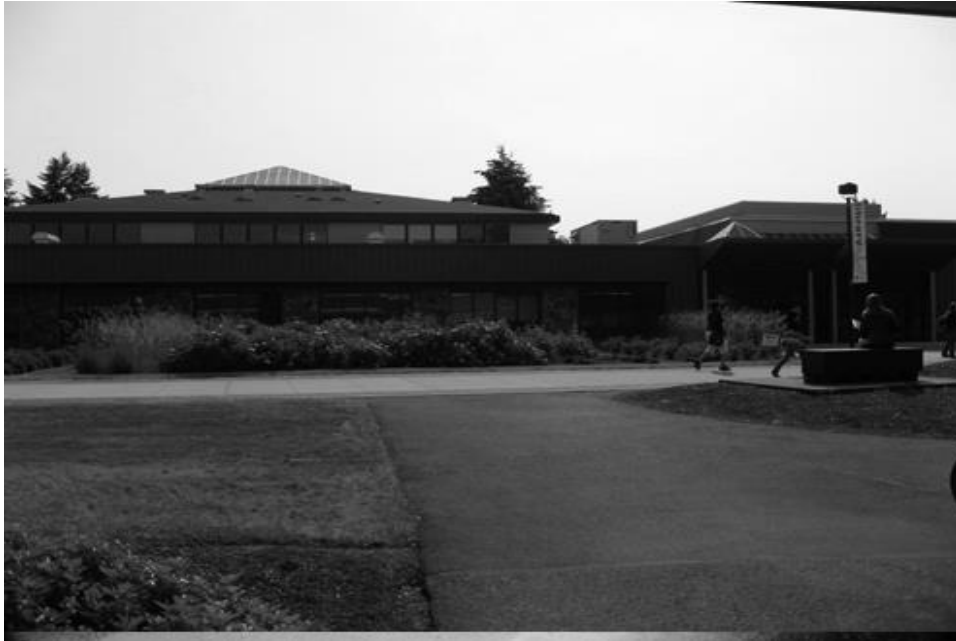
Pearl Wanamaker (220-7) STATE UFI: A01540 Main Campus (220A)
 AREA: 67,176 SF BUILT: 1966 REMODELED: No PREDOMINANT USE: Library
 CONSTRUCTION TYPE: Medium CRV/SF: \$361 REPLACEMENT VALUE: \$24,250,536

Primary Systems			
COMPONENT:	Structure	RATING: 2 x WEIGHT: 8 =	SCORE: 16
Minor cracks evident in a small portion of the structure			
COMMENTS:	Concrete columns and tilt-up panels; wood framing; steel frame; CMU		
COMPONENT:	Exterior Closure	RATING: 3 x WEIGHT: 8 =	SCORE: 24
Sound and weatherproof but with some deterioration evident			
COMMENTS:	Concrete panels w embedded stone; plaster soffits; cement-asbestos mansard tiles; metal panels; repairs funded 21-23		
COMPONENT:	Roofing	RATING: 2 x WEIGHT: 10 =	SCORE: 20
Majority of roofing and flashing appear sound, but a small portion of roofing shows deterioration where maintenance or minor repair needed			
COMMENTS:	Hypalon single-ply-funded 2011; 3-tab composition shingles-2008; skylights

Secondary Systems			
COMPONENT:	Floor Finishes	RATING: 1 x WEIGHT: 6 =	SCORE: 6
	Nice appearance, smooth transitions, level subfloors, no cracks/separating		
COMMENTS:	Carpet tile, carpet; vinyl tile; sheet vinyl; ceramic tile		
COMPONENT:	Wall Finishes	RATING: 1 x WEIGHT: 6 =	SCORE: 6
	Maintainable surfaces in good condition		
COMMENTS:	Gypsum board and ceramic tile; glass walls; concrete		
COMPONENT:	Ceiling Finishes	RATING: 1 x WEIGHT: 6 =	SCORE: 6
	Maintainable surfaces in good condition; good alignment and appearance		
COMMENTS:	Gypsum board and lay-in tile; direct-adhered tile		
COMPONENT:	Doors & Hardware	RATING: 1 x WEIGHT: 6 =	SCORE: 6
	Appropriate hardware, closers, panic devices; in good working order		
COMMENTS:	Interior wood/HM doors w HM frames; sidelites; exterior aluminum and HM doors/frames

Service Systems			
COMPONENT:	Elevators	RATING: 2 x WEIGHT: 6 =	SCORE: 12
	Aged elevators functional, but deterioration or abuse of finishes is evident		
COMMENTS:	2 stop; one passenger and one freight		
COMPONENT:	Plumbing	RATING: 1 x WEIGHT: 8 =	SCORE: 8
	Fixtures and piping appear to be in good condition; no evidence of leaks		
COMMENTS:	Copper, cast iron, steel and PVC piping; porcelain fixtures		
COMPONENT:	HVAC	RATING: 2 x WEIGHT: 8 =	SCORE: 16
	Equipment in fair condition; minor deterioration; controls require troubleshooting; office areas have A/C; hazardous areas are ventilated		
COMMENTS:	HW boiler; 2 air-cooled chillers serving a number of buildings- degraded; AHUs w VAVs		
COMPONENT:	Electrical	RATING: 1 x WEIGHT: 8 =	SCORE: 8
	Adequate service and distribution capacity for current/future needs		
COMMENTS:	2500amp 480/208v; 1200amp 408/277v		
COMPONENT:	Lights/Power	RATING: 3 x WEIGHT: 8 =	SCORE: 24

CONDITION: Adequate

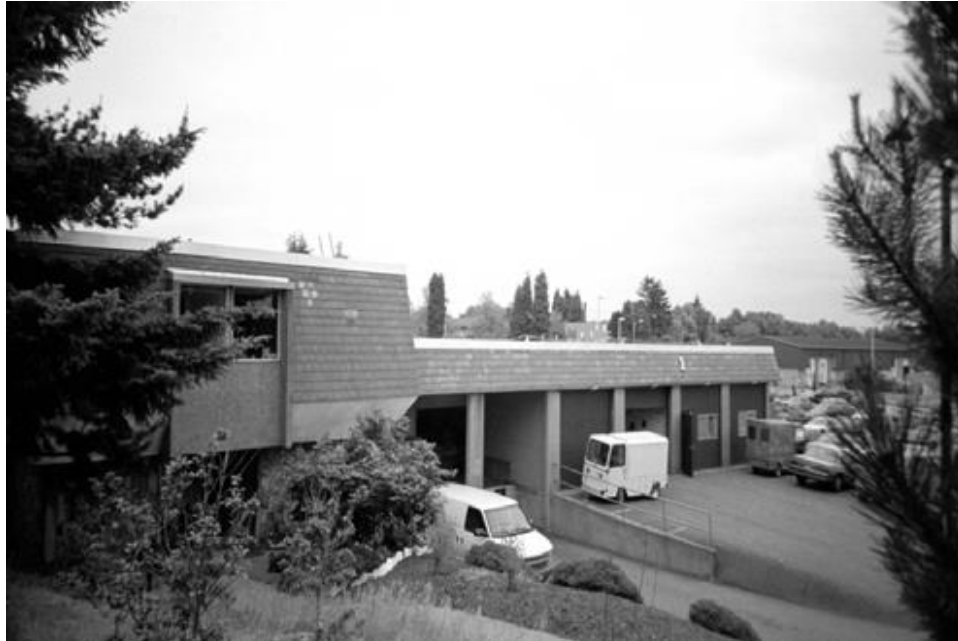
Nisqually (220-1) STATE UFI: A02786 Main Campus (220A)
AREA: 6,756 SF BUILT: 1970 REMODELED: No PREDOMINANT USE: Administration
CONSTRUCTION TYPE: Medium CRV/SF: \$323 REPLACEMENT VALUE: \$2,182,188

Primary Systems			
COMPONENT:	Structure	RATING: 3 x WEIGHT: 8 =	SCORE: 24
Some cracking evident but does not likely affect structural integrity; Visible defects apparent but are non-structural			
COMMENTS:	Concrete columns and tilt-up panels; wood framing		
COMPONENT:	Exterior Closure	RATING: 4 x WEIGHT: 8 =	SCORE: 32
General deterioration detected, one or more minor leaks apparent			
COMMENTS:	Concrete panels w embedded stone; plaster soffits; cement-asbestos mansard tiles		
COMPONENT:	Roofing	RATING: 3 x WEIGHT: 10 =	SCORE: 30
Some deterioration is evident in membrane and flashings; maintenance or minor repair is needed			
COMMENTS:	Hypalon single-ply roof; Mansard roof funded 2021-23

Secondary Systems			
COMPONENT:	Floor Finishes	RATING: 2 x WEIGHT: 6 =	SCORE: 12
	Some wear is evident; maintenance needed		
COMMENTS:	Carpet and carpet tile; vinyl tile; concrete; surface wear		
COMPONENT:	Wall Finishes	RATING: 3 x WEIGHT: 6 =	SCORE: 18
	Aging surfaces but sound; some maintenance is required		
COMMENTS:	Gypsum board; concrete		
COMPONENT:	Ceiling Finishes	RATING: 1 x WEIGHT: 6 =	SCORE: 6
	Maintainable surfaces in good condition; good alignment and appearance		
COMMENTS:	Gypsum board and lay-in tile		
COMPONENT:	Doors & Hardware	RATING: 3 x WEIGHT: 6 =	SCORE: 18
	Functional but dated		
COMMENTS:	Interior/exterior HM doors/frames-surface wear

CONDITION: Needs Improvement/Renovation

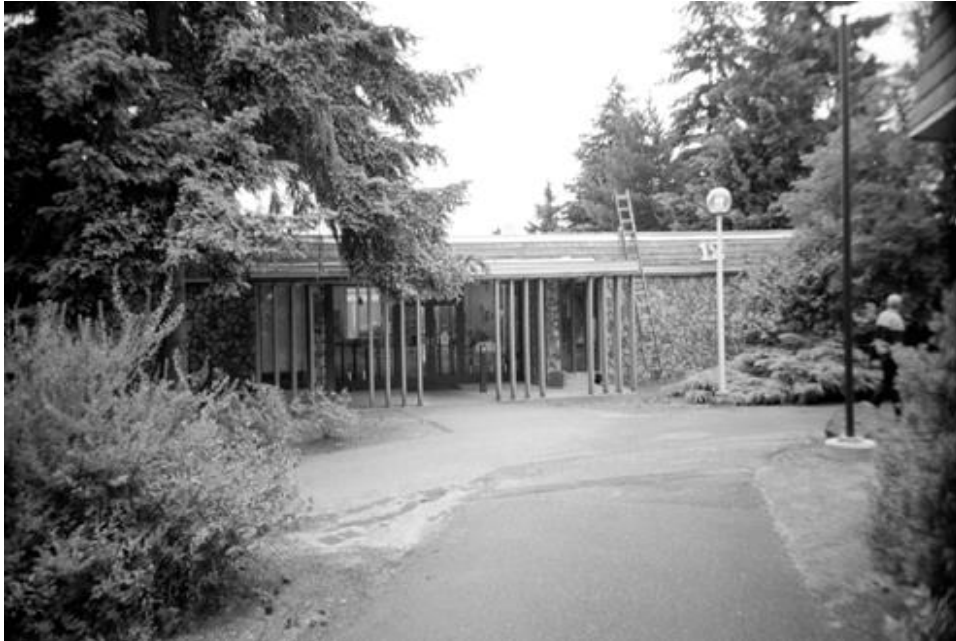
Mt Baker (220-9) STATE UFI: A04090 Main Campus (220A)
 AREA: 5,179 SF BUILT: 2014 REMODELED: No PREDOMINANT USE: Faculty Office
 CONSTRUCTION TYPE: Medium CRV/SF: \$323 REPLACEMENT VALUE: \$1,672,817

Primary Systems			
COMPONENT:	Structure	RATING: 2 x WEIGHT: 8 =	SCORE: 16
Minor cracks evident in a small portion of the structure			
COMMENTS:	Concrete columns and tilt-up panels; wood framing		
COMPONENT:	Exterior Closure	RATING: 1 x WEIGHT: 8 =	SCORE: 8
Weatherproof, tight, well-maintained exterior walls, doors, windows/finishes			
COMMENTS:	Concrete panels w embedded stone; plaster soffits; metal mansard		
COMPONENT:	Roofing	RATING: 1 x WEIGHT: 10 =	SCORE: 10
Flashing and penetrations appear sound and membrane appears water- tight; drainage is positive and there are overflow scuppers			
COMMENTS:	Hypalon single-ply

Secondary Systems			
COMPONENT:	Floor Finishes	RATING: 1 x WEIGHT: 6 =	SCORE: 6
Nice appearance, smooth transitions, level subfloors, no cracks/separating			
COMMENTS:			
COMPONENT:	Wall Finishes	RATING: 1 x WEIGHT: 6 =	SCORE: 6
Maintainable surfaces in good condition			
COMMENTS:			
COMPONENT:	Ceiling Finishes	RATING: 1 x WEIGHT: 6 =	SCORE: 6
Maintainable surfaces in good condition; good alignment and appearance			
COMMENTS:			
COMPONENT:	Doors & Hardware	RATING: 1 x WEIGHT: 6 =	SCORE: 6
Appropriate hardware, closers, panic devices; in good working order			
COMMENTS:

CONDITION: Superior

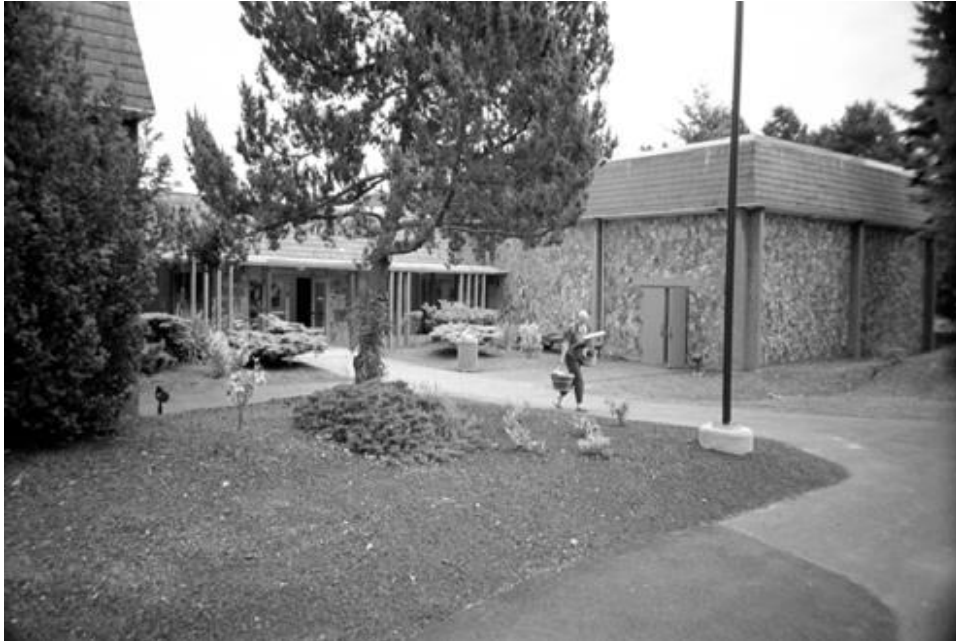
Giaudrone (220-5) STATE UFI: A04496 Main Campus (220A)
AREA: 11,610 SF BUILT: 1967 REMODELED: No PREDOMINANT USE: Visual Arts
CONSTRUCTION TYPE: Medium CRV/SF: \$379 REPLACEMENT VALUE: \$4,400,190

Primary Systems			
COMPONENT:	Structure	RATING: 3 x WEIGHT: 8.3 =	SCORE: 25
Some cracking evident but does not likely affect structural integrity; Visible defects apparent but are non-structural			
COMMENTS:	Concrete columns and tilt-up panels; wood framing		
COMPONENT:	Exterior Closure	RATING: 3 x WEIGHT: 8.3 =	SCORE: 25
Sound and weatherproof but with some deterioration evident			
COMMENTS:	Concrete panels w embedded stone; plaster soffits; cement-asbestos mansard tiles		
COMPONENT:	Roofing	RATING: 3 x WEIGHT: 10.4 =	SCORE: 31.3
Some deterioration is evident in membrane and flashings; maintenance or minor repair is needed			
COMMENTS:	Hypalon single-ply; needs surface restoration

Secondary Systems			
COMPONENT:	Floor Finishes	RATING: 3 x WEIGHT: 6.3 =	SCORE: 18.8
Some wear and minor imperfections are evident; beginning deterioration			
COMMENTS:	Vinyl tile; concrete-extensive surface wear; ceramic tile		
COMPONENT:	Wall Finishes	RATING: 2 x WEIGHT: 6.3 =	SCORE: 12.5
Maintainable surfaces, minor maintenance is required in some areas			
COMMENTS:	Gypsum board; ceramic tile; concrete		
COMPONENT:	Ceiling Finishes	RATING: 1 x WEIGHT: 6.3 =	SCORE: 6.3
Maintainable surfaces in good condition; good alignment and appearance			
COMMENTS:	Gypsum board; wood deck		
COMPONENT:	Doors & Hardware	RATING: 3 x WEIGHT: 6.3 =	SCORE: 18.8
Functional but dated			
COMMENTS:	Interior/exterior HM doors/frames; interior doors new in 2002

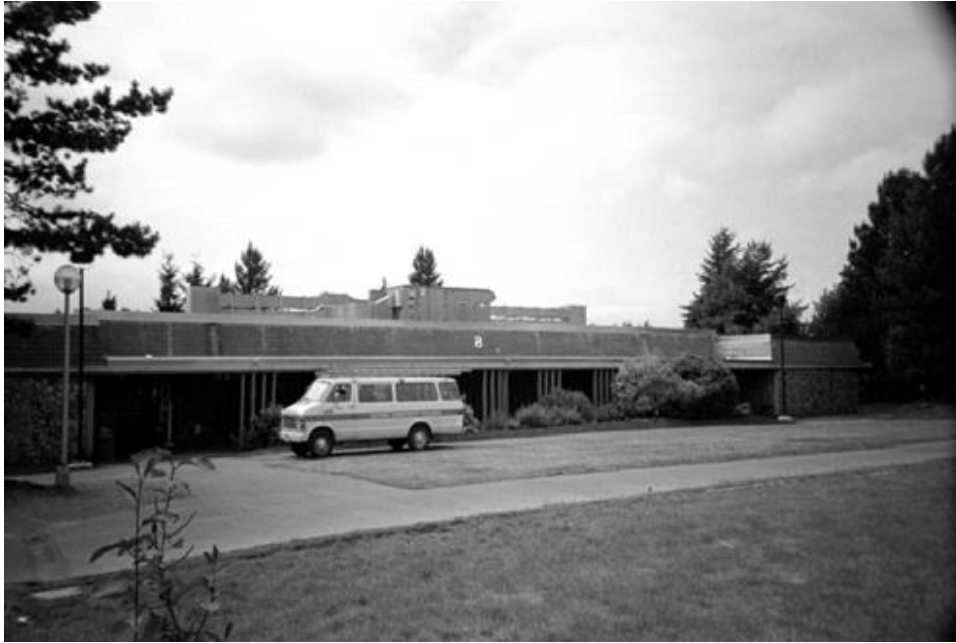
Tyee (220-8) STATE UFI: A05550 Main Campus (220A)
AREA: 9,553 SF BUILT: 1965 REMODELED: No PREDOMINANT USE: General Classroom
CONSTRUCTION TYPE: Medium CRV/SF: \$361 REPLACEMENT VALUE: \$3,448,633

Primary Systems			
COMPONENT:	Structure	RATING: 3 x WEIGHT: 8.3 =	SCORE: 25
Some cracking evident but does not likely affect structural integrity; Visible defects apparent but are non-structural			
COMMENTS:	Concrete columns and tilt-up panels; wood framing		
COMPONENT:	Exterior Closure	RATING: 2 x WEIGHT: 8.3 =	SCORE: 16.7
Weatherproof exterior, but generally appears poorly maintained			
COMMENTS:	Concrete panels w embedded stone; plaster soffits; metal mansard 2019		
COMPONENT:	Roofing	RATING: 1 x WEIGHT: 10.4 =	SCORE: 10.4
Flashing and penetrations appear sound and membrane appears water- tight; drainage is positive and there are overflow scuppers			
COMMENTS:	Hypalon single-ply-2002; canopy needs rear drains; metal mansard 2019

Secondary Systems			
COMPONENT:	Floor Finishes	RATING: 1 x WEIGHT: 6.3 =	SCORE: 6.3
	Nice appearance, smooth transitions, level subfloors, no cracks/separating		
COMMENTS:	Carpet-deteriorating; carpet tile; ceramic tile		
COMPONENT:	Wall Finishes	RATING: 1 x WEIGHT: 6.3 =	SCORE: 6.3
	Maintainable surfaces in good condition		
COMMENTS:	Gypsum board, concrete and ceramic tile		
COMPONENT:	Ceiling Finishes	RATING: 2 x WEIGHT: 6.3 =	SCORE: 12.5
	Aging surfaces in fair condition and good alignment		
COMMENTS:	Gypsum board and lay-in tile		
COMPONENT:	Doors & Hardware	RATING: 3 x WEIGHT: 6.3 =	SCORE: 18.8
	Functional but dated		
COMMENTS:	Interior/exterior HM doors/frames-surface wear

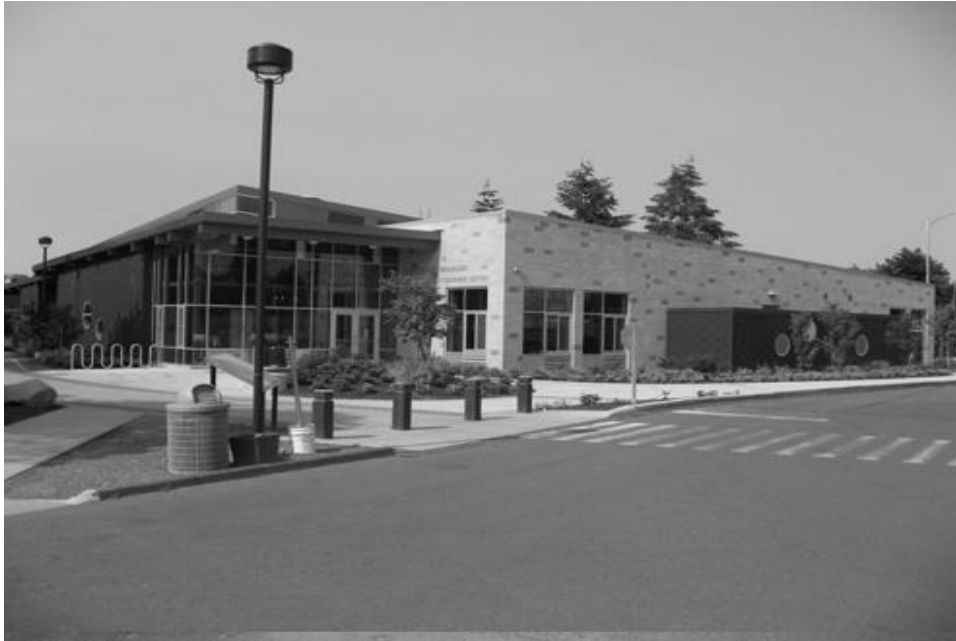
Annette B. Weyerhaeuser Early Learning Center (220-3) STATE UFI: A07995 Main Campus (220A)
 AREA: 13,000 SF BUILT: 2008 REMODELED: No PREDOMINANT USE: Child Care
 CONSTRUCTION TYPE: Medium CRV/SF: \$348 REPLACEMENT VALUE: \$4,524,000

Primary Systems			
COMPONENT:	Structure	RATING: 1 x WEIGHT: 8.8 = SCORE: 8.8	
No signs of settlement or cracking, no abrupt vertical changes Columns, bearing walls and roof structure appears sound/free of defects			
COMMENTS:	Paralam beams; wood frame; CMU		
COMPONENT:	Exterior Closure	RATING: 1 x WEIGHT: 8.8 = SCORE: 8.8	
Weatherproof, tight, well-maintained exterior walls, doors, windows/finishes			
COMMENTS:	Metal architectural panels; CMU; aluminum window walls; aluminum tiles		
COMPONENT:	Roofing	RATING: 1 x WEIGHT: 11 = SCORE: 11	
Flashing and penetrations appear sound and membrane appears water- tight; drainage is positive and there are overflow scuppers			
COMMENTS:	Standing seam metal roof; skylights

Secondary Systems			
COMPONENT:	Floor Finishes	RATING: 2 x WEIGHT: 6.6 =	SCORE: 13.2
Some wear is evident; maintenance needed			
COMMENTS:	Carpet tile; ceramic tile; quarry tile; sheet vinyl		
COMPONENT:	Wall Finishes	RATING: 1 x WEIGHT: 6.6 =	SCORE: 6.6
Maintainable surfaces in good condition			
COMMENTS:	Gypsum board; CMU; plastic panels		
COMPONENT:	Ceiling Finishes	RATING: 1 x WEIGHT: 6.6 =	SCORE: 6.6
Maintainable surfaces in good condition; good alignment and appearance			
COMMENTS:	Metal deck pan; wood strips; lay-in tile		
COMPONENT:	Doors & Hardware	RATING: 1 x WEIGHT: 6.6 =	SCORE: 6.6
Appropriate hardware, closers, panic devices; in good working order			
COMMENTS:	Interior wood glazed doors w aluminum and HM frames; exterior aluminum glazed doors/frames

Service Systems			
COMPONENT:	Elevators	RATING: 0 x WEIGHT: 0 =	SCORE: 0
No data			
COMMENTS:			
COMPONENT:	Plumbing	RATING: 1 x WEIGHT: 8.8 =	SCORE: 8.8
Fixtures and piping appear to be in good condition; no evidence of leaks			
COMMENTS:	Copper, cast iron, steel and PVC piping; porcelain fixtures		
COMPONENT:	HVAC	RATING: 4 x WEIGHT: 8.8 =	SCORE: 35.1
System partially adequate; many areas served by equipment needing repair; no A/C in offices, but hazardous areas are ventilated			
COMMENTS:	Hot water boiler; unit ventilators; hydronic in-floor heating; no A/C; natural ventilation		
COMPONENT:	Electrical	RATING: 1 x WEIGHT: 8.8 =	SCORE: 8.8
Adequate service and distribution capacity for current/future needs			
COMMENTS:	600amp 208/120v		
COMPONENT:	Lights/Power	RATING: 1 x WEIGHT: 8.8 =	SCORE: 8.8
Contemporary lighting with good work area illumination; ample outlets			
COMMENTS:	Hanging, lay-in, and recessed can fluorescent lighting

Safety Systems			
COMPONENT:	Life/Safety	RATING: 1 x WEIGHT: 11 = SCORE: 11	
	Appears to meet current codes		
COMMENTS:			
COMPONENT:	Fire Safety	RATING: 1 x WEIGHT: 11 = SCORE: 11	
	Locally monitored detection; alarm and strobes present; sprinklers in high hazard areas		
COMMENTS:			
COMPONENT:	Modifications	RATING: 0 x WEIGHT: 0 = SCORE: 0	
	No data		
COMMENTS:	New building

Quality Standards			
COMPONENT:	Maintenance	RATING: 1 x WEIGHT: 7.7 = SCORE: 7.7	
	Facility appears well maintained		
COMMENTS:			
COMPONENT:	Remaining Life	RATING: 1 x WEIGHT: 6.6 = SCORE: 6.6	
	Life expectancy is >20 years; minor system deterioration		
COMMENTS:	Well-constructed building; LEED Gold		
COMPONENT:	Appearance	RATING: 1 x WEIGHT: 6.6 = SCORE: 6.6	
	Well-constructed building; generally attractive interior and exterior		
COMMENTS:	Very bright and attractive interior; exterior design is very contemporary and attractive

CONDITION: Adequate

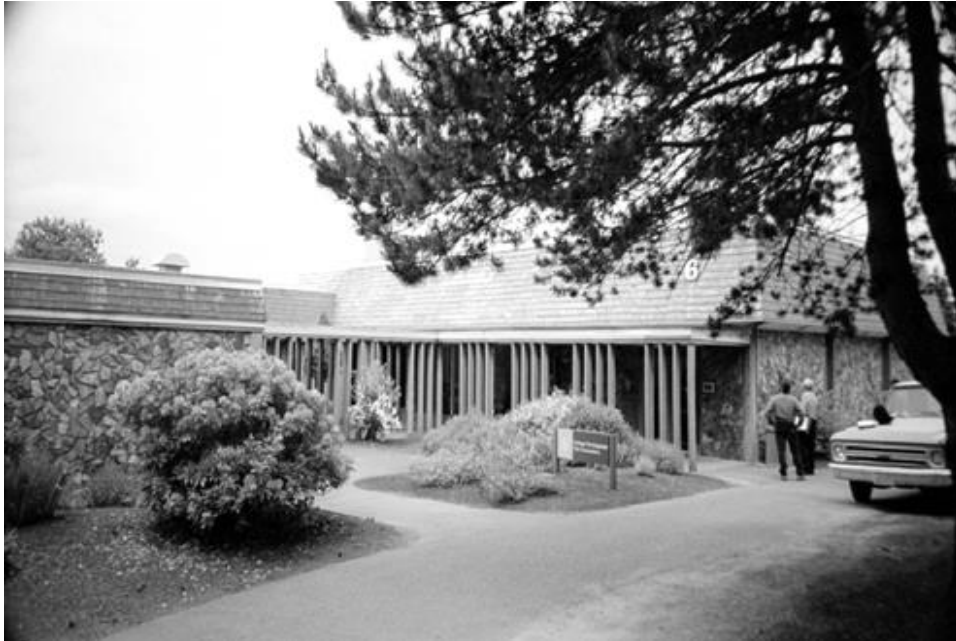
Vashon (220-6) STATE UFI: A08238 Main Campus (220A)
AREA: 7,120 SF BUILT: 1967 REMODELED: No PREDOMINANT USE: Administration
CONSTRUCTION TYPE: Medium CRV/SF: \$323 REPLACEMENT VALUE: \$2,299,760

Primary Systems			
COMPONENT:	Structure	RATING: 3 x WEIGHT: 8.3 =	SCORE: 25
Some cracking evident but does not likely affect structural integrity; Visible defects apparent but are non-structural			
COMMENTS:	Concrete columns and tilt-up panels; wood framing		
COMPONENT:	Exterior Closure	RATING: 3 x WEIGHT: 8.3 =	SCORE: 25
Sound and weatherproof but with some deterioration evident			
COMMENTS:	Concrete panels w embedded stone; plaster soffits; cement-asbestos mansard tiles		
COMPONENT:	Roofing	RATING: 3 x WEIGHT: 10.4 =	SCORE: 31.3
Some deterioration is evident in membrane and flashings; maintenance or minor repair is needed			
COMMENTS:	BUR w mineral-surfaced cap sheet-2010; mansard roof funded 21-23

Secondary Systems			
COMPONENT:	Floor Finishes	RATING: 1 x WEIGHT: 6.3 =	SCORE: 6.3
Nice appearance, smooth transitions, level subfloors, no cracks/separating			
COMMENTS:	Carpet; vinyl tile-surface wear; ceramic tile		
COMPONENT:	Wall Finishes	RATING: 1 x WEIGHT: 6.3 =	SCORE: 6.3
Maintainable surfaces in good condition			
COMMENTS:	Gypsum board; ceramic tile; concrete		
COMPONENT:	Ceiling Finishes	RATING: 1 x WEIGHT: 6.3 =	SCORE: 6.3
Maintainable surfaces in good condition; good alignment and appearance			
COMMENTS:	Acoustical tile; gypsum board; lay-in tile		
COMPONENT:	Doors & Hardware	RATING: 3 x WEIGHT: 6.3 =	SCORE: 18.8
Functional but dated			
COMMENTS:	Interior wood doors w HM frames-surface wear; exterior HM doors/frames

Service Systems			
COMPONENT:	Elevators	RATING: 0 x WEIGHT: 0 =	SCORE: 0
No data			
COMMENTS:			
COMPONENT:	Plumbing	RATING: 2 x WEIGHT: 8.3 =	SCORE: 16.7
Fixtures and piping are functional; finishes require maintenance			
COMMENTS:	Copper, galvanized and cast iron piping; porcelain fixtures		
COMPONENT:	HVAC	RATING: 1 x WEIGHT: 8.3 =	SCORE: 8.3
Equipment in good condition; easily controlled; serves all required spaces; All necessary spaces are adequately ventilated; A/C provided			
COMMENTS:	Rooftop packaged HVAC units-2002/2005		
COMPONENT:	Electrical	RATING: 1 x WEIGHT: 8.3 =	SCORE: 8.3
Adequate service and distribution capacity for current/future needs			
COMMENTS:	400amp 480/277v; 225amp 208/120v		
COMPONENT:	Lights/Power	RATING: 1 x WEIGHT: 8.3 =	SCORE: 8.3
Contemporary lighting with good work area illumination; ample outlets			
COMMENTS:	Ceiling mount, hanging and lay-in fluorescent lighting

Safety Systems			
COMPONENT:	Life/Safety	RATING: 1 x WEIGHT: 10.4 =	SCORE: 10.4
Appears to meet current codes			
COMMENTS:			
COMPONENT:	Fire Safety	RATING: 2 x WEIGHT: 10.4 =	SCORE: 20.9
Locally monitored detection; alarm present, but missing visual component or sprinklers			
COMMENTS:	New fire alarm panel in 2011		
COMPONENT:	Modifications	RATING: 1 x WEIGHT: 7.3 =	SCORE: 7.3
Modifications appear to be in compliance with codes and sound construction practices; HVAC/electrical service properly provided			
COMMENTS:	Interior renovation was well constructed

Quality Standards			
COMPONENT:	Maintenance	RATING: 2 x WEIGHT: 7.3 =	SCORE: 14.6
Routine maintenance is required; impact is minor			
COMMENTS:	Concrete canopy support columns have numerous spalls that need to be patched		
COMPONENT:	Remaining Life	RATING: 3 x WEIGHT: 6.3 =	SCORE: 18.8
Life expectancy is roughly 10-15 years; moderate system deterioration			
COMMENTS:	2006 comprehensive interior renovation has extended usable life		
COMPONENT:	Appearance	RATING: 3 x WEIGHT: 6.3 =	SCORE: 18.8
Average construction; average interior and exterior appearance			
COMMENTS:	Exterior not very attractive

CONDITION: Needs Improvement/Additional Maintenance

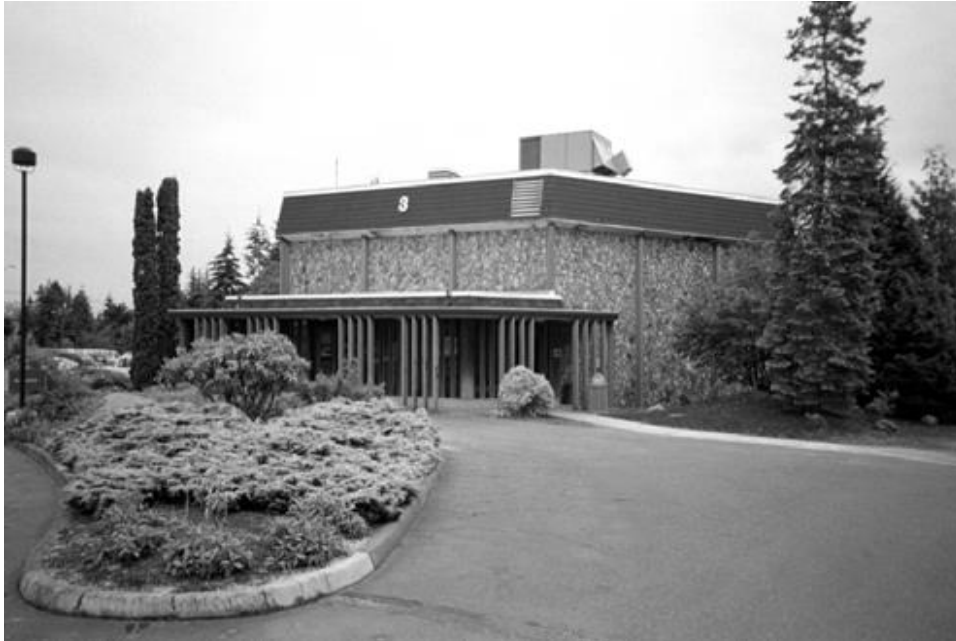
Columbia (220-2) STATE UFI: A08257 Main Campus (220A)
AREA: 6,928 SF BUILT: 1967 REMODELED: No PREDOMINANT USE: Performing Arts
CONSTRUCTION TYPE: Medium CRV/SF: \$404 REPLACEMENT VALUE: \$2,798,912

Primary Systems			
COMPONENT:	Structure	RATING: 3 x WEIGHT: 8.3 =	SCORE: 25
Some cracking evident but does not likely affect structural integrity; Visible defects apparent but are non-structural			
COMMENTS:	Concrete columns and tilt-up panels; wood framing		
COMPONENT:	Exterior Closure	RATING: 3 x WEIGHT: 8.3 =	SCORE: 25
Sound and weatherproof but with some deterioration evident			
COMMENTS:	Concrete panels w embedded stone; plaster soffits; cement-asbestos mansard tiles		
COMPONENT:	Roofing	RATING: 4 x WEIGHT: 10.4 =	SCORE: 41.7
General deterioration and some leaks are evident; resurfacing or partial repair is needed			
COMMENTS:	Hypalon single-ply; needs surface restoration

Secondary Systems			
COMPONENT:	Floor Finishes	RATING: 1 x WEIGHT: 6.3 =	SCORE: 6.3
Nice appearance, smooth transitions, level subfloors, no cracks/separating			
COMMENTS:	Carpet; wood; vinyl tile; ceramic tile		
COMPONENT:	Wall Finishes	RATING: 1 x WEIGHT: 6.3 =	SCORE: 6.3
Maintainable surfaces in good condition			
COMMENTS:	Gypsum board; ceramic tile; concrete		
COMPONENT:	Ceiling Finishes	RATING: 2 x WEIGHT: 6.3 =	SCORE: 12.5
Aging surfaces in fair condition and good alignment			
COMMENTS:	Gypsum board and lay-in tile; direct-adhered tile		
COMPONENT:	Doors & Hardware	RATING: 3 x WEIGHT: 6.3 =	SCORE: 18.8
Functional but dated			
COMMENTS:	Interior/exterior HM doors/frames-surface wear

Service Systems			
COMPONENT:	Elevators	RATING: 0 x WEIGHT: 0 =	SCORE: 0
No data			
COMMENTS:			
COMPONENT:	Plumbing	RATING: 3 x WEIGHT: 8.3 =	SCORE: 25
Fixtures are functional but dated; some leaks; maintenance required			
COMMENTS:	Copper; galvanized, steel and cast iron piping; porcelain fixtures		
COMPONENT:	HVAC	RATING: 1 x WEIGHT: 8.3 =	SCORE: 8.3
Equipment in good condition; easily controlled; serves all required spaces; All necessary spaces are adequately ventilated; A/C provided			
COMMENTS:	Rooftop packaged HVAC-1999/2009		
COMPONENT:	Electrical	RATING: 1 x WEIGHT: 8.3 =	SCORE: 8.3
Adequate service and distribution capacity for current/future needs			
COMMENTS:	600amp 480/277v		
COMPONENT:	Lights/Power	RATING: 2 x WEIGHT: 8.3 =	SCORE: 16.7
Contemporary lighting with good work area illumination; adequate number of outlets			
COMMENTS:	Hanging, lay-in and ceiling mount fluorescent lights and stage lighting

Quality Standards			
COMPONENT:	Maintenance	RATING: 1 x WEIGHT: 7.3 =	SCORE: 7.3
Facility appears well maintained			
COMMENTS:	Concrete canopy support columns have numerous spalls that need to be patched		
COMPONENT:	Remaining Life	RATING: 3 x WEIGHT: 6.3 =	SCORE: 18.8
Life expectancy is roughly 10-15 years; moderate system deterioration			
COMMENTS:	Sound structural shell; need comprehensive interior renovation to extend life		
COMPONENT:	Appearance	RATING: 3 x WEIGHT: 6.3 =	SCORE: 18.8
Average construction; average interior and exterior appearance			
COMMENTS:	Exterior is not attractive

CONDITION: Needs Improvement/Renovation

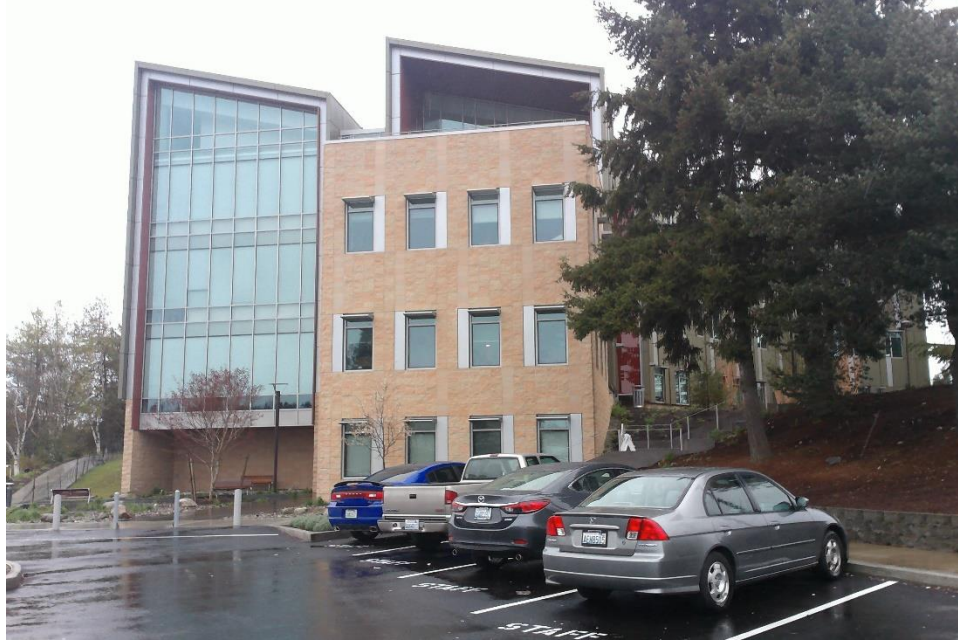
H.C. Joe Harned Center For Health Careers (220-13) STATE UFI: A21056 Main Campus (220A)
 AREA: 69,715 SF BUILT: 2014 REMODELED: No PREDOMINANT USE: Science/Technology
 CONSTRUCTION TYPE: No data CRV/SF: \$469 REPLACEMENT VALUE: \$32,696,335

Primary Systems			
COMPONENT:	Structure	RATING: 1 x WEIGHT: 8 =	SCORE: 8
No signs of settlement or cracking, no abrupt vertical changes Columns, bearing walls and roof structure appears sound/free of defects			
COMMENTS:	Concrete slab		
COMPONENT:	Exterior Closure	RATING: 1 x WEIGHT: 8 =	SCORE: 8
Weatherproof, tight, well-maintained exterior walls, doors, windows/finishes			
COMMENTS:	Metal siding		
COMPONENT:	Roofing	RATING: 1 x WEIGHT: 10 =	SCORE: 10
Flashing and penetrations appear sound and membrane appears water- tight; drainage is positive and there are overflow scuppers			
COMMENTS:	Metal and single-ply

Secondary Systems			
COMPONENT:	Floor Finishes	RATING: 1 x WEIGHT: 6 =	SCORE: 6
	Nice appearance, smooth transitions, level subfloors, no cracks/separating		
COMMENTS:	Concrete, carpet		
COMPONENT:	Wall Finishes	RATING: 1 x WEIGHT: 6 =	SCORE: 6
	Maintainable surfaces in good condition		
COMMENTS:	Gypsum, wood panel		
COMPONENT:	Ceiling Finishes	RATING: 1 x WEIGHT: 6 =	SCORE: 6
	Maintainable surfaces in good condition; good alignment and appearance		
COMMENTS:	GWB, acoustic tile		
COMPONENT:	Doors & Hardware	RATING: 1 x WEIGHT: 6 =	SCORE: 6
	Appropriate hardware, closers, panic devices; in good working order		
COMMENTS:	No Comments

Service Systems			
COMPONENT:	Elevators	RATING: 1 x WEIGHT: 6 =	SCORE: 6
	Appropriate and functional for occupancy and use		
COMMENTS:	Two elevators, 5-stop and 3-stop		
COMPONENT:	Plumbing	RATING: 1 x WEIGHT: 8 =	SCORE: 8
	Fixtures and piping appear to be in good condition; no evidence of leaks		
COMMENTS:	No data		
COMPONENT:	HVAC	RATING: 1 x WEIGHT: 8 =	SCORE: 8
	Equipment in good condition; easily controlled; serves all required spaces; All necessary spaces are adequately ventilated; A/C provided		
COMMENTS:	Ground source heat pump		
COMPONENT:	Electrical	RATING: 1 x WEIGHT: 8 =	SCORE: 8
	Adequate service and distribution capacity for current/future needs		
COMMENTS:	2000A 480/277V		
COMPONENT:	Lights/Power	RATING: 1 x WEIGHT: 8 =	SCORE: 8
	Contemporary lighting with good work area illumination; ample outlets		
COMMENTS:	No data

Safety Systems			
COMPONENT:	Life/Safety	RATING: 1 x WEIGHT: 10 =	SCORE: 10
	Appears to meet current codes		
COMMENTS:	No data		
COMPONENT:	Fire Safety	RATING: 1 x WEIGHT: 10 =	SCORE: 10
	Locally monitored detection; alarm and strobes present; sprinklers in high hazard areas		
COMMENTS:	No data		
COMPONENT:	Modifications	RATING: 1 x WEIGHT: 7 =	SCORE: 7
	Modifications appear to be in compliance with codes and sound construction practices; HVAC/electrical service properly provided		
COMMENTS:	No data

Quality Standards			
COMPONENT:	Maintenance	RATING: 1 x WEIGHT: 7 =	SCORE: 7
	Facility appears well maintained		
COMMENTS:	No data		
COMPONENT:	Remaining Life	RATING: 1 x WEIGHT: 6 =	SCORE: 6
	Life expectancy is >20 years; minor system deterioration		
COMMENTS:	No data		
COMPONENT:	Appearance	RATING: 1 x WEIGHT: 6 =	SCORE: 6
	Well-constructed building; generally attractive interior and exterior		
COMMENTS:	No data

CONDITION: Superior
