2021 FACILITY CONDITION SURVEY

Yakima Valley College

SURVEY CONDUCTED BY:
Steve Lewandowski
State Board for Community
and Technical Colleges

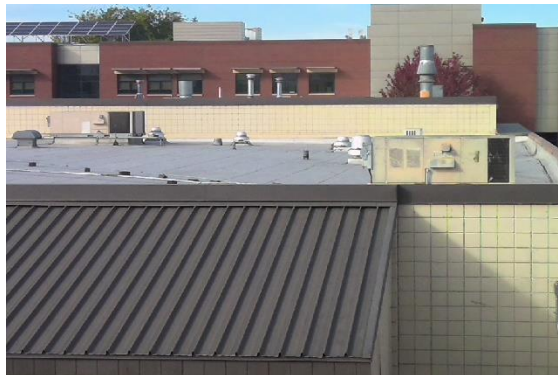
Carryover from prior survey : No
Location : Main Campus (160A)
Building name : Skills Center B (160-0)
Unique Facility Identifier (UFI) : A17315
Funding category in capital budget : Minor Works Facility appropriation
Unifomat category : D30-HVAC
Assessment : Asset is near or at the end of its useful life and should be replaced
Quantity : 2
Unit of measurement : EA
Component : Air Handler
Location within building or site : Roof
Issue clarity : Adequate information was provided to assess deficiency
Main cause of asset degradation or failure : Age/Wear
Detailed description : These college is concerned about the two air handlers serving the building. One unit has failed. Both units are beyond their expected life and should be replaced.
Recommended funding schedule : Immediate (scoring weight=4)
Estimated remaining life (years) : 3
Estimated average life expectancy (years) : 20
Scoring priority category 1 : System Use (scoring weight=15)

Category 1 percentage : 80 %
Scoring priority category 2 : High Repair/Repl. Cost (scoring weight=12)
Category 2 percentage : 20 %
Project construction estimate (MACC): \$70,000
Total project estimate (including soft costs): \$97,000
Additional points based on building condition: 0
Deficiency score : $4 \times ((15 \times 80\%) + (12 \times 20\%)) + 0 = 57.6$

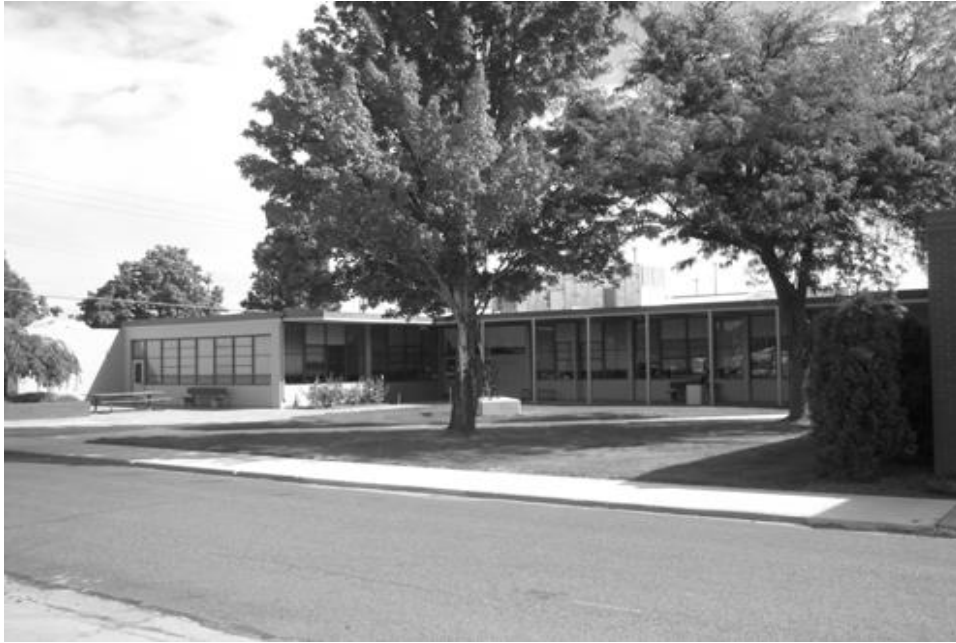
Sundquist Hall (160-014) STATE UF1: A04739 Main Campus (160A)
AREA: 33,779 SF BUILT: 1957 REMODELED: No PREDOMINANT USE: General Classroom
CONSTRUCTION TYPE: Medium CRV/SF: \$379 REPLACEMENT VALUE: \$12,802,241

Primary Systems			
COMPONENT:	Structure	RATING: 1 x WEIGHT: 8 =	SCORE: 8
No signs of settlement or cracking, no abrupt vertical changes Columns, bearing walls and roof structure appears sound/free of defects			
COMMENTS:	Brick and concrete		
COMPONENT:	Exterior Closure	RATING: 1 x WEIGHT: 8 =	SCORE: 8
Weatherproof, tight, well-maintained exterior walls, doors, windows/finishes			
COMMENTS:	Brick		
COMPONENT:	Roofing	RATING: 2 x WEIGHT: 10 =	SCORE: 20
Majority of roofing and flashing appear sound, but a small portion of roofing shows deterioration where maintenance or minor repair needed			
COMMENTS:	Modified bitumen cap sheet with mineral coating; skylight

Secondary Systems			
COMPONENT:	Floor Finishes	RATING: 2 x WEIGHT: 6 =	SCORE: 12
Some wear is evident; maintenance needed			
COMMENTS:	Carpet and vinyl tile; ceramic tile		
COMPONENT:	Wall Finishes	RATING: 1 x WEIGHT: 6 =	SCORE: 6
Maintainable surfaces in good condition			
COMMENTS:	Gypsum board; CMU; brick; ceramic tile		
COMPONENT:	Ceiling Finishes	RATING: 1 x WEIGHT: 6 =	SCORE: 6
Maintainable surfaces in good condition; good alignment and appearance			
COMMENTS:	Lay-in tile		
COMPONENT:	Doors & Hardware	RATING: 1 x WEIGHT: 6 =	SCORE: 6
Appropriate hardware, closers, panic devices; in good working order			
COMMENTS:	Interior wood doors w HM/wood frames; exterior aluminum doors/frames

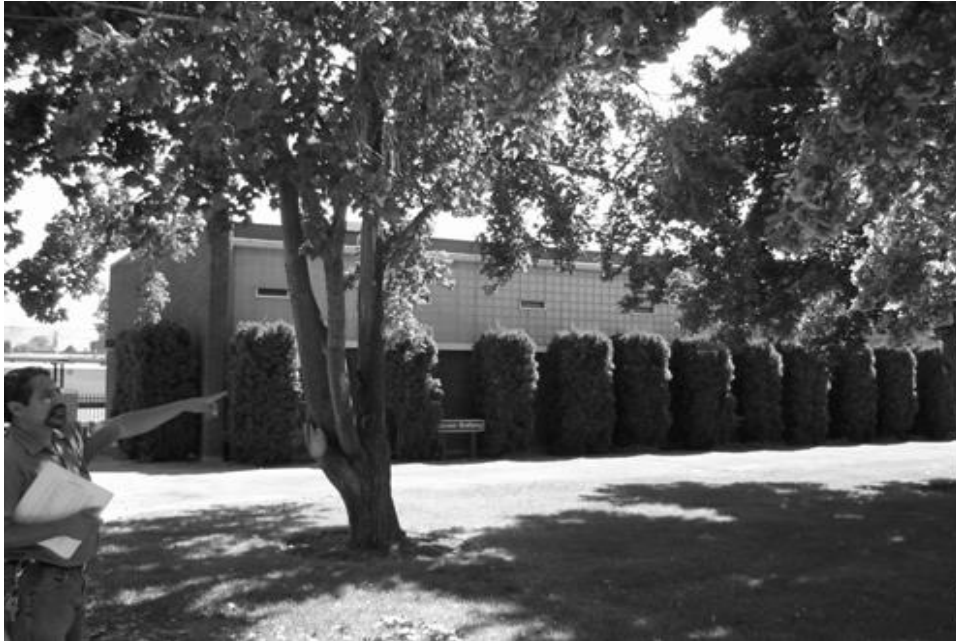
Larson Gallery (160-013) STATE UFI: A05737 Main Campus (160A)
 AREA: 3,386 SF BUILT: 1949 REMODELED: No PREDOMINANT USE: Visual Arts
 CONSTRUCTION TYPE: Medium CRV/SF: \$361 REPLACEMENT VALUE: \$1,222,346

Primary Systems			
COMPONENT:	Structure	RATING: 1 x WEIGHT: 8.3 =	SCORE: 8.3
No signs of settlement or cracking, no abrupt vertical changes Columns, bearing walls and roof structure appears sound/free of defects			
COMMENTS:	Concrete and brick		
COMPONENT:	Exterior Closure	RATING: 1 x WEIGHT: 8.3 =	SCORE: 8.3
Weatherproof, tight, well-maintained exterior walls, doors, windows/finishes			
COMMENTS:	Brick		
COMPONENT:	Roofing	RATING: 1 x WEIGHT: 10.4 =	SCORE: 10.4
Flashing and penetrations appear sound and membrane appears water- tight; drainage is positive and there are overflow scuppers			
COMMENTS:	BUR with UV coat; new roof in 2008

Secondary Systems			
COMPONENT:	Floor Finishes	RATING: 3 x WEIGHT: 6.3 =	SCORE: 18.8
Some wear and minor imperfections are evident; beginning deterioration			
COMMENTS:	9"x9" VAT and 12"x12" vinyl tile		
COMPONENT:	Wall Finishes	RATING: 2 x WEIGHT: 6.3 =	SCORE: 12.5
Maintainable surfaces, minor maintenance is required in some areas			
COMMENTS:	Concrete and brick walls		
COMPONENT:	Ceiling Finishes	RATING: 1 x WEIGHT: 6.3 =	SCORE: 6.3
Maintainable surfaces in good condition; good alignment and appearance			
COMMENTS:	Lay-in tile; gypsum board		
COMPONENT:	Doors & Hardware	RATING: 3 x WEIGHT: 6.3 =	SCORE: 18.8
Functional but dated			
COMMENTS:	Interior wood doors/frames; exterior HM doors/frames

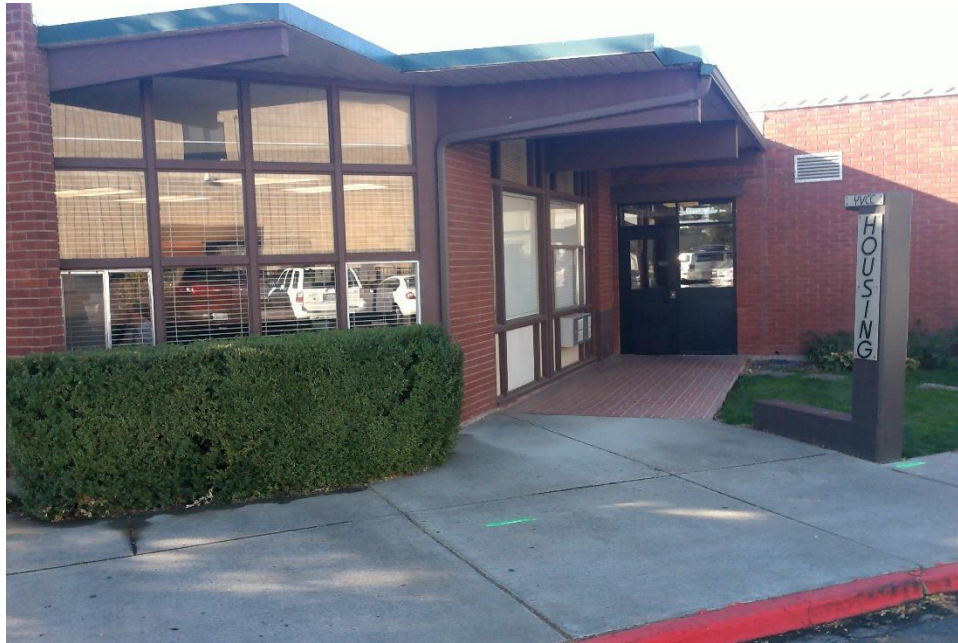
Student Residence Center (160-035) STATE UFI: A06686 Main Campus (160A)
AREA: 57,918 SF BUILT: 1961 REMODELED: No PREDOMINANT USE: Multi-Use
CONSTRUCTION TYPE: No data CRV/SF: \$360 REPLACEMENT VALUE: \$20,850,480

Primary Systems			
COMPONENT:	Structure	RATING: 1 x WEIGHT: 8.4 =	SCORE: 8.4
No signs of settlement or cracking, no abrupt vertical changes Columns, bearing walls and roof structure appears sound/free of defects			
COMMENTS:	No data		
COMPONENT:	Exterior Closure	RATING: 3 x WEIGHT: 8.4 =	SCORE: 25.2
Sound and weatherproof but with some deterioration evident			
COMMENTS:	No data		
COMPONENT:	Roofing	RATING: 3 x WEIGHT: 10.5 =	SCORE: 31.5
Some deterioration is evident in membrane and flashings; maintenance or minor repair is needed			
COMMENTS:	No data

Secondary Systems			
COMPONENT:	Floor Finishes	RATING: 3 x WEIGHT: 6.3 =	SCORE: 18.9
	Some wear and minor imperfections are evident; beginning deterioration		
COMMENTS:	No data		
COMPONENT:	Wall Finishes	RATING: 1 x WEIGHT: 6.3 =	SCORE: 6.3
	Maintainable surfaces in good condition		
COMMENTS:	No data		
COMPONENT:	Ceiling Finishes	RATING: 1 x WEIGHT: 6.3 =	SCORE: 6.3
	Maintainable surfaces in good condition; good alignment and appearance		
COMMENTS:	No data		
COMPONENT:	Doors & Hardware	RATING: 3 x WEIGHT: 6.3 =	SCORE: 18.9
	Functional but dated		
COMMENTS:	No data

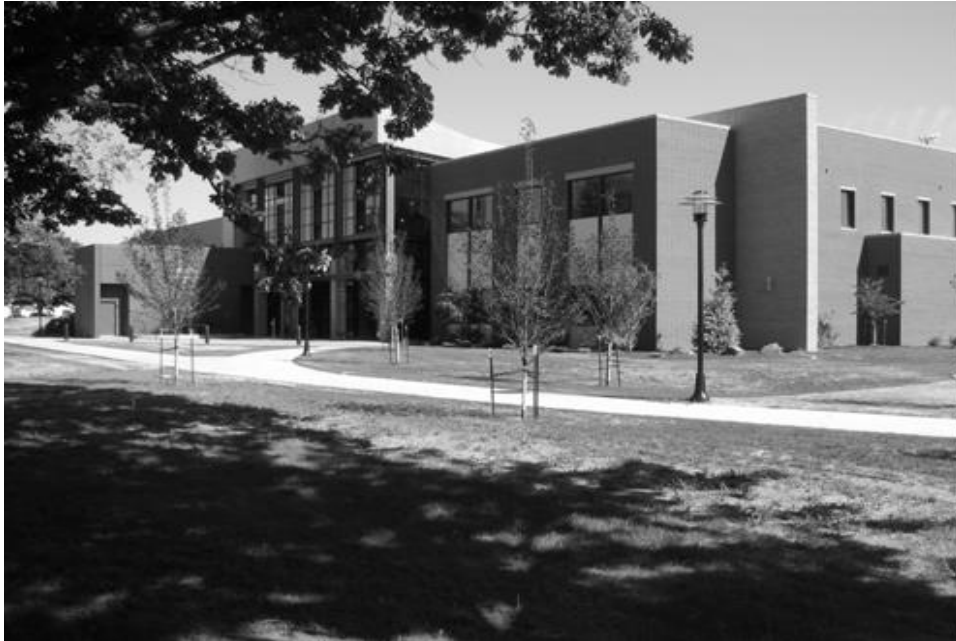
Deccio Building (160-018) STATE UFI: A09012 Main Campus (160A)
AREA: 74,646 SF BUILT: 2002 REMODELED: No PREDOMINANT USE: Multi-Use
CONSTRUCTION TYPE: Heavy CRV/SF: \$379 REPLACEMENT VALUE: \$28,290,834

Primary Systems			
COMPONENT:	Structure	RATING: 1 x WEIGHT: 8 =	SCORE: 8
No signs of settlement or cracking, no abrupt vertical changes Columns, bearing walls and roof structure appears sound/free of defects			
COMMENTS:	Steel; concrete; brick; foundation settling problems corrected		
COMPONENT:	Exterior Closure	RATING: 1 x WEIGHT: 8 =	SCORE: 8
Weatherproof, tight, well-maintained exterior walls, doors, windows/finishes			
COMMENTS:	Brick; aluminum panels; concrete; glass window walls; stucco		
COMPONENT:	Roofing	RATING: 2 x WEIGHT: 10 =	SCORE: 20
Majority of roofing and flashing appear sound, but a small portion of roofing shows deterioration where maintenance or minor repair needed			
COMMENTS:	Single-ply TPO; skylight

Secondary Systems			
COMPONENT:	Floor Finishes	RATING: 3 x WEIGHT: 6 =	SCORE: 18
	Some wear and minor imperfections are evident; beginning deterioration		
COMMENTS:	Terrazzo and vinyl tile-cracks in a number of areas; quarry tile; carpet; concrete		
COMPONENT:	Wall Finishes	RATING: 1 x WEIGHT: 6 =	SCORE: 6
	Maintainable surfaces in good condition		
COMMENTS:	Gypsum board; wood paneling; fabric panels; ceramic tile; brick; moveable partition walls		
COMPONENT:	Ceiling Finishes	RATING: 1 x WEIGHT: 6 =	SCORE: 6
	Maintainable surfaces in good condition; good alignment and appearance		
COMMENTS:	Lay-in ceiling tile; perforated tile; gypsum board		
COMPONENT:	Doors & Hardware	RATING: 1 x WEIGHT: 6 =	SCORE: 6
	Appropriate hardware, closers, panic devices; in good working order		
COMMENTS:	Interior wood doors w HM frames; exterior aluminum doors/frames

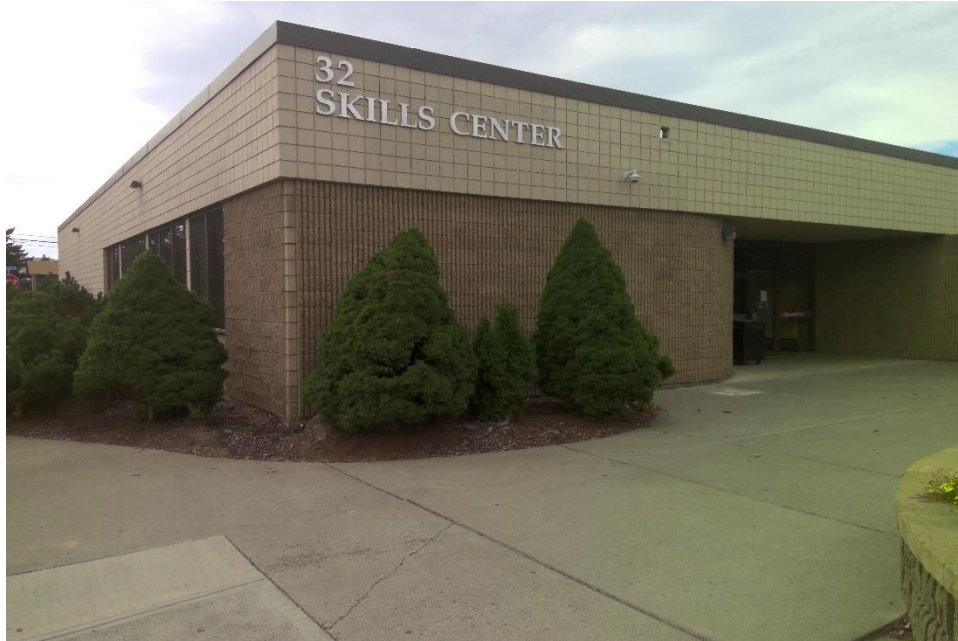
Skills Center (160-029) STATE UFI: A09333 Main Campus (160A)
AREA: 16,672 SF BUILT: 1980 REMODELED: No PREDOMINANT USE: Vocational Arts
CONSTRUCTION TYPE: Heavy CRV/SF: \$348 REPLACEMENT VALUE: \$5,801,856

Primary Systems			
COMPONENT:	Structure	RATING: 1 x WEIGHT: 8.3 =	SCORE: 8.3
No signs of settlement or cracking, no abrupt vertical changes Columns, bearing walls and roof structure appears sound/free of defects			
COMMENTS:	Steel trusses; CMU		
COMPONENT:	Exterior Closure	RATING: 2 x WEIGHT: 8.3 =	SCORE: 16.7
Weatherproof exterior, but generally appears poorly maintained			
COMMENTS:	CMU-flat and split-face; T1-11; Hardiboard horizontal beveled siding		
COMPONENT:	Roofing	RATING: 3 x WEIGHT: 10.4 =	SCORE: 31.3
Some deterioration is evident in membrane and flashings; maintenance or minor repair is needed			
COMMENTS:	BUR mineral surfaced cap sheet; Repairs & reconditioning funded 21-23

Secondary Systems			
COMPONENT:	Floor Finishes	RATING: 3 x WEIGHT: 6.3 =	SCORE: 18.8
Some wear and minor imperfections are evident; beginning deterioration			
COMMENTS:	Concrete; vinyl tile; ceramic tile; carpet; sheet vinyl-moderate wear		
COMPONENT:	Wall Finishes	RATING: 2 x WEIGHT: 6.3 =	SCORE: 12.5
Maintainable surfaces, minor maintenance is required in some areas			
COMMENTS:	CMU; carpet		
COMPONENT:	Ceiling Finishes	RATING: 2 x WEIGHT: 6.3 =	SCORE: 12.5
Aging surfaces in fair condition and good alignment			
COMMENTS:	Metal roof deck pan; lay-in tile-random minor damage		
COMPONENT:	Doors & Hardware	RATING: 3 x WEIGHT: 6.3 =	SCORE: 18.8
Functional but dated			
COMMENTS:	Interior wood doors w HM frames and HM doors/frames; exterior HM doors/frames; exterior aluminum doors/frames; exterior metal OH doors

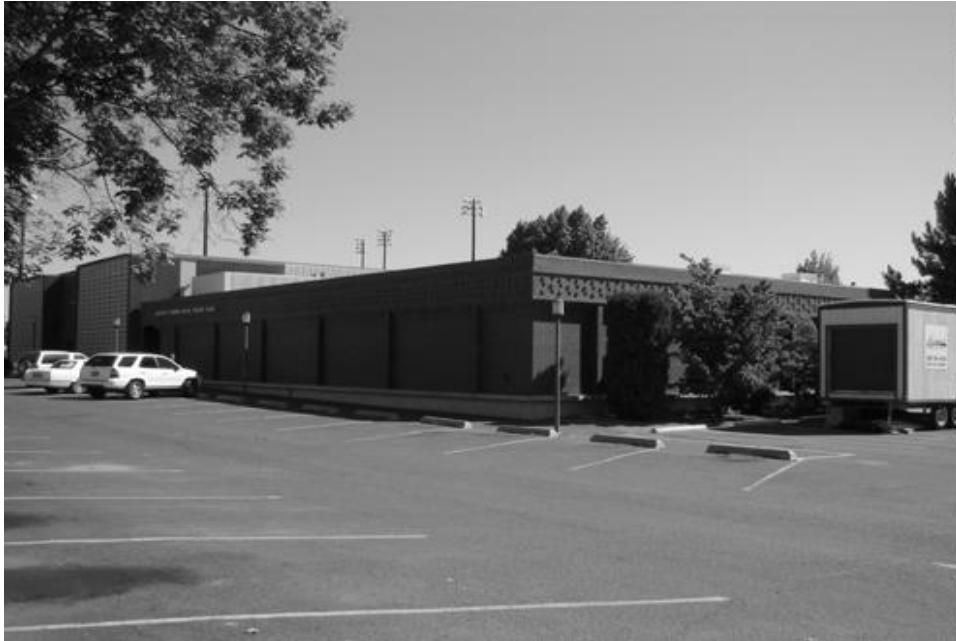
Brown Dental Clinic (160-003) STATE UFI: A09387 Main Campus (160A)
AREA: 15,038 SF BUILT: 1975 REMODELED: 2009 PREDOMINANT USE: Vocational Arts
CONSTRUCTION TYPE: Medium CRV/SF: \$379 REPLACEMENT VALUE: \$5,699,402

Primary Systems			
COMPONENT:	Structure	RATING: 2 x WEIGHT: 8.3 =	SCORE: 16.7
Minor cracks evident in a small portion of the structure			
COMMENTS:	Concrete; steel columns; brick		
COMPONENT:	Exterior Closure	RATING: 1 x WEIGHT: 8.3 =	SCORE: 8.3
Weatherproof, tight, well-maintained exterior walls, doors, windows/finishes			
COMMENTS:	Brick; metal panels		
COMPONENT:	Roofing	RATING: 1 x WEIGHT: 10.4 =	SCORE: 10.4
Flashing and penetrations appear sound and membrane appears water- tight; drainage is positive and there are overflow scuppers			
COMMENTS:	TPO single-ply membrane

Secondary Systems			
COMPONENT:	Floor Finishes	RATING: 2 x WEIGHT: 6.3 =	SCORE: 12.5
Some wear is evident; maintenance needed			
COMMENTS:	Carpet; vinyl tile; ceramic tile		
COMPONENT:	Wall Finishes	RATING: 1 x WEIGHT: 6.3 =	SCORE: 6.3
Maintainable surfaces in good condition			
COMMENTS:	Gypsum board; brick; ceramic tile		
COMPONENT:	Ceiling Finishes	RATING: 1 x WEIGHT: 6.3 =	SCORE: 6.3
Maintainable surfaces in good condition; good alignment and appearance			
COMMENTS:	Lay-in tile		
COMPONENT:	Doors & Hardware	RATING: 1 x WEIGHT: 6.3 =	SCORE: 6.3
Appropriate hardware, closers, panic devices; in good working order			
COMMENTS:	Interior HM doors/frames-some glazed; exterior aluminum doors/frames

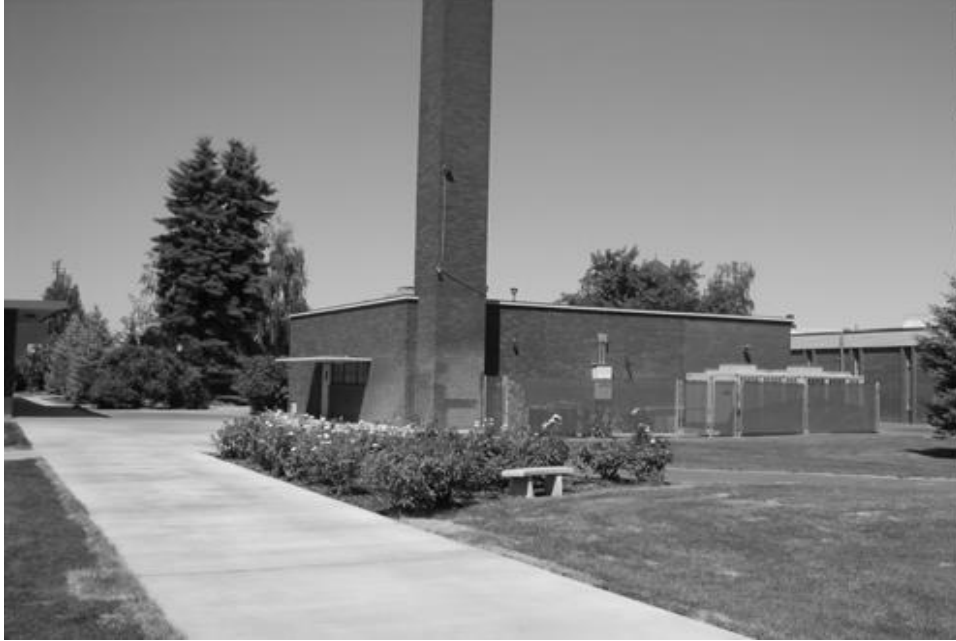
North Boiler Room (160-010) STATE UFI: A09445 Main Campus (160A)
AREA: 2,058 SF BUILT: 1949 REMODELED: No PREDOMINANT USE: Utilities
CONSTRUCTION TYPE: Medium CRV/SF: \$222 REPLACEMENT VALUE: \$456,876

Primary Systems			
COMPONENT:	Structure	RATING: 1 x WEIGHT: 9.2 = SCORE: 9.2	
No signs of settlement or cracking, no abrupt vertical changes Columns, bearing walls and roof structure appears sound/free of defects			
COMMENTS:	Brick and concrete		
COMPONENT:	Exterior Closure	RATING: 3 x WEIGHT: 9.2 = SCORE: 27.6	
Sound and weatherproof but with some deterioration evident			
COMMENTS:	Brick walls-need cleaning and minor tuck pointing		
COMPONENT:	Roofing	RATING: 1 x WEIGHT: 11.5 = SCORE: 11.5	
Flashing and penetrations appear sound and membrane appears water- tight; drainage is positive and there are overflow scuppers			
COMMENTS:	New built-up roof and coping in 2006

Secondary Systems			
COMPONENT:	Floor Finishes	RATING: 4 x WEIGHT: 6.9 =	SCORE: 27.6
	General deterioration evident; one-third to one-half of flooring exhibits extensive deterioration		
COMMENTS:	Concrete floor; some portions being removed in 2015		
COMPONENT:	Wall Finishes	RATING: 3 x WEIGHT: 6.9 =	SCORE: 20.7
	Aging surfaces but sound; some maintenance is required		
COMMENTS:	Brick walls-needs cleaning and minor tuck pointing		
COMPONENT:	Ceiling Finishes	RATING: 0 x WEIGHT: 0 =	SCORE: 0
	No data		
COMMENTS:	Concrete roof deck		
COMPONENT:	Doors & Hardware	RATING: 4 x WEIGHT: 6.9 =	SCORE: 27.6
	General deterioration evident in both door and hardware; some doors with significant deterioration		
COMMENTS:	Exterior HM doors/frames; OH metal coiling door

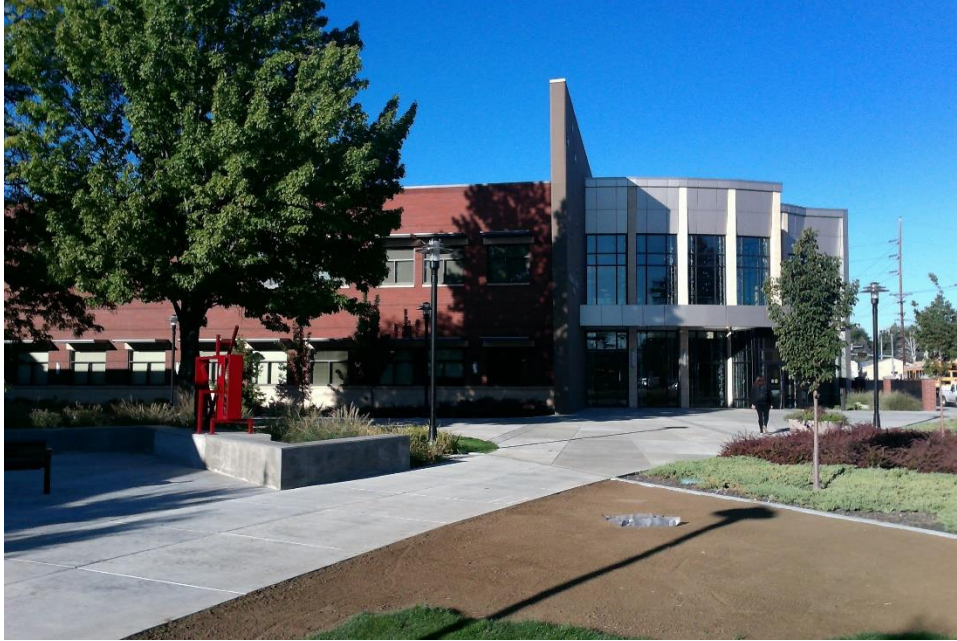
Palmer Martin Hall (160-020) STATE UFI: A21255 Main Campus (160A)
AREA: 47,848 SF BUILT: 2015 REMODELED: No PREDOMINANT USE: Classroom
CONSTRUCTION TYPE: No data CRV/SF: \$342 REPLACEMENT VALUE: \$16,364,016

Primary Systems			
COMPONENT:	Structure	RATING: 1 x WEIGHT: 8 =	SCORE: 8
No signs of settlement or cracking, no abrupt vertical changes Columns, bearing walls and roof structure appears sound/free of defects			
COMMENTS:	No data		
COMPONENT:	Exterior Closure	RATING: 1 x WEIGHT: 8 =	SCORE: 8
Weatherproof, tight, well-maintained exterior walls, doors, windows/finishes			
COMMENTS:	No data		
COMPONENT:	Roofing	RATING: 1 x WEIGHT: 10 =	SCORE: 10
Flashing and penetrations appear sound and membrane appears water- tight; drainage is positive and there are overflow scuppers			
COMMENTS:	No data

Secondary Systems			
COMPONENT:	Floor Finishes	RATING: 1 x WEIGHT: 6 =	SCORE: 6
	Nice appearance, smooth transitions, level subfloors, no cracks/separating		
COMMENTS:	No data		
COMPONENT:	Wall Finishes	RATING: 1 x WEIGHT: 6 =	SCORE: 6
	Maintainable surfaces in good condition		
COMMENTS:	No data		
COMPONENT:	Ceiling Finishes	RATING: 1 x WEIGHT: 6 =	SCORE: 6
	Maintainable surfaces in good condition; good alignment and appearance		
COMMENTS:	No data		
COMPONENT:	Doors & Hardware	RATING: 1 x WEIGHT: 6 =	SCORE: 6
	Appropriate hardware, closers, panic devices; in good working order		
COMMENTS:	No data

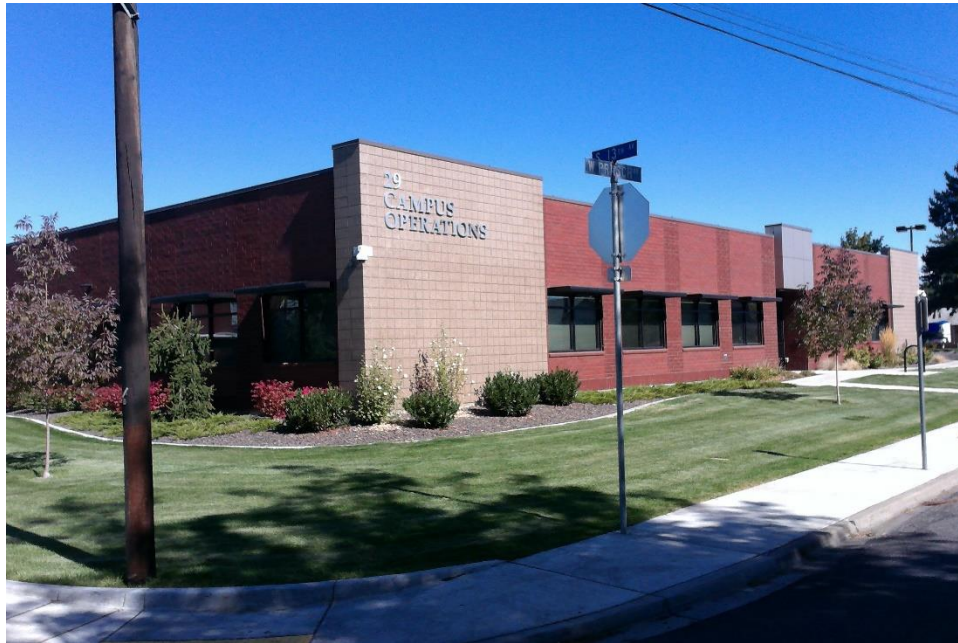
Campus Operations Complex Admin (160-029) STATE UFI: A21471 Main Campus (160A)
AREA: 10,009 SF BUILT: 2016 REMODELED: No PREDOMINANT USE: Central Service
CONSTRUCTION TYPE: No data CRV/SF: \$360 REPLACEMENT VALUE: \$3,603,240

Primary Systems			
COMPONENT:	Structure	RATING: 1 x WEIGHT: 8 =	SCORE: 8
No signs of settlement or cracking, no abrupt vertical changes Columns, bearing walls and roof structure appears sound/free of defects			
COMMENTS:	No data		
COMPONENT:	Exterior Closure	RATING: 1 x WEIGHT: 8 =	SCORE: 8
Weatherproof, tight, well-maintained exterior walls, doors, windows/finishes			
COMMENTS:	No data		
COMPONENT:	Roofing	RATING: 1 x WEIGHT: 10 =	SCORE: 10
Flashing and penetrations appear sound and membrane appears water- tight; drainage is positive and there are overflow scuppers			
COMMENTS:	No data

Secondary Systems			
COMPONENT:	Floor Finishes	RATING: 1 x WEIGHT: 6 =	SCORE: 6
	Nice appearance, smooth transitions, level subfloors, no cracks/separating		
COMMENTS:	No data		
COMPONENT:	Wall Finishes	RATING: 1 x WEIGHT: 6 =	SCORE: 6
	Maintainable surfaces in good condition		
COMMENTS:	No data		
COMPONENT:	Ceiling Finishes	RATING: 1 x WEIGHT: 6 =	SCORE: 6
	Maintainable surfaces in good condition; good alignment and appearance		
COMMENTS:	No data		
COMPONENT:	Doors & Hardware	RATING: 1 x WEIGHT: 6 =	SCORE: 6
	Appropriate hardware, closers, panic devices; in good working order		
COMMENTS:	No data

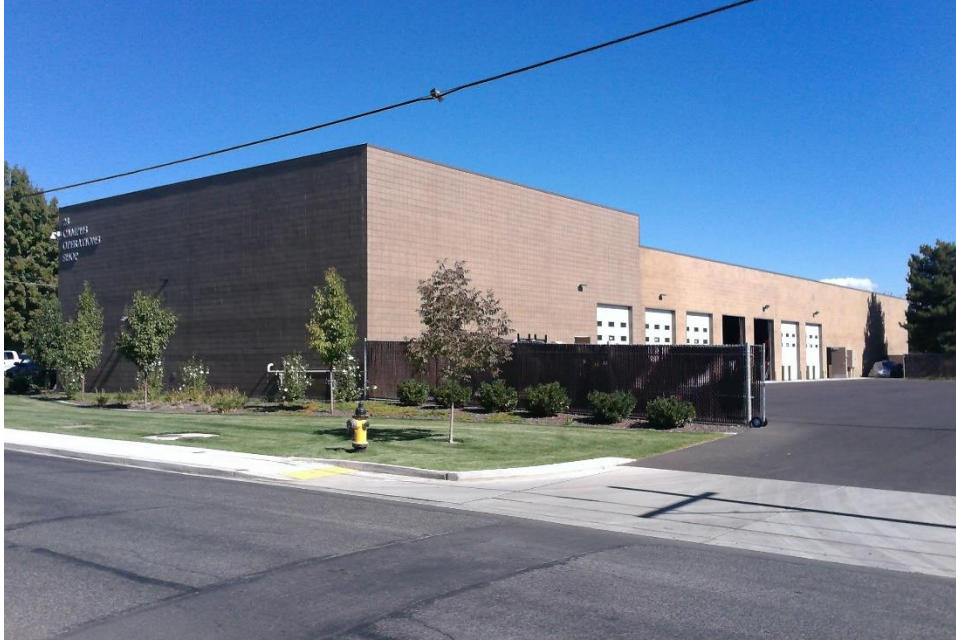
Campus Operations Complex Shop (160-028) STATE UFI: A21472 Main Campus (160A)
 AREA: 13,688 SF BUILT: 2016 REMODELED: No PREDOMINANT USE: Maintenance
 CONSTRUCTION TYPE: No data CRV/SF: \$234 REPLACEMENT VALUE: \$3,202,992

Primary Systems			
COMPONENT:	Structure	RATING: 1 x WEIGHT: 8 =	SCORE: 8
No signs of settlement or cracking, no abrupt vertical changes Columns, bearing walls and roof structure appears sound/free of defects			
COMMENTS:	No data		
COMPONENT:	Exterior Closure	RATING: 1 x WEIGHT: 8 =	SCORE: 8
Weatherproof, tight, well-maintained exterior walls, doors, windows/finishes			
COMMENTS:	No data		
COMPONENT:	Roofing	RATING: 1 x WEIGHT: 10 =	SCORE: 10
Flashing and penetrations appear sound and membrane appears water- tight; drainage is positive and there are overflow scuppers			
COMMENTS:	No data

Secondary Systems			
COMPONENT:	Floor Finishes	RATING: 1 x WEIGHT: 6 =	SCORE: 6
	Nice appearance, smooth transitions, level subfloors, no cracks/separating		
COMMENTS:	No data		
COMPONENT:	Wall Finishes	RATING: 1 x WEIGHT: 6 =	SCORE: 6
	Maintainable surfaces in good condition		
COMMENTS:	No data		
COMPONENT:	Ceiling Finishes	RATING: 1 x WEIGHT: 6 =	SCORE: 6
	Maintainable surfaces in good condition; good alignment and appearance		
COMMENTS:	No data		
COMPONENT:	Doors & Hardware	RATING: 1 x WEIGHT: 6 =	SCORE: 6
	Appropriate hardware, closers, panic devices; in good working order		
COMMENTS:	No data

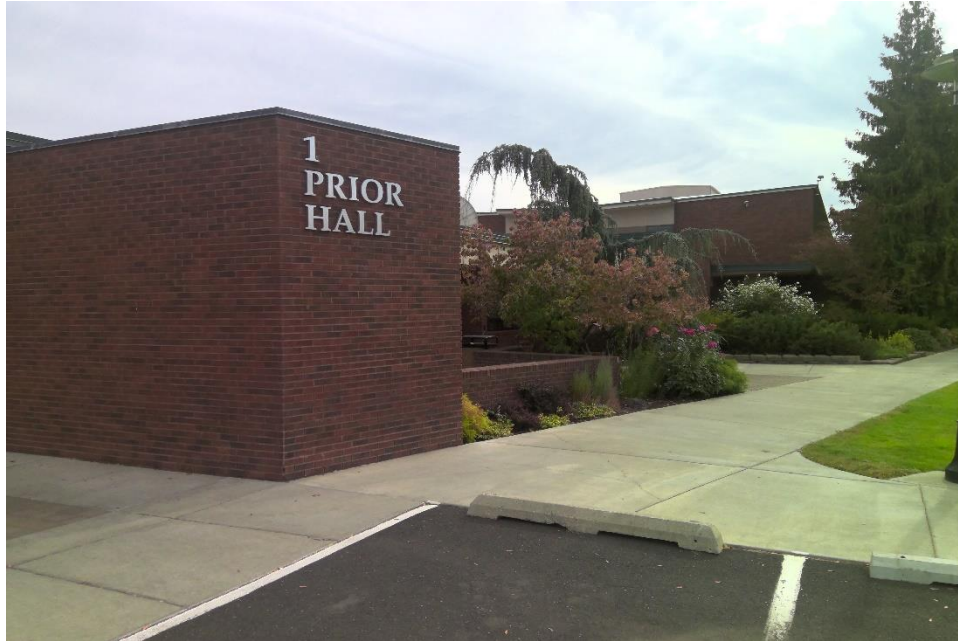
Prior Hall (160-001) STATE UFI: A03366 Main Campus (160A)
 AREA: 36,319 SF BUILT: 1949 REMODELED: 2015 PREDOMINANT USE: General Classroom
 CONSTRUCTION TYPE: Medium CRV/SF: \$361 REPLACEMENT VALUE: \$13,111,159

Primary Systems			
COMPONENT:	Structure	RATING: 1 x WEIGHT: 8 =	SCORE: 8
No signs of settlement or cracking, no abrupt vertical changes Columns, bearing walls and roof structure appears sound/free of defects			
COMMENTS:	Concrete		
COMPONENT:	Exterior Closure	RATING: 1 x WEIGHT: 8 =	SCORE: 8
Weatherproof, tight, well-maintained exterior walls, doors, windows/finishes			
COMMENTS:	EIFS applied over brick exterior in 1989		
COMPONENT:	Roofing	RATING: 2 x WEIGHT: 10 =	SCORE: 20
Majority of roofing and flashing appear sound, but a small portion of roofing shows deterioration where maintenance or minor repair needed			
COMMENTS:	Built-up roof w UV coating applied in 2013

Secondary Systems			
COMPONENT:	Floor Finishes	RATING: 3 x WEIGHT: 6 =	SCORE: 18
	Some wear and minor imperfections are evident; beginning deterioration		
COMMENTS:	Sheet vinyl; vinyl-tile; ceramic tile; carpet		
COMPONENT:	Wall Finishes	RATING: 1 x WEIGHT: 6 =	SCORE: 6
	Maintainable surfaces in good condition		
COMMENTS:	Gypsum board; ceramic tile		
COMPONENT:	Ceiling Finishes	RATING: 2 x WEIGHT: 6 =	SCORE: 12
	Aging surfaces in fair condition and good alignment		
COMMENTS:	Lay-in tile		
COMPONENT:	Doors & Hardware	RATING: 2 x WEIGHT: 6 =	SCORE: 12
	Fairly modern door surfaces and hardware with minor deterioration; good working order		
COMMENTS:	Interior wood doors/frames; exterior aluminum doors/frames; OH coiling door

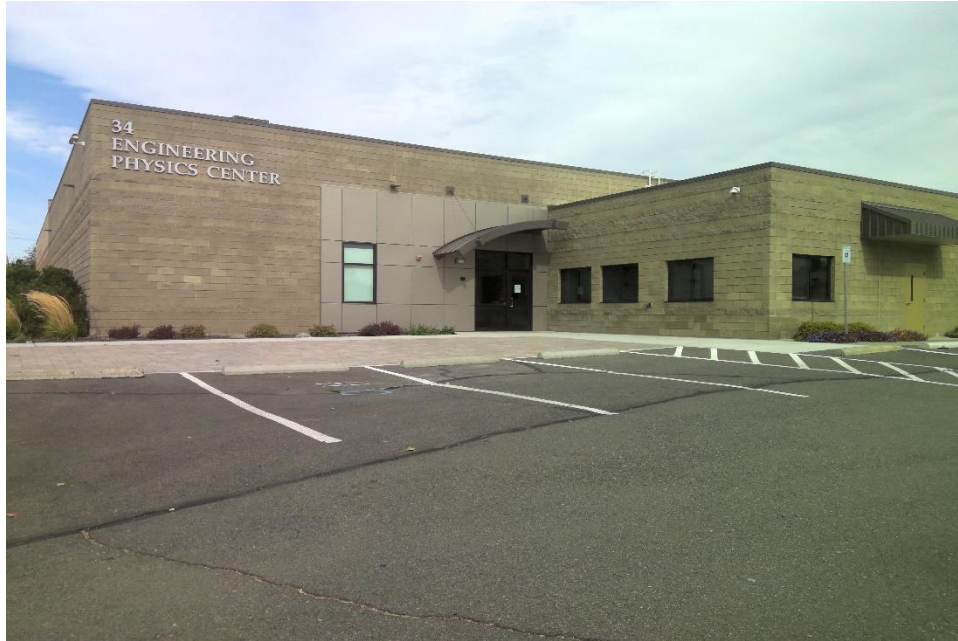
Engineering Physics Center (160-034) STATE UFI: A05665 Main Campus (160A)
AREA: 8,161 SF BUILT: 2000 REMODELED: 2018 PREDOMINANT USE: Maintenance
CONSTRUCTION TYPE: Medium CRV/SF: \$335 REPLACEMENT VALUE: \$2,733,935

Primary Systems			
COMPONENT:	Structure	RATING: 1 x WEIGHT: 8 =	SCORE: 8
No signs of settlement or cracking, no abrupt vertical changes Columns, bearing walls and roof structure appears sound/free of defects			
COMMENTS:	Concrete and CMU; wood trusses; steel columns		
COMPONENT:	Exterior Closure	RATING: 1 x WEIGHT: 8 =	SCORE: 8
Weatherproof, tight, well-maintained exterior walls, doors, windows/finishes			
COMMENTS:	CMU walls		
COMPONENT:	Roofing	RATING: 1 x WEIGHT: 10 =	SCORE: 10
Flashing and penetrations appear sound and membrane appears water- tight; drainage is positive and there are overflow scuppers			
COMMENTS:	Modified bitumen mineral-surfaced cap sheet

Secondary Systems			
COMPONENT:	Floor Finishes	RATING: 2 x WEIGHT: 6 =	SCORE: 12
	Some wear is evident; maintenance needed		
COMMENTS:	Vinyl tile; carpet; concrete in shop area		
COMPONENT:	Wall Finishes	RATING: 2 x WEIGHT: 6 =	SCORE: 12
	Maintainable surfaces, minor maintenance is required in some areas		
COMMENTS:	Gypsum board in office area; CMU in shops		
COMPONENT:	Ceiling Finishes	RATING: 1 x WEIGHT: 6 =	SCORE: 6
	Maintainable surfaces in good condition; good alignment and appearance		
COMMENTS:	Lay-in tile in offices; wood roof deck in shops		
COMPONENT:	Doors & Hardware	RATING: 1 x WEIGHT: 6 =	SCORE: 6
	Appropriate hardware, closers, panic devices; in good working order		
COMMENTS:	Interior wood and HM doors w HM frames; exterior HM doors/frames; metal H doors

Service Systems			
COMPONENT:	Elevators	RATING: 3 x WEIGHT: 6 =	SCORE: 18
	Elevators provided but functionality is inadequate; Unreliable operation		
COMMENTS:	Offices 2nd floor		
COMPONENT:	Plumbing	RATING: 1 x WEIGHT: 8 =	SCORE: 8
	Fixtures and piping appear to be in good condition; no evidence of leaks		
COMMENTS:	Copper, cast iron, steel and ABS piping; porcelain fixtures		
COMPONENT:	HVAC	RATING: 1 x WEIGHT: 8 =	SCORE: 8
	Equipment in good condition; easily controlled; serves all required spaces; All necessary spaces are adequately ventilated; A/C provided		
COMMENTS:	Gas unit heaters; FAG furnace w A/C		
COMPONENT:	Electrical	RATING: 1 x WEIGHT: 8 =	SCORE: 8
	Adequate service and distribution capacity for current/future needs		
COMMENTS:	200amp 208/120v		
COMPONENT:	Lights/Power	RATING: 1 x WEIGHT: 8 =	SCORE: 8
	Contemporary lighting with good work area illumination; ample outlets		
COMMENTS:	Lay-in, ceiling-mount and hanging fluorescent lighting

Quality Standards			
COMPONENT:	Maintenance	RATING: 1 x WEIGHT: 7 = SCORE: 7	
	Facility appears well maintained		
COMMENTS:			
COMPONENT:	Remaining Life	RATING: 1 x WEIGHT: 6 = SCORE: 6	
	Life expectancy is >20 years; minor system deterioration		
COMMENTS:	Well built; should have a 40+ year life		
COMPONENT:	Appearance	RATING: 1 x WEIGHT: 6 = SCORE: 6	
	Well-constructed building; generally attractive interior and exterior		
COMMENTS:

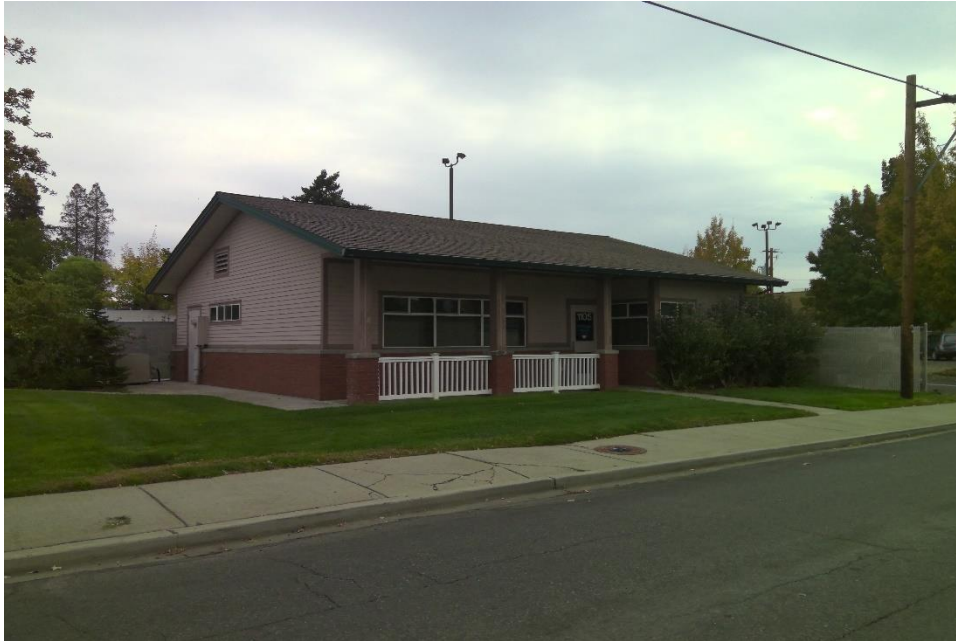
Resource Center (160-025) STATE UFI: A05972 Main Campus (160A)
 AREA: 1,205 SF BUILT: 2002 REMODELED: No PREDOMINANT USE: Child Services
 CONSTRUCTION TYPE: Light CRV/SF: \$222 REPLACEMENT VALUE: \$267,510

Primary Systems			
COMPONENT:	Structure	RATING: 1 x WEIGHT: 8.8 = SCORE: 8.8	
No signs of settlement or cracking, no abrupt vertical changes Columns, bearing walls and roof structure appears sound/free of defects			
COMMENTS:	Wood framing; concrete slab		
COMPONENT:	Exterior Closure	RATING: 1 x WEIGHT: 8.8 = SCORE: 8.8	
Weatherproof, tight, well-maintained exterior walls, doors, windows/finishes			
COMMENTS:	Hardi-board lap siding; brick facing; plywood soffits		
COMPONENT:	Roofing	RATING: 1 x WEIGHT: 11 = SCORE: 11	
Flashing and penetrations appear sound and membrane appears water- tight; drainage is positive and there are overflow scuppers			
COMMENTS:	3-tab asphalt shingles

Secondary Systems			
COMPONENT:	Floor Finishes	RATING: 2 x WEIGHT: 6.6 =	SCORE: 13.2
Some wear is evident; maintenance needed			
COMMENTS:	Carpet; vinyl tile		
COMPONENT:	Wall Finishes	RATING: 1 x WEIGHT: 6.6 =	SCORE: 6.6
Maintainable surfaces in good condition			
COMMENTS:	Gypsum board		
COMPONENT:	Ceiling Finishes	RATING: 1 x WEIGHT: 6.6 =	SCORE: 6.6
Maintainable surfaces in good condition; good alignment and appearance			
COMMENTS:	Lay-in tile		
COMPONENT:	Doors & Hardware	RATING: 1 x WEIGHT: 6.6 =	SCORE: 6.6
Appropriate hardware, closers, panic devices; in good working order			
COMMENTS:	Interior wood doors w HM frames; exterior HM doors/frames

Service Systems			
COMPONENT:	Elevators	RATING: 0 x WEIGHT: 0 =	SCORE: 0
No data			
COMMENTS:			
COMPONENT:	Plumbing	RATING: 1 x WEIGHT: 8.8 =	SCORE: 8.8
Fixtures and piping appear to be in good condition; no evidence of leaks			
COMMENTS:	Copper, cast iron and steel piping; porcelain fixtures		
COMPONENT:	HVAC	RATING: 1 x WEIGHT: 8.8 =	SCORE: 8.8
Equipment in good condition; easily controlled; serves all required spaces; All necessary spaces are adequately ventilated; A/C provided			
COMMENTS:	Split system heat pump		
COMPONENT:	Electrical	RATING: 1 x WEIGHT: 8.8 =	SCORE: 8.8
Adequate service and distribution capacity for current/future needs			
COMMENTS:	200amp 240/120v		
COMPONENT:	Lights/Power	RATING: 1 x WEIGHT: 8.8 =	SCORE: 8.8
Contemporary lighting with good work area illumination; ample outlets			
COMMENTS:	Lay-in fluorescent fixtures and recessed can lights

Quality Standards			
COMPONENT:	Maintenance	RATING: 1 x WEIGHT: 7.7 =	SCORE: 7.7
	Facility appears well maintained		
COMMENTS:	Not occupied; appears to be low maintenance		
COMPONENT:	Remaining Life	RATING: 1 x WEIGHT: 6.6 =	SCORE: 6.6
	Life expectancy is >20 years; minor system deterioration		
COMMENTS:	Should last 35+ years		
COMPONENT:	Appearance	RATING: 1 x WEIGHT: 6.6 =	SCORE: 6.6
	Well-constructed building; generally attractive interior and exterior		
COMMENTS:

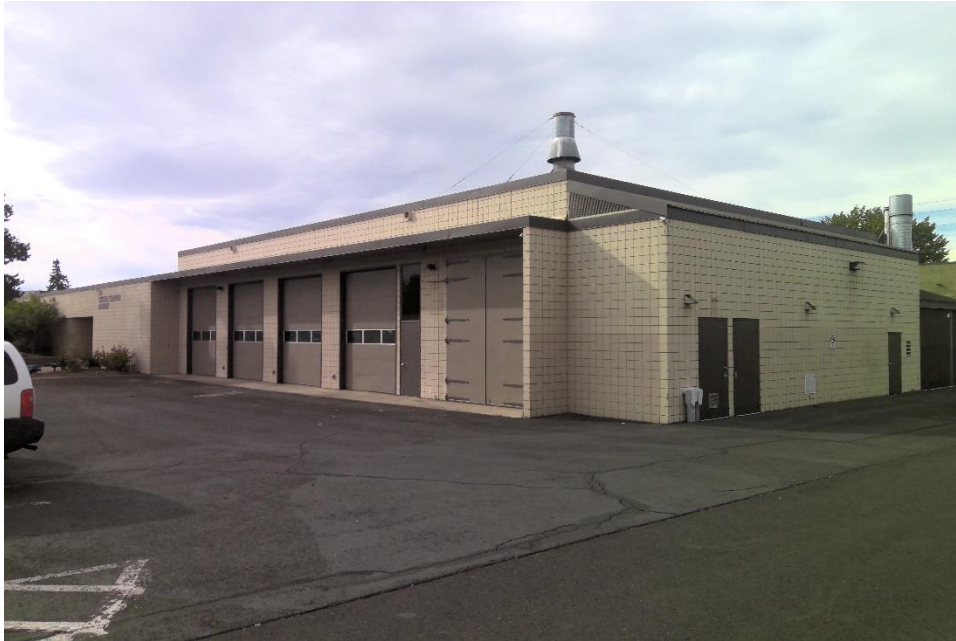
Skills Center B (160-0) STATE UFI: A17315 Main Campus (160A)
AREA: 12,330 SF BUILT: 0 REMODELED: No PREDOMINANT USE: Classroom
CONSTRUCTION TYPE: No data CRV/SF: \$342 REPLACEMENT VALUE: \$4,216,860

Primary Systems			
COMPONENT:	Structure	RATING: 2 x WEIGHT: 8.8 = SCORE: 17.6	
	Minor cracks evident in a small portion of the structure		
COMMENTS:	No data		
COMPONENT:	Exterior Closure	RATING: 2 x WEIGHT: 8.8 = SCORE: 17.6	
	Weatherproof exterior, but generally appears poorly maintained		
COMMENTS:	No data		
COMPONENT:	Roofing	RATING: 3 x WEIGHT: 11 = SCORE: 32.9	
	Some deterioration is evident in membrane and flashings; maintenance or minor repair is needed		
COMMENTS:	No data

Secondary Systems			
COMPONENT:	Floor Finishes	RATING: 3 x WEIGHT: 6.6 =	SCORE: 19.8
	Some wear and minor imperfections are evident; beginning deterioration		
COMMENTS:	No data		
COMPONENT:	Wall Finishes	RATING: 3 x WEIGHT: 6.6 =	SCORE: 19.8
	Aging surfaces but sound; some maintenance is required		
COMMENTS:	No data		
COMPONENT:	Ceiling Finishes	RATING: 2 x WEIGHT: 6.6 =	SCORE: 13.2
	Aging surfaces in fair condition and good alignment		
COMMENTS:	No data		
COMPONENT:	Doors & Hardware	RATING: 3 x WEIGHT: 6.6 =	SCORE: 19.8
	Functional but dated		
COMMENTS:	No data

Service Systems			
COMPONENT:	Elevators	RATING: 0 x WEIGHT: 0 =	SCORE: 0
	No data		
COMMENTS:	No data		
COMPONENT:	Plumbing	RATING: 2 x WEIGHT: 8.8 =	SCORE: 17.6
	Fixtures and piping are functional; finishes require maintenance		
COMMENTS:	No data		
COMPONENT:	HVAC	RATING: 4 x WEIGHT: 8.8 =	SCORE: 35.1
	System partially adequate; many areas served by equipment needing repair; no A/C in offices, but hazardous areas are ventilated		
COMMENTS:	Rooftop units require repair		
COMPONENT:	Electrical	RATING: 1 x WEIGHT: 8.8 =	SCORE: 8.8
	Adequate service and distribution capacity for current/future needs		
COMMENTS:	No data		
COMPONENT:	Lights/Power	RATING: 2 x WEIGHT: 8.8 =	SCORE: 17.6
	Contemporary lighting with good work area illumination; adequate number of outlets		
COMMENTS:	No data

Safety Systems			
COMPONENT:	Life/Safety	RATING: 2 x WEIGHT: 11 = SCORE: 22	
	Most areas meet current codes; some areas meet codes for prior construction phases		
COMMENTS:	No data		
COMPONENT:	Fire Safety	RATING: 2 x WEIGHT: 11 = SCORE: 22	
	Locally monitored detection; alarm present, but missing visual component or sprinklers		
COMMENTS:	No data		
COMPONENT:	Modifications	RATING: 0 x WEIGHT: 0 = SCORE: 0	
	No data		
COMMENTS:	No data

Quality Standards			
COMPONENT:	Maintenance	RATING: 3 x WEIGHT: 7.7 = SCORE: 23.1	
	Routine maintenance is required; deferred maintenance is evident; impact is minor to moderate		
COMMENTS:	No data		
COMPONENT:	Remaining Life	RATING: 3 x WEIGHT: 6.6 = SCORE: 19.8	
	Life expectancy is roughly 10-15 years; moderate system deterioration		
COMMENTS:	No data		
COMPONENT:	Appearance	RATING: 2 x WEIGHT: 6.6 = SCORE: 13.2	
	Well-constructed building; average interior and exterior appearance		
COMMENTS:	No data

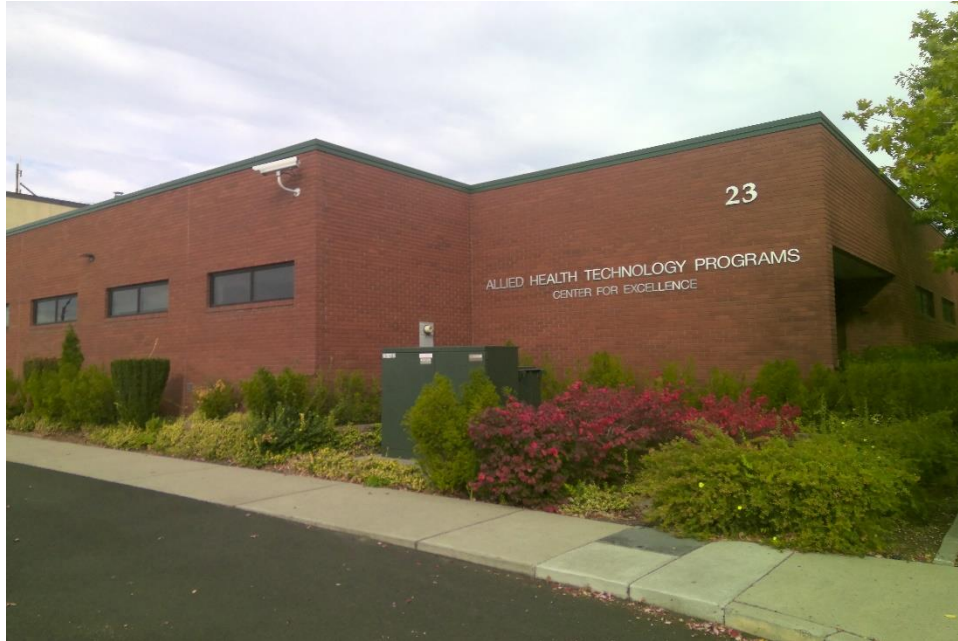
Allied Health (160-23) STATE UFI: A26119 Main Campus (160A)
 AREA: 15,133 SF BUILT: 0 REMODELED: No PREDOMINANT USE: Multi-Use
 CONSTRUCTION TYPE: No data CRV/SF: \$379 REPLACEMENT VALUE: \$5,735,407

Primary Systems			
COMPONENT:	Structure	RATING: 1 x WEIGHT: 8.3 = SCORE: 8.3	
No signs of settlement or cracking, no abrupt vertical changes Columns, bearing walls and roof structure appears sound/free of defects			
COMMENTS:	No data		
COMPONENT:	Exterior Closure	RATING: 1 x WEIGHT: 8.3 = SCORE: 8.3	
Weatherproof, tight, well-maintained exterior walls, doors, windows/finishes			
COMMENTS:	No data		
COMPONENT:	Roofing	RATING: 2 x WEIGHT: 10.4 = SCORE: 20.9	
Majority of roofing and flashing appear sound, but a small portion of roofing shows deterioration where maintenance or minor repair needed			
COMMENTS:	No data

Secondary Systems			
COMPONENT:	Floor Finishes	RATING: 1 x WEIGHT: 6.3 =	SCORE: 6.3
	Nice appearance, smooth transitions, level subfloors, no cracks/separating		
COMMENTS:	No data		
COMPONENT:	Wall Finishes	RATING: 2 x WEIGHT: 6.3 =	SCORE: 12.5
	Maintainable surfaces, minor maintenance is required in some areas		
COMMENTS:	No data		
COMPONENT:	Ceiling Finishes	RATING: 1 x WEIGHT: 6.3 =	SCORE: 6.3
	Maintainable surfaces in good condition; good alignment and appearance		
COMMENTS:	No data		
COMPONENT:	Doors & Hardware	RATING: 1 x WEIGHT: 6.3 =	SCORE: 6.3
	Appropriate hardware, closers, panic devices; in good working order		
COMMENTS:	No data

Service Systems			
COMPONENT:	Elevators	RATING: 0 x WEIGHT: 0 =	SCORE: 0
	No data		
COMMENTS:	No data		
COMPONENT:	Plumbing	RATING: 1 x WEIGHT: 8.3 =	SCORE: 8.3
	Fixtures and piping appear to be in good condition; no evidence of leaks		
COMMENTS:	No data		
COMPONENT:	HVAC	RATING: 2 x WEIGHT: 8.3 =	SCORE: 16.7
	Equipment in fair condition; minor deterioration; controls require troubleshooting; office areas have A/C; hazardous areas are ventilated		
COMMENTS:	No data		
COMPONENT:	Electrical	RATING: 1 x WEIGHT: 8.3 =	SCORE: 8.3
	Adequate service and distribution capacity for current/future needs		
COMMENTS:	No data		
COMPONENT:	Lights/Power	RATING: 1 x WEIGHT: 8.3 =	SCORE: 8.3
	Contemporary lighting with good work area illumination; ample outlets		
COMMENTS:	No data

Safety Systems			
COMPONENT:	Life/Safety	RATING: 1 x WEIGHT: 10.4 = SCORE: 10.4	
	Appears to meet current codes		
COMMENTS:	No data		
COMPONENT:	Fire Safety	RATING: 1 x WEIGHT: 10.4 = SCORE: 10.4	
	Locally monitored detection; alarm and strobes present; sprinklers in high hazard areas		
COMMENTS:	No data		
COMPONENT:	Modifications	RATING: 1 x WEIGHT: 7.3 = SCORE: 7.3	
	Modifications appear to be in compliance with codes and sound construction practices; HVAC/electrical service properly provided		
COMMENTS:	No data

Quality Standards			
COMPONENT:	Maintenance	RATING: 1 x WEIGHT: 7.3 = SCORE: 7.3	
	Facility appears well maintained		
COMMENTS:	No data		
COMPONENT:	Remaining Life	RATING: 1 x WEIGHT: 6.3 = SCORE: 6.3	
	Life expectancy is >20 years; minor system deterioration		
COMMENTS:	No data		
COMPONENT:	Appearance	RATING: 1 x WEIGHT: 6.3 = SCORE: 6.3	
	Well-constructed building; generally attractive interior and exterior		
COMMENTS:	No data

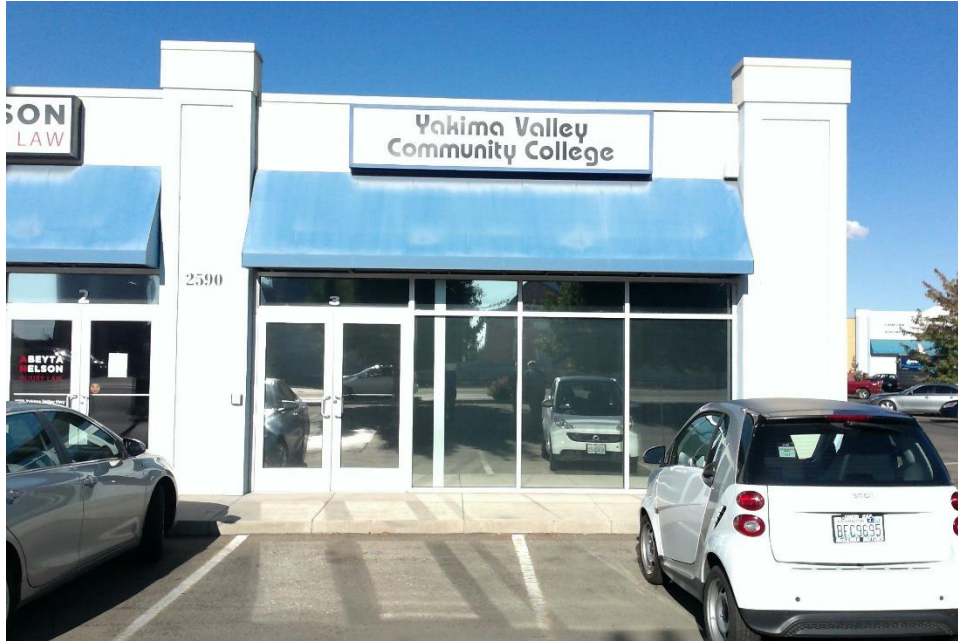
Sunnyside (160-039) STATE UFI: A21289 Main Campus (160D)
 AREA: 3,940 SF BUILT: 0 REMODELED: No PREDOMINANT USE: Office
 CONSTRUCTION TYPE: No data CRV/SF: \$300 REPLACEMENT VALUE: \$1,182,000

Primary Systems			
COMPONENT:	Structure	RATING: 1 x WEIGHT: 8.8 =	SCORE: 8.8
No signs of settlement or cracking, no abrupt vertical changes Columns, bearing walls and roof structure appears sound/free of defects			
COMMENTS:	No data		
COMPONENT:	Exterior Closure	RATING: 2 x WEIGHT: 8.8 =	SCORE: 17.6
Weatherproof exterior, but generally appears poorly maintained			
COMMENTS:	No data		
COMPONENT:	Roofing	RATING: 2 x WEIGHT: 11 =	SCORE: 22
Majority of roofing and flashing appear sound, but a small portion of roofing shows deterioration where maintenance or minor repair needed			
COMMENTS:	No data

Secondary Systems			
COMPONENT:	Floor Finishes	RATING: 2 x WEIGHT: 6.6 =	SCORE: 13.2
Some wear is evident; maintenance needed			
COMMENTS:	No data		
COMPONENT:	Wall Finishes	RATING: 2 x WEIGHT: 6.6 =	SCORE: 13.2
Maintainable surfaces, minor maintenance is required in some areas			
COMMENTS:	No data		
COMPONENT:	Ceiling Finishes	RATING: 1 x WEIGHT: 6.6 =	SCORE: 6.6
Maintainable surfaces in good condition; good alignment and appearance			
COMMENTS:	No data		
COMPONENT:	Doors & Hardware	RATING: 1 x WEIGHT: 6.6 =	SCORE: 6.6
Appropriate hardware, closers, panic devices; in good working order			
COMMENTS:	No data

Service Systems			
COMPONENT:	Elevators	RATING: 0 x WEIGHT: 0 =	SCORE: 0
No data			
COMMENTS:	No data		
COMPONENT:	Plumbing	RATING: 1 x WEIGHT: 8.8 =	SCORE: 8.8
Fixtures and piping appear to be in good condition; no evidence of leaks			
COMMENTS:	No data		
COMPONENT:	HVAC	RATING: 1 x WEIGHT: 8.8 =	SCORE: 8.8
Equipment in good condition; easily controlled; serves all required spaces; All necessary spaces are adequately ventilated; A/C provided			
COMMENTS:	No data		
COMPONENT:	Electrical	RATING: 1 x WEIGHT: 8.8 =	SCORE: 8.8
Adequate service and distribution capacity for current/future needs			
COMMENTS:	No data		
COMPONENT:	Lights/Power	RATING: 1 x WEIGHT: 8.8 =	SCORE: 8.8
Contemporary lighting with good work area illumination; ample outlets			
COMMENTS:	No data

Safety Systems				
COMPONENT:	Life/Safety	RATING: 1	x WEIGHT: 11	= SCORE: 11
	Appears to meet current codes			
COMMENTS:	No data			
COMPONENT:	Fire Safety	RATING: 2	x WEIGHT: 11	= SCORE: 22
	Locally monitored detection; alarm present, but missing visual component or sprinklers			
COMMENTS:	No data			
COMPONENT:	Modifications	RATING: 0	x WEIGHT: 0	= SCORE: 0
	No data			
COMMENTS:	No data

Quality Standards				
COMPONENT:	Maintenance	RATING: 1	x WEIGHT: 7.7	= SCORE: 7.7
	Facility appears well maintained			
COMMENTS:	No data			
COMPONENT:	Remaining Life	RATING: 1	x WEIGHT: 6.6	= SCORE: 6.6
	Life expectancy is >20 years; minor system deterioration			
COMMENTS:	No data			
COMPONENT:	Appearance	RATING: 3	x WEIGHT: 6.6	= SCORE: 19.8
	Average construction; average interior and exterior appearance			
COMMENTS:	No data

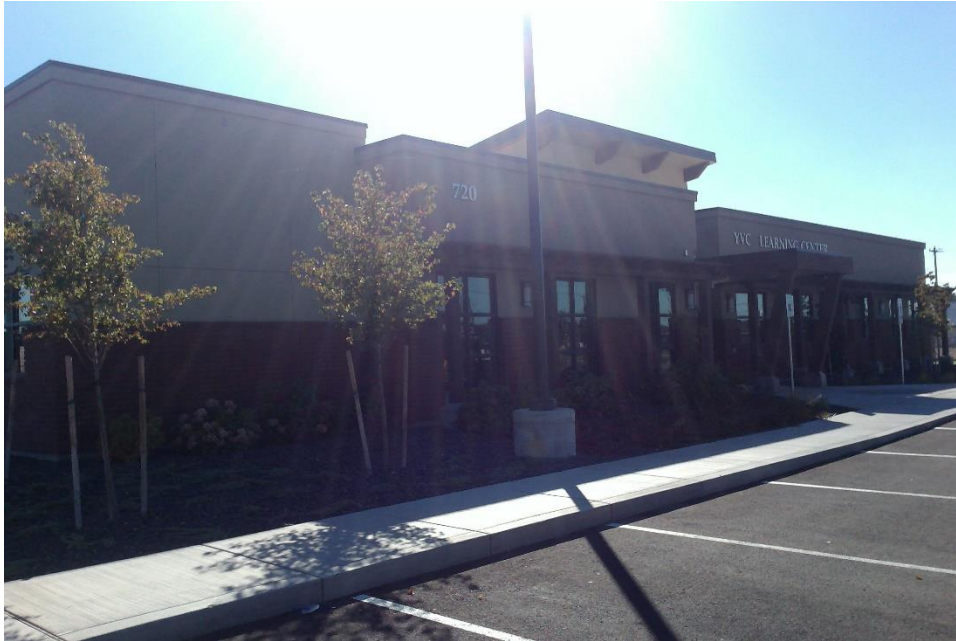
Toppenish Learning Center (160-041) STATE UFI: A21301 Main Campus (160C)
AREA: 7,015 SF BUILT: 2016 REMODELED: No PREDOMINANT USE: Office
CONSTRUCTION TYPE: No data CRV/SF: \$300 REPLACEMENT VALUE: \$2,104,500

Primary Systems			
COMPONENT:	Structure	RATING: 1 x WEIGHT: 8.3 =	SCORE: 8.3
No signs of settlement or cracking, no abrupt vertical changes Columns, bearing walls and roof structure appears sound/free of defects			
COMMENTS:	No data		
COMPONENT:	Exterior Closure	RATING: 1 x WEIGHT: 8.3 =	SCORE: 8.3
Weatherproof, tight, well-maintained exterior walls, doors, windows/finishes			
COMMENTS:	No data		
COMPONENT:	Roofing	RATING: 1 x WEIGHT: 10.4 =	SCORE: 10.4
Flashing and penetrations appear sound and membrane appears water- tight; drainage is positive and there are overflow scuppers			
COMMENTS:	No data

Secondary Systems			
COMPONENT:	Floor Finishes	RATING: 1 x WEIGHT: 6.3 =	SCORE: 6.3
	Nice appearance, smooth transitions, level subfloors, no cracks/separating		
COMMENTS:	No data		
COMPONENT:	Wall Finishes	RATING: 1 x WEIGHT: 6.3 =	SCORE: 6.3
	Maintainable surfaces in good condition		
COMMENTS:	No data		
COMPONENT:	Ceiling Finishes	RATING: 1 x WEIGHT: 6.3 =	SCORE: 6.3
	Maintainable surfaces in good condition; good alignment and appearance		
COMMENTS:	No data		
COMPONENT:	Doors & Hardware	RATING: 1 x WEIGHT: 6.3 =	SCORE: 6.3
	Appropriate hardware, closers, panic devices; in good working order		
COMMENTS:	No data

Service Systems			
COMPONENT:	Elevators	RATING: 0 x WEIGHT: 0 =	SCORE: 0
	No data		
COMMENTS:	No data		
COMPONENT:	Plumbing	RATING: 1 x WEIGHT: 8.3 =	SCORE: 8.3
	Fixtures and piping appear to be in good condition; no evidence of leaks		
COMMENTS:	No data		
COMPONENT:	HVAC	RATING: 1 x WEIGHT: 8.3 =	SCORE: 8.3
	Equipment in good condition; easily controlled; serves all required spaces; All necessary spaces are adequately ventilated; A/C provided		
COMMENTS:	No data		
COMPONENT:	Electrical	RATING: 1 x WEIGHT: 8.3 =	SCORE: 8.3
	Adequate service and distribution capacity for current/future needs		
COMMENTS:	No data		
COMPONENT:	Lights/Power	RATING: 1 x WEIGHT: 8.3 =	SCORE: 8.3
	Contemporary lighting with good work area illumination; ample outlets		
COMMENTS:	No data

Safety Systems			
COMPONENT:	Life/Safety	RATING: 1 x WEIGHT: 10.4 =	SCORE: 10.4
	Appears to meet current codes		
COMMENTS:	No data		
COMPONENT:	Fire Safety	RATING: 1 x WEIGHT: 10.4 =	SCORE: 10.4
	Locally monitored detection; alarm and strobes present; sprinklers in high hazard areas		
COMMENTS:	No data		
COMPONENT:	Modifications	RATING: 1 x WEIGHT: 7.3 =	SCORE: 7.3
	Modifications appear to be in compliance with codes and sound construction practices; HVAC/electrical service properly provided		
COMMENTS:	No data

Quality Standards			
COMPONENT:	Maintenance	RATING: 1 x WEIGHT: 7.3 =	SCORE: 7.3
	Facility appears well maintained		
COMMENTS:	No data		
COMPONENT:	Remaining Life	RATING: 1 x WEIGHT: 6.3 =	SCORE: 6.3
	Life expectancy is >20 years; minor system deterioration		
COMMENTS:	No data		
COMPONENT:	Appearance	RATING: 1 x WEIGHT: 6.3 =	SCORE: 6.3
	Well-constructed building; generally attractive interior and exterior		
COMMENTS:	No data
