2023 FACILITY CONDITION SURVEY

Bates Technical College

SURVEY CONDUCTED BY:
Steve Lewandowski
State Board for Community
and Technical Colleges

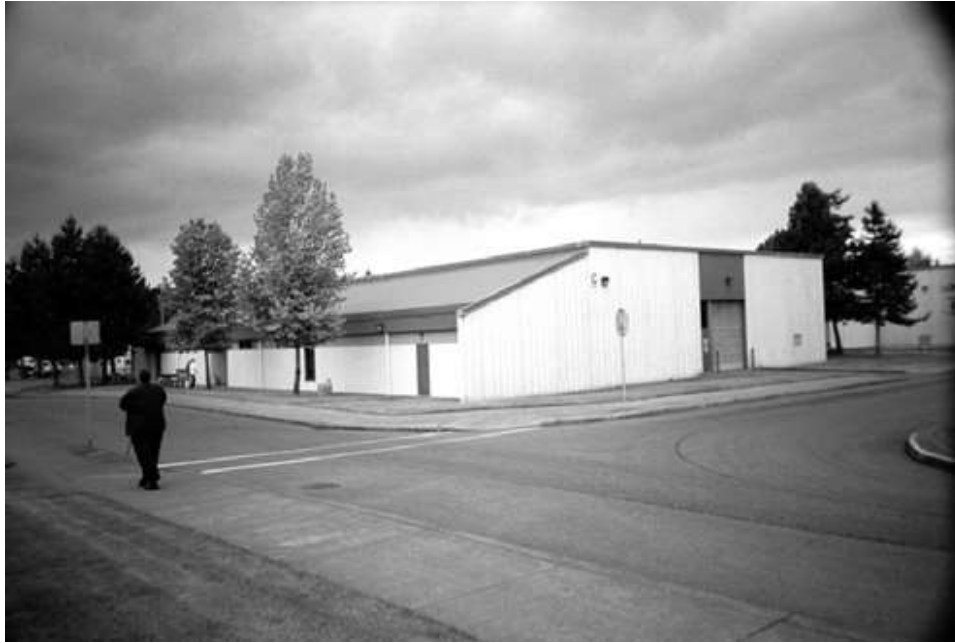
S.C. Bldg. C (280-6) STATE UFI: A00042 South Campus (280B)
 AREA: 41,760 SF BUILT: 1987 REMODELED: No PREDOMINANT USE: Vocational Arts
 CONSTRUCTION TYPE: Heavy CRV/SF: \$395 REPLACEMENT VALUE: \$16,495,200

Primary Systems			
COMPONENT:	Structure	RATING: 1 x WEIGHT: 8.3 =	SCORE: 8.3
No signs of settlement or cracking, no abrupt vertical changes Columns, bearing walls and roof structure appears sound/free of defects			
COMMENTS:	Cast concrete; steel framing; steel joists		
COMPONENT:	Exterior Closure	RATING: 3 x WEIGHT: 8.3 =	SCORE: 25
Sound and weatherproof but with some physical deterioration evident			
COMMENTS:	Concrete; stucco; metal fascia		
COMPONENT:	Roofing	RATING: 3 x WEIGHT: 10.4 =	SCORE: 31.3
Some deterioration is evident in membrane and flashings; maintenance or minor repair is needed			
COMMENTS:	Hypalon membrane over metal roof-2006; standing seam metal

Secondary Systems			
COMPONENT:	Floor Finishes	RATING: 2 x WEIGHT: 6.3 =	SCORE: 12.5
Some wear is evident on finish; maintenance needed			
COMMENTS:	Vinyl tile; carpet; concrete; vinyl sheet floor		
COMPONENT:	Wall Finishes	RATING: 2 x WEIGHT: 6.3 =	SCORE: 12.5
Maintainable surfaces, minor maintenance is required in some areas			
COMMENTS:	Gypsum board; concrete; ceramic tile		
COMPONENT:	Ceiling Finishes	RATING: 2 x WEIGHT: 6.3 =	SCORE: 12.5
Aging surfaces in fair condition and good alignment			
COMMENTS:	Lay-in tile; gypsum board; metal framing.		
COMPONENT:	Doors & Hardware	RATING: 3 x WEIGHT: 6.3 =	SCORE: 18.8
Functional, but dated; some maintenance required			
COMMENTS:	Interior wood and HM doors w HM frames; exterior HM doors/frames; coiling doors

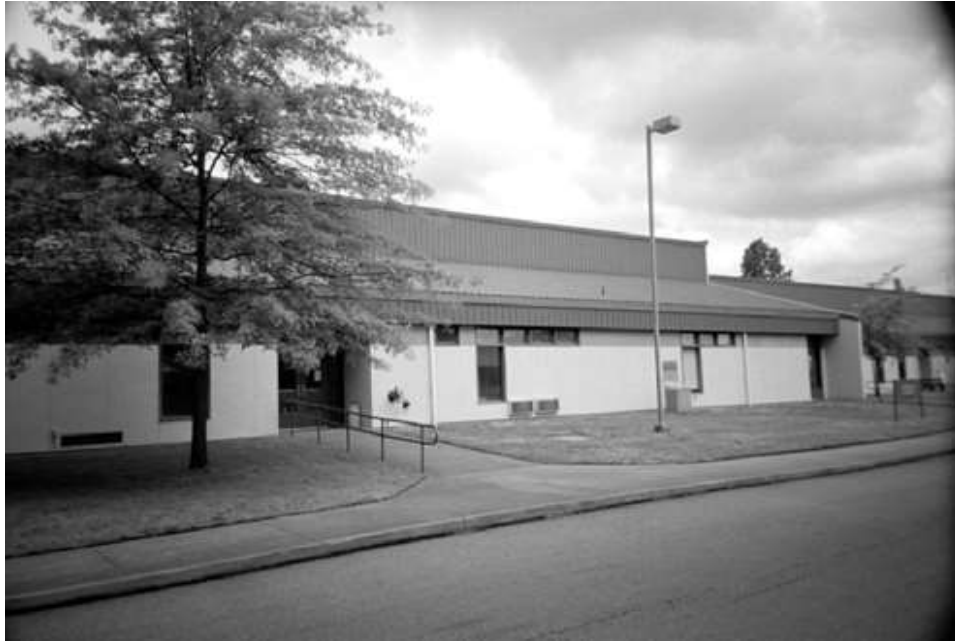
S.C. Bldg. B (280-5) STATE UFI: A00368 South Campus (280B)
 AREA: 72,940 SF BUILT: 1987 REMODELED: No PREDOMINANT USE: Vocational Arts
 CONSTRUCTION TYPE: Heavy CRV/SF: \$395 REPLACEMENT VALUE: \$28,811,300

Primary Systems			
COMPONENT:	Structure	RATING: 1 x WEIGHT: 8 =	SCORE: 8
No signs of settlement or cracking, no abrupt vertical changes Columns, bearing walls and roof structure appears sound/free of defects			
COMMENTS:	Cast concrete; steel framing; steel joists		
COMPONENT:	Exterior Closure	RATING: 3 x WEIGHT: 8 =	SCORE: 24
Sound and weatherproof but with some physical deterioration evident			
COMMENTS:	Concrete; stucco; metal fascia		
COMPONENT:	Roofing	RATING: 2 x WEIGHT: 10 =	SCORE: 20
Majority of roofing and flashing appear sound, but a small portion of roofing shows deterioration where maintenance or minor repair needed			
COMMENTS:	Hypalon membrane over metal roof-2006; standing seam metal

Secondary Systems			
COMPONENT:	Floor Finishes	RATING: 2 x WEIGHT: 6 = SCORE: 12	
	Some wear is evident on finish; maintenance needed		
COMMENTS:	Vinyl tile; carpet; concrete; vinyl sheet floor		
COMPONENT:	Wall Finishes	RATING: 2 x WEIGHT: 6 = SCORE: 12	
	Maintainable surfaces, minor maintenance is required in some areas		
COMMENTS:	Gypsum board; concrete; CMU; ceramic tile		
COMPONENT:	Ceiling Finishes	RATING: 3 x WEIGHT: 6 = SCORE: 18	
	Some wear and tear; Minor damage, staining or deterioration		
COMMENTS:	Lay-in tile; gypsum board; metal framing		
COMPONENT:	Doors & Hardware	RATING: 2 x WEIGHT: 6 = SCORE: 12	
	Fairly modern door surfaces and hardware with minor deterioration; good working order		
COMMENTS:	Interior/exterior HM doors/frames-surface wear; Overhead doors 2022

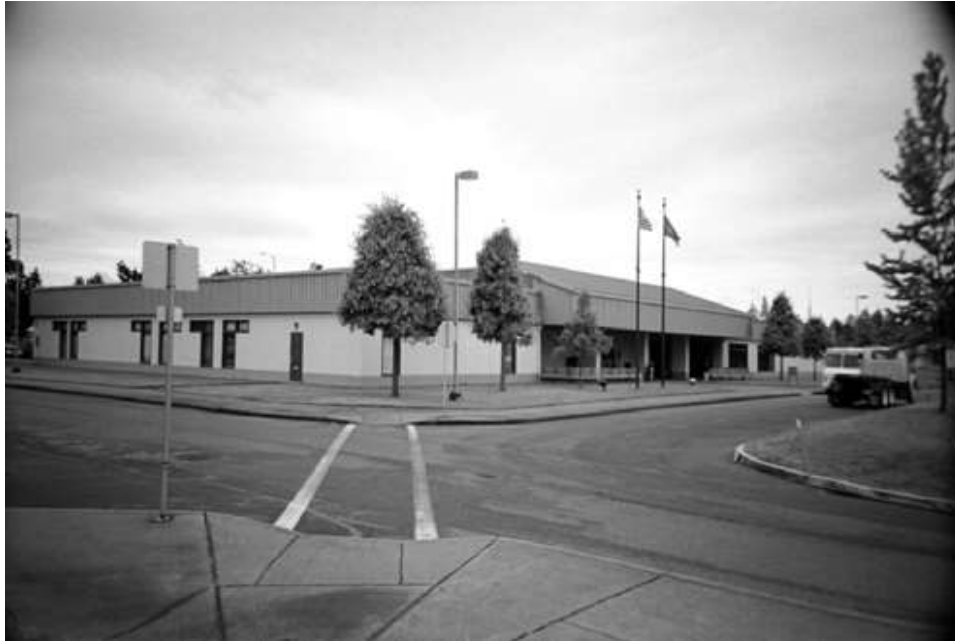
S.C. Bldg. A (280-4) STATE UFI: A01591 South Campus (280B)
AREA: 31,356 SF BUILT: 1987 REMODELED: No PREDOMINANT USE: Mixed Use
CONSTRUCTION TYPE: Heavy CRV/SF: \$395 REPLACEMENT VALUE: \$12,385,620

Primary Systems			
COMPONENT:	Structure	RATING: 1 x WEIGHT: 8.3 =	SCORE: 8.3
No signs of settlement or cracking, no abrupt vertical changes Columns, bearing walls and roof structure appears sound/free of defects			
COMMENTS:	Cast concrete; steel framing		
COMPONENT:	Exterior Closure	RATING: 2 x WEIGHT: 8.3 =	SCORE: 16.7
Weatherproof exterior, but finish appears poorly maintained			
COMMENTS:	Concrete; stucco; metal fascia; lay-in tile soffits		
COMPONENT:	Roofing	RATING: 1 x WEIGHT: 10.4 =	SCORE: 10.4
Flashing and penetrations appear sound and membrane appears water- tight; drainage is positive and there are overflow scuppers			
COMMENTS:	Hypalon membrane over metal roof-2004; standing seam metal

Secondary Systems			
COMPONENT:	Floor Finishes	RATING: 2 x WEIGHT: 6.3 =	SCORE: 12.5
Some wear is evident on finish; maintenance needed			
COMMENTS:	Vinyl tile; carpet and carpet tile; concrete; vinyl sheet floor; quarry tile; linoleum; ceramic tile		
COMPONENT:	Wall Finishes	RATING: 1 x WEIGHT: 6.3 =	SCORE: 6.3
Maintainable surfaces in good condition			
COMMENTS:	Gypsum board; concrete; ceramic tile		
COMPONENT:	Ceiling Finishes	RATING: 1 x WEIGHT: 6.3 =	SCORE: 6.3
Maintainable surfaces in good condition; good alignment and appearance			
COMMENTS:	Lay-in tile; gypsum board; metal framing		
COMPONENT:	Doors & Hardware	RATING: 2 x WEIGHT: 6.3 =	SCORE: 12.5
Fairly modern door surfaces and hardware with minor deterioration; good working order			
COMMENTS:	Interior wood/HM doors w HM frames-surface wear; exterior HM doors/frames-surface wear

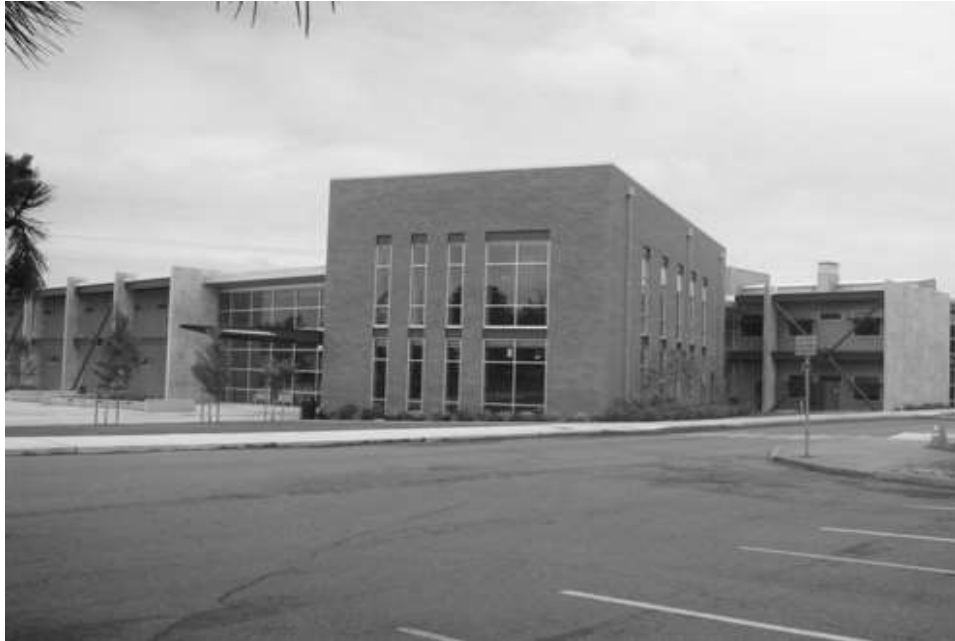
S.C. Bldg. E (280-11) STATE UFI: A06330 South Campus (280B)
 AREA: 44,557 SF BUILT: 2007 REMODELED: No PREDOMINANT USE: Vocational Arts
 CONSTRUCTION TYPE: Heavy CRV/SF: \$395 REPLACEMENT VALUE: \$17,600,015

Primary Systems			
COMPONENT:	Structure	RATING: 1 x WEIGHT: 8 =	SCORE: 8
No signs of settlement or cracking, no abrupt vertical changes Columns, bearing walls and roof structure appears sound/free of defects			
COMMENTS:	Steel frame and concrete		
COMPONENT:	Exterior Closure	RATING: 1 x WEIGHT: 8 =	SCORE: 8
Weatherproof, tight, well-maintained exterior walls, doors, windows/finishes			
COMMENTS:	Brick; metal architectural panels; concrete; clearstory windows; aluminum window walls		
COMPONENT:	Roofing	RATING: 1 x WEIGHT: 10 =	SCORE: 10
Flashing and penetrations appear sound and membrane appears water- tight; drainage is positive and there are overflow scuppers			
COMMENTS:	Single-ply PVC membrane

Secondary Systems			
COMPONENT:	Floor Finishes	RATING: 2 x WEIGHT: 6 = SCORE: 12	
	Some wear is evident on finish; maintenance needed		
COMMENTS:	Concrete; carpet tile; linoleum; ceramic tile; polished concrete floors-badly cracked/discolored		
COMPONENT:	Wall Finishes	RATING: 2 x WEIGHT: 6 = SCORE: 12	
	Maintainable surfaces, minor maintenance is required in some areas		
COMMENTS:	Concrete; gypsum board; ceramic tile		
COMPONENT:	Ceiling Finishes	RATING: 1 x WEIGHT: 6 = SCORE: 6	
	Maintainable surfaces in good condition; good alignment and appearance		
COMMENTS:	Metal roof deck; acoustical ceiling panels; lay-in tile		
COMPONENT:	Doors & Hardware	RATING: 1 x WEIGHT: 6 = SCORE: 6	
	Appropriate hardware, closers, panic devices; in good working order		
COMMENTS:	Interior wood doors w HM frames; aluminum framed glazed entry doors and frames

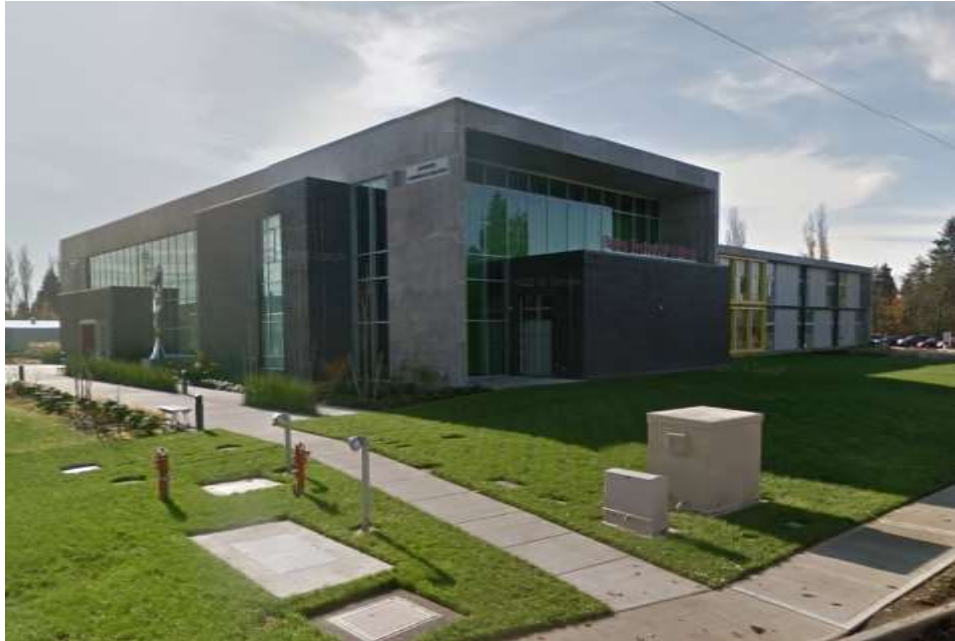
C.C Advanced Technology Building - Bldg. B (280-12) STATE UFI: A21454 South Campus (280B)
 AREA: 51,629 SF BUILT: 2016 REMODELED: No PREDOMINANT USE: Vocational Arts
 CONSTRUCTION TYPE: No data CRV/SF: \$375 REPLACEMENT VALUE: \$19,360,875

Primary Systems			
COMPONENT:	Structure	RATING: 1 x WEIGHT: 8.4 =	SCORE: 8.4
No signs of settlement or cracking, no abrupt vertical changes Columns, bearing walls and roof structure appears sound/free of defects			
COMMENTS:	No data		
COMPONENT:	Exterior Closure	RATING: 1 x WEIGHT: 8.4 =	SCORE: 8.4
Weatherproof, tight, well-maintained exterior walls, doors, windows/finishes			
COMMENTS:	No data		
COMPONENT:	Roofing	RATING: 1 x WEIGHT: 10.5 =	SCORE: 10.5
Flashing and penetrations appear sound and membrane appears water- tight; drainage is positive and there are overflow scuppers			
COMMENTS:	No data

Secondary Systems			
COMPONENT:	Floor Finishes	RATING: 1 x WEIGHT: 6.3 = SCORE: 6.3	
	Nice appearance, smooth transitions, level subfloors, no cracks/separating		
COMMENTS:	No data		
COMPONENT:	Wall Finishes	RATING: 1 x WEIGHT: 6.3 = SCORE: 6.3	
	Maintainable surfaces in good condition		
COMMENTS:	No data		
COMPONENT:	Ceiling Finishes	RATING: 1 x WEIGHT: 6.3 = SCORE: 6.3	
	Maintainable surfaces in good condition; good alignment and appearance		
COMMENTS:	No data		
COMPONENT:	Doors & Hardware	RATING: 1 x WEIGHT: 6.3 = SCORE: 6.3	
	Appropriate hardware, closers, panic devices; in good working order		
COMMENTS:	No data

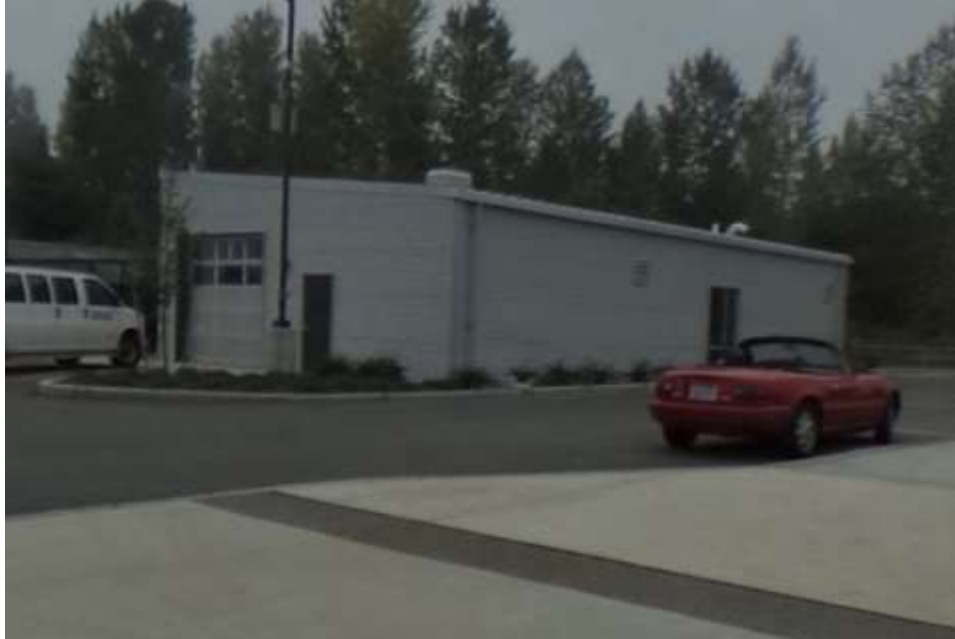
C.C. Maintenance Bldg. - Bldg. C (280-13) STATE UFI: A21455 South Campus (280B)
AREA: 2,690 SF BUILT: 2016 REMODELED: No PREDOMINANT USE: Storage
CONSTRUCTION TYPE: No data CRV/SF: \$231 REPLACEMENT VALUE: \$621,390

Primary Systems			
COMPONENT:	Structure	RATING: 1 x WEIGHT: 8.8 = SCORE: 8.8	
No signs of settlement or cracking, no abrupt vertical changes Columns, bearing walls and roof structure appears sound/free of defects			
COMMENTS:	No data		
COMPONENT:	Exterior Closure	RATING: 1 x WEIGHT: 8.8 = SCORE: 8.8	
Weatherproof, tight, well-maintained exterior walls, doors, windows/finishes			
COMMENTS:	No data		
COMPONENT:	Roofing	RATING: 1 x WEIGHT: 11 = SCORE: 11	
Flashing and penetrations appear sound and membrane appears water- tight; drainage is positive and there are overflow scuppers			
COMMENTS:	No data

Secondary Systems			
COMPONENT:	Floor Finishes	RATING: 1 x WEIGHT: 6.6 =	SCORE: 6.6
	Nice appearance, smooth transitions, level subfloors, no cracks/separating		
COMMENTS:	No data		
COMPONENT:	Wall Finishes	RATING: 1 x WEIGHT: 6.6 =	SCORE: 6.6
	Maintainable surfaces in good condition		
COMMENTS:	No data		
COMPONENT:	Ceiling Finishes	RATING: 1 x WEIGHT: 6.6 =	SCORE: 6.6
	Maintainable surfaces in good condition; good alignment and appearance		
COMMENTS:	No data		
COMPONENT:	Doors & Hardware	RATING: 1 x WEIGHT: 6.6 =	SCORE: 6.6
	Appropriate hardware, closers, panic devices; in good working order		
COMMENTS:	No data

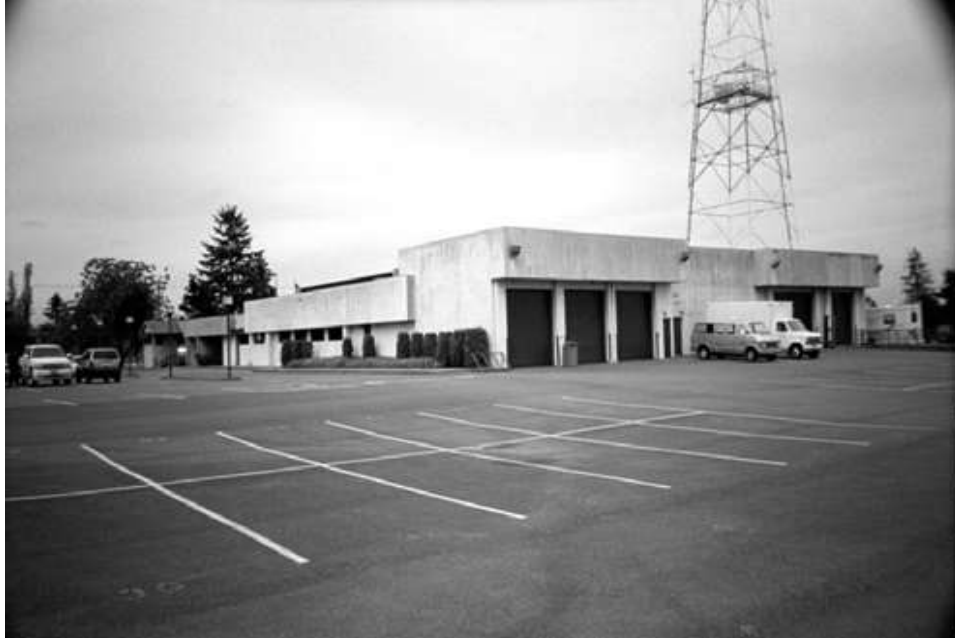
C.C. Communications Technology Building - Bldg A (280-10) STATE UFI: A03194 Central Mohler
Campus (280F)

Primary Systems			
COMPONENT:	Structure	RATING: 1 x WEIGHT: 8 =	SCORE: 8
No signs of settlement or cracking, no abrupt vertical changes Columns, bearing walls and roof structure appears sound/free of defects			
COMMENTS:	Concrete and CMU walls; steel roof joists.		
COMPONENT:	Exterior Closure	RATING: 3 x WEIGHT: 8 =	SCORE: 24
Sound and weatherproof but with some physical deterioration evident			
COMMENTS:	Concrete; CMU and stucco; extensive hairline stucco cracking; some concrete panel cracks		
COMPONENT:	Roofing	RATING: 2 x WEIGHT: 10 =	SCORE: 20
Majority of roofing and flashing appear sound, but a small portion of roofing shows deterioration where maintenance or minor repair needed			
COMMENTS:	BUR w mineral-surfaced cap sheet and EPDM-2003

Secondary Systems			
COMPONENT:	Floor Finishes	RATING: 3 x WEIGHT: 6 = SCORE: 18	
	Some physical wear and minor imperfections are evident; beginning deterioration		
COMMENTS:	Concrete; vinyl tile; carpet; sheet vinyl; wood parquet		
COMPONENT:	Wall Finishes	RATING: 2 x WEIGHT: 6 = SCORE: 12	
	Maintainable surfaces, minor maintenance is required in some areas		
COMMENTS:	Concrete; CMU; gypsum board; wood panels and wood slats		
COMPONENT:	Ceiling Finishes	RATING: 3 x WEIGHT: 6 = SCORE: 18	
	Some wear and tear; Minor damage, staining or deterioration		
COMMENTS:	Concrete deck; lay-in tile; concealed spline tile; ventwood		
COMPONENT:	Doors & Hardware	RATING: 3 x WEIGHT: 6 = SCORE: 18	
	Functional, but dated; some maintenance required		
COMMENTS:	Interior wood/laminate doors w HM frames; exterior HM doors/frames; metal coiling doors
