2023 FACILITY CONDITION SURVEY

Clark College

SURVEY CONDUCTED BY:
Steve Lewandowski
State Board for Community
and Technical Colleges

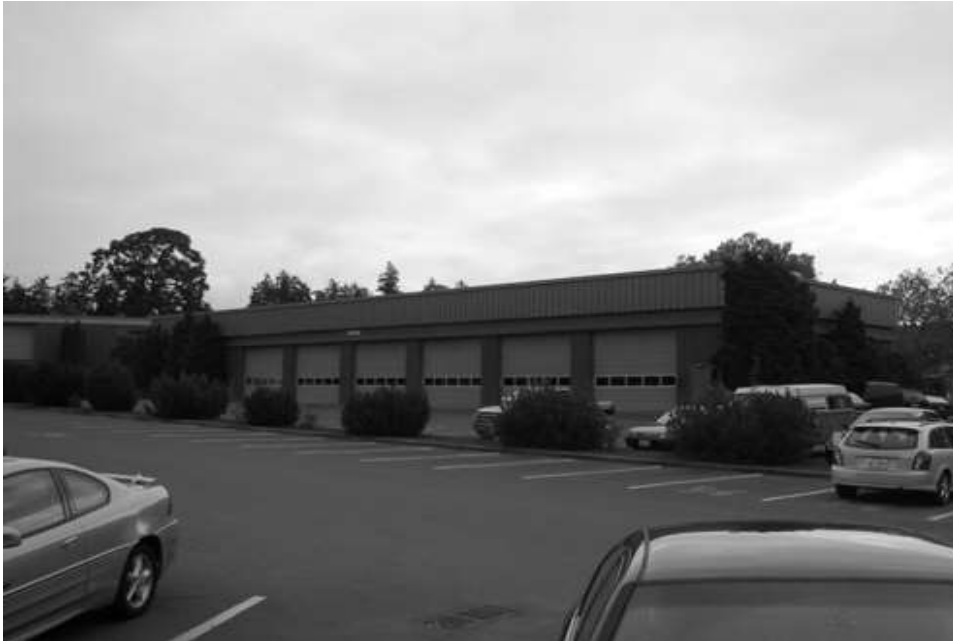
Diesel (140-DSL) STATE UFI: A00901 Main Campus (140A)
AREA: 13,910 SF BUILT: 1971 REMODELED: No PREDOMINANT USE: Vocational Arts
CONSTRUCTION TYPE: Medium CRV/SF: \$395 REPLACEMENT VALUE: \$5,494,450

Primary Systems			
COMPONENT:	Structure	RATING: 1 x WEIGHT: 8.3 =	SCORE: 8.3
No signs of settlement or cracking, no abrupt vertical changes Columns, bearing walls and roof structure appears sound/free of defects			
COMMENTS:	Poured concrete; concrete columns; wood frame		
COMPONENT:	Exterior Closure	RATING: 3 x WEIGHT: 8.3 =	SCORE: 25
Sound and weatherproof but with some physical deterioration evident			
COMMENTS:	Concrete; metal fascia-random damage		
COMPONENT:	Roofing	RATING: 1 x WEIGHT: 10.4 =	SCORE: 10.4
Flashing and penetrations appear sound and membrane appears water- tight; drainage is positive and there are overflow scuppers			
COMMENTS:	Single-ply Hypalon membrane

Secondary Systems			
COMPONENT:	Floor Finishes	RATING: 3 x WEIGHT: 6.3 =	SCORE: 18.8
Some physical wear and minor imperfections are evident; beginning deterioration			
COMMENTS:	Concrete; vinyl tile-surface wear; ceramic tile		
COMPONENT:	Wall Finishes	RATING: 2 x WEIGHT: 6.3 =	SCORE: 12.5
Maintainable surfaces, minor maintenance is required in some areas			
COMMENTS:	Concrete; CMU		
COMPONENT:	Ceiling Finishes	RATING: 2 x WEIGHT: 6.3 =	SCORE: 12.5
Aging surfaces in fair condition and good alignment			
COMMENTS:	Wood T&G roof deck; lay-in tile; direct-adhered tile		
COMPONENT:	Doors & Hardware	RATING: 2 x WEIGHT: 6.3 =	SCORE: 12.5
Fairly modern door surfaces and hardware with minor deterioration; good working order			
COMMENTS:	Exterior/interior HM doors/frames; OH metal doors

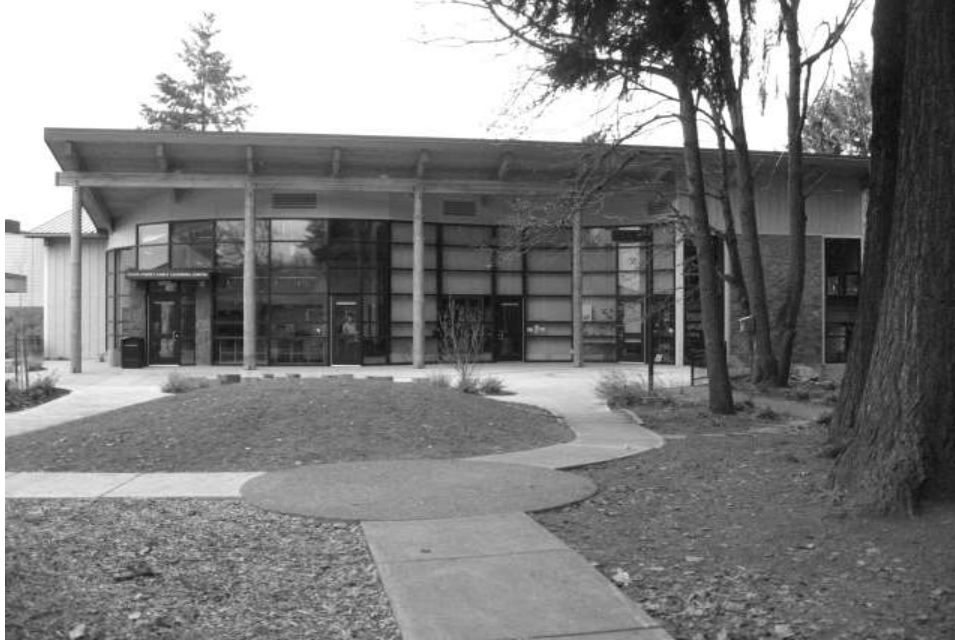
Early Learning Center (140-ELC) STATE UFI: A10067 Main Campus (140A)
 AREA: 6,175 SF BUILT: 2011 REMODELED: No PREDOMINANT USE: Child Care
 CONSTRUCTION TYPE: Medium CRV/SF: \$363 REPLACEMENT VALUE: \$2,241,525

Primary Systems			
COMPONENT:	Structure	RATING: 1 x WEIGHT: 8.8 = SCORE: 8.8	
No signs of settlement or cracking, no abrupt vertical changes Columns, bearing walls and roof structure appears sound/free of defects			
COMMENTS:	Wood frame; concrete; glu-lam beams		
COMPONENT:	Exterior Closure	RATING: 1 x WEIGHT: 8.8 = SCORE: 8.8	
Weatherproof, tight, well-maintained exterior walls, doors, windows/finishes			
COMMENTS:	Slate rock facing; aluminum window walls; horizontal; beveled cement board; board/bat cement board		
COMPONENT:	Roofing	RATING: 1 x WEIGHT: 11 = SCORE: 11	
Flashing and penetrations appear sound and membrane appears water- tight; drainage is positive and there are overflow scuppers			
COMMENTS:	TPO single-ply membrane; standing seam metal

Secondary Systems			
COMPONENT:	Floor Finishes	RATING: 2 x WEIGHT: 6.6 = SCORE: 13.2	
	Some wear is evident on finish; maintenance needed		
COMMENTS:	Linoleum; sheet vinyl; ceramic tile		
COMPONENT:	Wall Finishes	RATING: 2 x WEIGHT: 6.6 = SCORE: 13.2	
	Maintainable surfaces, minor maintenance is required in some areas		
COMMENTS:	Gypsum board; ceramic tile; slate rock; window walls		
COMPONENT:	Ceiling Finishes	RATING: 1 x WEIGHT: 6.6 = SCORE: 6.6	
	Maintainable surfaces in good condition; good alignment and appearance		
COMMENTS:	Lay-in tile; wood t&g roof deck		
COMPONENT:	Doors & Hardware	RATING: 1 x WEIGHT: 6.6 = SCORE: 6.6	
	Appropriate hardware, closers, panic devices; in good working order		
COMMENTS:	Interior wood doors w HM frames; exterior aluminum doors/frames

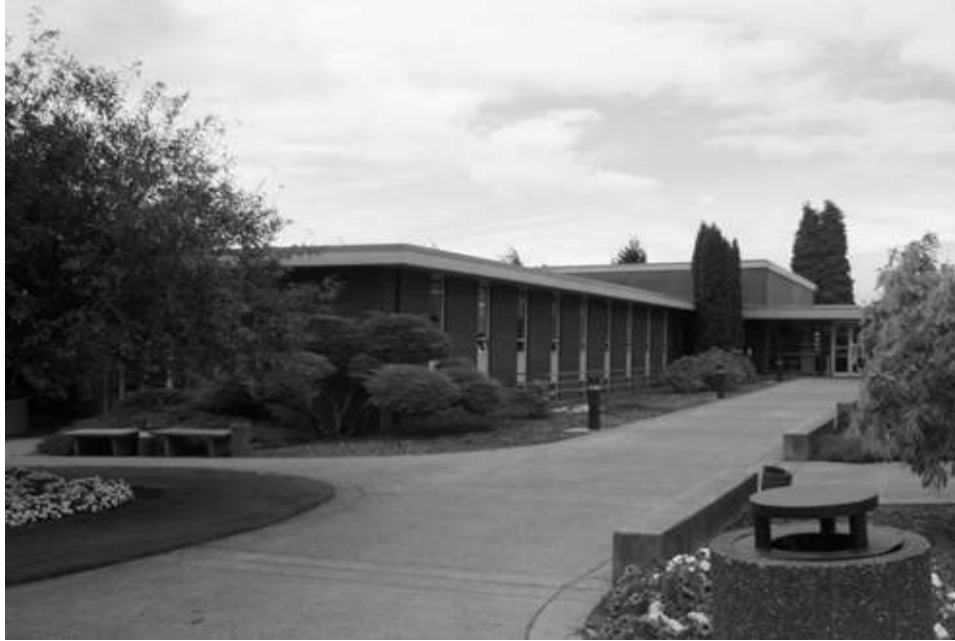
Foster Hall (140-FHL) STATE UFI: A07210 Main Campus (140A)
 AREA: 13,442 SF BUILT: 1966 REMODELED: No PREDOMINANT USE: Faculty Office
 CONSTRUCTION TYPE: Medium CRV/SF: \$336 REPLACEMENT VALUE: \$4,516,512

Primary Systems			
COMPONENT:	Structure	RATING: 2 x WEIGHT: 8 =	SCORE: 16
Minor cracks evident in a small portion of the structure			
COMMENTS:	Brick; wood frame; concrete; seismic integrity concerns		
COMPONENT:	Exterior Closure	RATING: 3 x WEIGHT: 8 =	SCORE: 24
Sound and weatherproof but with some physical deterioration evident			
COMMENTS:	Brick-random mortar deterioration		
COMPONENT:	Roofing	RATING: 1 x WEIGHT: 10 =	SCORE: 10
Flashing and penetrations appear sound and membrane appears water-tight; drainage is positive and there are overflow scuppers			
COMMENTS:	Single-ply 2016

Secondary Systems			
COMPONENT:	Floor Finishes	RATING: 3 x WEIGHT: 6 = SCORE: 18	
	Some physical wear and minor imperfections are evident; beginning deterioration		
COMMENTS:	Vinyl tile; carpet; sheet vinyl; concrete		
COMPONENT:	Wall Finishes	RATING: 1 x WEIGHT: 6 = SCORE: 6	
	Maintainable surfaces in good condition		
COMMENTS:	Brick; plaster; gypsum board		
COMPONENT:	Ceiling Finishes	RATING: 1 x WEIGHT: 6 = SCORE: 6	
	Maintainable surfaces in good condition; good alignment and appearance		
COMMENTS:	Lay-in and direct adhered tile		
COMPONENT:	Doors & Hardware	RATING: 3 x WEIGHT: 6 = SCORE: 18	
	Functional, but dated; some maintenance required		
COMMENTS:	Interior wood doors w HM frames-general surface wear; exterior aluminum/HM doors

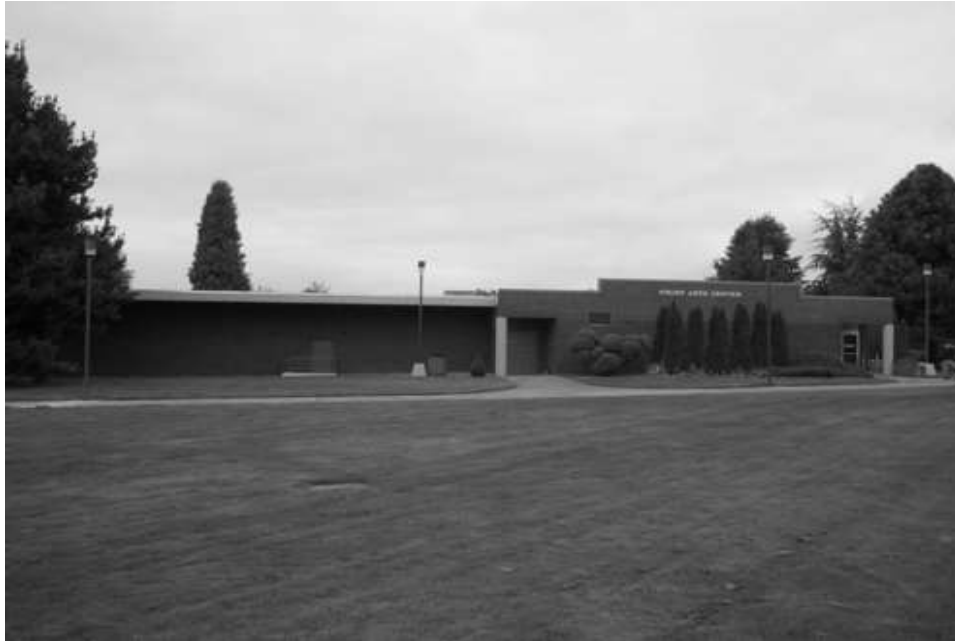
Frost Arts Center (140-FAC) STATE UFI: A06742 Main Campus (140A)
AREA: 21,365 SF BUILT: 1958 REMODELED: No PREDOMINANT USE: Visual Arts
CONSTRUCTION TYPE: Medium CRV/SF: \$376 REPLACEMENT VALUE: \$8,033,240

Primary Systems			
COMPONENT:	Structure	RATING: 1 x WEIGHT: 8 =	SCORE: 8
No signs of settlement or cracking, no abrupt vertical changes Columns, bearing walls and roof structure appears sound/free of defects			
COMMENTS:	Wood frame; concrete; brick; glu-lam beams		
COMPONENT:	Exterior Closure	RATING: 2 x WEIGHT: 8 =	SCORE: 16
Weatherproof exterior, but finish appears poorly maintained			
COMMENTS:	Brick-random mortar deterioration; plywood soffits		
COMPONENT:	Roofing	RATING: 2 x WEIGHT: 10 =	SCORE: 20
Majority of roofing and flashing appear sound, but a small portion of roofing shows deterioration where maintenance or minor repair needed			
COMMENTS:	Single-ply TPO membrane-2003; standing seam metal

Secondary Systems			
COMPONENT:	Floor Finishes	RATING: 4 x WEIGHT: 6 =	SCORE: 24
General deterioration evident; one-third to one-half of flooring exhibits extensive deterioration			
COMMENTS:	Vinyl tile; carpet; concrete; ceramic tile; sheet vinyl		
COMPONENT:	Wall Finishes	RATING: 3 x WEIGHT: 6 =	SCORE: 18
Aging surfaces, but sound; some maintenance is required			
COMMENTS:	Gypsum board; CMU; plaster; brick; ceramic tile; concrete		
COMPONENT:	Ceiling Finishes	RATING: 3 x WEIGHT: 6 =	SCORE: 18
Some wear and tear; Minor damage, staining or deterioration			
COMMENTS:	Direct adhered tile-general deterioration; lay-in tile; wood deck; concrete deck; wood strips		
COMPONENT:	Doors & Hardware	RATING: 3 x WEIGHT: 6 =	SCORE: 18
Functional, but dated; some maintenance required			
COMMENTS:	Interior wood/HM doors/frames-surface wear; exterior aluminum/HM doors/frames

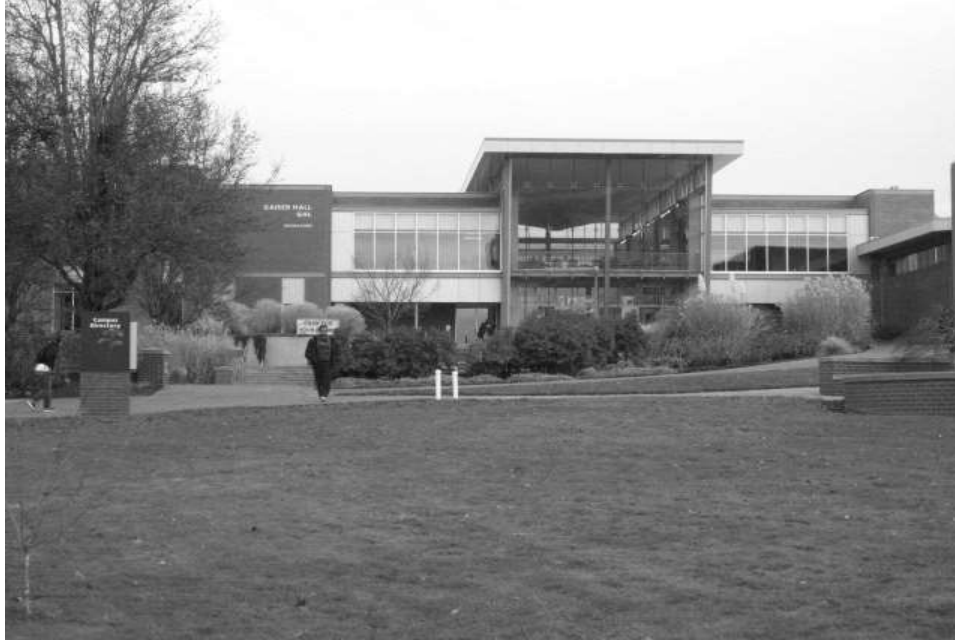
Gaiser Hall (140-GHL) STATE UFI: A09419 Main Campus (140A)
 AREA: 93,029 SF BUILT: 1958 REMODELED: 2008 PREDOMINANT USE: Student Center
 CONSTRUCTION TYPE: Medium CRV/SF: \$391 REPLACEMENT VALUE: \$36,374,339

Primary Systems			
COMPONENT:	Structure	RATING: 1 x WEIGHT: 8 =	SCORE: 8
No signs of settlement or cracking, no abrupt vertical changes Columns, bearing walls and roof structure appears sound/free of defects			
COMMENTS:	Steel framing; wood framing; brick; concrete		
COMPONENT:	Exterior Closure	RATING: 1 x WEIGHT: 8 =	SCORE: 8
Weatherproof, tight, well-maintained exterior walls, doors, windows/finishes			
COMMENTS:	Brick; glass window walls; concrete; CMU; metal panels		
COMPONENT:	Roofing	RATING: 2 x WEIGHT: 10 =	SCORE: 20
Majority of roofing and flashing appear sound, but a small portion of roofing shows deterioration where maintenance or minor repair needed			
COMMENTS:	Hypalon single-ply membrane-some deterioration; TPO single-ply membrane

Secondary Systems			
COMPONENT:	Floor Finishes	RATING: 1 x WEIGHT: 6 = SCORE: 6	
	Nice appearance, smooth transitions, level subfloors, no cracks/separating		
COMMENTS:	Vinyl tile; carpet; ceramic tile; sheet vinyl; concrete; wood strip; epoxy		
COMPONENT:	Wall Finishes	RATING: 1 x WEIGHT: 6 = SCORE: 6	
	Maintainable surfaces in good condition		
COMMENTS:	Gypsum board-dinged/marred; ceramic tile; brick; wood panels and strips; plaster; CMU; vinyl wall covering		
COMPONENT:	Ceiling Finishes	RATING: 2 x WEIGHT: 6 = SCORE: 12	
	Aging surfaces in fair condition and good alignment		
COMMENTS:	Lay-in tile; gypsum board; direct-adhered tile-surface wear		
COMPONENT:	Doors & Hardware	RATING: 1 x WEIGHT: 6 = SCORE: 6	
	Appropriate hardware, closers, panic devices; in good working order		
COMMENTS:	Interior wood/HM doors w HM frames; exterior aluminum/HM doors/frames

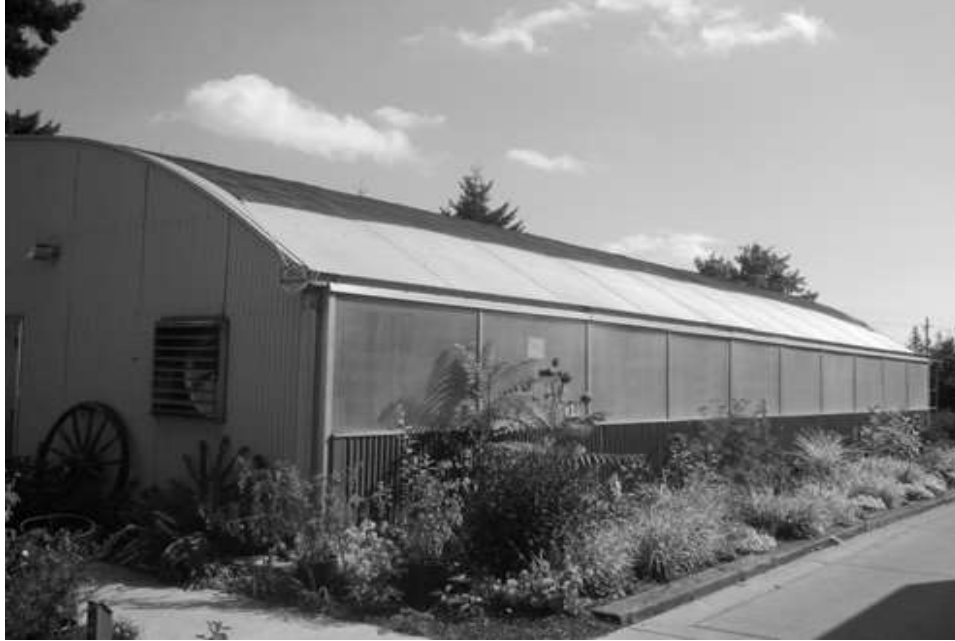
Greenhouse (140-GRH) STATE UFI: A05797 Main Campus (140A)
 AREA: 2,354 SF BUILT: 1979 REMODELED: No PREDOMINANT USE: Greenhouse
 CONSTRUCTION TYPE: Light CRV/SF: \$198 REPLACEMENT VALUE: \$466,092

Primary Systems			
COMPONENT:	Structure	RATING: 1 x WEIGHT: 8.7 = SCORE: 8.7	
No signs of settlement or cracking, no abrupt vertical changes Columns, bearing walls and roof structure appears sound/free of defects			
COMMENTS:	Steel framing		
COMPONENT:	Exterior Closure	RATING: 3 x WEIGHT: 8.7 = SCORE: 26.1	
Sound and weatherproof but with some physical deterioration evident			
COMMENTS:	Plexiglas panels		
COMPONENT:	Roofing	RATING: 3 x WEIGHT: 10.9 = SCORE: 32.7	
Some deterioration is evident in membrane and flashings; maintenance or minor repair is needed			
COMMENTS:	Plexiglas panels

Secondary Systems			
COMPONENT:	Floor Finishes	RATING: 3 x WEIGHT: 6.5 =	SCORE: 19.6
Some physical wear and minor imperfections are evident; beginning deterioration			
COMMENTS:	Part concrete; part gravel/dirt		
COMPONENT:	Wall Finishes	RATING: 2 x WEIGHT: 6.5 =	SCORE: 13.1
Maintainable surfaces, minor maintenance is required in some areas			
COMMENTS:	Plexiglas panels		
COMPONENT:	Ceiling Finishes	RATING: 0 x WEIGHT: 0 =	SCORE: 0
No data			
COMMENTS:	Plexiglas panels		
COMPONENT:	Doors & Hardware	RATING: 3 x WEIGHT: 6.5 =	SCORE: 19.6
Functional, but dated; some maintenance required			
COMMENTS:	exterior HM doors/frames-surface wear

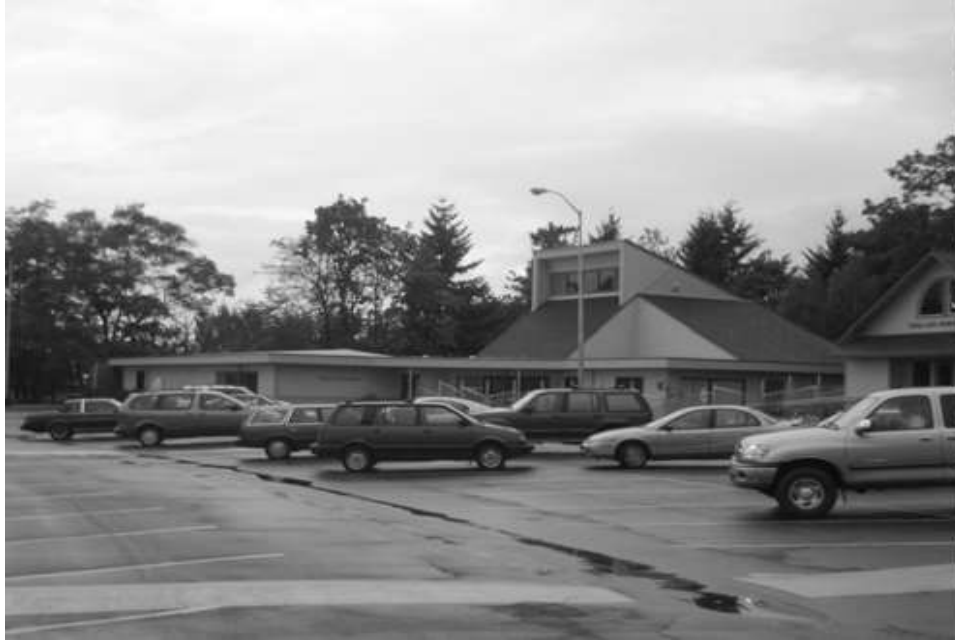
Haag Parent Education (140-PAR) STATE UFI: A03762 Main Campus (140A)
AREA: 7,812 SF BUILT: 1975 REMODELED: No PREDOMINANT USE: Child Care Education
CONSTRUCTION TYPE: Light CRV/SF: \$231 REPLACEMENT VALUE: \$1,804,572

Primary Systems			
COMPONENT:	Structure	RATING: 2 x WEIGHT: 8.3 =	SCORE: 16.7
Minor cracks evident in a small portion of the structure			
COMMENTS:	Wood frame		
COMPONENT:	Exterior Closure	RATING: 2 x WEIGHT: 8.3 =	SCORE: 16.7
Weatherproof exterior, but finish appears poorly maintained			
COMMENTS:	Horizontal Hardie-board siding; T1-11 plywood panels		
COMPONENT:	Roofing	RATING: 1 x WEIGHT: 10.4 =	SCORE: 10.4
Flashing and penetrations appear sound and membrane appears water- tight; drainage is positive and there are overflow scuppers			
COMMENTS:	3-tab 2012

Secondary Systems			
COMPONENT:	Floor Finishes	RATING: 2 x WEIGHT: 6.3 =	SCORE: 12.5
Some wear is evident on finish; maintenance needed			
COMMENTS:	Vinyl tile-surface wear; carpet; sheet vinyl		
COMPONENT:	Wall Finishes	RATING: 1 x WEIGHT: 6.3 =	SCORE: 6.3
Maintainable surfaces in good condition			
COMMENTS:	Gypsum board		
COMPONENT:	Ceiling Finishes	RATING: 1 x WEIGHT: 6.3 =	SCORE: 6.3
Maintainable surfaces in good condition; good alignment and appearance			
COMMENTS:	Gypsum board; direct adhered tile		
COMPONENT:	Doors & Hardware	RATING: 3 x WEIGHT: 6.3 =	SCORE: 18.8
Functional, but dated; some maintenance required			
COMMENTS:	Interior/exterior wood doors w HM frames

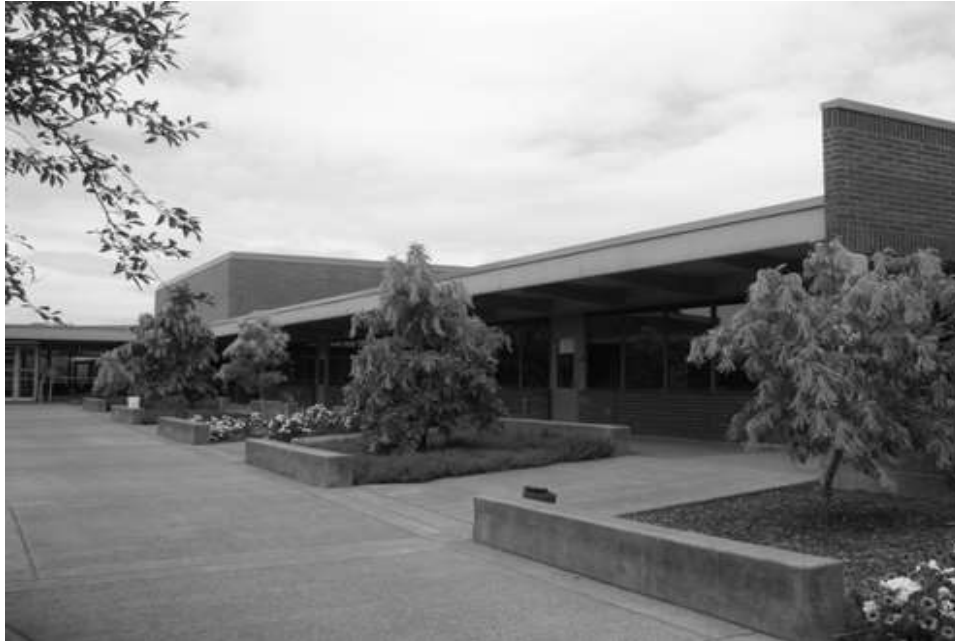
Hanna Hall (140-HHL) STATE UFI: A04633 Main Campus (140A)
AREA: 18,765 SF BUILT: 1958 REMODELED: No PREDOMINANT USE: General Classroom
CONSTRUCTION TYPE: Light CRV/SF: \$376 REPLACEMENT VALUE: \$7,055,640

Primary Systems			
COMPONENT:	Structure	RATING: 1 x WEIGHT: 8.3 =	SCORE: 8.3
No signs of settlement or cracking, no abrupt vertical changes Columns, bearing walls and roof structure appears sound/free of defects			
COMMENTS:	Wood frame; brick		
COMPONENT:	Exterior Closure	RATING: 3 x WEIGHT: 8.3 =	SCORE: 25
Sound and weatherproof but with some physical deterioration evident			
COMMENTS:	Brick; plywood and plaster soffits-random damage		
COMPONENT:	Roofing	RATING: 2 x WEIGHT: 10.4 =	SCORE: 20.9
Majority of roofing and flashing appear sound, but a small portion of roofing shows deterioration where maintenance or minor repair needed			
COMMENTS:	Standing seam metal-2002; single-ply TPO membrane-2002

Secondary Systems			
COMPONENT:	Floor Finishes	RATING: 3 x WEIGHT: 6.3 =	SCORE: 18.8
Some physical wear and minor imperfections are evident; beginning deterioration			
COMMENTS:	Vinyl and ceramic tile		
COMPONENT:	Wall Finishes	RATING: 3 x WEIGHT: 6.3 =	SCORE: 18.8
Aging surfaces, but sound; some maintenance is required			
COMMENTS:	Plaster; brick; vinyl wall panels		
COMPONENT:	Ceiling Finishes	RATING: 2 x WEIGHT: 6.3 =	SCORE: 12.5
Aging surfaces in fair condition and good alignment			
COMMENTS:	Direct adhered tile; lay-in tile		
COMPONENT:	Doors & Hardware	RATING: 3 x WEIGHT: 6.3 =	SCORE: 18.8
Functional, but dated; some maintenance required			
COMMENTS:	Interior HM doors/frames-surface wear; exterior aluminum/HM doors/frames

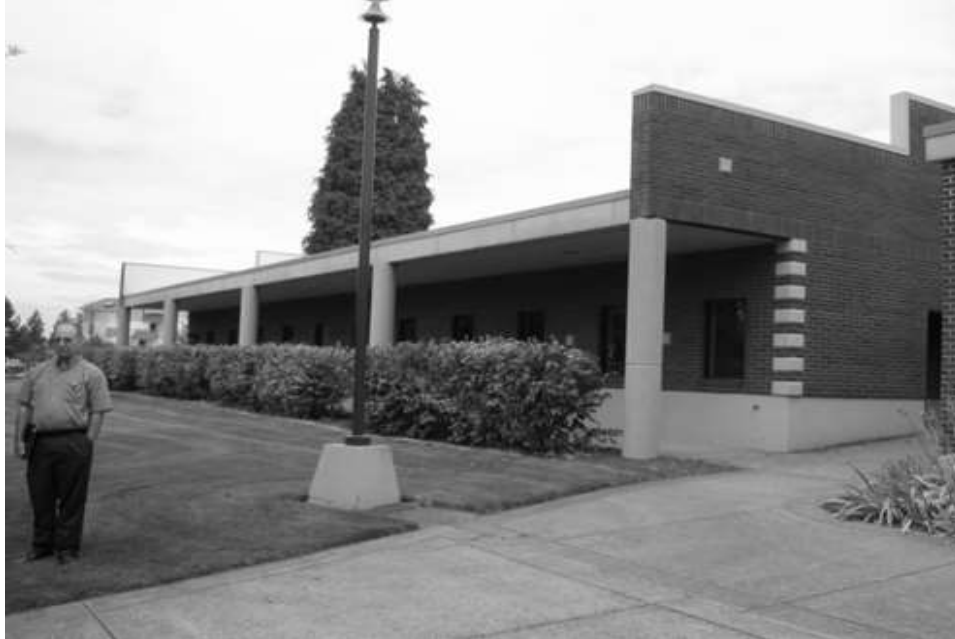
Hawkins Hall (140-HKH) STATE UFI: A01409 Main Campus (140A)
AREA: 4,951 SF BUILT: 1990 REMODELED: No PREDOMINANT USE: General Classroom
CONSTRUCTION TYPE: Medium CRV/SF: \$376 REPLACEMENT VALUE: \$1,861,576

Primary Systems			
COMPONENT:	Structure	RATING: 1 x WEIGHT: 9.3 =	SCORE: 9.3
No signs of settlement or cracking, no abrupt vertical changes Columns, bearing walls and roof structure appears sound/free of defects			
COMMENTS:	Wood framing; brick; concrete		
COMPONENT:	Exterior Closure	RATING: 1 x WEIGHT: 9.3 =	SCORE: 9.3
Weatherproof, tight, well-maintained exterior walls, doors, windows/finishes			
COMMENTS:	Brick; Masonite soffits		
COMPONENT:	Roofing	RATING: 2 x WEIGHT: 11.7 =	SCORE: 23.4
Majority of roofing and flashing appear sound, but a small portion of roofing shows deterioration where maintenance or minor repair needed			
COMMENTS:	Hypalon single-ply membrane

Secondary Systems			
COMPONENT:	Floor Finishes	RATING: 3 x WEIGHT: 7 =	SCORE: 21
Some physical wear and minor imperfections are evident; beginning deterioration			
COMMENTS:	Vinyl tile; carpet		
COMPONENT:	Wall Finishes	RATING: 2 x WEIGHT: 7 =	SCORE: 14
Maintainable surfaces, minor maintenance is required in some areas			
COMMENTS:	Gypsum board-marred/dinged		
COMPONENT:	Ceiling Finishes	RATING: 2 x WEIGHT: 7 =	SCORE: 14
Aging surfaces in fair condition and good alignment			
COMMENTS:	Lay-in tile; gypsum board		
COMPONENT:	Doors & Hardware	RATING: 3 x WEIGHT: 7 =	SCORE: 21
Functional, but dated; some maintenance required			
COMMENTS:	Interior wood doors w HM frames-surface wear; exterior HM doors/frames

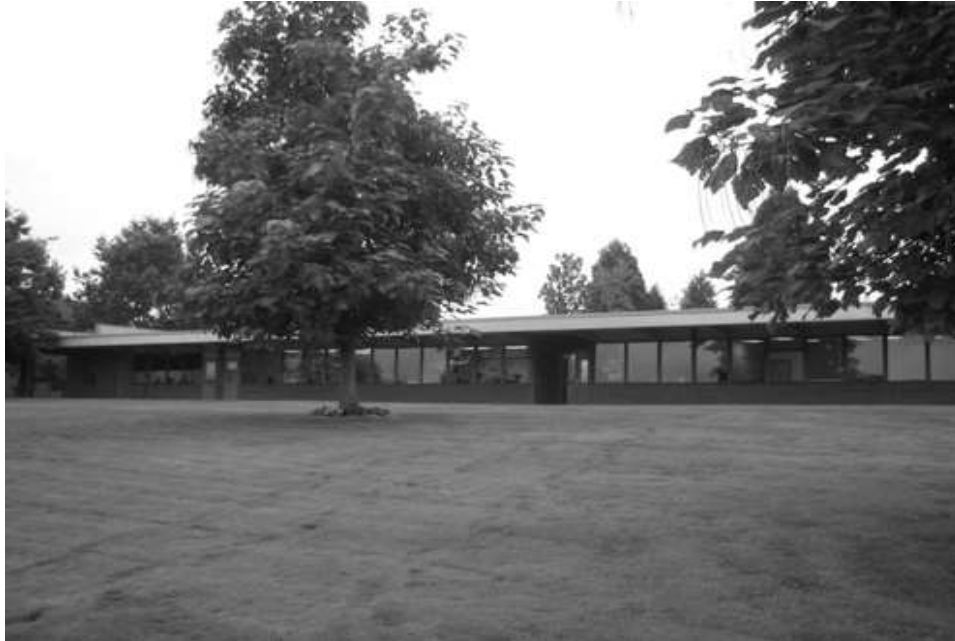
Health Sciences (140-HSC) STATE UFI: A03980 Main Campus (140A)
AREA: 17,195 SF BUILT: 1958 REMODELED: 1996 PREDOMINANT USE: Vocational Arts
CONSTRUCTION TYPE: Medium CRV/SF: \$395 REPLACEMENT VALUE: \$6,792,025

Primary Systems			
COMPONENT:	Structure	RATING: 1 x WEIGHT: 8.3 =	SCORE: 8.3
No signs of settlement or cracking, no abrupt vertical changes Columns, bearing walls and roof structure appears sound/free of defects			
COMMENTS:	Brick; wood framing; concrete		
COMPONENT:	Exterior Closure	RATING: 2 x WEIGHT: 8.3 =	SCORE: 16.7
Weatherproof exterior, but finish appears poorly maintained			
COMMENTS:	Brick; wood soffits		
COMPONENT:	Roofing	RATING: 3 x WEIGHT: 10.4 =	SCORE: 31.3
Some deterioration is evident in membrane and flashings; maintenance or minor repair is needed			
COMMENTS:	Single-ply Hypalon membrane 1994; Some areas need minor repaired; should replace 2017-19

Secondary Systems			
COMPONENT:	Floor Finishes	RATING: 1 x WEIGHT: 6.3 = SCORE: 6.3	
	Nice appearance, smooth transitions, level subfloors, no cracks/separating		
COMMENTS:	Vinyl tile-surface wear; carpet tile-surface wear; ceramic tile; sheet vinyl;; vinyl tile		
COMPONENT:	Wall Finishes	RATING: 1 x WEIGHT: 6.3 = SCORE: 6.3	
	Maintainable surfaces in good condition		
COMMENTS:	Gypsum board-dinged/marred; vinyl wall covering; ceramic tile; brick		
COMPONENT:	Ceiling Finishes	RATING: 1 x WEIGHT: 6.3 = SCORE: 6.3	
	Maintainable surfaces in good condition; good alignment and appearance		
COMMENTS:	Lay-in tile' gypsum board		
COMPONENT:	Doors & Hardware	RATING: 2 x WEIGHT: 6.3 = SCORE: 12.5	
	Fairly modern door surfaces and hardware with minor deterioration; good working order		
COMMENTS:	Interior wood/HM/laminate doors w HM frames-surface wear; exterior aluminum/HM doors/frames

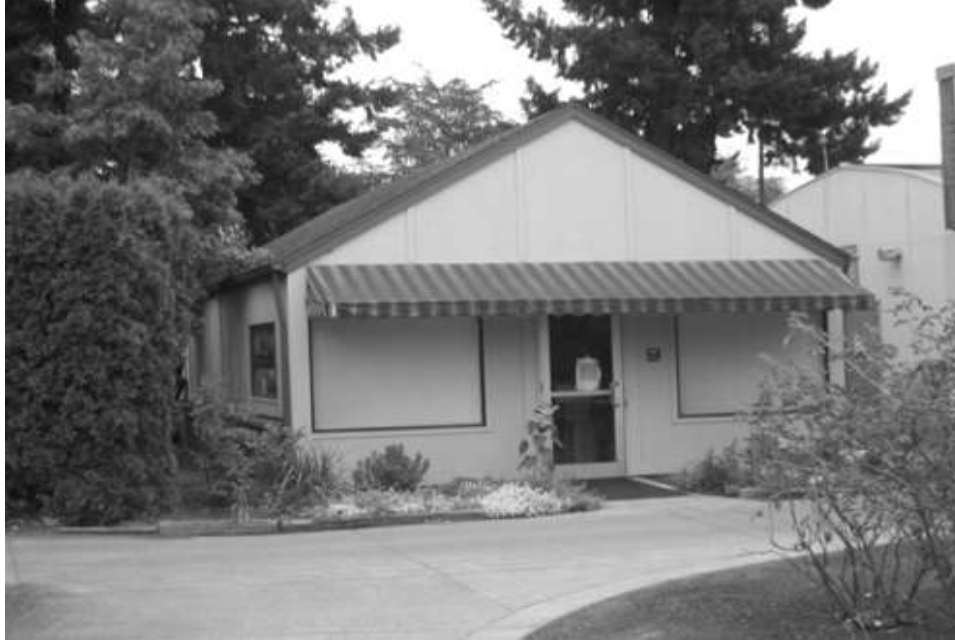
Horticulture Resource Ctr (140-SC4) STATE UFI: A02938 Main Campus (140A)
AREA: 808 SF BUILT: 1987 REMODELED: No PREDOMINANT USE: Classroom
CONSTRUCTION TYPE: Light CRV/SF: \$198 REPLACEMENT VALUE: \$159,984

Primary Systems			
COMPONENT:	Structure	RATING: 1 x WEIGHT: 8.8 =	SCORE: 8.8
No signs of settlement or cracking, no abrupt vertical changes Columns, bearing walls and roof structure appears sound/free of defects			
COMMENTS:	Wood framing; brick		
COMPONENT:	Exterior Closure	RATING: 3 x WEIGHT: 8.8 =	SCORE: 26.5
Sound and weatherproof but with some physical deterioration evident			
COMMENTS:	Brick; plywood panels		
COMPONENT:	Roofing	RATING: 3 x WEIGHT: 11.1 =	SCORE: 33.2
Some deterioration is evident in membrane and flashings; maintenance or minor repair is needed			
COMMENTS:	3 tab asphalt shingles

Secondary Systems			
COMPONENT:	Floor Finishes	RATING: 3 x WEIGHT: 6.6 =	SCORE: 19.9
Some physical wear and minor imperfections are evident; beginning deterioration			
COMMENTS:	Bare concrete-cracks throughout		
COMPONENT:	Wall Finishes	RATING: 1 x WEIGHT: 6.6 =	SCORE: 6.6
Maintainable surfaces in good condition			
COMMENTS:	Painted plywood		
COMPONENT:	Ceiling Finishes	RATING: 2 x WEIGHT: 6.6 =	SCORE: 13.3
Aging surfaces in fair condition and good alignment			
COMMENTS:	Wood strip ceiling		
COMPONENT:	Doors & Hardware	RATING: 3 x WEIGHT: 6.6 =	SCORE: 19.9
Functional, but dated; some maintenance required			
COMMENTS:	Interior/exterior HM doors/frames-surface wear

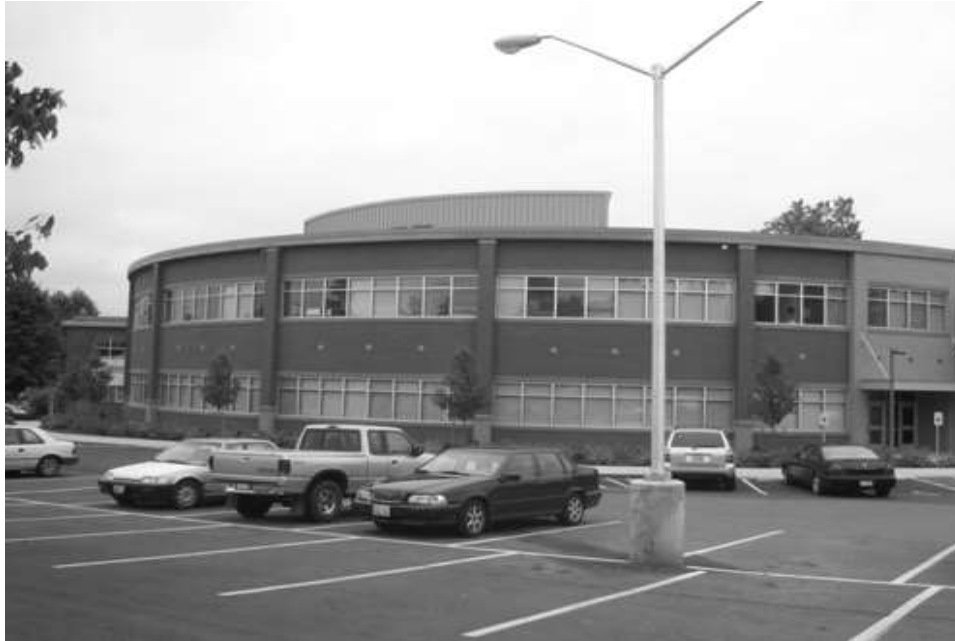
Joan Stout Hall (140-JSH) STATE UFI: A08111 Main Campus (140A)
AREA: 19,943 SF BUILT: 2006 REMODELED: No PREDOMINANT USE: General Classroom
CONSTRUCTION TYPE: Heavy CRV/SF: \$376 REPLACEMENT VALUE: \$7,498,568

Primary Systems			
COMPONENT:	Structure	RATING: 1 x WEIGHT: 8 =	SCORE: 8
No signs of settlement or cracking, no abrupt vertical changes Columns, bearing walls and roof structure appears sound/free of defects			
COMMENTS:	Steel frame; concrete; brick		
COMPONENT:	Exterior Closure	RATING: 1 x WEIGHT: 8 =	SCORE: 8
Weatherproof, tight, well-maintained exterior walls, doors, windows/finishes			
COMMENTS:	Brick; concrete; metal architectural panels		
COMPONENT:	Roofing	RATING: 1 x WEIGHT: 10 =	SCORE: 10
Flashing and penetrations appear sound and membrane appears water- tight; drainage is positive and there are overflow scuppers			
COMMENTS:	Single-ply TPO membrane

Secondary Systems			
COMPONENT:	Floor Finishes	RATING: 3 x WEIGHT: 6 =	SCORE: 18
Some physical wear and minor imperfections are evident; beginning deterioration			
COMMENTS:	Carpet; sheet vinyl-surface wear; vinyl tile; ceramic tile		
COMPONENT:	Wall Finishes	RATING: 1 x WEIGHT: 6 =	SCORE: 6
Maintainable surfaces in good condition			
COMMENTS:	Gypsum board; brick; ceramic tile		
COMPONENT:	Ceiling Finishes	RATING: 1 x WEIGHT: 6 =	SCORE: 6
Maintainable surfaces in good condition; good alignment and appearance			
COMMENTS:	Gypsum board; lay-in tile		
COMPONENT:	Doors & Hardware	RATING: 1 x WEIGHT: 6 =	SCORE: 6
Appropriate hardware, closers, panic devices; in good working order			
COMMENTS:	Interior glazed wood doors w HM frames; sidelites; exterior aluminum doors/frames

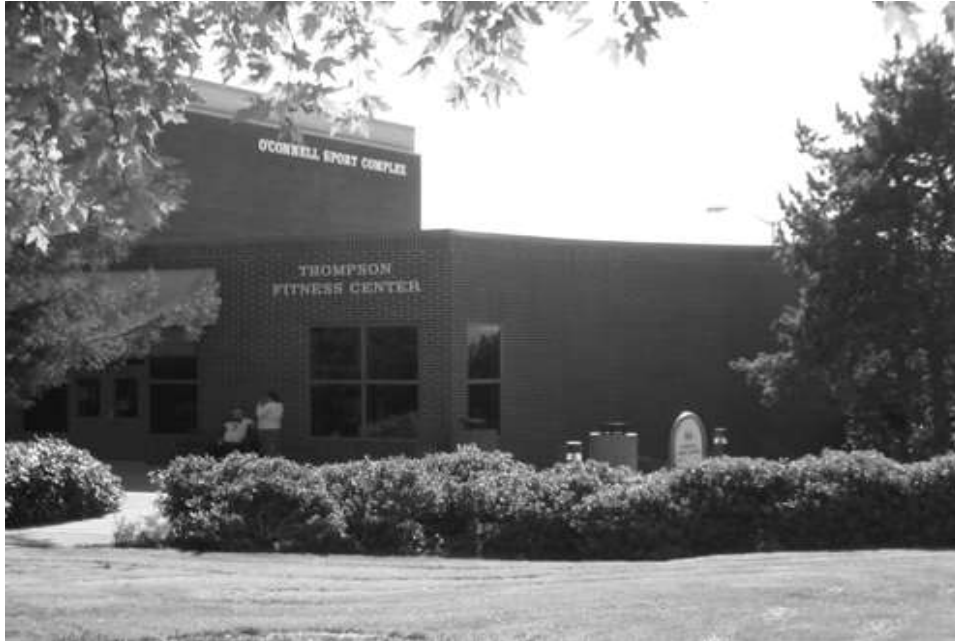
O'Connell Sport Center (140-OSC) STATE UFI: A04234 Main Campus (140A)
 AREA: 46,910 SF BUILT: 1958 REMODELED: 2008 PREDOMINANT USE: Gymnasium
 CONSTRUCTION TYPE: Medium CRV/SF: \$349 REPLACEMENT VALUE: \$16,371,590

Primary Systems			
COMPONENT:	Structure	RATING: 2 x WEIGHT: 8 =	SCORE: 16
Minor cracks evident in a small portion of the structure			
COMMENTS:	Wood frame; concrete; glu-lam beams; steel frame		
COMPONENT:	Exterior Closure	RATING: 1 x WEIGHT: 8 =	SCORE: 8
Weatherproof, tight, well-maintained exterior walls, doors, windows/finishes			
COMMENTS:	Brick; concrete; metal panels		
COMPONENT:	Roofing	RATING: 2 x WEIGHT: 10 =	SCORE: 20
Majority of roofing and flashing appear sound, but a small portion of roofing shows deterioration where maintenance or minor repair needed			
COMMENTS:	Single-ply TPO membrane-2003; single-ply Hypalon on 1993 addition

Secondary Systems			
COMPONENT:	Floor Finishes	RATING: 2 x WEIGHT: 6 = SCORE: 12	
Some wear is evident on finish; maintenance needed			
COMMENTS:	Epoxy floors; concrete; vinyl tile-surface wear; wood; carpet-surface wear; ceramic tile; sheet vinyl		
COMPONENT:	Wall Finishes	RATING: 2 x WEIGHT: 6 = SCORE: 12	
Maintainable surfaces, minor maintenance is required in some areas			
COMMENTS:	Plywood; gypsum board-marred/dinged; ceramic tile		
COMPONENT:	Ceiling Finishes	RATING: 2 x WEIGHT: 6 = SCORE: 12	
Aging surfaces in fair condition and good alignment			
COMMENTS:	Tectum panels; lay-in tile		
COMPONENT:	Doors & Hardware	RATING: 2 x WEIGHT: 6 = SCORE: 12	
Fairly modern door surfaces and hardware with minor deterioration; good working order			
COMMENTS:	Interior wood doors w HM frames-surface wear; exterior aluminum/HM doors/frames

Service Systems			
COMPONENT:	Elevators	RATING: 1 x WEIGHT: 6 = SCORE: 6	
Appropriate and functional for occupancy and use			
COMMENTS:	2 stop		
COMPONENT:	Plumbing	RATING: 3 x WEIGHT: 8 = SCORE: 24	
Fixtures are functional but dated; some leaks; maintenance required			
COMMENTS:	Galvanized, copper, cast iron and steel piping; porcelain fixtures		
COMPONENT:	HVAC	RATING: 2 x WEIGHT: 8 = SCORE: 16	
Equipment in fair condition; minor deterioration; controls require troubleshooting; most areas have A/C; hazardous areas are ventilated			
COMMENTS:	AHU w hot/chilled water coils-2011; convectors; rooftop multizone HVAC units; hot/chilled water from central plant		
COMPONENT:	Electrical	RATING: 3 x WEIGHT: 8 = SCORE: 24	
Service capacity meets current needs but inadequate for future			
COMMENTS:	800amp 208/120v		
COMPONENT:	Lights/Power	RATING: 2 x WEIGHT: 8 = SCORE: 16	
Contemporary lighting with good work area illumination; adequate number of outlets; some finishes appear aged

Safety Systems			
COMPONENT:	Life/Safety	RATING: 2 x WEIGHT: 10 = SCORE: 20	
	Most areas meet current codes; some areas meet codes for prior construction phases		
COMMENTS:			
COMPONENT:	Fire Safety	RATING: 1 x WEIGHT: 10 = SCORE: 10	
	Locally monitored detection; alarm and strobes present; sprinklers in high hazard areas		
COMMENTS:	New fire alarm panel 2017		
COMPONENT:	Modifications	RATING: 1 x WEIGHT: 7 = SCORE: 7	
	Modifications appear to be in compliance with codes and sound construction practices; HVAC/electrical service properly provided		
COMMENTS:	Modifications look well done

Quality Standards			
COMPONENT:	Maintenance	RATING: 1 x WEIGHT: 7 = SCORE: 7	
	Facility appears well maintained		
COMMENTS:			
COMPONENT:	Remaining Life	RATING: 3 x WEIGHT: 6 = SCORE: 18	
	Life expectancy is roughly 10-15 years; moderate system deterioration		
COMMENTS:	1993 remodel and 3,100 GSF addition		
COMPONENT:	Appearance	RATING: 3 x WEIGHT: 6 = SCORE: 18	
	Average construction; average interior and exterior appearance		
COMMENTS:	Exterior is very utilitarian

CONDITION: Needs Improvement/Additional Maintenance

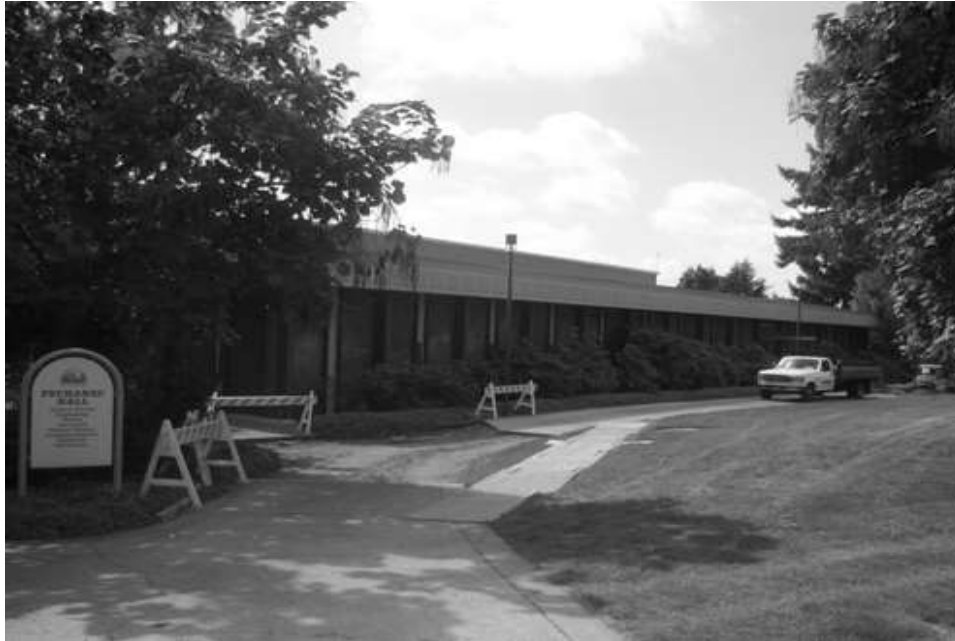
Pechanec Hall (140-APH) STATE UFI: A03068 Main Campus (140A)
 AREA: 26,567 SF BUILT: 1966 REMODELED: No PREDOMINANT USE: General Classroom
 CONSTRUCTION TYPE: Medium CRV/SF: \$376 REPLACEMENT VALUE: \$9,989,192

Primary Systems			
COMPONENT:	Structure	RATING: 1 x WEIGHT: 8 =	SCORE: 8
No signs of settlement or cracking, no abrupt vertical changes Columns, bearing walls and roof structure appears sound/free of defects			
COMMENTS:	Poured concrete frame; brick		
COMPONENT:	Exterior Closure	RATING: 1 x WEIGHT: 8 =	SCORE: 8
Weatherproof, tight, well-maintained exterior walls, doors, windows/finishes			
COMMENTS:	Brick; concrete; new fascia-2004; mortar repairs-2008		
COMPONENT:	Roofing	RATING: 1 x WEIGHT: 10 =	SCORE: 10
Flashing and penetrations appear sound and membrane appears water- tight; drainage is positive and there are overflow scuppers			
COMMENTS:	Single-ply TPO membrane-2002

Secondary Systems			
COMPONENT:	Floor Finishes	RATING: 3 x WEIGHT: 6 = SCORE: 18	
	Some physical wear and minor imperfections are evident; beginning deterioration		
COMMENTS:	Vinyl tile; carpet-surface wear; ceramic tile; epoxy floor; concrete; VAT		
COMPONENT:	Wall Finishes	RATING: 3 x WEIGHT: 6 = SCORE: 18	
	Aging surfaces, but sound; some maintenance is required		
COMMENTS:	Gypsum board; plaster; brick; ceramic tile; CMU; concrete		
COMPONENT:	Ceiling Finishes	RATING: 1 x WEIGHT: 6 = SCORE: 6	
	Maintainable surfaces in good condition; good alignment and appearance		
COMMENTS:	Lay-in tile; direct adhered tile; concrete		
COMPONENT:	Doors & Hardware	RATING: 3 x WEIGHT: 6 = SCORE: 18	
	Functional, but dated; some maintenance required		
COMMENTS:	Interior wood doors/frames-marred/dinged; exterior aluminum doors/frames

Service Systems			
COMPONENT:	Elevators	RATING: 1 x WEIGHT: 6 = SCORE: 6	
	Appropriate and functional for occupancy and use		
COMMENTS:	2 stop		
COMPONENT:	Plumbing	RATING: 3 x WEIGHT: 8 = SCORE: 24	
	Fixtures are functional but dated; some leaks; maintenance required		
COMMENTS:	Copper, cast iron, galvanized, PVC and steel piping; porcelain fixtures		
COMPONENT:	HVAC	RATING: 3 x WEIGHT: 8 = SCORE: 24	
	System generally adequate; some deterioration; needs balancing; some areas have A/C; hazardous areas are ventilated		
COMMENTS:	AHU w hot/chilled water coils and fan powered mixing boxes; hot/chilled water from central plant		
COMPONENT:	Electrical	RATING: 3 x WEIGHT: 8 = SCORE: 24	
	Service capacity meets current needs but inadequate for future		
COMMENTS:	1200amp 120/208v; funded in 03 to replace; not done		
COMPONENT:	Lights/Power	RATING: 3 x WEIGHT: 8 = SCORE: 24	
	Adequate work area illumination; adequate outlets for current use; maintenance required

Safety Systems			
COMPONENT:	Life/Safety	RATING: 3 x WEIGHT: 10 = SCORE: 30	
	Generally meets codes for vintage of construction		
COMMENTS:			
COMPONENT:	Fire Safety	RATING: 1 x WEIGHT: 10 = SCORE: 10	
	Locally monitored detection; alarm and strobes present; sprinklers in high hazard areas		
COMMENTS:			
COMPONENT:	Modifications	RATING: 1 x WEIGHT: 7 = SCORE: 7	
	Modifications appear to be in compliance with codes and sound construction practices; HVAC/electrical service properly provided		
COMMENTS:	None evident

Quality Standards			
COMPONENT:	Maintenance	RATING: 3 x WEIGHT: 7 = SCORE: 21	
	Routine maintenance is required; deferred maintenance is evident; impact is minor to moderate		
COMMENTS:			
COMPONENT:	Remaining Life	RATING: 3 x WEIGHT: 6 = SCORE: 18	
	Life expectancy is roughly 10-15 years; moderate system deterioration		
COMMENTS:			
COMPONENT:	Appearance	RATING: 3 x WEIGHT: 6 = SCORE: 18	
	Average construction; average interior and exterior appearance		
COMMENTS:	Average looking interior and exterior

CONDITION: Needs Improvement/Additional Maintenance

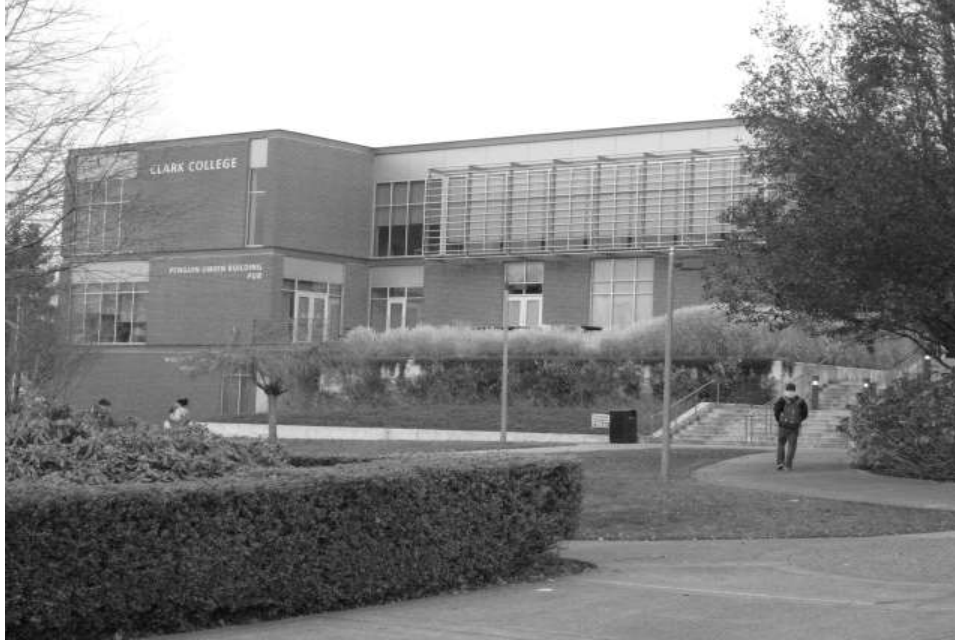
Penguin Union Building (140-PUB) STATE UFI: A06964 Main Campus (140A)
 AREA: 47,048 SF BUILT: 2005 REMODELED: No PREDOMINANT USE: Student Center
 CONSTRUCTION TYPE: Medium CRV/SF: \$391 REPLACEMENT VALUE: \$18,395,768

Primary Systems			
COMPONENT:	Structure	RATING: 1 x WEIGHT: 8 = SCORE: 8	
No signs of settlement or cracking, no abrupt vertical changes Columns, bearing walls and roof structure appears sound/free of defects			
COMMENTS:	Concrete; steel frame; wood frame		
COMPONENT:	Exterior Closure	RATING: 2 x WEIGHT: 8 = SCORE: 16	
Weatherproof exterior, but finish appears poorly maintained			
COMMENTS:	Brick; aluminum window walls; concrete; CMU		
COMPONENT:	Roofing	RATING: 1 x WEIGHT: 10 = SCORE: 10	
Flashing and penetrations appear sound and membrane appears water- tight; drainage is positive and there are overflow scuppers			
COMMENTS:	TPO single-ply membrane-2003 and 2005

Secondary Systems			
COMPONENT:	Floor Finishes	RATING: 2 x WEIGHT: 6 =	SCORE: 12
Some wear is evident on finish; maintenance needed			
COMMENTS:	Carpet; vinyl tile-surface wear; concrete; ceramic tile; laminate flooring		
COMPONENT:	Wall Finishes	RATING: 1 x WEIGHT: 6 =	SCORE: 6
Maintainable surfaces in good condition			
COMMENTS:	Gypsum board; decorative wood strips; concrete; ceramic tile; CMU		
COMPONENT:	Ceiling Finishes	RATING: 1 x WEIGHT: 6 =	SCORE: 6
Maintainable surfaces in good condition; good alignment and appearance			
COMMENTS:	Lay-in tile; wood strips; concrete; direct-adhered tile		
COMPONENT:	Doors & Hardware	RATING: 1 x WEIGHT: 6 =	SCORE: 6
Appropriate hardware, closers, panic devices; in good working order			
COMMENTS:	Interior wood doors w HM frames; exterior aluminum/HM doors/frames

Service Systems			
COMPONENT:	Elevators	RATING: 1 x WEIGHT: 6 =	SCORE: 6
Appropriate and functional for occupancy and use			
COMMENTS:	3-stop		
COMPONENT:	Plumbing	RATING: 1 x WEIGHT: 8 =	SCORE: 8
Fixtures and piping appear to be in good condition; no evidence of leaks			
COMMENTS:	Copper, cast iron and steel piping; porcelain fixtures		
COMPONENT:	HVAC	RATING: 1 x WEIGHT: 8 =	SCORE: 8
Equipment in good condition; easily controlled; serves all required spaces; All necessary spaces are adequately ventilated; A/C provided throughout			
COMMENTS:	AHUs with chilled/hot water coils; VAVs with reheat; hot/chilled water from central plant		
COMPONENT:	Electrical	RATING: 1 x WEIGHT: 8 =	SCORE: 8
Adequate service and distribution capacity for current/future needs			
COMMENTS:	1600amp 208/120v		
COMPONENT:	Lights/Power	RATING: 1 x WEIGHT: 8 =	SCORE: 8
Contemporary lighting with good work area illumination; ample outlets

Safety Systems			
COMPONENT:	Life/Safety	RATING: 1 x WEIGHT: 10 = SCORE: 10	
	Appears to meet current codes		
COMMENTS:			
COMPONENT:	Fire Safety	RATING: 1 x WEIGHT: 10 = SCORE: 10	
	Locally monitored detection; alarm and strobes present; sprinklers in high hazard areas		
COMMENTS:			
COMPONENT:	Modifications	RATING: 1 x WEIGHT: 7 = SCORE: 7	
	Modifications appear to be in compliance with codes and sound construction practices; HVAC/electrical service properly provided		
COMMENTS:	2005 comprehensive renovation of Gaiser Hall-West was well constructed

Quality Standards			
COMPONENT:	Maintenance	RATING: 1 x WEIGHT: 7 = SCORE: 7	
	Facility appears well maintained		
COMMENTS:			
COMPONENT:	Remaining Life	RATING: 1 x WEIGHT: 6 = SCORE: 6	
	Life expectancy is >20 years; minor system deterioration		
COMMENTS:	Includes the west wing of Gaiser Hall, integrated with building in 2005		
COMPONENT:	Appearance	RATING: 1 x WEIGHT: 6 = SCORE: 6	
	Well-constructed building; generally attractive interior and exterior		
COMMENTS:

CONDITION: Adequate

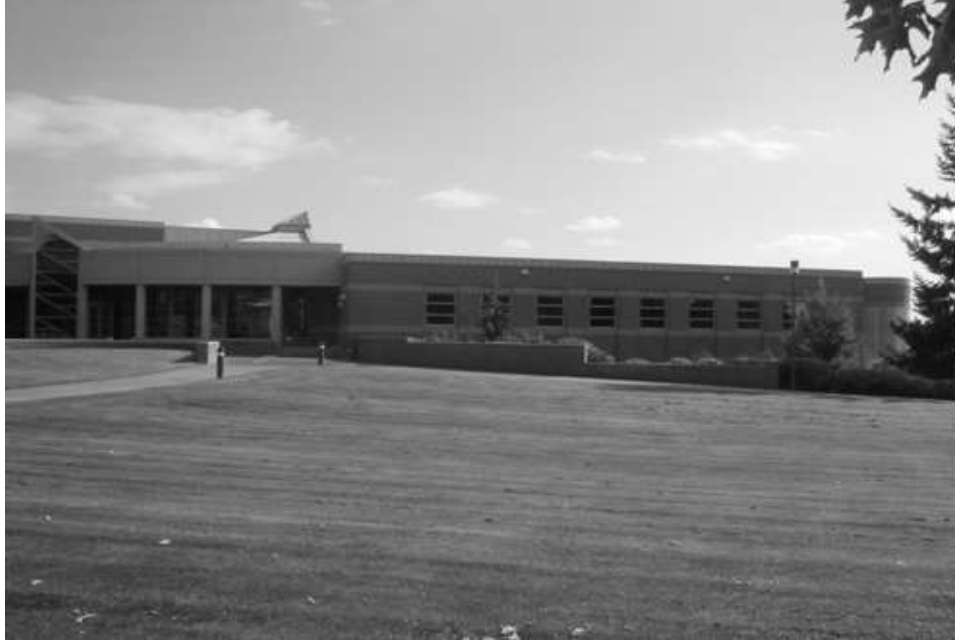
Scarpelli Hall (140-SHL) STATE UFI: A00594 Main Campus (140A)
AREA: 41,192 SF BUILT: 1994 REMODELED: No PREDOMINANT USE: Computer Lab.
CONSTRUCTION TYPE: Heavy CRV/SF: \$376 REPLACEMENT VALUE: \$15,488,192

Primary Systems			
COMPONENT:	Structure	RATING: 1 x WEIGHT: 8.4 =	SCORE: 8.4
No signs of settlement or cracking, no abrupt vertical changes Columns, bearing walls and roof structure appears sound/free of defects			
COMMENTS:	Steel frame; brick; concrete		
COMPONENT:	Exterior Closure	RATING: 1 x WEIGHT: 8.4 =	SCORE: 8.4
Weatherproof, tight, well-maintained exterior walls, doors, windows/finishes			
COMMENTS:	Brick; dryvit fascia; glass block; aluminum window walls		
COMPONENT:	Roofing	RATING: 3 x WEIGHT: 10.5 =	SCORE: 31.5
Some deterioration is evident in membrane and flashings; maintenance or minor repair is needed			
COMMENTS:	Single-ply Hypalon membrane-wear evident; Kalwall skylights

Secondary Systems			
COMPONENT:	Floor Finishes	RATING: 2 x WEIGHT: 6.3 = SCORE: 12.6	
	Some wear is evident on finish; maintenance needed		
COMMENTS:	Sheet vinyl-surface wear; vinyl tile; ceramic tile; concrete; carpet-surface wear		
COMPONENT:	Wall Finishes	RATING: 2 x WEIGHT: 6.3 = SCORE: 12.6	
	Maintainable surfaces, minor maintenance is required in some areas		
COMMENTS:	Ceramic tile; veneer plaster w zolotone surfacing; gypsum board		
COMPONENT:	Ceiling Finishes	RATING: 2 x WEIGHT: 6.3 = SCORE: 12.6	
	Aging surfaces in fair condition and good alignment		
COMMENTS:	Gypsum board; lay-in tile		
COMPONENT:	Doors & Hardware	RATING: 1 x WEIGHT: 6.3 = SCORE: 6.3	
	Appropriate hardware, closers, panic devices; in good working order		
COMMENTS:	Interior wood doors w HM frames; exterior aluminum/HM doors/frames

Service Systems			
COMPONENT:	Elevators	RATING: 2 x WEIGHT: 6.3 = SCORE: 12.6	
	Aged elevators functional, but deterioration or abuse of finishes is evident		
COMMENTS:	3 stop		
COMPONENT:	Plumbing	RATING: 1 x WEIGHT: 8.4 = SCORE: 8.4	
	Fixtures and piping appear to be in good condition; no evidence of leaks		
COMMENTS:	Copper, cast iron and steel piping; porcelain fixtures		
COMPONENT:	HVAC	RATING: 2 x WEIGHT: 8.4 = SCORE: 16.8	
	Equipment in fair condition; minor deterioration; controls require troubleshooting; most areas have A/C; hazardous areas are ventilated		
COMMENTS:	Multi-zone AHUs w hot/chilled water coils; fan-powered VAVs; hot/chilled water from central plant		
COMPONENT:	Electrical	RATING: 1 x WEIGHT: 8.4 = SCORE: 8.4	
	Adequate service and distribution capacity for current/future needs		
COMMENTS:	1200amp 208/120v		
COMPONENT:	Lights/Power	RATING: 2 x WEIGHT: 8.4 = SCORE: 16.8	
	Contemporary lighting with good work area illumination; adequate number of outlets; some finishes appear aged

Safety Systems			
COMPONENT:	Life/Safety	RATING: 1 x WEIGHT: 10.5 =	SCORE: 10.5
Appears to meet current codes			
COMMENTS:			
COMPONENT:	Fire Safety	RATING: 1 x WEIGHT: 10.5 =	SCORE: 10.5
Locally monitored detection; alarm and strobes present; sprinklers in high hazard areas			
COMMENTS:			
COMPONENT:	Modifications	RATING: 0 x WEIGHT: 0 =	SCORE: 0
No data			
COMMENTS: No modifications evident

Quality Standards			
COMPONENT:	Maintenance	RATING: 1 x WEIGHT: 7.4 =	SCORE: 7.4
Facility appears well maintained			
COMMENTS:			
COMPONENT:	Remaining Life	RATING: 1 x WEIGHT: 6.3 =	SCORE: 6.3
Life expectancy is >20 years; minor system deterioration			
COMMENTS:			
COMPONENT:	Appearance	RATING: 1 x WEIGHT: 6.3 =	SCORE: 6.3
Well-constructed building; generally attractive interior and exterior			
COMMENTS:

CONDITION: Adequate

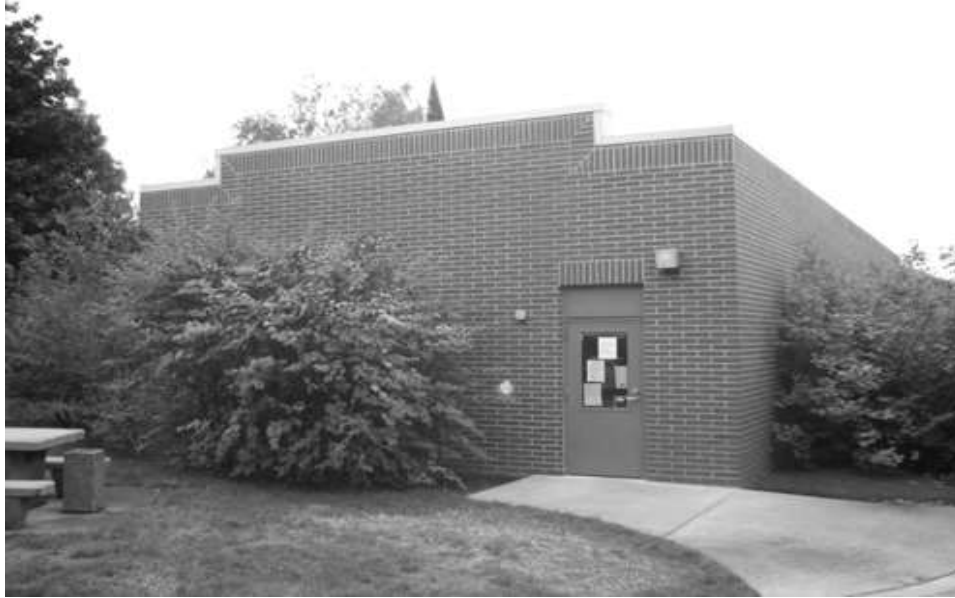
Science Laboratory (140-SC3) STATE UFI: A00803 Main Campus (140A)
AREA: 1,856 SF BUILT: 1994 REMODELED: No PREDOMINANT USE: Classroom
CONSTRUCTION TYPE: No data CRV/SF: \$464 REPLACEMENT VALUE: \$861,184

Primary Systems			
COMPONENT:	Structure	RATING: 1 x WEIGHT: 8.8 = SCORE: 8.8	
No signs of settlement or cracking, no abrupt vertical changes Columns, bearing walls and roof structure appears sound/free of defects			
COMMENTS:	No data		
COMPONENT:	Exterior Closure	RATING: 1 x WEIGHT: 8.8 = SCORE: 8.8	
Weatherproof, tight, well-maintained exterior walls, doors, windows/finishes			
COMMENTS:	No data		
COMPONENT:	Roofing	RATING: 3 x WEIGHT: 11 = SCORE: 32.9	
Some deterioration is evident in membrane and flashings; maintenance or minor repair is needed			
COMMENTS:	No data

Secondary Systems			
COMPONENT:	Floor Finishes	RATING: 1 x WEIGHT: 6.6 =	SCORE: 6.6
	Nice appearance, smooth transitions, level subfloors, no cracks/separating		
COMMENTS:	No data		
COMPONENT:	Wall Finishes	RATING: 1 x WEIGHT: 6.6 =	SCORE: 6.6
	Maintainable surfaces in good condition		
COMMENTS:	No data		
COMPONENT:	Ceiling Finishes	RATING: 1 x WEIGHT: 6.6 =	SCORE: 6.6
	Maintainable surfaces in good condition; good alignment and appearance		
COMMENTS:	No data		
COMPONENT:	Doors & Hardware	RATING: 2 x WEIGHT: 6.6 =	SCORE: 13.2
	Fairly modern door surfaces and hardware with minor deterioration; good working order		
COMMENTS:	No data

Service Systems			
COMPONENT:	Elevators	RATING: 0 x WEIGHT: 0 =	SCORE: 0
	No data		
COMMENTS:	No data		
COMPONENT:	Plumbing	RATING: 1 x WEIGHT: 8.8 =	SCORE: 8.8
	Fixtures and piping appear to be in good condition; no evidence of leaks		
COMMENTS:	No data		
COMPONENT:	HVAC	RATING: 2 x WEIGHT: 8.8 =	SCORE: 17.6
	Equipment in fair condition; minor deterioration; controls require troubleshooting; most areas have A/C; hazardous areas are ventilated		
COMMENTS:	No data		
COMPONENT:	Electrical	RATING: 1 x WEIGHT: 8.8 =	SCORE: 8.8
	Adequate service and distribution capacity for current/future needs		
COMMENTS:	No data		
COMPONENT:	Lights/Power	RATING: 1 x WEIGHT: 8.8 =	SCORE: 8.8
	Contemporary lighting with good work area illumination; ample outlets		
COMMENTS:	No data

Safety Systems			
COMPONENT:	Life/Safety	RATING: 3 x WEIGHT: 11 = SCORE: 32.9	
	Generally meets codes for vintage of construction		
COMMENTS:	No data		
COMPONENT:	Fire Safety	RATING: 2 x WEIGHT: 11 = SCORE: 22	
	Locally monitored detection; alarm present, but missing visual component or sprinklers		
COMMENTS:	No data		
COMPONENT:	Modifications	RATING: 0 x WEIGHT: 0 = SCORE: 0	
	No data		
COMMENTS:	No data

Quality Standards			
COMPONENT:	Maintenance	RATING: 1 x WEIGHT: 7.7 = SCORE: 7.7	
	Facility appears well maintained		
COMMENTS:	No data		
COMPONENT:	Remaining Life	RATING: 1 x WEIGHT: 6.6 = SCORE: 6.6	
	Life expectancy is >20 years; minor system deterioration		
COMMENTS:	No data		
COMPONENT:	Appearance	RATING: 3 x WEIGHT: 6.6 = SCORE: 19.8	
	Average construction; average interior and exterior appearance		
COMMENTS:	No data

CONDITION: Adequate
