2023 FACILITY CONDITION SURVEY

Clark College

SURVEY CONDUCTED BY:
Steve Lewandowski
State Board for Community
and Technical Colleges

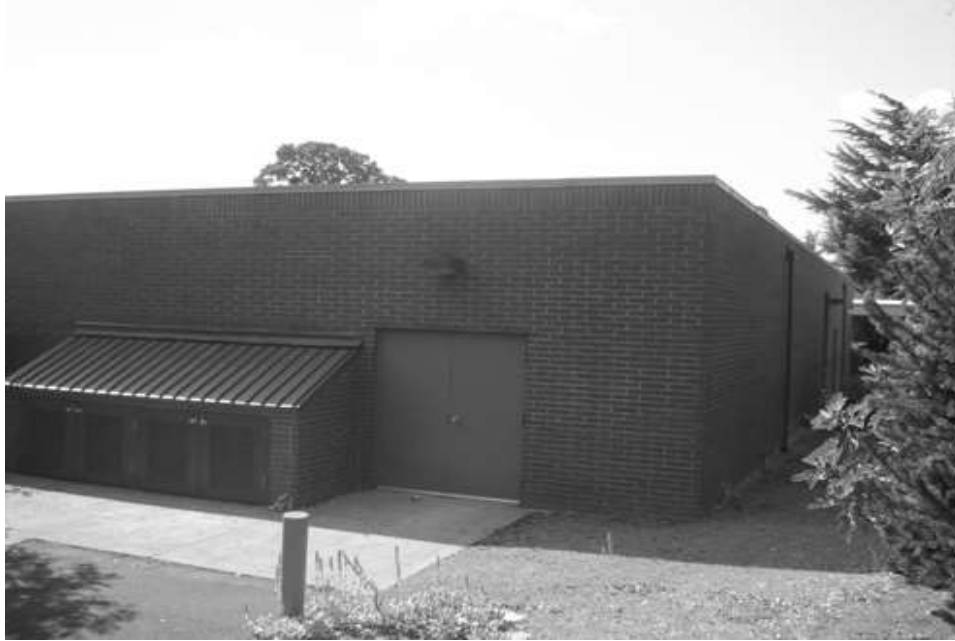
Science Service Center (140-SC2) STATE UFI: A07086 Main Campus (140A)
AREA: 6,282 SF BUILT: 1980 REMODELED: No PREDOMINANT USE: Classroom
CONSTRUCTION TYPE: No data CRV/SF: \$356 REPLACEMENT VALUE: \$2,236,392

Primary Systems			
COMPONENT:	Structure	RATING: 1 x WEIGHT: 8.3 =	SCORE: 8.3
No signs of settlement or cracking, no abrupt vertical changes Columns, bearing walls and roof structure appears sound/free of defects			
COMMENTS:	No data		
COMPONENT:	Exterior Closure	RATING: 2 x WEIGHT: 8.3 =	SCORE: 16.7
Weatherproof exterior, but finish appears poorly maintained			
COMMENTS:	No data		
COMPONENT:	Roofing	RATING: 3 x WEIGHT: 10.4 =	SCORE: 31.3
Some deterioration is evident in membrane and flashings; maintenance or minor repair is needed			
COMMENTS:	No data

Secondary Systems			
COMPONENT:	Floor Finishes	RATING: 2 x WEIGHT: 6.3 =	SCORE: 12.5
Some wear is evident on finish; maintenance needed			
COMMENTS:	No data		
COMPONENT:	Wall Finishes	RATING: 1 x WEIGHT: 6.3 =	SCORE: 6.3
Maintainable surfaces in good condition			
COMMENTS:	No data		
COMPONENT:	Ceiling Finishes	RATING: 2 x WEIGHT: 6.3 =	SCORE: 12.5
Aging surfaces in fair condition and good alignment			
COMMENTS:	No data		
COMPONENT:	Doors & Hardware	RATING: 3 x WEIGHT: 6.3 =	SCORE: 18.8
Functional, but dated; some maintenance required			
COMMENTS:	No data

Service Systems			
COMPONENT:	Elevators	RATING: 0 x WEIGHT: 0 =	SCORE: 0
No data			
COMMENTS:	No data		
COMPONENT:	Plumbing	RATING: 3 x WEIGHT: 8.3 =	SCORE: 25
Fixtures are functional but dated; some leaks; maintenance required			
COMMENTS:	No data		
COMPONENT:	HVAC	RATING: 3 x WEIGHT: 8.3 =	SCORE: 25
System generally adequate; some deterioration; needs balancing; some areas have A/C; hazardous areas are ventilated			
COMMENTS:	No data		
COMPONENT:	Electrical	RATING: 1 x WEIGHT: 8.3 =	SCORE: 8.3
Adequate service and distribution capacity for current/future needs			
COMMENTS:	No data		
COMPONENT:	Lights/Power	RATING: 3 x WEIGHT: 8.3 =	SCORE: 25
Adequate work area illumination; adequate outlets for current use; maintenance required			
COMMENTS:	No data

Quality Standards			
COMPONENT:	Maintenance	RATING: 3 x WEIGHT: 7.3 =	SCORE: 21.9
Routine maintenance is required; deferred maintenance is evident; impact is minor to moderate			
COMMENTS:	No data		
COMPONENT:	Remaining Life	RATING: 3 x WEIGHT: 6.3 =	SCORE: 18.8
Life expectancy is roughly 10-15 years; moderate system deterioration			
COMMENTS:	No data		
COMPONENT:	Appearance	RATING: 3 x WEIGHT: 6.3 =	SCORE: 18.8
Average construction; average interior and exterior appearance			
COMMENTS:	No data
