2023 FACILITY CONDITION SURVEY

Columbia Basin College

SURVEY CONDUCTED BY:
Steve Lewandowski
State Board for Community
and Technical Colleges

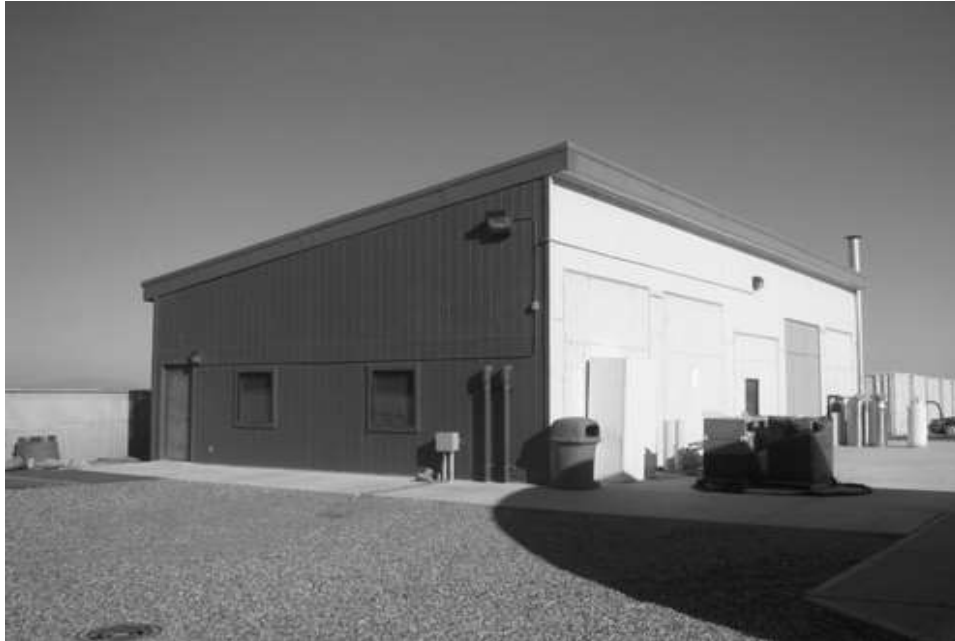
Maintenance Annex (190-00MA) STATE UF: A08655 Main Campus (190A)
AREA: 1,971 SF BUILT: 1994 REMODELED: No PREDOMINANT USE: Maintenance
CONSTRUCTION TYPE: Light CRV/SF: \$231 REPLACEMENT VALUE: \$455,301

| Primary Systems | | | |
|--|---|---|---|
| Some cracking evident but does not likely affect structural integrity; Visible defects apparent but are non-structural | | | |
| COMMENTS: | T1-11 repaired and painted in 2002 | | |

| Secondary Systems | | | |
|---|--|---|---|
| Some physical wear and minor imperfections are evident; beginning deterioration | | | |

| Service Systems | | | |
|---|--|---|---|
| Equipment in fair condition; minor deterioration; controls require troubleshooting; most areas have A/C; hazardous areas are ventilated | | | |

| Quality Standards | | | |
|---|---|---|---|
| Life expectancy is roughly 10-15 years; moderate system deterioration | | | |

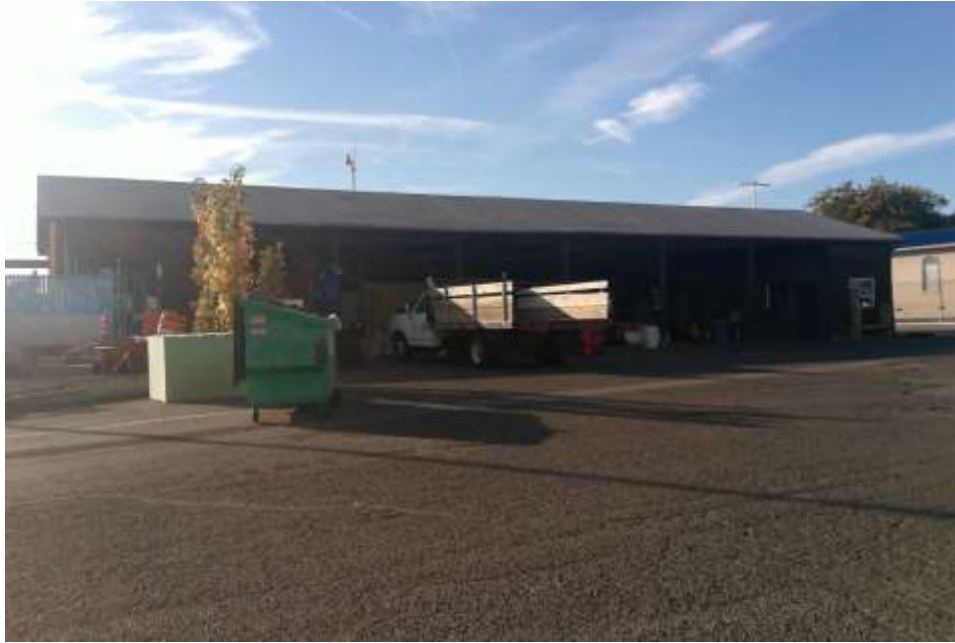
Maintenance Bldg M-1 (190-COXN) STATE UFI: A10623 Main Campus (190A)
AREA: 1,944 SF BUILT: 2000 REMODELED: No PREDOMINANT USE: Maintenance
CONSTRUCTION TYPE: No data CRV/SF: \$244 REPLACEMENT VALUE: \$474,336

| Primary Systems | | | |
|--|---|---|---|
| Visible settlement and potential structural failure; potential safety hazard Structural defects apparent in superstructure | | | |
| General deterioration detected, one or more minor leaks apparent | | | |
| Some deterioration is evident in membrane and flashings; maintenance or minor repair is needed | | | |

| Secondary Systems | | | |
|--|---|---|---|
| Inoperable, deteriorating and outdated; non-secure | | | |

| Service Systems | | | |
|---|---|---|---|
| Fixtures are functional but dated; some leaks; maintenance required | | | |

| Safety Systems | | | |
|---|---|---|--|
| | Life safety or accessibility violations exist; Missing exit signs or extinguishers throughout; No alarm or sprinklers | | |

| Quality Standards | | | |
|---|---|---|--|
| | General deterioration is evident; lack of adequate maintenance is evident; impact is moderate to severe | | |
| | Life expectancy is <5 years; significant system deterioration | | |

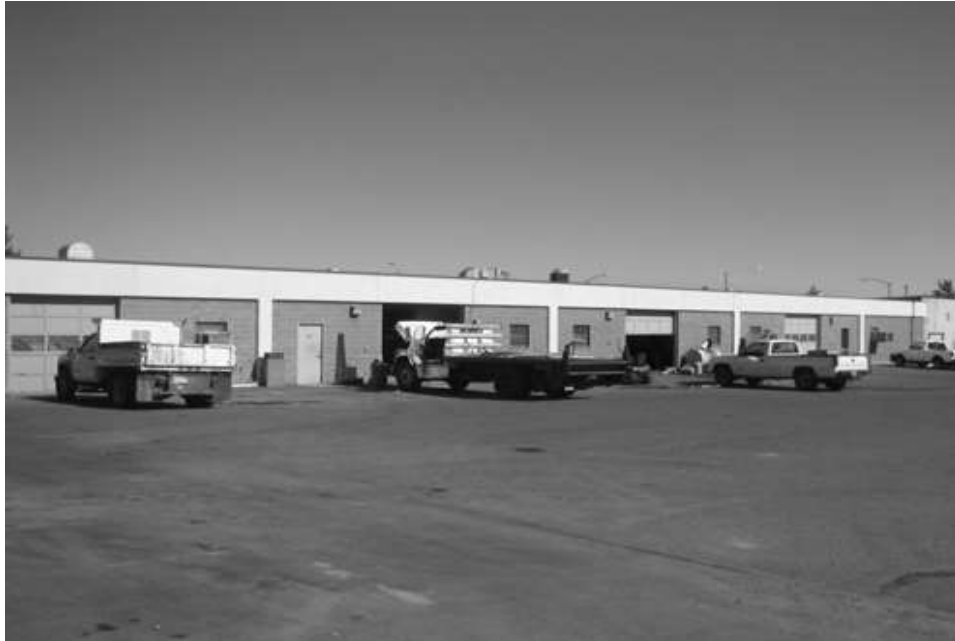
Maintenance Building (190-00M) STATE UFI: A09109 Main Campus (190A)
AREA: 7,233 SF BUILT: 1972 REMODELED: No PREDOMINANT USE: Maintenance
CONSTRUCTION TYPE: Medium CRV/SF: \$349 REPLACEMENT VALUE: \$2,524,317

| Primary Systems | | | |
|--|--|---|---|
| COMMENTS: | Built-up roof; deteriorated; needs replacement; funded in 2011; skylight | | |

| Secondary Systems | | | |
|--|---|---|---|
| COMMENTS: | Interior/exterior HM doors/frames; wood OH doors-some deteriorating | | |

| Service Systems | | | |
|--|--|---|---|
| Inadequate capacity, zoning and distribution; equipment deteriorating; areas with A/C extremely limited; no ventilation in hazardous areas | | | |
| COMMENTS: | Rooftop packaged unit-needs replacement; funded in 2011; electric unit heaters | | |

| Safety Systems | | | |
|---|---|--|--|
| Life safety or accessibility violations exist; Missing exit signs or extinguishers throughout; No alarm or sprinklers | | | |

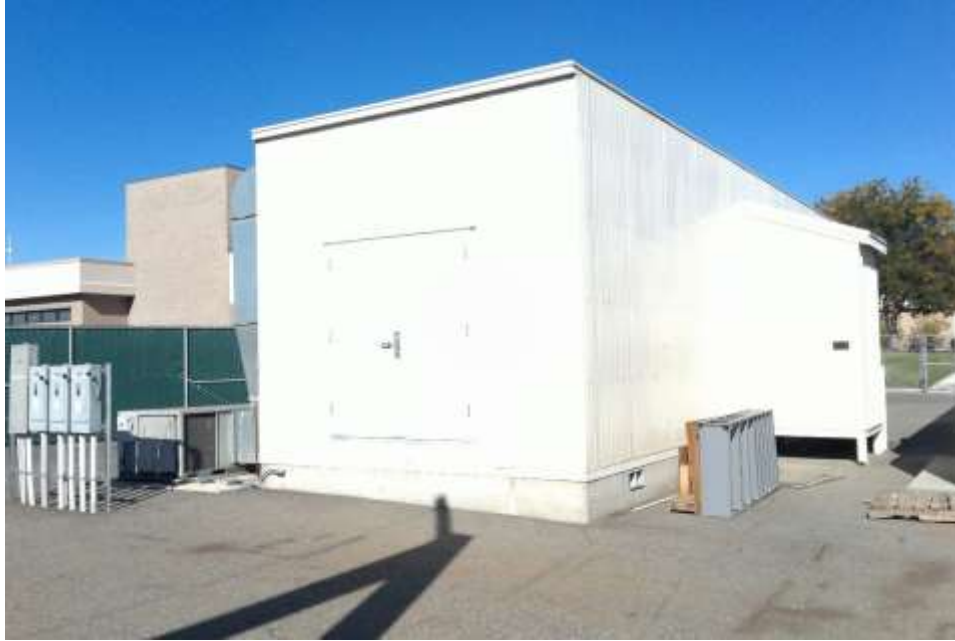
Microscope Modular (190-0M1) STATE UFI: A03501 Main Campus (190A)
AREA: 840 SF BUILT: 1998 REMODELED: No PREDOMINANT USE: Science Lab.
CONSTRUCTION TYPE: Temporary CRV/SF: \$231 REPLACEMENT VALUE: \$194,040

| Primary Systems | | | |
|--|---|---|---|
| Some cracking evident but does not likely affect structural integrity; Visible defects apparent but are non-structural | | | |
| Some deterioration is evident in membrane and flashings; maintenance or minor repair is needed | | | |

| Secondary Systems | | | |
|---|---|---|--|
| | Deteriorated, significant number of stained or sagging areas; inappropriate for occupancy | | |
| | Inoperable, deteriorating and outdated; non-secure | | |

| Service Systems | | | |
|---|---|---|--|
| | Elevators provided but functionality is inadequate; Unreliable operation | | |

| Safety Systems | | | |
|---|---|---|--|
| Life safety or accessibility violations exist; Missing exit signs or extinguishers throughout; No alarm or sprinklers | | | |

| Quality Standards | | | |
|---|---|---|--|
| General deterioration is evident; lack of adequate maintenance is evident; impact is moderate to severe | | | |
| Life expectancy is <5 years; significant system deterioration | | | |

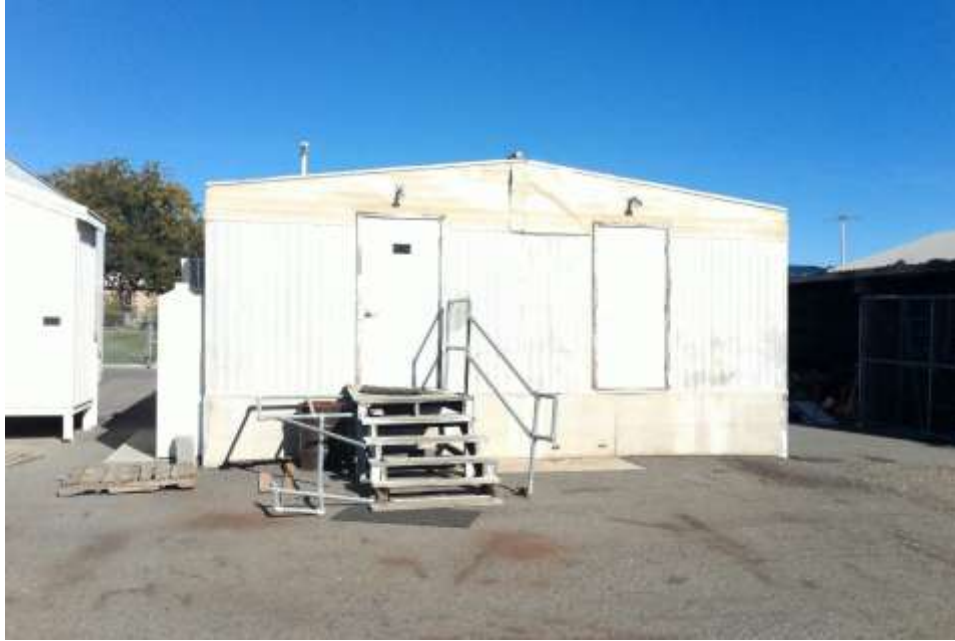
Modular Classroom (190-0M2) STATE UFI: A06803 Main Campus (190A)
AREA: 1,200 SF BUILT: 1998 REMODELED: No PREDOMINANT USE: General Classroom
CONSTRUCTION TYPE: Temporary CRV/SF: \$231 REPLACEMENT VALUE: \$277,200

| Primary Systems | | | |
|--|--|--|--|
| Visible settlement and potential structural failure; potential safety hazard Structural defects apparent in superstructure | | | |
| COMMENTS: | Metal frame; cement board; Wood columns rotted at foundation | | |
| Significant deterioration, leaking and air infiltration apparent | | | |
| Some deterioration is evident in membrane and flashings; maintenance or minor repair is needed | | | |
