2023 FACILITY CONDITION SURVEY

Edmonds Community College

SURVEY CONDUCTED BY:
Steve Lewandowski
State Board for Community
and Technical Colleges

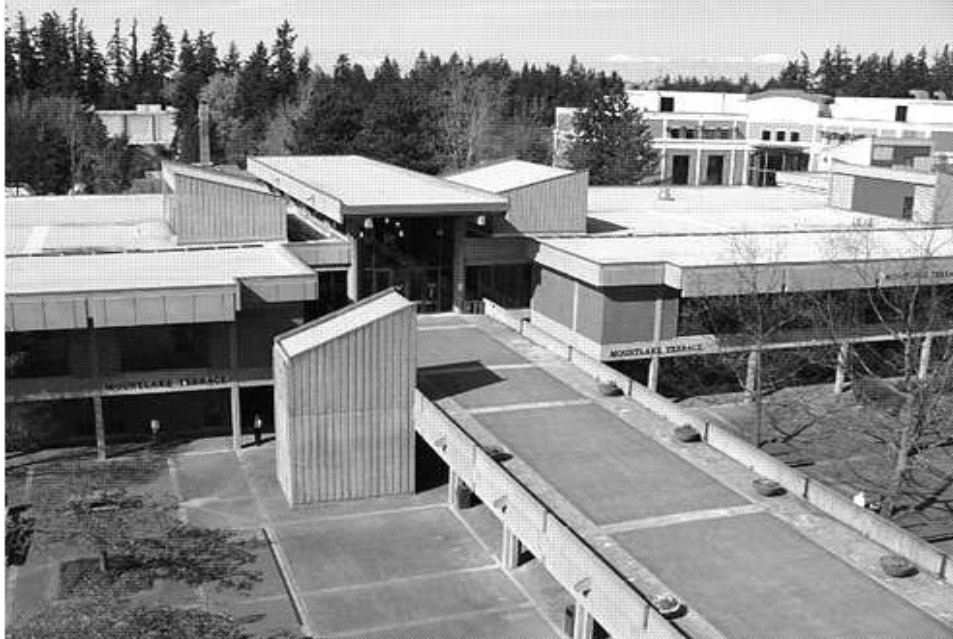
Mountlake Terrace Hall (230-MLT) STATE UFI: A09413 Main Campus (230A)
 AREA: 60,401 SF BUILT: 1970 REMODELED: 2006 PREDOMINANT USE: General Classroom
 CONSTRUCTION TYPE: Heavy CRV/SF: \$395 REPLACEMENT VALUE: \$23,858,395

Primary Systems			
COMPONENT:	Structure	RATING: 1 x WEIGHT: 8 =	SCORE: 8
No signs of settlement or cracking, no abrupt vertical changes Columns, bearing walls and roof structure appears sound/free of defects			
COMMENTS:	concrete; steel		
COMPONENT:	Exterior Closure	RATING: 2 x WEIGHT: 8 =	SCORE: 16
Weatherproof exterior, but finish appears poorly maintained			
COMMENTS:	Brick; pre-cast concrete fascia		
COMPONENT:	Roofing	RATING: 1 x WEIGHT: 10 =	SCORE: 10
Flashing and penetrations appear sound and membrane appears water- tight; drainage is positive and there are overflow scuppers			
COMMENTS:	Built-up roofing

Secondary Systems			
COMPONENT:	Floor Finishes	RATING: 2 x WEIGHT: 6 =	SCORE: 12
Some wear is evident on finish; maintenance needed			
COMMENTS:	Brick; vinyl tile; ceramic tile; concrete; carpet		
COMPONENT:	Wall Finishes	RATING: 3 x WEIGHT: 6 =	SCORE: 18
Aging surfaces, but sound; some maintenance is required			
COMMENTS:	Concrete, gypsum board; wood panels; ceramic tile		
COMPONENT:	Ceiling Finishes	RATING: 1 x WEIGHT: 6 =	SCORE: 6
Maintainable surfaces in good condition; good alignment and appearance			
COMMENTS:	Exposed concrete structure; lay-in tile; gypsum board		
COMPONENT:	Doors & Hardware	RATING: 2 x WEIGHT: 6 =	SCORE: 12
Fairly modern door surfaces and hardware with minor deterioration; good working order			
COMMENTS:	Interior wood doors w HM frames-some sidelites; exterior aluminum doors/frames

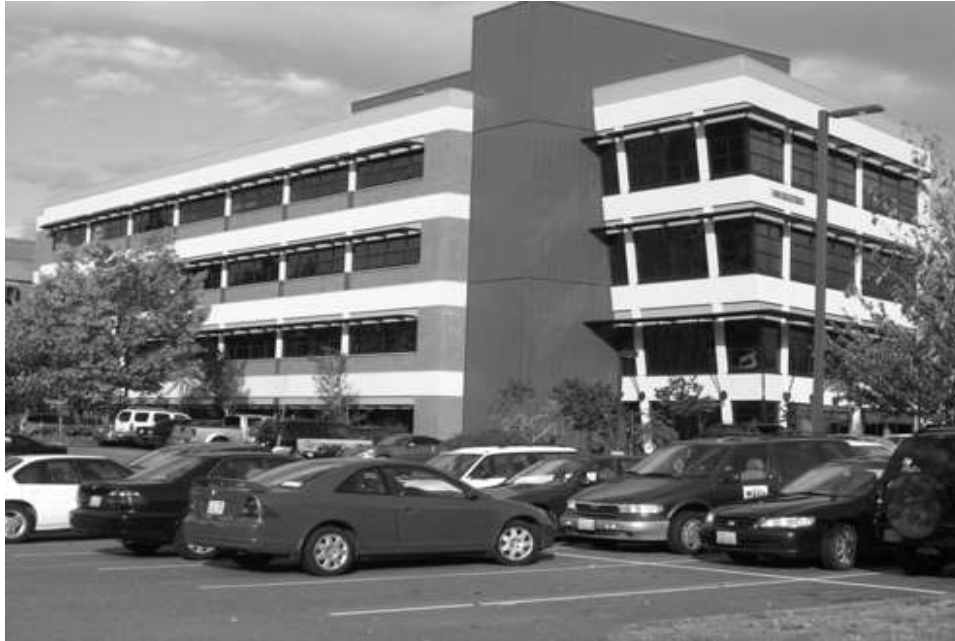
Mukilteo Hall (230-MUK) STATE UFI: A06234 Main Campus (230A)
AREA: 67,279 SF BUILT: 2003 REMODELED: No PREDOMINANT USE: General Classroom
CONSTRUCTION TYPE: Heavy CRV/SF: \$376 REPLACEMENT VALUE: \$25,296,904

Primary Systems			
COMPONENT:	Structure	RATING: 1 x WEIGHT: 8.4 = SCORE: 8.4	
No signs of settlement or cracking, no abrupt vertical changes Columns, bearing walls and roof structure appears sound/free of defects			
COMMENTS:	Steel frame		
COMPONENT:	Exterior Closure	RATING: 1 x WEIGHT: 8.4 = SCORE: 8.4	
Weatherproof, tight, well-maintained exterior walls, doors, windows/finishes			
COMMENTS:	Brick; plaster panels; metal panels; aluminum window walls		
COMPONENT:	Roofing	RATING: 2 x WEIGHT: 10.5 = SCORE: 21	
Majority of roofing and flashing appear sound, but a small portion of roofing shows deterioration where maintenance or minor repair needed			
COMMENTS:	BUR w mineral surfaced cap sheet

Secondary Systems			
COMPONENT:	Floor Finishes	RATING: 2 x WEIGHT: 6.3 = SCORE: 12.6	
	Some wear is evident on finish; maintenance needed		
COMMENTS:	Carpet; ceramic tile; vinyl tile; concrete; plywood in theater		
COMPONENT:	Wall Finishes	RATING: 2 x WEIGHT: 6.3 = SCORE: 12.6	
	Maintainable surfaces, minor maintenance is required in some areas		
COMMENTS:	Gypsum board; ceramic tile; wood panels		
COMPONENT:	Ceiling Finishes	RATING: 1 x WEIGHT: 6.3 = SCORE: 6.3	
	Maintainable surfaces in good condition; good alignment and appearance		
COMMENTS:	Lay-in tiles; exposed roof deck pan		
COMPONENT:	Doors & Hardware	RATING: 1 x WEIGHT: 6.3 = SCORE: 6.3	
	Appropriate hardware, closers, panic devices; in good working order		
COMMENTS:	Interior wood doors w HM frames-some glazed insets and side lites; interior HM doors/frames; exterior aluminum doors/frames; coiling doors

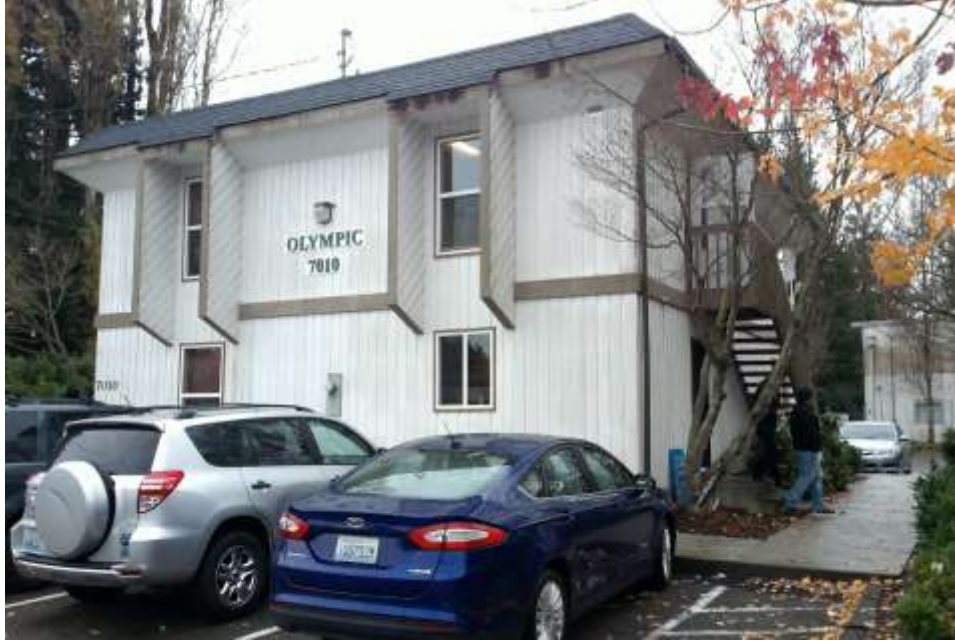
Olympic Building (230-OLY) STATE UFI: A10597 Main Campus (230A)
AREA: 2,565 SF BUILT: 1976 REMODELED: No PREDOMINANT USE: Vacant
CONSTRUCTION TYPE: No data CRV/SF: \$306 REPLACEMENT VALUE: \$784,890

Primary Systems			
COMPONENT:	Structure	RATING: 2 x WEIGHT: 8 =	SCORE: 16
Minor cracks evident in a small portion of the structure			
COMMENTS:	No data		
COMPONENT:	Exterior Closure	RATING: 1 x WEIGHT: 8 =	SCORE: 8
Weatherproof, tight, well-maintained exterior walls, doors, windows/finishes			
COMMENTS:	No data		
COMPONENT:	Roofing	RATING: 3 x WEIGHT: 10 =	SCORE: 30
Some deterioration is evident in membrane and flashings; maintenance or minor repair is needed			
COMMENTS:	No data

Secondary Systems			
COMPONENT:	Floor Finishes	RATING: 3 x WEIGHT: 6 = SCORE: 18	
	Some physical wear and minor imperfections are evident; beginning deterioration		
COMMENTS:	No data		
COMPONENT:	Wall Finishes	RATING: 2 x WEIGHT: 6 = SCORE: 12	
	Maintainable surfaces, minor maintenance is required in some areas		
COMMENTS:	No data		
COMPONENT:	Ceiling Finishes	RATING: 1 x WEIGHT: 6 = SCORE: 6	
	Maintainable surfaces in good condition; good alignment and appearance		
COMMENTS:	No data		
COMPONENT:	Doors & Hardware	RATING: 3 x WEIGHT: 6 = SCORE: 18	
	Functional, but dated; some maintenance required		
COMMENTS:	No data

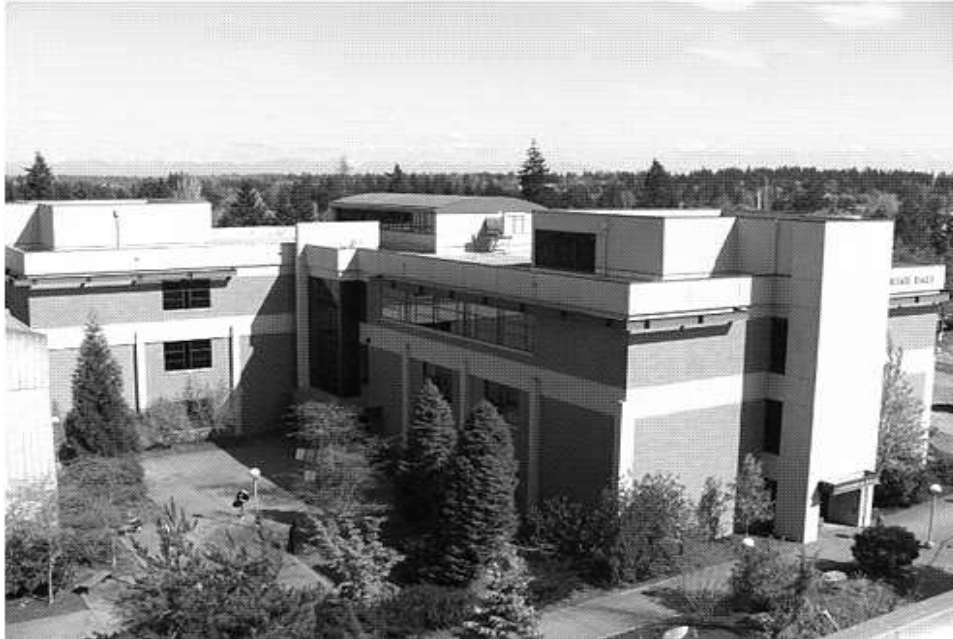
Snohomish Hall (230-SNH) STATE UFI: A05555 Main Campus (230A)
 AREA: 50,400 SF BUILT: 1996 REMODELED: No PREDOMINANT USE: Computer Lab.
 CONSTRUCTION TYPE: Heavy CRV/SF: \$395 REPLACEMENT VALUE: \$19,908,000

Primary Systems			
COMPONENT:	Structure	RATING: 1 x WEIGHT: 8 =	SCORE: 8
No signs of settlement or cracking, no abrupt vertical changes Columns, bearing walls and roof structure appears sound/free of defects			
COMMENTS:	Concrete and steel frame; CMU		
COMPONENT:	Exterior Closure	RATING: 1 x WEIGHT: 8 =	SCORE: 8
Weatherproof, tight, well-maintained exterior walls, doors, windows/finishes			
COMMENTS:	Concrete frame w/ brick infill; stucco		
COMPONENT:	Roofing	RATING: 1 x WEIGHT: 10 =	SCORE: 10
Flashing and penetrations appear sound and membrane appears water- tight; drainage is positive and there are overflow scuppers			
COMMENTS:	Single-ply 2014. standing seam metal at atrium

Secondary Systems			
COMPONENT:	Floor Finishes	RATING: 2 x WEIGHT: 6 =	SCORE: 12
Some wear is evident on finish; maintenance needed			
COMMENTS:	Ceramic tile, linoleum; carpet; vinyl tile		
COMPONENT:	Wall Finishes	RATING: 2 x WEIGHT: 6 =	SCORE: 12
Maintainable surfaces, minor maintenance is required in some areas			
COMMENTS:	Gypsum board; wood accents; concrete; ceramic tile; moveable partition walls		
COMPONENT:	Ceiling Finishes	RATING: 1 x WEIGHT: 6 =	SCORE: 6
Maintainable surfaces in good condition; good alignment and appearance			
COMMENTS:	Lay-in tile; gypsum board; metal deck pan; ceiling steel trusses, glu-lam beams		
COMPONENT:	Doors & Hardware	RATING: 2 x WEIGHT: 6 =	SCORE: 12
Fairly modern door surfaces and hardware with minor deterioration; good working order			
COMMENTS:	Interior wood doors w HM frames-frame finishes badly worn; exterior aluminum sliding doors/frames

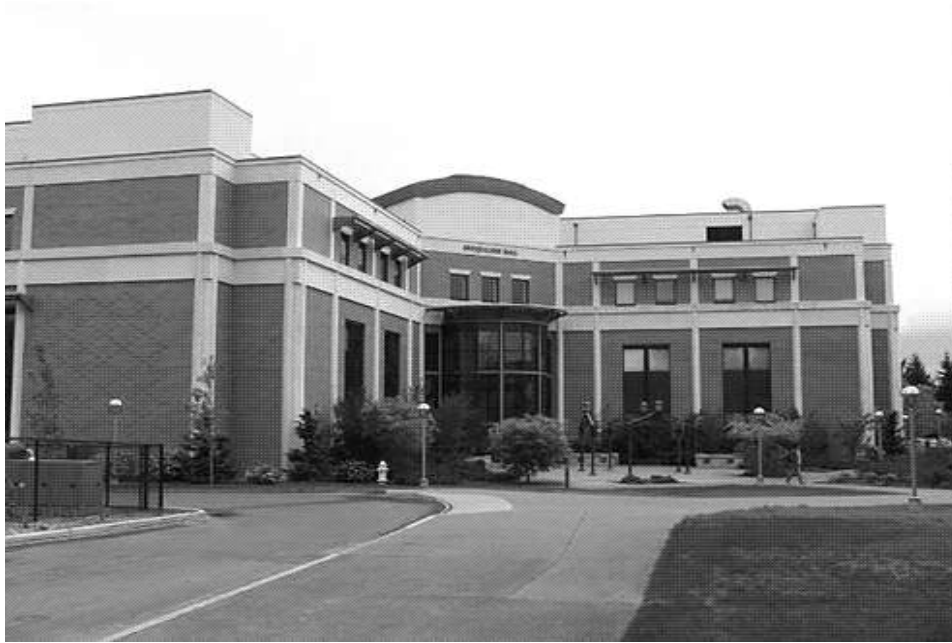
Snoqualmie Hall (230-SQL) STATE UFI: A08635 Main Campus (230A)
AREA: 50,538 SF BUILT: 2002 REMODELED: No PREDOMINANT USE: Multi-Use
CONSTRUCTION TYPE: Heavy CRV/SF: \$395 REPLACEMENT VALUE: \$19,962,510

Primary Systems			
COMPONENT:	Structure	RATING: 1 x WEIGHT: 8 =	SCORE: 8
No signs of settlement or cracking, no abrupt vertical changes Columns, bearing walls and roof structure appears sound/free of defects			
COMMENTS:	Concrete; structural steel; steel entry atrium structure		
COMPONENT:	Exterior Closure	RATING: 1 x WEIGHT: 8 =	SCORE: 8
Weatherproof, tight, well-maintained exterior walls, doors, windows/finishes			
COMMENTS:	Brick panels; pre-cast concrete elements; aluminum window walls; stucco		
COMPONENT:	Roofing	RATING: 2 x WEIGHT: 10 =	SCORE: 20
Majority of roofing and flashing appear sound, but a small portion of roofing shows deterioration where maintenance or minor repair needed			
COMMENTS:	BUR mineral-surfaced cap sheet; standing seam metal; Kalwall skylight

Secondary Systems			
COMPONENT:	Floor Finishes	RATING: 1 x WEIGHT: 6 = SCORE: 6	
	Nice appearance, smooth transitions, level subfloors, no cracks/separating		
COMMENTS:	Carpet; ceramic tile		
COMPONENT:	Wall Finishes	RATING: 3 x WEIGHT: 6 = SCORE: 18	
	Aging surfaces, but sound; some maintenance is required		
COMMENTS:	Gypsum board; ceramic tile		
COMPONENT:	Ceiling Finishes	RATING: 1 x WEIGHT: 6 = SCORE: 6	
	Maintainable surfaces in good condition; good alignment and appearance		
COMMENTS:	Lay-in tiles; gypsum board; meal deck pan		
COMPONENT:	Doors & Hardware	RATING: 1 x WEIGHT: 6 = SCORE: 6	
	Appropriate hardware, closers, panic devices; in good working order		
COMMENTS:	Interior wood doors w HM frames; exterior aluminum doors/frames and HM doors/frames

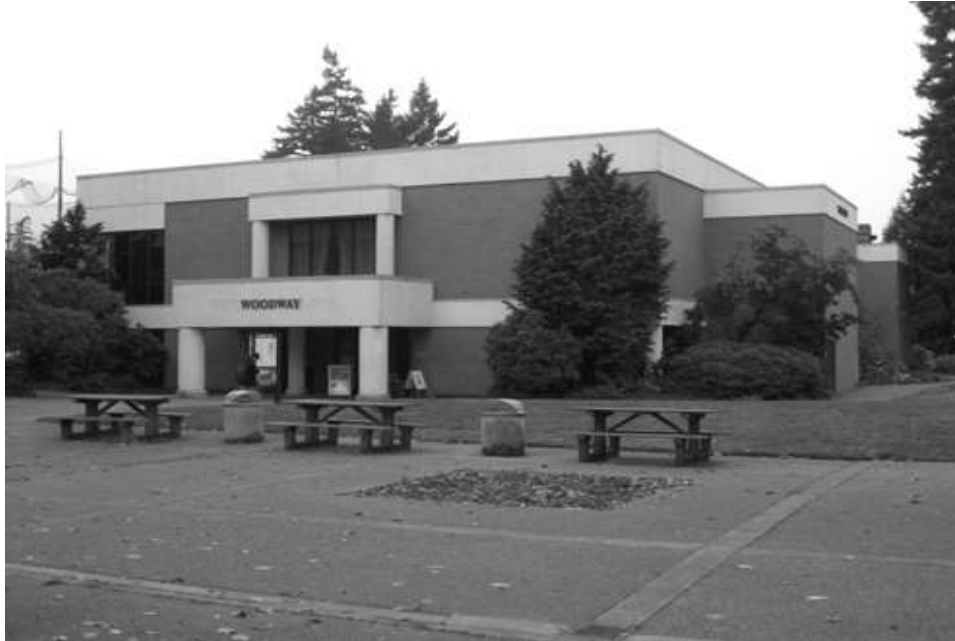
Woodway Hall (230-WWY) STATE UFI: A01301 Main Campus (230A)
AREA: 25,782 SF BUILT: 0 REMODELED: No PREDOMINANT USE: Student Center
CONSTRUCTION TYPE: Heavy CRV/SF: \$391 REPLACEMENT VALUE: \$10,080,762

Primary Systems			
COMPONENT:	Structure	RATING: 1 x WEIGHT: 8 =	SCORE: 8
No signs of settlement or cracking, no abrupt vertical changes Columns, bearing walls and roof structure appears sound/free of defects			
COMMENTS:	Structural steel frame		
COMPONENT:	Exterior Closure	RATING: 1 x WEIGHT: 8 =	SCORE: 8
Weatherproof, tight, well-maintained exterior walls, doors, windows/finishes			
COMMENTS:	Brick; stucco lower and fascia panels; aluminum window walls		
COMPONENT:	Roofing	RATING: 1 x WEIGHT: 10 =	SCORE: 10
Flashing and penetrations appear sound and membrane appears water- tight; drainage is positive and there are overflow scuppers			
COMMENTS:	EPDM membrane; repairs and reconditioning funded 21-23

Secondary Systems			
COMPONENT:	Floor Finishes	RATING: 2 x WEIGHT: 6 =	SCORE: 12
Some wear is evident on finish; maintenance needed			
COMMENTS:	Ceramic tile; carpet; concrete; ceramic tile; carpet		
COMPONENT:	Wall Finishes	RATING: 1 x WEIGHT: 6 =	SCORE: 6
Maintainable surfaces in good condition			
COMMENTS:	Gypsum board; brick-leak at southeast wall above windows		
COMPONENT:	Ceiling Finishes	RATING: 2 x WEIGHT: 6 =	SCORE: 12
Aging surfaces in fair condition and good alignment			
COMMENTS:	Lay-in tile; gypsum board		
COMPONENT:	Doors & Hardware	RATING: 3 x WEIGHT: 6 =	SCORE: 18
Functional, but dated; some maintenance required			
COMMENTS:	Interior wood doors w HM frames; exterior aluminum doors/frames-random wear

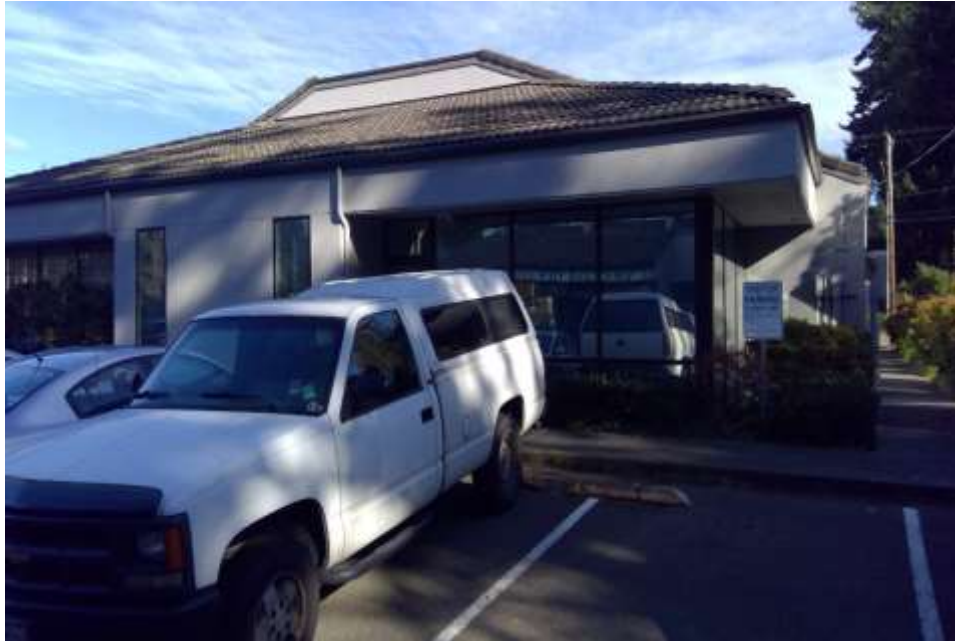
Maltby (230-MAB) STATE UFI: A07024 Main Campus (230A)
 AREA: 8,046 SF BUILT: 1992 REMODELED: No PREDOMINANT USE: Student Support
 CONSTRUCTION TYPE: Light CRV/SF: \$231 REPLACEMENT VALUE: \$1,858,626

Primary Systems			
COMPONENT:	Structure	RATING: 1 x WEIGHT: 8.3 =	SCORE: 8.3
No signs of settlement or cracking, no abrupt vertical changes Columns, bearing walls and roof structure appears sound/free of defects			
COMMENTS:	Wood frame and roof trusses		
COMPONENT:	Exterior Closure	RATING: 1 x WEIGHT: 8.3 =	SCORE: 8.3
Weatherproof, tight, well-maintained exterior walls, doors, windows/finishes			
COMMENTS:	Stucco-random cracks throughout; corrugated metal panels; aluminum window wall		
COMPONENT:	Roofing	RATING: 2 x WEIGHT: 10.4 =	SCORE: 20.9
Majority of roofing and flashing appear sound, but a small portion of roofing shows deterioration where maintenance or minor repair needed			
COMMENTS:	Concrete tile on sloped roof; BUR w mineral-surfaced cap sheet

Secondary Systems			
COMPONENT:	Floor Finishes	RATING: 1 x WEIGHT: 6.3 =	SCORE: 6.3
Nice appearance, smooth transitions, level subfloors, no cracks/separating			
COMMENTS:	Carpet; linoleum; ceramic tile; vinyl tile-surface wear		
COMPONENT:	Wall Finishes	RATING: 1 x WEIGHT: 6.3 =	SCORE: 6.3
Maintainable surfaces in good condition			
COMMENTS:	Gypsum board; ceramic tile		
COMPONENT:	Ceiling Finishes	RATING: 1 x WEIGHT: 6.3 =	SCORE: 6.3
Maintainable surfaces in good condition; good alignment and appearance			
COMMENTS:	Lay-in tile		
COMPONENT:	Doors & Hardware	RATING: 1 x WEIGHT: 6.3 =	SCORE: 6.3
Appropriate hardware, closers, panic devices; in good working order			
COMMENTS:	Interior wood doors w HM frames; exterior aluminum doors/frames

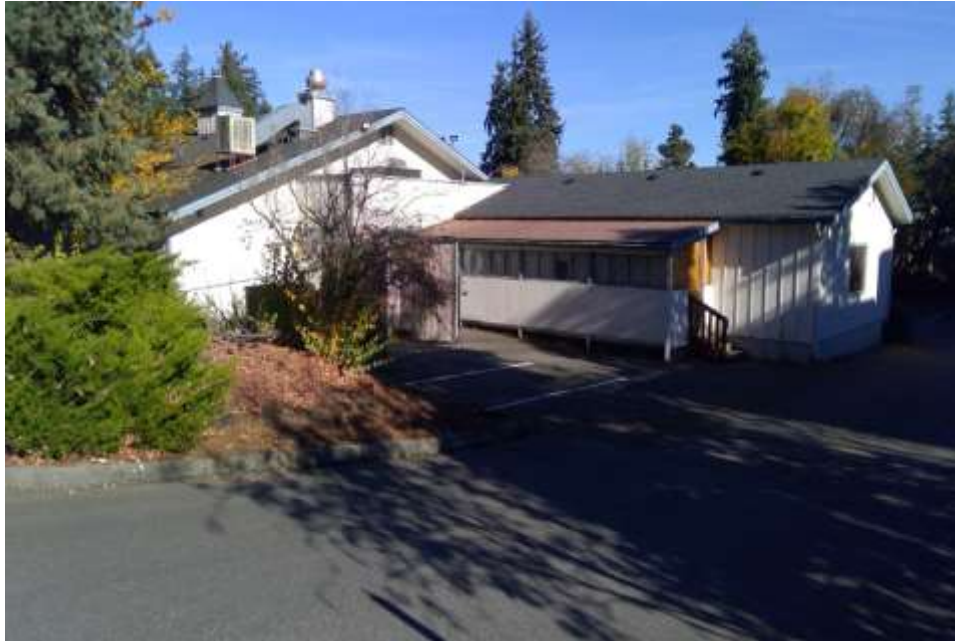
Elks Building (230-ELK) STATE UFI: A25278 Main Campus (230A)
AREA: 5,796 SF BUILT: 1980 REMODELED: No PREDOMINANT USE: Classroom
CONSTRUCTION TYPE: No data CRV/SF: \$356 REPLACEMENT VALUE: \$2,063,376

Primary Systems			
COMPONENT:	Structure	RATING: 2 x WEIGHT: 8.8 = SCORE: 17.6	
Minor cracks evident in a small portion of the structure			
COMMENTS:	No data		
COMPONENT:	Exterior Closure	RATING: 2 x WEIGHT: 8.8 = SCORE: 17.6	
Weatherproof exterior, but finish appears poorly maintained			
COMMENTS:	No data		
COMPONENT:	Roofing	RATING: 2 x WEIGHT: 11 = SCORE: 22	
Majority of roofing and flashing appear sound, but a small portion of roofing shows deterioration where maintenance or minor repair needed			
COMMENTS:	No data

Secondary Systems			
COMPONENT:	Floor Finishes	RATING: 3 x WEIGHT: 6.6 =	SCORE: 19.8
Some physical wear and minor imperfections are evident; beginning deterioration			
COMMENTS:	No data		
COMPONENT:	Wall Finishes	RATING: 2 x WEIGHT: 6.6 =	SCORE: 13.2
Maintainable surfaces, minor maintenance is required in some areas			
COMMENTS:	No data		
COMPONENT:	Ceiling Finishes	RATING: 2 x WEIGHT: 6.6 =	SCORE: 13.2
Aging surfaces in fair condition and good alignment			
COMMENTS:	No data		
COMPONENT:	Doors & Hardware	RATING: 3 x WEIGHT: 6.6 =	SCORE: 19.8
Functional, but dated; some maintenance required			
COMMENTS:	No data

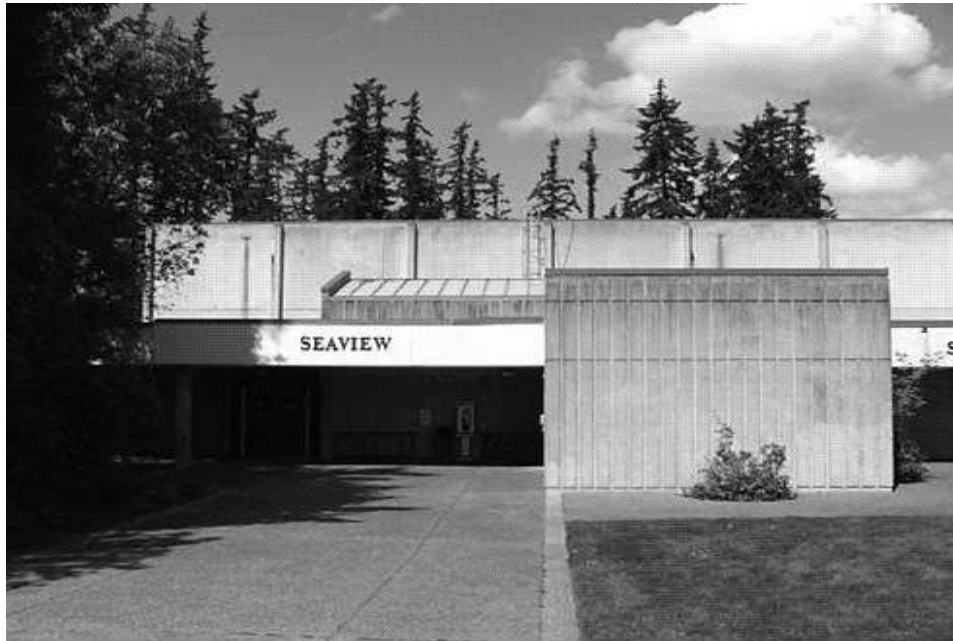
Seaview Gymnasium (230-SEA) STATE UFI: A04248 Main Campus (230A)
AREA: 30,100 SF BUILT: 1976 REMODELED: No PREDOMINANT USE: Gymnasium
CONSTRUCTION TYPE: Heavy CRV/SF: \$349 REPLACEMENT VALUE: \$10,504,900

Primary Systems			
COMPONENT:	Structure	RATING: 1 x WEIGHT: 8.3 =	SCORE: 8.3
No signs of settlement or cracking, no abrupt vertical changes Columns, bearing walls and roof structure appears sound/free of defects			
COMMENTS:	Poured-in-place and tilt-up concrete panels; open web steel roof joists		
COMPONENT:	Exterior Closure	RATING: 2 x WEIGHT: 8.3 =	SCORE: 16.7
Weatherproof exterior, but finish appears poorly maintained			
COMMENTS:	Concrete; stucco soffits - spawling		
COMPONENT:	Roofing	RATING: 2 x WEIGHT: 10.4 =	SCORE: 20.9
Majority of roofing and flashing appear sound, but a small portion of roofing shows deterioration where maintenance or minor repair needed			
COMMENTS:	Built-up roof on metal deck 2012

Secondary Systems			
COMPONENT:	Floor Finishes	RATING: 2 x WEIGHT: 6.3 =	SCORE: 12.5
Some wear is evident on finish; maintenance needed			
COMMENTS:	Hardwood; carpet; vinyl and ceramic tile; new Rhino floor in locker rooms		
COMPONENT:	Wall Finishes	RATING: 2 x WEIGHT: 6.3 =	SCORE: 12.5
Maintainable surfaces, minor maintenance is required in some areas			
COMMENTS:	Gypsum board; hard board panels; concrete; CMU; ceramic tile		
COMPONENT:	Ceiling Finishes	RATING: 2 x WEIGHT: 6.3 =	SCORE: 12.5
Aging surfaces in fair condition and good alignment			
COMMENTS:	Lay-in tile; gypsum board		
COMPONENT:	Doors & Hardware	RATING: 5 x WEIGHT: 6.3 =	SCORE: 31.3
Inoperable, deteriorating and outdated; non-secure			
COMMENTS:	Interior wood doors w HM frames and HM doors/frames; exterior HM doors/frames

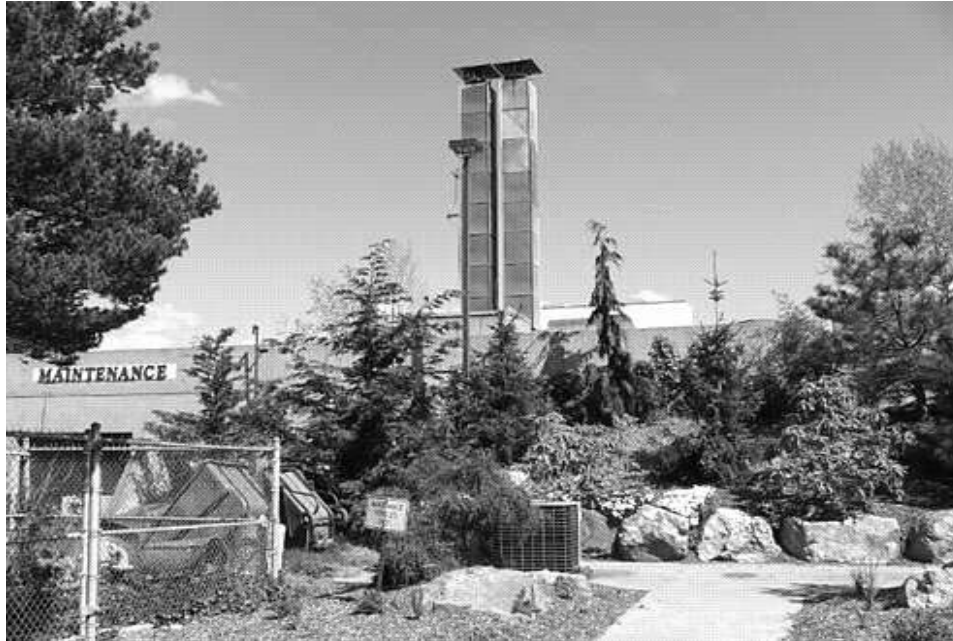
Utility (230-UTY) STATE UFI: A04725 Main Campus (230A)
 AREA: 6,932 SF BUILT: 1972 REMODELED: 2003 PREDOMINANT USE: Central Plant
 CONSTRUCTION TYPE: Heavy CRV/SF: \$264 REPLACEMENT VALUE: \$1,830,048

Primary Systems			
COMPONENT:	Structure	RATING: 1 x WEIGHT: 8.3 = SCORE: 8.3	
No signs of settlement or cracking, no abrupt vertical changes Columns, bearing walls and roof structure appears sound/free of defects			
COMMENTS:	Concrete; steel frame		
COMPONENT:	Exterior Closure	RATING: 3 x WEIGHT: 8.3 = SCORE: 25	
Sound and weatherproof but with some physical deterioration evident			
COMMENTS:	Concrete; metal OH door		
COMPONENT:	Roofing	RATING: 3 x WEIGHT: 10.4 = SCORE: 31.3	
Some deterioration is evident in membrane and flashings; maintenance or minor repair is needed			
COMMENTS:	Concrete aggregate roof deck; extensive cracking throughout; needs repair

Secondary Systems			
COMPONENT:	Floor Finishes	RATING: 1 x WEIGHT: 6.3 =	SCORE: 6.3
Nice appearance, smooth transitions, level subfloors, no cracks/separating			
COMMENTS:	Concrete; vinyl tile		
COMPONENT:	Wall Finishes	RATING: 3 x WEIGHT: 6.3 =	SCORE: 18.8
Aging surfaces, but sound; some maintenance is required			
COMMENTS:	Concrete		
COMPONENT:	Ceiling Finishes	RATING: 3 x WEIGHT: 6.3 =	SCORE: 18.8
Some wear and tear; Minor damage, staining or deterioration			
COMMENTS:	Concrete; steel deck pan		
COMPONENT:	Doors & Hardware	RATING: 3 x WEIGHT: 6.3 =	SCORE: 18.8
Functional, but dated; some maintenance required			
COMMENTS:	Exterior HM doors/frames; metal coiling door

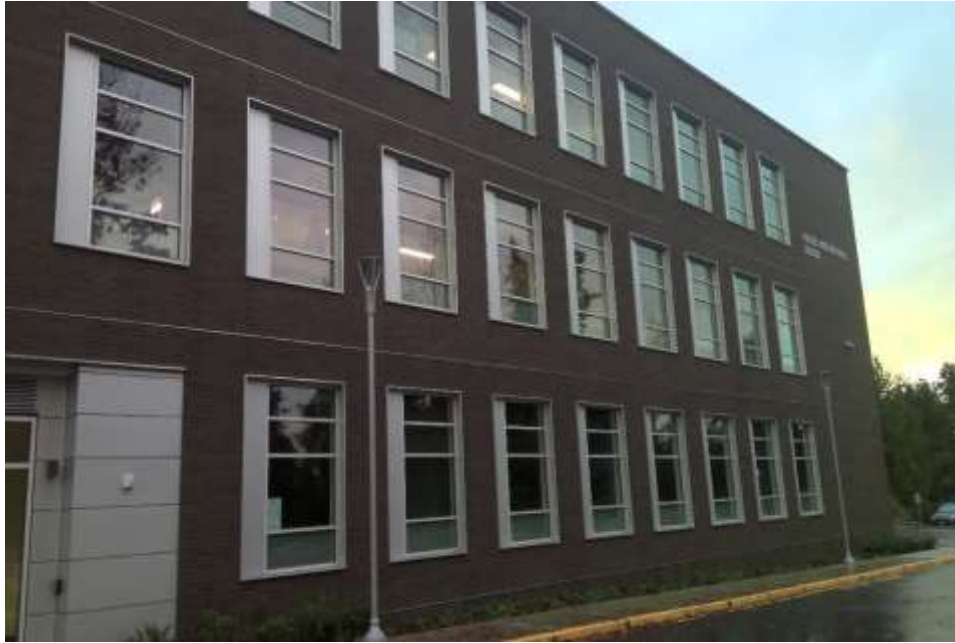
Hazel Miller Hall (230-HZL) STATE UFI: A26593 Main Campus (230A)
AREA: 66,261 SF BUILT: 2020 REMODELED: No PREDOMINANT USE: Classroom
CONSTRUCTION TYPE: No data CRV/SF: \$356 REPLACEMENT VALUE: \$23,588,916

Primary Systems	
COMPONENT: Structure	RATING: 1 x WEIGHT: 8.4 = SCORE: 8.4
No signs of settlement or cracking, no abrupt vertical changes Columns, bearing walls and roof structure appears sound/free of defects	
COMMENTS: No data	
COMPONENT: Exterior Closure	RATING: 1 x WEIGHT: 8.4 = SCORE: 8.4
Weatherproof, tight, well-maintained exterior walls, doors, windows/finishes	
COMMENTS: No data	
COMPONENT: Roofing	RATING: 1 x WEIGHT: 10.5 = SCORE: 10.5
Flashing and penetrations appear sound and membrane appears water- tight; drainage is positive and there are overflow scuppers	
COMMENTS: No data

Secondary Systems			
COMPONENT:	Floor Finishes	RATING: 1 x WEIGHT: 6.3 =	SCORE: 6.3
	Nice appearance, smooth transitions, level subfloors, no cracks/separating		
COMMENTS:	No data		
COMPONENT:	Wall Finishes	RATING: 1 x WEIGHT: 6.3 =	SCORE: 6.3
	Maintainable surfaces in good condition		
COMMENTS:	No data		
COMPONENT:	Ceiling Finishes	RATING: 1 x WEIGHT: 6.3 =	SCORE: 6.3
	Maintainable surfaces in good condition; good alignment and appearance		
COMMENTS:	No data		
COMPONENT:	Doors & Hardware	RATING: 1 x WEIGHT: 6.3 =	SCORE: 6.3
	Appropriate hardware, closers, panic devices; in good working order		
COMMENTS:	No data
