2023 FACILITY CONDITION SURVEY

Everett Community College

SURVEY CONDUCTED BY:
Steve Lewandowski
State Board for Community
and Technical Colleges

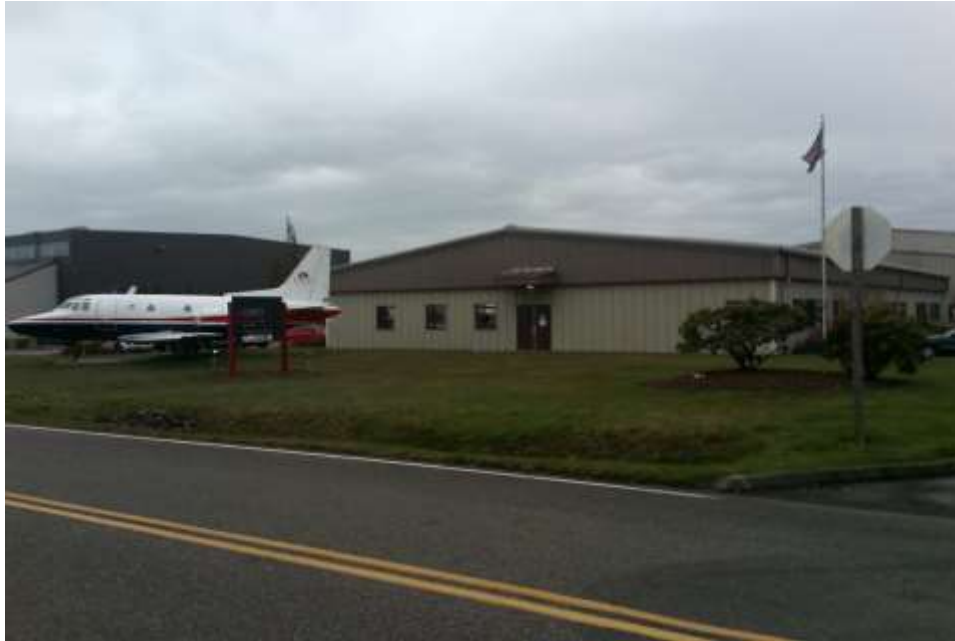
Avatn Admin/Classrm (050-C80) STATE UFI: A05169 Paine Field Campus (050C)
AREA: 10,392 SF BUILT: 1961 REMODELED: 2015 PREDOMINANT USE: General Classroom
CONSTRUCTION TYPE: Medium CRV/SF: \$330 REPLACEMENT VALUE: \$3,429,360

Primary Systems			
COMPONENT:	Structure	RATING: 1 x WEIGHT: 8.3 =	SCORE: 8.3
No signs of settlement or cracking, no abrupt vertical changes Columns, bearing walls and roof structure appears sound/free of defects			
COMMENTS:	Engineered metal building system; steel frame		
COMPONENT:	Exterior Closure	RATING: 1 x WEIGHT: 8.3 =	SCORE: 8.3
Weatherproof, tight, well-maintained exterior walls, doors, windows/finishes			
COMMENTS:	Metal panels		
COMPONENT:	Roofing	RATING: 3 x WEIGHT: 10.4 =	SCORE: 31.3
Some deterioration is evident in membrane and flashings; maintenance or minor repair is needed			
COMMENTS:	Metal panels; intermittent roof leaks reported; replacement funded 23-25

Secondary Systems			
COMPONENT:	Floor Finishes	RATING: 1 x WEIGHT: 6.3 =	SCORE: 6.3
Nice appearance, smooth transitions, level subfloors, no cracks/separating			
COMMENTS:	Vinyl asbestos tile; carpet-general wear; ceramic tile; carpet tile		
COMPONENT:	Wall Finishes	RATING: 1 x WEIGHT: 6.3 =	SCORE: 6.3
Maintainable surfaces in good condition			
COMMENTS:	Gypsum board and ceramic tile		
COMPONENT:	Ceiling Finishes	RATING: 2 x WEIGHT: 6.3 =	SCORE: 12.5
Aging surfaces in fair condition and good alignment			
COMMENTS:	Lay-in tiles-random staining throughout		
COMPONENT:	Doors & Hardware	RATING: 2 x WEIGHT: 6.3 =	SCORE: 12.5
Fairly modern door surfaces and hardware with minor deterioration; good working order			
COMMENTS:	Exterior and interior HM doors and frames-general marring

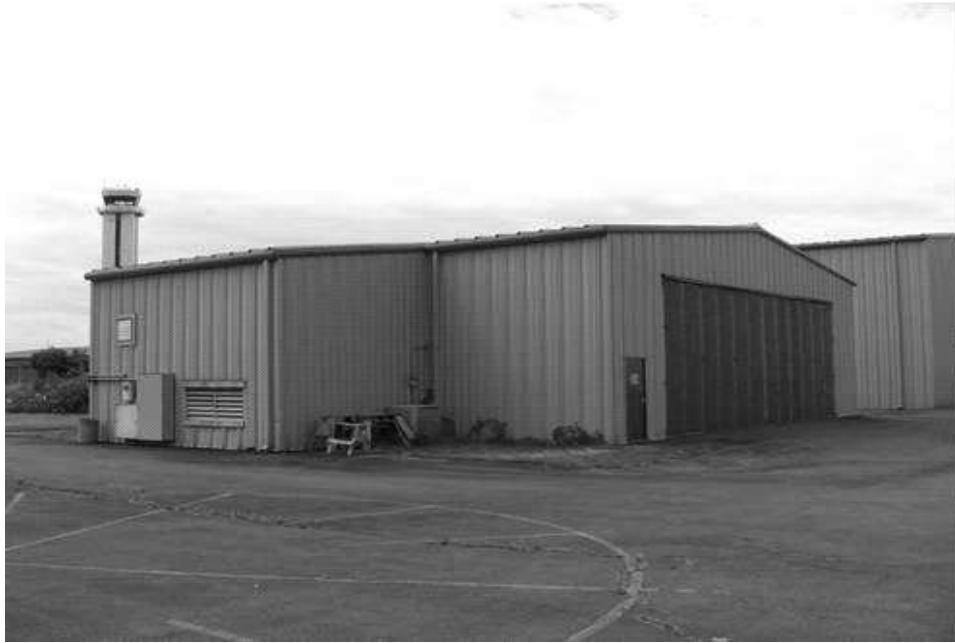
Avatn Paint Bldg (050-C82) STATE UFI: A03573 Paine Field Campus (050C)
AREA: 2,400 SF BUILT: 1958 REMODELED: No PREDOMINANT USE: Vocational Arts
CONSTRUCTION TYPE: Medium CRV/SF: \$330 REPLACEMENT VALUE: \$792,000

Primary Systems			
COMPONENT:	Structure	RATING: 1 x WEIGHT: 9.8 = SCORE: 9.8	
No signs of settlement or cracking, no abrupt vertical changes Columns, bearing walls and roof structure appears sound/free of defects			
COMMENTS:	Engineered metal building; steel frame		
COMPONENT:	Exterior Closure	RATING: 1 x WEIGHT: 9.8 = SCORE: 9.8	
Weatherproof, tight, well-maintained exterior walls, doors, windows/finishes			
COMMENTS:	Metal panels		
COMPONENT:	Roofing	RATING: 2 x WEIGHT: 12.3 = SCORE: 24.5	
Majority of roofing and flashing appear sound, but a small portion of roofing shows deterioration where maintenance or minor repair needed			
COMMENTS:	Metal panels

Secondary Systems			
COMPONENT:	Floor Finishes	RATING: 3 x WEIGHT: 7.4 =	SCORE: 22.1
Some physical wear and minor imperfections are evident; beginning deterioration			
COMMENTS:	Concrete-cracking throughout		
COMPONENT:	Wall Finishes	RATING: 3 x WEIGHT: 7.4 =	SCORE: 22.1
Aging surfaces, but sound; some maintenance is required			
COMMENTS:	Gypsum board; exposed structure & encapsulated insulation; plywood wainscot		
COMPONENT:	Ceiling Finishes	RATING: 1 x WEIGHT: 7.4 =	SCORE: 7.4
Maintainable surfaces in good condition; good alignment and appearance			
COMMENTS:	Exposed structural & encapsulated insulation		
COMPONENT:	Doors & Hardware	RATING: 4 x WEIGHT: 7.4 =	SCORE: 29.4
General deterioration evident in both door and hardware; some doors with significant deterioration			
COMMENTS:	Exterior and interior HM doors/frames; folding hangar door-older fiberglass panels (failing)

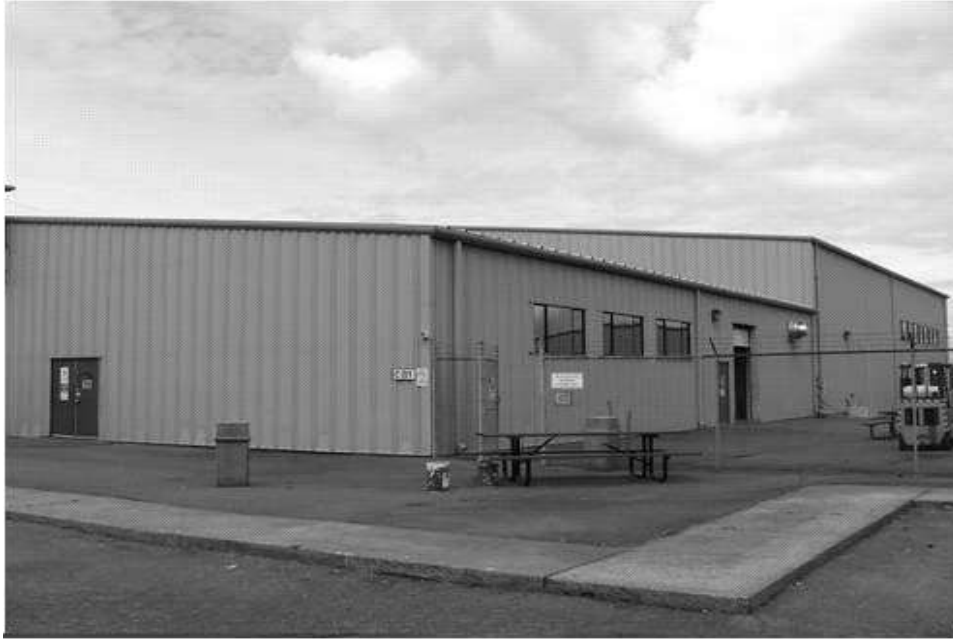
Avatn Shop/Hanger (050-C81) STATE UFI: A08614 Paine Field Campus (050C)
 AREA: 31,200 SF BUILT: 1958 REMODELED: No PREDOMINANT USE: Vocational Arts
 CONSTRUCTION TYPE: Medium CRV/SF: \$330 REPLACEMENT VALUE: \$10,296,000

Primary Systems			
COMPONENT:	Structure	RATING: 1 x WEIGHT: 8.8 = SCORE: 8.8	
No signs of settlement or cracking, no abrupt vertical changes Columns, bearing walls and roof structure appears sound/free of defects			
COMMENTS:	Engineered metal building; steel frame		
COMPONENT:	Exterior Closure	RATING: 1 x WEIGHT: 8.8 = SCORE: 8.8	
Weatherproof, tight, well-maintained exterior walls, doors, windows/finishes			
COMMENTS:	Metal panels		
COMPONENT:	Roofing	RATING: 2 x WEIGHT: 11 = SCORE: 22	
Majority of roofing and flashing appear sound, but a small portion of roofing shows deterioration where maintenance or minor repair needed			
COMMENTS:	Metal panels. Intermittent leaks at roof transition.

Secondary Systems			
COMPONENT:	Floor Finishes	RATING: 3 x WEIGHT: 6.6 =	SCORE: 19.8
Some physical wear and minor imperfections are evident; beginning deterioration			
COMMENTS:	Concrete; vinyl tile-surface wear; ceramic tile		
COMPONENT:	Wall Finishes	RATING: 2 x WEIGHT: 6.6 =	SCORE: 13.2
Maintainable surfaces, minor maintenance is required in some areas			
COMMENTS:	Gypsum board; exposed structure & encapsulated insulation; ceramic tile		
COMPONENT:	Ceiling Finishes	RATING: 1 x WEIGHT: 6.6 =	SCORE: 6.6
Maintainable surfaces in good condition; good alignment and appearance			
COMMENTS:	Gypsum board; exposed structure & encapsulated insulation		
COMPONENT:	Doors & Hardware	RATING: 3 x WEIGHT: 6.6 =	SCORE: 19.8
Functional, but dated; some maintenance required			
COMMENTS:	Exterior & interior HM doors/frames-general marring; folding exterior hangar door

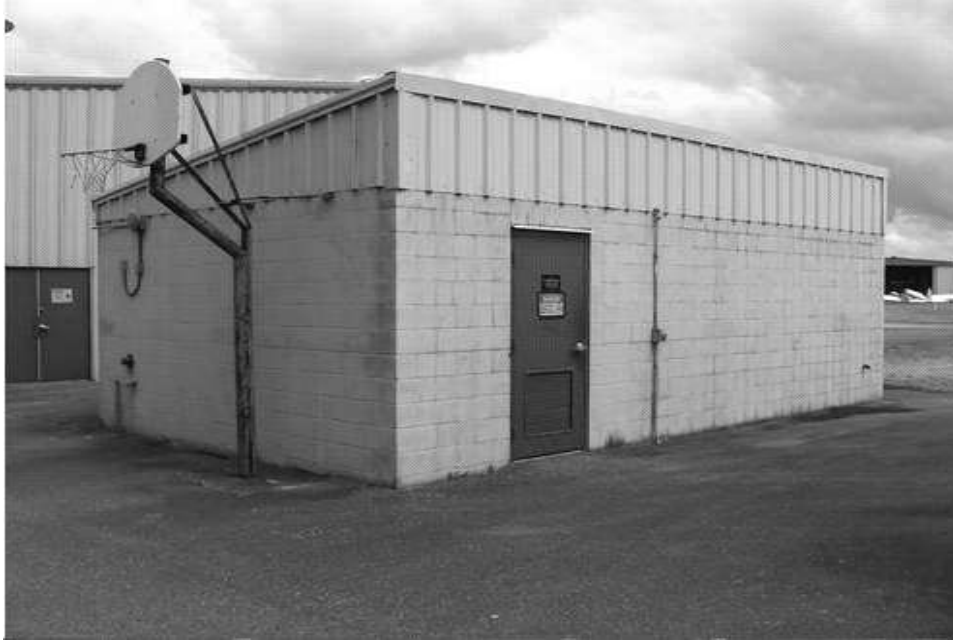
Aviation Flammable Storage Bldg (050-C83) STATE UFI: A20271 Paine Field Campus (050C)
AREA: 375 SF BUILT: 1958 REMODELED: No PREDOMINANT USE: Vocational Arts
CONSTRUCTION TYPE: No data CRV/SF: \$231 REPLACEMENT VALUE: \$86,625

Primary Systems			
COMPONENT:	Structure	RATING: 3 x WEIGHT: 11.6 =	SCORE: 34.7
Some cracking evident but does not likely affect structural integrity; Visible defects apparent but are non-structural			
COMMENTS:	Concrete; CMU; steel stud-sloped roof framing		
COMPONENT:	Exterior Closure	RATING: 4 x WEIGHT: 11.6 =	SCORE: 46.3
General deterioration detected, one or more minor leaks apparent			
COMMENTS:	CMU; metal corrugated panel fascia-dented		
COMPONENT:	Roofing	RATING: 4 x WEIGHT: 14.5 =	SCORE: 57.8
General deterioration and some leaks are evident; reconditioning or partial repair is needed			
COMMENTS:	Metal panels; significant leaks

Secondary Systems			
COMPONENT:	Floor Finishes	RATING: 1 x WEIGHT: 8.7 =	SCORE: 8.7
Nice appearance, smooth transitions, level subfloors, no cracks/separating			
COMMENTS:	Concrete		
COMPONENT:	Wall Finishes	RATING: 0 x WEIGHT: 0 =	SCORE: 0
No data			
COMMENTS:	CMU with random cracking		
COMPONENT:	Ceiling Finishes	RATING: 0 x WEIGHT: 0 =	SCORE: 0
No data			
COMMENTS:	Concrete slabs		
COMPONENT:	Doors & Hardware	RATING: 3 x WEIGHT: 8.7 =	SCORE: 26
Functional, but dated; some maintenance required			
COMMENTS:	Exterior HM doors/frames

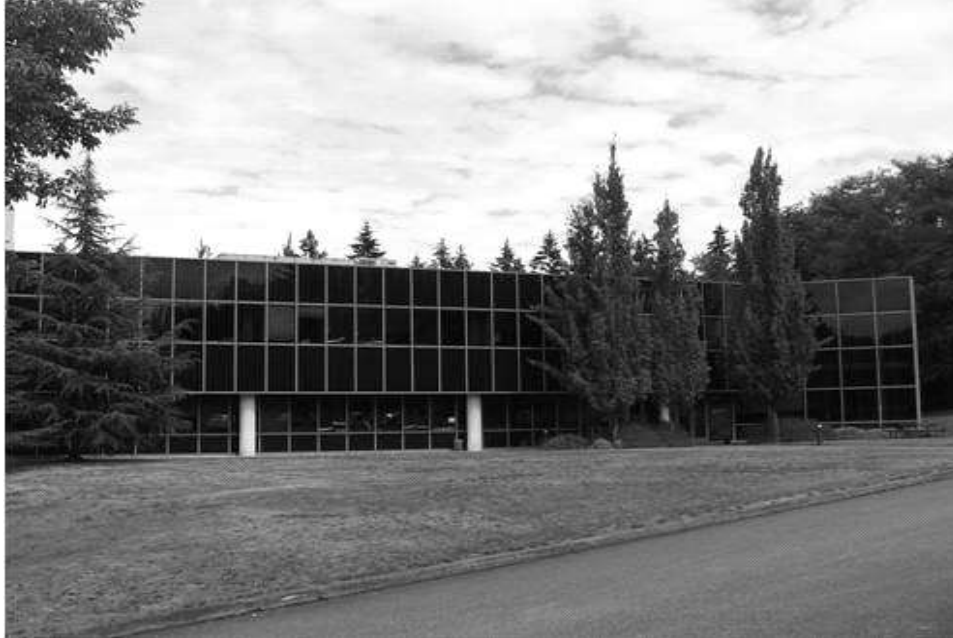
Corporate And Continuing Ed Center (050-ATC) STATE UFI: A06897 Applied Technology Training
Ctr. (050D)

Primary Systems			
COMPONENT:	Structure	RATING: 1 x WEIGHT: 8 =	SCORE: 8
No signs of settlement or cracking, no abrupt vertical changes Columns, bearing walls and roof structure appears sound/free of defects			
COMMENTS:	Structural steel		
COMPONENT:	Exterior Closure	RATING: 2 x WEIGHT: 8 =	SCORE: 16
Weatherproof exterior, but finish appears poorly maintained			
COMMENTS:	Painted aluminum curtain walls; stucco over concrete stair tower walls; metal panels		
COMPONENT:	Roofing	RATING: 1 x WEIGHT: 10 =	SCORE: 10
Flashing and penetrations appear sound and membrane appears water- tight; drainage is positive and there are overflow scuppers			
COMMENTS:	BUR w mineral surfaced capsheet-2011

Secondary Systems			
COMPONENT:	Floor Finishes	RATING: 1 x WEIGHT: 6 = SCORE: 6	
	Nice appearance, smooth transitions, level subfloors, no cracks/separating		
COMMENTS:	Carpet-worn; carpet tile; vinyl tile		
COMPONENT:	Wall Finishes	RATING: 1 x WEIGHT: 6 = SCORE: 6	
	Maintainable surfaces in good condition		
COMMENTS:	Gypsum board; ceramic tile		
COMPONENT:	Ceiling Finishes	RATING: 1 x WEIGHT: 6 = SCORE: 6	
	Maintainable surfaces in good condition; good alignment and appearance		
COMMENTS:	Gypsum board; lay-in tile-water staining		
COMPONENT:	Doors & Hardware	RATING: 1 x WEIGHT: 6 = SCORE: 6	
	Appropriate hardware, closers, panic devices; in good working order		
COMMENTS:	Interior wood doors w HM frames; exterior aluminum doors/frames and HM doors/frames

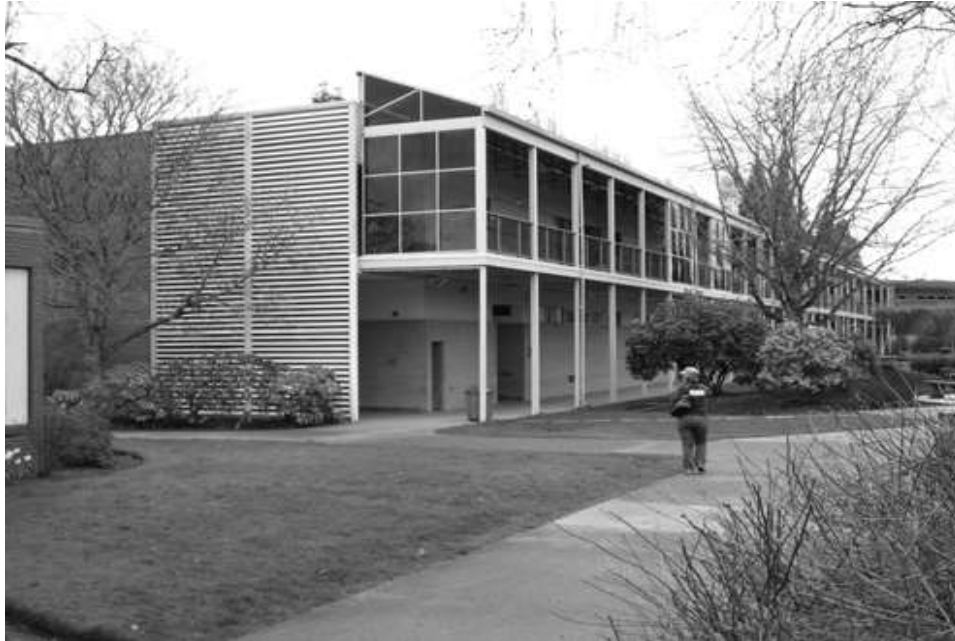
Baker Hall (050-00B) STATE UFI: A10077 Main Campus (050A)
 AREA: 23,710 SF BUILT: 1961 REMODELED: No PREDOMINANT USE: General Classroom
 CONSTRUCTION TYPE: Heavy CRV/SF: \$376 REPLACEMENT VALUE: \$8,914,960

Primary Systems			
COMPONENT:	Structure	RATING: 3 x WEIGHT: 8 = SCORE: 24	
Some cracking evident but does not likely affect structural integrity; Visible defects apparent but are non-structural			
COMMENTS:	Concrete; steel; CMU; glu-lam beams; seismic deficiencies		
COMPONENT:	Exterior Closure	RATING: 3 x WEIGHT: 8 = SCORE: 24	
Sound and weatherproof but with some physical deterioration evident			
COMMENTS:	Brick; EIFS; plywood soffits		
COMPONENT:	Roofing	RATING: 1 x WEIGHT: 10 = SCORE: 10	
Flashing and penetrations appear sound and membrane appears water- tight; drainage is positive and there are overflow scuppers			
COMMENTS:	Single ply EPDM; metal panels on covered walkway; New single ply 2011

Secondary Systems			
COMPONENT:	Floor Finishes	RATING: 3 x WEIGHT: 6 = SCORE: 18	
	Some physical wear and minor imperfections are evident; beginning deterioration		
COMMENTS:	Vinyl asbestos & composition tile; badly worn carpet; brick; ceramic tile		
COMPONENT:	Wall Finishes	RATING: 1 x WEIGHT: 6 = SCORE: 6	
	Maintainable surfaces in good condition		
COMMENTS:	Gypsum board; brick; CMU; ceramic tile		
COMPONENT:	Ceiling Finishes	RATING: 3 x WEIGHT: 6 = SCORE: 18	
	Some wear and tear; Minor damage, staining or deterioration		
COMMENTS:	Lay-in tile; gypsum board		
COMPONENT:	Doors & Hardware	RATING: 3 x WEIGHT: 6 = SCORE: 18	
	Functional, but dated; some maintenance required		
COMMENTS:	Interior and exterior wood doors w HM frames-random wear

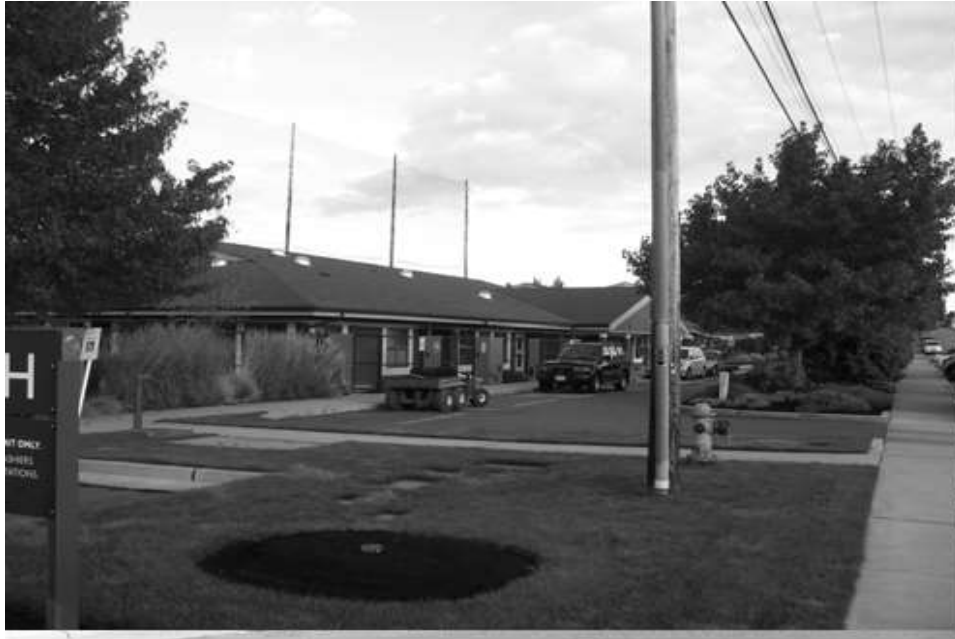
Early Learning Center (050-ELC) STATE UFI: A07474 Main Campus (050A)
 AREA: 14,000 SF BUILT: 2004 REMODELED: 2010 PREDOMINANT USE: Early Learning
 CONSTRUCTION TYPE: Light CRV/SF: \$264 REPLACEMENT VALUE: \$3,696,000

Primary Systems			
COMPONENT:	Structure	RATING: 1 x WEIGHT: 8.3 = SCORE: 8.3	
No signs of settlement or cracking, no abrupt vertical changes Columns, bearing walls and roof structure appears sound/free of defects			
COMMENTS:	Wood frame and trusses		
COMPONENT:	Exterior Closure	RATING: 2 x WEIGHT: 8.3 = SCORE: 16.7	
Weatherproof exterior, but finish appears poorly maintained			
COMMENTS:	T1-11 siding; ruff-sawn upper panels; plywood soffits; aluminum window walls; clearstory windows		
COMPONENT:	Roofing	RATING: 1 x WEIGHT: 10.4 = SCORE: 10.4	
Flashing and penetrations appear sound and membrane appears water- tight; drainage is positive and there are overflow scuppers			
COMMENTS:	Composition shingle roof-2008; Sonotube skylights

Secondary Systems			
COMPONENT:	Floor Finishes	RATING: 2 x WEIGHT: 6.3 = SCORE: 12.5	
	Some wear is evident on finish; maintenance needed		
COMMENTS:	Linoleum, vinyl tile, and carpet tile		
COMPONENT:	Wall Finishes	RATING: 2 x WEIGHT: 6.3 = SCORE: 12.5	
	Maintainable surfaces, minor maintenance is required in some areas		
COMMENTS:	Gypsum board; laminate wall panels		
COMPONENT:	Ceiling Finishes	RATING: 1 x WEIGHT: 6.3 = SCORE: 6.3	
	Maintainable surfaces in good condition; good alignment and appearance		
COMMENTS:	Gypsum board; lay-in tile; acoustic panels		
COMPONENT:	Doors & Hardware	RATING: 1 x WEIGHT: 6.3 = SCORE: 6.3	
	Appropriate hardware, closers, panic devices; in good working order		
COMMENTS:	Interior wood glazed doors w HM frames and HM doors/frames; exterior HM glazed doors/frames

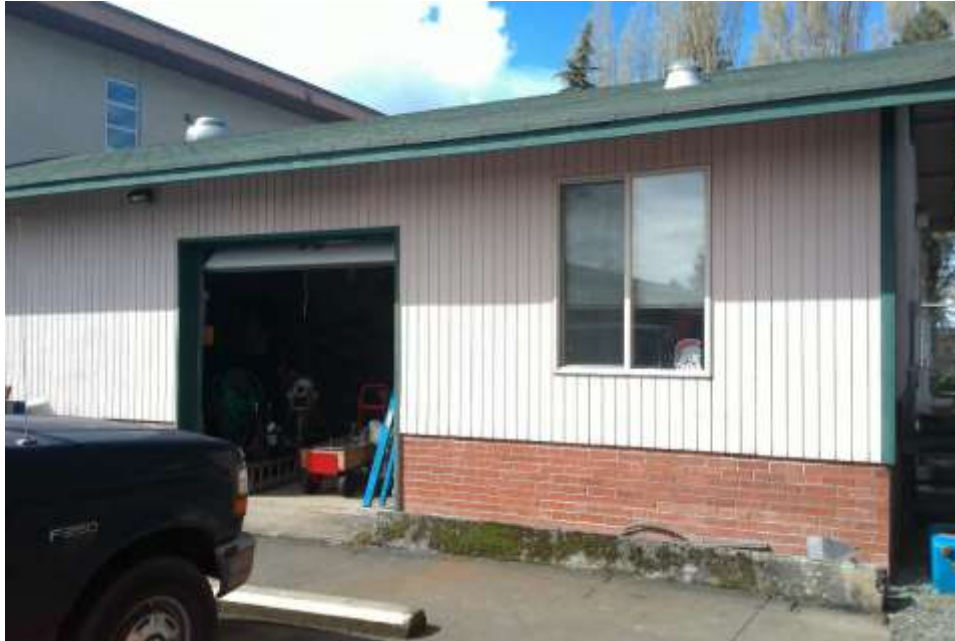
Engineering Shed (050-ENG) STATE UFI: A10118 Main Campus (050A)
AREA: 1,500 SF BUILT: 1976 REMODELED: No PREDOMINANT USE: Storage
CONSTRUCTION TYPE: Light CRV/SF: \$150 REPLACEMENT VALUE: \$225,000

Primary Systems			
COMPONENT:	Structure	RATING: 1 x WEIGHT: 8.4 =	SCORE: 8.4
No signs of settlement or cracking, no abrupt vertical changes Columns, bearing walls and roof structure appears sound/free of defects			
COMMENTS:	No data		
COMPONENT:	Exterior Closure	RATING: 2 x WEIGHT: 8.4 =	SCORE: 16.8
Weatherproof exterior, but finish appears poorly maintained			
COMMENTS:	No data		
COMPONENT:	Roofing	RATING: 1 x WEIGHT: 10.5 =	SCORE: 10.5
Flashing and penetrations appear sound and membrane appears water- tight; drainage is positive and there are overflow scuppers			
COMMENTS:	Asphalt shingles

Secondary Systems			
COMPONENT:	Floor Finishes	RATING: 3 x WEIGHT: 6.3 = SCORE: 18.9	
	Some physical wear and minor imperfections are evident; beginning deterioration		
COMMENTS:	No data		
COMPONENT:	Wall Finishes	RATING: 3 x WEIGHT: 6.3 = SCORE: 18.9	
	Aging surfaces, but sound; some maintenance is required		
COMMENTS:	No data		
COMPONENT:	Ceiling Finishes	RATING: 3 x WEIGHT: 6.3 = SCORE: 18.9	
	Some wear and tear; Minor damage, staining or deterioration		
COMMENTS:	No data		
COMPONENT:	Doors & Hardware	RATING: 2 x WEIGHT: 6.3 = SCORE: 12.6	
	Fairly modern door surfaces and hardware with minor deterioration; good working order		
COMMENTS:	No data

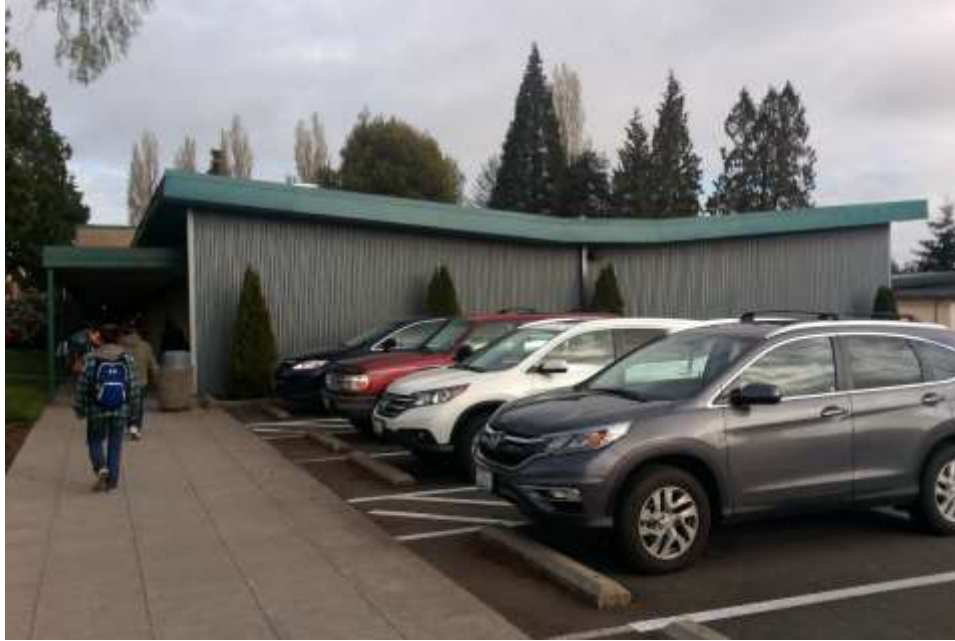
Glacier Hall (050-GLA) STATE UFI: A10143 Main Campus (050A)
AREA: 6,196 SF BUILT: 1958 REMODELED: No PREDOMINANT USE: Vocational Arts
CONSTRUCTION TYPE: No data CRV/SF: \$375 REPLACEMENT VALUE: \$2,323,500

Primary Systems			
COMPONENT:	Structure	RATING: 1 x WEIGHT: 8 =	SCORE: 8
No signs of settlement or cracking, no abrupt vertical changes Columns, bearing walls and roof structure appears sound/free of defects			
COMMENTS:	No data		
COMPONENT:	Exterior Closure	RATING: 3 x WEIGHT: 8 =	SCORE: 24
Sound and weatherproof but with some physical deterioration evident			
COMMENTS:	No data		
COMPONENT:	Roofing	RATING: 3 x WEIGHT: 10 =	SCORE: 30
Some deterioration is evident in membrane and flashings; maintenance or minor repair is needed			
COMMENTS:	No data

Secondary Systems			
COMPONENT:	Floor Finishes	RATING: 1 x WEIGHT: 6 = SCORE: 6	
	Nice appearance, smooth transitions, level subfloors, no cracks/separating		
COMMENTS:	No data		
COMPONENT:	Wall Finishes	RATING: 2 x WEIGHT: 6 = SCORE: 12	
	Maintainable surfaces, minor maintenance is required in some areas		
COMMENTS:	No data		
COMPONENT:	Ceiling Finishes	RATING: 2 x WEIGHT: 6 = SCORE: 12	
	Aging surfaces in fair condition and good alignment		
COMMENTS:	No data		
COMPONENT:	Doors & Hardware	RATING: 2 x WEIGHT: 6 = SCORE: 12	
	Fairly modern door surfaces and hardware with minor deterioration; good working order		
COMMENTS:	No data

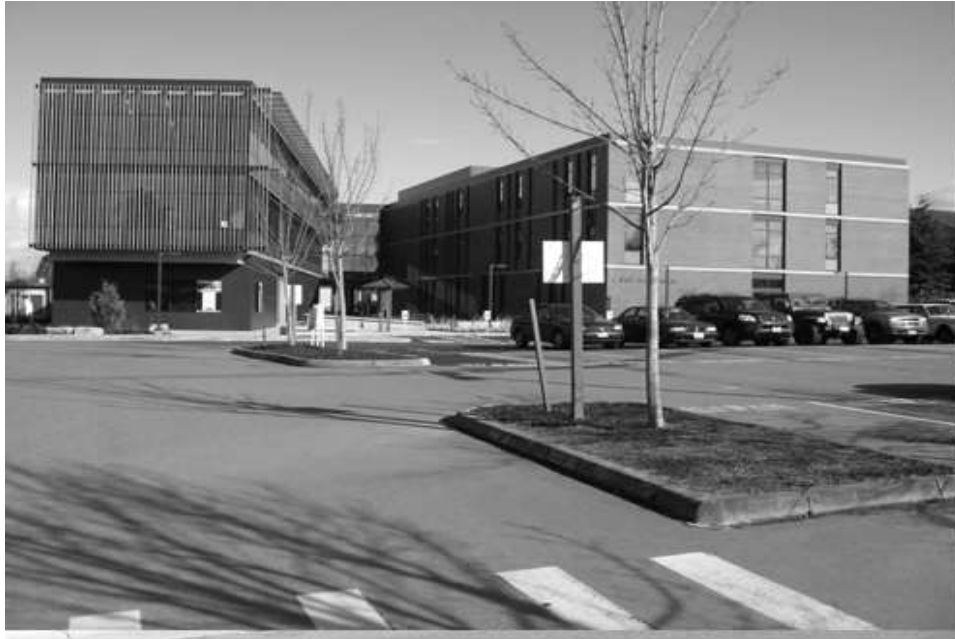
Gray Wolf Hall (050-GWH) STATE UFI: A03275 Main Campus (050A)
AREA: 77,000 SF BUILT: 2012 REMODELED: No PREDOMINANT USE: General Classroom
CONSTRUCTION TYPE: Heavy CRV/SF: \$376 REPLACEMENT VALUE: \$28,952,000

Primary Systems			
COMPONENT:	Structure	RATING: 1 x WEIGHT: 8.4 = SCORE: 8.4	
No signs of settlement or cracking, no abrupt vertical changes Columns, bearing walls and roof structure appears sound/free of defects			
COMMENTS:	Concrete beams and columns; steel framing		
COMPONENT:	Exterior Closure	RATING: 1 x WEIGHT: 8.4 = SCORE: 8.4	
Weatherproof, tight, well-maintained exterior walls, doors, windows/finishes			
COMMENTS:	Brick; concrete ledgers; steel/wood sunscreens		
COMPONENT:	Roofing	RATING: 1 x WEIGHT: 10.5 = SCORE: 10.5	
Flashing and penetrations appear sound and membrane appears water- tight; drainage is positive and there are overflow scuppers			
COMMENTS:	PVC single-ply membrane

Secondary Systems			
COMPONENT:	Floor Finishes	RATING: 1 x WEIGHT: 6.3 = SCORE: 6.3	
	Nice appearance, smooth transitions, level subfloors, no cracks/separating		
COMMENTS:	Carpet tile; wood block; linoleum; concrete		
COMPONENT:	Wall Finishes	RATING: 2 x WEIGHT: 6.3 = SCORE: 12.6	
	Maintainable surfaces, minor maintenance is required in some areas		
COMMENTS:	Concrete; gypsum board; vinyl covering; brick; moveable partition walls		
COMPONENT:	Ceiling Finishes	RATING: 1 x WEIGHT: 6.3 = SCORE: 6.3	
	Maintainable surfaces in good condition; good alignment and appearance		
COMMENTS:	Lay-in tiles; gypsum board		
COMPONENT:	Doors & Hardware	RATING: 1 x WEIGHT: 6.3 = SCORE: 6.3	
	Appropriate hardware, closers, panic devices; in good working order		
COMMENTS:	Interior wood doors w HM frames and sidelites-glazing in offices; exterior aluminum doors/frames

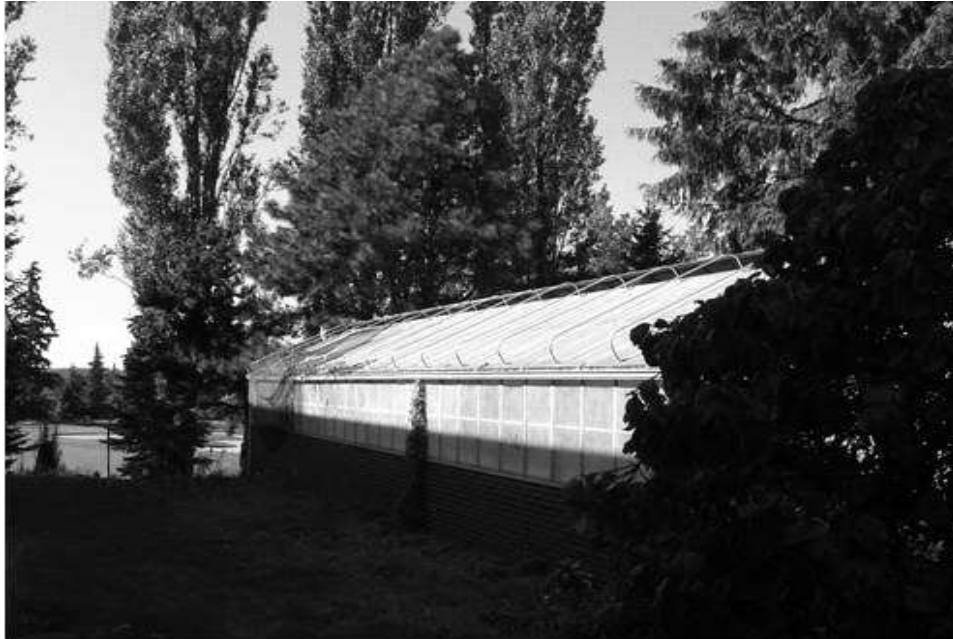
Greenh (050-0GH) STATE UFI: A10590 Main Campus (050A)
 AREA: 1,660 SF BUILT: 1977 REMODELED: 2013 PREDOMINANT USE: Greenhouse
 CONSTRUCTION TYPE: Light CRV/SF: \$198 REPLACEMENT VALUE: \$328,680

Primary Systems			
COMPONENT:	Structure	RATING: 1 x WEIGHT: 9.7 = SCORE: 9.7	
No signs of settlement or cracking, no abrupt vertical changes Columns, bearing walls and roof structure appears sound/free of defects			
COMMENTS:	Aluminum framing		
COMPONENT:	Exterior Closure	RATING: 2 x WEIGHT: 9.7 = SCORE: 19.3	
Weatherproof exterior, but finish appears poorly maintained			
COMMENTS:	Brick base; acrylic glazing		
COMPONENT:	Roofing	RATING: 1 x WEIGHT: 12.1 = SCORE: 12.1	
Flashing and penetrations appear sound and membrane appears water- tight; drainage is positive and there are overflow scuppers			
COMMENTS:	Metal panels; acrylic panels 2007

Secondary Systems			
COMPONENT:	Floor Finishes	RATING: 1 x WEIGHT: 7.2 = SCORE: 7.2	
	Nice appearance, smooth transitions, level subfloors, no cracks/separating		
COMMENTS:	Concrete slab		
COMPONENT:	Wall Finishes	RATING: 3 x WEIGHT: 7.2 = SCORE: 21.7	
	Aging surfaces, but sound; some maintenance is required		
COMMENTS:	Brick and acrylic panels		
COMPONENT:	Ceiling Finishes	RATING: 0 x WEIGHT: 0 = SCORE: 0	
	No data		
COMMENTS:	Acrylic		
COMPONENT:	Doors & Hardware	RATING: 3 x WEIGHT: 7.2 = SCORE: 21.7	
	Functional, but dated; some maintenance required		
COMMENTS:	Aluminum doors/frames

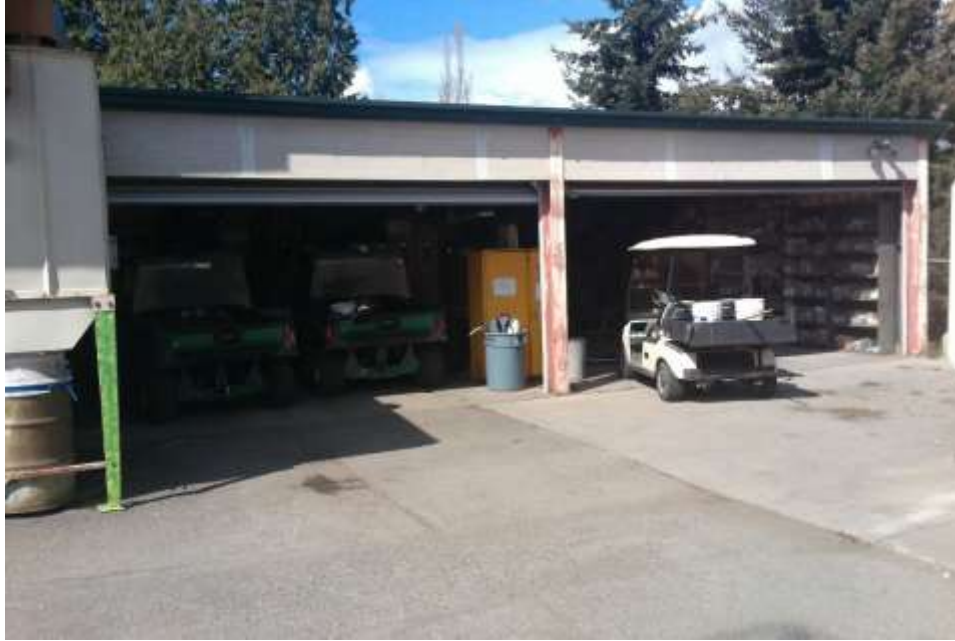
Ground (050-OGR) STATE UFI: A07927 Main Campus (050A)
AREA: 860 SF BUILT: 1970 REMODELED: No PREDOMINANT USE: Maintenance
CONSTRUCTION TYPE: Light CRV/SF: \$264 REPLACEMENT VALUE: \$227,040

Primary Systems			
COMPONENT:	Structure	RATING: 1 x WEIGHT: 11.1 =	SCORE: 11.1
No signs of settlement or cracking, no abrupt vertical changes Columns, bearing walls and roof structure appears sound/free of defects			
COMMENTS:	Wood frame on slab		
COMPONENT:	Exterior Closure	RATING: 3 x WEIGHT: 11.1 =	SCORE: 33.4
Sound and weatherproof but with some physical deterioration evident			
COMMENTS:	Brick veneer base; T1-11 siding; plywood soffits		
COMPONENT:	Roofing	RATING: 3 x WEIGHT: 13.9 =	SCORE: 41.7
Some deterioration is evident in membrane and flashings; maintenance or minor repair is needed			
COMMENTS:	Composition shingles

Secondary Systems			
COMPONENT:	Floor Finishes	RATING: 1 x WEIGHT: 8.3 =	SCORE: 8.3
Nice appearance, smooth transitions, level subfloors, no cracks/separating			
COMMENTS:	Concrete; vinyl tile		
COMPONENT:	Wall Finishes	RATING: 0 x WEIGHT: 0 =	SCORE: 0
No data			
COMMENTS:	exposed structure		
COMPONENT:	Ceiling Finishes	RATING: 0 x WEIGHT: 0 =	SCORE: 0
No data			
COMMENTS:	T&G decking		
COMPONENT:	Doors & Hardware	RATING: 2 x WEIGHT: 8.3 =	SCORE: 16.7
Fairly modern door surfaces and hardware with minor deterioration; good working order			
COMMENTS:	Interior wood door/frame; exterior HM door/frame; OH sectional door

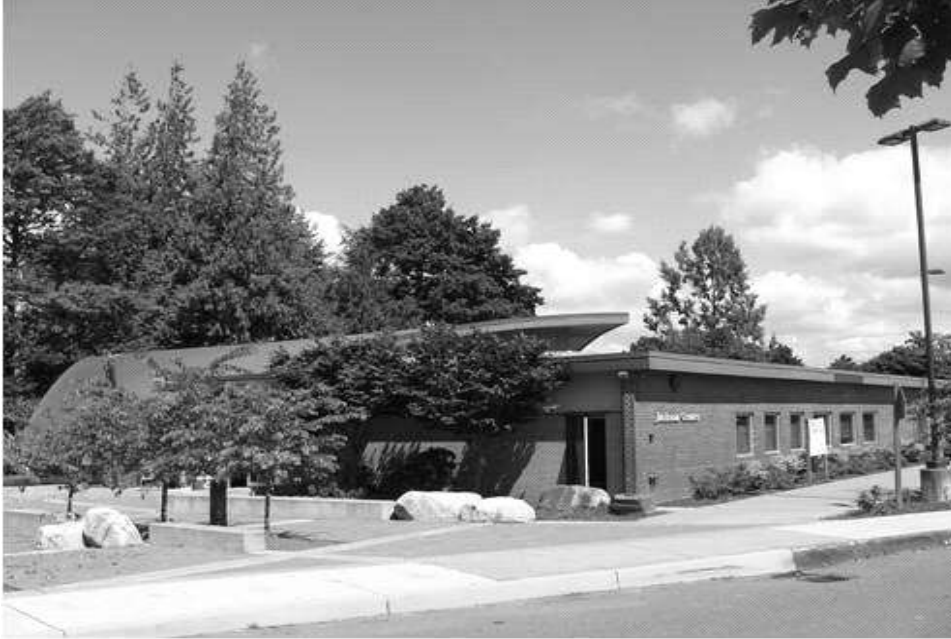
Jackson (050-BCR) STATE UFI: A07164 Main Campus (050A)
 AREA: 12,971 SF BUILT: 1968 REMODELED: 2012 PREDOMINANT USE: Multi-Use
 CONSTRUCTION TYPE: Medium CRV/SF: \$395 REPLACEMENT VALUE: \$5,123,545

Primary Systems			
COMPONENT:	Structure	RATING: 1 x WEIGHT: 8 =	SCORE: 8
No signs of settlement or cracking, no abrupt vertical changes Columns, bearing walls and roof structure appears sound/free of defects			
COMMENTS:	Concrete; structural steel; CMU; glu-lam beams		
COMPONENT:	Exterior Closure	RATING: 1 x WEIGHT: 8 =	SCORE: 8
Weatherproof, tight, well-maintained exterior walls, doors, windows/finishes			
COMMENTS:	Brick, marblecrete, metal fascia & soffit		
COMPONENT:	Roofing	RATING: 1 x WEIGHT: 10 =	SCORE: 10
Flashing and penetrations appear sound and membrane appears water- tight; drainage is positive and there are overflow scuppers			
COMMENTS:	EPDM at flat area; C-plast membrane on curved roof; PVC single-ply membrane in 2007

Secondary Systems			
COMPONENT:	Floor Finishes	RATING: 1 x WEIGHT: 6 = SCORE: 6	
	Nice appearance, smooth transitions, level subfloors, no cracks/separating		
COMMENTS:	VAT and vinyl composition tile; ceramic tile		
COMPONENT:	Wall Finishes	RATING: 1 x WEIGHT: 6 = SCORE: 6	
	Maintainable surfaces in good condition		
COMMENTS:	Brick; concrete; ceramic tile; CMU		
COMPONENT:	Ceiling Finishes	RATING: 1 x WEIGHT: 6 = SCORE: 6	
	Maintainable surfaces in good condition; good alignment and appearance		
COMMENTS:	Direct-adhered and lay-in tiles; gypsum board		
COMPONENT:	Doors & Hardware	RATING: 1 x WEIGHT: 6 = SCORE: 6	
	Appropriate hardware, closers, panic devices; in good working order		
COMMENTS:	Interior wood doors w HM frames; exterior aluminum and HM doors/frames

Service Systems			
COMPONENT:	Elevators	RATING: 1 x WEIGHT: 6 = SCORE: 6	
	Appropriate and functional for occupancy and use		
COMMENTS:	2 stop; main floor and basement used for records storage		
COMPONENT:	Plumbing	RATING: 1 x WEIGHT: 8 = SCORE: 8	
	Fixtures and piping appear to be in good condition; no evidence of leaks		
COMMENTS:	Galvanized, cast iron, steel and copper piping; porcelain fixtures		
COMPONENT:	HVAC	RATING: 1 x WEIGHT: 8 = SCORE: 8	
	Equipment in good condition; easily controlled; serves all required spaces; All necessary spaces are adequately ventilated; A/C provided throughout		
COMMENTS:	Rooftop packaged HVAC unit-2007; Boiler and majority HVAC replaced 2012		
COMPONENT:	Electrical	RATING: 1 x WEIGHT: 8 = SCORE: 8	
	Adequate service and distribution capacity for current/future needs		
COMMENTS:	400amp 208/120v; new transformer in 2008		
COMPONENT:	Lights/Power	RATING: 1 x WEIGHT: 8 = SCORE: 8

Safety Systems			
COMPONENT:	Life/Safety	RATING: 3 x WEIGHT: 10 = SCORE: 30	
	Generally meets codes for vintage of construction		
COMMENTS:			
COMPONENT:	Fire Safety	RATING: 1 x WEIGHT: 10 = SCORE: 10	
	Locally monitored detection; alarm and strobes present; sprinklers in high hazard areas		
COMMENTS:	New fire alarm panel in 2008		
COMPONENT:	Modifications	RATING: 1 x WEIGHT: 7 = SCORE: 7	
	Modifications appear to be in compliance with codes and sound construction practices; HVAC/electrical service properly provided		
COMMENTS:	Remodel of student services area 2011

Quality Standards			
COMPONENT:	Maintenance	RATING: 1 x WEIGHT: 7 = SCORE: 7	
	Facility appears well maintained		
COMMENTS:			
COMPONENT:	Remaining Life	RATING: 2 x WEIGHT: 6 = SCORE: 12	
	Life expectancy is 15-20 years; minor to moderate system deterioration		
COMMENTS:	Structurally adequate building; interior remodel could extend useful life		
COMPONENT:	Appearance	RATING: 3 x WEIGHT: 6 = SCORE: 18	
	Average construction; average interior and exterior appearance		
COMMENTS:

CONDITION: Adequate

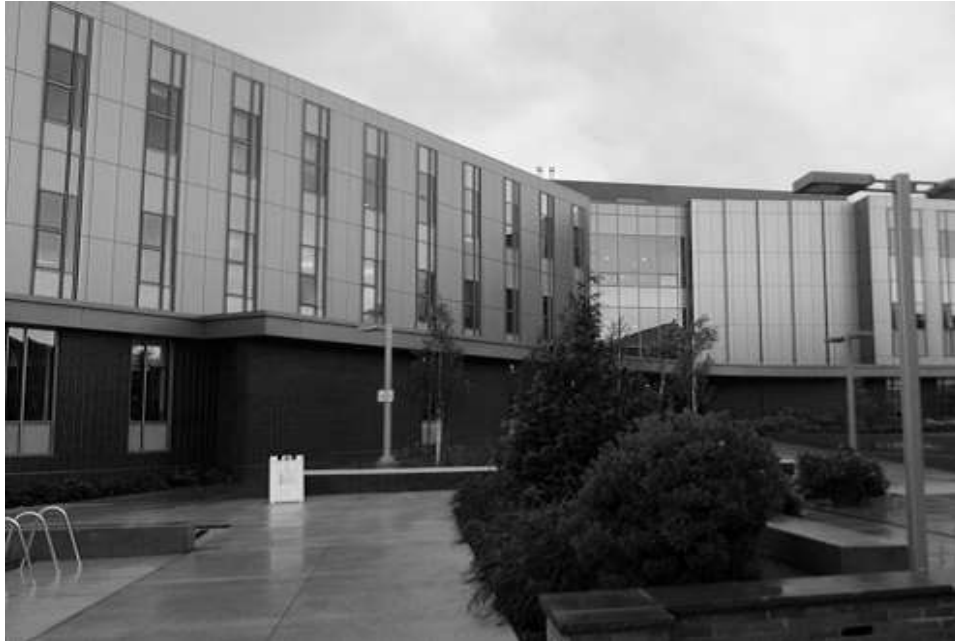
Liberty Hall (050-LBH) STATE UFI: A13569 Main Campus (050A)
AREA: 88,000 SF BUILT: 2013 REMODELED: No PREDOMINANT USE: Classroom
CONSTRUCTION TYPE: Heavy CRV/SF: \$643 REPLACEMENT VALUE: \$56,584,000

Primary Systems			
COMPONENT:	Structure	RATING: 1 x WEIGHT: 8.4 = SCORE: 8.4	
No signs of settlement or cracking, no abrupt vertical changes Columns, bearing walls and roof structure appears sound/free of defects			
COMMENTS:			
COMPONENT:	Exterior Closure	RATING: 1 x WEIGHT: 8.4 = SCORE: 8.4	
Weatherproof, tight, well-maintained exterior walls, doors, windows/finishes			
COMMENTS:			
COMPONENT:	Roofing	RATING: 1 x WEIGHT: 10.5 = SCORE: 10.5	
Flashing and penetrations appear sound and membrane appears water- tight; drainage is positive and there are overflow scuppers			
COMMENTS:

Secondary Systems			
COMPONENT:	Floor Finishes	RATING: 1 x WEIGHT: 6.3 = SCORE: 6.3	
	Nice appearance, smooth transitions, level subfloors, no cracks/separating		
COMMENTS:			
COMPONENT:	Wall Finishes	RATING: 1 x WEIGHT: 6.3 = SCORE: 6.3	
	Maintainable surfaces in good condition		
COMMENTS:			
COMPONENT:	Ceiling Finishes	RATING: 1 x WEIGHT: 6.3 = SCORE: 6.3	
	Maintainable surfaces in good condition; good alignment and appearance		
COMMENTS:			
COMPONENT:	Doors & Hardware	RATING: 1 x WEIGHT: 6.3 = SCORE: 6.3	
	Appropriate hardware, closers, panic devices; in good working order		
COMMENTS:

Service Systems			
COMPONENT:	Elevators	RATING: 1 x WEIGHT: 6.3 = SCORE: 6.3	
	Appropriate and functional for occupancy and use		
COMMENTS:			
COMPONENT:	Plumbing	RATING: 1 x WEIGHT: 8.4 = SCORE: 8.4	
	Fixtures and piping appear to be in good condition; no evidence of leaks		
COMMENTS:			
COMPONENT:	HVAC	RATING: 1 x WEIGHT: 8.4 = SCORE: 8.4	
	Equipment in good condition; easily controlled; serves all required spaces; All necessary spaces are adequately ventilated; A/C provided throughout		
COMMENTS:			
COMPONENT:	Electrical	RATING: 1 x WEIGHT: 8.4 = SCORE: 8.4	
	Adequate service and distribution capacity for current/future needs		
COMMENTS:			
COMPONENT:	Lights/Power	RATING: 1 x WEIGHT: 8.4 = SCORE: 8.4	
	Contemporary lighting with good work area illumination; ample outlets		
COMMENTS:

Safety Systems			
COMPONENT:	Life/Safety	RATING: 1 x WEIGHT: 10.5 =	SCORE: 10.5
Appears to meet current codes			
COMMENTS:			
COMPONENT:	Fire Safety	RATING: 1 x WEIGHT: 10.5 =	SCORE: 10.5
Locally monitored detection; alarm and strobes present; sprinklers in high hazard areas			
COMMENTS:			
COMPONENT:	Modifications	RATING: 0 x WEIGHT: 0 =	SCORE: 0
No data			
COMMENTS: None - New building

Quality Standards			
COMPONENT:	Maintenance	RATING: 1 x WEIGHT: 7.4 =	SCORE: 7.4
Facility appears well maintained			
COMMENTS:			
COMPONENT:	Remaining Life	RATING: 1 x WEIGHT: 6.3 =	SCORE: 6.3
Life expectancy is >20 years; minor system deterioration			
COMMENTS:			
COMPONENT:	Appearance	RATING: 1 x WEIGHT: 6.3 =	SCORE: 6.3
Well-constructed building; generally attractive interior and exterior			
COMMENTS:

CONDITION: Superior

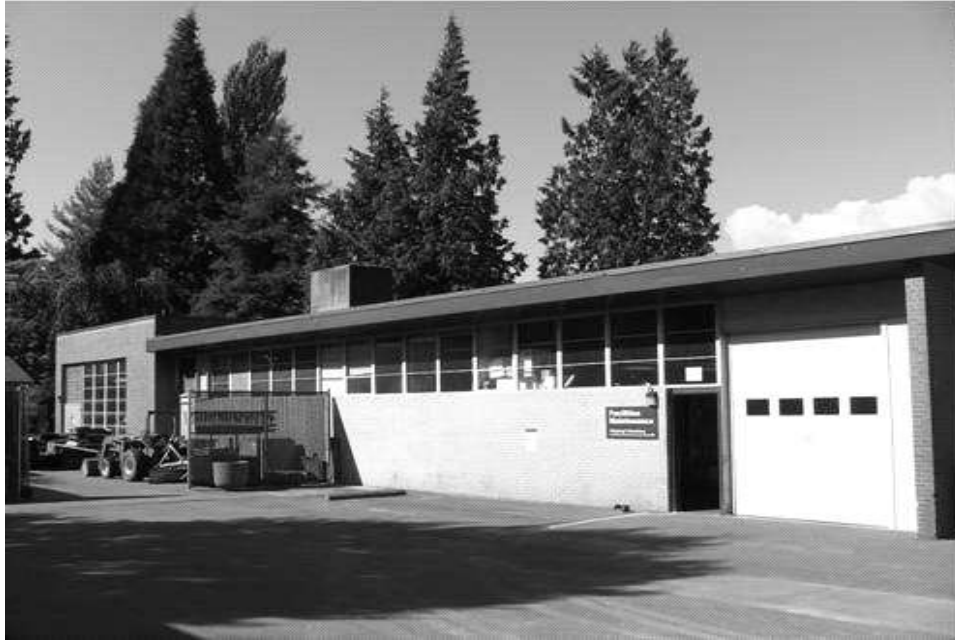
Maintenance (050-OMT) STATE UFI: A10257 Main Campus (050A)
AREA: 6,651 SF BUILT: 1958 REMODELED: No PREDOMINANT USE: Maintenance
CONSTRUCTION TYPE: Medium CRV/SF: \$264 REPLACEMENT VALUE: \$1,755,864

Primary Systems			
COMPONENT:	Structure	RATING: 1 x WEIGHT: 8.3 =	SCORE: 8.3
No signs of settlement or cracking, no abrupt vertical changes Columns, bearing walls and roof structure appears sound/free of defects			
COMMENTS:	Steel frame; glu-lam roof beams; CMU		
COMPONENT:	Exterior Closure	RATING: 3 x WEIGHT: 8.3 =	SCORE: 25
Sound and weatherproof but with some physical deterioration evident			
COMMENTS:	Brick veneer over CMU; cement board soffits		
COMPONENT:	Roofing	RATING: 3 x WEIGHT: 10.4 =	SCORE: 31.3
Some deterioration is evident in membrane and flashings; maintenance or minor repair is needed			
COMMENTS:	Single-ply EPDM; no leak problems reported

Secondary Systems			
COMPONENT:	Floor Finishes	RATING: 2 x WEIGHT: 6.3 =	SCORE: 12.5
Some wear is evident on finish; maintenance needed			
COMMENTS:	Concrete; carpet; vinyl tile		
COMPONENT:	Wall Finishes	RATING: 3 x WEIGHT: 6.3 =	SCORE: 18.8
Aging surfaces, but sound; some maintenance is required			
COMMENTS:	Gypsum board and CMU		
COMPONENT:	Ceiling Finishes	RATING: 1 x WEIGHT: 6.3 =	SCORE: 6.3
Maintainable surfaces in good condition; good alignment and appearance			
COMMENTS:	Exposed structure; wood decking; lay-in tiles; gypsum board		
COMPONENT:	Doors & Hardware	RATING: 3 x WEIGHT: 6.3 =	SCORE: 18.8
Functional, but dated; some maintenance required			
COMMENTS:	Interior wood and HM doors w HM frames; exterior HM doors/frames

Service Systems			
COMPONENT:	Elevators	RATING: 0 x WEIGHT: 0 =	SCORE: 0
No data			
COMMENTS:			
COMPONENT:	Plumbing	RATING: 3 x WEIGHT: 8.3 =	SCORE: 25
Fixtures are functional but dated; some leaks; maintenance required			
COMMENTS:	Galvanized, cast iron, steel and copper piping; porcelain fixtures		
COMPONENT:	HVAC	RATING: 3 x WEIGHT: 8.3 =	SCORE: 25
System generally adequate; some deterioration; needs balancing; some areas have A/C; hazardous areas are ventilated			
COMMENTS:	49 year old steam boilers; steam unit heaters; dust collector		
COMPONENT:	Electrical	RATING: 1 x WEIGHT: 8.3 =	SCORE: 8.3
Adequate service and distribution capacity for current/future needs			
COMMENTS:	1600amp 208/120v; new in 2010		
COMPONENT:	Lights/Power	RATING: 3 x WEIGHT: 8.3 =	SCORE: 25
Adequate work area illumination; adequate outlets for current use; maintenance required			
COMMENTS:	Lay-in, hanging and surface-mount fluorescent fixtures

Quality Standards			
COMPONENT:	Maintenance	RATING: 2 x WEIGHT: 7.3 =	SCORE: 14.6
Routine maintenance is required; impact is minor			
COMMENTS:			
COMPONENT:	Remaining Life	RATING: 3 x WEIGHT: 6.3 =	SCORE: 18.8
Life expectancy is roughly 10-15 years; moderate system deterioration			
COMMENTS:			
COMPONENT:	Appearance	RATING: 5 x WEIGHT: 6.3 =	SCORE: 31.3
Poor to average construction; very unattractive exterior and interior spaces			
COMMENTS:

CONDITION: Needs Improvement/Renovation

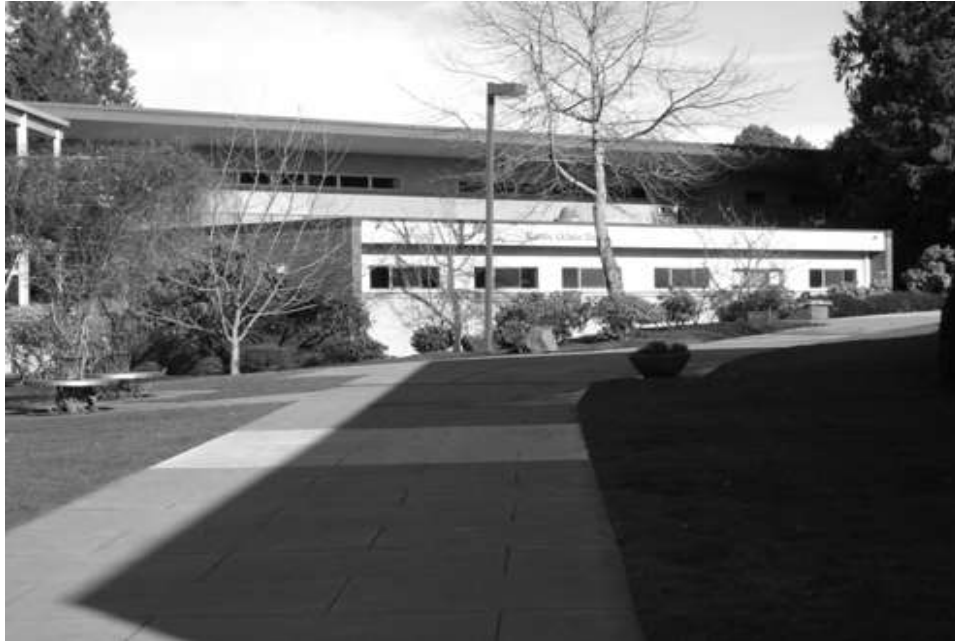
Monte Cristo (050-00M) STATE UFI: A10131 Main Campus (050A)
AREA: 22,956 SF BUILT: 1958 REMODELED: No PREDOMINANT USE: Science Lab.
CONSTRUCTION TYPE: Medium CRV/SF: \$489 REPLACEMENT VALUE: \$11,225,484

Primary Systems			
COMPONENT:	Structure	RATING: 3 x WEIGHT: 8 =	SCORE: 24
Some cracking evident but does not likely affect structural integrity; Visible defects apparent but are non-structural			
COMMENTS:	Concrete; structural steel;		
COMPONENT:	Exterior Closure	RATING: 3 x WEIGHT: 8 =	SCORE: 24
Sound and weatherproof but with some physical deterioration evident			
COMMENTS:	Weatherization problems, many windows leaking & deteriorating		
COMPONENT:	Roofing	RATING: 4 x WEIGHT: 10 =	SCORE: 40
General deterioration and some leaks are evident; reconditioning or partial repair is needed			
COMMENTS:	EPDM single-ply roof

Secondary Systems			
COMPONENT:	Floor Finishes	RATING: 3 x WEIGHT: 6 = SCORE: 18	
	Some physical wear and minor imperfections are evident; beginning deterioration		
COMMENTS:	Vinyl tile; ceramic tile		
COMPONENT:	Wall Finishes	RATING: 3 x WEIGHT: 6 = SCORE: 18	
	Aging surfaces, but sound; some maintenance is required		
COMMENTS:	Gypsum board; brick; ceramic tile		
COMPONENT:	Ceiling Finishes	RATING: 3 x WEIGHT: 6 = SCORE: 18	
	Some wear and tear; Minor damage, staining or deterioration		
COMMENTS:	Lay-in tile		
COMPONENT:	Doors & Hardware	RATING: 4 x WEIGHT: 6 = SCORE: 24	
	General deterioration evident in both door and hardware; some doors with significant deterioration		
COMMENTS:	Interior and exterior wood doors/HM frames

Service Systems			
COMPONENT:	Elevators	RATING: 3 x WEIGHT: 6 = SCORE: 18	
	Elevators provided but functionality is inadequate; Unreliable operation		
COMMENTS:	Shared elevator with Baker; too small		
COMPONENT:	Plumbing	RATING: 4 x WEIGHT: 8 = SCORE: 32	
	General deterioration of most fixtures and pipes; moderate number of leaks and blockage areas; need repairs		
COMMENTS:	Galvanized, cast iron and steel; no fixtures		
COMPONENT:	HVAC	RATING: 4 x WEIGHT: 8 = SCORE: 32	
	System partially adequate; many areas served by equipment needing repair; areas with A/C very limited, but hazardous areas are ventilated		
COMMENTS:	Univents for heating only on first floor. Second floor has fan coils.		
COMPONENT:	Electrical	RATING: 3 x WEIGHT: 8 = SCORE: 24	
	Service capacity meets current needs but inadequate for future		
COMMENTS:	600amp 208/120v		
COMPONENT:	Lights/Power	RATING: 3 x WEIGHT: 8 = SCORE: 24	
	Adequate work area illumination; adequate outlets for current use; maintenance required

Safety Systems			
COMPONENT:	Life/Safety	RATING: 3 x WEIGHT: 10 = SCORE: 30	
	Generally meets codes for vintage of construction		
COMMENTS:			
COMPONENT:	Fire Safety	RATING: 2 x WEIGHT: 10 = SCORE: 20	
	Locally monitored detection; alarm present, but missing visual component or sprinklers		
COMMENTS:			
COMPONENT:	Modifications	RATING: 5 x WEIGHT: 7 = SCORE: 35	
	Modifications not well thought out or constructed; inadequate HVAC and electrical service provided		
COMMENTS:

Quality Standards			
COMPONENT:	Maintenance	RATING: 4 x WEIGHT: 7 = SCORE: 28	
	Lack of maintenance in some areas is evident; impact is moderate		
COMMENTS:			
COMPONENT:	Remaining Life	RATING: 5 x WEIGHT: 6 = SCORE: 30	
	Life expectancy is <5 years; significant system deterioration		
COMMENTS:	BLDG. TO BE USED AS SURGE FOR PENDING REPLACEMENT CONSTRUCTION; THEN DEMOLISHED		
COMPONENT:	Appearance	RATING: 5 x WEIGHT: 6 = SCORE: 30	
	Poor to average construction; very unattractive exterior and interior spaces		
COMMENTS:

CONDITION: Replace or Renovate

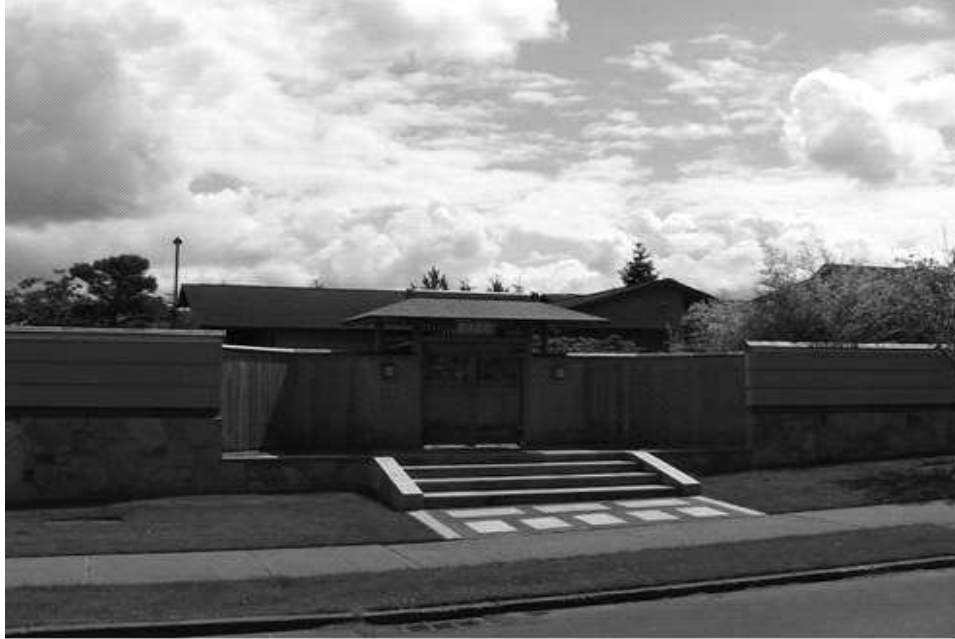
Nippon Business Institute (050-AX2) STATE UFI: A10288 Main Campus (050A)
AREA: 4,667 SF BUILT: 1938 REMODELED: No PREDOMINANT USE: Multi-Use
CONSTRUCTION TYPE: Medium CRV/SF: \$395 REPLACEMENT VALUE: \$1,843,465

Primary Systems			
COMPONENT:	Structure	RATING: 2 x WEIGHT: 8.3 =	SCORE: 16.7
Minor cracks evident in a small portion of the structure			
COMMENTS:	Wood frame; CMU; Glu-lam beams		
COMPONENT:	Exterior Closure	RATING: 3 x WEIGHT: 8.3 =	SCORE: 25
Sound and weatherproof but with some physical deterioration evident			
COMMENTS:	Brick; CMU; stucco; wood-frame window wall; vinyl siding-damaged		
COMPONENT:	Roofing	RATING: 1 x WEIGHT: 10.4 =	SCORE: 10.4
Flashing and penetrations appear sound and membrane appears water- tight; drainage is positive and there are overflow scuppers			
COMMENTS:	Composition shingles 2020

Secondary Systems			
COMPONENT:	Floor Finishes	RATING: 3 x WEIGHT: 6.3 =	SCORE: 18.8
Some physical wear and minor imperfections are evident; beginning deterioration			
COMMENTS:	Carpet tile; ceramic tile,, carpet; sheet vinyl; Tatami mats		
COMPONENT:	Wall Finishes	RATING: 1 x WEIGHT: 6.3 =	SCORE: 6.3
Maintainable surfaces in good condition			
COMMENTS:	Gypsum board; sliding paper screens		
COMPONENT:	Ceiling Finishes	RATING: 2 x WEIGHT: 6.3 =	SCORE: 12.5
Aging surfaces in fair condition and good alignment			
COMMENTS:	Gypsum board; wood slats; lay-in tile		
COMPONENT:	Doors & Hardware	RATING: 2 x WEIGHT: 6.3 =	SCORE: 12.5
Fairly modern door surfaces and hardware with minor deterioration; good working order			
COMMENTS:	Interior wood doors/frames and metal coiling door; exterior HM doors/frames

Service Systems			
COMPONENT:	Elevators	RATING: 0 x WEIGHT: 0 =	SCORE: 0
No data			
COMMENTS:			
COMPONENT:	Plumbing	RATING: 1 x WEIGHT: 8.3 =	SCORE: 8.3
Fixtures and piping appear to be in good condition; no evidence of leaks			
COMMENTS:	Copper, cast iron, steel and PVC piping; porcelain fixtures		
COMPONENT:	HVAC	RATING: 1 x WEIGHT: 8.3 =	SCORE: 8.3
Equipment in good condition; easily controlled; serves all required spaces; All necessary spaces are adequately ventilated; A/C provided throughout			
COMMENTS:	Split system heat pumps 2020		
COMPONENT:	Electrical	RATING: 1 x WEIGHT: 8.3 =	SCORE: 8.3
Adequate service and distribution capacity for current/future needs			
COMMENTS:	200amp 208/120v		
COMPONENT:	Lights/Power	RATING: 1 x WEIGHT: 8.3 =	SCORE: 8.3
Contemporary lighting with good work area illumination; ample outlets			
COMMENTS:	Hanging, recessed can, wall-mount and ceiling-mount fluorescent fixtures

Quality Standards			
COMPONENT:	Maintenance	RATING: 1 x WEIGHT: 7.3 =	SCORE: 7.3
Facility appears well maintained			
COMMENTS:			
COMPONENT:	Remaining Life	RATING: 1 x WEIGHT: 6.3 =	SCORE: 6.3
Life expectancy is >20 years; minor system deterioration			
COMMENTS:			
COMPONENT:	Appearance	RATING: 2 x WEIGHT: 6.3 =	SCORE: 12.5
Well-constructed building; average interior and exterior appearance			
COMMENTS: Historic building; Large Japanese style garden greatly enhances aesthetics

CONDITION: Adequate

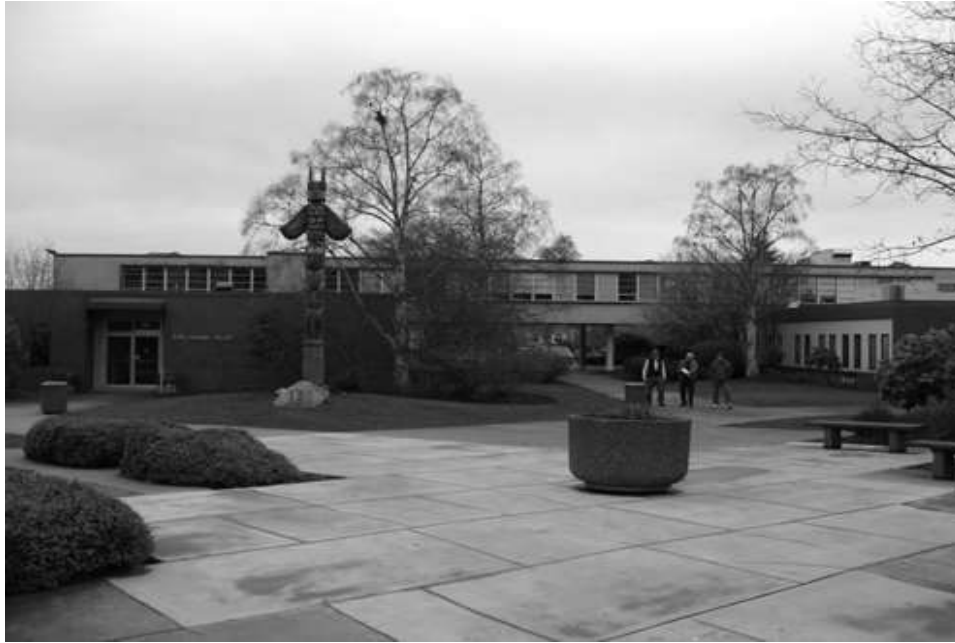
Olympus Hall (050-000) STATE UFI: A10814 Main Campus (050A)
AREA: 23,612 SF BUILT: 1958 REMODELED: 2015 PREDOMINANT USE: Multi-Use
CONSTRUCTION TYPE: Medium CRV/SF: \$395 REPLACEMENT VALUE: \$9,326,740

Primary Systems			
COMPONENT:	Structure	RATING: 2 x WEIGHT: 8 =	SCORE: 16
Minor cracks evident in a small portion of the structure			
COMMENTS: Concrete; steel; wood; seismic issues			
COMPONENT:	Exterior Closure	RATING: 1 x WEIGHT: 8 =	SCORE: 8
Weatherproof, tight, well-maintained exterior walls, doors, windows/finishes			
COMMENTS: Brick veneer, marblecrete, EIFS, plaster soffits			
COMPONENT:	Roofing	RATING: 1 x WEIGHT: 10 =	SCORE: 10
Flashing and penetrations appear sound and membrane appears water- tight; drainage is positive and there are overflow scuppers			
COMMENTS: Single ply EPDM membrane, mechanically fastened

Secondary Systems			
COMPONENT:	Floor Finishes	RATING: 2 x WEIGHT: 6 = SCORE: 12	
	Some wear is evident on finish; maintenance needed		
COMMENTS:	Carpet-WORN; concrete; ceramic tile; terrazzo stair; sheet vinyl		
COMPONENT:	Wall Finishes	RATING: 1 x WEIGHT: 6 = SCORE: 6	
	Maintainable surfaces in good condition		
COMMENTS:	Gypsum board; hardboard; ceramic tile		
COMPONENT:	Ceiling Finishes	RATING: 1 x WEIGHT: 6 = SCORE: 6	
	Maintainable surfaces in good condition; good alignment and appearance		
COMMENTS:	Lay-in tile; gypsum board; random deterioration		
COMPONENT:	Doors & Hardware	RATING: 3 x WEIGHT: 6 = SCORE: 18	
	Functional, but dated; some maintenance required		
COMMENTS:	Interior wood doors w HM frames; exterior aluminum doors/frames; mix of ages and types

Service Systems			
COMPONENT:	Elevators	RATING: 3 x WEIGHT: 6 = SCORE: 18	
	Elevators provided but functionality is inadequate; Unreliable operation		
COMMENTS:	2 stop		
COMPONENT:	Plumbing	RATING: 3 x WEIGHT: 8 = SCORE: 24	
	Fixtures are functional but dated; some leaks; maintenance required		
COMMENTS:	Galvanized, cast iron, copper, and steel piping; porcelain fixtures		
COMPONENT:	HVAC	RATING: 1 x WEIGHT: 8 = SCORE: 8	
	Equipment in good condition; easily controlled; serves all required spaces; All necessary spaces are adequately ventilated; A/C provided throughout		
COMMENTS:	Fan coil units in each classroom, multi-zone rooftop units serving offices 2016		
COMPONENT:	Electrical	RATING: 1 x WEIGHT: 8 = SCORE: 8	
	Adequate service and distribution capacity for current/future needs		
COMMENTS:	1200amp 480/120v - new in 2005; also feeds Baker Hall		
COMPONENT:	Lights/Power	RATING: 2 x WEIGHT: 8 = SCORE: 16

Safety Systems			
COMPONENT:	Life/Safety	RATING: 2 x WEIGHT: 10 = SCORE: 20	
Most areas meet current codes; some areas meet codes for prior construction phases			
COMMENTS:			
COMPONENT:	Fire Safety	RATING: 2 x WEIGHT: 10 = SCORE: 20	
Locally monitored detection; alarm present, but missing visual component or sprinklers			
COMMENTS:			
COMPONENT:	Modifications	RATING: 2 x WEIGHT: 7 = SCORE: 14	
Modifications appear to be in compliance with codes and sound construction practices, however, HVAC/electrical service was not properly reconfigured			
COMMENTS: South wing remodels are dated

Quality Standards			
COMPONENT:	Maintenance	RATING: 2 x WEIGHT: 7 = SCORE: 14	
Routine maintenance is required; impact is minor			
COMMENTS: A lot of deferred repairs as building was a high priority for replacement			
COMPONENT:	Remaining Life	RATING: 2 x WEIGHT: 6 = SCORE: 12	
Life expectancy is 15-20 years; minor to moderate system deterioration			
COMMENTS:			
COMPONENT:	Appearance	RATING: 2 x WEIGHT: 6 = SCORE: 12	
Well-constructed building; average interior and exterior appearance			
COMMENTS: Mid-century modernist design but very spartan; unattractive interiors

CONDITION: Needs Improvement/Additional Maintenance
