2023 FACILITY CONDITION SURVEY

Everett Community College

SURVEY CONDUCTED BY:
Steve Lewandowski
State Board for Community
and Technical Colleges

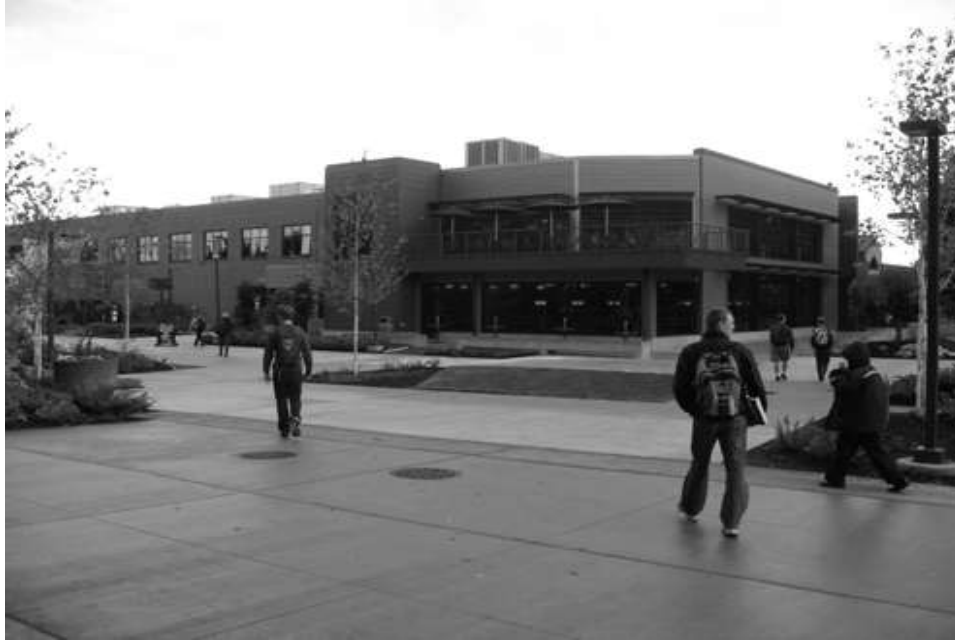
Parks/Terrey (050-LSC) STATE UFI: A00051 Main Campus (050A)
AREA: 85,069 SF BUILT: 1988 REMODELED: 2011 PREDOMINANT USE: Student Center
CONSTRUCTION TYPE: Heavy CRV/SF: \$391 REPLACEMENT VALUE: \$33,261,979

Primary Systems			
COMPONENT:	Structure	RATING: 1 x WEIGHT: 8 =	SCORE: 8
No signs of settlement or cracking, no abrupt vertical changes Columns, bearing walls and roof structure appears sound/free of defects			
COMMENTS:	Concrete; steel-frame; glu-lam beams		
COMPONENT:	Exterior Closure	RATING: 2 x WEIGHT: 8 =	SCORE: 16
Weatherproof exterior, but finish appears poorly maintained			
COMMENTS:	Brick; stucco; metal fascia; laminate panels; aluminum window walls		
COMPONENT:	Roofing	RATING: 3 x WEIGHT: 10 =	SCORE: 30
Some deterioration is evident in membrane and flashings; maintenance or minor repair is needed			
COMMENTS:	BUR mineral cap sheet membrane-2009; metal roof sections - faded; repairs funded 23-25

Secondary Systems			
COMPONENT:	Floor Finishes	RATING: 2 x WEIGHT: 6 = SCORE: 12	
	Some wear is evident on finish; maintenance needed		
COMMENTS:	Vinyl tile; carpet-lots of upstairs wear; concrete; ceramic tile; carpet tile		
COMPONENT:	Wall Finishes	RATING: 1 x WEIGHT: 6 = SCORE: 6	
	Maintainable surfaces in good condition		
COMMENTS:	Gypsum board; CMU; ceramic tile		
COMPONENT:	Ceiling Finishes	RATING: 2 x WEIGHT: 6 = SCORE: 12	
	Aging surfaces in fair condition and good alignment		
COMMENTS:	Lay-in tile; gypsum board; metal deck pan		
COMPONENT:	Doors & Hardware	RATING: 1 x WEIGHT: 6 = SCORE: 6	
	Appropriate hardware, closers, panic devices; in good working order		
COMMENTS:	Interior wood and laminate doors w HM frames-some glazed; exterior aluminum doors/frames; metal coiling door

Service Systems			
COMPONENT:	Elevators	RATING: 1 x WEIGHT: 6 = SCORE: 6	
	Appropriate and functional for occupancy and use		
COMMENTS:	Partial first floor; full second floor west side; partial third floor		
COMPONENT:	Plumbing	RATING: 1 x WEIGHT: 8 = SCORE: 8	
	Fixtures and piping appear to be in good condition; no evidence of leaks		
COMMENTS:	Copper, cast iron, steel, ABS and PVC piping; porcelain fixtures		
COMPONENT:	HVAC	RATING: 1 x WEIGHT: 8 = SCORE: 8	
	Equipment in good condition; easily controlled; serves all required spaces; All necessary spaces are adequately ventilated; A/C provided throughout		
COMMENTS:	2 HW boilers-2011; rooftop packaged HVAC units w DX cooling; split system HVAC units		
COMPONENT:	Electrical	RATING: 1 x WEIGHT: 8 = SCORE: 8	
	Adequate service and distribution capacity for current/future needs		
COMMENTS:	1200amp 480/277v		
COMPONENT:	Lights/Power	RATING: 1 x WEIGHT: 8 = SCORE: 8

Safety Systems			
COMPONENT:	Life/Safety	RATING: 1 x WEIGHT: 10 = SCORE: 10	
	Appears to meet current codes		
COMMENTS:			
COMPONENT:	Fire Safety	RATING: 1 x WEIGHT: 10 = SCORE: 10	
	Locally monitored detection; alarm and strobes present; sprinklers in high hazard areas		
COMMENTS:	New fire alarm panel in 2008		
COMPONENT:	Modifications	RATING: 1 x WEIGHT: 7 = SCORE: 7	
	Modifications appear to be in compliance with codes and sound construction practices; HVAC/electrical service properly provided		
COMMENTS:	2005; 2011 cafeteria / dining renovation (10k SF); 2020 security office remodel (6k SF); all well done

Quality Standards			
COMPONENT:	Maintenance	RATING: 1 x WEIGHT: 7 = SCORE: 7	
	Facility appears well maintained		
COMMENTS:			
COMPONENT:	Remaining Life	RATING: 1 x WEIGHT: 6 = SCORE: 6	
	Life expectancy is >20 years; minor system deterioration		
COMMENTS:	Interior renovations have modernized the building		
COMPONENT:	Appearance	RATING: 1 x WEIGHT: 6 = SCORE: 6	
	Well-constructed building; generally attractive interior and exterior		
COMMENTS:

TOTAL SCORE = 204 PREVIOUS BIENNIUM SCORE = 186
CONDITION: Adequate

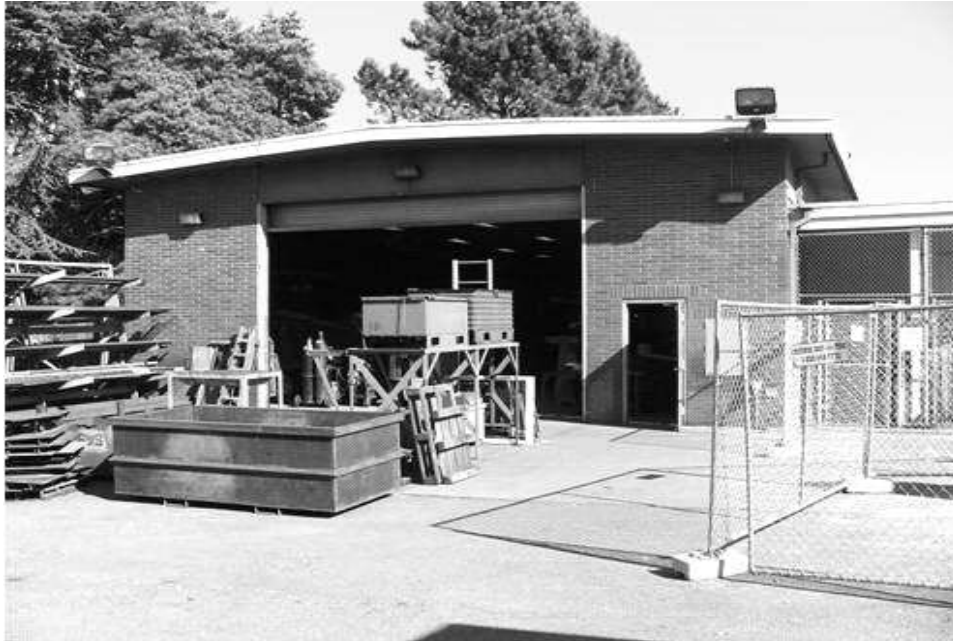
Pilchuk (050-PIL)	STATE UFI: A01047	Main Campus (050A)	
AREA: 4,674 SF	BUILT: 1958	REMODELED: No	PREDOMINANT USE: Vocational Arts
CONSTRUCTION TYPE: Medium	CRV/SF: \$395	REPLACEMENT VALUE: \$1,846,230

Primary Systems			
COMPONENT:	Structure	RATING: 1 x WEIGHT: 8.7 = SCORE: 8.7	
No signs of settlement or cracking, no abrupt vertical changes Columns, bearing walls and roof structure appears sound/free of defects			
COMMENTS:	Structural brick; open web wood/steel roof joists; concrete		
COMPONENT:	Exterior Closure	RATING: 1 x WEIGHT: 8.7 = SCORE: 8.7	
Weatherproof, tight, well-maintained exterior walls, doors, windows/finishes			
COMMENTS:	Brick		
COMPONENT:	Roofing	RATING: 5 x WEIGHT: 10.9 = SCORE: 54.5	
Leaking and deterioration is to point where new roof is required			
COMMENTS:	Single ply PVC membrane; no leak problems reported

Secondary Systems			
COMPONENT:	Floor Finishes	RATING: 1 x WEIGHT: 6.5 =	SCORE: 6.5
Nice appearance, smooth transitions, level subfloors, no cracks/separating			
COMMENTS:	Concrete		
COMPONENT:	Wall Finishes	RATING: 3 x WEIGHT: 6.5 =	SCORE: 19.6
Aging surfaces, but sound; some maintenance is required			
COMMENTS:	Brick		
COMPONENT:	Ceiling Finishes	RATING: 2 x WEIGHT: 6.5 =	SCORE: 13.1
Aging surfaces in fair condition and good alignment			
COMMENTS:	Metal deck pan		
COMPONENT:	Doors & Hardware	RATING: 3 x WEIGHT: 6.5 =	SCORE: 19.6
Functional, but dated; some maintenance required			
COMMENTS:	Interior and exterior HM doors/frames; OH metal door

Service Systems			
COMPONENT:	Elevators	RATING: 0 x WEIGHT: 0 =	SCORE: 0
No data			
COMMENTS:			
COMPONENT:	Plumbing	RATING: 3 x WEIGHT: 8.7 =	SCORE: 26.1
Fixtures are functional but dated; some leaks; maintenance required			
COMMENTS:	Galvanized, cast iron and steel piping; porcelain fixtures		
COMPONENT:	HVAC	RATING: 3 x WEIGHT: 8.7 =	SCORE: 26.1
System generally adequate; some deterioration; needs balancing; some areas have A/C; hazardous areas are ventilated			
COMMENTS:	Steam unit heaters; no cooling; powered ventilation-badly deteriorated; 2011 replacement		
COMPONENT:	Electrical	RATING: 2 x WEIGHT: 8.7 =	SCORE: 17.4
Adequate service and distribution capacity for current/future needs; some deterioration evident			
COMMENTS:	800amp 480/277v; transformer new in 2009		
COMPONENT:	Lights/Power	RATING: 3 x WEIGHT: 8.7 =	SCORE: 26.1
Adequate work area illumination; adequate outlets for current use; maintenance required

Quality Standards			
COMPONENT:	Maintenance	RATING: 3 x WEIGHT: 7.6 = SCORE: 22.9	
	Routine maintenance is required; deferred maintenance is evident; impact is minor to moderate		
COMMENTS:			
COMPONENT:	Remaining Life	RATING: 3 x WEIGHT: 6.5 = SCORE: 19.6	
	Life expectancy is roughly 10-15 years; moderate system deterioration		
COMMENTS:	Building would be structurally adequate for shop type uses for 10+ years		
COMPONENT:	Appearance	RATING: 5 x WEIGHT: 6.5 = SCORE: 32.7	
	Poor to average construction; very unattractive exterior and interior spaces		
COMMENTS:

CONDITION: Needs Improvement/Renovation

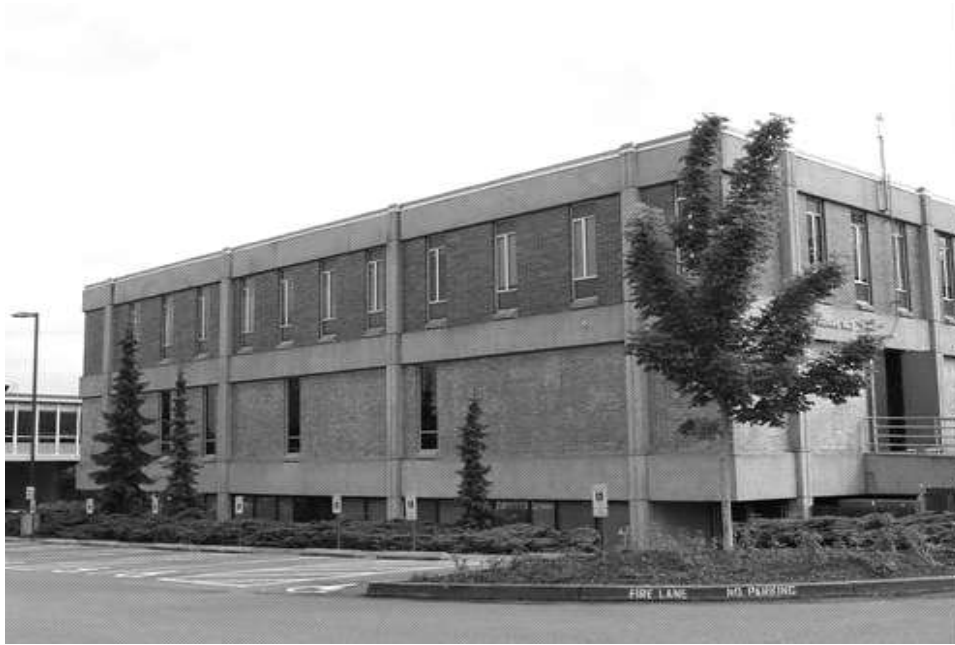
Rainier Hall (050-00R) STATE UFI: A10896 Main Campus (050A)
AREA: 34,719 SF BUILT: 1972 REMODELED: 2011 PREDOMINANT USE: General Classroom
CONSTRUCTION TYPE: Heavy CRV/SF: \$376 REPLACEMENT VALUE: \$13,054,344

Primary Systems			
COMPONENT:	Structure	RATING: 2 x WEIGHT: 8 =	SCORE: 16
Minor cracks evident in a small portion of the structure			
COMMENTS: Concrete; CMU; brick; minor seismic concerns			
COMPONENT:	Exterior Closure	RATING: 1 x WEIGHT: 8 =	SCORE: 8
Weatherproof, tight, well-maintained exterior walls, doors, windows/finishes			
COMMENTS: Concrete frame; brick infill; stucco			
COMPONENT:	Roofing	RATING: 1 x WEIGHT: 10 =	SCORE: 10
Flashing and penetrations appear sound and membrane appears water- tight; drainage is positive and there are overflow scuppers			
COMMENTS: BUR w mineral surface capsheet-2010

Secondary Systems			
COMPONENT:	Floor Finishes	RATING: 3 x WEIGHT: 6 =	SCORE: 18
Some physical wear and minor imperfections are evident; beginning deterioration			
COMMENTS:	Quarry tile; carpet and carpet tile; vinyl tile; ceramic tile; wearing carpet throughout		
COMPONENT:	Wall Finishes	RATING: 2 x WEIGHT: 6 =	SCORE: 12
Maintainable surfaces, minor maintenance is required in some areas			
COMMENTS:	Gypsum board; brick; ceramic tile; concrete		
COMPONENT:	Ceiling Finishes	RATING: 2 x WEIGHT: 6 =	SCORE: 12
Aging surfaces in fair condition and good alignment			
COMMENTS:	Lay-in tile; gypsum board		
COMPONENT:	Doors & Hardware	RATING: 1 x WEIGHT: 6 =	SCORE: 6
Appropriate hardware, closers, panic devices; in good working order			
COMMENTS:	Interior wood doors w HM frames; exterior aluminum doors/frames-some wear

Service Systems			
COMPONENT:	Elevators	RATING: 3 x WEIGHT: 6 =	SCORE: 18
Elevators provided but functionality is inadequate; Unreliable operation			
COMMENTS:	3 stop		
COMPONENT:	Plumbing	RATING: 3 x WEIGHT: 8 =	SCORE: 24
Fixtures are functional but dated; some leaks; maintenance required			
COMMENTS:	Galvanized, cast iron, copper and steel piping; porcelain fixtures		
COMPONENT:	HVAC	RATING: 2 x WEIGHT: 8 =	SCORE: 16
Equipment in fair condition; minor deterioration; controls require troubleshooting; most areas have A/C; hazardous areas are ventilated			
COMMENTS:	Built-Up AHUs; air-cooled chiller; 2 HW boilers in 2010		
COMPONENT:	Electrical	RATING: 1 x WEIGHT: 8 =	SCORE: 8
Adequate service and distribution capacity for current/future needs			
COMMENTS:	800amp 480/277v; breaker upgrades to distribution panels; 35kW emergency generator		
COMPONENT:	Lights/Power	RATING: 1 x WEIGHT: 8 =	SCORE: 8
Contemporary lighting with good work area illumination; ample outlets

Safety Systems			
COMPONENT:	Life/Safety	RATING: 3 x WEIGHT: 10 = SCORE: 30	
	Generally meets codes for vintage of construction		
COMMENTS:			
COMPONENT:	Fire Safety	RATING: 2 x WEIGHT: 10 = SCORE: 20	
	Locally monitored detection; alarm present, but missing visual component or sprinklers		
COMMENTS:			
COMPONENT:	Modifications	RATING: 1 x WEIGHT: 7 = SCORE: 7	
	Modifications appear to be in compliance with codes and sound construction practices; HVAC/electrical service properly provided		
COMMENTS:	Third floor completely remodeled in 2010; first floor previously remodeled

Quality Standards			
COMPONENT:	Maintenance	RATING: 1 x WEIGHT: 7 = SCORE: 7	
	Facility appears well maintained		
COMMENTS:			
COMPONENT:	Remaining Life	RATING: 2 x WEIGHT: 6 = SCORE: 12	
	Life expectancy is 15-20 years; minor to moderate system deterioration		
COMMENTS:	Building is structurally sound; remodels on two floors have extended life		
COMPONENT:	Appearance	RATING: 3 x WEIGHT: 6 = SCORE: 18	
	Average construction; average interior and exterior appearance		
COMMENTS:	Exterior of building is very spartan

CONDITION: Needs Improvement/Additional Maintenance

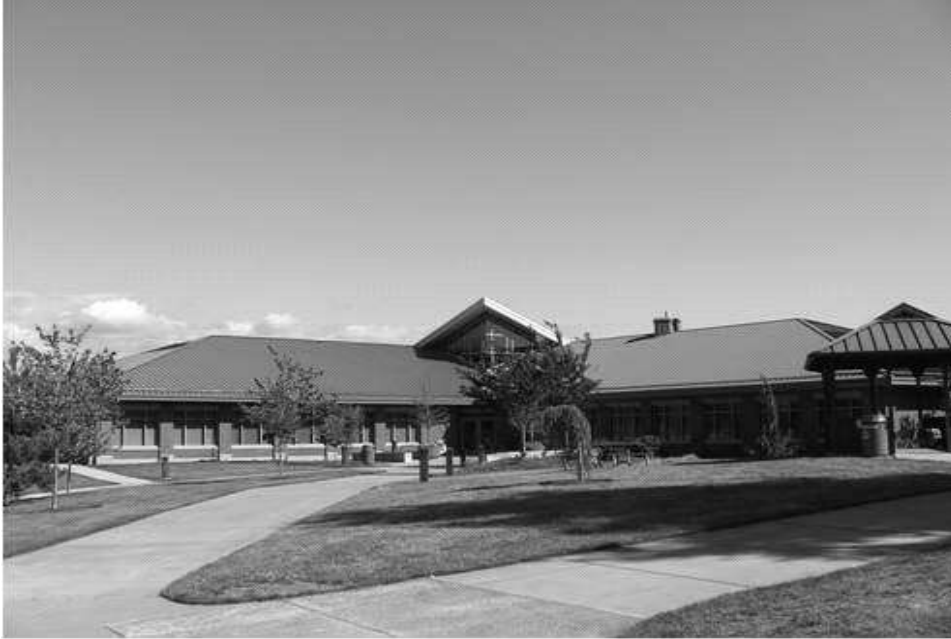
Shuksan (050-ITC) STATE UFI: A10553 Main Campus (050A)
AREA: 41,000 SF BUILT: 1999 REMODELED: 2015 PREDOMINANT USE: Multi-Use
CONSTRUCTION TYPE: Heavy CRV/SF: \$395 REPLACEMENT VALUE: \$16,195,000

Primary Systems			
COMPONENT:	Structure	RATING: 1 x WEIGHT: 8.4 =	SCORE: 8.4
No signs of settlement or cracking, no abrupt vertical changes Columns, bearing walls and roof structure appears sound/free of defects			
COMMENTS:	Structural steel; concrete		
COMPONENT:	Exterior Closure	RATING: 1 x WEIGHT: 8.4 =	SCORE: 8.4
Weatherproof, tight, well-maintained exterior walls, doors, windows/finishes			
COMMENTS:	Brick veneer; aluminum panels; gypsum board soffits		
COMPONENT:	Roofing	RATING: 1 x WEIGHT: 10.5 =	SCORE: 10.5
Flashing and penetrations appear sound and membrane appears water- tight; drainage is positive and there are overflow scuppers			
COMMENTS:	Metal standing seam

Secondary Systems			
COMPONENT:	Floor Finishes	RATING: 2 x WEIGHT: 6.3 = SCORE: 12.6	
	Some wear is evident on finish; maintenance needed		
COMMENTS:	Carpet-worn; carpet tile; concrete; ceramic tile; sheet vinyl		
COMPONENT:	Wall Finishes	RATING: 2 x WEIGHT: 6.3 = SCORE: 12.6	
	Maintainable surfaces, minor maintenance is required in some areas		
COMMENTS:	Gypsum board and ceramic tile		
COMPONENT:	Ceiling Finishes	RATING: 1 x WEIGHT: 6.3 = SCORE: 6.3	
	Maintainable surfaces in good condition; good alignment and appearance		
COMMENTS:	Gypsum board and lay-in tiles		
COMPONENT:	Doors & Hardware	RATING: 2 x WEIGHT: 6.3 = SCORE: 12.6	
	Fairly modern door surfaces and hardware with minor deterioration; good working order		
COMMENTS:	Interior wood doors w HM frames-random marring; exterior aluminum doors/frames; panic bar problems

Service Systems			
COMPONENT:	Elevators	RATING: 1 x WEIGHT: 6.3 = SCORE: 6.3	
	Appropriate and functional for occupancy and use		
COMMENTS:	2 stop		
COMPONENT:	Plumbing	RATING: 1 x WEIGHT: 8.4 = SCORE: 8.4	
	Fixtures and piping appear to be in good condition; no evidence of leaks		
COMMENTS:	Copper, cast iron, steel and ABS piping; porcelain fixtures		
COMPONENT:	HVAC	RATING: 1 x WEIGHT: 8.4 = SCORE: 8.4	
	Equipment in good condition; easily controlled; serves all required spaces; All necessary spaces are adequately ventilated; A/C provided throughout		
COMMENTS:	Air cooled chiller; AHUs and VAVs w hot water heat served from central plant; stand-alone boiler funded in 2011; emergency generator		
COMPONENT:	Electrical	RATING: 1 x WEIGHT: 8.4 = SCORE: 8.4	
	Adequate service and distribution capacity for current/future needs		
COMMENTS:	1600amp, 408/277v		
COMPONENT:	Lights/Power	RATING: 1 x WEIGHT: 8.4 = SCORE: 8.4

Safety Systems			
COMPONENT:	Life/Safety	RATING: 1 x WEIGHT: 10.5 =	SCORE: 10.5
Appears to meet current codes			
COMMENTS:			
COMPONENT:	Fire Safety	RATING: 1 x WEIGHT: 10.5 =	SCORE: 10.5
Locally monitored detection; alarm and strobes present; sprinklers in high hazard areas			
COMMENTS:	new panel 2009		
COMPONENT:	Modifications	RATING: 0 x WEIGHT: 0 =	SCORE: 0
No data			
COMMENTS:	No significant modifications evident

CONDITION: Adequate

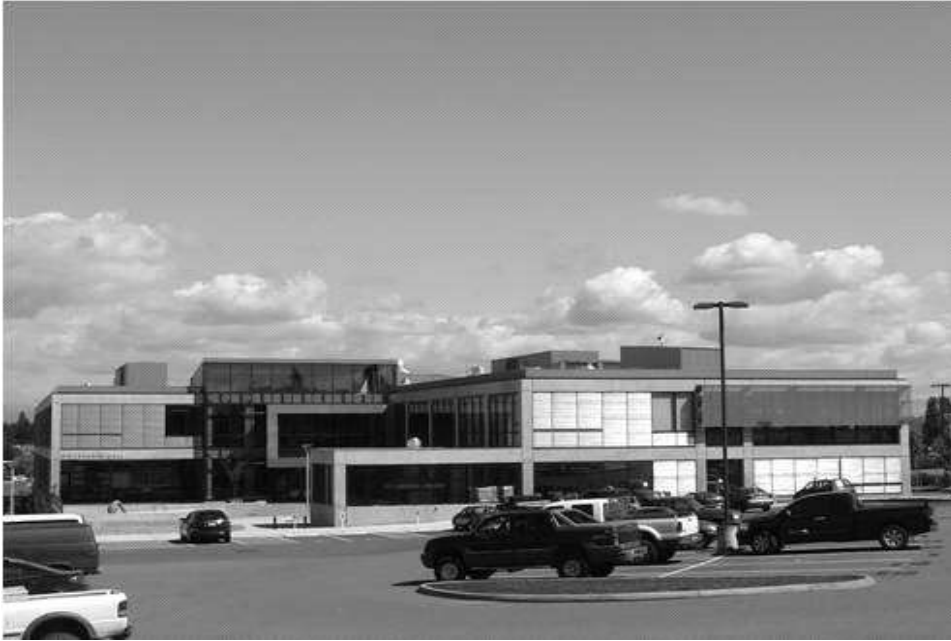
Whitehorse Hall (050-WHI) STATE UFI: A01739 Main Campus (050A)
 AREA: 88,000 SF BUILT: 2006 REMODELED: No PREDOMINANT USE: Multi-use
 CONSTRUCTION TYPE: Heavy CRV/SF: \$395 REPLACEMENT VALUE: \$34,760,000

Primary Systems			
COMPONENT:	Structure	RATING: 1 x WEIGHT: 8.4 = SCORE: 8.4	
No signs of settlement or cracking, no abrupt vertical changes Columns, bearing walls and roof structure appears sound/free of defects			
COMMENTS:	Concrete and steel columns and beams		
COMPONENT:	Exterior Closure	RATING: 2 x WEIGHT: 8.4 = SCORE: 16.8	
Weatherproof exterior, but finish appears poorly maintained			
COMMENTS:	Concrete frame; brick; laminate panels; perforated metal screens; metal sunshades; aluminum window walls		
COMPONENT:	Roofing	RATING: 1 x WEIGHT: 10.5 = SCORE: 10.5	
Flashing and penetrations appear sound and membrane appears water- tight; drainage is positive and there are overflow scuppers			
COMMENTS:	BUR mineral -surfaces capsheet; standing seam metal

Secondary Systems			
COMPONENT:	Floor Finishes	RATING: 2 x WEIGHT: 6.3 =	SCORE: 12.6
Some wear is evident on finish; maintenance needed			
COMMENTS:	Concrete; carpet tile; linoleum; wood planking		
COMPONENT:	Wall Finishes	RATING: 1 x WEIGHT: 6.3 =	SCORE: 6.3
Maintainable surfaces in good condition			
COMMENTS:	Gypsum board; concrete; wood panels; plastic laminate		
COMPONENT:	Ceiling Finishes	RATING: 1 x WEIGHT: 6.3 =	SCORE: 6.3
Maintainable surfaces in good condition; good alignment and appearance			
COMMENTS:	Concrete; gypsum board; lay-in tile; perforated tile;. metal & wood panels		
COMPONENT:	Doors & Hardware	RATING: 1 x WEIGHT: 6.3 =	SCORE: 6.3
Appropriate hardware, closers, panic devices; in good working order			
COMMENTS:	Interior wood doors w HM frames and sidelites-some glazed; exterior aluminum and HM doors/frames; OH glazed metal door

CONDITION: Superior

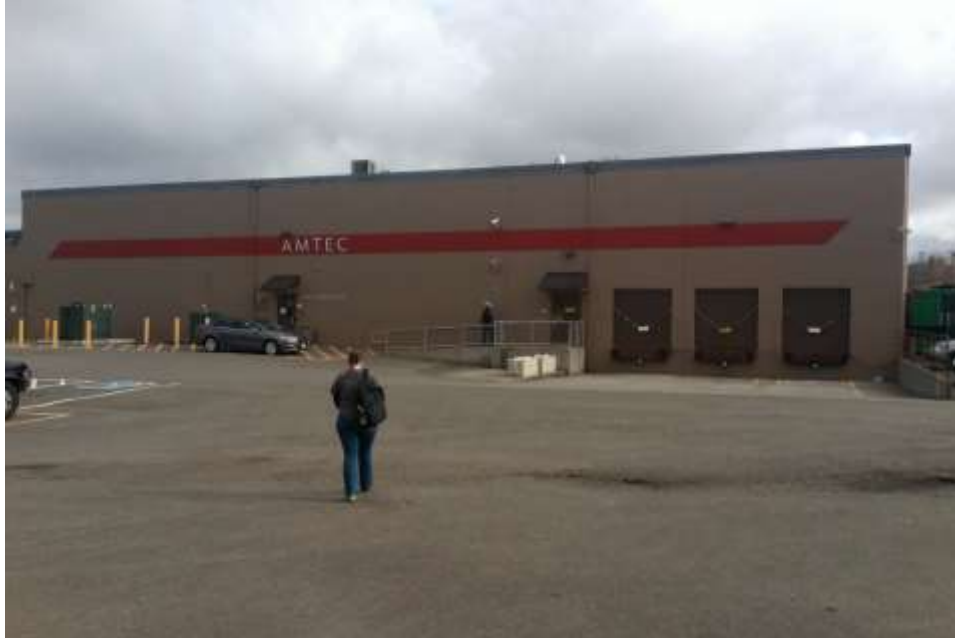
Advanced Manufacturing And Training Center (050-AMT) STATE UFI: A21057 Main Campus
(050B)

Primary Systems			
COMPONENT:	Structure	RATING: 1 x WEIGHT: 8.3 =	SCORE: 8.3
No signs of settlement or cracking, no abrupt vertical changes Columns, bearing walls and roof structure appears sound/free of defects			
COMMENTS:	No data		
COMPONENT:	Exterior Closure	RATING: 1 x WEIGHT: 8.3 =	SCORE: 8.3
Weatherproof, tight, well-maintained exterior walls, doors, windows/finishes			
COMMENTS:	No data		
COMPONENT:	Roofing	RATING: 3 x WEIGHT: 10.4 =	SCORE: 31.3
Some deterioration is evident in membrane and flashings; maintenance or minor repair is needed			
COMMENTS:	No data

Secondary Systems			
COMPONENT:	Floor Finishes	RATING: 1 x WEIGHT: 6.3 = SCORE: 6.3	
	Nice appearance, smooth transitions, level subfloors, no cracks/separating		
COMMENTS:	No data		
COMPONENT:	Wall Finishes	RATING: 1 x WEIGHT: 6.3 = SCORE: 6.3	
	Maintainable surfaces in good condition		
COMMENTS:	No data		
COMPONENT:	Ceiling Finishes	RATING: 1 x WEIGHT: 6.3 = SCORE: 6.3	
	Maintainable surfaces in good condition; good alignment and appearance		
COMMENTS:	No data		
COMPONENT:	Doors & Hardware	RATING: 1 x WEIGHT: 6.3 = SCORE: 6.3	
	Appropriate hardware, closers, panic devices; in good working order		
COMMENTS:	No data
