2023 FACILITY CONDITION SURVEY

Grays Harbor College

SURVEY CONDUCTED BY:
Steve Lewandowski
State Board for Community
and Technical Colleges

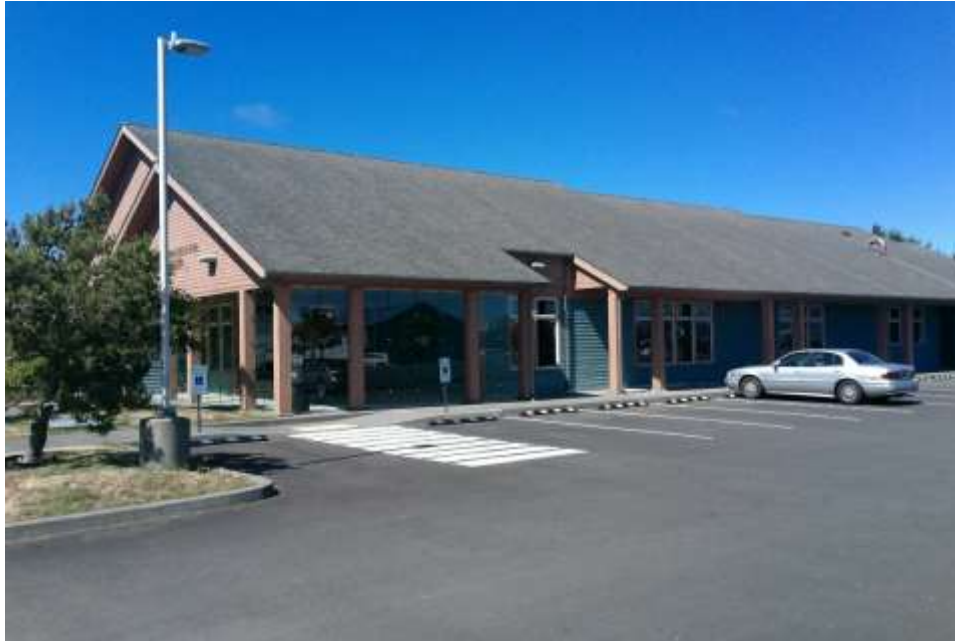
Columbia Education Center (020-2600) STATE UFI: A01306 Columbia Ed. Center (020E)
 AREA: 6,342 SF BUILT: 2006 REMODELED: No PREDOMINANT USE: Multi-Use
 CONSTRUCTION TYPE: Medium CRV/SF: \$363 REPLACEMENT VALUE: \$2,302,146

Primary Systems			
COMPONENT:	Structure	RATING: 1 x WEIGHT: 8.3 = SCORE: 8.3	
No signs of settlement or cracking, no abrupt vertical changes Columns, bearing walls and roof structure appears sound/free of defects			
COMMENTS:	Wood frame; concrete foundation		
COMPONENT:	Exterior Closure	RATING: 2 x WEIGHT: 8.3 = SCORE: 16.7	
Weatherproof exterior, but finish appears poorly maintained			
COMMENTS:	Cement board lap siding; wood shingles; plywood soffits; glass wind screens; wood needs refinishing.		
COMPONENT:	Roofing	RATING: 1 x WEIGHT: 10.4 = SCORE: 10.4	
Flashing and penetrations appear sound and membrane appears water- tight; drainage is positive and there are overflow scuppers			
COMMENTS:	Composition 3-tab shingles

Secondary Systems			
COMPONENT:	Floor Finishes	RATING: 2 x WEIGHT: 6.3 =	SCORE: 12.5
Some wear is evident on finish; maintenance needed			
COMMENTS:	Colored concrete and carpet-surface wear		
COMPONENT:	Wall Finishes	RATING: 1 x WEIGHT: 6.3 =	SCORE: 6.3
Maintainable surfaces in good condition			
COMMENTS:	Gypsum board; recycled vertical T&G wood; ceramic tile		
COMPONENT:	Ceiling Finishes	RATING: 1 x WEIGHT: 6.3 =	SCORE: 6.3
Maintainable surfaces in good condition; good alignment and appearance			
COMMENTS:	Gypsum board and direct-adhered tile		
COMPONENT:	Doors & Hardware	RATING: 2 x WEIGHT: 6.3 =	SCORE: 12.5
Fairly modern door surfaces and hardware with minor deterioration; good working order			
COMMENTS:	Interior/exterior wood doors/frames

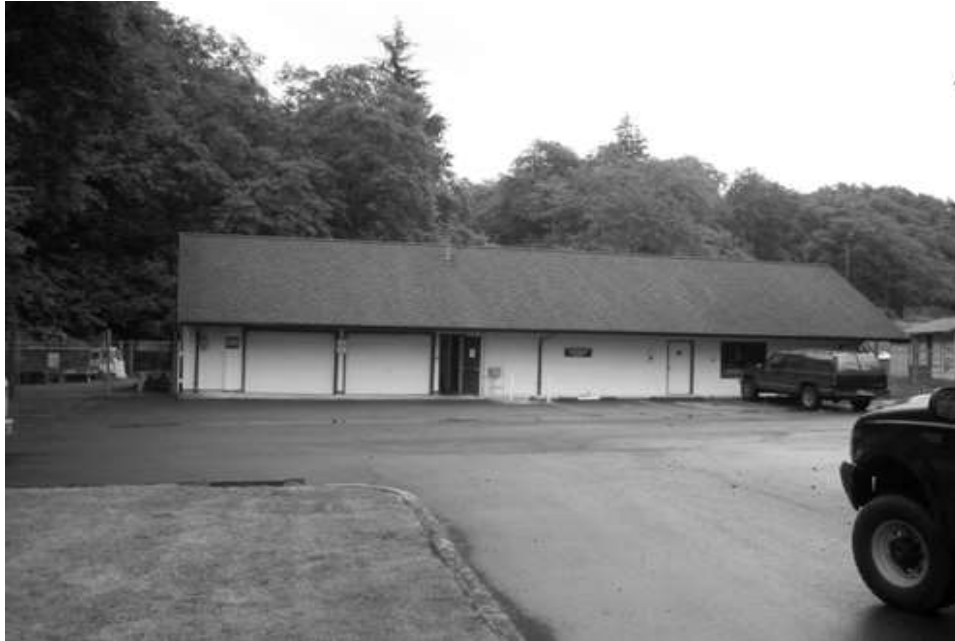
Acqua (020-1700) STATE UFI: A01579 Main Campus (020A)
AREA: 3,856 SF BUILT: 1984 REMODELED: No PREDOMINANT USE: Science Lab.
CONSTRUCTION TYPE: Light CRV/SF: \$231 REPLACEMENT VALUE: \$890,736

Primary Systems			
COMPONENT:	Structure	RATING: 4 x WEIGHT: 8.3 =	SCORE: 33.4
Some structural flaws potentially exist and should be evaluated by a structural engineer			
COMMENTS:	CMU; wood framing; garage has a slab settling problem		
COMPONENT:	Exterior Closure	RATING: 2 x WEIGHT: 8.3 =	SCORE: 16.7
Weatherproof exterior, but finish appears poorly maintained			
COMMENTS:	CMU; T1-11 plywood-surface wear		
COMPONENT:	Roofing	RATING: 1 x WEIGHT: 10.4 =	SCORE: 10.4
Flashing and penetrations appear sound and membrane appears water- tight; drainage is positive and there are overflow scuppers			
COMMENTS:	composite shingles-moss buildup 2015

Secondary Systems			
COMPONENT:	Floor Finishes	RATING: 2 x WEIGHT: 6.3 =	SCORE: 12.5
Some wear is evident on finish; maintenance needed			
COMMENTS:	Concrete throughout		
COMPONENT:	Wall Finishes	RATING: 2 x WEIGHT: 6.3 =	SCORE: 12.5
Maintainable surfaces, minor maintenance is required in some areas			
COMMENTS:	Gypsum board; CMU		
COMPONENT:	Ceiling Finishes	RATING: 3 x WEIGHT: 6.3 =	SCORE: 18.8
Some wear and tear; Minor damage, staining or deterioration			
COMMENTS:	Direct adhered tile; gypsum board; plywood		
COMPONENT:	Doors & Hardware	RATING: 3 x WEIGHT: 6.3 =	SCORE: 18.8
Functional, but dated; some maintenance required			
COMMENTS:	Interior/exterior HM doors/frames-surface wear; wood OH doors

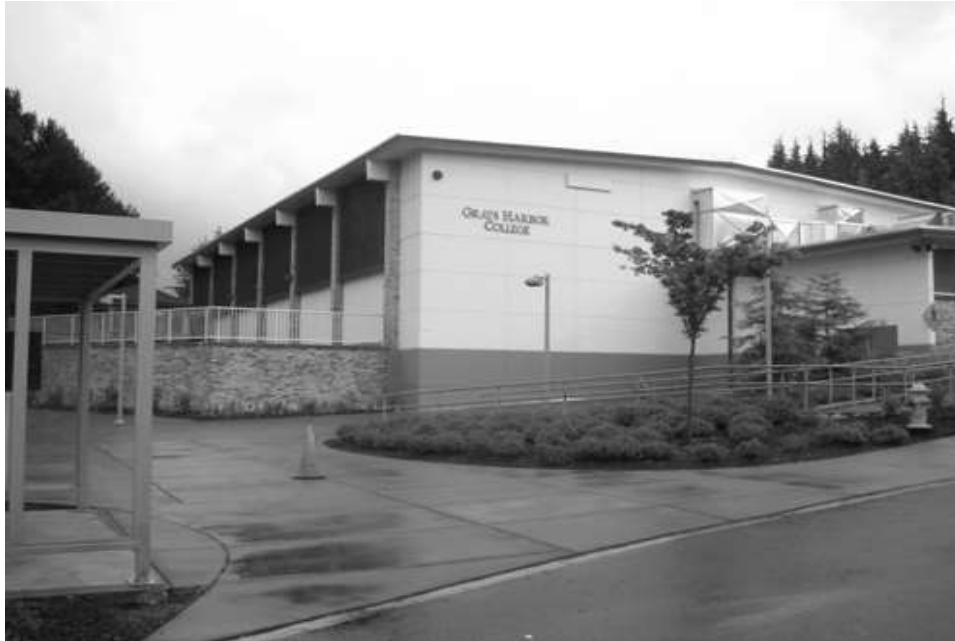
Physed (020-500) STATE UFI: A02269 Main Campus (020A)
 AREA: 18,814 SF BUILT: 1957 REMODELED: No PREDOMINANT USE: Gymnasium
 CONSTRUCTION TYPE: Medium CRV/SF: \$349 REPLACEMENT VALUE: \$6,566,086

Primary Systems			
COMPONENT:	Structure	RATING: 3 x WEIGHT: 8.3 =	SCORE: 25
Some cracking evident but does not likely affect structural integrity; Visible defects apparent but are non-structural			
COMMENTS:	Cast concrete; wood framing		
COMPONENT:	Exterior Closure	RATING: 2 x WEIGHT: 8.3 =	SCORE: 16.7
Weatherproof exterior, but finish appears poorly maintained			
COMMENTS:	Concrete; dryvit; brick		
COMPONENT:	Roofing	RATING: 1 x WEIGHT: 10.4 =	SCORE: 10.4
Flashing and penetrations appear sound and membrane appears water- tight; drainage is positive and there are overflow scuppers			
COMMENTS:	TPO single-ply membrane-2010

Secondary Systems			
COMPONENT:	Floor Finishes	RATING: 2 x WEIGHT: 6.3 =	SCORE: 12.5
Some wear is evident on finish; maintenance needed			
COMMENTS:	Hardwood; concrete; vinyl tile-surface wear; ceramic tile; sheet vinyl; carpet-surface wear		
COMPONENT:	Wall Finishes	RATING: 2 x WEIGHT: 6.3 =	SCORE: 12.5
Maintainable surfaces, minor maintenance is required in some areas			
COMMENTS:	Concrete; gypsum board; ceramic tile; CMU		
COMPONENT:	Ceiling Finishes	RATING: 3 x WEIGHT: 6.3 =	SCORE: 18.8
Some wear and tear; Minor damage, staining or deterioration			
COMMENTS:	Tectum panels; direct adhered tile		
COMPONENT:	Doors & Hardware	RATING: 3 x WEIGHT: 6.3 =	SCORE: 18.8
Functional, but dated; some maintenance required			
COMMENTS:	Interior wood/HM doors w HM frames-surface wear; exterior HM doors/frames

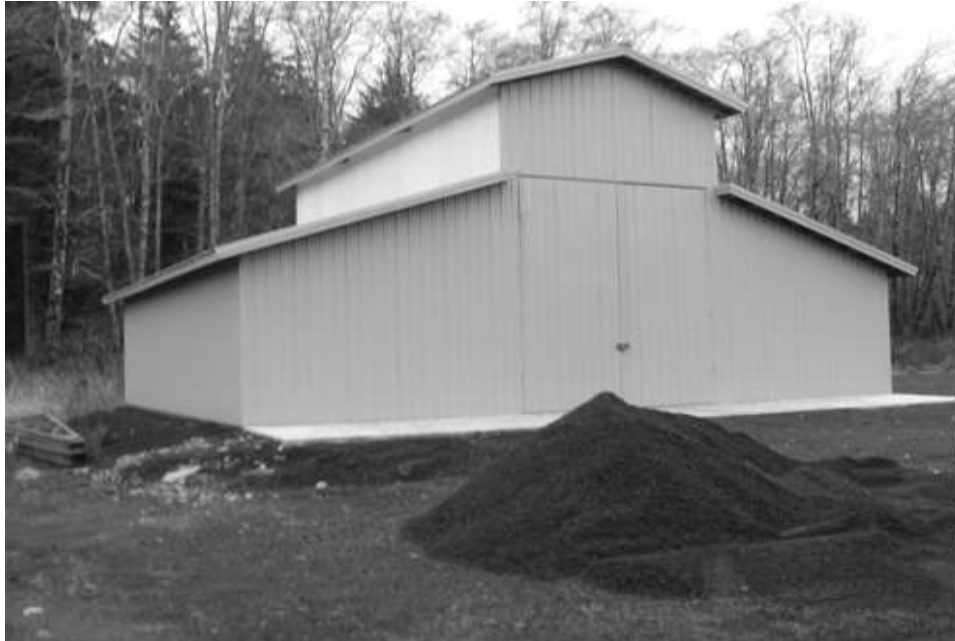
Sand Shed (020-2700) STATE UFI: A03359 Main Campus (020A)
AREA: 1,945 SF BUILT: 2010 REMODELED: No PREDOMINANT USE: Storage
CONSTRUCTION TYPE: Light CRV/SF: \$54 REPLACEMENT VALUE: \$105,030

Primary Systems			
COMPONENT:	Structure	RATING: 1 x WEIGHT: 14.1 =	SCORE: 14.1
No signs of settlement or cracking, no abrupt vertical changes Columns, bearing walls and roof structure appears sound/free of defects			
COMMENTS:	Wood framing		
COMPONENT:	Exterior Closure	RATING: 2 x WEIGHT: 14.1 =	SCORE: 28.1
Weatherproof exterior, but finish appears poorly maintained			
COMMENTS:	Metal panels		
COMPONENT:	Roofing	RATING: 1 x WEIGHT: 17.6 =	SCORE: 17.6
Flashing and penetrations appear sound and membrane appears water- tight; drainage is positive and there are overflow scuppers			
COMMENTS:	Metal panels

Secondary Systems			
COMPONENT:	Floor Finishes	RATING: 2 x WEIGHT: 10.6 =	SCORE: 21.1
Some wear is evident on finish; maintenance needed			
COMMENTS:	Concrete		
COMPONENT:	Wall Finishes	RATING: 0 x WEIGHT: 0 =	SCORE: 0
No data			
COMMENTS:	Metal panels		
COMPONENT:	Ceiling Finishes	RATING: 0 x WEIGHT: 0 =	SCORE: 0
No data			
COMMENTS:	Metal panels		
COMPONENT:	Doors & Hardware	RATING: 3 x WEIGHT: 10.6 =	SCORE: 31.7
Functional, but dated; some maintenance required			
COMMENTS:	Metal panel doors

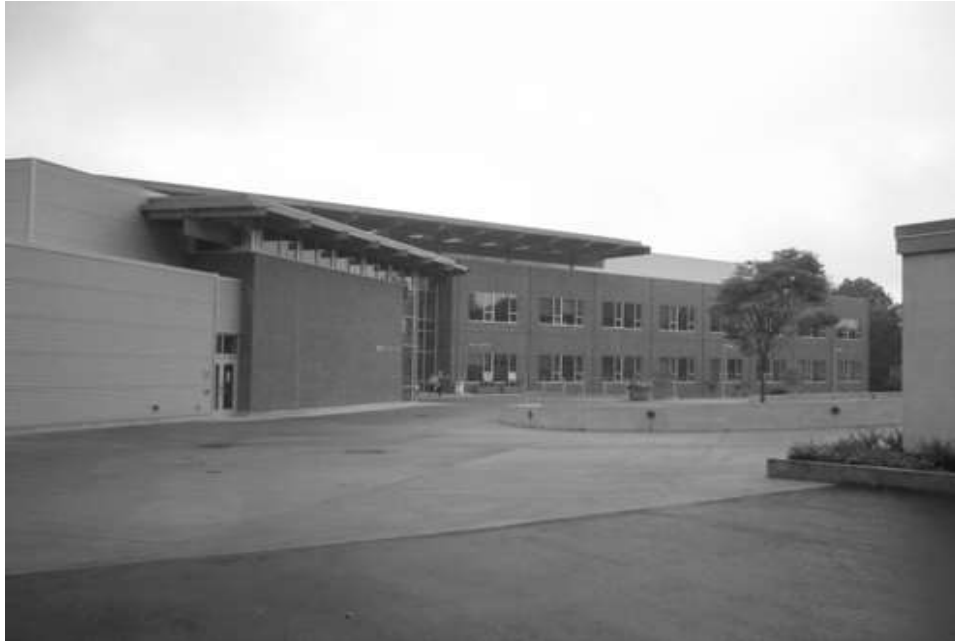
Manspeaker Instructional (020-2000) STATE UFI: A04686 Main Campus (020A)
AREA: 71,755 SF BUILT: 2007 REMODELED: No PREDOMINANT USE: General Classroom
CONSTRUCTION TYPE: Heavy CRV/SF: \$376 REPLACEMENT VALUE: \$26,979,880

Primary Systems			
COMPONENT:	Structure	RATING: 1 x WEIGHT: 8 =	SCORE: 8
No signs of settlement or cracking, no abrupt vertical changes Columns, bearing walls and roof structure appears sound/free of defects			
COMMENTS:	Steel frame; cast concrete		
COMPONENT:	Exterior Closure	RATING: 1 x WEIGHT: 8 =	SCORE: 8
Weatherproof, tight, well-maintained exterior walls, doors, windows/finishes			
COMMENTS:	Aluminum window walls; concrete; brick; metal wall panels; T&G car decking		
COMPONENT:	Roofing	RATING: 2 x WEIGHT: 10 =	SCORE: 20
Majority of roofing and flashing appear sound, but a small portion of roofing shows deterioration where maintenance or minor repair needed			
COMMENTS:	Single-ply TPO membrane

Secondary Systems			
COMPONENT:	Floor Finishes	RATING: 2 x WEIGHT: 6 = SCORE: 12	
	Some wear is evident on finish; maintenance needed		
COMMENTS:	Polished concrete; carpet-random staining; ceramic tile; 2x4 end-grain wood		
COMPONENT:	Wall Finishes	RATING: 1 x WEIGHT: 6 = SCORE: 6	
	Maintainable surfaces in good condition		
COMMENTS:	Gypsum board; bare concrete; ceramic tile; acoustical panels; wood panels		
COMPONENT:	Ceiling Finishes	RATING: 1 x WEIGHT: 6 = SCORE: 6	
	Maintainable surfaces in good condition; good alignment and appearance		
COMMENTS:	Open mesh and solid panel lay-in tile; gypsum board		
COMPONENT:	Doors & Hardware	RATING: 1 x WEIGHT: 6 = SCORE: 6	
	Appropriate hardware, closers, panic devices; in good working order		
COMMENTS:	Interior wood doors w HM frames; sidelites; exterior aluminum doors/frames

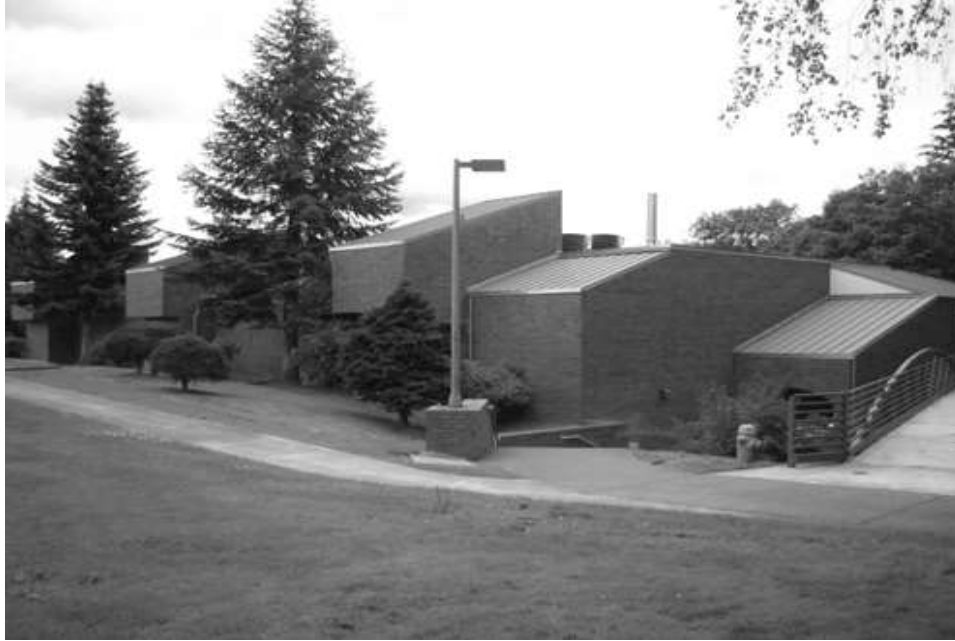
Physci (020-800) STATE UFI: A05609 Main Campus (020A)
AREA: 18,238 SF BUILT: 1971 REMODELED: No PREDOMINANT USE: Science Lab.
CONSTRUCTION TYPE: Heavy CRV/SF: \$489 REPLACEMENT VALUE: \$8,918,382

Primary Systems			
COMPONENT:	Structure	RATING: 1 x WEIGHT: 8 =	SCORE: 8
No signs of settlement or cracking, no abrupt vertical changes Columns, bearing walls and roof structure appears sound/free of defects			
COMMENTS:	Concrete; CMU; wood framing		
COMPONENT:	Exterior Closure	RATING: 2 x WEIGHT: 8 =	SCORE: 16
Weatherproof exterior, but finish appears poorly maintained			
COMMENTS:	Concrete; CMU; brick-random deterioration; plaster		
COMPONENT:	Roofing	RATING: 3 x WEIGHT: 10 =	SCORE: 30
Some deterioration is evident in membrane and flashings; maintenance or minor repair is needed			
COMMENTS:	Hypalon single-ply membrane 2010; metal panels 1971

Secondary Systems			
COMPONENT:	Floor Finishes	RATING: 2 x WEIGHT: 6 = SCORE: 12	
	Some wear is evident on finish; maintenance needed		
COMMENTS:	Ceramic tile; vinyl tile and carpet-surface wear; concrete		
COMPONENT:	Wall Finishes	RATING: 2 x WEIGHT: 6 = SCORE: 12	
	Maintainable surfaces, minor maintenance is required in some areas		
COMMENTS:	Gypsum board; CMU; ceramic tile; wood strips; wood panels		
COMPONENT:	Ceiling Finishes	RATING: 1 x WEIGHT: 6 = SCORE: 6	
	Maintainable surfaces in good condition; good alignment and appearance		
COMMENTS:	Lay-in tile-tile-grid deterioration in labs 2013; direct adhered tile; exposed concrete structure		
COMPONENT:	Doors & Hardware	RATING: 2 x WEIGHT: 6 = SCORE: 12	
	Fairly modern door surfaces and hardware with minor deterioration; good working order		
COMMENTS:	Interior wood doors w HM frames; exterior aluminum doors/frames-surface wear

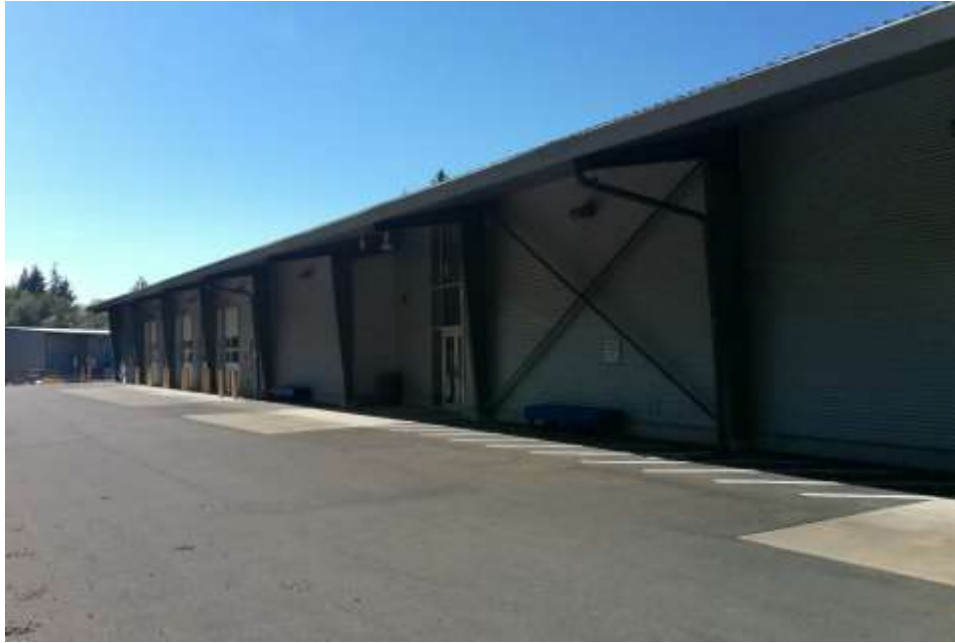
Auto/Weld Technology (020-1900) STATE UFI: A05800 Main Campus (020A)
AREA: 21,750 SF BUILT: 2007 REMODELED: No PREDOMINANT USE: Vocational Arts
CONSTRUCTION TYPE: Medium CRV/SF: \$395 REPLACEMENT VALUE: \$8,591,250

Primary Systems			
COMPONENT:	Structure	RATING: 1 x WEIGHT: 8.3 =	SCORE: 8.3
No signs of settlement or cracking, no abrupt vertical changes Columns, bearing walls and roof structure appears sound/free of defects			
COMMENTS:	Steel frame		
COMPONENT:	Exterior Closure	RATING: 2 x WEIGHT: 8.3 =	SCORE: 16.7
Weatherproof exterior, but finish appears poorly maintained			
COMMENTS:	Standing seam metal panels; corrugated metal panels; concrete		
COMPONENT:	Roofing	RATING: 1 x WEIGHT: 10.4 =	SCORE: 10.4
Flashing and penetrations appear sound and membrane appears water- tight; drainage is positive and there are overflow scuppers			
COMMENTS:	Standing seam metal

Secondary Systems			
COMPONENT:	Floor Finishes	RATING: 1 x WEIGHT: 6.3 = SCORE: 6.3	
	Nice appearance, smooth transitions, level subfloors, no cracks/separating		
COMMENTS:	Concrete		
COMPONENT:	Wall Finishes	RATING: 2 x WEIGHT: 6.3 = SCORE: 12.5	
	Maintainable surfaces, minor maintenance is required in some areas		
COMMENTS:	Gypsum board; plastic panels		
COMPONENT:	Ceiling Finishes	RATING: 1 x WEIGHT: 6.3 = SCORE: 6.3	
	Maintainable surfaces in good condition; good alignment and appearance		
COMMENTS:	Exposed insulated structure; lay-in tile		
COMPONENT:	Doors & Hardware	RATING: 1 x WEIGHT: 6.3 = SCORE: 6.3	
	Appropriate hardware, closers, panic devices; in good working order		
COMMENTS:	Interior wood doors w HM frames; exterior HM/aluminum doors/frames; metal OH doors

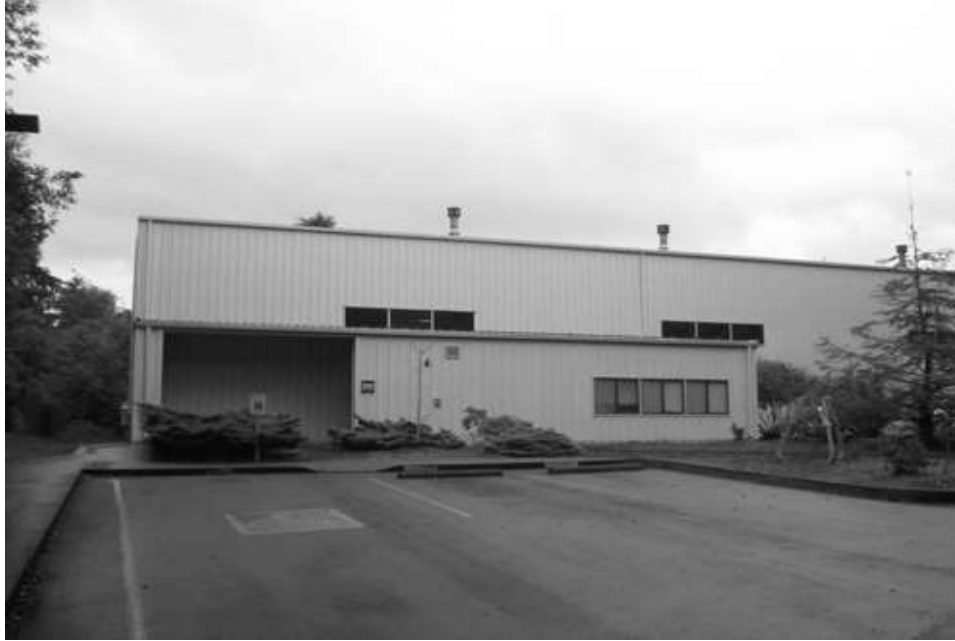
Heavy Equipment Shop (020-1800) STATE UFI: A05882 Main Campus (020A)
AREA: 9,484 SF BUILT: 1988 REMODELED: No PREDOMINANT USE: Vocational Arts
CONSTRUCTION TYPE: Light CRV/SF: \$395 REPLACEMENT VALUE: \$3,746,180

Primary Systems			
COMPONENT:	Structure	RATING: 1 x WEIGHT: 8.8 =	SCORE: 8.8
No signs of settlement or cracking, no abrupt vertical changes Columns, bearing walls and roof structure appears sound/free of defects			
COMMENTS:	Steel frame		
COMPONENT:	Exterior Closure	RATING: 1 x WEIGHT: 8.8 =	SCORE: 8.8
Weatherproof, tight, well-maintained exterior walls, doors, windows/finishes			
COMMENTS:	Metal panels-painted in 2008		
COMPONENT:	Roofing	RATING: 3 x WEIGHT: 11 =	SCORE: 32.9
Some deterioration is evident in membrane and flashings; maintenance or minor repair is needed			
COMMENTS:	Metal panel roof-coated in 2007; soffit leaks at entry

Secondary Systems			
COMPONENT:	Floor Finishes	RATING: 3 x WEIGHT: 6.6 = SCORE: 19.8	
	Some physical wear and minor imperfections are evident; beginning deterioration		
COMMENTS:	Concrete-portion is coated with epoxy; flaking finish		
COMPONENT:	Wall Finishes	RATING: 3 x WEIGHT: 6.6 = SCORE: 19.8	
	Aging surfaces, but sound; some maintenance is required		
COMMENTS:	Gypsum board-scuffed/dinged; plywood; vinyl-clad insulation; laminate panels		
COMPONENT:	Ceiling Finishes	RATING: 2 x WEIGHT: 6.6 = SCORE: 13.2	
	Aging surfaces in fair condition and good alignment		
COMMENTS:	Lay-in tile; plywood; gypsum board; vinyl-clad insulation		
COMPONENT:	Doors & Hardware	RATING: 3 x WEIGHT: 6.6 = SCORE: 19.8	
	Functional, but dated; some maintenance required		
COMMENTS:	Interior and exterior HM doors/frames; sectional metal OH doors; surface wear throughout

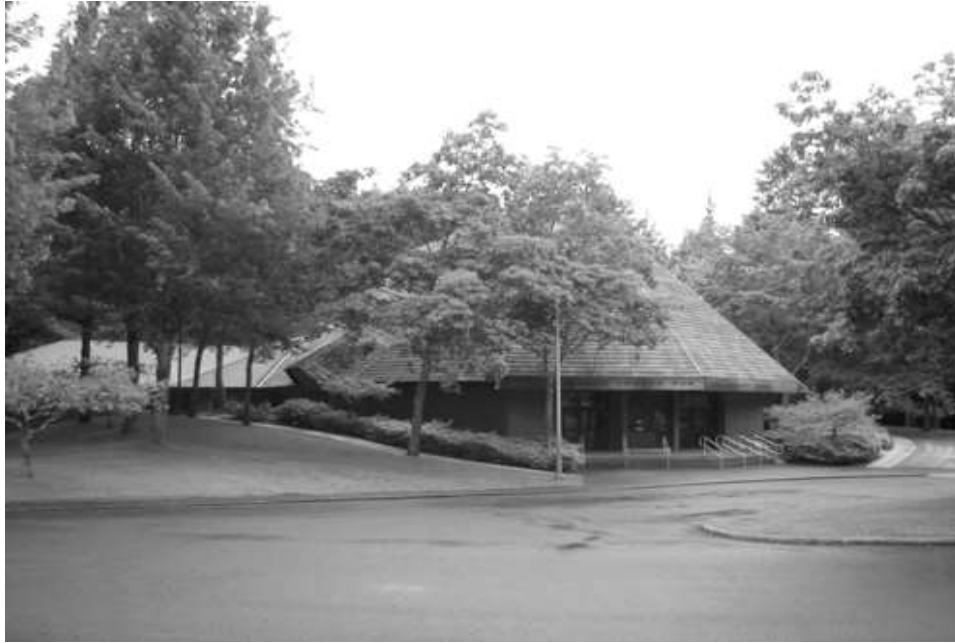
Bishop (020-1600) STATE UFI: A05956 Main Campus (020A)
AREA: 17,144 SF BUILT: 1974 REMODELED: No PREDOMINANT USE: Performing Arts
CONSTRUCTION TYPE: Medium CRV/SF: \$421 REPLACEMENT VALUE: \$7,217,624

Primary Systems			
COMPONENT:	Structure	RATING: 1 x WEIGHT: 8.3 =	SCORE: 8.3
No signs of settlement or cracking, no abrupt vertical changes Columns, bearing walls and roof structure appears sound/free of defects			
COMMENTS:	Wood framing; brick; some steel		
COMPONENT:	Exterior Closure	RATING: 1 x WEIGHT: 8.3 =	SCORE: 8.3
Weatherproof, tight, well-maintained exterior walls, doors, windows/finishes			
COMMENTS:	Brick; plywood soffits; Hardie-board siding		
COMPONENT:	Roofing	RATING: 2 x WEIGHT: 10.4 =	SCORE: 20.9
Majority of roofing and flashing appear sound, but a small portion of roofing shows deterioration where maintenance or minor repair needed			
COMMENTS:	Significant portion of tile roof replaced in 2005; 3-tab composite shingles

Secondary Systems			
COMPONENT:	Floor Finishes	RATING: 3 x WEIGHT: 6.3 =	SCORE: 18.8
Some physical wear and minor imperfections are evident; beginning deterioration			
COMMENTS:	Carpet-surface wear; sheet vinyl-surface wear; plywood; ceramic tile; concrete		
COMPONENT:	Wall Finishes	RATING: 1 x WEIGHT: 6.3 =	SCORE: 6.3
Maintainable surfaces in good condition			
COMMENTS:	Gypsum board; brick; ceramic tile; wood strip; plastic panels		
COMPONENT:	Ceiling Finishes	RATING: 1 x WEIGHT: 6.3 =	SCORE: 6.3
Maintainable surfaces in good condition; good alignment and appearance			
COMMENTS:	Gypsum board; plywood ceiling; direct-adhered tile		
COMPONENT:	Doors & Hardware	RATING: 3 x WEIGHT: 6.3 =	SCORE: 18.8
Functional, but dated; some maintenance required			
COMMENTS:	Interior wood/HM/laminate doors w HM frames; exterior HM doors/frames-surface wear

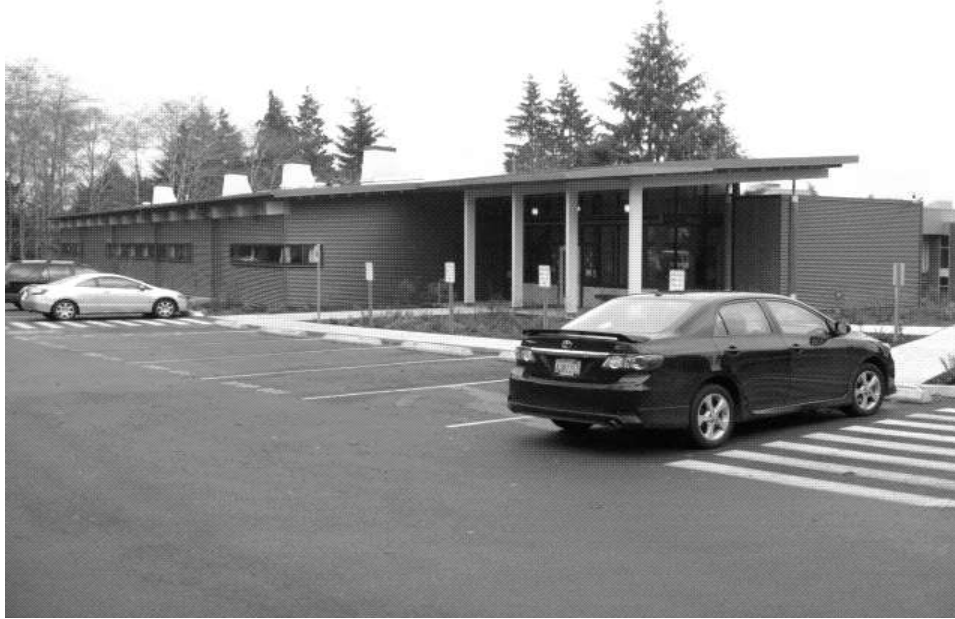
Child Care Center (020-1400) STATE UFI: A07080 Main Campus (020A)
 AREA: 6,246 SF BUILT: 2010 REMODELED: No PREDOMINANT USE: Child Care
 CONSTRUCTION TYPE: Medium CRV/SF: \$363 REPLACEMENT VALUE: \$2,267,298

Primary Systems			
COMPONENT:	Structure	RATING: 1 x WEIGHT: 8.3 = SCORE: 8.3	
No signs of settlement or cracking, no abrupt vertical changes Columns, bearing walls and roof structure appears sound/free of defects			
COMMENTS:	Wood frame		
COMPONENT:	Exterior Closure	RATING: 1 x WEIGHT: 8.3 = SCORE: 8.3	
Weatherproof, tight, well-maintained exterior walls, doors, windows/finishes			
COMMENTS:	Corrugated metal panels; vertical wood t&g; aluminum window walls		
COMPONENT:	Roofing	RATING: 1 x WEIGHT: 10.4 = SCORE: 10.4	
Flashing and penetrations appear sound and membrane appears water- tight; drainage is positive and there are overflow scuppers			
COMMENTS:	TPO single-ply; temperature-controlled operable skylights

Secondary Systems			
COMPONENT:	Floor Finishes	RATING: 2 x WEIGHT: 6.3 =	SCORE: 12.5
Some wear is evident on finish; maintenance needed			
COMMENTS:	Concrete; ceramic tile; sheet vinyl		
COMPONENT:	Wall Finishes	RATING: 2 x WEIGHT: 6.3 =	SCORE: 12.5
Maintainable surfaces, minor maintenance is required in some areas			
COMMENTS:	Vertical t&g cedar; concrete; laminate panels; gypsum board		
COMPONENT:	Ceiling Finishes	RATING: 1 x WEIGHT: 6.3 =	SCORE: 6.3
Maintainable surfaces in good condition; good alignment and appearance			
COMMENTS:	T&G cedar; gypsum board		
COMPONENT:	Doors & Hardware	RATING: 1 x WEIGHT: 6.3 =	SCORE: 6.3
Appropriate hardware, closers, panic devices; in good working order			
COMMENTS:	Interior wood doors/frames; exterior aluminum/HM doors/frames

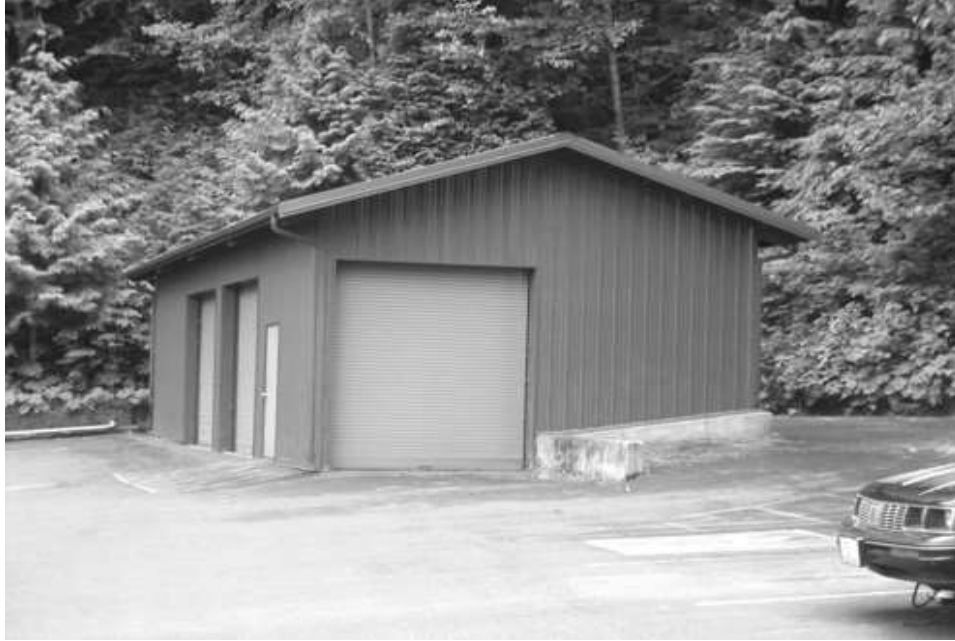
Vocational Storage (020-2300) STATE UFI: A07195 Main Campus (020A)
AREA: 960 SF BUILT: 1997 REMODELED: No PREDOMINANT USE: Storage
CONSTRUCTION TYPE: Light CRV/SF: \$231 REPLACEMENT VALUE: \$221,760

Primary Systems			
COMPONENT:	Structure	RATING: 1 x WEIGHT: 11.8 =	SCORE: 11.8
No signs of settlement or cracking, no abrupt vertical changes Columns, bearing walls and roof structure appears sound/free of defects			
COMMENTS:	Wood framing; concrete slab		
COMPONENT:	Exterior Closure	RATING: 2 x WEIGHT: 11.8 =	SCORE: 23.6
Weatherproof exterior, but finish appears poorly maintained			
COMMENTS:	Metal wall panels		
COMPONENT:	Roofing	RATING: 2 x WEIGHT: 14.7 =	SCORE: 29.5
Majority of roofing and flashing appear sound, but a small portion of roofing shows deterioration where maintenance or minor repair needed			
COMMENTS:	Metal roof

Secondary Systems			
COMPONENT:	Floor Finishes	RATING: 1 x WEIGHT: 8.8 =	SCORE: 8.8
Nice appearance, smooth transitions, level subfloors, no cracks/separating			
COMMENTS:	Concrete		
COMPONENT:	Wall Finishes	RATING: 0 x WEIGHT: 0 =	SCORE: 0
No data			
COMMENTS:	Metal wall panels		
COMPONENT:	Ceiling Finishes	RATING: 0 x WEIGHT: 0 =	SCORE: 0
No data			
COMMENTS:	Metal panels		
COMPONENT:	Doors & Hardware	RATING: 3 x WEIGHT: 8.8 =	SCORE: 26.5
Functional, but dated; some maintenance required			
COMMENTS:	Exterior HM doors/frames-surface wear; metal OH doors-surface wear

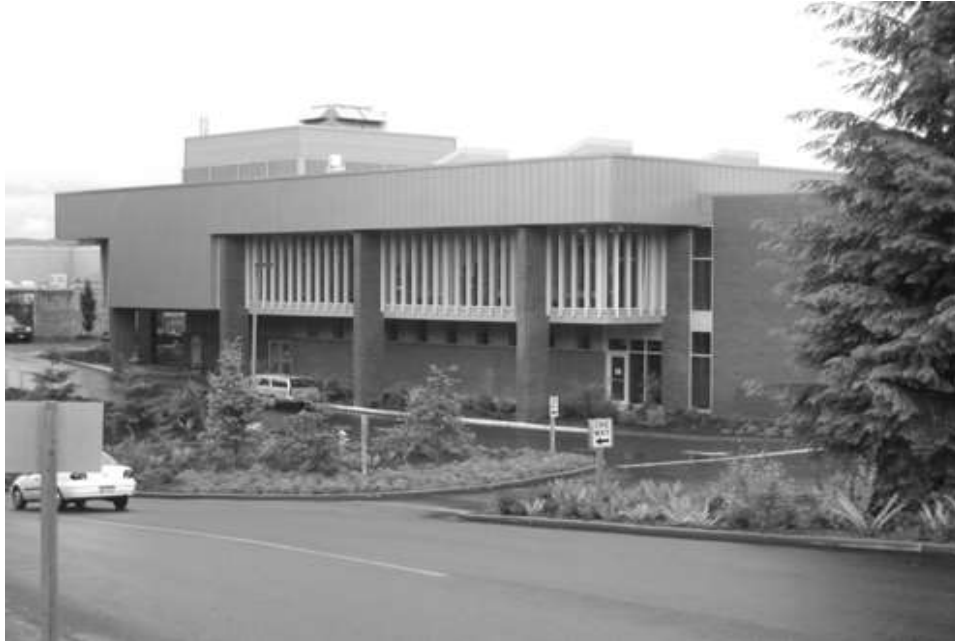
Lib (020-1500) STATE UFI: A09264 Main Campus (020A)
AREA: 25,155 SF BUILT: 1966 REMODELED: 2004 PREDOMINANT USE: Library
CONSTRUCTION TYPE: Medium CRV/SF: \$376 REPLACEMENT VALUE: \$9,458,280

Primary Systems			
COMPONENT:	Structure	RATING: 1 x WEIGHT: 8 =	SCORE: 8
No signs of settlement or cracking, no abrupt vertical changes Columns, bearing walls and roof structure appears sound/free of defects			
COMMENTS:	Wood; concrete		
COMPONENT:	Exterior Closure	RATING: 1 x WEIGHT: 8 =	SCORE: 8
Weatherproof, tight, well-maintained exterior walls, doors, windows/finishes			
COMMENTS:	Concrete; brick; metal panels; aluminum window walls		
COMPONENT:	Roofing	RATING: 2 x WEIGHT: 10 =	SCORE: 20
Majority of roofing and flashing appear sound, but a small portion of roofing shows deterioration where maintenance or minor repair needed			
COMMENTS:	Hypalon single-ply membrane; skylights

Secondary Systems			
COMPONENT:	Floor Finishes	RATING: 2 x WEIGHT: 6 =	SCORE: 12
Some wear is evident on finish; maintenance needed			
COMMENTS:	Carpet and vinyl tile-surface wear; slate tile; ceramic tile; cement		
COMPONENT:	Wall Finishes	RATING: 1 x WEIGHT: 6 =	SCORE: 6
Maintainable surfaces in good condition			
COMMENTS:	Gypsum board; wood; ceramic tile; brick		
COMPONENT:	Ceiling Finishes	RATING: 1 x WEIGHT: 6 =	SCORE: 6
Maintainable surfaces in good condition; good alignment and appearance			
COMMENTS:	Lay-in tile; gypsum board		
COMPONENT:	Doors & Hardware	RATING: 1 x WEIGHT: 6 =	SCORE: 6
Appropriate hardware, closers, panic devices; in good working order			
COMMENTS:	Interior wood doors w aluminum frames; sidelites; exterior aluminum doors/frames

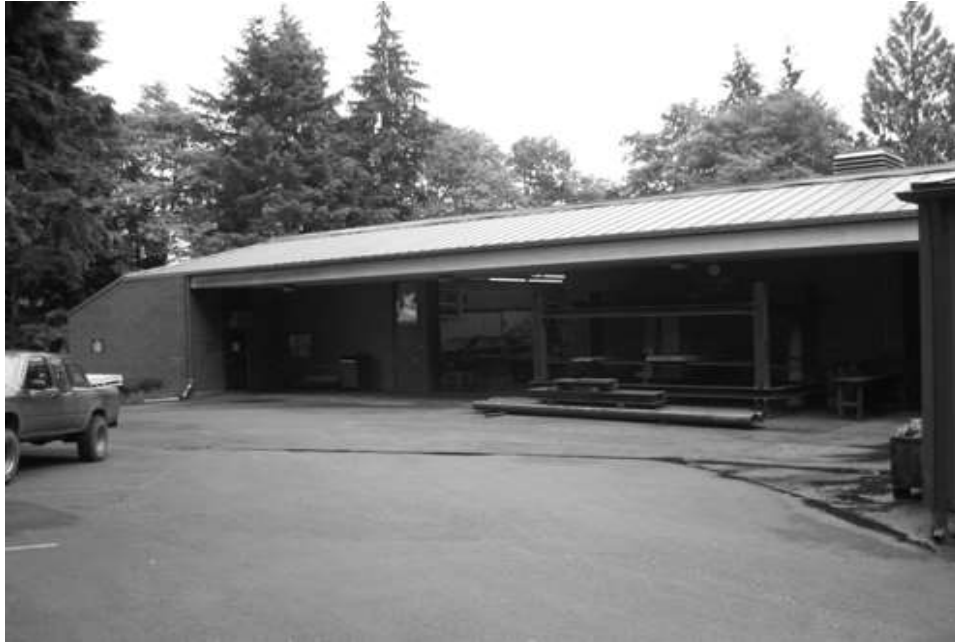
Voktek (020-700) STATE UFI: A09725 Main Campus (020A)
 AREA: 23,305 SF BUILT: 1971 REMODELED: 2010 PREDOMINANT USE: Vocational Arts
 CONSTRUCTION TYPE: Medium CRV/SF: \$395 REPLACEMENT VALUE: \$9,205,475

Primary Systems			
COMPONENT:	Structure	RATING: 1 x WEIGHT: 8 =	SCORE: 8
No signs of settlement or cracking, no abrupt vertical changes Columns, bearing walls and roof structure appears sound/free of defects			
COMMENTS:	Concrete; CMU; wood framing; glu-lam beams		
COMPONENT:	Exterior Closure	RATING: 3 x WEIGHT: 8 =	SCORE: 24
Sound and weatherproof but with some physical deterioration evident			
COMMENTS:	CMU; concrete; brick; metal panels; plaster soffits		
COMPONENT:	Roofing	RATING: 2 x WEIGHT: 10 =	SCORE: 20
Majority of roofing and flashing appear sound, but a small portion of roofing shows deterioration where maintenance or minor repair needed			
COMMENTS:	Standing seam metal; Hypalon single-ply membrane-2008

Secondary Systems			
COMPONENT:	Floor Finishes	RATING: 2 x WEIGHT: 6 = SCORE: 12	
	Some wear is evident on finish; maintenance needed		
COMMENTS:	Concrete; vinyl tile; ceramic tile; carpet		
COMPONENT:	Wall Finishes	RATING: 2 x WEIGHT: 6 = SCORE: 12	
	Maintainable surfaces, minor maintenance is required in some areas		
COMMENTS:	CMU; gypsum board		
COMPONENT:	Ceiling Finishes	RATING: 2 x WEIGHT: 6 = SCORE: 12	
	Aging surfaces in fair condition and good alignment		
COMMENTS:	Gypsum board; wood roof deck; direct adhered tile		
COMPONENT:	Doors & Hardware	RATING: 1 x WEIGHT: 6 = SCORE: 6	
	Appropriate hardware, closers, panic devices; in good working order		
COMMENTS:	Interior wood/HM doors w HM frames; exterior HM doors/frames; metal OH and coiling doors

Service Systems			
COMPONENT:	Elevators	RATING: 3 x WEIGHT: 6 = SCORE: 18	
	Elevators provided but functionality is inadequate; Unreliable operation		
COMMENTS:	No elevator to lower area		
COMPONENT:	Plumbing	RATING: 3 x WEIGHT: 8 = SCORE: 24	
	Fixtures are functional but dated; some leaks; maintenance required		
COMMENTS:	Galvanized, cast iron, copper and steel piping; porcelain fixtures		
COMPONENT:	HVAC	RATING: 3 x WEIGHT: 8 = SCORE: 24	
	System generally adequate; some deterioration; needs balancing; some areas have A/C; hazardous areas are ventilated		
COMMENTS:	AHUs (2013) with electric strip heat; duct heaters; ceiling furnaces		
COMPONENT:	Electrical	RATING: 1 x WEIGHT: 8 = SCORE: 8	
	Adequate service and distribution capacity for current/future needs		
COMMENTS:	1600amp 480/277v; 1200amp 208/120v		
COMPONENT:	Lights/Power	RATING: 1 x WEIGHT: 8 = SCORE: 8	
	Contemporary lighting with good work area illumination; ample outlets

Safety Systems			
COMPONENT:	Life/Safety	RATING: 3 x WEIGHT: 10 = SCORE: 30	
	Generally meets codes for vintage of construction		
COMMENTS:			
COMPONENT:	Fire Safety	RATING: 1 x WEIGHT: 10 = SCORE: 10	
	Locally monitored detection; alarm and strobes present; sprinklers in high hazard areas		
COMMENTS:	Partial sprinklers		
COMPONENT:	Modifications	RATING: 1 x WEIGHT: 7 = SCORE: 7	
	Modifications appear to be in compliance with codes and sound construction practices; HVAC/electrical service properly provided		
COMMENTS:	Upper floor renovation and minor lower floor remodel were well executed

Quality Standards			
COMPONENT:	Maintenance	RATING: 1 x WEIGHT: 7 = SCORE: 7	
	Facility appears well maintained		
COMMENTS:			
COMPONENT:	Remaining Life	RATING: 2 x WEIGHT: 6 = SCORE: 12	
	Life expectancy is 15-20 years; minor to moderate system deterioration		
COMMENTS:	2010 upper floor renovation has greatly enhanced building and extended useful life		
COMPONENT:	Appearance	RATING: 3 x WEIGHT: 6 = SCORE: 18	
	Average construction; average interior and exterior appearance		
COMMENTS:	Very utilitarian exterior

CONDITION: Needs Improvement/Additional Maintenance

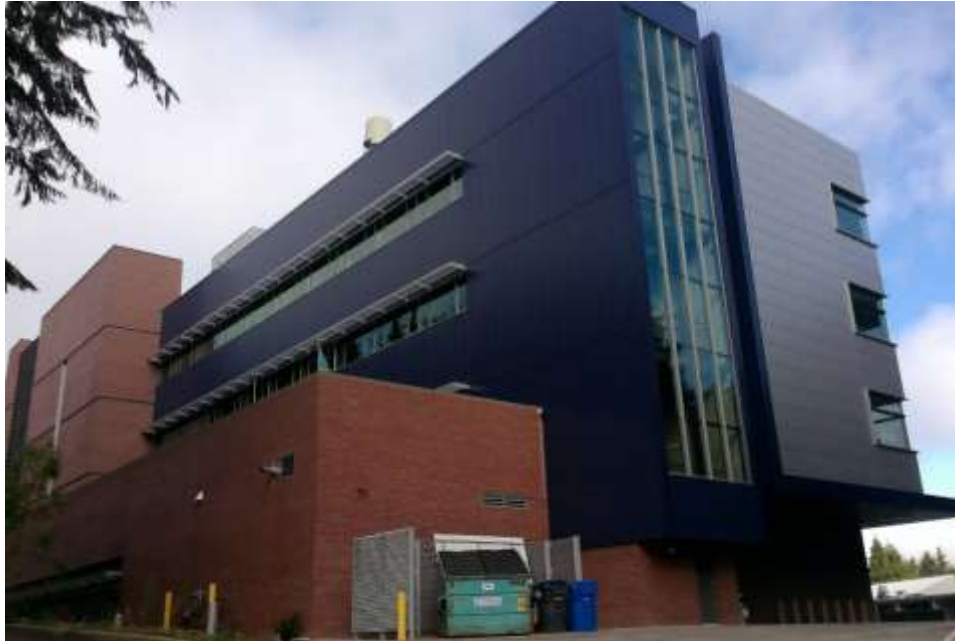
Schermer Instructional (020-4000) STATE UFI: A21240 Main Campus (020A)
AREA: 70,350 SF BUILT: 2015 REMODELED: No PREDOMINANT USE: Classroom
CONSTRUCTION TYPE: No data CRV/SF: \$356 REPLACEMENT VALUE: \$25,044,600

Primary Systems			
COMPONENT:	Structure	RATING: 1 x WEIGHT: 8.4 =	SCORE: 8.4
No signs of settlement or cracking, no abrupt vertical changes Columns, bearing walls and roof structure appears sound/free of defects			
COMMENTS:	Concrete frame		
COMPONENT:	Exterior Closure	RATING: 2 x WEIGHT: 8.4 =	SCORE: 16.8
Weatherproof exterior, but finish appears poorly maintained			
COMMENTS:	Masonry, metal panels; several window headers leak		
COMPONENT:	Roofing	RATING: 1 x WEIGHT: 10.5 =	SCORE: 10.5
Flashing and penetrations appear sound and membrane appears water- tight; drainage is positive and there are overflow scuppers			
COMMENTS:	Single-ply, green roof

Secondary Systems			
COMPONENT:	Floor Finishes	RATING: 1 x WEIGHT: 6.3 = SCORE: 6.3	
	Nice appearance, smooth transitions, level subfloors, no cracks/separating		
COMMENTS:	VCT, carpet, tile, terrazzo, polished concrete		
COMPONENT:	Wall Finishes	RATING: 1 x WEIGHT: 6.3 = SCORE: 6.3	
	Maintainable surfaces in good condition		
COMMENTS:	GWB, concrete, masonry		
COMPONENT:	Ceiling Finishes	RATING: 1 x WEIGHT: 6.3 = SCORE: 6.3	
	Maintainable surfaces in good condition; good alignment and appearance		
COMMENTS:	Wood, GWB		
COMPONENT:	Doors & Hardware	RATING: 1 x WEIGHT: 6.3 = SCORE: 6.3	
	Appropriate hardware, closers, panic devices; in good working order		
COMMENTS:	Wood doors, HM frames

Service Systems			
COMPONENT:	Elevators	RATING: 1 x WEIGHT: 6.3 = SCORE: 6.3	
	Appropriate and functional for occupancy and use		
COMMENTS:	5-stop		
COMPONENT:	Plumbing	RATING: 1 x WEIGHT: 8.4 = SCORE: 8.4	
	Fixtures and piping appear to be in good condition; no evidence of leaks		
COMMENTS:	No data		
COMPONENT:	HVAC	RATING: 2 x WEIGHT: 8.4 = SCORE: 16.8	
	Equipment in fair condition; minor deterioration; controls require troubleshooting; most areas have A/C; hazardous areas are ventilated		
COMMENTS:	Geothermal heat pump with boiler back up; chiller partial failure due to design.		
COMPONENT:	Electrical	RATING: 1 x WEIGHT: 8.4 = SCORE: 8.4	
	Adequate service and distribution capacity for current/future needs		
COMMENTS:	Four 2000Amp gear		
COMPONENT:	Lights/Power	RATING: 1 x WEIGHT: 8.4 = SCORE: 8.4	
	Contemporary lighting with good work area illumination; ample outlets		
COMMENTS:	LED, T5

Safety Systems			
COMPONENT:	Life/Safety	RATING: 1 x WEIGHT: 10.5 =	SCORE: 10.5
	Appears to meet current codes		
COMMENTS:	No data		
COMPONENT:	Fire Safety	RATING: 1 x WEIGHT: 10.5 =	SCORE: 10.5
	Locally monitored detection; alarm and strobes present; sprinklers in high hazard areas		
COMMENTS:	No data		
COMPONENT:	Modifications	RATING: 0 x WEIGHT: 0 =	SCORE: 0
	No data		
COMMENTS:	No data

Quality Standards			
COMPONENT:	Maintenance	RATING: 1 x WEIGHT: 7.4 =	SCORE: 7.4
	Facility appears well maintained		
COMMENTS:	No data		
COMPONENT:	Remaining Life	RATING: 1 x WEIGHT: 6.3 =	SCORE: 6.3
	Life expectancy is >20 years; minor system deterioration		
COMMENTS:	No data		
COMPONENT:	Appearance	RATING: 1 x WEIGHT: 6.3 =	SCORE: 6.3
	Well-constructed building; generally attractive interior and exterior		
COMMENTS:	No data

CONDITION: Superior

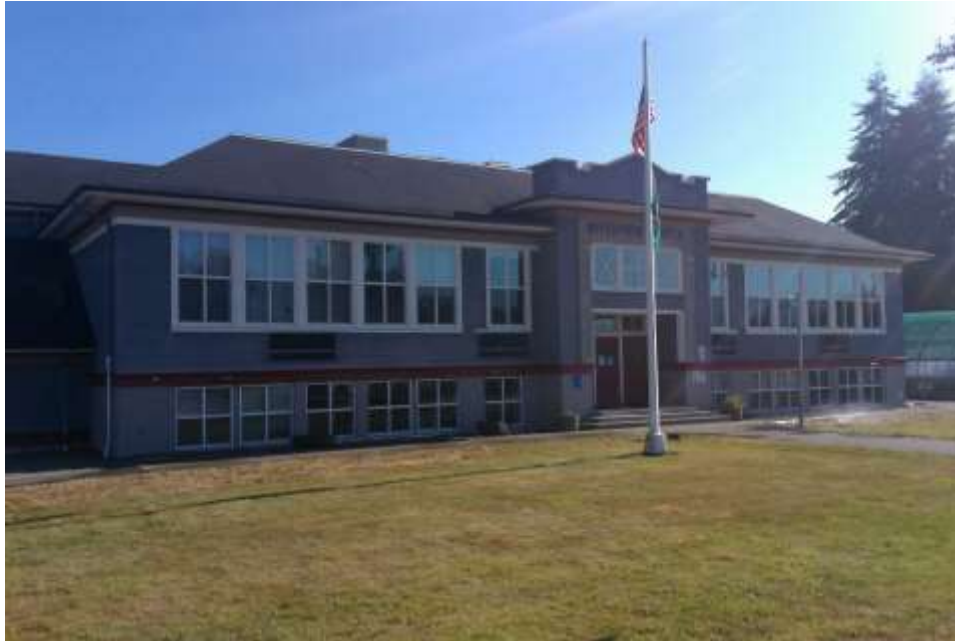
Riverview Education Ctr (020-2200) STATE UFI: A04555 Riverview Ed. Center (020C)
AREA: 12,660 SF BUILT: 1925 REMODELED: 2001 PREDOMINANT USE: General Classroom
CONSTRUCTION TYPE: Medium CRV/SF: \$376 REPLACEMENT VALUE: \$4,760,160

Primary Systems			
COMPONENT:	Structure	RATING: 1 x WEIGHT: 8 =	SCORE: 8
No signs of settlement or cracking, no abrupt vertical changes Columns, bearing walls and roof structure appears sound/free of defects			
COMMENTS:	Concrete; wood framing		
COMPONENT:	Exterior Closure	RATING: 2 x WEIGHT: 8 =	SCORE: 16
Weatherproof exterior, but finish appears poorly maintained			
COMMENTS:	Wood horizontal beveled siding-mix of original and new; concrete. Needs paint.		
COMPONENT:	Roofing	RATING: 1 x WEIGHT: 10 =	SCORE: 10
Flashing and penetrations appear sound and membrane appears water- tight; drainage is positive and there are overflow scuppers			
COMMENTS:	Composition 3-tab shingles-2001; TPO single ply membrane-2007

Secondary Systems			
COMPONENT:	Floor Finishes	RATING: 2 x WEIGHT: 6 =	SCORE: 12
Some wear is evident on finish; maintenance needed			
COMMENTS:	Carpet, vinyl tile and sheet flooring		
COMPONENT:	Wall Finishes	RATING: 1 x WEIGHT: 6 =	SCORE: 6
Maintainable surfaces in good condition			
COMMENTS:	Gypsum board and vinyl wall panels		
COMPONENT:	Ceiling Finishes	RATING: 1 x WEIGHT: 6 =	SCORE: 6
Maintainable surfaces in good condition; good alignment and appearance			
COMMENTS:	Direct adhered tile; lay-in tile; gypsum board		
COMPONENT:	Doors & Hardware	RATING: 2 x WEIGHT: 6 =	SCORE: 12
Fairly modern door surfaces and hardware with minor deterioration; good working order			
COMMENTS:	Interior wood/HM doors/frames-surface wear; exterior aluminum/wood doors/frames

Service Systems			
COMPONENT:	Elevators	RATING: 1 x WEIGHT: 6 =	SCORE: 6
Appropriate and functional for occupancy and use			
COMMENTS:	2 stop		
COMPONENT:	Plumbing	RATING: 1 x WEIGHT: 8 =	SCORE: 8
Fixtures and piping appear to be in good condition; no evidence of leaks			
COMMENTS:	Copper, cast iron, steel and PVC piping; porcelain fixtures		
COMPONENT:	HVAC	RATING: 2 x WEIGHT: 8 =	SCORE: 16
Equipment in fair condition; minor deterioration; controls require troubleshooting; most areas have A/C; hazardous areas are ventilated			
COMMENTS:	Roof mount packaged HVAC units; classroom univent units- several replaced 19-23		
COMPONENT:	Electrical	RATING: 1 x WEIGHT: 8 =	SCORE: 8
Adequate service and distribution capacity for current/future needs			
COMMENTS:	800amp 208/120v		
COMPONENT:	Lights/Power	RATING: 1 x WEIGHT: 8 =	SCORE: 8
Contemporary lighting with good work area illumination; ample outlets			
COMMENTS:	Lay-in, suspended and ceiling-mount fluorescent lights

Safety Systems			
COMPONENT:	Life/Safety	RATING: 1 x WEIGHT: 10 = SCORE: 10	
	Appears to meet current codes		
COMMENTS:			
COMPONENT:	Fire Safety	RATING: 2 x WEIGHT: 10 = SCORE: 20	
	Locally monitored detection; alarm present, but missing visual component or sprinklers		
COMMENTS:			
COMPONENT:	Modifications	RATING: 1 x WEIGHT: 7 = SCORE: 7	
	Modifications appear to be in compliance with codes and sound construction practices; HVAC/electrical service properly provided		
COMMENTS:	77 year old building was completely renovated in 2001

Quality Standards			
COMPONENT:	Maintenance	RATING: 1 x WEIGHT: 7 = SCORE: 7	
	Facility appears well maintained		
COMMENTS:			
COMPONENT:	Remaining Life	RATING: 1 x WEIGHT: 6 = SCORE: 6	
	Life expectancy is >20 years; minor system deterioration		
COMMENTS:	Comprehensive renovation has upgraded all major building systems		
COMPONENT:	Appearance	RATING: 1 x WEIGHT: 6 = SCORE: 6	
	Well-constructed building; generally attractive interior and exterior		
COMMENTS:

CONDITION: Adequate

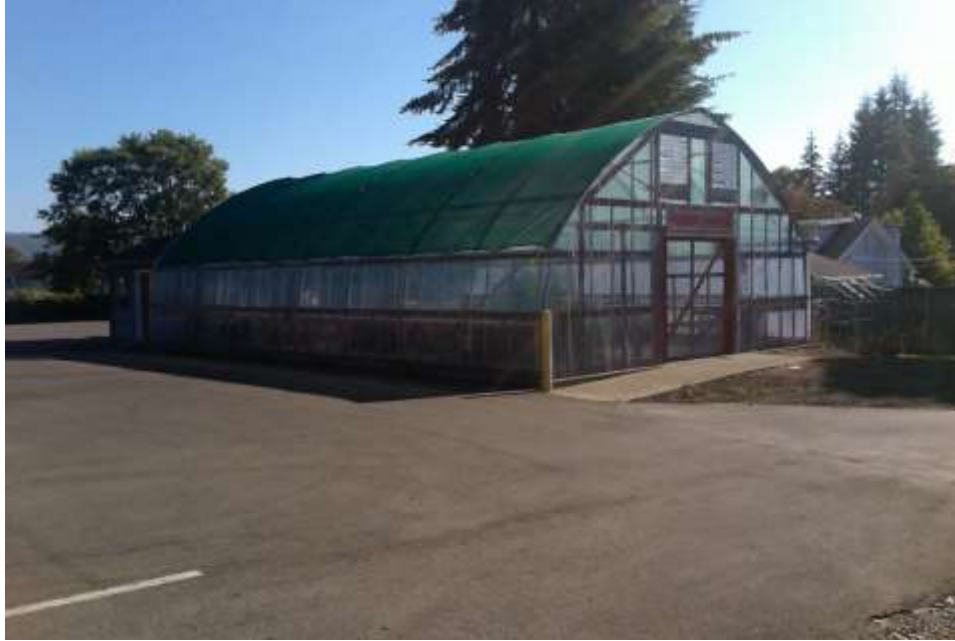
Leon Lead Rec Greenhouse (020-2200G) STATE UFI: A05541 Riverview Ed. Center (020C)
AREA: 1,824 SF BUILT: 2009 REMODELED: No PREDOMINANT USE: Classroom
CONSTRUCTION TYPE: No data CRV/SF: \$356 REPLACEMENT VALUE: \$649,344

Primary Systems			
COMPONENT:	Structure	RATING: 1 x WEIGHT: 10.2 =	SCORE: 10.2
No signs of settlement or cracking, no abrupt vertical changes Columns, bearing walls and roof structure appears sound/free of defects			
COMMENTS:	No Comments		
COMPONENT:	Exterior Closure	RATING: 3 x WEIGHT: 10.2 =	SCORE: 30.5
Sound and weatherproof but with some physical deterioration evident			
COMMENTS:	No data		
COMPONENT:	Roofing	RATING: 4 x WEIGHT: 12.7 =	SCORE: 50.8
General deterioration and some leaks are evident; reconditioning or partial repair is needed			
COMMENTS:	plastic panels

Secondary Systems			
COMPONENT:	Floor Finishes	RATING: 3 x WEIGHT: 7.6 = SCORE: 22.9	
	Some physical wear and minor imperfections are evident; beginning deterioration		
COMMENTS:	concrete, gravel		
COMPONENT:	Wall Finishes	RATING: 3 x WEIGHT: 7.6 = SCORE: 22.9	
	Aging surfaces, but sound; some maintenance is required		
COMMENTS:	Drywall in shed		
COMPONENT:	Ceiling Finishes	RATING: 0 x WEIGHT: 0 = SCORE: 0	
	No data		
COMMENTS:	None		
COMPONENT:	Doors & Hardware	RATING: 3 x WEIGHT: 7.6 = SCORE: 22.9	
	Functional, but dated; some maintenance required		
COMMENTS:	No data

Service Systems			
COMPONENT:	Elevators	RATING: 0 x WEIGHT: 0 = SCORE: 0	
	No data		
COMMENTS:	No data		
COMPONENT:	Plumbing	RATING: 1 x WEIGHT: 10.2 = SCORE: 10.2	
	Fixtures and piping appear to be in good condition; no evidence of leaks		
COMMENTS:	No data		
COMPONENT:	HVAC	RATING: 3 x WEIGHT: 10.2 = SCORE: 30.5	
	System generally adequate; some deterioration; needs balancing; some areas have A/C; hazardous areas are ventilated		
COMMENTS:	No data		
COMPONENT:	Electrical	RATING: 1 x WEIGHT: 10.2 = SCORE: 10.2	
	Adequate service and distribution capacity for current/future needs		
COMMENTS:	No data		
COMPONENT:	Lights/Power	RATING: 3 x WEIGHT: 10.2 = SCORE: 30.5	
	Adequate work area illumination; adequate outlets for current use; maintenance required		
COMMENTS:	No data

Quality Standards			
COMPONENT:	Maintenance	RATING: 1 x WEIGHT: 8.9 =	SCORE: 8.9
	Facility appears well maintained		
COMMENTS:	No data		
COMPONENT:	Remaining Life	RATING: 1 x WEIGHT: 7.6 =	SCORE: 7.6
	Life expectancy is >20 years; minor system deterioration		
COMMENTS:	No data		
COMPONENT:	Appearance	RATING: 3 x WEIGHT: 7.6 =	SCORE: 22.9
	Average construction; average interior and exterior appearance		
COMMENTS:	No data

CONDITION: Needs Improvement/Renovation
