2023 FACILITY CONDITION SURVEY

Highline College

SURVEY CONDUCTED BY:
Steve Lewandowski
State Board for Community
and Technical Colleges

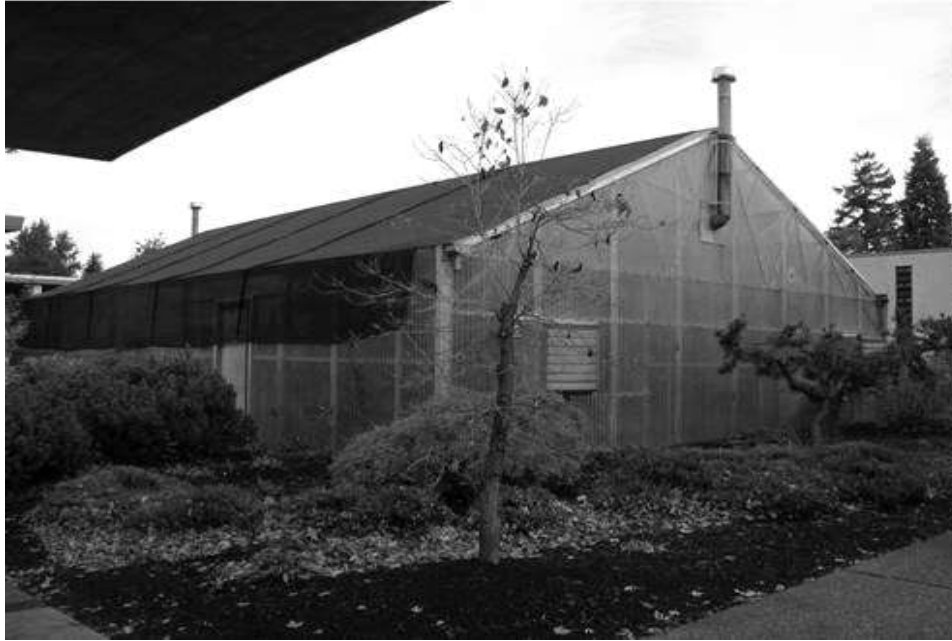
Greenhouse B Bldg (090-12B) STATE UFI: A03887 Main Campus (090A)
AREA: 1,500 SF BUILT: 1981 REMODELED: 2015 PREDOMINANT USE: Greenhouse
CONSTRUCTION TYPE: Light CRV/SF: \$153 REPLACEMENT VALUE: \$229,500

Primary Systems			
COMPONENT:	Structure	RATING: 1 x WEIGHT: 9.6 =	SCORE: 9.6
No signs of settlement or cracking, no abrupt vertical changes Columns, bearing walls and roof structure appears sound/free of defects			
COMMENTS:	Galvanized. metal frame & trusses		
COMPONENT:	Exterior Closure	RATING: 1 x WEIGHT: 9.6 =	SCORE: 9.6
Weatherproof, tight, well-maintained exterior walls, doors, windows/finishes			
COMMENTS:	Fiberglass corrugated panels		
COMPONENT:	Roofing	RATING: 1 x WEIGHT: 12 =	SCORE: 12
Flashing and penetrations appear sound and membrane appears water- tight; drainage is positive and there are overflow scuppers			
COMMENTS:	Fiberglass corrugated panels

Secondary Systems			
COMPONENT:	Floor Finishes	RATING: 1 x WEIGHT: 7.2 =	SCORE: 7.2
Nice appearance, smooth transitions, level subfloors, no cracks/separating			
COMMENTS:	Concrete; gravel		
COMPONENT:	Wall Finishes	RATING: 0 x WEIGHT: 0 =	SCORE: 0
No data			
COMMENTS:	Fiberglass panels		
COMPONENT:	Ceiling Finishes	RATING: 0 x WEIGHT: 0 =	SCORE: 0
No data			
COMMENTS:	Fiberglass panels		
COMPONENT:	Doors & Hardware	RATING: 3 x WEIGHT: 7.2 =	SCORE: 21.5
Functional, but dated; some maintenance required			
COMMENTS:	Exterior HM door/frame

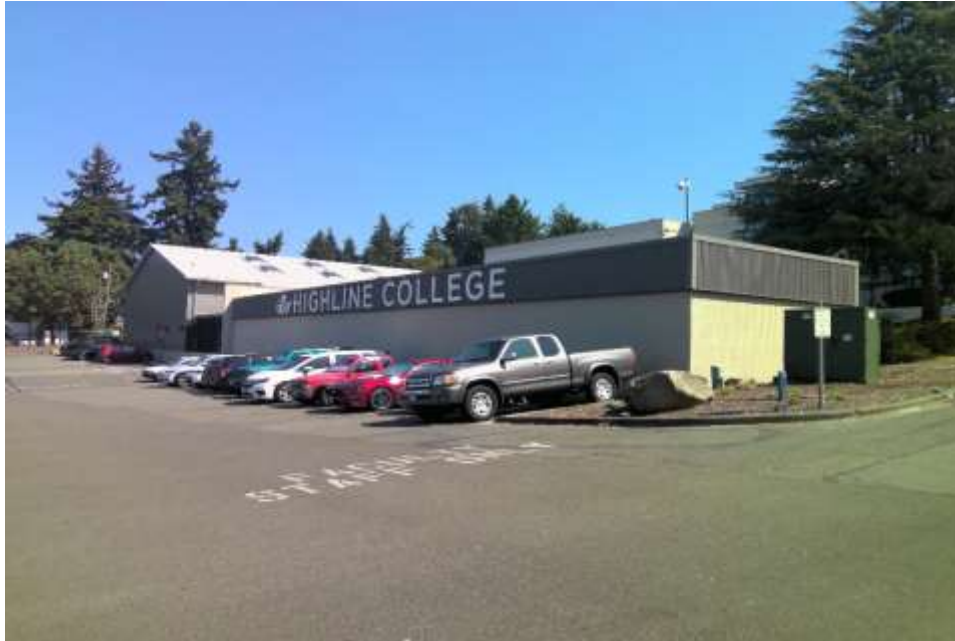
Grounds Compound (090-24A) STATE UFI: A00326 Main Campus (090A)
AREA: 3,004 SF BUILT: 1980 REMODELED: No PREDOMINANT USE: Maintenance
CONSTRUCTION TYPE: Light CRV/SF: \$264 REPLACEMENT VALUE: \$793,056

Primary Systems			
COMPONENT:	Structure	RATING: 1 x WEIGHT: 8.7 =	SCORE: 8.7
No signs of settlement or cracking, no abrupt vertical changes Columns, bearing walls and roof structure appears sound/free of defects			
COMMENTS: Fluted CMU structure; wood roof trusses			
COMPONENT:	Exterior Closure	RATING: 1 x WEIGHT: 8.7 =	SCORE: 8.7
Weatherproof, tight, well-maintained exterior walls, doors, windows/finishes			
COMMENTS: Fluted CMU; plywood fascia			
COMPONENT:	Roofing	RATING: 1 x WEIGHT: 10.9 =	SCORE: 10.9
Flashing and penetrations appear sound and membrane appears water- tight; drainage is positive and there are overflow scuppers			
COMMENTS: TPO single-ply-2000

Secondary Systems			
COMPONENT:	Floor Finishes	RATING: 1 x WEIGHT: 6.5 =	SCORE: 6.5
Nice appearance, smooth transitions, level subfloors, no cracks/separating			
COMMENTS:	Concrete		
COMPONENT:	Wall Finishes	RATING: 3 x WEIGHT: 6.5 =	SCORE: 19.6
Aging surfaces, but sound; some maintenance is required			
COMMENTS:	CMU; gypsum board		
COMPONENT:	Ceiling Finishes	RATING: 0 x WEIGHT: 0 =	SCORE: 0
No data			
COMMENTS:	Gypsum board; wood deck		
COMPONENT:	Doors & Hardware	RATING: 3 x WEIGHT: 6.5 =	SCORE: 19.6
Functional, but dated; some maintenance required			
COMMENTS:	Interior/exterior HM doors/frames; wood sliding doors

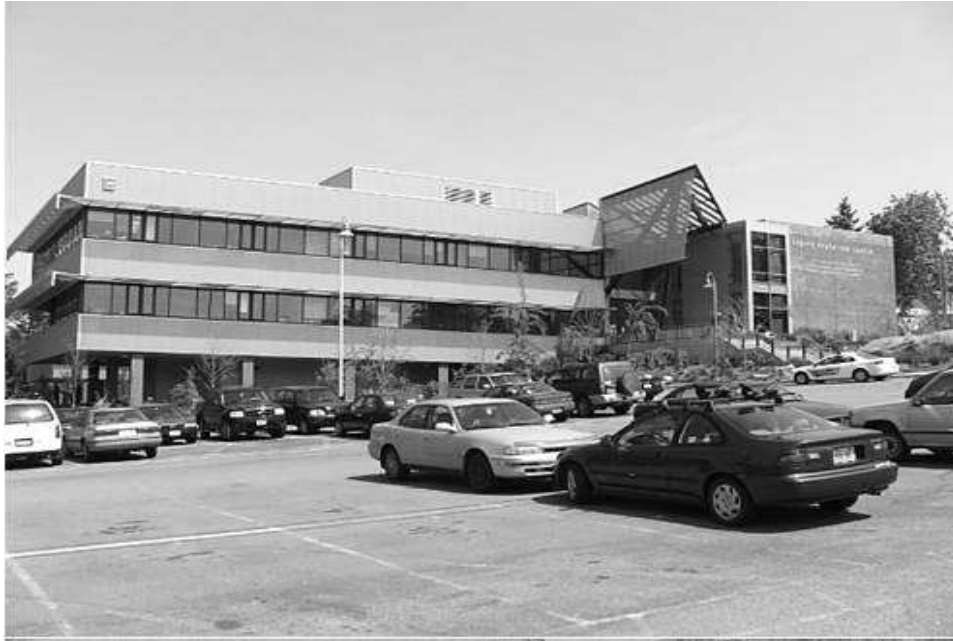
Higher Education Center (090-29) STATE UFI: A06060 Main Campus (090A)
AREA: 79,695 SF BUILT: 2004 REMODELED: No PREDOMINANT USE: General Classroom
CONSTRUCTION TYPE: Heavy CRV/SF: \$376 REPLACEMENT VALUE: \$29,965,320

Primary Systems			
COMPONENT:	Structure	RATING: 1 x WEIGHT: 8.4 =	SCORE: 8.4
No signs of settlement or cracking, no abrupt vertical changes Columns, bearing walls and roof structure appears sound/free of defects			
COMMENTS:	Concrete frame; steel framed entry canopies		
COMPONENT:	Exterior Closure	RATING: 1 x WEIGHT: 8.4 =	SCORE: 8.4
Weatherproof, tight, well-maintained exterior walls, doors, windows/finishes			
COMMENTS:	Corrugated metal siding; aluminum panels; cement board panels; concrete wall & frame		
COMPONENT:	Roofing	RATING: 1 x WEIGHT: 10.5 =	SCORE: 10.5
Flashing and penetrations appear sound and membrane appears water- tight; drainage is positive and there are overflow scuppers			
COMMENTS:	BUR w mineral-surfaced cap sheet

Secondary Systems			
COMPONENT:	Floor Finishes	RATING: 1 x WEIGHT: 6.3 = SCORE: 6.3	
	Nice appearance, smooth transitions, level subfloors, no cracks/separating		
COMMENTS:	Carpet tiles; slate; linoleum; concrete; wood strips; ceramic tile		
COMPONENT:	Wall Finishes	RATING: 1 x WEIGHT: 6.3 = SCORE: 6.3	
	Maintainable surfaces in good condition		
COMMENTS:	Gypsum board; concrete; vinyl/metal fiber wall panels; ceramic tile		
COMPONENT:	Ceiling Finishes	RATING: 1 x WEIGHT: 6.3 = SCORE: 6.3	
	Maintainable surfaces in good condition; good alignment and appearance		
COMMENTS:	Suspended perforated metal ceiling and ceiling tile; gypsum board		
COMPONENT:	Doors & Hardware	RATING: 1 x WEIGHT: 6.3 = SCORE: 6.3	
	Appropriate hardware, closers, panic devices; in good working order		
COMMENTS:	Interior wood doors w HM frames; exterior HM doors/frames

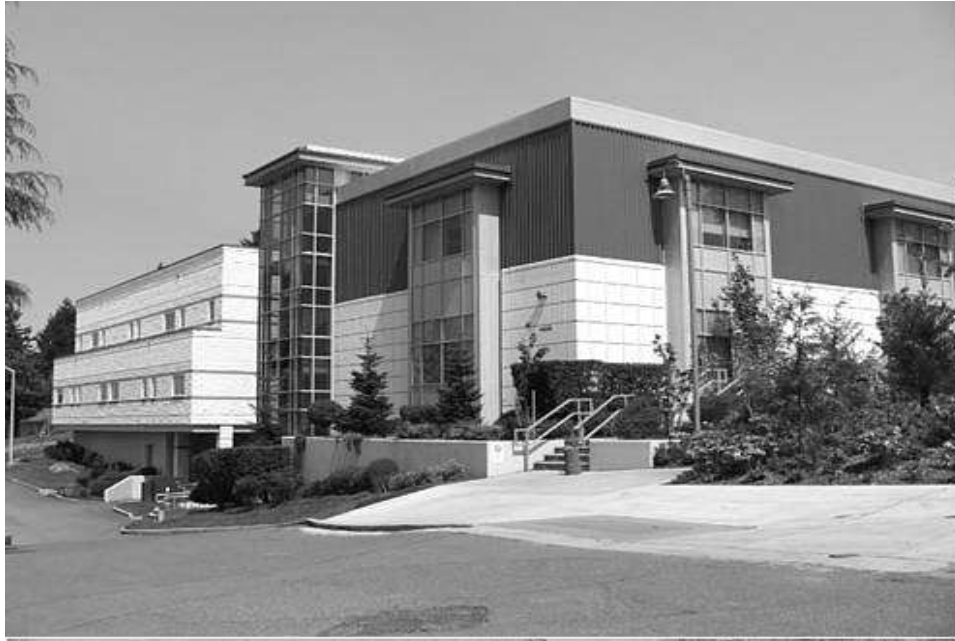
Instructional Computer Ct (090-30) STATE UFI: A04923 Main Campus (090A)
 AREA: 39,821 SF BUILT: 1989 REMODELED: 2002 PREDOMINANT USE: Computer Lab.
 CONSTRUCTION TYPE: Heavy CRV/SF: \$376 REPLACEMENT VALUE: \$14,972,696

Primary Systems			
COMPONENT:	Structure	RATING: 1 x WEIGHT: 8 =	SCORE: 8
No signs of settlement or cracking, no abrupt vertical changes Columns, bearing walls and roof structure appears sound/free of defects			
COMMENTS:	Concrete; CMU		
COMPONENT:	Exterior Closure	RATING: 1 x WEIGHT: 8 =	SCORE: 8
Weatherproof, tight, well-maintained exterior walls, doors, windows/finishes			
COMMENTS:	Concrete; CMU; aluminum building panels; corrugated metal siding; tube steel trellis		
COMPONENT:	Roofing	RATING: 1 x WEIGHT: 10 =	SCORE: 10
Flashing and penetrations appear sound and membrane appears water- tight; drainage is positive and there are overflow scuppers			
COMMENTS:	Hypalon single-ply membrane-1991, resurface half 2015, half in 2017; skylights

Secondary Systems			
COMPONENT:	Floor Finishes	RATING: 2 x WEIGHT: 6 = SCORE: 12	
	Some wear is evident on finish; maintenance needed		
COMMENTS:	Carpet; vinyl tile; ceramic tile; rubber		
COMPONENT:	Wall Finishes	RATING: 1 x WEIGHT: 6 = SCORE: 6	
	Maintainable surfaces in good condition		
COMMENTS:	Gypsum board; CMU; ceramic tile		
COMPONENT:	Ceiling Finishes	RATING: 1 x WEIGHT: 6 = SCORE: 6	
	Maintainable surfaces in good condition; good alignment and appearance		
COMMENTS:	Gypsum board; lay-in tile		
COMPONENT:	Doors & Hardware	RATING: 1 x WEIGHT: 6 = SCORE: 6	
	Appropriate hardware, closers, panic devices; in good working order		
COMMENTS:	Interior wood/laminate doors w HM frames; exterior aluminum and HM doors/frames

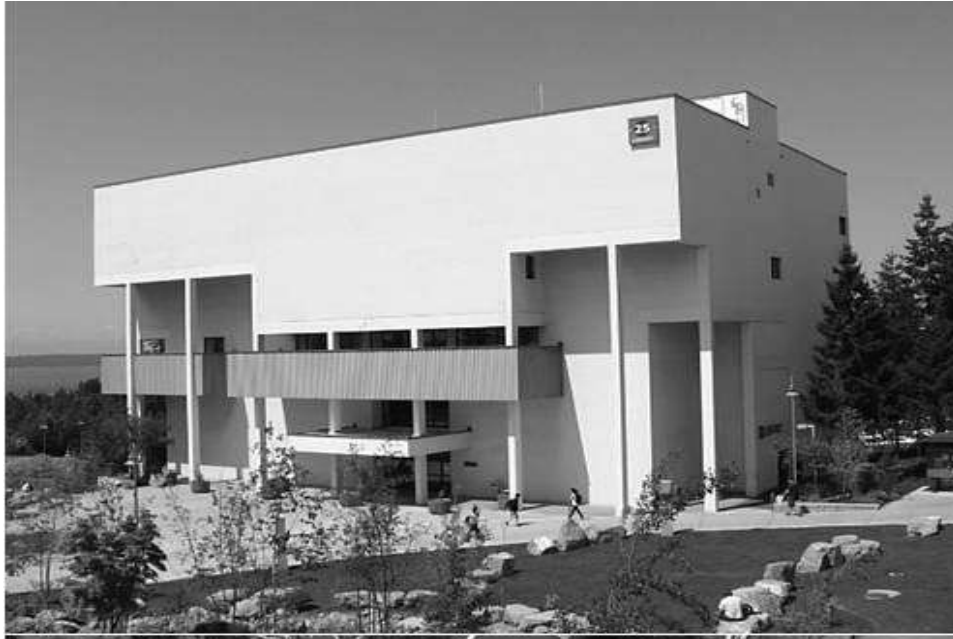
Library (090-25) STATE UFI: A01792 Main Campus (090A)
 AREA: 72,529 SF BUILT: 1978 REMODELED: 2000 PREDOMINANT USE: Library
 CONSTRUCTION TYPE: Heavy CRV/SF: \$376 REPLACEMENT VALUE: \$27,270,904

Primary Systems			
COMPONENT:	Structure	RATING: 1 x WEIGHT: 8 =	SCORE: 8
No signs of settlement or cracking, no abrupt vertical changes Columns, bearing walls and roof structure appears sound/free of defects			
COMMENTS:	Concrete frame		
COMPONENT:	Exterior Closure	RATING: 3 x WEIGHT: 8 =	SCORE: 24
Sound and weatherproof but with some physical deterioration evident			
COMMENTS:	CMU, plaster soffits-extensive peeling paint		
COMPONENT:	Roofing	RATING: 1 x WEIGHT: 10 =	SCORE: 10
Flashing and penetrations appear sound and membrane appears water- tight; drainage is positive and there are overflow scuppers			
COMMENTS:	PVC single-ply-2000

Secondary Systems			
COMPONENT:	Floor Finishes	RATING: 3 x WEIGHT: 6 = SCORE: 18	
	Some physical wear and minor imperfections are evident; beginning deterioration		
COMMENTS:	Carpet; carpet tile; vinyl tile; ceramic tile; concrete		
COMPONENT:	Wall Finishes	RATING: 2 x WEIGHT: 6 = SCORE: 12	
	Maintainable surfaces, minor maintenance is required in some areas		
COMMENTS:	Gypsum board; wood paneling; ceramic tile; acoustical tile; CMU		
COMPONENT:	Ceiling Finishes	RATING: 1 x WEIGHT: 6 = SCORE: 6	
	Maintainable surfaces in good condition; good alignment and appearance		
COMMENTS:	Lay-in tile; concealed spline tile; gypsum board; concrete		
COMPONENT:	Doors & Hardware	RATING: 3 x WEIGHT: 6 = SCORE: 18	
	Functional, but dated; some maintenance required		
COMMENTS:	Interior wood and HM doors w HM frames; exterior sliding aluminum doors/frames-to be replaced in 2012

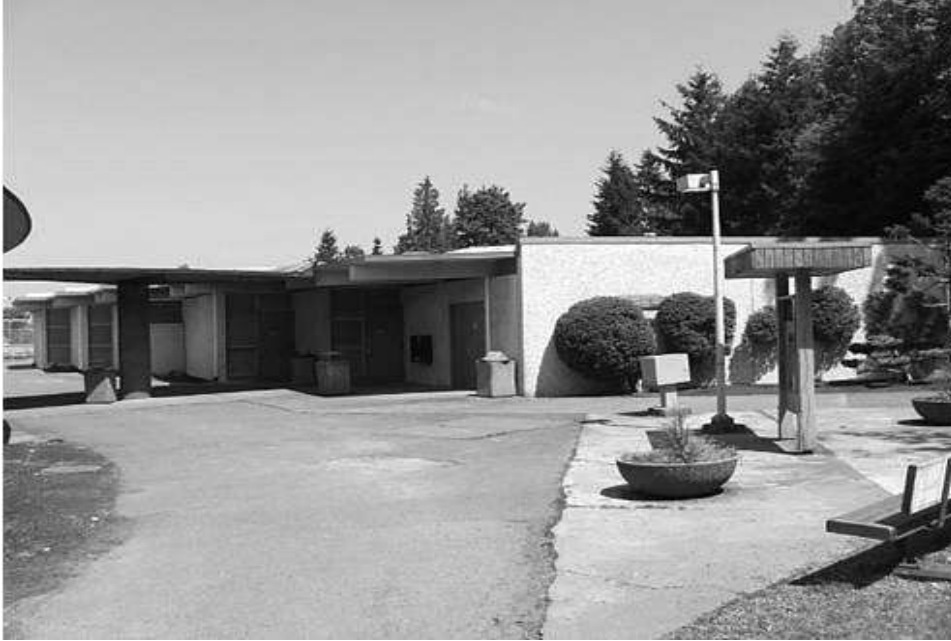
Lockerroom (090-27) STATE UFI: A09056 Main Campus (090A)
AREA: 12,080 SF BUILT: 1964 REMODELED: 2014 PREDOMINANT USE: PE
CONSTRUCTION TYPE: Heavy CRV/SF: \$330 REPLACEMENT VALUE: \$3,986,400

Primary Systems			
COMPONENT:	Structure	RATING: 3 x WEIGHT: 8.3 =	SCORE: 25
Some cracking evident but does not likely affect structural integrity; Visible defects apparent but are non-structural			
COMMENTS: Concrete frame and tilt-up panels; seismic upgrades needed			
COMPONENT:	Exterior Closure	RATING: 3 x WEIGHT: 8.3 =	SCORE: 25
Sound and weatherproof but with some physical deterioration evident			
COMMENTS: Exposed marble aggregate panels-joints need caulking			
COMPONENT:	Roofing	RATING: 4 x WEIGHT: 10.4 =	SCORE: 41.7
General deterioration and some leaks are evident; reconditioning or partial repair is needed			
COMMENTS: Hypalon single-ply; funded for replacement in 2009; not done

Secondary Systems			
COMPONENT:	Floor Finishes	RATING: 3 x WEIGHT: 6.3 =	SCORE: 18.8
Some physical wear and minor imperfections are evident; beginning deterioration			
COMMENTS:	Polished concrete; rubber flooring; ceramic tile; hardwood		
COMPONENT:	Wall Finishes	RATING: 3 x WEIGHT: 6.3 =	SCORE: 18.8
Aging surfaces, but sound; some maintenance is required			
COMMENTS:	CMU; concrete; gypsum board; ceramic tile		
COMPONENT:	Ceiling Finishes	RATING: 3 x WEIGHT: 6.3 =	SCORE: 18.8
Some wear and tear; Minor damage, staining or deterioration			
COMMENTS:	Exposed structure w/infill glue-on tile; lay-in tile; plastic panels		
COMPONENT:	Doors & Hardware	RATING: 3 x WEIGHT: 6.3 =	SCORE: 18.8
Functional, but dated; some maintenance required			
COMMENTS:	Interior/exterior HM doors/frames

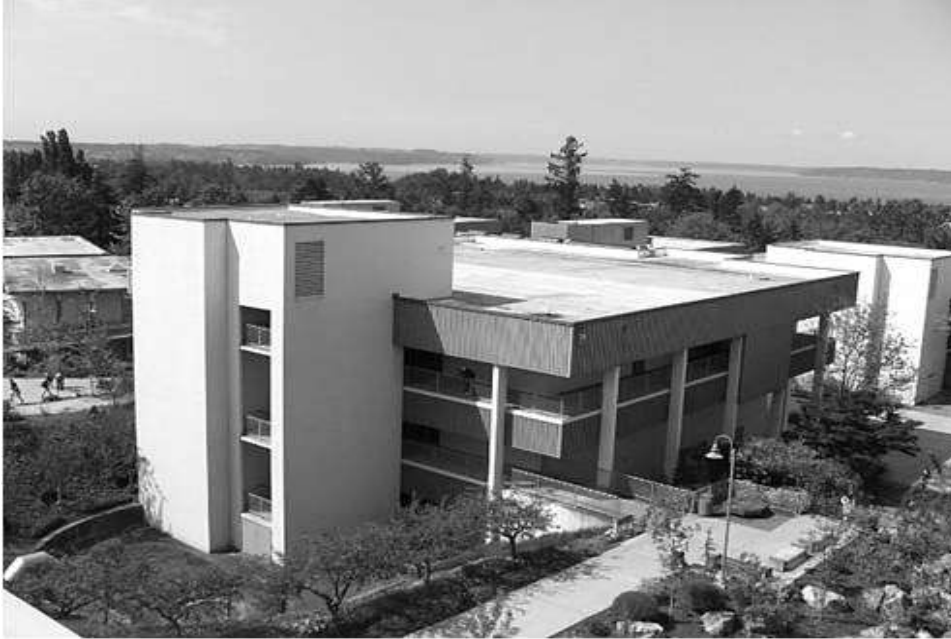
Multipurposea (090-23) STATE UFI: A04195 Main Campus (090A)
AREA: 22,669 SF BUILT: 1975 REMODELED: No PREDOMINANT USE: General Classroom
CONSTRUCTION TYPE: Heavy CRV/SF: \$376 REPLACEMENT VALUE: \$8,523,544

Primary Systems			
COMPONENT:	Structure	RATING: 1 x WEIGHT: 8 =	SCORE: 8
No signs of settlement or cracking, no abrupt vertical changes Columns, bearing walls and roof structure appears sound/free of defects			
COMMENTS:	Concrete frame		
COMPONENT:	Exterior Closure	RATING: 1 x WEIGHT: 8 =	SCORE: 8
Weatherproof, tight, well-maintained exterior walls, doors, windows/finishes			
COMMENTS:	Concrete; fluted CMU; perforated metal soffits; corrugated metal siding; cement board		
COMPONENT:	Roofing	RATING: 2 x WEIGHT: 10 =	SCORE: 20
Majority of roofing and flashing appear sound, but a small portion of roofing shows deterioration where maintenance or minor repair needed			
COMMENTS:	PVC single-ply-2000

Secondary Systems			
COMPONENT:	Floor Finishes	RATING: 2 x WEIGHT: 6 = SCORE: 12	
	Some wear is evident on finish; maintenance needed		
COMMENTS:	Carpet; vinyl tile; sheet vinyl; concrete		
COMPONENT:	Wall Finishes	RATING: 3 x WEIGHT: 6 = SCORE: 18	
	Aging surfaces, but sound; some maintenance is required		
COMMENTS:	Gypsum board; CMU		
COMPONENT:	Ceiling Finishes	RATING: 4 x WEIGHT: 6 = SCORE: 24	
	General deterioration and moderate amount of staining or damage apparent		
COMMENTS:	Lay-in tile; perforated metal panels; random deterioration		
COMPONENT:	Doors & Hardware	RATING: 3 x WEIGHT: 6 = SCORE: 18	
	Functional, but dated; some maintenance required		
COMMENTS:	Interior wood doors w HM frames; exterior HM doors/frames

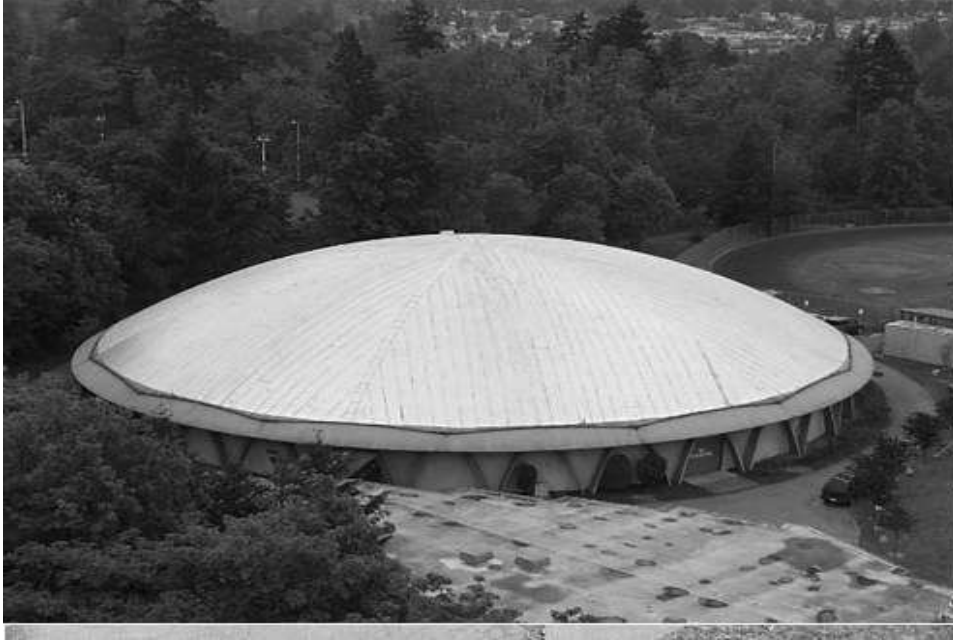
Pavilion (090-28) STATE UFI: A07277 Main Campus (090A)
AREA: 22,687 SF BUILT: 1964 REMODELED: No PREDOMINANT USE: Gymnasium
CONSTRUCTION TYPE: Heavy CRV/SF: \$349 REPLACEMENT VALUE: \$7,917,763

Primary Systems			
COMPONENT:	Structure	RATING: 3 x WEIGHT: 9.7 =	SCORE: 29
Some cracking evident but does not likely affect structural integrity; Visible defects apparent but are non-structural			
COMMENTS:	Concrete tension ring & arches, glu-lam beam framed dome; seismic concerns		
COMPONENT:	Exterior Closure	RATING: 3 x WEIGHT: 9.7 =	SCORE: 29
Sound and weatherproof but with some physical deterioration evident			
COMMENTS:	Exposed marble aggregate panels; joints need caulk		
COMPONENT:	Roofing	RATING: 3 x WEIGHT: 12.1 =	SCORE: 36.2
Some deterioration is evident in membrane and flashings; maintenance or minor repair is needed			
COMMENTS:	BUR Siplast system-1995

Secondary Systems			
COMPONENT:	Floor Finishes	RATING: 1 x WEIGHT: 7.2 =	SCORE: 7.2
Nice appearance, smooth transitions, level subfloors, no cracks/separating			
COMMENTS:	Refinished wood gym floor in 2005		
COMPONENT:	Wall Finishes	RATING: 1 x WEIGHT: 7.2 =	SCORE: 7.2
Maintainable surfaces in good condition			
COMMENTS:	Concrete		
COMPONENT:	Ceiling Finishes	RATING: 0 x WEIGHT: 0 =	SCORE: 0
No data			
COMMENTS:	Exposed structure; random damage of insulation over exposed structure		
COMPONENT:	Doors & Hardware	RATING: 3 x WEIGHT: 7.2 =	SCORE: 21.7
Functional, but dated; some maintenance required			
COMMENTS:	Exterior HM doors/frames; coiling door

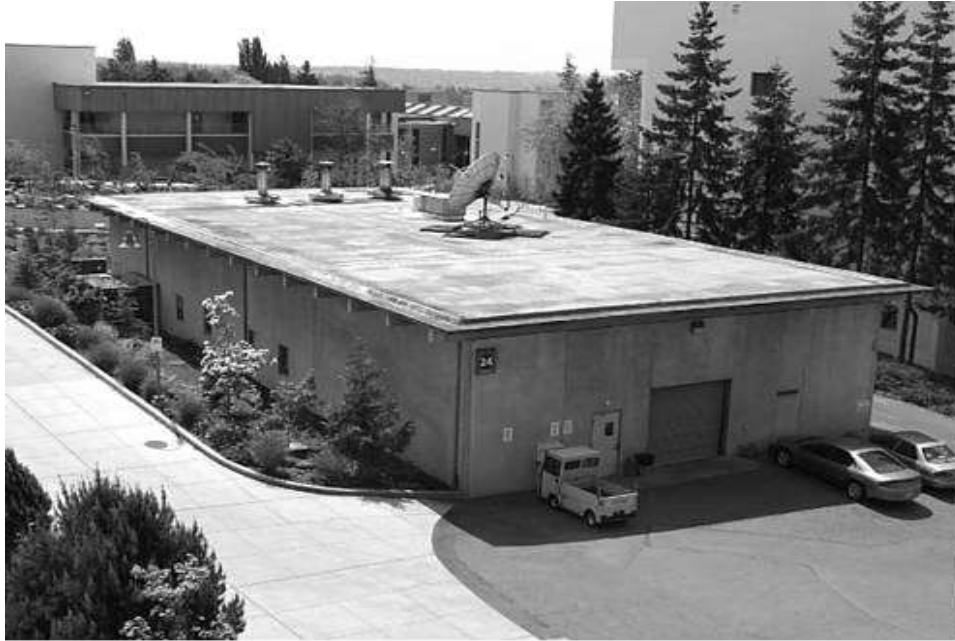
Physical Plant (090-24) STATE UFI: A00414 Main Campus (090A)
 AREA: 7,719 SF BUILT: 1964 REMODELED: No PREDOMINANT USE: Maintenance
 CONSTRUCTION TYPE: Heavy CRV/SF: \$264 REPLACEMENT VALUE: \$2,037,816

Primary Systems			
COMPONENT:	Structure	RATING: 1 x WEIGHT: 8.3 = SCORE: 8.3	
No signs of settlement or cracking, no abrupt vertical changes Columns, bearing walls and roof structure appears sound/free of defects			
COMMENTS:	Concrete frame and tilt-up panels; glu-lam beams w/ steel columns		
COMPONENT:	Exterior Closure	RATING: 1 x WEIGHT: 8.3 = SCORE: 8.3	
Weatherproof, tight, well-maintained exterior walls, doors, windows/finishes			
COMMENTS:	Exposed marble aggregate panels		
COMPONENT:	Roofing	RATING: 1 x WEIGHT: 10.4 = SCORE: 10.4	
Flashing and penetrations appear sound and membrane appears water- tight; drainage is positive and there are overflow scuppers			
COMMENTS:	Hypalon single-ply 2019

Secondary Systems			
COMPONENT:	Floor Finishes	RATING: 1 x WEIGHT: 6.3 =	SCORE: 6.3
Nice appearance, smooth transitions, level subfloors, no cracks/separating			
COMMENTS:	Carpet; vinyl tile; sheet vinyl; concrete slab; laminate		
COMPONENT:	Wall Finishes	RATING: 2 x WEIGHT: 6.3 =	SCORE: 12.5
Maintainable surfaces, minor maintenance is required in some areas			
COMMENTS:	Gypsum board; CMU		
COMPONENT:	Ceiling Finishes	RATING: 1 x WEIGHT: 6.3 =	SCORE: 6.3
Maintainable surfaces in good condition; good alignment and appearance			
COMMENTS:	Lay-in tile; concrete; 2x4s on edge		
COMPONENT:	Doors & Hardware	RATING: 1 x WEIGHT: 6.3 =	SCORE: 6.3
Appropriate hardware, closers, panic devices; in good working order			
COMMENTS:	Interior wood doors w HM frames; exterior HM doors/frames; coiling door

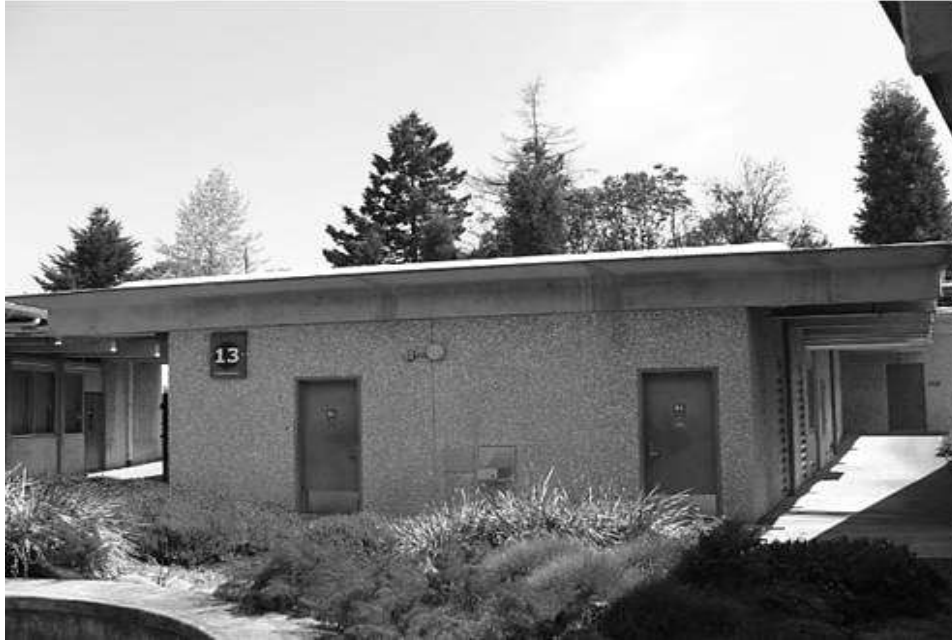
Science Lecture Bldg (090-13) STATE UFI: A08178 Main Campus (090A)
AREA: 3,957 SF BUILT: 1964 REMODELED: 1998 PREDOMINANT USE: General Classroom
CONSTRUCTION TYPE: Heavy CRV/SF: \$376 REPLACEMENT VALUE: \$1,487,832

Primary Systems			
COMPONENT:	Structure	RATING: 2 x WEIGHT: 8.3 = SCORE: 16.7	
Minor cracks evident in a small portion of the structure			
COMMENTS:	Concrete frame and tilt-up panels		
COMPONENT:	Exterior Closure	RATING: 2 x WEIGHT: 8.3 = SCORE: 16.7	
Weatherproof exterior, but finish appears poorly maintained			
COMMENTS:	Exposed marble aggregate panels; joint re-caulk needed		
COMPONENT:	Roofing	RATING: 3 x WEIGHT: 10.4 = SCORE: 31.3	
Some deterioration is evident in membrane and flashings; maintenance or minor repair is needed			
COMMENTS:	Hypalon single-ply-1998-minor wear

Secondary Systems			
COMPONENT:	Floor Finishes	RATING: 2 x WEIGHT: 6.3 = SCORE: 12.5	
	Some wear is evident on finish; maintenance needed		
COMMENTS:	Carpet; vinyl tile; ceramic tile		
COMPONENT:	Wall Finishes	RATING: 1 x WEIGHT: 6.3 = SCORE: 6.3	
	Maintainable surfaces in good condition		
COMMENTS:	Gypsum board and ceramic tile		
COMPONENT:	Ceiling Finishes	RATING: 2 x WEIGHT: 6.3 = SCORE: 12.5	
	Aging surfaces in fair condition and good alignment		
COMMENTS:	Lay-in tile and gypsum board; good condition		
COMPONENT:	Doors & Hardware	RATING: 3 x WEIGHT: 6.3 = SCORE: 18.8	
	Functional, but dated; some maintenance required		
COMMENTS:	Interior wood doors w HM frames; exterior HM doors/frames-surface wear

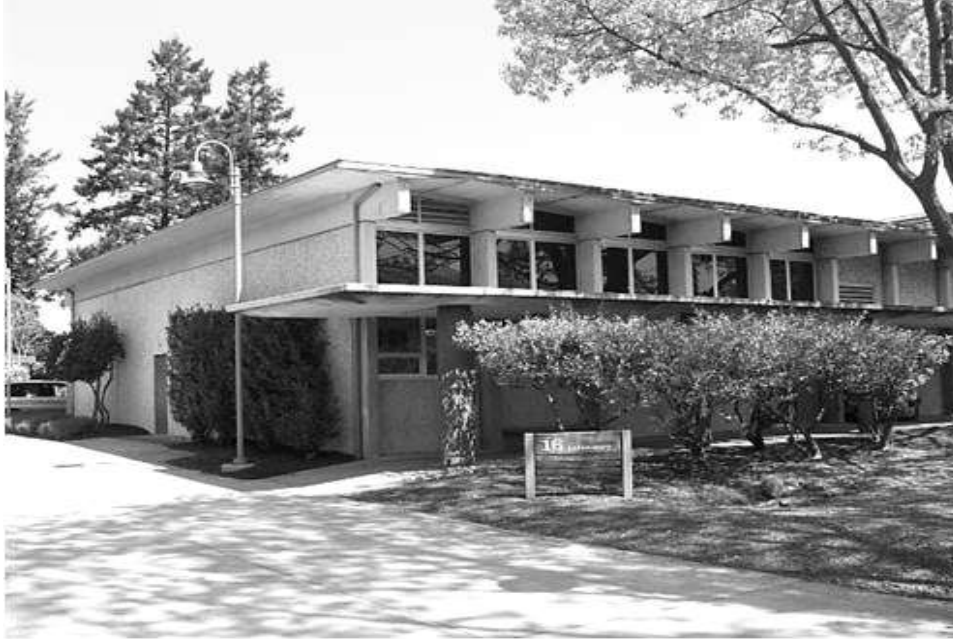
Technology Lab Bldg (090-16) STATE UFI: A02946 Main Campus (090A)
AREA: 22,879 SF BUILT: 1967 REMODELED: 2015 PREDOMINANT USE: Visual Arts
CONSTRUCTION TYPE: Heavy CRV/SF: \$376 REPLACEMENT VALUE: \$8,602,504

Primary Systems			
COMPONENT:	Structure	RATING: 2 x WEIGHT: 8.3 = SCORE: 16.7	
Minor cracks evident in a small portion of the structure			
COMMENTS: Concrete frame and tilt-up panels; steel frame addition			
COMPONENT:	Exterior Closure	RATING: 1 x WEIGHT: 8.3 = SCORE: 8.3	
Weatherproof, tight, well-maintained exterior walls, doors, windows/finishes			
COMMENTS: Exposed marble aggregate panels, repairs 2019			
COMPONENT:	Roofing	RATING: 2 x WEIGHT: 10.4 = SCORE: 20.9	
Majority of roofing and flashing appear sound, but a small portion of roofing shows deterioration where maintenance or minor repair needed			
COMMENTS: Hypalon single-ply membrane. Re-coated 2016

Secondary Systems			
COMPONENT:	Floor Finishes	RATING: 1 x WEIGHT: 6.3 = SCORE: 6.3	
	Nice appearance, smooth transitions, level subfloors, no cracks/separating		
COMMENTS:	Concrete slab; vinyl tile, carpet, ceramic tile		
COMPONENT:	Wall Finishes	RATING: 1 x WEIGHT: 6.3 = SCORE: 6.3	
	Maintainable surfaces in good condition		
COMMENTS:	Gypsum board; CMU; concrete, ceramic tile		
COMPONENT:	Ceiling Finishes	RATING: 1 x WEIGHT: 6.3 = SCORE: 6.3	
	Maintainable surfaces in good condition; good alignment and appearance		
COMMENTS:	Lay-in tile; wood deck structure		
COMPONENT:	Doors & Hardware	RATING: 1 x WEIGHT: 6.3 = SCORE: 6.3	
	Appropriate hardware, closers, panic devices; in good working order		
COMMENTS:	Interior laminate doors w HM frames; exterior HM doors/frames; coiling door; OH metal door

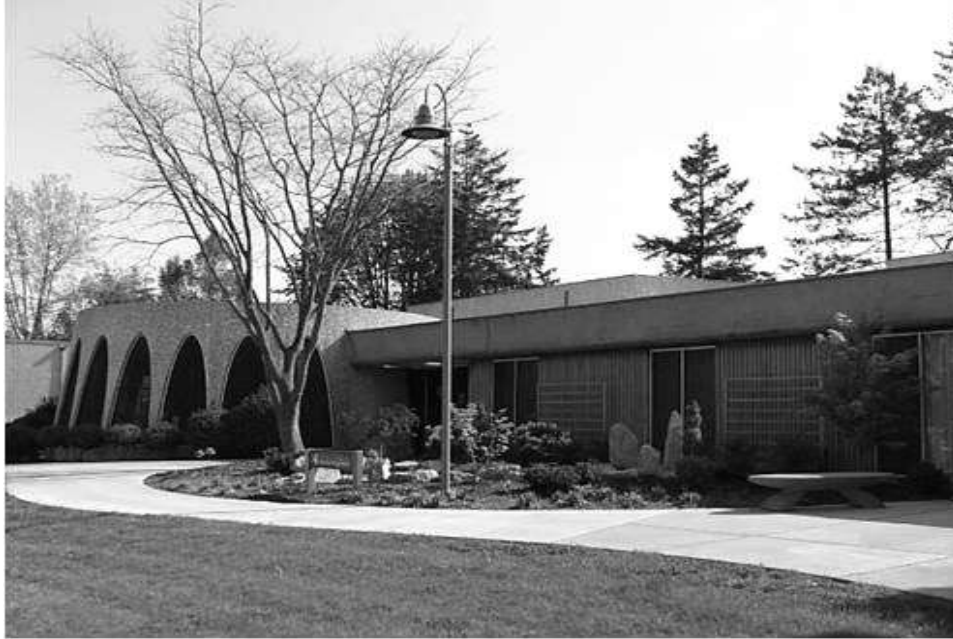
Performing Arts Bldg (090-4) STATE UFI: A00072 Main Campus (090A)
AREA: 13,041 SF BUILT: 1967 REMODELED: 2013 PREDOMINANT USE: Performing Arts
CONSTRUCTION TYPE: Heavy CRV/SF: \$421 REPLACEMENT VALUE: \$5,490,261

Primary Systems			
COMPONENT:	Structure	RATING: 1 x WEIGHT: 8.3 =	SCORE: 8.3
No signs of settlement or cracking, no abrupt vertical changes Columns, bearing walls and roof structure appears sound/free of defects			
COMMENTS:	Concrete frame and tilt-up panels, steel		
COMPONENT:	Exterior Closure	RATING: 1 x WEIGHT: 8.3 =	SCORE: 8.3
Weatherproof, tight, well-maintained exterior walls, doors, windows/finishes			
COMMENTS:	Renovation 2013		
COMPONENT:	Roofing	RATING: 1 x WEIGHT: 10.4 =	SCORE: 10.4
Flashing and penetrations appear sound and membrane appears water- tight; drainage is positive and there are overflow scuppers			
COMMENTS:	Renovation 2013

Secondary Systems			
COMPONENT:	Floor Finishes	RATING: 1 x WEIGHT: 6.3 =	SCORE: 6.3
Nice appearance, smooth transitions, level subfloors, no cracks/separating			
COMMENTS:	Aggregate concrete; carpet and carpet tile; vinyl tile; wood tile; ceramic tile		
COMPONENT:	Wall Finishes	RATING: 1 x WEIGHT: 6.3 =	SCORE: 6.3
Maintainable surfaces in good condition			
COMMENTS:	Gypsum board; wood paneling; concrete; marblecrete; ceramic tile; speaker cloth		
COMPONENT:	Ceiling Finishes	RATING: 1 x WEIGHT: 6.3 =	SCORE: 6.3
Maintainable surfaces in good condition; good alignment and appearance			
COMMENTS:	Direct-adhered and lay-in tile; exposed structure		
COMPONENT:	Doors & Hardware	RATING: 2 x WEIGHT: 6.3 =	SCORE: 12.5
Fairly modern door surfaces and hardware with minor deterioration; good working order			
COMMENTS:	Interior wood doors w HM frames; exterior aluminum and HM doors/frames

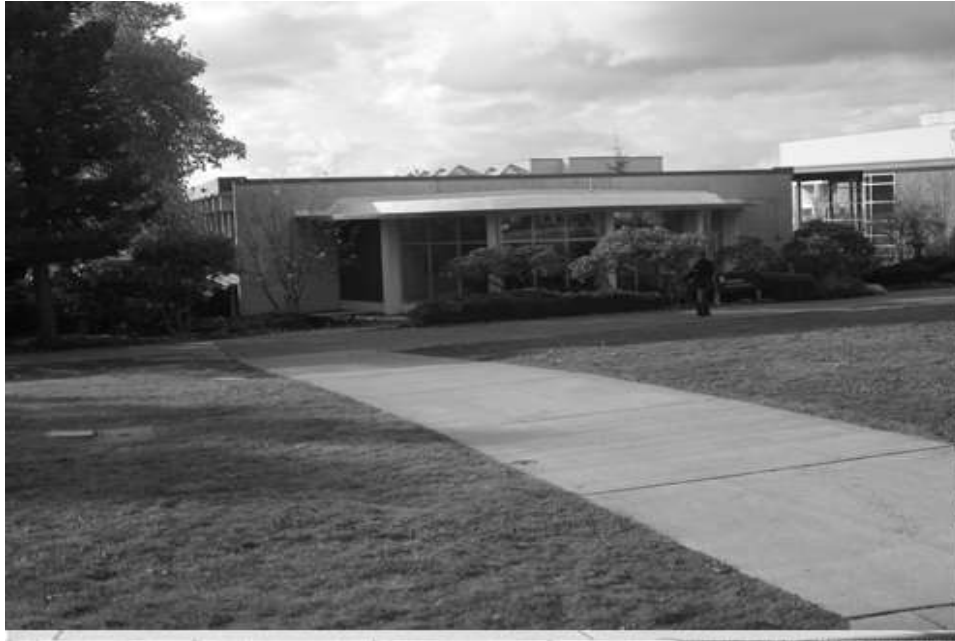
Instruction Admin (090-9) STATE UFI: A01061 Main Campus (090A)
AREA: 9,906 SF BUILT: 1967 REMODELED: 2011 PREDOMINANT USE: Administration
CONSTRUCTION TYPE: Heavy CRV/SF: \$336 REPLACEMENT VALUE: \$3,328,416

Primary Systems			
COMPONENT:	Structure	RATING: 1 x WEIGHT: 8 =	SCORE: 8
No signs of settlement or cracking, no abrupt vertical changes Columns, bearing walls and roof structure appears sound/free of defects			
COMMENTS:	Concrete frame and tilt-up panels; structural steel seismic bracing		
COMPONENT:	Exterior Closure	RATING: 1 x WEIGHT: 8 =	SCORE: 8
Weatherproof, tight, well-maintained exterior walls, doors, windows/finishes			
COMMENTS:	Exposed marble aggregate panels; aluminum window walls; metal panels		
COMPONENT:	Roofing	RATING: 1 x WEIGHT: 10 =	SCORE: 10
Flashing and penetrations appear sound and membrane appears water- tight; drainage is positive and there are overflow scuppers			
COMMENTS:	TPO single-ply-2011

Secondary Systems			
COMPONENT:	Floor Finishes	RATING: 1 x WEIGHT: 6 =	SCORE: 6
	Nice appearance, smooth transitions, level subfloors, no cracks/separating		
COMMENTS:	Exposed aggregate; carpet tile; ceramic tile; sheet flooring		
COMPONENT:	Wall Finishes	RATING: 1 x WEIGHT: 6 =	SCORE: 6
	Maintainable surfaces in good condition		
COMMENTS:	Exposed aggregate; gypsum board; plastic panels		
COMPONENT:	Ceiling Finishes	RATING: 1 x WEIGHT: 6 =	SCORE: 6
	Maintainable surfaces in good condition; good alignment and appearance		
COMMENTS:	Lay-in and direct-adhered tile; gypsum board		
COMPONENT:	Doors & Hardware	RATING: 1 x WEIGHT: 6 =	SCORE: 6
	Appropriate hardware, closers, panic devices; in good working order		
COMMENTS:	interior wood doors/frames; exterior aluminum doors/frames

Service Systems			
COMPONENT:	Elevators	RATING: 1 x WEIGHT: 6 =	SCORE: 6
	Appropriate and functional for occupancy and use		
COMMENTS:	2 story split level w ADA lift		
COMPONENT:	Plumbing	RATING: 1 x WEIGHT: 8 =	SCORE: 8
	Fixtures and piping appear to be in good condition; no evidence of leaks		
COMMENTS:	Copper, cast iron, steel and PVC piping; porcelain fixtures		
COMPONENT:	HVAC	RATING: 2 x WEIGHT: 8 =	SCORE: 16
	Equipment in fair condition; minor deterioration; controls require troubleshooting; most areas have A/C; hazardous areas are ventilated		
COMMENTS:	Air cooled chiller; AHUs; new ductwork; hot water from central plant		
COMPONENT:	Electrical	RATING: 1 x WEIGHT: 8 =	SCORE: 8
	Adequate service and distribution capacity for current/future needs		
COMMENTS:	200amp 480/277v; 125amp 208/120v		
COMPONENT:	Lights/Power	RATING: 1 x WEIGHT: 8 =	SCORE: 8
	Contemporary lighting with good work area illumination; ample outlets

Safety Systems			
COMPONENT:	Life/Safety	RATING: 4 x WEIGHT: 10 = SCORE: 40	
	Generally meets codes for vintage of construction; minor health or accessibility violations exist		
COMMENTS:	Entrances are not accessible		
COMPONENT:	Fire Safety	RATING: 1 x WEIGHT: 10 = SCORE: 10	
	Locally monitored detection; alarm and strobes present; sprinklers in high hazard areas		
COMMENTS:	Partial sprinklers		
COMPONENT:	Modifications	RATING: 1 x WEIGHT: 7 = SCORE: 7	
	Modifications appear to be in compliance with codes and sound construction practices; HVAC/electrical service properly provided		
COMMENTS:	2011 interior renovation was well constructed

Quality Standards			
COMPONENT:	Maintenance	RATING: 1 x WEIGHT: 7 = SCORE: 7	
	Facility appears well maintained		
COMMENTS:			
COMPONENT:	Remaining Life	RATING: 1 x WEIGHT: 6 = SCORE: 6	
	Life expectancy is >20 years; minor system deterioration		
COMMENTS:	Complete interior renovation and new windows, roof and HVAC-2011		
COMPONENT:	Appearance	RATING: 3 x WEIGHT: 6 = SCORE: 18	
	Average construction; average interior and exterior appearance		
COMMENTS:	Very utilitarian exterior

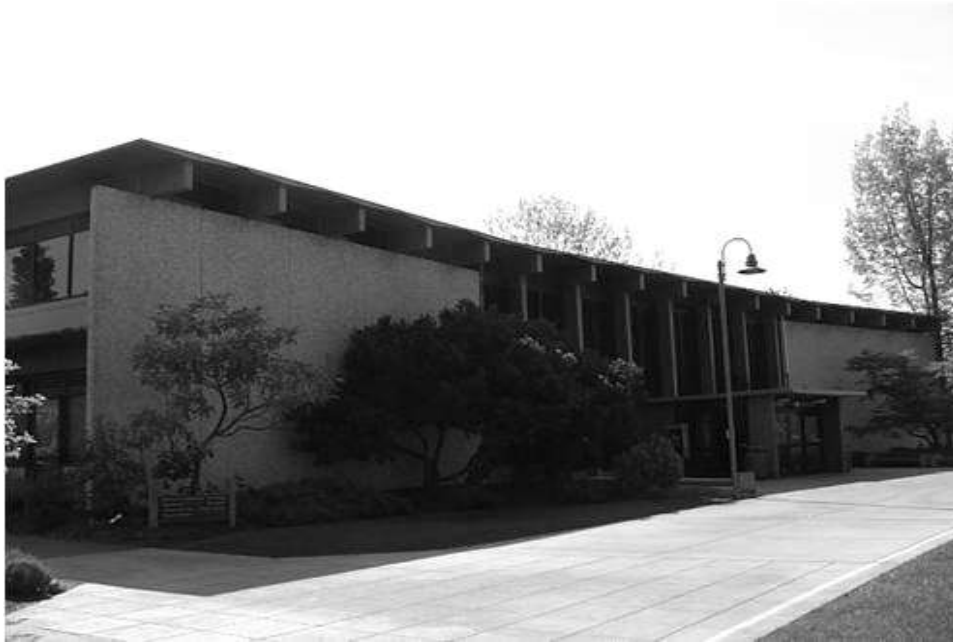
Student Services (090-6) STATE UFI: A06008 Main Campus (090A)
AREA: 22,795 SF BUILT: 1964 REMODELED: 2006 PREDOMINANT USE: Student Services
CONSTRUCTION TYPE: Heavy CRV/SF: \$336 REPLACEMENT VALUE: \$7,659,120

Primary Systems			
COMPONENT:	Structure	RATING: 3 x WEIGHT: 8 =	SCORE: 24
Some cracking evident but does not likely affect structural integrity; Visible defects apparent but are non-structural			
COMMENTS:	Concrete frame and tilt-up panels; damage on north and south eyebrows		
COMPONENT:	Exterior Closure	RATING: 1 x WEIGHT: 8 =	SCORE: 8
Weatherproof, tight, well-maintained exterior walls, doors, windows/finishes			
COMMENTS:	Exposed marble aggregate panels-joints need caulking; exterior stair rails and steel painted and sealed 2014		
COMPONENT:	Roofing	RATING: 1 x WEIGHT: 10 =	SCORE: 10
Flashing and penetrations appear sound and membrane appears water- tight; drainage is positive and there are overflow scuppers			
COMMENTS:	Hypalon single-ply membrane-2007

Secondary Systems			
COMPONENT:	Floor Finishes	RATING: 2 x WEIGHT: 6 = SCORE: 12	
	Some wear is evident on finish; maintenance needed		
COMMENTS:	Carpet; carpet tile; linoleum; vinyl tile; ceramic tile		
COMPONENT:	Wall Finishes	RATING: 1 x WEIGHT: 6 = SCORE: 6	
	Maintainable surfaces in good condition		
COMMENTS:	Gypsum board; ceramic tile; aluminum window walls		
COMPONENT:	Ceiling Finishes	RATING: 2 x WEIGHT: 6 = SCORE: 12	
	Aging surfaces in fair condition and good alignment		
COMMENTS:	Lay-in tile; gypsum board		
COMPONENT:	Doors & Hardware	RATING: 3 x WEIGHT: 6 = SCORE: 18	
	Functional, but dated; some maintenance required		
COMMENTS:	Interior wood doors w sidelites and HM frames; HM doors/frames-surface wear; aluminum glazed doors; exterior aluminum doors/frames-2010

Service Systems			
COMPONENT:	Elevators	RATING: 1 x WEIGHT: 6 = SCORE: 6	
	Appropriate and functional for occupancy and use		
COMMENTS:	2 stop - controls 2020		
COMPONENT:	Plumbing	RATING: 3 x WEIGHT: 8 = SCORE: 24	
	Fixtures are functional but dated; some leaks; maintenance required		
COMMENTS:	Galvanized, copper, cast iron, steel and PVC piping; porcelain fixtures		
COMPONENT:	HVAC	RATING: 2 x WEIGHT: 8 = SCORE: 16	
	Equipment in fair condition; minor deterioration; controls require troubleshooting; most areas have A/C; hazardous areas are ventilated		
COMMENTS:	Water source heat pumps; HW boiler; cooling tower; system re-commissioning needed to determine problem areas		
COMPONENT:	Electrical	RATING: 2 x WEIGHT: 8 = SCORE: 16	
	Adequate service and distribution capacity for current/future needs; some deterioration evident		
COMMENTS:	800amp 480/277v; also feeds Bldgs. 05 and 11		
COMPONENT:	Lights/Power	RATING: 1 x WEIGHT: 8 = SCORE: 8

Safety Systems			
COMPONENT:	Life/Safety	RATING: 2 x WEIGHT: 10 = SCORE: 20	
	Most areas meet current codes; some areas meet codes for prior construction phases		
COMMENTS:			
COMPONENT:	Fire Safety	RATING: 2 x WEIGHT: 10 = SCORE: 20	
	Locally monitored detection; alarm present, but missing visual component or sprinklers		
COMMENTS:			
COMPONENT:	Modifications	RATING: 1 x WEIGHT: 7 = SCORE: 7	
	Modifications appear to be in compliance with codes and sound construction practices; HVAC/electrical service properly provided		
COMMENTS:	2006 interior remodels appear to be well completed

Quality Standards			
COMPONENT:	Maintenance	RATING: 1 x WEIGHT: 7 = SCORE: 7	
	Facility appears well maintained		
COMMENTS:			
COMPONENT:	Remaining Life	RATING: 3 x WEIGHT: 6 = SCORE: 18	
	Life expectancy is roughly 10-15 years; moderate system deterioration		
COMMENTS:	2006 remodel updated many interior finishes		
COMPONENT:	Appearance	RATING: 3 x WEIGHT: 6 = SCORE: 18	
	Average construction; average interior and exterior appearance		
COMMENTS:	Exterior is very dated and utilitarian

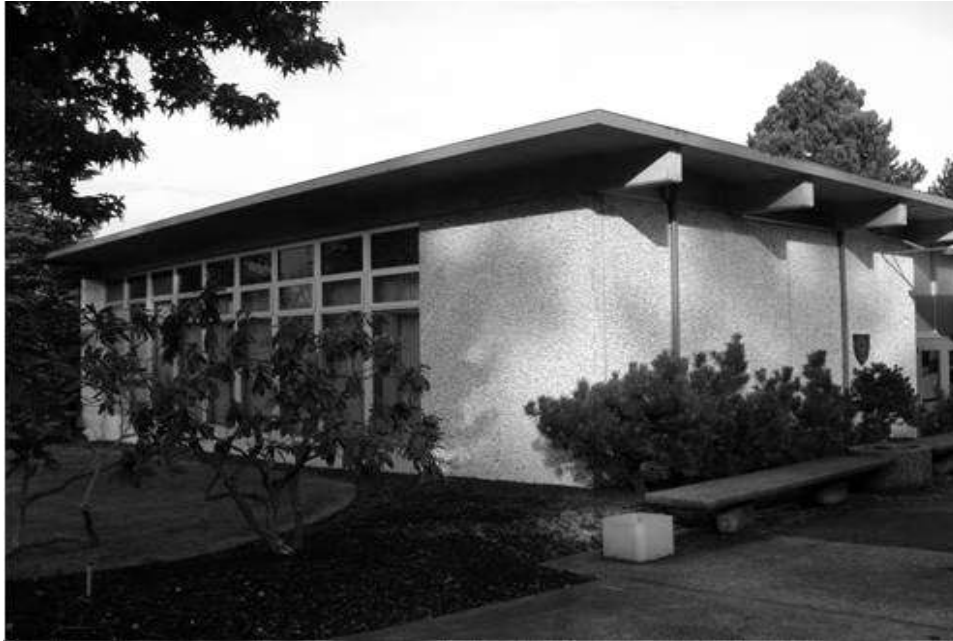
Conference Center (090-2) STATE UFI: A06759 Main Campus (090A)
AREA: 2,697 SF BUILT: 1964 REMODELED: No PREDOMINANT USE: Conferences
CONSTRUCTION TYPE: Heavy CRV/SF: \$336 REPLACEMENT VALUE: \$906,192

Primary Systems			
COMPONENT:	Structure	RATING: 1 x WEIGHT: 8.3 = SCORE: 8.3	
No signs of settlement or cracking, no abrupt vertical changes Columns, bearing walls and roof structure appears sound/free of defects			
COMMENTS:	Concrete frame and tilt-up panels		
COMPONENT:	Exterior Closure	RATING: 1 x WEIGHT: 8.3 = SCORE: 8.3	
Weatherproof, tight, well-maintained exterior walls, doors, windows/finishes			
COMMENTS:	Exposed marble aggregate panels		
COMPONENT:	Roofing	RATING: 1 x WEIGHT: 10.4 = SCORE: 10.4	
Flashing and penetrations appear sound and membrane appears water- tight; drainage is positive and there are overflow scuppers			
COMMENTS:	Hypalon single-ply-2018

Secondary Systems			
COMPONENT:	Floor Finishes	RATING: 2 x WEIGHT: 6.3 =	SCORE: 12.5
Some wear is evident on finish; maintenance needed			
COMMENTS:	Carpet tile; vinyl tile; sheet vinyl; ceramic tile		
COMPONENT:	Wall Finishes	RATING: 1 x WEIGHT: 6.3 =	SCORE: 6.3
Maintainable surfaces in good condition			
COMMENTS:	Gypsum board; concrete		
COMPONENT:	Ceiling Finishes	RATING: 1 x WEIGHT: 6.3 =	SCORE: 6.3
Maintainable surfaces in good condition; good alignment and appearance			
COMMENTS:	Lay-in tile and gypsum board		
COMPONENT:	Doors & Hardware	RATING: 3 x WEIGHT: 6.3 =	SCORE: 18.8
Functional, but dated; some maintenance required			
COMMENTS:	Interior wood doors w HM frames; exterior HM doors/frames-well-worn finishes

Service Systems			
COMPONENT:	Elevators	RATING: 0 x WEIGHT: 0 =	SCORE: 0
No data			
COMMENTS:			
COMPONENT:	Plumbing	RATING: 2 x WEIGHT: 8.3 =	SCORE: 16.7
Fixtures and piping are functional; finishes require maintenance			
COMMENTS:	Copper and ABS piping for small kitchen sink		
COMPONENT:	HVAC	RATING: 4 x WEIGHT: 8.3 =	SCORE: 33.4
System partially adequate; many areas served by equipment needing repair; areas with A/C very limited, but hazardous areas are ventilated			
COMMENTS:	Hot water heating from central plant; ventilation; no A/C; Air handler 2021		
COMPONENT:	Electrical	RATING: 1 x WEIGHT: 8.3 =	SCORE: 8.3
Adequate service and distribution capacity for current/future needs			
COMMENTS:	100amp 240/120v; 70amp 208/120v		
COMPONENT:	Lights/Power	RATING: 1 x WEIGHT: 8.3 =	SCORE: 8.3
Contemporary lighting with good work area illumination; ample outlets			
COMMENTS:	Lay-in parabolic and ceiling-mount fluorescent lighting

Safety Systems			
COMPONENT:	Life/Safety	RATING: 3 x WEIGHT: 10.4 = SCORE: 31.3	
	Generally meets codes for vintage of construction		
COMMENTS:			
COMPONENT:	Fire Safety	RATING: 2 x WEIGHT: 10.4 = SCORE: 20.9	
	Locally monitored detection; alarm present, but missing visual component or sprinklers		
COMMENTS:			
COMPONENT:	Modifications	RATING: 1 x WEIGHT: 7.3 = SCORE: 7.3	
	Modifications appear to be in compliance with codes and sound construction practices; HVAC/electrical service properly provided		
COMMENTS:	Interior remodel well thought out and in compliance with codes

Quality Standards			
COMPONENT:	Maintenance	RATING: 1 x WEIGHT: 7.3 = SCORE: 7.3	
	Facility appears well maintained		
COMMENTS:			
COMPONENT:	Remaining Life	RATING: 1 x WEIGHT: 6.3 = SCORE: 6.3	
	Life expectancy is >20 years; minor system deterioration		
COMMENTS:			
COMPONENT:	Appearance	RATING: 3 x WEIGHT: 6.3 = SCORE: 18.8	
	Average construction; average interior and exterior appearance		
COMMENTS:	Attractive small conference center with kitchen; unattractive exterior
