# **2023** FACILITY CONDITION SURVEY

Peninsula College

SURVEY CONDUCTED BY:  
Steve Lewandowski  
State Board for Community  
and Technical Colleges

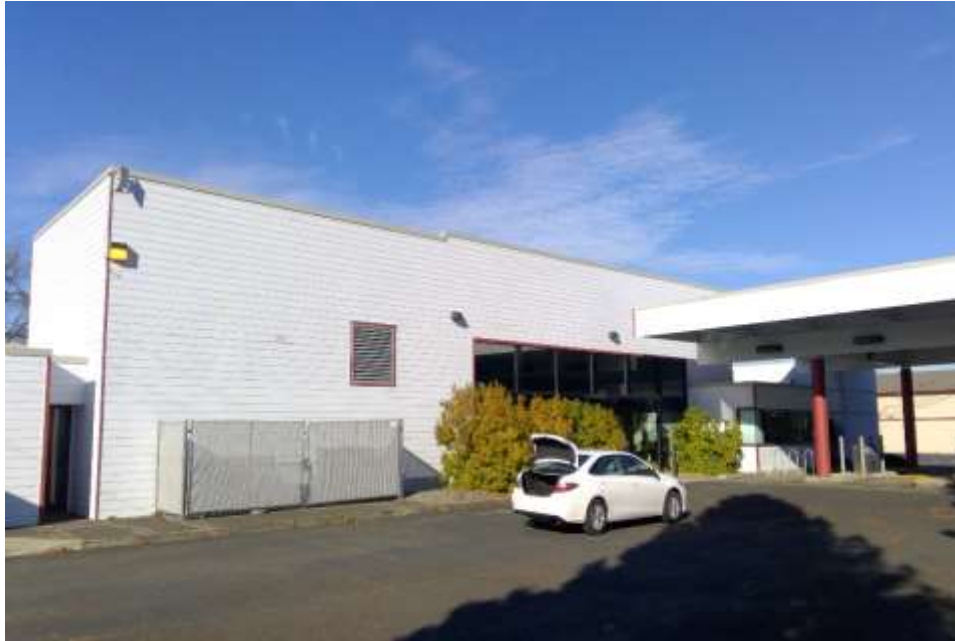
Forks Branch Campus (010-0FK)      STATE UFI: A21034      Forks Campus (010C)  
AREA: 12,452 SF      BUILT: 0      REMODELED: 2014      PREDOMINANT USE: Classroom  
CONSTRUCTION TYPE: No data      CRV/SF: \$231      REPLACEMENT VALUE: \$2,876,412

Primary Systems			
COMPONENT:	Structure	RATING: 1 x WEIGHT: 8.3 =	SCORE: 8.3
No signs of settlement or cracking, no abrupt vertical changes Columns, bearing walls and roof structure appears sound/free of defects			
COMMENTS:	Remodeled 2014		
COMPONENT:	Exterior Closure	RATING: 3 x WEIGHT: 8.3 =	SCORE: 25
Sound and weatherproof but with some physical deterioration evident			
COMMENTS:	Hardiplank - needs to be resealed and painted; The deteriorated south and east sections of siding funded 21-23		
COMPONENT:	Roofing	RATING: 1 x WEIGHT: 10.4 =	SCORE: 10.4
Flashing and penetrations appear sound and membrane appears water- tight; drainage is positive and there are overflow scuppers			
COMMENTS:	No data

Secondary Systems			
COMPONENT:	Floor Finishes	RATING: 1 x WEIGHT: 6.3 =	SCORE: 6.3
Nice appearance, smooth transitions, level subfloors, no cracks/separating			
COMMENTS:	Carpet		
COMPONENT:	Wall Finishes	RATING: 1 x WEIGHT: 6.3 =	SCORE: 6.3
Maintainable surfaces in good condition			
COMMENTS:	No data		
COMPONENT:	Ceiling Finishes	RATING: 1 x WEIGHT: 6.3 =	SCORE: 6.3
Maintainable surfaces in good condition; good alignment and appearance			
COMMENTS:	GWB; ACT		
COMPONENT:	Doors & Hardware	RATING: 1 x WEIGHT: 6.3 =	SCORE: 6.3
Appropriate hardware, closers, panic devices; in good working order			
COMMENTS:	No data

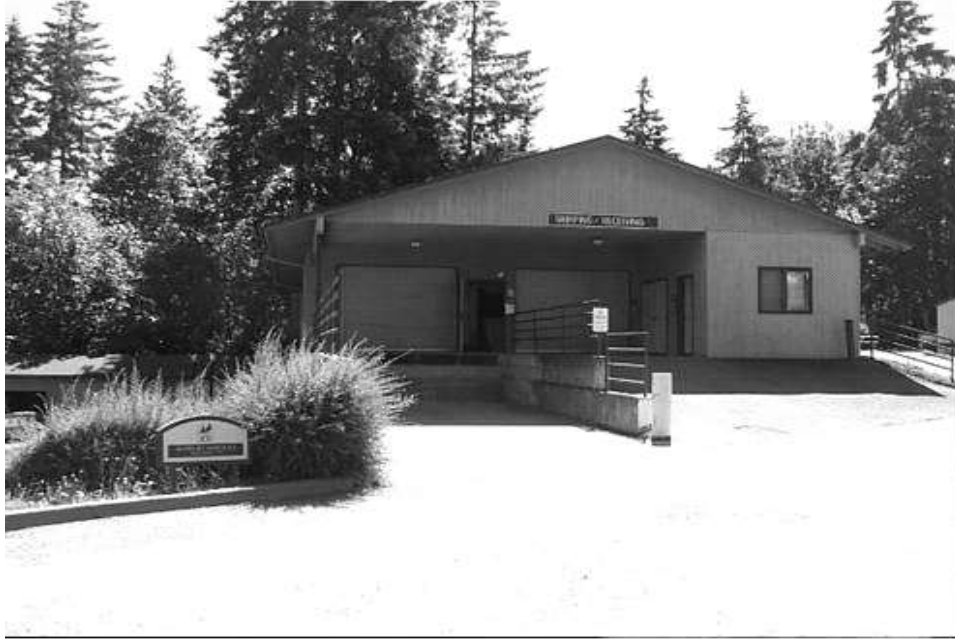
Maint/Ship-Rec/Storage (010-00T)      STATE UFI: A00467      Main Campus (010A)  
AREA: 6,594 SF      BUILT: 1977      REMODELED: No      PREDOMINANT USE: Maintenance  
CONSTRUCTION TYPE: Medium      CRV/SF: \$231      REPLACEMENT VALUE: \$1,523,214

Primary Systems			
COMPONENT:	Structure	RATING: 1 x WEIGHT: 8 =	SCORE: 8
No signs of settlement or cracking, no abrupt vertical changes Columns, bearing walls and roof structure appears sound/free of defects			
COMMENTS:	Wood frame; glu-lam floor beams; steel columns; concrete		
COMPONENT:	Exterior Closure	RATING: 1 x WEIGHT: 8 =	SCORE: 8
Weatherproof, tight, well-maintained exterior walls, doors, windows/finishes			
COMMENTS:	Concrete, vertical cedar siding		
COMPONENT:	Roofing	RATING: 1 x WEIGHT: 10 =	SCORE: 10
Flashing and penetrations appear sound and membrane appears water- tight; drainage is positive and there are overflow scuppers			
COMMENTS:	Composition shingles

Secondary Systems			
COMPONENT:	Floor Finishes	RATING: 4 x WEIGHT: 6 =	SCORE: 24
General deterioration evident; one-third to one-half of flooring exhibits extensive deterioration			
COMMENTS:	Concrete; carpet; vinyl tile; sheet vinyl; general wear,		
COMPONENT:	Wall Finishes	RATING: 2 x WEIGHT: 6 =	SCORE: 12
Maintainable surfaces, minor maintenance is required in some areas			
COMMENTS:	Gypsum board		
COMPONENT:	Ceiling Finishes	RATING: 1 x WEIGHT: 6 =	SCORE: 6
Maintainable surfaces in good condition; good alignment and appearance			
COMMENTS:	Gypsum board; exposed wood trusses & encapsulated insulation		
COMPONENT:	Doors & Hardware	RATING: 3 x WEIGHT: 6 =	SCORE: 18
Functional, but dated; some maintenance required			
COMMENTS:	Interior wood doors w HM frames-surface wear; exterior HM doors/frames-surface wear; metal OH coiling doors funded 21-23

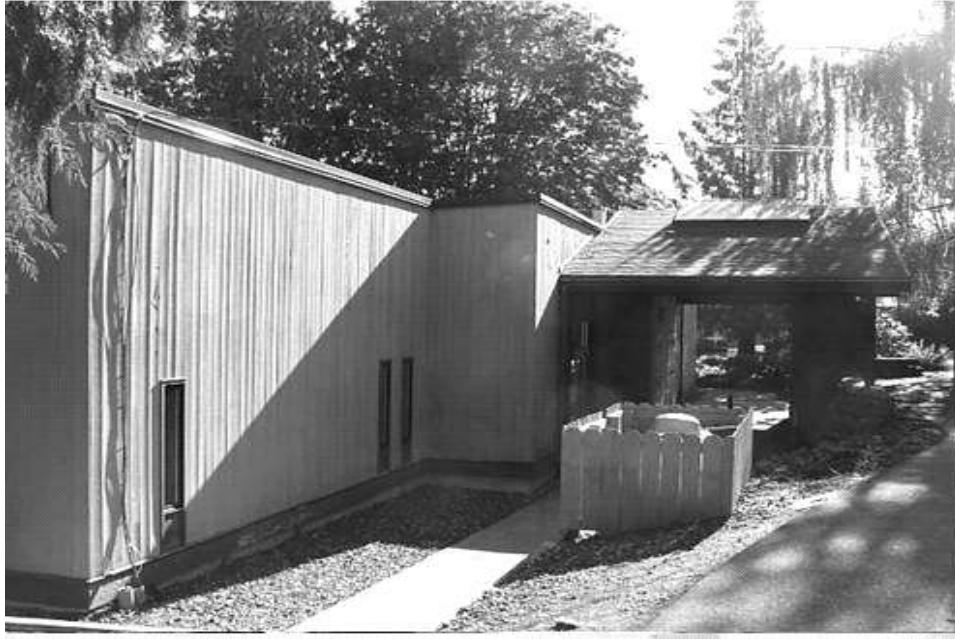
Art (010-00P)      STATE UFI: A01722      Main Campus (010A)  
 AREA: 4,550 SF      BUILT: 1971      REMODELED: No      PREDOMINANT USE: Visual Arts  
 CONSTRUCTION TYPE: Medium      CRV/SF: \$395      REPLACEMENT VALUE: \$1,797,250

Primary Systems			
COMPONENT:	Structure	RATING: 1 x WEIGHT: 8.3 = SCORE: 8.3	
No signs of settlement or cracking, no abrupt vertical changes Columns, bearing walls and roof structure appears sound/free of defects			
COMMENTS:	Wood frame; glu-lam beams		
COMPONENT:	Exterior Closure	RATING: 2 x WEIGHT: 8.3 = SCORE: 16.7	
Weatherproof exterior, but finish appears poorly maintained			
COMMENTS:	Vertical cedar siding-surface wear; brick veneer; wood framed large covered entry structure		
COMPONENT:	Roofing	RATING: 2 x WEIGHT: 10.4 = SCORE: 20.9	
Majority of roofing and flashing appear sound, but a small portion of roofing shows deterioration where maintenance or minor repair needed			
COMMENTS:	Composition shingles; Hypalon single-ply-some wear; Kalwall skylights

Secondary Systems			
COMPONENT:	Floor Finishes	RATING: 1 x WEIGHT: 6.3 = SCORE: 6.3	
	Nice appearance, smooth transitions, level subfloors, no cracks/separating		
COMMENTS:	Concrete; carpet; sheet vinyl		
COMPONENT:	Wall Finishes	RATING: 1 x WEIGHT: 6.3 = SCORE: 6.3	
	Maintainable surfaces in good condition		
COMMENTS:	Gypsum board		
COMPONENT:	Ceiling Finishes	RATING: 1 x WEIGHT: 6.3 = SCORE: 6.3	
	Maintainable surfaces in good condition; good alignment and appearance		
COMMENTS:	Gypsum board; direct-adhered & lay-in tile		
COMPONENT:	Doors & Hardware	RATING: 2 x WEIGHT: 6.3 = SCORE: 12.5	
	Fairly modern door surfaces and hardware with minor deterioration; good working order		
COMMENTS:	Interior wood doors/frames-surface wear; exterior aluminum/wood doors/frames-surface wear

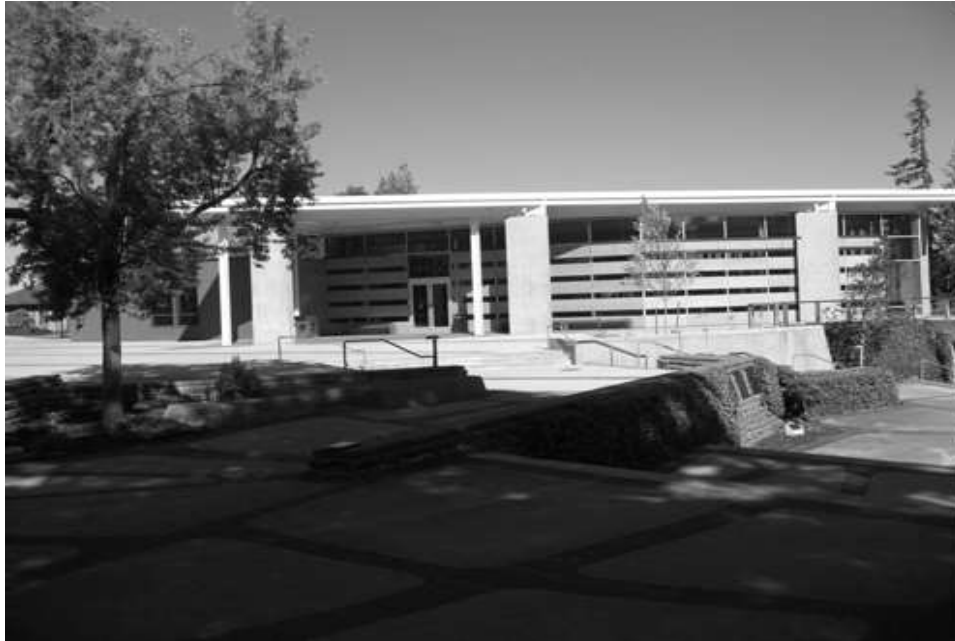
Library Resource Center (010-00B)      STATE UFI: A02004      Main Campus (010A)  
 AREA: 26,680 SF      BUILT: 2008      REMODELED: No      PREDOMINANT USE: Library  
 CONSTRUCTION TYPE: Heavy      CRV/SF: \$376      REPLACEMENT VALUE: \$10,031,680

Primary Systems			
COMPONENT:	Structure	RATING: 1 x WEIGHT: 8.8 = SCORE: 8.8	
No signs of settlement or cracking, no abrupt vertical changes Columns, bearing walls and roof structure appears sound/free of defects			
COMMENTS:	Structural steel; brick; concrete		
COMPONENT:	Exterior Closure	RATING: 1 x WEIGHT: 8.8 = SCORE: 8.8	
Weatherproof, tight, well-maintained exterior walls, doors, windows/finishes			
COMMENTS:	Brick; Perdia panels; concrete; aluminum window walls; aluminum panels		
COMPONENT:	Roofing	RATING: 1 x WEIGHT: 11 = SCORE: 11	
Flashing and penetrations appear sound and membrane appears water- tight; drainage is positive and there are overflow scuppers			
COMMENTS:	PVC single-ply; glass skylights

Secondary Systems			
COMPONENT:	Floor Finishes	RATING: 1 x WEIGHT: 6.6 = SCORE: 6.6	
	Nice appearance, smooth transitions, level subfloors, no cracks/separating		
COMMENTS:	Carpet tile and ceramic tile		
COMPONENT:	Wall Finishes	RATING: 1 x WEIGHT: 6.6 = SCORE: 6.6	
	Maintainable surfaces in good condition		
COMMENTS:	Wood panels; gypsum board; ceramic tile; concrete; interior glass walls		
COMPONENT:	Ceiling Finishes	RATING: 1 x WEIGHT: 6.6 = SCORE: 6.6	
	Maintainable surfaces in good condition; good alignment and appearance		
COMMENTS:	Exposed structure; lay-in tile; perforated metal strips		
COMPONENT:	Doors & Hardware	RATING: 1 x WEIGHT: 6.6 = SCORE: 6.6	
	Appropriate hardware, closers, panic devices; in good working order		
COMMENTS:	Interior wood/HM doors w HM frames; sidelites; exterior aluminum/HM doors/frames

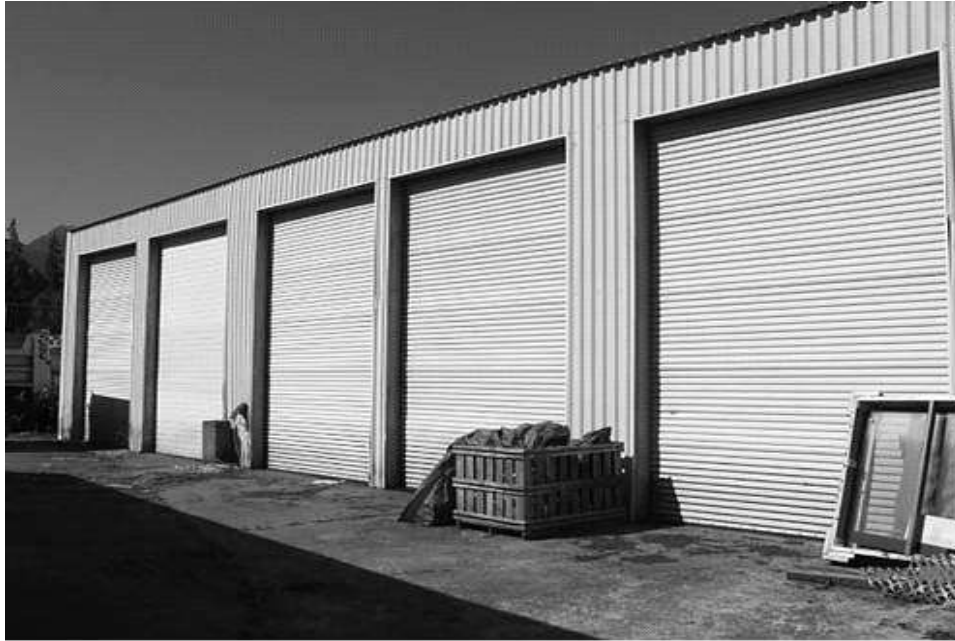
Steel Storage Bldg-A/D (010-00R)      STATE UFI: A02443      Main Campus (010A)  
 AREA: 1,800 SF      BUILT: 1977      REMODELED: No      PREDOMINANT USE: Storage  
 CONSTRUCTION TYPE: Medium      CRV/SF: \$198      REPLACEMENT VALUE: \$356,400

Primary Systems			
COMPONENT:	Structure	RATING: 1 x WEIGHT: 11.1 =	SCORE: 11.1
No signs of settlement or cracking, no abrupt vertical changes Columns, bearing walls and roof structure appears sound/free of defects			
COMMENTS:	Engineered steel-frame		
COMPONENT:	Exterior Closure	RATING: 3 x WEIGHT: 11.1 =	SCORE: 33.4
Sound and weatherproof but with some physical deterioration evident			
COMMENTS:	Metal building panels-some damage		
COMPONENT:	Roofing	RATING: 1 x WEIGHT: 13.9 =	SCORE: 13.9
Flashing and penetrations appear sound and membrane appears water- tight; drainage is positive and there are overflow scuppers			
COMMENTS:	Metal building panels

Secondary Systems			
COMPONENT:	Floor Finishes	RATING: 1 x WEIGHT: 8.3 =	SCORE: 8.3
Nice appearance, smooth transitions, level subfloors, no cracks/separating			
COMMENTS:	Concrete		
COMPONENT:	Wall Finishes	RATING: 0 x WEIGHT: 0 =	SCORE: 0
No data			
COMMENTS:	Steel structure; metal and fiberglass panels		
COMPONENT:	Ceiling Finishes	RATING: 0 x WEIGHT: 0 =	SCORE: 0
No data			
COMMENTS:	Steel structure and encapsulated insulation		
COMPONENT:	Doors & Hardware	RATING: 4 x WEIGHT: 8.3 =	SCORE: 33.4
General deterioration evident in both door and hardware; some doors with significant deterioration			
COMMENTS:	Exterior HM door/frame; coiling OH metal doors-surface wear

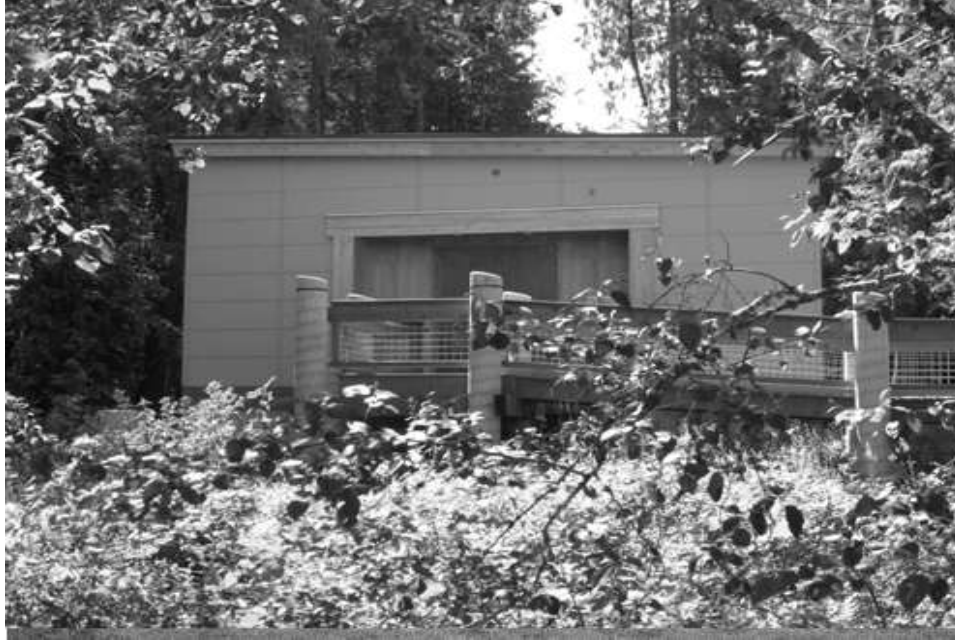
House Of Learning (010-OLH)      STATE UFI: A02471      Main Campus (010A)  
AREA: 2,988 SF      BUILT: 2007      REMODELED: No      PREDOMINANT USE: Multi-Use  
CONSTRUCTION TYPE: Medium      CRV/SF: \$395      REPLACEMENT VALUE: \$1,180,260

Primary Systems			
COMPONENT:	Structure	RATING: 1 x WEIGHT: 9.2 =	SCORE: 9.2
No signs of settlement or cracking, no abrupt vertical changes Columns, bearing walls and roof structure appears sound/free of defects			
COMMENTS:	Timber post and beam framing		
COMPONENT:	Exterior Closure	RATING: 1 x WEIGHT: 9.2 =	SCORE: 9.2
Weatherproof, tight, well-maintained exterior walls, doors, windows/finishes			
COMMENTS:	Cement-board panel siding; cedar trim		
COMPONENT:	Roofing	RATING: 1 x WEIGHT: 11.5 =	SCORE: 11.5
Flashing and penetrations appear sound and membrane appears water- tight; drainage is positive and there are overflow scuppers			
COMMENTS:	Modified bitumen torch down mineral coated cap sheet; skylights

Secondary Systems			
COMPONENT:	Floor Finishes	RATING: 1 x WEIGHT: 6.9 = SCORE: 6.9	
	Nice appearance, smooth transitions, level subfloors, no cracks/separating		
COMMENTS:	Polished concrete		
COMPONENT:	Wall Finishes	RATING: 1 x WEIGHT: 6.9 = SCORE: 6.9	
	Maintainable surfaces in good condition		
COMMENTS:	Rough swan cedar boards; gypsum board; laminate panels		
COMPONENT:	Ceiling Finishes	RATING: 1 x WEIGHT: 6.9 = SCORE: 6.9	
	Maintainable surfaces in good condition; good alignment and appearance		
COMMENTS:	OSB panels; gypsum board		
COMPONENT:	Doors & Hardware	RATING: 1 x WEIGHT: 6.9 = SCORE: 6.9	
	Appropriate hardware, closers, panic devices; in good working order		
COMMENTS:	Interior wood doors/frames; exterior wood/HM doors and wood frames

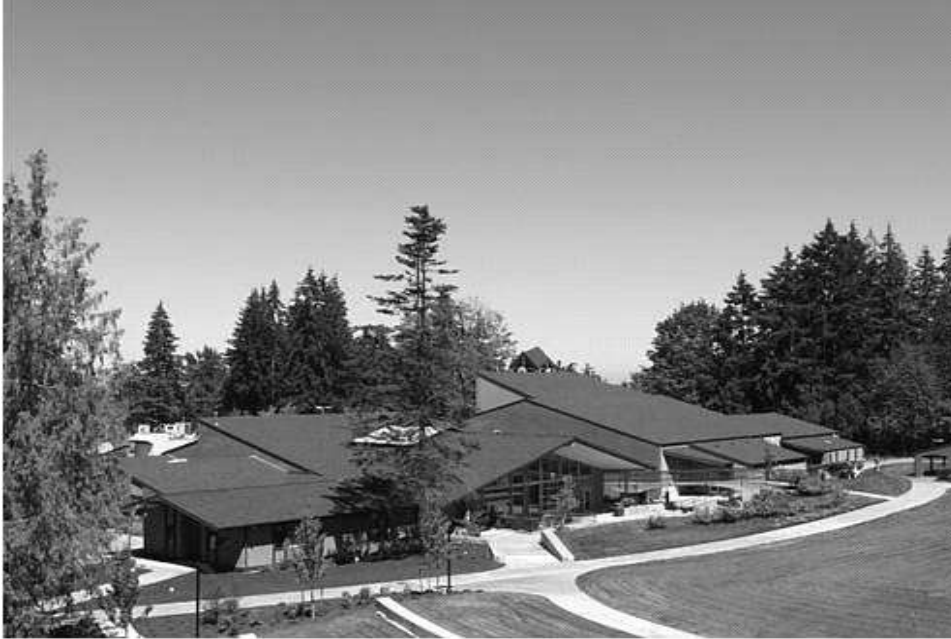
Theatre/Student Union (010-00J)      STATE UFI: A04882      Main Campus (010A)  
AREA: 29,511 SF      BUILT: 1966      REMODELED: No      PREDOMINANT USE: Multi-Use  
CONSTRUCTION TYPE: Heavy      CRV/SF: \$395      REPLACEMENT VALUE: \$11,656,845

Primary Systems			
COMPONENT:	Structure	RATING: 2 x WEIGHT: 8.3 =	SCORE: 16.7
Minor cracks evident in a small portion of the structure			
COMMENTS:	Wood frame; concrete; structure steel; CMU; glu-lam beams; wood/steel roof joists		
COMPONENT:	Exterior Closure	RATING: 3 x WEIGHT: 8.3 =	SCORE: 25
Sound and weatherproof but with some physical deterioration evident			
COMMENTS:	Brick veneer, vertical cedar siding-surface wear; aluminum window walls; clearstory windows		
COMPONENT:	Roofing	RATING: 2 x WEIGHT: 10.4 =	SCORE: 20.9
Majority of roofing and flashing appear sound, but a small portion of roofing shows deterioration where maintenance or minor repair needed			
COMMENTS:	Composition shingles; Kalwall skylights; Hypalon single-ply

Secondary Systems			
COMPONENT:	Floor Finishes	RATING: 2 x WEIGHT: 6.3 = SCORE: 12.5	
Some wear is evident on finish; maintenance needed			
COMMENTS:	Vinyl tile-surface wear; carpet-stained; concrete; sheet vinyl; rubber; quarry and ceramic tile		
COMPONENT:	Wall Finishes	RATING: 2 x WEIGHT: 6.3 = SCORE: 12.5	
Maintainable surfaces, minor maintenance is required in some areas			
COMMENTS:	Gypsum board; brick; CMU; ceramic tile; cedar t&g boards; plastic panels		
COMPONENT:	Ceiling Finishes	RATING: 3 x WEIGHT: 6.3 = SCORE: 18.8	
Some wear and tear; Minor damage, staining or deterioration			
COMMENTS:	Direct-adhered & lay-in tile; gypsum board; cedar boards, plaster, stained and missing tiles		
COMPONENT:	Doors & Hardware	RATING: 3 x WEIGHT: 6.3 = SCORE: 18.8	
Functional, but dated; some maintenance required			
COMMENTS:	Interior wood doors/frames; exterior wood/HM doors/frames; general surface wear

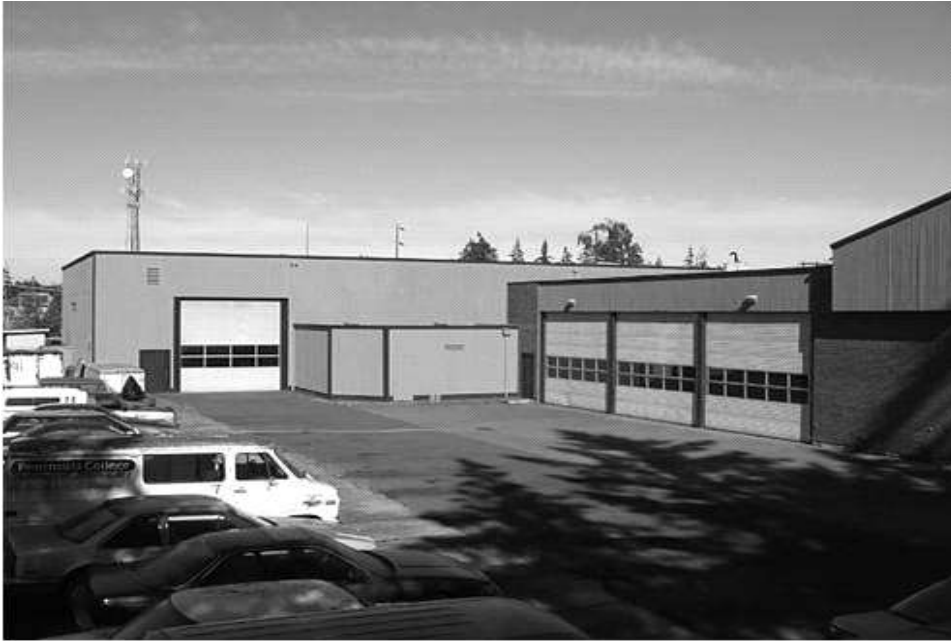
Auto/Diesel Mechanics (010-00Q)      STATE UFI: A05205      Main Campus (010A)  
 AREA: 18,002 SF      BUILT: 1969      REMODELED: No      PREDOMINANT USE: Vocational Arts  
 CONSTRUCTION TYPE: Heavy      CRV/SF: \$395      REPLACEMENT VALUE: \$7,110,790

Primary Systems			
COMPONENT:	Structure	RATING: 1 x WEIGHT: 8.3 =	SCORE: 8.3
No signs of settlement or cracking, no abrupt vertical changes Columns, bearing walls and roof structure appears sound/free of defects			
COMMENTS:	Wood frame; structural brick; CMU; glu-lam beams; steel frame		
COMPONENT:	Exterior Closure	RATING: 3 x WEIGHT: 8.3 =	SCORE: 25
Sound and weatherproof but with some physical deterioration evident			
COMMENTS:	Brick, brick veneer, vertical cedar siding-surface wear; clearstory windows		
COMPONENT:	Roofing	RATING: 2 x WEIGHT: 10.4 =	SCORE: 20.9
Majority of roofing and flashing appear sound, but a small portion of roofing shows deterioration where maintenance or minor repair needed			
COMMENTS:	Composition shingles; Hypalon single-ply 2017

Secondary Systems			
COMPONENT:	Floor Finishes	RATING: 3 x WEIGHT: 6.3 = SCORE: 18.8	
	Some physical wear and minor imperfections are evident; beginning deterioration		
COMMENTS:	Concrete; vinyl tile; carpet; ceramic tile		
COMPONENT:	Wall Finishes	RATING: 3 x WEIGHT: 6.3 = SCORE: 18.8	
	Aging surfaces, but sound; some maintenance is required		
COMMENTS:	Gypsum board; ceramic tile; Masonite panels		
COMPONENT:	Ceiling Finishes	RATING: 3 x WEIGHT: 6.3 = SCORE: 18.8	
	Some wear and tear; Minor damage, staining or deterioration		
COMMENTS:	Gypsum board-general wear		
COMPONENT:	Doors & Hardware	RATING: 3 x WEIGHT: 6.3 = SCORE: 18.8	
	Functional, but dated; some maintenance required		
COMMENTS:	Interior wood/HM doors w HM frames-surface wear; exterior wood/HM doors/frames-general wear; metal OH doors

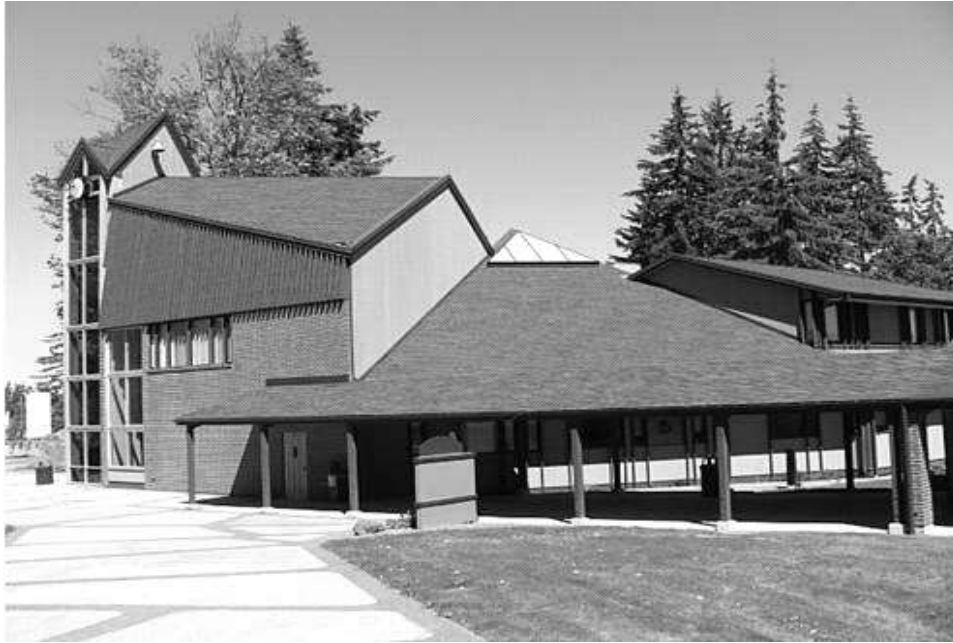
Student Services Center (010-00D)      STATE UFI: A05724      Main Campus (010A)  
AREA: 15,770 SF      BUILT: 1965      REMODELED: 2003      PREDOMINANT USE: Administration  
CONSTRUCTION TYPE: Medium      CRV/SF: \$336      REPLACEMENT VALUE: \$5,298,720

Primary Systems			
COMPONENT:	Structure	RATING: 1 x WEIGHT: 8 =	SCORE: 8
No signs of settlement or cracking, no abrupt vertical changes Columns, bearing walls and roof structure appears sound/free of defects			
COMMENTS:	Steel frame, glu-lam roof beams		
COMPONENT:	Exterior Closure	RATING: 2 x WEIGHT: 8 =	SCORE: 16
Weatherproof exterior, but finish appears poorly maintained			
COMMENTS:	Cedar siding & brick veneer; aluminum glazed window wall		
COMPONENT:	Roofing	RATING: 3 x WEIGHT: 10 =	SCORE: 30
Some deterioration is evident in membrane and flashings; maintenance or minor repair is needed			
COMMENTS:	Composition shingles; Kalwall and glass skylights

Secondary Systems			
COMPONENT:	Floor Finishes	RATING: 2 x WEIGHT: 6 =	SCORE: 12
Some wear is evident on finish; maintenance needed			
COMMENTS:	Carpet-surface wear; linoleum; ceramic tile		
COMPONENT:	Wall Finishes	RATING: 1 x WEIGHT: 6 =	SCORE: 6
Maintainable surfaces in good condition			
COMMENTS:	Gypsum board with some wood accents; vinyl wall panels		
COMPONENT:	Ceiling Finishes	RATING: 1 x WEIGHT: 6 =	SCORE: 6
Maintainable surfaces in good condition; good alignment and appearance			
COMMENTS:	Gypsum board; lay-in tile; T&G wood boards		
COMPONENT:	Doors & Hardware	RATING: 1 x WEIGHT: 6 =	SCORE: 6
Appropriate hardware, closers, panic devices; in good working order			
COMMENTS:	Interior wood/HM doors w HM frames; exterior aluminum/HM doors/frames

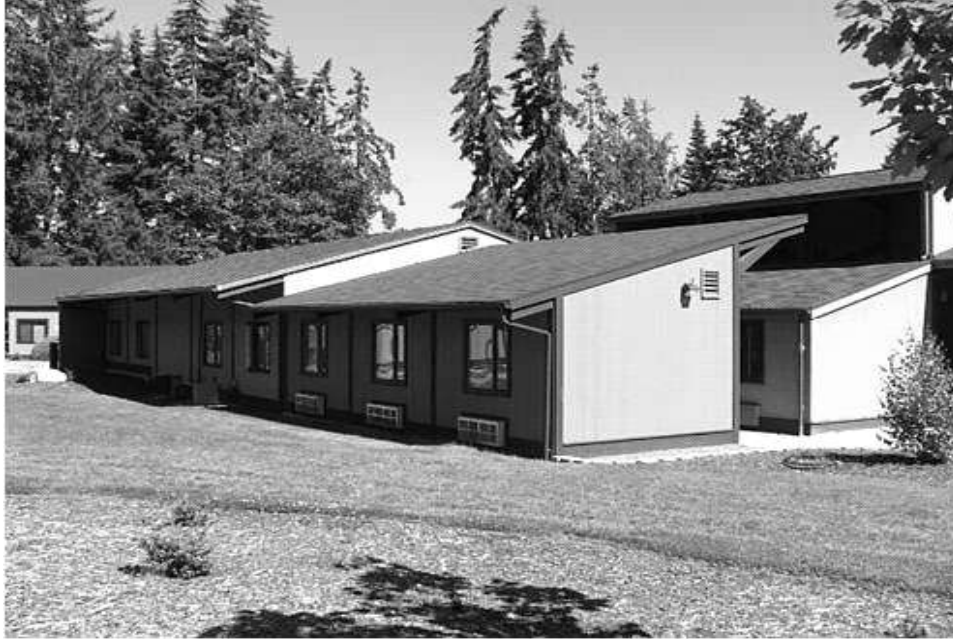
Communications (010-00U)      STATE UFI: A07011      Main Campus (010A)  
 AREA: 2,220 SF      BUILT: 1995      REMODELED: 2006      PREDOMINANT USE: General Classroom  
 CONSTRUCTION TYPE: Medium      CRV/SF: \$376      REPLACEMENT VALUE: \$834,720

Primary Systems			
COMPONENT:	Structure	RATING: 1 x WEIGHT: 8.3 =	SCORE: 8.3
No signs of settlement or cracking, no abrupt vertical changes Columns, bearing walls and roof structure appears sound/free of defects			
COMMENTS:	Wood frame; glu-lam beams; wood trusses		
COMPONENT:	Exterior Closure	RATING: 3 x WEIGHT: 8.3 =	SCORE: 25
Sound and weatherproof but with some physical deterioration evident			
COMMENTS:	Brick veneer; vertical cedar siding-worn finishes		
COMPONENT:	Roofing	RATING: 2 x WEIGHT: 10.4 =	SCORE: 20.9
Majority of roofing and flashing appear sound, but a small portion of roofing shows deterioration where maintenance or minor repair needed			
COMMENTS:	Composition shingles

Secondary Systems			
COMPONENT:	Floor Finishes	RATING: 2 x WEIGHT: 6.3 =	SCORE: 12.5
Some wear is evident on finish; maintenance needed			
COMMENTS:	Carpet-surface wear; sheet vinyl, laminate		
COMPONENT:	Wall Finishes	RATING: 2 x WEIGHT: 6.3 =	SCORE: 12.5
Maintainable surfaces, minor maintenance is required in some areas			
COMMENTS:	Gypsum board; wood paneling; vinyl wall cover		
COMPONENT:	Ceiling Finishes	RATING: 1 x WEIGHT: 6.3 =	SCORE: 6.3
Maintainable surfaces in good condition; good alignment and appearance			
COMMENTS:	Gypsum board; lay-in tile		
COMPONENT:	Doors & Hardware	RATING: 3 x WEIGHT: 6.3 =	SCORE: 18.8
Functional, but dated; some maintenance required			
COMMENTS:	Exterior & interior wood doors/HM frames-surface wear

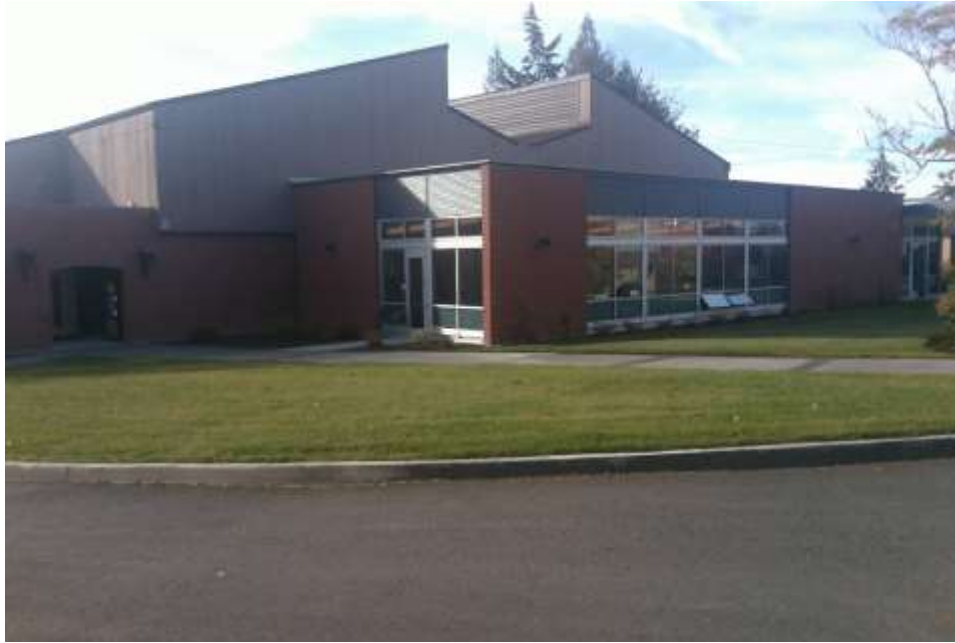
Gymnasium (010-00N)      STATE UFI: A07261      Main Campus (010A)  
AREA: 16,896 SF      BUILT: 1966      REMODELED: 2017      PREDOMINANT USE: Gymnasium  
CONSTRUCTION TYPE: Heavy      CRV/SF: \$363      REPLACEMENT VALUE: \$6,133,248

Primary Systems			
COMPONENT:	Structure	RATING: 3 x WEIGHT: 8.3 =	SCORE: 25
Some cracking evident but does not likely affect structural integrity; Visible defects apparent but are non-structural			
COMMENTS:	CMU; steel framing; glu-lam beams & purlins; wood frame		
COMPONENT:	Exterior Closure	RATING: 2 x WEIGHT: 8.3 =	SCORE: 16.7
Weatherproof exterior, but finish appears poorly maintained			
COMMENTS:	Vertical cedar siding-surface wear; brick veneer; cracks in east elevation brick		
COMPONENT:	Roofing	RATING: 1 x WEIGHT: 10.4 =	SCORE: 10.4
Flashing and penetrations appear sound and membrane appears water-tight; drainage is positive and there are overflow scuppers			
COMMENTS:	Composition shingles; single-ply Hypalon 2017

Secondary Systems			
COMPONENT:	Floor Finishes	RATING: 2 x WEIGHT: 6.3 =	SCORE: 12.5
Some wear is evident on finish; maintenance needed			
COMMENTS:	Hardwood floor; carpet-surface wear; vinyl asbestos & composition tile; sheet vinyl-surface wear; ceramic tile-cracks; concrete		
COMPONENT:	Wall Finishes	RATING: 2 x WEIGHT: 6.3 =	SCORE: 12.5
Maintainable surfaces, minor maintenance is required in some areas			
COMMENTS:	Gypsum board; CMU; hardboard tectum panels; ceramic tile-random wear/cracks throughout		
COMPONENT:	Ceiling Finishes	RATING: 3 x WEIGHT: 6.3 =	SCORE: 18.8
Some wear and tear; Minor damage, staining or deterioration			
COMMENTS:	Direct-adhered & lay-in tile-badly deteriorated; gypsum board; wood decking		
COMPONENT:	Doors & Hardware	RATING: 2 x WEIGHT: 6.3 =	SCORE: 12.5
Fairly modern door surfaces and hardware with minor deterioration; good working order			
COMMENTS:	Interior and exterior wood/HM doors w wood frames-surface wear

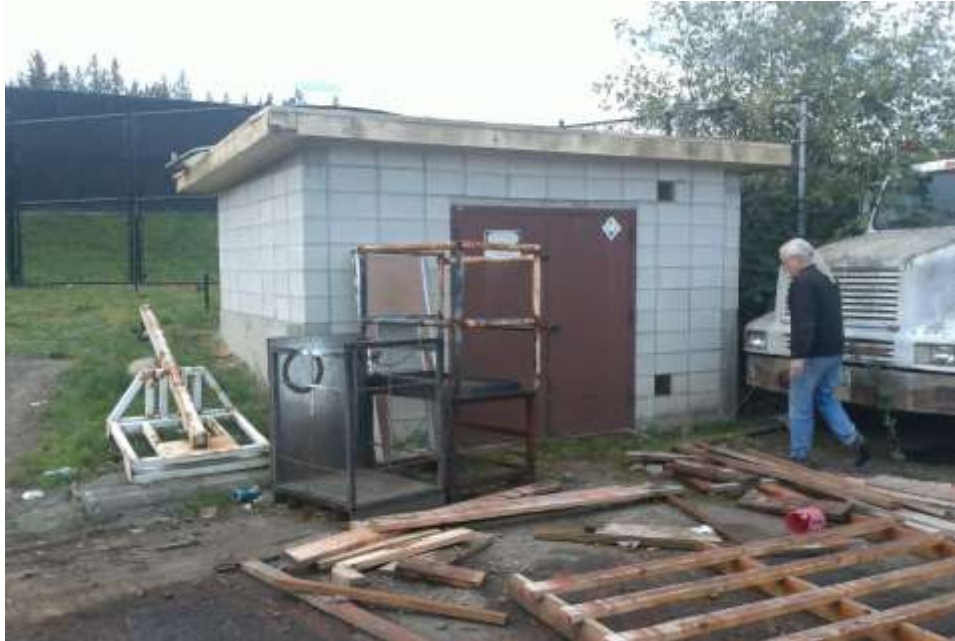
Wisha Storage - A/D (010-00S)      STATE UFI: A07598      Main Campus (010A)  
AREA: 500 SF      BUILT: 1976      REMODELED: No      PREDOMINANT USE: Central Storage  
CONSTRUCTION TYPE: No data      CRV/SF: \$150      REPLACEMENT VALUE: \$75,000

Primary Systems			
COMPONENT:	Structure	RATING: 1 x WEIGHT: 17.4 =	SCORE: 17.4
No signs of settlement or cracking, no abrupt vertical changes Columns, bearing walls and roof structure appears sound/free of defects			
COMMENTS:	No data		
COMPONENT:	Exterior Closure	RATING: 3 x WEIGHT: 17.4 =	SCORE: 52.3
Sound and weatherproof but with some physical deterioration evident			
COMMENTS:	No data		
COMPONENT:	Roofing	RATING: 3 x WEIGHT: 21.8 =	SCORE: 65.4
Some deterioration is evident in membrane and flashings; maintenance or minor repair is needed			
COMMENTS:	No data

Secondary Systems			
COMPONENT:	Floor Finishes	RATING: 3 x WEIGHT: 13.1 =	SCORE: 39.2
Some physical wear and minor imperfections are evident; beginning deterioration			
COMMENTS:	No data		
COMPONENT:	Wall Finishes	RATING: 0 x WEIGHT: 0 =	SCORE: 0
No data			
COMMENTS:	No data		
COMPONENT:	Ceiling Finishes	RATING: 0 x WEIGHT: 0 =	SCORE: 0
No data			
COMMENTS:	No data		
COMPONENT:	Doors & Hardware	RATING: 3 x WEIGHT: 13.1 =	SCORE: 39.2
Functional, but dated; some maintenance required			
COMMENTS:	No data

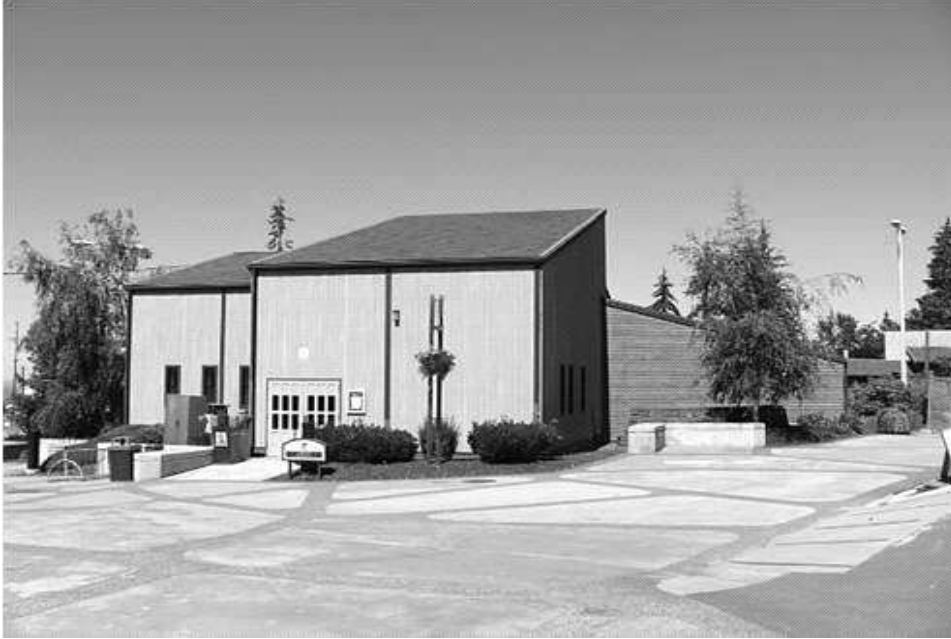
Conference Center (010-00A)      STATE UFI: A07625      Main Campus (010A)  
AREA: 5,728 SF      BUILT: 1990      REMODELED: No      PREDOMINANT USE: General Classroom  
CONSTRUCTION TYPE: Light      CRV/SF: \$376      REPLACEMENT VALUE: \$2,153,728

Primary Systems			
COMPONENT:	Structure	RATING: 1 x WEIGHT: 8.3 =	SCORE: 8.3
No signs of settlement or cracking, no abrupt vertical changes Columns, bearing walls and roof structure appears sound/free of defects			
COMMENTS:	Wood frame		
COMPONENT:	Exterior Closure	RATING: 3 x WEIGHT: 8.3 =	SCORE: 25
Sound and weatherproof but with some physical deterioration evident			
COMMENTS:	Vertical cedar siding; brick veneer end walls		
COMPONENT:	Roofing	RATING: 3 x WEIGHT: 10.4 =	SCORE: 31.3
Some deterioration is evident in membrane and flashings; maintenance or minor repair is needed			
COMMENTS:	Composition shingles-lots of moss buildup

Secondary Systems			
COMPONENT:	Floor Finishes	RATING: 2 x WEIGHT: 6.3 =	SCORE: 12.5
Some wear is evident on finish; maintenance needed			
COMMENTS:	Carpet tile-surface wear, vinyl tile, concrete; carpet-puckering		
COMPONENT:	Wall Finishes	RATING: 1 x WEIGHT: 6.3 =	SCORE: 6.3
Maintainable surfaces in good condition			
COMMENTS:	Gypsum board-scuffed/marred; plastic wall panels		
COMPONENT:	Ceiling Finishes	RATING: 1 x WEIGHT: 6.3 =	SCORE: 6.3
Maintainable surfaces in good condition; good alignment and appearance			
COMMENTS:	Gypsum board; lay-in tile		
COMPONENT:	Doors & Hardware	RATING: 2 x WEIGHT: 6.3 =	SCORE: 12.5
Fairly modern door surfaces and hardware with minor deterioration; good working order			
COMMENTS:	Interior wood doors w HM frames; exterior wood/HM doors w wood/HM frames-surface wear

Service Systems			
COMPONENT:	Elevators	RATING: 0 x WEIGHT: 0 =	SCORE: 0
No data			
COMMENTS:			
COMPONENT:	Plumbing	RATING: 1 x WEIGHT: 8.3 =	SCORE: 8.3
Fixtures and piping appear to be in good condition; no evidence of leaks			
COMMENTS:	Copper, cast iron and steel piping; porcelain fixtures		
COMPONENT:	HVAC	RATING: 1 x WEIGHT: 8.3 =	SCORE: 8.3
Equipment in good condition; easily controlled; serves all required spaces; All necessary spaces are adequately ventilated; A/C provided throughout			
COMMENTS:	Split system heat pumps		
COMPONENT:	Electrical	RATING: 1 x WEIGHT: 8.3 =	SCORE: 8.3
Adequate service and distribution capacity for current/future needs			
COMMENTS:	800amp 208/120v		
COMPONENT:	Lights/Power	RATING: 1 x WEIGHT: 8.3 =	SCORE: 8.3
Contemporary lighting with good work area illumination; ample outlets			
COMMENTS:	Hanging panel, ceiling-mount, wall-mount and recessed can fluorescent lights

Safety Systems			
COMPONENT:	Life/Safety	RATING: 1 x WEIGHT: 10.4 = SCORE: 10.4	
	Appears to meet current codes		
COMMENTS:			
COMPONENT:	Fire Safety	RATING: 2 x WEIGHT: 10.4 = SCORE: 20.9	
	Locally monitored detection; alarm present, but missing visual component or sprinklers		
COMMENTS:			
COMPONENT:	Modifications	RATING: 3 x WEIGHT: 7.3 = SCORE: 21.9	
	Some modifications lack code compliance; HVAC service not fully considered during renovation		
COMMENTS:	Modifications do not seem to have been well planned

Quality Standards			
COMPONENT:	Maintenance	RATING: 2 x WEIGHT: 7.3 = SCORE: 14.6	
	Routine maintenance is required; impact is minor		
COMMENTS:	Poor roof maintenance		
COMPONENT:	Remaining Life	RATING: 1 x WEIGHT: 6.3 = SCORE: 6.3	
	Life expectancy is >20 years; minor system deterioration		
COMMENTS:	1/2 of building currently vacant; change in use planned		
COMPONENT:	Appearance	RATING: 3 x WEIGHT: 6.3 = SCORE: 18.8	
	Average construction; average interior and exterior appearance		
COMMENTS:	Very plain vanilla interior and average exterior

CONDITION: Adequate

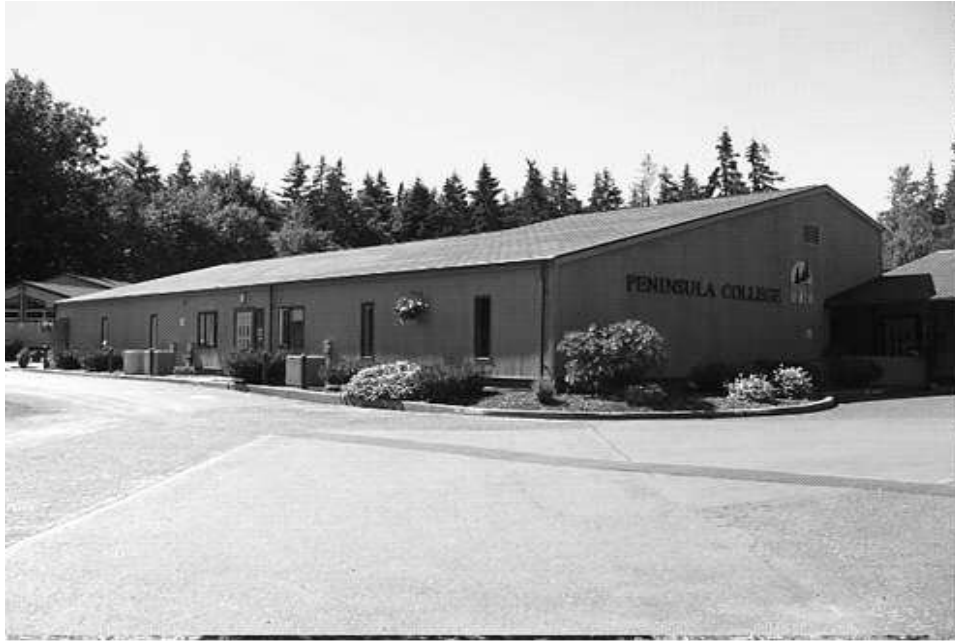
Comp Res/Technical (010-00V)      STATE UFI: A08208      Main Campus (010A)  
AREA: 3,510 SF      BUILT: 1996      REMODELED: No      PREDOMINANT USE: Computer Lab.  
CONSTRUCTION TYPE: Medium      CRV/SF: \$376      REPLACEMENT VALUE: \$1,319,760

Primary Systems			
COMPONENT:	Structure	RATING: 1 x WEIGHT: 8.8 =	SCORE: 8.8
No signs of settlement or cracking, no abrupt vertical changes Columns, bearing walls and roof structure appears sound/free of defects			
COMMENTS:	Wood frame; wood trusses		
COMPONENT:	Exterior Closure	RATING: 2 x WEIGHT: 8.8 =	SCORE: 17.7
Weatherproof exterior, but finish appears poorly maintained			
COMMENTS:	Wood siding; cedar decking; vertical wood siding-worn finishes		
COMPONENT:	Roofing	RATING: 2 x WEIGHT: 11.1 =	SCORE: 22.1
Majority of roofing and flashing appear sound, but a small portion of roofing shows deterioration where maintenance or minor repair needed			
COMMENTS:	Composition shingles-lots of moss

Secondary Systems			
COMPONENT:	Floor Finishes	RATING: 2 x WEIGHT: 6.6 = SCORE: 13.3	
	Some wear is evident on finish; maintenance needed		
COMMENTS:	Carpet tile-surface wear		
COMPONENT:	Wall Finishes	RATING: 1 x WEIGHT: 6.6 = SCORE: 6.6	
	Maintainable surfaces in good condition		
COMMENTS:	Gypsum board		
COMPONENT:	Ceiling Finishes	RATING: 1 x WEIGHT: 6.6 = SCORE: 6.6	
	Maintainable surfaces in good condition; good alignment and appearance		
COMMENTS:	Lay-in tile; gypsum board		
COMPONENT:	Doors & Hardware	RATING: 2 x WEIGHT: 6.6 = SCORE: 13.3	
	Fairly modern door surfaces and hardware with minor deterioration; good working order		
COMMENTS:	Interior wood doors w HM frames; exterior wood doors/frames

Service Systems			
COMPONENT:	Elevators	RATING: 0 x WEIGHT: 0 = SCORE: 0	
	No data		
COMMENTS:			
COMPONENT:	Plumbing	RATING: 0 x WEIGHT: 0 = SCORE: 0	
	No data		
COMMENTS:			
COMPONENT:	HVAC	RATING: 1 x WEIGHT: 8.8 = SCORE: 8.8	
	Equipment in good condition; easily controlled; serves all required spaces; All necessary spaces are adequately ventilated; A/C provided throughout		
COMMENTS:	Split system heat pumps		
COMPONENT:	Electrical	RATING: 1 x WEIGHT: 8.8 = SCORE: 8.8	
	Adequate service and distribution capacity for current/future needs		
COMMENTS:	400amp 208/120v		
COMPONENT:	Lights/Power	RATING: 1 x WEIGHT: 8.8 = SCORE: 8.8	
	Contemporary lighting with good work area illumination; ample outlets		
COMMENTS:	Lay-in fluorescent lights

Safety Systems			
COMPONENT:	Life/Safety	RATING: 1 x WEIGHT: 11.1 = SCORE: 11.1	
	Appears to meet current codes		
COMMENTS:			
COMPONENT:	Fire Safety	RATING: 2 x WEIGHT: 11.1 = SCORE: 22.1	
	Locally monitored detection; alarm present, but missing visual component or sprinklers		
COMMENTS:			
COMPONENT:	Modifications	RATING: 1 x WEIGHT: 7.7 = SCORE: 7.7	
	Modifications appear to be in compliance with codes and sound construction practices; HVAC/electrical service properly provided		
COMMENTS:	None apparent

Quality Standards			
COMPONENT:	Maintenance	RATING: 1 x WEIGHT: 7.7 = SCORE: 7.7	
	Facility appears well maintained		
COMMENTS:			
COMPONENT:	Remaining Life	RATING: 1 x WEIGHT: 6.6 = SCORE: 6.6	
	Life expectancy is >20 years; minor system deterioration		
COMMENTS:			
COMPONENT:	Appearance	RATING: 3 x WEIGHT: 6.6 = SCORE: 19.9	
	Average construction; average interior and exterior appearance		
COMMENTS:	Building not very attractive; outdated, low scale design

CONDITION: Adequate

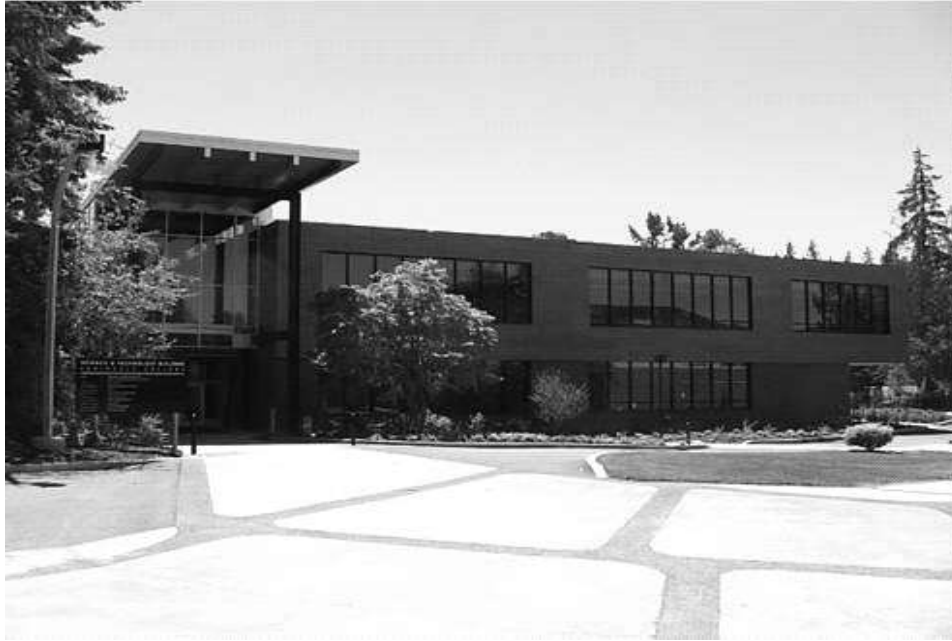
Science & Technology (010-00M)      STATE UFI: A08813      Main Campus (010A)  
AREA: 56,000 SF      BUILT: 2007      REMODELED: No      PREDOMINANT USE: Science Lab.  
CONSTRUCTION TYPE: Heavy      CRV/SF: \$489      REPLACEMENT VALUE: \$27,384,000

Primary Systems			
COMPONENT:	Structure	RATING: 1 x WEIGHT: 8.4 =	SCORE: 8.4
No signs of settlement or cracking, no abrupt vertical changes Columns, bearing walls and roof structure appears sound/free of defects			
COMMENTS:	Structural steel frame; glu-lam roof beams		
COMPONENT:	Exterior Closure	RATING: 1 x WEIGHT: 8.4 =	SCORE: 8.4
Weatherproof, tight, well-maintained exterior walls, doors, windows/finishes			
COMMENTS:	Brick; Perdia panels; aluminum window walls; standing seam metal panels		
COMPONENT:	Roofing	RATING: 1 x WEIGHT: 10.5 =	SCORE: 10.5
Flashing and penetrations appear sound and membrane appears water- tight; drainage is positive and there are overflow scuppers			
COMMENTS:	Single ply PVC membrane; planted "green" lecture hall roof

Secondary Systems			
COMPONENT:	Floor Finishes	RATING: 2 x WEIGHT: 6.3 = SCORE: 12.6	
	Some wear is evident on finish; maintenance needed		
COMMENTS:	Slate; linoleum & carpet tiles-surface wear; concrete; ceramic tile		
COMPONENT:	Wall Finishes	RATING: 1 x WEIGHT: 6.3 = SCORE: 6.3	
	Maintainable surfaces in good condition		
COMMENTS:	Gypsum board; exposed steel structure; wood panels; ceramic tile		
COMPONENT:	Ceiling Finishes	RATING: 1 x WEIGHT: 6.3 = SCORE: 6.3	
	Maintainable surfaces in good condition; good alignment and appearance		
COMMENTS:	Exposed structure; gypsum board; wood decking; suspended wood and perforated metal panels		
COMPONENT:	Doors & Hardware	RATING: 1 x WEIGHT: 6.3 = SCORE: 6.3	
	Appropriate hardware, closers, panic devices; in good working order		
COMMENTS:	Interior wood/HM/aluminum doors/frames; sidelites; exterior aluminum/HM doors/frames

Service Systems			
COMPONENT:	Elevators	RATING: 1 x WEIGHT: 6.3 = SCORE: 6.3	
	Appropriate and functional for occupancy and use		
COMMENTS:	2 stop		
COMPONENT:	Plumbing	RATING: 1 x WEIGHT: 8.4 = SCORE: 8.4	
	Fixtures and piping appear to be in good condition; no evidence of leaks		
COMMENTS:	Copper, cast iron, steel and PVC piping; porcelain fixtures; waterless urinals		
COMPONENT:	HVAC	RATING: 2 x WEIGHT: 8.4 = SCORE: 16.8	
	Equipment in fair condition; minor deterioration; controls require troubleshooting; most areas have A/C; hazardous areas are ventilated		
COMMENTS:	Ground-source rooftop heat pumps; split-system rooftop AHUs w duct reheat; 2 HW boilers; fin-tube radiators		
COMPONENT:	Electrical	RATING: 1 x WEIGHT: 8.4 = SCORE: 8.4	
	Adequate service and distribution capacity for current/future needs		
COMMENTS:	2000amp 480/277v		
COMPONENT:	Lights/Power	RATING: 1 x WEIGHT: 8.4 = SCORE: 8.4	
	Contemporary lighting with good work area illumination; ample outlets

Safety Systems			
COMPONENT:	Life/Safety	RATING: 1 x WEIGHT: 10.5 =	SCORE: 10.5
Appears to meet current codes			
COMMENTS:			
COMPONENT:	Fire Safety	RATING: 1 x WEIGHT: 10.5 =	SCORE: 10.5
Locally monitored detection; alarm and strobes present; sprinklers in high hazard areas			
COMMENTS:			
COMPONENT:	Modifications	RATING: 0 x WEIGHT: 0 =	SCORE: 0
No data			
COMMENTS: None

Quality Standards			
COMPONENT:	Maintenance	RATING: 1 x WEIGHT: 7.4 =	SCORE: 7.4
Facility appears well maintained			
COMMENTS: Well maintained, except for roof; intensive use of exterior wood may be maintenance issue			
COMPONENT:	Remaining Life	RATING: 1 x WEIGHT: 6.3 =	SCORE: 6.3
Life expectancy is >20 years; minor system deterioration			
COMMENTS:			
COMPONENT:	Appearance	RATING: 1 x WEIGHT: 6.3 =	SCORE: 6.3
Well-constructed building; generally attractive interior and exterior			
COMMENTS: Attractive, modern campus building reflecting traditions with innovative materials

CONDITION: Superior

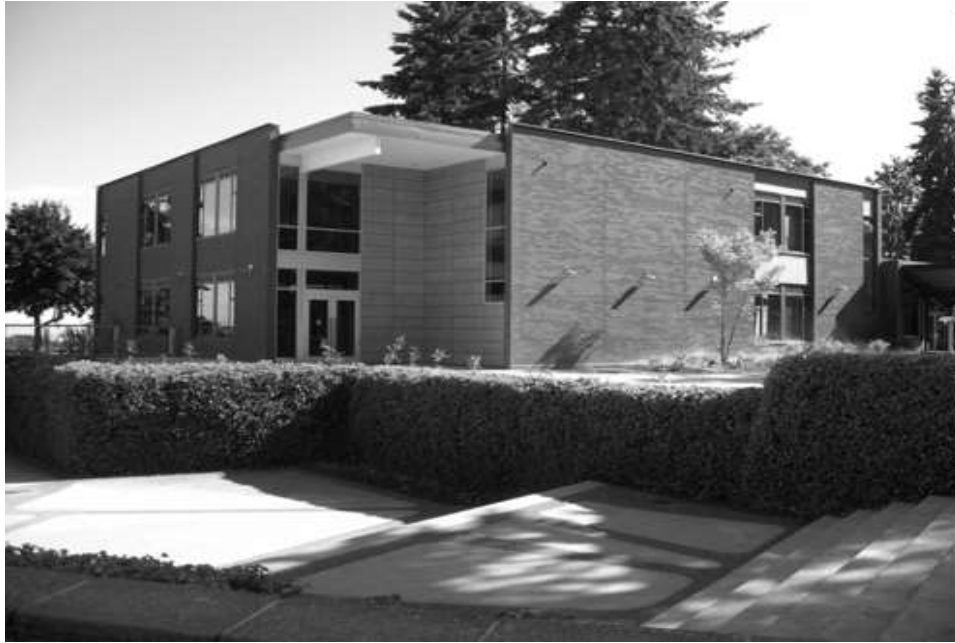
Administration (010-00C)      STATE UFI: A09924      Main Campus (010A)  
 AREA: 10,846 SF      BUILT: 1965      REMODELED: 2008      PREDOMINANT USE: Administration  
 CONSTRUCTION TYPE: Medium      CRV/SF: \$336      REPLACEMENT VALUE: \$3,644,256

Primary Systems			
COMPONENT:	Structure	RATING: 1 x WEIGHT: 8 =	SCORE: 8
No signs of settlement or cracking, no abrupt vertical changes Columns, bearing walls and roof structure appears sound/free of defects			
COMMENTS:	Wood frame, glu-lam rafters; brick		
COMPONENT:	Exterior Closure	RATING: 2 x WEIGHT: 8 =	SCORE: 16
Weatherproof exterior, but finish appears poorly maintained			
COMMENTS:	Brick veneer, vertical cedar siding; metal panels; wood panels		
COMPONENT:	Roofing	RATING: 1 x WEIGHT: 10 =	SCORE: 10
Flashing and penetrations appear sound and membrane appears water- tight; drainage is positive and there are overflow scuppers			
COMMENTS:	Composition shingles; PVC single-ply; glass skylights

Secondary Systems			
COMPONENT:	Floor Finishes	RATING: 2 x WEIGHT: 6 =	SCORE: 12
Some wear is evident on finish; maintenance needed			
COMMENTS:	Carpet, linoleum, ceramic tile		
COMPONENT:	Wall Finishes	RATING: 1 x WEIGHT: 6 =	SCORE: 6
Maintainable surfaces in good condition			
COMMENTS:	Gypsum board; brick; ceramic tile; cedar; vinyl wall panels		
COMPONENT:	Ceiling Finishes	RATING: 1 x WEIGHT: 6 =	SCORE: 6
Maintainable surfaces in good condition; good alignment and appearance			
COMMENTS:	Direct-adhered lay-in tile; gypsum board; wood t&g		
COMPONENT:	Doors & Hardware	RATING: 2 x WEIGHT: 6 =	SCORE: 12
Fairly modern door surfaces and hardware with minor deterioration; good working order			
COMMENTS:	Interior wood doors w HM frames; sidelites; exterior aluminum/HM doors/frames

Service Systems			
COMPONENT:	Elevators	RATING: 1 x WEIGHT: 6 =	SCORE: 6
Appropriate and functional for occupancy and use			
COMMENTS:	1 story and 2 story wings		
COMPONENT:	Plumbing	RATING: 1 x WEIGHT: 8 =	SCORE: 8
Fixtures and piping appear to be in good condition; no evidence of leaks			
COMMENTS:	Copper, cast iron and steel piping; porcelain fixtures		
COMPONENT:	HVAC	RATING: 2 x WEIGHT: 8 =	SCORE: 16
Equipment in fair condition; minor deterioration; controls require troubleshooting; most areas have A/C; hazardous areas are ventilated			
COMMENTS:	Split system heat pumps. Some inadequate spaces.		
COMPONENT:	Electrical	RATING: 1 x WEIGHT: 8 =	SCORE: 8
Adequate service and distribution capacity for current/future needs			
COMMENTS:	1000amp 208/120v		
COMPONENT:	Lights/Power	RATING: 1 x WEIGHT: 8 =	SCORE: 8
Contemporary lighting with good work area illumination; ample outlets			
COMMENTS:	Hanging, lay-in, wall-mount and circular pendant fluorescent lights

Safety Systems			
COMPONENT:	Life/Safety	RATING: 1 x WEIGHT: 10 = SCORE: 10	
	Appears to meet current codes		
COMMENTS:			
COMPONENT:	Fire Safety	RATING: 1 x WEIGHT: 10 = SCORE: 10	
	Locally monitored detection; alarm and strobes present; sprinklers in high hazard areas		
COMMENTS:			
COMPONENT:	Modifications	RATING: 1 x WEIGHT: 7 = SCORE: 7	
	Modifications appear to be in compliance with codes and sound construction practices; HVAC/electrical service properly provided		
COMMENTS:	Well thought out functional renovation of original wing in 2004

Quality Standards			
COMPONENT:	Maintenance	RATING: 1 x WEIGHT: 7 = SCORE: 7	
	Facility appears well maintained		
COMMENTS:			
COMPONENT:	Remaining Life	RATING: 1 x WEIGHT: 6 = SCORE: 6	
	Life expectancy is >20 years; minor system deterioration		
COMMENTS:	8,280 GSF two-story addition in 2008 and renovation of original wing have extended useful building life		
COMPONENT:	Appearance	RATING: 2 x WEIGHT: 6 = SCORE: 12	
	Well-constructed building; average interior and exterior appearance		
COMMENTS:	Exterior of original wing is very utilitarian

CONDITION: Adequate

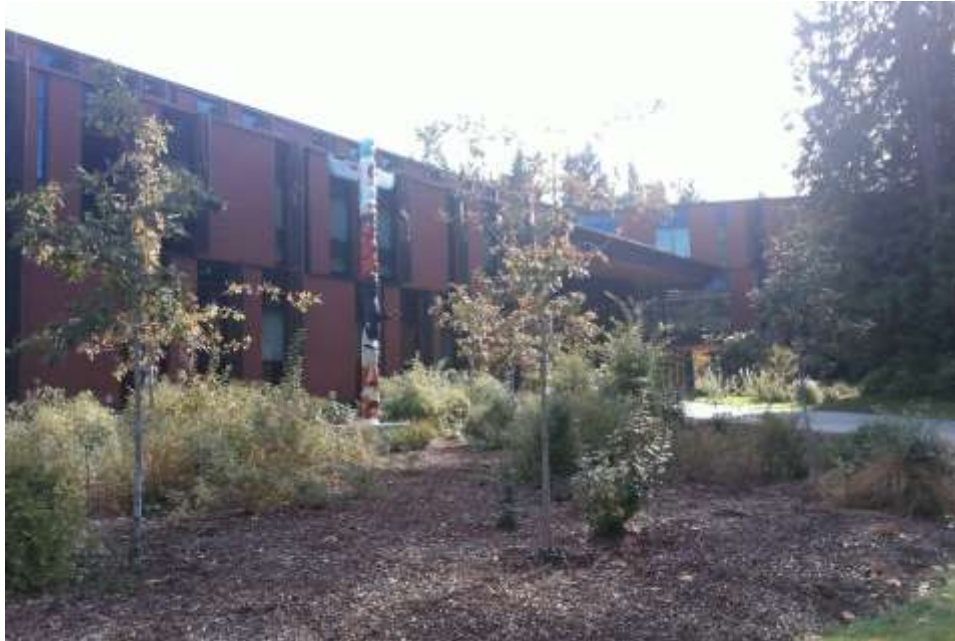
Maier Hall (010-00E)      STATE UFI: A10433      Main Campus (010A)  
 AREA: 62,950 SF      BUILT: 2011      REMODELED: No      PREDOMINANT USE: General Classroom  
 CONSTRUCTION TYPE: Heavy      CRV/SF: \$494      REPLACEMENT VALUE: \$31,097,300

Primary Systems			
COMPONENT:	Structure	RATING: 1 x WEIGHT: 8 = SCORE: 8	
No signs of settlement or cracking, no abrupt vertical changes Columns, bearing walls and roof structure appears sound/free of defects			
COMMENTS:	Structural steel; concrete		
COMPONENT:	Exterior Closure	RATING: 1 x WEIGHT: 8 = SCORE: 8	
Weatherproof, tight, well-maintained exterior walls, doors, windows/finishes			
COMMENTS:	Brick; Perdia panels; wood strip soffits; aluminum window walls; metal sun screens		
COMPONENT:	Roofing	RATING: 1 x WEIGHT: 10 = SCORE: 10	
Flashing and penetrations appear sound and membrane appears water- tight; drainage is positive and there are overflow scuppers			
COMMENTS:	PVC single-ply; moss absorptive "green roof"; glass skylights

Secondary Systems			
COMPONENT:	Floor Finishes	RATING: 1 x WEIGHT: 6 = SCORE: 6	
	Nice appearance, smooth transitions, level subfloors, no cracks/separating		
COMMENTS:	Polished concrete; carpet tile; epoxy coating in rest rooms; hardwood		
COMPONENT:	Wall Finishes	RATING: 1 x WEIGHT: 6 = SCORE: 6	
	Maintainable surfaces in good condition		
COMMENTS:	Gypsum board; concrete; fabric covered plywood; ceramic tile; Perdia panels		
COMPONENT:	Ceiling Finishes	RATING: 1 x WEIGHT: 6 = SCORE: 6	
	Maintainable surfaces in good condition; good alignment and appearance		
COMMENTS:	Lay-in tile; wood strips; metal deck pan; gypsum board; perforated metal tile		
COMPONENT:	Doors & Hardware	RATING: 1 x WEIGHT: 6 = SCORE: 6	
	Appropriate hardware, closers, panic devices; in good working order		
COMMENTS:	Interior wood/HM doors w HM frames; sidelites; exterior aluminum doors/frames; glazed OH metal doors

Service Systems			
COMPONENT:	Elevators	RATING: 1 x WEIGHT: 6 = SCORE: 6	
	Appropriate and functional for occupancy and use		
COMMENTS:	3 stop		
COMPONENT:	Plumbing	RATING: 1 x WEIGHT: 8 = SCORE: 8	
	Fixtures and piping appear to be in good condition; no evidence of leaks		
COMMENTS:	Copper, cast iron, steel and PVC piping; porcelain fixtures		
COMPONENT:	HVAC	RATING: 2 x WEIGHT: 8 = SCORE: 16	
	Equipment in fair condition; minor deterioration; controls require troubleshooting; most areas have A/C; hazardous areas are ventilated		
COMMENTS:	Ground source heat pumps; hydronic floor heat; wall perimeter hydronic radiators; AHUs; "chilled beam" tempered water ceiling cooling panels		
COMPONENT:	Electrical	RATING: 1 x WEIGHT: 8 = SCORE: 8	
	Adequate service and distribution capacity for current/future needs		
COMMENTS:	2000amp 480/277v		
COMPONENT:	Lights/Power	RATING: 1 x WEIGHT: 8 = SCORE: 8	
	Contemporary lighting with good work area illumination; ample outlets

Safety Systems			
COMPONENT:	Life/Safety	RATING: 1 x WEIGHT: 10 = SCORE: 10	
	Appears to meet current codes		
COMMENTS:			
COMPONENT:	Fire Safety	RATING: 1 x WEIGHT: 10 = SCORE: 10	
	Locally monitored detection; alarm and strobes present; sprinklers in high hazard areas		
COMMENTS:			
COMPONENT:	Modifications	RATING: 1 x WEIGHT: 7 = SCORE: 7	
	Modifications appear to be in compliance with codes and sound construction practices; HVAC/electrical service properly provided		
COMMENTS:	Brand new building

Quality Standards			
COMPONENT:	Maintenance	RATING: 1 x WEIGHT: 7 = SCORE: 7	
	Facility appears well maintained		
COMMENTS:			
COMPONENT:	Remaining Life	RATING: 1 x WEIGHT: 6 = SCORE: 6	
	Life expectancy is >20 years; minor system deterioration		
COMMENTS:			
COMPONENT:	Appearance	RATING: 1 x WEIGHT: 6 = SCORE: 6	
	Well-constructed building; generally attractive interior and exterior		
COMMENTS:	High-tech LEEDS building, but better thought out than similar buildings; should be easier to maintain

TOTAL SCORE = 154      PREVIOUS BIENNIUM SCORE = 154  
CONDITION: Superior
