# **2023** FACILITY CONDITION SURVEY

Peninsula College

SURVEY CONDUCTED BY:  
Steve Lewandowski  
State Board for Community  
and Technical Colleges

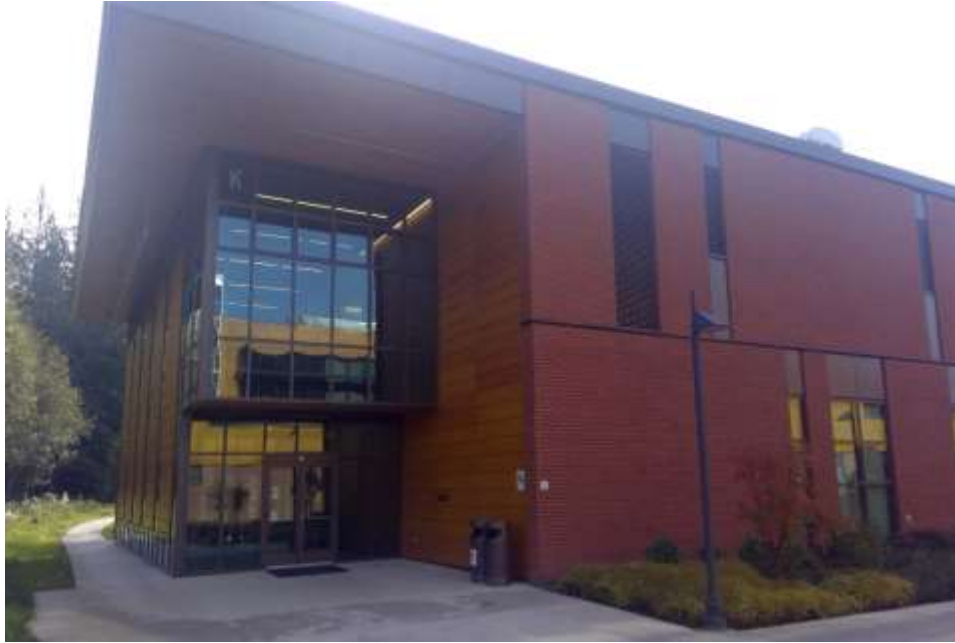
Allied Health & Ecdc (010-00K)      STATE UFI: A25537      Main Campus (010A)  
AREA: 41,650 SF      BUILT: 2017      REMODELED: No      PREDOMINANT USE: Classroom  
CONSTRUCTION TYPE: No data      CRV/SF: \$356      REPLACEMENT VALUE: \$14,827,400

Primary Systems			
COMPONENT:	Structure	RATING: 1 x WEIGHT: 8.4 =	SCORE: 8.4
No signs of settlement or cracking, no abrupt vertical changes Columns, bearing walls and roof structure appears sound/free of defects			
COMMENTS:	No data		
COMPONENT:	Exterior Closure	RATING: 1 x WEIGHT: 8.4 =	SCORE: 8.4
Weatherproof, tight, well-maintained exterior walls, doors, windows/finishes			
COMMENTS:	No data		
COMPONENT:	Roofing	RATING: 1 x WEIGHT: 10.5 =	SCORE: 10.5
Flashing and penetrations appear sound and membrane appears water- tight; drainage is positive and there are overflow scuppers			
COMMENTS:	No data

Secondary Systems			
COMPONENT:	Floor Finishes	RATING: 1 x WEIGHT: 6.3 =	SCORE: 6.3
	Nice appearance, smooth transitions, level subfloors, no cracks/separating		
COMMENTS:	No data		
COMPONENT:	Wall Finishes	RATING: 1 x WEIGHT: 6.3 =	SCORE: 6.3
	Maintainable surfaces in good condition		
COMMENTS:	No data		
COMPONENT:	Ceiling Finishes	RATING: 1 x WEIGHT: 6.3 =	SCORE: 6.3
	Maintainable surfaces in good condition; good alignment and appearance		
COMMENTS:	No data		
COMPONENT:	Doors & Hardware	RATING: 1 x WEIGHT: 6.3 =	SCORE: 6.3
	Appropriate hardware, closers, panic devices; in good working order		
COMMENTS:	No data

Service Systems			
COMPONENT:	Elevators	RATING: 1 x WEIGHT: 6.3 =	SCORE: 6.3
	Appropriate and functional for occupancy and use		
COMMENTS:	No data		
COMPONENT:	Plumbing	RATING: 1 x WEIGHT: 8.4 =	SCORE: 8.4
	Fixtures and piping appear to be in good condition; no evidence of leaks		
COMMENTS:	No data		
COMPONENT:	HVAC	RATING: 1 x WEIGHT: 8.4 =	SCORE: 8.4
	Equipment in good condition; easily controlled; serves all required spaces; All necessary spaces are adequately ventilated; A/C provided throughout		
COMMENTS:	No data		
COMPONENT:	Electrical	RATING: 1 x WEIGHT: 8.4 =	SCORE: 8.4
	Adequate service and distribution capacity for current/future needs		
COMMENTS:	No data		
COMPONENT:	Lights/Power	RATING: 1 x WEIGHT: 8.4 =	SCORE: 8.4
	Contemporary lighting with good work area illumination; ample outlets		
COMMENTS:	No data

Safety Systems			
COMPONENT:	Life/Safety	RATING: 1 x WEIGHT: 10.5 =	SCORE: 10.5
	Appears to meet current codes		
COMMENTS:	No data		
COMPONENT:	Fire Safety	RATING: 1 x WEIGHT: 10.5 =	SCORE: 10.5
	Locally monitored detection; alarm and strobes present; sprinklers in high hazard areas		
COMMENTS:	No data		
COMPONENT:	Modifications	RATING: 0 x WEIGHT: 0 =	SCORE: 0
	No data		
COMMENTS:	No data

Quality Standards			
COMPONENT:	Maintenance	RATING: 1 x WEIGHT: 7.4 =	SCORE: 7.4
	Facility appears well maintained		
COMMENTS:	No data		
COMPONENT:	Remaining Life	RATING: 1 x WEIGHT: 6.3 =	SCORE: 6.3
	Life expectancy is >20 years; minor system deterioration		
COMMENTS:	No data		
COMPONENT:	Appearance	RATING: 1 x WEIGHT: 6.3 =	SCORE: 6.3
	Well-constructed building; generally attractive interior and exterior		
COMMENTS:	No data

CONDITION: Superior
