2023 FACILITY CONDITION SURVEY

Seattle Central College

SURVEY CONDUCTED BY:
Steve Lewandowski
State Board for Community
and Technical Colleges

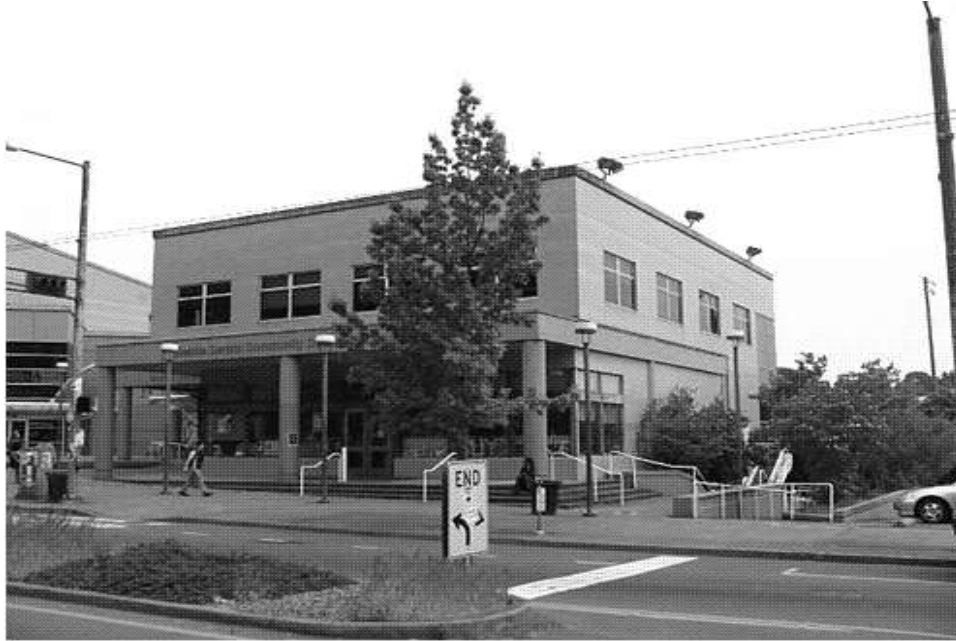
Bookstore (062-BS)	STATE UFI: A01833	Main Campus (062A)
AREA: 14,765 SF	BUILT: 1994	REMODELED: No
CONSTRUCTION TYPE: Heavy	CRV/SF: \$395	REPLACEMENT VALUE: \$5,832,175
PREDOMINANT USE: Student Center

Primary Systems			
COMPONENT:	Structure	RATING: 1 x WEIGHT: 8 =	SCORE: 8
No signs of settlement or cracking, no abrupt vertical changes Columns, bearing walls and roof structure appears sound/free of defects			
COMMENTS:	Concrete structure		
COMPONENT:	Exterior Closure	RATING: 2 x WEIGHT: 8 =	SCORE: 16
Weatherproof exterior, but finish appears poorly maintained			
COMMENTS:	Concrete; ceramic tile		
COMPONENT:	Roofing	RATING: 4 x WEIGHT: 10 =	SCORE: 40
General deterioration and some leaks are evident; reconditioning or partial repair is needed			
COMMENTS:	Hypalon single-ply; BUR with mineral-surfaced capsheet

Secondary Systems			
COMPONENT:	Floor Finishes	RATING: 1 x WEIGHT: 6 =	SCORE: 6
	Nice appearance, smooth transitions, level subfloors, no cracks/separating		
COMMENTS:	Linoleum-surface wear/stains; concrete; carpet-worn; ceramic tile		
COMPONENT:	Wall Finishes	RATING: 2 x WEIGHT: 6 =	SCORE: 12
	Maintainable surfaces, minor maintenance is required in some areas		
COMMENTS:	Gypsum board-marred/dinged; ceramic tile		
COMPONENT:	Ceiling Finishes	RATING: 2 x WEIGHT: 6 =	SCORE: 12
	Aging surfaces in fair condition and good alignment		
COMMENTS:	Lay-in tile; exposed concrete deck		
COMPONENT:	Doors & Hardware	RATING: 3 x WEIGHT: 6 =	SCORE: 18
	Functional, but dated; some maintenance required		
COMMENTS:	Interior wood doors w HM frames-surface wear; exterior aluminum/wood doors/frames

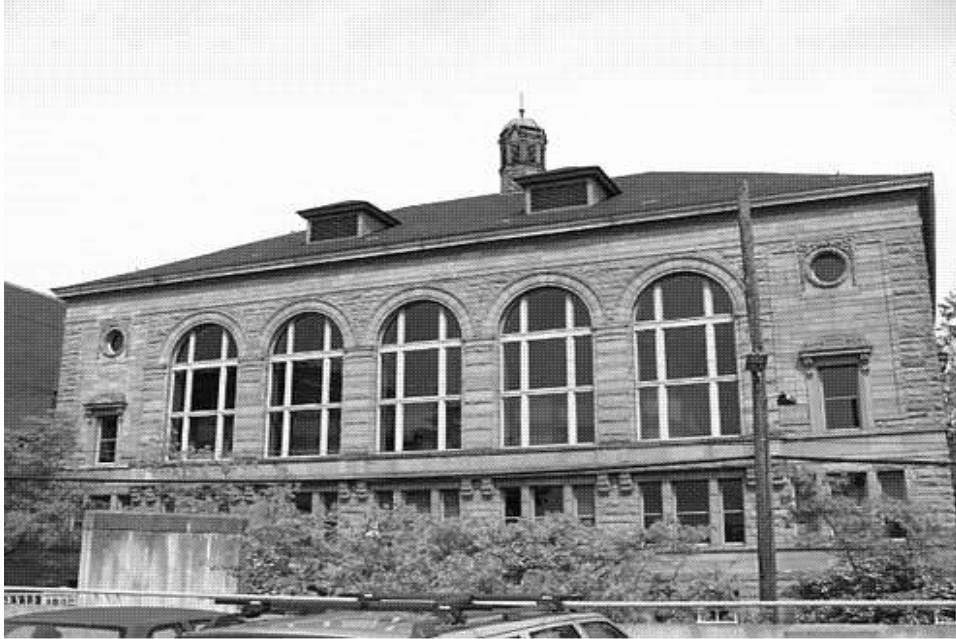
Broadway Performance Hall (062-BPH) STATE UFI: A02918 Main Campus (062A)
 AREA: 38,043 SF BUILT: 1977 REMODELED: No PREDOMINANT USE: Performing Arts
 CONSTRUCTION TYPE: Heavy CRV/SF: \$421 REPLACEMENT VALUE: \$16,016,103

Primary Systems			
COMPONENT:	Structure	RATING: 1 x WEIGHT: 8 =	SCORE: 8
No signs of settlement or cracking, no abrupt vertical changes Columns, bearing walls and roof structure appears sound/free of defects			
COMMENTS:	Structural steel frame; heavy timber roof trusses		
COMPONENT:	Exterior Closure	RATING: 2 x WEIGHT: 8 =	SCORE: 16
Weatherproof exterior, but finish appears poorly maintained			
COMMENTS:	Historic "Wilkerson Sandstone" (not sealed)		
COMPONENT:	Roofing	RATING: 2 x WEIGHT: 10 =	SCORE: 20
Majority of roofing and flashing appear sound, but a small portion of roofing shows deterioration where maintenance or minor repair needed			
COMMENTS:	Composition 3-tab shingles-2003

Secondary Systems			
COMPONENT:	Floor Finishes	RATING: 3 x WEIGHT: 6 =	SCORE: 18
Some physical wear and minor imperfections are evident; beginning deterioration			
COMMENTS:	Wood parquet and strip flooring; carpet-stained; ceramic tile; concrete; linoleum; Vinyl tile-surface wear		
COMPONENT:	Wall Finishes	RATING: 3 x WEIGHT: 6 =	SCORE: 18
Aging surfaces, but sound; some maintenance is required			
COMMENTS:	Gypsum board-marred/surface wear; ceramic tile; acoustical panels		
COMPONENT:	Ceiling Finishes	RATING: 3 x WEIGHT: 6 =	SCORE: 18
Some wear and tear; Minor damage, staining or deterioration			
COMMENTS:	Gypsum board; suspended wood-lattice panels; lay-in and direct-adhered tile		
COMPONENT:	Doors & Hardware	RATING: 3 x WEIGHT: 6 =	SCORE: 18
Functional, but dated; some maintenance required			
COMMENTS:	Interior wood/HM doors/frames; exterior wood doors/frames

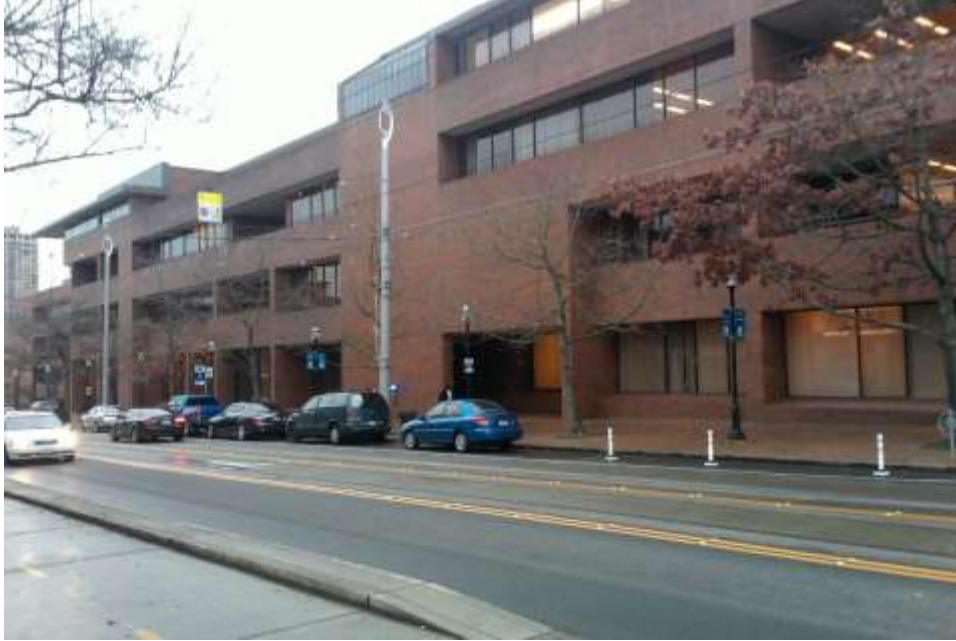
Broadway/Edison (062-BE) STATE UFI: A02501 Main Campus (062A)
AREA: 442,984 SF BUILT: 1973 REMODELED: 2010 PREDOMINANT USE: Multi-Use
CONSTRUCTION TYPE: Heavy CRV/SF: \$395 REPLACEMENT VALUE: \$17,497,868

Primary Systems			
COMPONENT:	Structure	RATING: 2 x WEIGHT: 8 =	SCORE: 16
Minor cracks evident in a small portion of the structure			
COMMENTS:	Partial concrete frame, partial heavy timber		
COMPONENT:	Exterior Closure	RATING: 4 x WEIGHT: 8 =	SCORE: 32
General deterioration detected, one or more minor leaks apparent			
COMMENTS:	Stucco-major renovation in 2010		
COMPONENT:	Roofing	RATING: 2 x WEIGHT: 10 =	SCORE: 20
Majority of roofing and flashing appear sound, but a small portion of roofing shows deterioration where maintenance or minor repair needed			
COMMENTS:	PVC single-ply membrane-2010

Secondary Systems			
COMPONENT:	Floor Finishes	RATING: 2 x WEIGHT: 6 =	SCORE: 12
Some wear is evident on finish; maintenance needed			
COMMENTS:	Brick; ceramic tile; carpet; vinyl tile; concrete, epoxy; linoleum; carpet tile		
COMPONENT:	Wall Finishes	RATING: 2 x WEIGHT: 6 =	SCORE: 12
Maintainable surfaces, minor maintenance is required in some areas			
COMMENTS:	Brick; ceramic tile; CMU; gypsum board; concrete		
COMPONENT:	Ceiling Finishes	RATING: 3 x WEIGHT: 6 =	SCORE: 18
Some wear and tear; Minor damage, staining or deterioration			
COMMENTS:	Lay-in tile; tectum panels; direct-adhered tile		
COMPONENT:	Doors & Hardware	RATING: 3 x WEIGHT: 6 =	SCORE: 18
Functional, but dated; some maintenance required			
COMMENTS:	Interior wood/HM doors/frames-surface wear throughout; exterior aluminum doors/frames

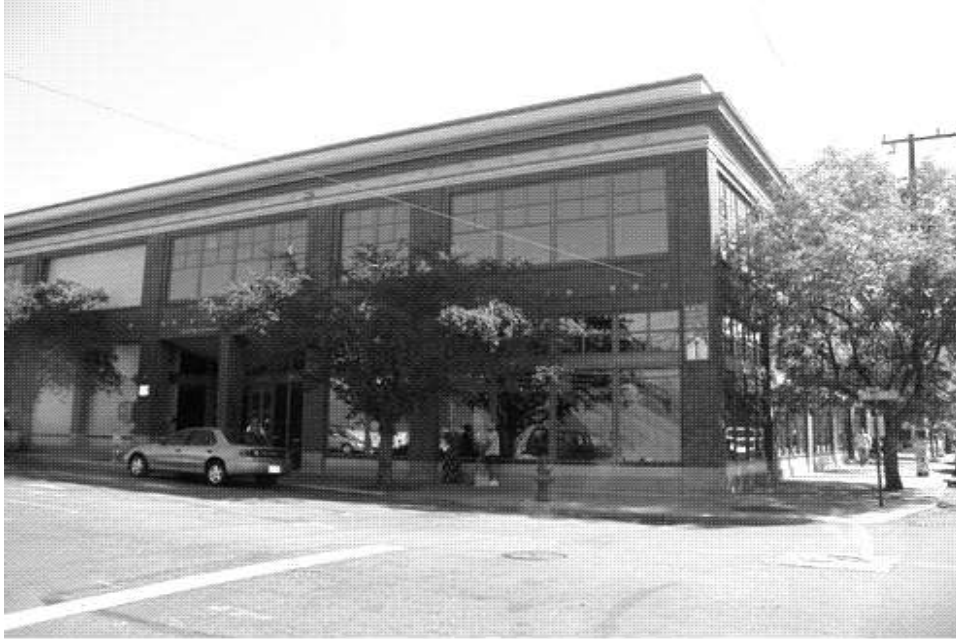
District Office (062-AS) STATE UFI: A00438 Main Campus (062A)
AREA: 47,668 SF BUILT: 1912 REMODELED: No PREDOMINANT USE: Administration
CONSTRUCTION TYPE: Heavy CRV/SF: \$336 REPLACEMENT VALUE: \$16,016,448

Primary Systems			
COMPONENT:	Structure	RATING: 1 x WEIGHT: 8 =	SCORE: 8
No signs of settlement or cracking, no abrupt vertical changes Columns, bearing walls and roof structure appears sound/free of defects			
COMMENTS:	Concrete; heavy timber; steel-frame; wood framing		
COMPONENT:	Exterior Closure	RATING: 2 x WEIGHT: 8 =	SCORE: 16
Weatherproof exterior, but finish appears poorly maintained			
COMMENTS:	Brick with concrete base; ceramic tile. Windows 2017		
COMPONENT:	Roofing	RATING: 2 x WEIGHT: 10 =	SCORE: 20
Majority of roofing and flashing appear sound, but a small portion of roofing shows deterioration where maintenance or minor repair needed			
COMMENTS:	Single-ply membrane 2017; Kalwall skylights

Secondary Systems			
COMPONENT:	Floor Finishes	RATING: 1 x WEIGHT: 6 =	SCORE: 6
	Nice appearance, smooth transitions, level subfloors, no cracks/separating		
COMMENTS:	Ceramic tile; vinyl tile;-surface wear; carpet-surface wear; 2x4 laminated		
COMPONENT:	Wall Finishes	RATING: 2 x WEIGHT: 6 =	SCORE: 12
	Maintainable surfaces, minor maintenance is required in some areas		
COMMENTS:	Gypsum board-marred/dinged; brick; ceramic tile		
COMPONENT:	Ceiling Finishes	RATING: 3 x WEIGHT: 6 =	SCORE: 18
	Some wear and tear; Minor damage, staining or deterioration		
COMMENTS:	Gypsum board; exposed horizontal wood studs; lay-in tile-stained		
COMPONENT:	Doors & Hardware	RATING: 2 x WEIGHT: 6 =	SCORE: 12
	Fairly modern door surfaces and hardware with minor deterioration; good working order		
COMMENTS:	Interior wood doors w HM frames; exterior HM doors/frames

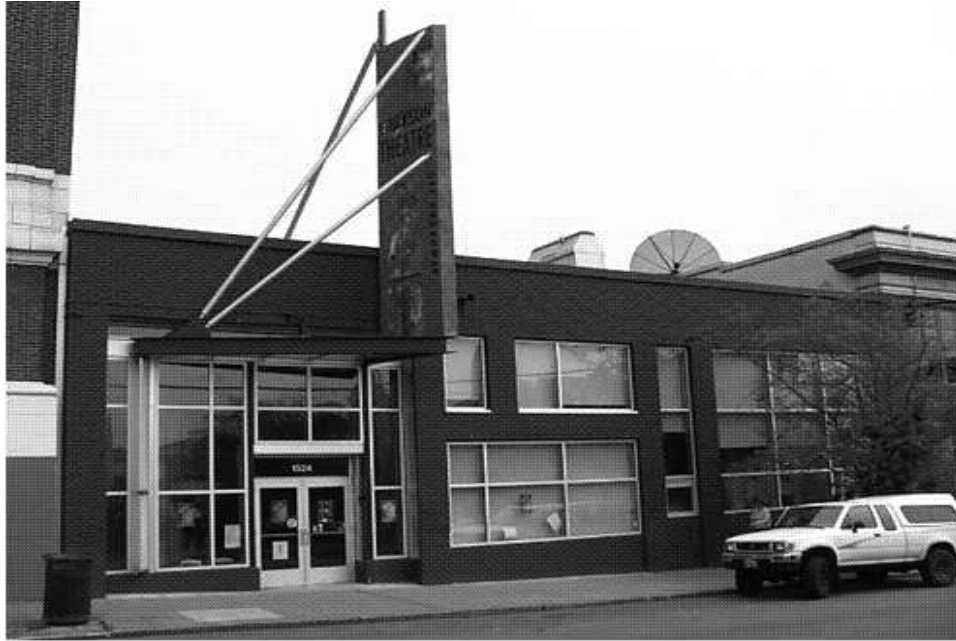
Erickson Theater (062-ET) STATE UFI: A09728 Main Campus (062A)
AREA: 11,500 SF BUILT: 1981 REMODELED: 2005 PREDOMINANT USE: Performing Arts
CONSTRUCTION TYPE: Medium CRV/SF: \$421 REPLACEMENT VALUE: \$4,841,500

Primary Systems			
COMPONENT:	Structure	RATING: 1 x WEIGHT: 8.3 = SCORE: 8.3	
No signs of settlement or cracking, no abrupt vertical changes Columns, bearing walls and roof structure appears sound/free of defects			
COMMENTS:	Wood frame; heavy timber trusses and beams; steel columns; seismic improvements done		
COMPONENT:	Exterior Closure	RATING: 2 x WEIGHT: 8.3 = SCORE: 16.7	
Weatherproof exterior, but finish appears poorly maintained			
COMMENTS:	Brick; concrete; glass block; CMU		
COMPONENT:	Roofing	RATING: 3 x WEIGHT: 10.4 = SCORE: 31.3	
Some deterioration is evident in membrane and flashings; maintenance or minor repair is needed			
COMMENTS:	BUR with mineral-surfaced cap sheet

Secondary Systems			
COMPONENT:	Floor Finishes	RATING: 2 x WEIGHT: 6.3 = SCORE: 12.5	
	Some wear is evident on finish; maintenance needed		
COMMENTS:	Concrete; carpet; rubber stage floor		
COMPONENT:	Wall Finishes	RATING: 1 x WEIGHT: 6.3 = SCORE: 6.3	
	Maintainable surfaces in good condition		
COMMENTS:	Gypsum board; corrugated plastic panels; painted concrete; CMU		
COMPONENT:	Ceiling Finishes	RATING: 2 x WEIGHT: 6.3 = SCORE: 12.5	
	Aging surfaces in fair condition and good alignment		
COMMENTS:	Gypsum board; exposed structure; suspended corrugated plastic panels (Kalwall)		
COMPONENT:	Doors & Hardware	RATING: 2 x WEIGHT: 6.3 = SCORE: 12.5	
	Fairly modern door surfaces and hardware with minor deterioration; good working order		
COMMENTS:	Interior wood/HM doors w HM frames; exterior aluminum doors/frames; metal coiling door

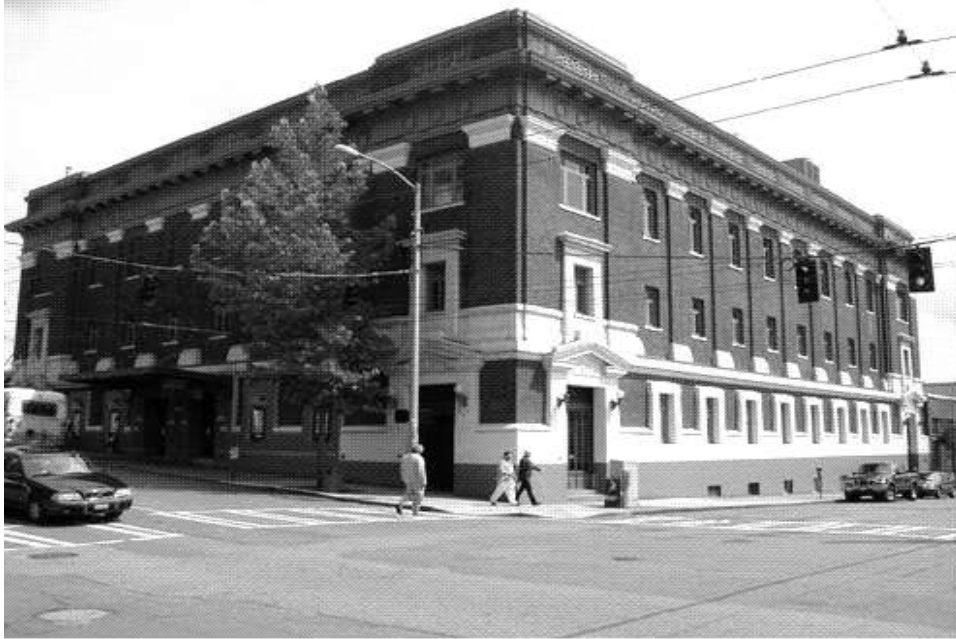
Fine Arts Building (062-FA) STATE UFI: A07769 Main Campus (062A)
AREA: 64,820 SF BUILT: 1915 REMODELED: 1992 PREDOMINANT USE: Visual Arts
CONSTRUCTION TYPE: Heavy CRV/SF: \$421 REPLACEMENT VALUE: \$27,289,220

Primary Systems			
COMPONENT:	Structure	RATING: 2 x WEIGHT: 8 =	SCORE: 16
Minor cracks evident in a small portion of the structure			
COMMENTS:	Concrete structure		
COMPONENT:	Exterior Closure	RATING: 2 x WEIGHT: 8 =	SCORE: 16
Weatherproof exterior, but finish appears poorly maintained			
COMMENTS:	Brick; sheet metal coping & frieze; concrete block		
COMPONENT:	Roofing	RATING: 2 x WEIGHT: 10 =	SCORE: 20
Majority of roofing and flashing appear sound, but a small portion of roofing shows deterioration where maintenance or minor repair needed			
COMMENTS:	BUR with mineral-surfaced capsheet; standing seam metal

Secondary Systems			
COMPONENT:	Floor Finishes	RATING: 3 x WEIGHT: 6 = SCORE: 18	
	Some physical wear and minor imperfections are evident; beginning deterioration		
COMMENTS:	Terrazzo; linoleum; hardwood; vinyl tile-surface wear; ceramic tile; carpet-surface wear; concrete		
COMPONENT:	Wall Finishes	RATING: 3 x WEIGHT: 6 = SCORE: 18	
	Aging surfaces, but sound; some maintenance is required		
COMMENTS:	Plaster-spalling area at entry; gypsum board-marred/dinged; marble wainscot		
COMPONENT:	Ceiling Finishes	RATING: 1 x WEIGHT: 6 = SCORE: 6	
	Maintainable surfaces in good condition; good alignment and appearance		
COMMENTS:	Plaster; gypsum board; wood trim; lay-in tile; concrete deck; suspended expanded metal lath		
COMPONENT:	Doors & Hardware	RATING: 3 x WEIGHT: 6 = SCORE: 18	
	Functional, but dated; some maintenance required		
COMMENTS:	Interior laminated/HM/wood doors w wood/HM frames-surface wear; sidelites; exterior wood doors/frames-surface wear

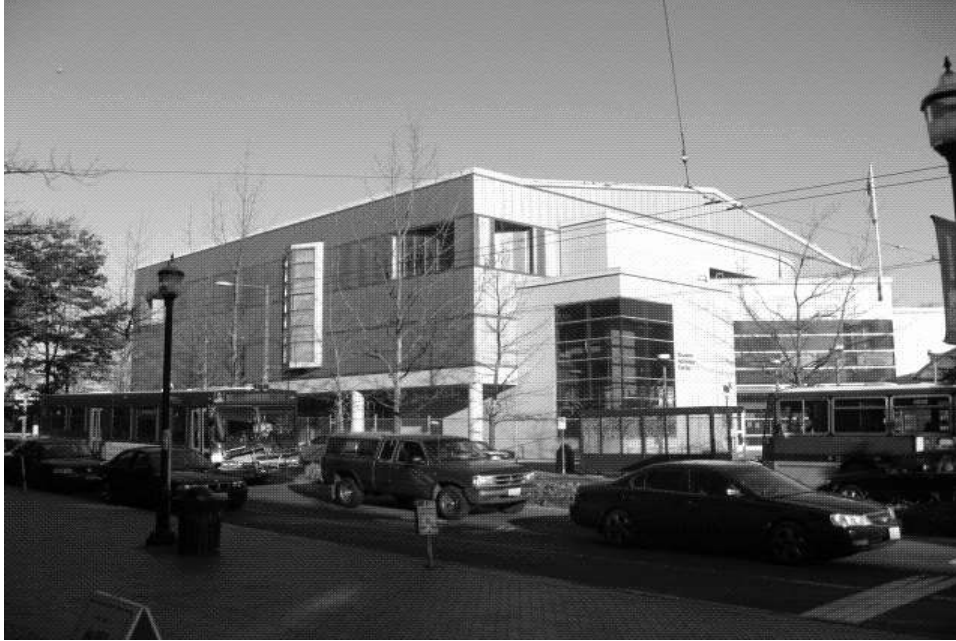
Mitchell Activity Center (062-MAC) STATE UFI: A06198 Main Campus (062A)
AREA: 78,600 SF BUILT: 1994 REMODELED: No PREDOMINANT USE: Gymnasium
CONSTRUCTION TYPE: Heavy CRV/SF: \$349 REPLACEMENT VALUE: \$27,431,400

Primary Systems			
COMPONENT:	Structure	RATING: 2 x WEIGHT: 8.4 = SCORE: 16.8	
	Minor cracks evident in a small portion of the structure		
COMMENTS:	Concrete; steel frame		
COMPONENT:	Exterior Closure	RATING: 2 x WEIGHT: 8.4 = SCORE: 16.8	
	Weatherproof exterior, but finish appears poorly maintained		
COMMENTS:	Concrete; corrugated metal panels		
COMPONENT:	Roofing	RATING: 2 x WEIGHT: 10.5 = SCORE: 21	
	Majority of roofing and flashing appear sound, but a small portion of roofing shows deterioration where maintenance or minor repair needed		
COMMENTS:	BUR with mineral-surfaced capsheet; standing seam metal

Secondary Systems			
COMPONENT:	Floor Finishes	RATING: 2 x WEIGHT: 6.3 =	SCORE: 12.6
Some wear is evident on finish; maintenance needed			
COMMENTS:	Carpet-surface wear/stains; sheet vinyl; concrete; ceramic tile; hardwood; Rhino liner		
COMPONENT:	Wall Finishes	RATING: 2 x WEIGHT: 6.3 =	SCORE: 12.6
Maintainable surfaces, minor maintenance is required in some areas			
COMMENTS:	Concrete; gypsum board		
COMPONENT:	Ceiling Finishes	RATING: 2 x WEIGHT: 6.3 =	SCORE: 12.6
Aging surfaces in fair condition and good alignment			
COMMENTS:	Concrete deck pan; wood lattice panels; lay-in tile; gypsum board		
COMPONENT:	Doors & Hardware	RATING: 3 x WEIGHT: 6.3 =	SCORE: 18.9
Functional, but dated; some maintenance required			
COMMENTS:	Interior wood doors w HM frames-surface wear; sidelites; exterior aluminum doors/frames

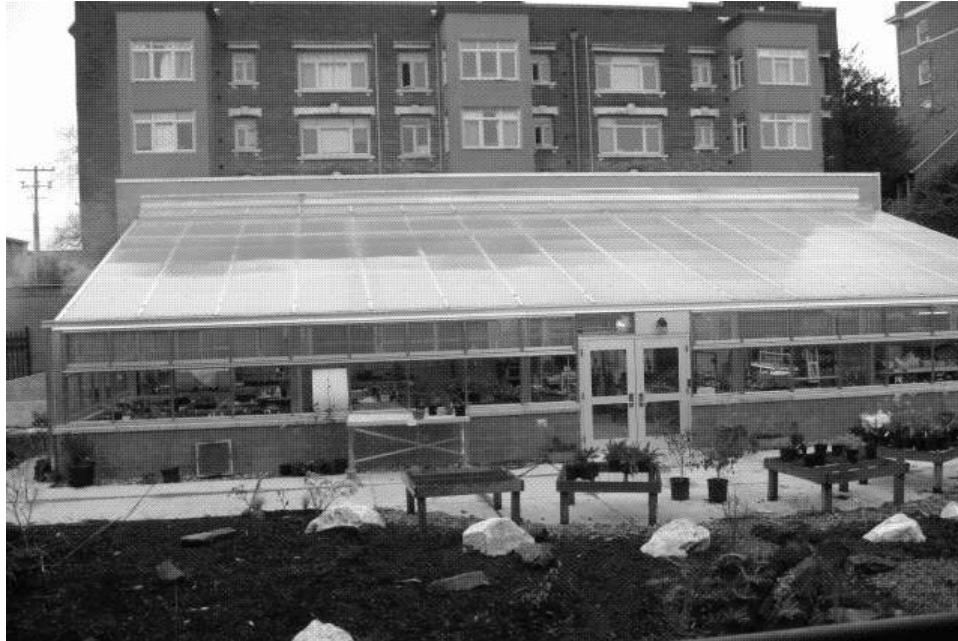
Plant Sciences Lab (062-PSL) STATE UFI: A10698 Main Campus (062A)
 AREA: 1,827 SF BUILT: 2010 REMODELED: No PREDOMINANT USE: Greenhouse
 CONSTRUCTION TYPE: Medium CRV/SF: \$494 REPLACEMENT VALUE: \$902,538

Primary Systems			
COMPONENT:	Structure	RATING: 1 x WEIGHT: 8.8 = SCORE: 8.8	
No signs of settlement or cracking, no abrupt vertical changes Columns, bearing walls and roof structure appears sound/free of defects			
COMMENTS:	Aluminum frame; CMU		
COMPONENT:	Exterior Closure	RATING: 2 x WEIGHT: 8.8 = SCORE: 17.6	
Weatherproof exterior, but finish appears poorly maintained			
COMMENTS:	Glass panels; CMU		
COMPONENT:	Roofing	RATING: 1 x WEIGHT: 11 = SCORE: 11	
Flashing and penetrations appear sound and membrane appears water- tight; drainage is positive and there are overflow scuppers			
COMMENTS:	Polycarbonate panels

Secondary Systems			
COMPONENT:	Floor Finishes	RATING: 1 x WEIGHT: 6.6 =	SCORE: 6.6
Nice appearance, smooth transitions, level subfloors, no cracks/separating			
COMMENTS:	Concrete		
COMPONENT:	Wall Finishes	RATING: 1 x WEIGHT: 6.6 =	SCORE: 6.6
Maintainable surfaces in good condition			
COMMENTS:	Concrete; CMU; glass panels; plastic panels; plywood; polycarbonate panels		
COMPONENT:	Ceiling Finishes	RATING: 1 x WEIGHT: 6.6 =	SCORE: 6.6
Maintainable surfaces in good condition; good alignment and appearance			
COMMENTS:	Polycarbonate panels; gypsum board; mesh curtains		
COMPONENT:	Doors & Hardware	RATING: 1 x WEIGHT: 6.6 =	SCORE: 6.6
Appropriate hardware, closers, panic devices; in good working order			
COMMENTS:	Interior HM doors/frames; exterior aluminum doors/frames

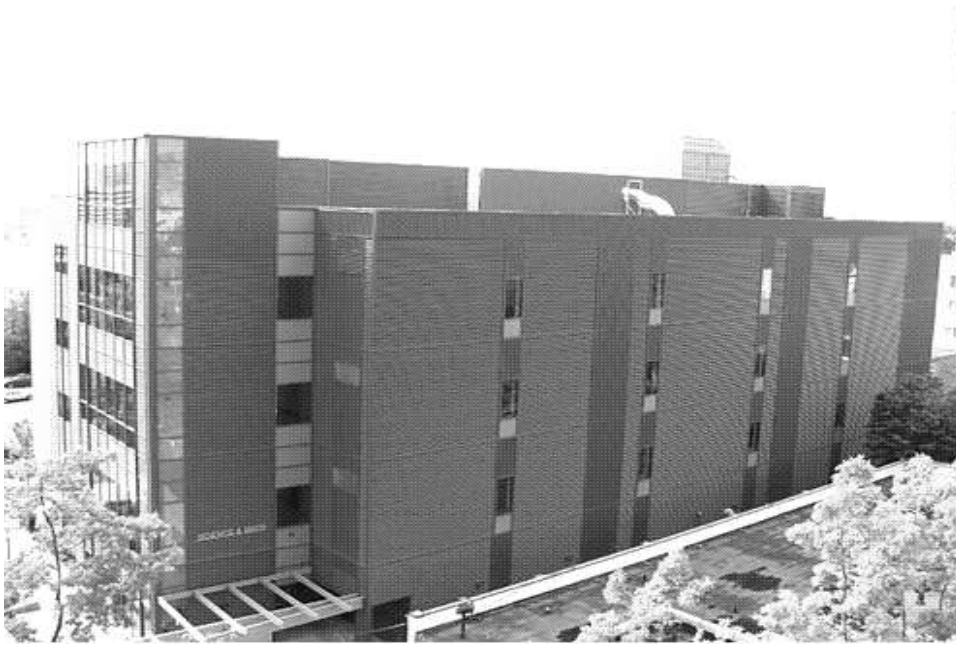
Science And Math (062-SAM) STATE UFI: A03954 Main Campus (062A)
AREA: 84,300 SF BUILT: 2006 REMODELED: No PREDOMINANT USE: Science Lab.
CONSTRUCTION TYPE: Heavy CRV/SF: \$489 REPLACEMENT VALUE: \$41,222,700

Primary Systems			
COMPONENT:	Structure	RATING: 1 x WEIGHT: 8 =	SCORE: 8
No signs of settlement or cracking, no abrupt vertical changes Columns, bearing walls and roof structure appears sound/free of defects			
COMMENTS:	Steel frame		
COMPONENT:	Exterior Closure	RATING: 1 x WEIGHT: 8 =	SCORE: 8
Weatherproof, tight, well-maintained exterior walls, doors, windows/finishes			
COMMENTS:	Brick; corrugated and flat metal panels		
COMPONENT:	Roofing	RATING: 2 x WEIGHT: 10 =	SCORE: 20
Majority of roofing and flashing appear sound, but a small portion of roofing shows deterioration where maintenance or minor repair needed			
COMMENTS:	BUR membrane with aluminum UV coating

Secondary Systems			
COMPONENT:	Floor Finishes	RATING: 2 x WEIGHT: 6 =	SCORE: 12
Some wear is evident on finish; maintenance needed			
COMMENTS:	Linoleum; ceramic tile; concrete; vinyl tile-surface wear; carpet-surface wear		
COMPONENT:	Wall Finishes	RATING: 3 x WEIGHT: 6 =	SCORE: 18
Aging surfaces, but sound; some maintenance is required			
COMMENTS:	Gypsum board-marred/dinged; ceramic tile		
COMPONENT:	Ceiling Finishes	RATING: 1 x WEIGHT: 6 =	SCORE: 6
Maintainable surfaces in good condition; good alignment and appearance			
COMMENTS:	Lay-in tile; gypsum board		
COMPONENT:	Doors & Hardware	RATING: 1 x WEIGHT: 6 =	SCORE: 6
Appropriate hardware, closers, panic devices; in good working order			
COMMENTS:	Interior wood/HM doors w HM frames; exterior aluminum doors/frames

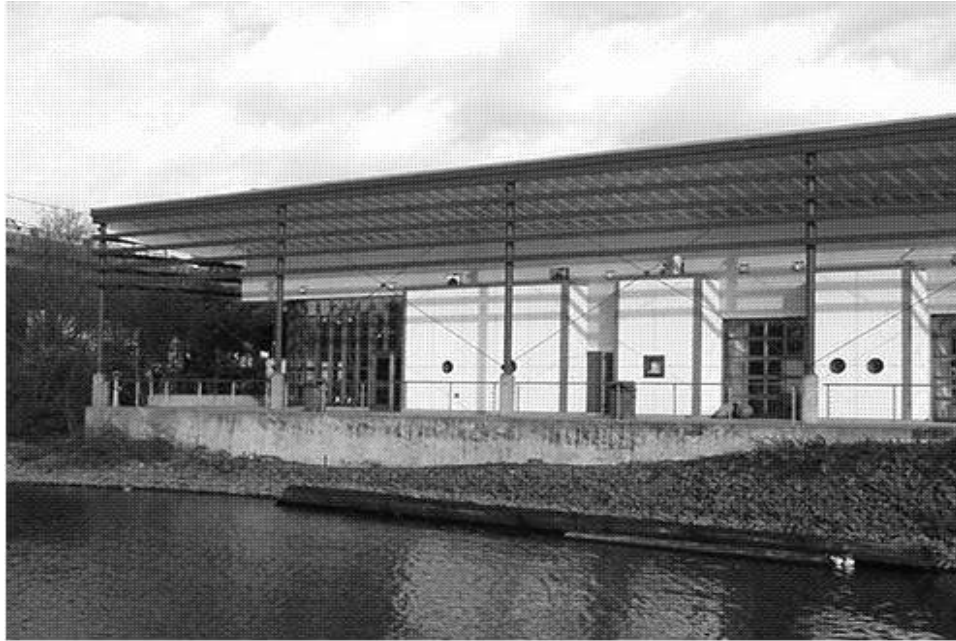
Marine Tech (062-SMAC) STATE UFI: A02017 Trident Campus (062C)
AREA: 7,560 SF BUILT: 1987 REMODELED: No PREDOMINANT USE: Vocational Arts
CONSTRUCTION TYPE: Medium CRV/SF: \$395 REPLACEMENT VALUE: \$2,986,200

Primary Systems			
COMPONENT:	Structure	RATING: 1 x WEIGHT: 8.8 =	SCORE: 8.8
No signs of settlement or cracking, no abrupt vertical changes Columns, bearing walls and roof structure appears sound/free of defects			
COMMENTS:	Wood frame; CMU		
COMPONENT:	Exterior Closure	RATING: 4 x WEIGHT: 8.8 =	SCORE: 35.1
General deterioration detected, one or more minor leaks apparent			
COMMENTS:	Plywood and metal corrugated panels; glass window walls		
COMPONENT:	Roofing	RATING: 2 x WEIGHT: 11 =	SCORE: 22
Majority of roofing and flashing appear sound, but a small portion of roofing shows deterioration where maintenance or minor repair needed			
COMMENTS:	Metal screw-down roof panels-rusting/popping of screws; needs PVC overlay

Secondary Systems			
COMPONENT:	Floor Finishes	RATING: 4 x WEIGHT: 6.6 =	SCORE: 26.3
General deterioration evident; one-third to one-half of flooring exhibits extensive deterioration			
COMMENTS:	Concrete and vinyl tile-surface wear		
COMPONENT:	Wall Finishes	RATING: 4 x WEIGHT: 6.6 =	SCORE: 26.3
Aging surfaces generally require maintenance; some areas require repair			
COMMENTS:	Gypsum board-marred; plywood		
COMPONENT:	Ceiling Finishes	RATING: 2 x WEIGHT: 6.6 =	SCORE: 13.2
Aging surfaces in fair condition and good alignment			
COMMENTS:	Exposed roof structure; gypsum board		
COMPONENT:	Doors & Hardware	RATING: 4 x WEIGHT: 6.6 =	SCORE: 26.3
General deterioration evident in both door and hardware; some doors with significant deterioration			
COMMENTS:	Wood glazed doors w HM frames-surface wear; wood glazed OH doors

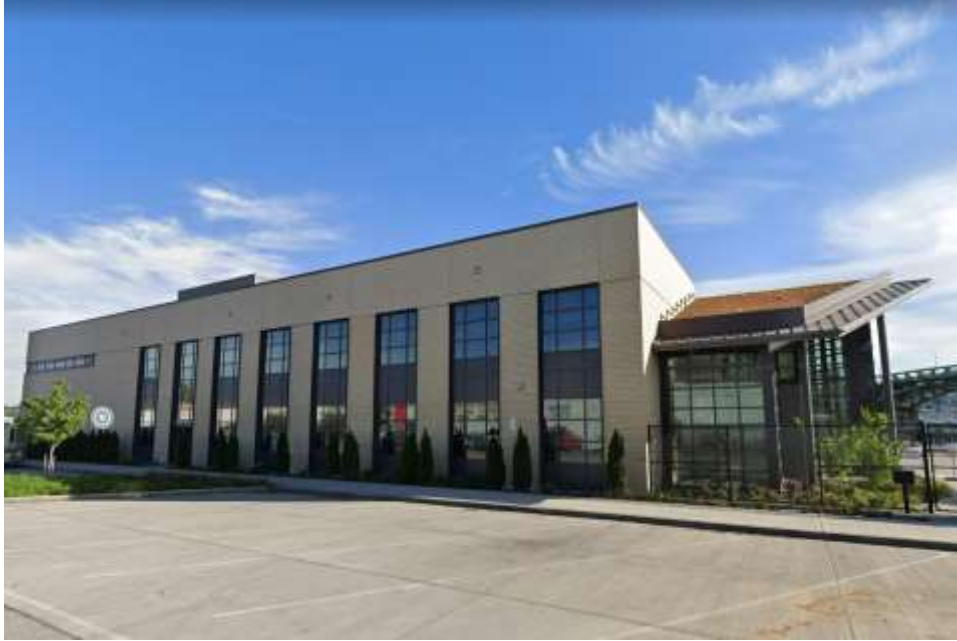
New Maritime Building (062-MT1) STATE UFI: A25602 Trident Campus (062C)
AREA: 22,451 SF BUILT: 2016 REMODELED: No PREDOMINANT USE: Classroom
CONSTRUCTION TYPE: No data CRV/SF: \$356 REPLACEMENT VALUE: \$7,992,556

Primary Systems			
COMPONENT:	Structure	RATING: 1 x WEIGHT: 8.4 = SCORE: 8.4	
No signs of settlement or cracking, no abrupt vertical changes Columns, bearing walls and roof structure appears sound/free of defects			
COMMENTS:	No data		
COMPONENT:	Exterior Closure	RATING: 1 x WEIGHT: 8.4 = SCORE: 8.4	
Weatherproof, tight, well-maintained exterior walls, doors, windows/finishes			
COMMENTS:	No data		
COMPONENT:	Roofing	RATING: 1 x WEIGHT: 10.5 = SCORE: 10.5	
Flashing and penetrations appear sound and membrane appears water- tight; drainage is positive and there are overflow scuppers			
COMMENTS:	No data

Secondary Systems			
COMPONENT:	Floor Finishes	RATING: 1 x WEIGHT: 6.3 =	SCORE: 6.3
	Nice appearance, smooth transitions, level subfloors, no cracks/separating		
COMMENTS:	No data		
COMPONENT:	Wall Finishes	RATING: 1 x WEIGHT: 6.3 =	SCORE: 6.3
	Maintainable surfaces in good condition		
COMMENTS:	No data		
COMPONENT:	Ceiling Finishes	RATING: 1 x WEIGHT: 6.3 =	SCORE: 6.3
	Maintainable surfaces in good condition; good alignment and appearance		
COMMENTS:	No data		
COMPONENT:	Doors & Hardware	RATING: 1 x WEIGHT: 6.3 =	SCORE: 6.3
	Appropriate hardware, closers, panic devices; in good working order		
COMMENTS:	No data

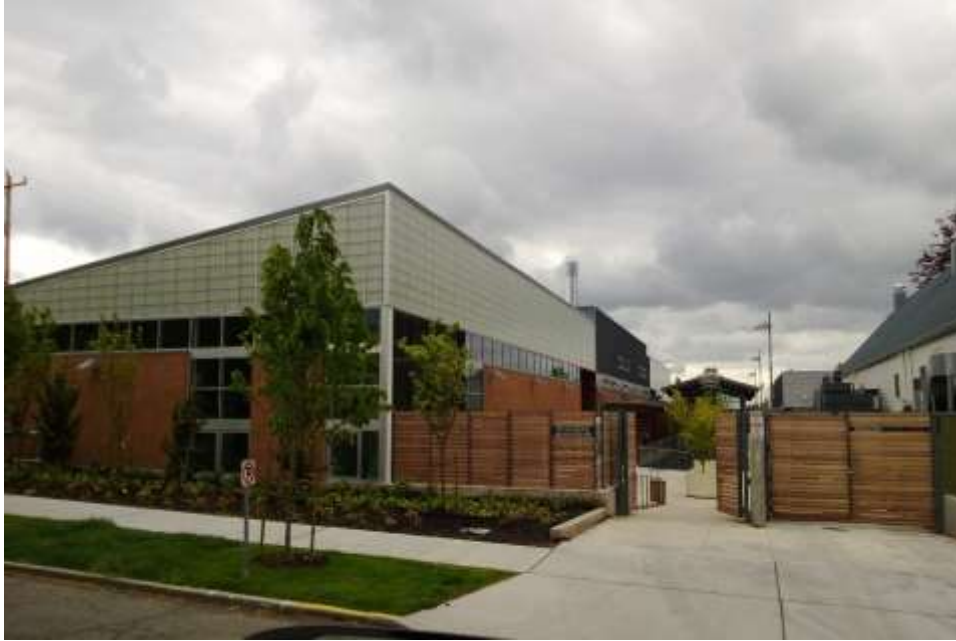
Wood Constr Center (062-WCC) STATE UFI: A10964 Wood Construction Campus (062B)
AREA: 61,050 SF BUILT: 2012 REMODELED: No PREDOMINANT USE: Vocational Arts
CONSTRUCTION TYPE: No data CRV/SF: \$375 REPLACEMENT VALUE: \$22,893,750

Primary Systems			
COMPONENT:	Structure	RATING: 1 x WEIGHT: 8.4 =	SCORE: 8.4
No signs of settlement or cracking, no abrupt vertical changes Columns, bearing walls and roof structure appears sound/free of defects			
COMMENTS:	No data		
COMPONENT:	Exterior Closure	RATING: 2 x WEIGHT: 8.4 =	SCORE: 16.8
Weatherproof exterior, but finish appears poorly maintained			
COMMENTS:	No data		
COMPONENT:	Roofing	RATING: 2 x WEIGHT: 10.5 =	SCORE: 21
Majority of roofing and flashing appear sound, but a small portion of roofing shows deterioration where maintenance or minor repair needed			
COMMENTS:	No data

Secondary Systems			
COMPONENT:	Floor Finishes	RATING: 1 x WEIGHT: 6.3 =	SCORE: 6.3
	Nice appearance, smooth transitions, level subfloors, no cracks/separating		
COMMENTS:	No data		
COMPONENT:	Wall Finishes	RATING: 2 x WEIGHT: 6.3 =	SCORE: 12.6
	Maintainable surfaces, minor maintenance is required in some areas		
COMMENTS:	No data		
COMPONENT:	Ceiling Finishes	RATING: 1 x WEIGHT: 6.3 =	SCORE: 6.3
	Maintainable surfaces in good condition; good alignment and appearance		
COMMENTS:	No data		
COMPONENT:	Doors & Hardware	RATING: 1 x WEIGHT: 6.3 =	SCORE: 6.3
	Appropriate hardware, closers, panic devices; in good working order		
COMMENTS:	No data

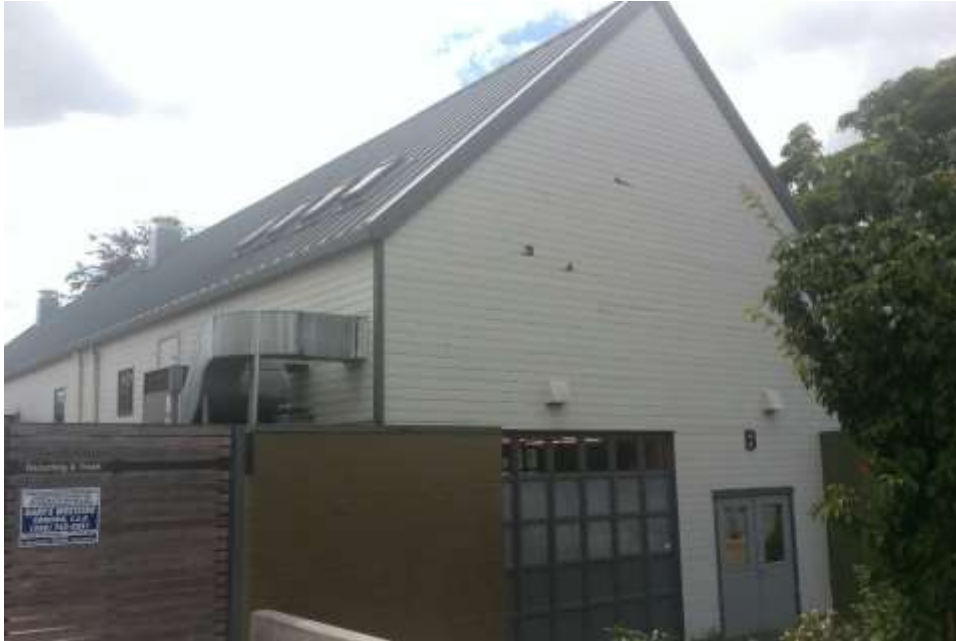
Wood Construct Cntr/Core (062-WCCC) STATE UFI: A08261 Wood Construction Campus (062B)
 AREA: 6,700 SF BUILT: 1990 REMODELED: No PREDOMINANT USE: Vocational Arts
 CONSTRUCTION TYPE: Medium CRV/SF: \$395 REPLACEMENT VALUE: \$2,646,500

Primary Systems			
COMPONENT:	Structure	RATING: 1 x WEIGHT: 8.8 = SCORE: 8.8	
No signs of settlement or cracking, no abrupt vertical changes Columns, bearing walls and roof structure appears sound/free of defects			
COMMENTS:			
COMPONENT:	Exterior Closure	RATING: 1 x WEIGHT: 8.8 = SCORE: 8.8	
Weatherproof, tight, well-maintained exterior walls, doors, windows/finishes			
COMMENTS:			
COMPONENT:	Roofing	RATING: 1 x WEIGHT: 11 = SCORE: 11	
Flashing and penetrations appear sound and membrane appears water- tight; drainage is positive and there are overflow scuppers			
COMMENTS: Metal roof 2022

Secondary Systems			
COMPONENT:	Floor Finishes	RATING: 2 x WEIGHT: 6.6 =	SCORE: 13.2
Some wear is evident on finish; maintenance needed			
COMMENTS:			
COMPONENT:	Wall Finishes	RATING: 2 x WEIGHT: 6.6 =	SCORE: 13.2
Maintainable surfaces, minor maintenance is required in some areas			
COMMENTS:			
COMPONENT:	Ceiling Finishes	RATING: 2 x WEIGHT: 6.6 =	SCORE: 13.2
Aging surfaces in fair condition and good alignment			
COMMENTS:			
COMPONENT:	Doors & Hardware	RATING: 2 x WEIGHT: 6.6 =	SCORE: 13.2
Fairly modern door surfaces and hardware with minor deterioration; good working order			
COMMENTS:

Service Systems			
COMPONENT:	Elevators	RATING: 0 x WEIGHT: 0 =	SCORE: 0
No data			
COMMENTS: none. 2nd floor areas can only be used for storage.			
COMPONENT:	Plumbing	RATING: 2 x WEIGHT: 8.8 =	SCORE: 17.6
Fixtures and piping are functional; finishes require maintenance			
COMMENTS:			
COMPONENT:	HVAC	RATING: 1 x WEIGHT: 8.8 =	SCORE: 8.8
Equipment in good condition; easily controlled; serves all required spaces; All necessary spaces are adequately ventilated; A/C provided throughout			
COMMENTS:			
COMPONENT:	Electrical	RATING: 1 x WEIGHT: 8.8 =	SCORE: 8.8
Adequate service and distribution capacity for current/future needs			
COMMENTS:			
COMPONENT:	Lights/Power	RATING: 1 x WEIGHT: 8.8 =	SCORE: 8.8
Contemporary lighting with good work area illumination; ample outlets			
COMMENTS:

Safety Systems			
COMPONENT:	Life/Safety	RATING: 1 x WEIGHT: 11 = SCORE: 11	
	Appears to meet current codes		
COMMENTS:			
COMPONENT:	Fire Safety	RATING: 1 x WEIGHT: 11 = SCORE: 11	
	Locally monitored detection; alarm and strobes present; sprinklers in high hazard areas		
COMMENTS:			
COMPONENT:	Modifications	RATING: 0 x WEIGHT: 0 = SCORE: 0	
	No data		
COMMENTS:

Quality Standards			
COMPONENT:	Maintenance	RATING: 2 x WEIGHT: 7.7 = SCORE: 15.4	
	Routine maintenance is required; impact is minor		
COMMENTS:			
COMPONENT:	Remaining Life	RATING: 1 x WEIGHT: 6.6 = SCORE: 6.6	
	Life expectancy is >20 years; minor system deterioration		
COMMENTS:			
COMPONENT:	Appearance	RATING: 3 x WEIGHT: 6.6 = SCORE: 19.8	
	Average construction; average interior and exterior appearance		
COMMENTS:	Somewhat attractive, matching adjacent building

CONDITION: Adequate
