2023 FACILITY CONDITION SURVEY

Shoreline Community College

SURVEY CONDUCTED BY:
Steve Lewandowski
State Board for Community
and Technical Colleges

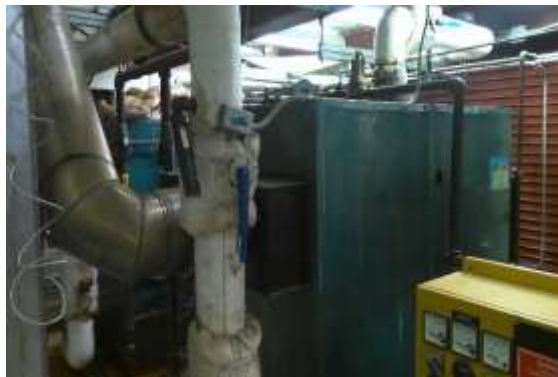
Deficiency F02

The galvanized cast iron and copper domestic water lines have degraded. There are several joints that leak. The flow is restricted due to congested pipes. The lower level has the greatest number of leaks and congestion. The water lines should be replaced on the lower floor.

Carryover from prior survey : No
Location : Main Campus (070A)
Building name : Foss (070-50)
Unique Facility Identifier (UFI) : A06886
Funding category in capital budget : Minor Works Facility appropriation
Unifomat category : D20-Plumbing
Assessment : Asset is near or at the end of its useful life and should be replaced
Quantity : 1
Unit of measurement : LS
Component : Domestic water line
Location within building or site : Multiple
Issue clarity : Adequate information was provided to assess deficiency
Main cause of asset degradation or failure : Age/Wear
Detailed description : The galvanized cast iron and copper domestic water lines have degraded. There are several joints that leak. The flow is restricted due to congested pipes. The lower level has the greatest number of leaks and congestion. The water lines should be replaced on the lower floor.
Recommended funding schedule : Immediate (scoring weight=4)

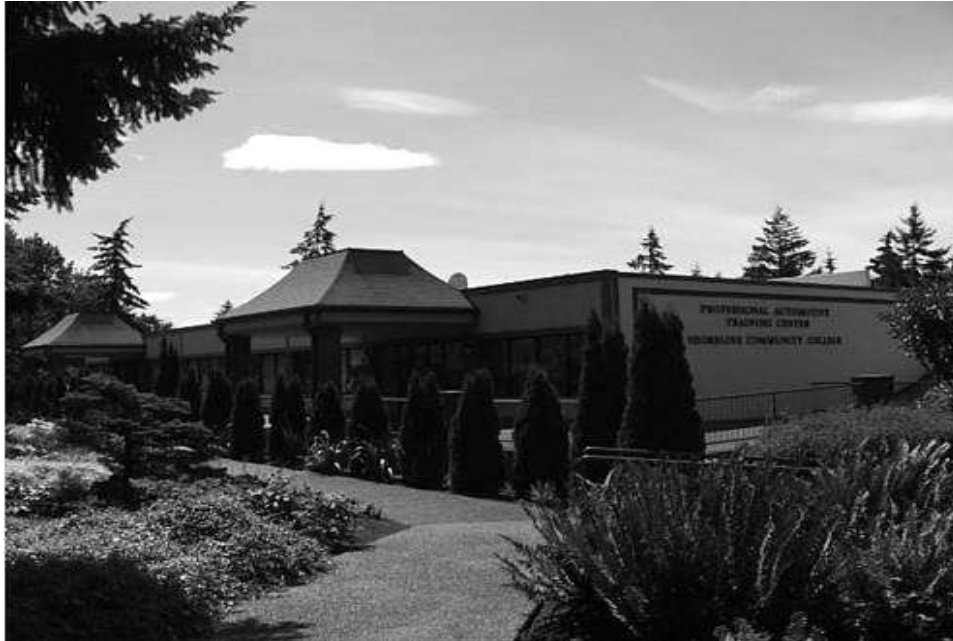
Automotive (070-21) STATE UFI: A00465 Main Campus (070A)
 AREA: 50,065 SF BUILT: 2009 REMODELED: No PREDOMINANT USE: Vocational Arts
 CONSTRUCTION TYPE: Medium CRV/SF: \$395 REPLACEMENT VALUE: \$19,775,675

Primary Systems			
COMPONENT:	Structure	RATING: 2 x WEIGHT: 8 =	SCORE: 16
Minor cracks evident in a small portion of the structure			
COMMENTS: Concrete tilt-up; wood trusses; steel beams & bar joists			
COMPONENT:	Exterior Closure	RATING: 1 x WEIGHT: 8 =	SCORE: 8
Weatherproof, tight, well-maintained exterior walls, doors, windows/finishes			
COMMENTS: Vertical wood siding; brick veneer over entry columns; concrete			
COMPONENT:	Roofing	RATING: 3 x WEIGHT: 10 =	SCORE: 30
Some deterioration is evident in membrane and flashings; maintenance or minor repair is needed			
COMMENTS: PVC single-ply membrane; BUR w/mineral-surfaced cap sheet; composition shingles on cupolas & sloped east roof

Secondary Systems			
COMPONENT:	Floor Finishes	RATING: 1 x WEIGHT: 6 = SCORE: 6	
	Nice appearance, smooth transitions, level subfloors, no cracks/separating		
COMMENTS:	Carpet; carpet tile; vinyl tiles; concrete		
COMPONENT:	Wall Finishes	RATING: 1 x WEIGHT: 6 = SCORE: 6	
	Maintainable surfaces in good condition		
COMMENTS:	Gypsum board; ceramic tile		
COMPONENT:	Ceiling Finishes	RATING: 1 x WEIGHT: 6 = SCORE: 6	
	Maintainable surfaces in good condition; good alignment and appearance		
COMMENTS:	Gypsum board; plywood; lay-in tile; metal deck pan		
COMPONENT:	Doors & Hardware	RATING: 2 x WEIGHT: 6 = SCORE: 12	
	Fairly modern door surfaces and hardware with minor deterioration; good working order		
COMMENTS:	Interior wood/HM doors w HM frames-surface wear; exterior aluminum doors/frames; OH metal doors; OH coiling doors

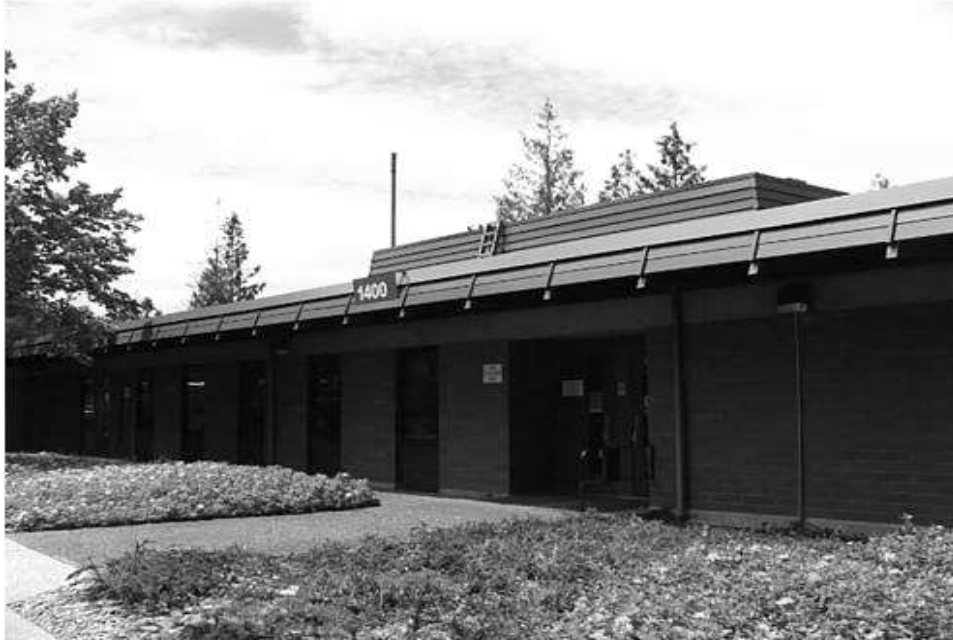
Ba-O-C (070-14) STATE UFI: A05916 Main Campus (070A)
 AREA: 6,144 SF BUILT: 1976 REMODELED: No PREDOMINANT USE: Computer Lab.
 CONSTRUCTION TYPE: Medium CRV/SF: \$376 REPLACEMENT VALUE: \$2,310,144

Primary Systems			
COMPONENT:	Structure	RATING: 1 x WEIGHT: 8.3 = SCORE: 8.3	
No signs of settlement or cracking, no abrupt vertical changes Columns, bearing walls and roof structure appears sound/free of defects			
COMMENTS:	Concrete; structural brick; glu-lam beams; steel columns		
COMPONENT:	Exterior Closure	RATING: 1 x WEIGHT: 8.3 = SCORE: 8.3	
Weatherproof, tight, well-maintained exterior walls, doors, windows/finishes			
COMMENTS:	Brick; aluminum fascia; aluminum siding on mechanical screens		
COMPONENT:	Roofing	RATING: 5 x WEIGHT: 10.4 = SCORE: 52.1	
Leaking and deterioration is to point where new roof is required			
COMMENTS:	Built-up roof w/aggregate ballast; ply deterioration; funded in 2013 to replace

Secondary Systems			
COMPONENT:	Floor Finishes	RATING: 3 x WEIGHT: 6.3 =	SCORE: 18.8
Some physical wear and minor imperfections are evident; beginning deterioration			
COMMENTS:	Carpet; vinyl tile; ceramic tile		
COMPONENT:	Wall Finishes	RATING: 3 x WEIGHT: 6.3 =	SCORE: 18.8
Aging surfaces, but sound; some maintenance is required			
COMMENTS:	Brick; gypsum board; ceramic tile; vinyl wall covering-seam separation		
COMPONENT:	Ceiling Finishes	RATING: 3 x WEIGHT: 6.3 =	SCORE: 18.8
Some wear and tear; Minor damage, staining or deterioration			
COMMENTS:	Direct-adhered tile; glu-lam beams		
COMPONENT:	Doors & Hardware	RATING: 1 x WEIGHT: 6.3 =	SCORE: 6.3
Appropriate hardware, closers, panic devices; in good working order			
COMMENTS:	Interior wood doors w HM frames; exterior HM doors/frames

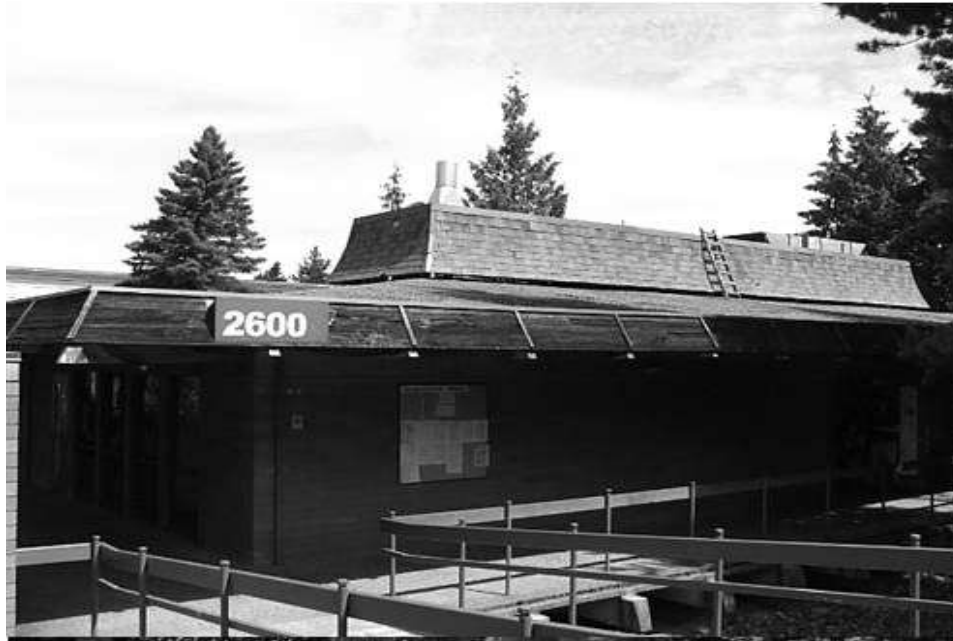
Biolab (070-26) STATE UFI: A06410 Main Campus (070A)
AREA: 5,820 SF BUILT: 1965 REMODELED: No PREDOMINANT USE: Science Lab.
CONSTRUCTION TYPE: Medium CRV/SF: \$489 REPLACEMENT VALUE: \$2,845,980

Primary Systems			
COMPONENT:	Structure	RATING: 3 x WEIGHT: 8.3 =	SCORE: 25
Some cracking evident but does not likely affect structural integrity; Visible defects apparent but are non-structural			
COMMENTS:	Concrete; structural brick; glu-lam beams; steel columns		
COMPONENT:	Exterior Closure	RATING: 3 x WEIGHT: 8.3 =	SCORE: 25
Sound and weatherproof but with some physical deterioration evident			
COMMENTS:	Brick; Hardie-board fascia; exposed wood beams; concrete asbestos tiles on mechanical screens		
COMPONENT:	Roofing	RATING: 3 x WEIGHT: 10.4 =	SCORE: 31.3
Some deterioration is evident in membrane and flashings; maintenance or minor repair is needed			
COMMENTS:	Gravel ballast BUR

Secondary Systems			
COMPONENT:	Floor Finishes	RATING: 3 x WEIGHT: 6.3 =	SCORE: 18.8
Some physical wear and minor imperfections are evident; beginning deterioration			
COMMENTS:	Vinyl asbestos tiles		
COMPONENT:	Wall Finishes	RATING: 2 x WEIGHT: 6.3 =	SCORE: 12.5
Maintainable surfaces, minor maintenance is required in some areas			
COMMENTS:	Gypsum board; brick		
COMPONENT:	Ceiling Finishes	RATING: 3 x WEIGHT: 6.3 =	SCORE: 18.8
Some wear and tear; Minor damage, staining or deterioration			
COMMENTS:	Direct-adhered tile; exposed glu-lam beams; lots of stained tiles		
COMPONENT:	Doors & Hardware	RATING: 3 x WEIGHT: 6.3 =	SCORE: 18.8
Functional, but dated; some maintenance required			
COMMENTS:	Interior and exterior wood doors w HM frames-surface wear

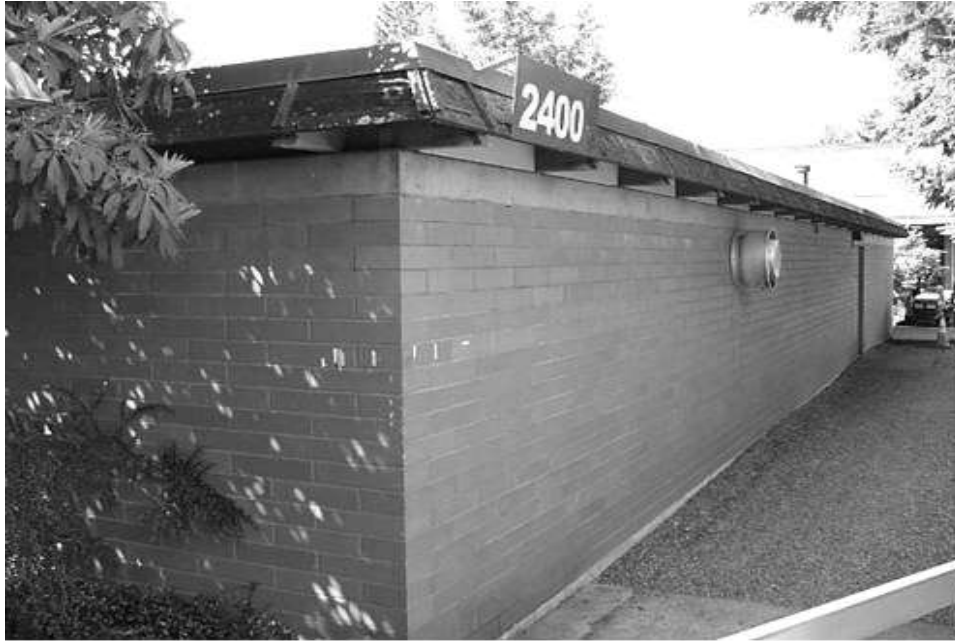
Biosup (070-24) STATE UFI: A04825 Main Campus (070A)
 AREA: 1,500 SF BUILT: 1965 REMODELED: No PREDOMINANT USE: Storage
 CONSTRUCTION TYPE: Medium CRV/SF: \$264 REPLACEMENT VALUE: \$396,000

Primary Systems			
COMPONENT:	Structure	RATING: 1 x WEIGHT: 8.3 = SCORE: 8.3	
No signs of settlement or cracking, no abrupt vertical changes Columns, bearing walls and roof structure appears sound/free of defects			
COMMENTS:	Concrete; structural brick; wood beams; metal framed greenhouse		
COMPONENT:	Exterior Closure	RATING: 3 x WEIGHT: 8.3 = SCORE: 25	
Sound and weatherproof but with some physical deterioration evident			
COMMENTS:	Brick; cedar fascia & soffits; exposed wood beams		
COMPONENT:	Roofing	RATING: 3 x WEIGHT: 10.4 = SCORE: 31.3	
Some deterioration is evident in membrane and flashings; maintenance or minor repair is needed			
COMMENTS:	Built-up roof w/gravel ballast

Secondary Systems			
COMPONENT:	Floor Finishes	RATING: 1 x WEIGHT: 6.3 = SCORE: 6.3	
	Nice appearance, smooth transitions, level subfloors, no cracks/separating		
COMMENTS:	Concrete		
COMPONENT:	Wall Finishes	RATING: 1 x WEIGHT: 6.3 = SCORE: 6.3	
	Maintainable surfaces in good condition		
COMMENTS:	Concrete; brick		
COMPONENT:	Ceiling Finishes	RATING: 3 x WEIGHT: 6.3 = SCORE: 18.8	
	Some wear and tear; Minor damage, staining or deterioration		
COMMENTS:	Gypsum board; exposed wood beams		
COMPONENT:	Doors & Hardware	RATING: 3 x WEIGHT: 6.3 = SCORE: 18.8	
	Functional, but dated; some maintenance required		
COMMENTS:	Exterior wood and HM doors w HM frames-surface wear

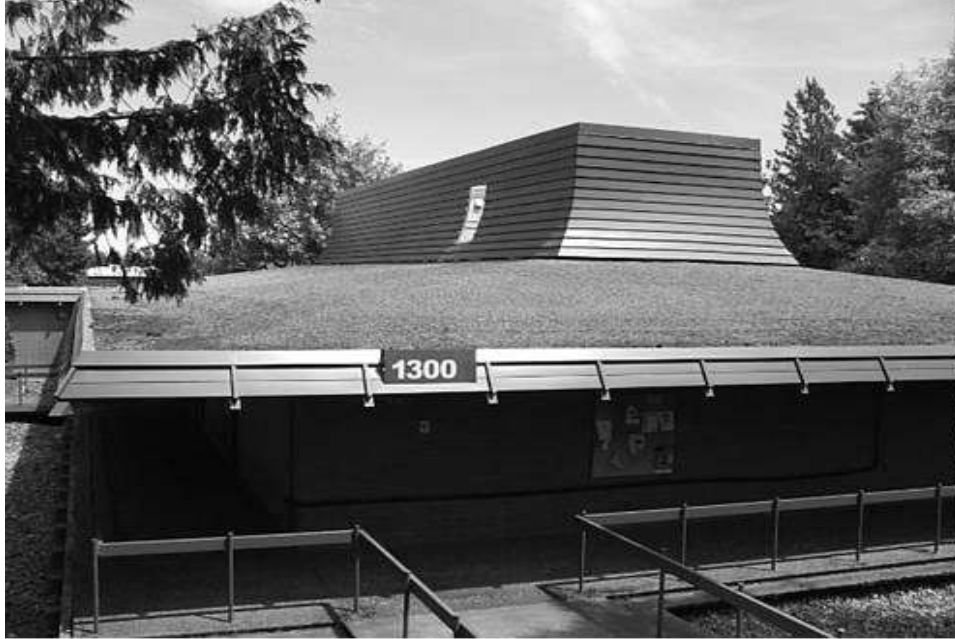
Busadm (070-13) STATE UFI: A06715 Main Campus (070A)
 AREA: 6,534 SF BUILT: 1966 REMODELED: No PREDOMINANT USE: General Classroom
 CONSTRUCTION TYPE: Medium CRV/SF: \$376 REPLACEMENT VALUE: \$2,456,784

Primary Systems			
COMPONENT:	Structure	RATING: 1 x WEIGHT: 8.3 = SCORE: 8.3	
No signs of settlement or cracking, no abrupt vertical changes Columns, bearing walls and roof structure appears sound/free of defects			
COMMENTS:	Concrete; structural brick; glu-lam beams; steel columns		
COMPONENT:	Exterior Closure	RATING: 1 x WEIGHT: 8.3 = SCORE: 8.3	
Weatherproof, tight, well-maintained exterior walls, doors, windows/finishes			
COMMENTS:	Brick; aluminum fascia; aluminum siding on mechanical screens		
COMPONENT:	Roofing	RATING: 3 x WEIGHT: 10.4 = SCORE: 31.3	
Some deterioration is evident in membrane and flashings; maintenance or minor repair is needed			
COMMENTS:	Built-up roof w/aggregate ballast; skylight

Secondary Systems			
COMPONENT:	Floor Finishes	RATING: 1 x WEIGHT: 6.3 = SCORE: 6.3	
	Nice appearance, smooth transitions, level subfloors, no cracks/separating		
COMMENTS:	Carpet; vinyl tile; sheet vinyl		
COMPONENT:	Wall Finishes	RATING: 1 x WEIGHT: 6.3 = SCORE: 6.3	
	Maintainable surfaces in good condition		
COMMENTS:	Gypsum; board brick; concrete		
COMPONENT:	Ceiling Finishes	RATING: 2 x WEIGHT: 6.3 = SCORE: 12.5	
	Aging surfaces in fair condition and good alignment		
COMMENTS:	Lay-in tile; gypsum board perimeter soffits		
COMPONENT:	Doors & Hardware	RATING: 1 x WEIGHT: 6.3 = SCORE: 6.3	
	Appropriate hardware, closers, panic devices; in good working order		
COMMENTS:	Interior wood doors/frames; exterior wood doors w HM frames

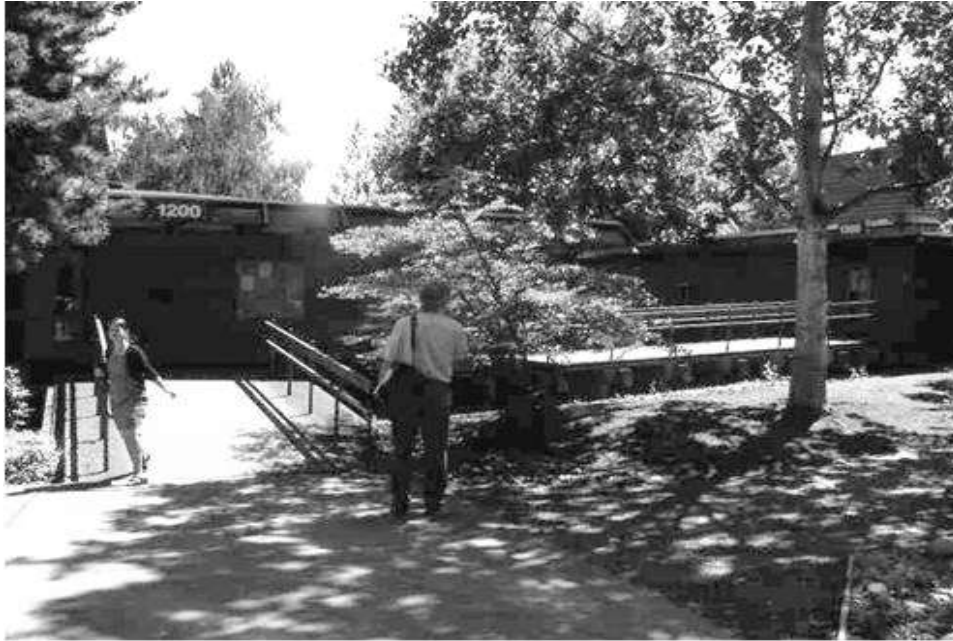
Buslab (070-12) STATE UFI: A09918 Main Campus (070A)
 AREA: 2,690 SF BUILT: 1965 REMODELED: No PREDOMINANT USE: Administration
 CONSTRUCTION TYPE: Medium CRV/SF: \$336 REPLACEMENT VALUE: \$903,840

Primary Systems			
COMPONENT:	Structure	RATING: 1 x WEIGHT: 8.3 = SCORE: 8.3	
No signs of settlement or cracking, no abrupt vertical changes Columns, bearing walls and roof structure appears sound/free of defects			
COMMENTS:	Concrete; structural brick; glu-lam beams; steel columns		
COMPONENT:	Exterior Closure	RATING: 2 x WEIGHT: 8.3 = SCORE: 16.7	
Weatherproof exterior, but finish appears poorly maintained			
COMMENTS:	Brick; aluminum soffits; exposed wood beams; aluminum siding on mechanical screens		
COMPONENT:	Roofing	RATING: 1 x WEIGHT: 10.4 = SCORE: 10.4	
Flashing and penetrations appear sound and membrane appears water- tight; drainage is positive and there are overflow scuppers			
COMMENTS:	BUR w mineral-surfaced cap sheet-2008

Secondary Systems			
COMPONENT:	Floor Finishes	RATING: 3 x WEIGHT: 6.3 =	SCORE: 18.8
Some physical wear and minor imperfections are evident; beginning deterioration			
COMMENTS:	Vinyl tile; carpet tile; VAT		
COMPONENT:	Wall Finishes	RATING: 2 x WEIGHT: 6.3 =	SCORE: 12.5
Maintainable surfaces, minor maintenance is required in some areas			
COMMENTS:	Gypsum board; brick; concrete		
COMPONENT:	Ceiling Finishes	RATING: 3 x WEIGHT: 6.3 =	SCORE: 18.8
Some wear and tear; Minor damage, staining or deterioration			
COMMENTS:	Direct-adhered tile and exposed wood beams		
COMPONENT:	Doors & Hardware	RATING: 1 x WEIGHT: 6.3 =	SCORE: 6.3
Appropriate hardware, closers, panic devices; in good working order			
COMMENTS:	Interior wood glazed doors/frames; exterior wood doors/frames

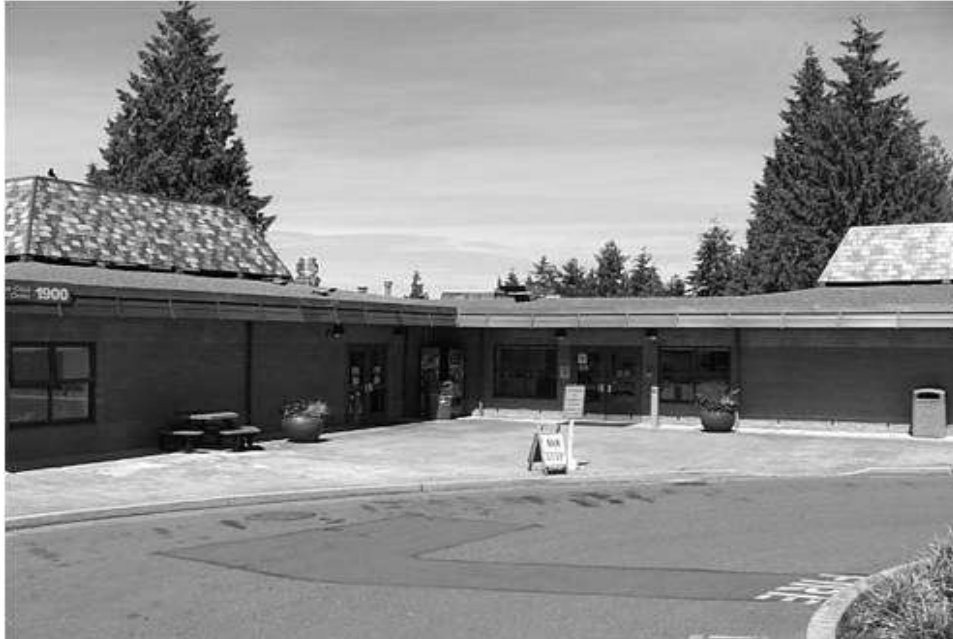
Early Childhood Ed Center (070-19) STATE UFI: A09607 Main Campus (070A)
 AREA: 8,300 SF BUILT: 1994 REMODELED: No PREDOMINANT USE: Child Care/Instr.
 CONSTRUCTION TYPE: Medium CRV/SF: \$264 REPLACEMENT VALUE: \$2,191,200

Primary Systems			
COMPONENT:	Structure	RATING: 1 x WEIGHT: 8.3 = SCORE: 8.3	
No signs of settlement or cracking, no abrupt vertical changes Columns, bearing walls and roof structure appears sound/free of defects			
COMMENTS:	Wood; glu-lam beams; steel studs; steel columns		
COMPONENT:	Exterior Closure	RATING: 1 x WEIGHT: 8.3 = SCORE: 8.3	
Weatherproof, tight, well-maintained exterior walls, doors, windows/finishes			
COMMENTS:	Brick; CMU; aluminum fascia; concrete tiles on mechanical screens		
COMPONENT:	Roofing	RATING: 1 x WEIGHT: 10.4 = SCORE: 10.4	
Flashing and penetrations appear sound and membrane appears water- tight; drainage is positive and there are overflow scuppers			
COMMENTS:	Built-up roof 2016

Secondary Systems			
COMPONENT:	Floor Finishes	RATING: 1 x WEIGHT: 6.3 = SCORE: 6.3	
	Nice appearance, smooth transitions, level subfloors, no cracks/separating		
COMMENTS:	Vinyl tile; carpet; sheet vinyl		
COMPONENT:	Wall Finishes	RATING: 1 x WEIGHT: 6.3 = SCORE: 6.3	
	Maintainable surfaces in good condition		
COMMENTS:	Gypsum board; ceramic tile; plastic panels		
COMPONENT:	Ceiling Finishes	RATING: 1 x WEIGHT: 6.3 = SCORE: 6.3	
	Maintainable surfaces in good condition; good alignment and appearance		
COMMENTS:	Lay-in tile, gypsum board; exposed beams		
COMPONENT:	Doors & Hardware	RATING: 3 x WEIGHT: 6.3 = SCORE: 18.8	
	Functional, but dated; some maintenance required		
COMMENTS:	Interior wood doors-surface wear w HM frames; exterior HM doors/frames-surface wear

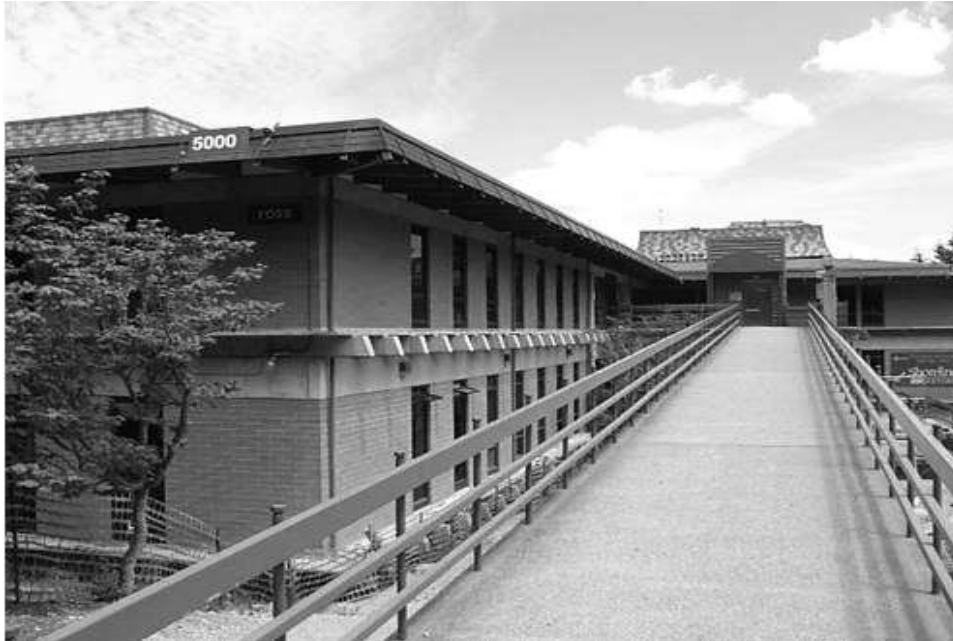
Foss (070-50) STATE UFI: A06886 Main Campus (070A)
 AREA: 54,756 SF BUILT: 1972 REMODELED: No PREDOMINANT USE: Administration
 CONSTRUCTION TYPE: Medium CRV/SF: \$336 REPLACEMENT VALUE: \$18,398,016

Primary Systems			
COMPONENT:	Structure	RATING: 1 x WEIGHT: 8 =	SCORE: 8
No signs of settlement or cracking, no abrupt vertical changes Columns, bearing walls and roof structure appears sound/free of defects			
COMMENTS:	Concrete frame		
COMPONENT:	Exterior Closure	RATING: 3 x WEIGHT: 8 =	SCORE: 24
Sound and weatherproof but with some physical deterioration evident			
COMMENTS:	Brick; aluminum fascia; concrete asbestos tile on mechanical screens		
COMPONENT:	Roofing	RATING: 1 x WEIGHT: 10 =	SCORE: 10
Flashing and penetrations appear sound and membrane appears water- tight; drainage is positive and there are overflow scuppers			
COMMENTS:	Built-up roof w/aggregate ballast-1992; replacement funded 2021

Secondary Systems			
COMPONENT:	Floor Finishes	RATING: 3 x WEIGHT: 6 = SCORE: 18	
	Some physical wear and minor imperfections are evident; beginning deterioration		
COMMENTS:	Carpet; carpet tile; vinyl tile; ceramic tile		
COMPONENT:	Wall Finishes	RATING: 2 x WEIGHT: 6 = SCORE: 12	
	Maintainable surfaces, minor maintenance is required in some areas		
COMMENTS:	Brick; gypsum board; ceramic tile; Vinyl wall covering		
COMPONENT:	Ceiling Finishes	RATING: 3 x WEIGHT: 6 = SCORE: 18	
	Some wear and tear; Minor damage, staining or deterioration		
COMMENTS:	Concrete structure; gypsum board; direct-adhered and lay-in tile; glu-lam beams		
COMPONENT:	Doors & Hardware	RATING: 3 x WEIGHT: 6 = SCORE: 18	
	Functional, but dated; some maintenance required		
COMMENTS:	Interior and exterior wood doors w HM frames-wood surface wear; exterior aluminum doors/frames and wood doors w HM frames

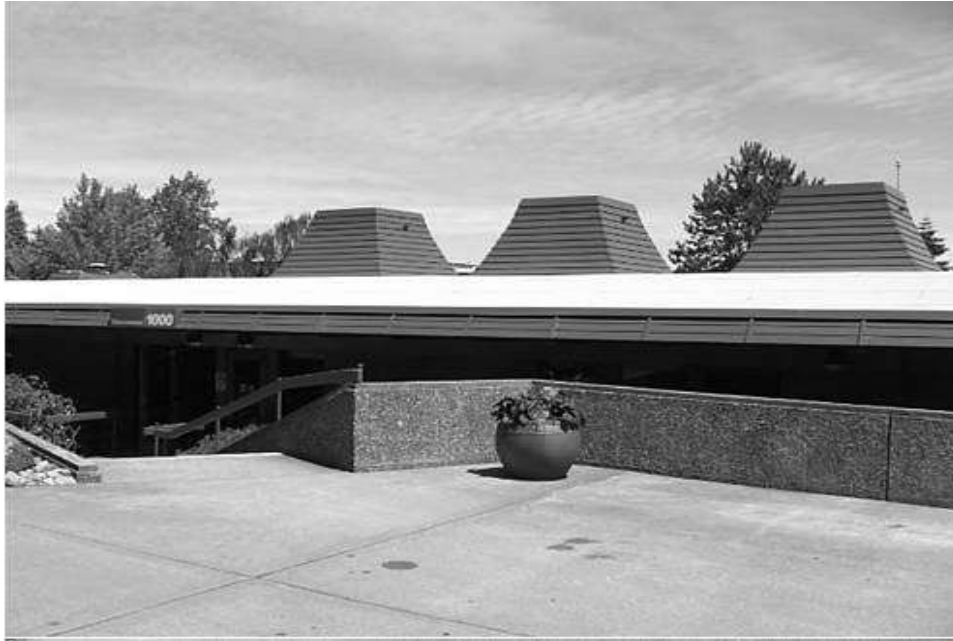
Genadm (070-10) STATE UFI: A02391 Main Campus (070A)
 AREA: 13,160 SF BUILT: 1965 REMODELED: No PREDOMINANT USE: Administration
 CONSTRUCTION TYPE: Medium CRV/SF: \$336 REPLACEMENT VALUE: \$4,421,760

Primary Systems			
COMPONENT:	Structure	RATING: 1 x WEIGHT: 8.3 =	SCORE: 8.3
No signs of settlement or cracking, no abrupt vertical changes Columns, bearing walls and roof structure appears sound/free of defects			
COMMENTS:	Concrete; structural brick; glu-lam beams; steel columns		
COMPONENT:	Exterior Closure	RATING: 1 x WEIGHT: 8.3 =	SCORE: 8.3
Weatherproof, tight, well-maintained exterior walls, doors, windows/finishes			
COMMENTS:	Brick; aluminum fascia & soffits; exposed wood beams; aluminum siding on mechanical screens		
COMPONENT:	Roofing	RATING: 1 x WEIGHT: 10.4 =	SCORE: 10.4
Flashing and penetrations appear sound and membrane appears water- tight; drainage is positive and there are overflow scuppers			
COMMENTS:	BUR w mineral-surfaced cap sheet-2005

Secondary Systems			
COMPONENT:	Floor Finishes	RATING: 2 x WEIGHT: 6.3 = SCORE: 12.5	
	Some wear is evident on finish; maintenance needed		
COMMENTS:	Carpet-general wear; ceramic tile; VAT		
COMPONENT:	Wall Finishes	RATING: 1 x WEIGHT: 6.3 = SCORE: 6.3	
	Maintainable surfaces in good condition		
COMMENTS:	Gypsum board; brick; concrete		
COMPONENT:	Ceiling Finishes	RATING: 3 x WEIGHT: 6.3 = SCORE: 18.8	
	Some wear and tear; Minor damage, staining or deterioration		
COMMENTS:	Direct-adhered tile; exposed wood beams; foam insulation at art gallery		
COMPONENT:	Doors & Hardware	RATING: 3 x WEIGHT: 6.3 = SCORE: 18.8	
	Functional, but dated; some maintenance required		
COMMENTS:	Interior wood doors/frames-random wear; exterior wood/laminate doors/HM frames-some surface wear

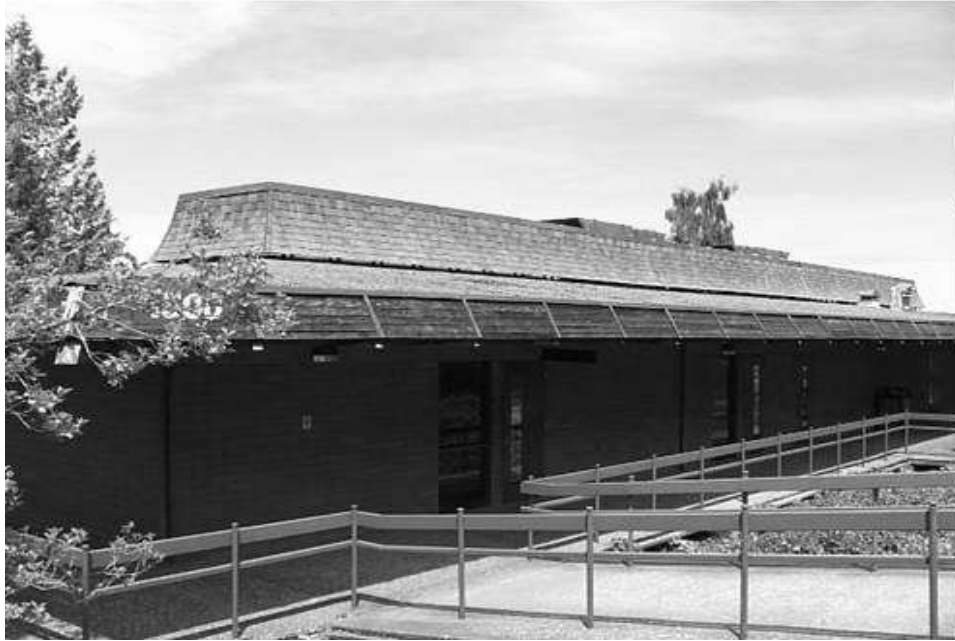
Humcla (070-15) STATE UFI: A02462 Main Campus (070A)
AREA: 10,480 SF BUILT: 1965 REMODELED: No PREDOMINANT USE: General Classroom
CONSTRUCTION TYPE: Medium CRV/SF: \$376 REPLACEMENT VALUE: \$3,940,480

Primary Systems			
COMPONENT:	Structure	RATING: 2 x WEIGHT: 8.3 = SCORE: 16.7	
Minor cracks evident in a small portion of the structure			
COMMENTS:	Concrete, structural brick, glu-lam beams, steel columns.		
COMPONENT:	Exterior Closure	RATING: 2 x WEIGHT: 8.3 = SCORE: 16.7	
Weatherproof exterior, but finish appears poorly maintained			
COMMENTS:	Brick; cedar fascia & soffits; exposed wood beams; metal panels on mechanical screens 2020		
COMPONENT:	Roofing	RATING: 1 x WEIGHT: 10.4 = SCORE: 10.4	
Flashing and penetrations appear sound and membrane appears water- tight; drainage is positive and there are overflow scuppers			
COMMENTS:	New 2011

Secondary Systems			
COMPONENT:	Floor Finishes	RATING: 1 x WEIGHT: 6.3 = SCORE: 6.3	
	Nice appearance, smooth transitions, level subfloors, no cracks/separating		
COMMENTS:	Vinyl asbestos tile; carpet-general wear; ceramic tile		
COMPONENT:	Wall Finishes	RATING: 1 x WEIGHT: 6.3 = SCORE: 6.3	
	Maintainable surfaces in good condition		
COMMENTS:	Gypsum board; brick; 1x4 cedar paneling		
COMPONENT:	Ceiling Finishes	RATING: 1 x WEIGHT: 6.3 = SCORE: 6.3	
	Maintainable surfaces in good condition; good alignment and appearance		
COMMENTS:	Direct-adhered tile; gypsum board; exposed wood beams		
COMPONENT:	Doors & Hardware	RATING: 3 x WEIGHT: 6.3 = SCORE: 18.8	
	Functional, but dated; some maintenance required		
COMMENTS:	Interior wood doors/frames-generally worn finishes; exterior HM/wood doors w HM frames

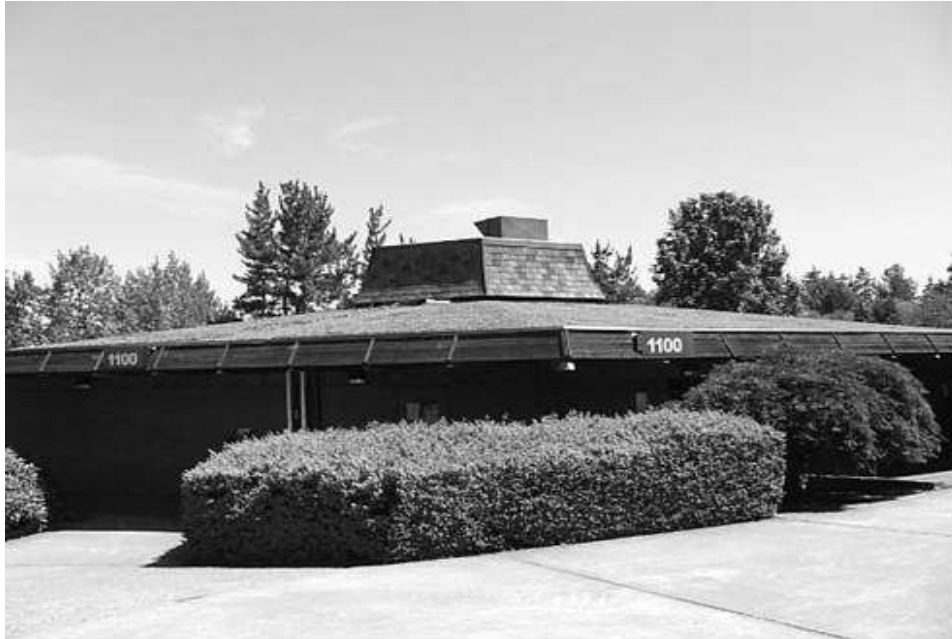
Lecture Hall (070-11) STATE UFI: A01137 Main Campus (070A)
 AREA: 4,367 SF BUILT: 1967 REMODELED: No PREDOMINANT USE: General Classroom
 CONSTRUCTION TYPE: Medium CRV/SF: \$376 REPLACEMENT VALUE: \$1,641,992

Primary Systems			
COMPONENT:	Structure	RATING: 1 x WEIGHT: 8.8 = SCORE: 8.8	
No signs of settlement or cracking, no abrupt vertical changes Columns, bearing walls and roof structure appears sound/free of defects			
COMMENTS:	Concrete; structural brick; glu-lam beams; steel columns; slab-on-grade.		
COMPONENT:	Exterior Closure	RATING: 2 x WEIGHT: 8.8 = SCORE: 17.7	
Weatherproof exterior, but finish appears poorly maintained			
COMMENTS:	Brick; aluminum soffits; exposed wood beams; aluminum siding on mechanical screens		
COMPONENT:	Roofing	RATING: 1 x WEIGHT: 11.1 = SCORE: 11.1	
Flashing and penetrations appear sound and membrane appears water- tight; drainage is positive and there are overflow scuppers			
COMMENTS:	BUR w mineral-surfaced cap sheet-2008

Secondary Systems			
COMPONENT:	Floor Finishes	RATING: 1 x WEIGHT: 6.6 = SCORE: 6.6	
	Nice appearance, smooth transitions, level subfloors, no cracks/separating		
COMMENTS:	Vinyl tile and carpet tile		
COMPONENT:	Wall Finishes	RATING: 1 x WEIGHT: 6.6 = SCORE: 6.6	
	Maintainable surfaces in good condition		
COMMENTS:	Gypsum board; brick; 1x4 cedar paneling		
COMPONENT:	Ceiling Finishes	RATING: 1 x WEIGHT: 6.6 = SCORE: 6.6	
	Maintainable surfaces in good condition; good alignment and appearance		
COMMENTS:	Gypsum board; lay-in tile; exposed wood beams		
COMPONENT:	Doors & Hardware	RATING: 1 x WEIGHT: 6.6 = SCORE: 6.6	
	Appropriate hardware, closers, panic devices; in good working order		
COMMENTS:	Interior wood doors w HM frames; exterior HM doors/frames

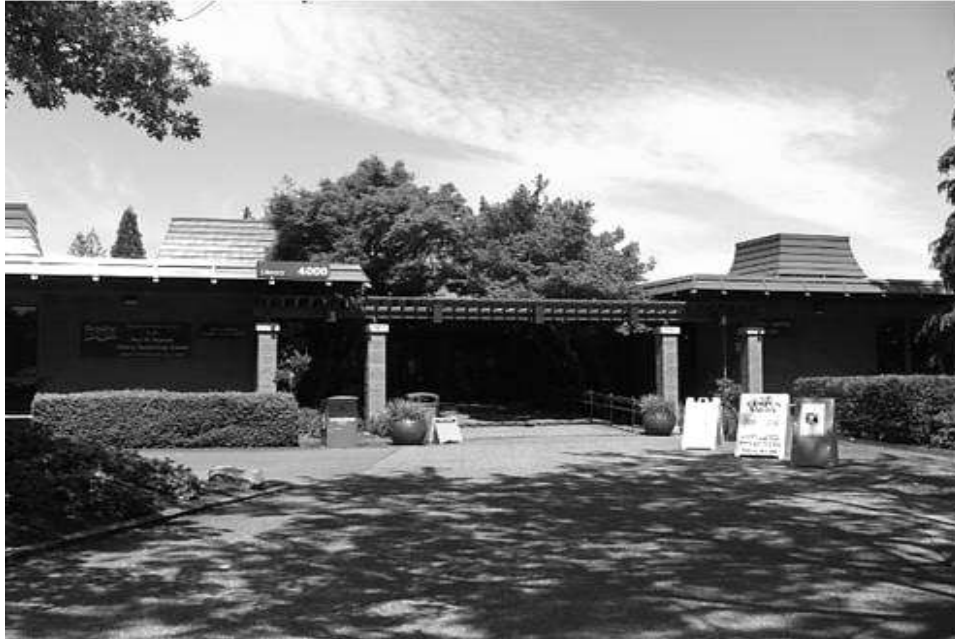
Library (070-40) STATE UFI: A03204 Main Campus (070A)
AREA: 52,680 SF BUILT: 2002 REMODELED: No PREDOMINANT USE: Library
CONSTRUCTION TYPE: Heavy CRV/SF: \$376 REPLACEMENT VALUE: \$19,807,680

Primary Systems			
COMPONENT:	Structure	RATING: 1 x WEIGHT: 8 =	SCORE: 8
No signs of settlement or cracking, no abrupt vertical changes Columns, bearing walls and roof structure appears sound/free of defects			
COMMENTS:	Concrete; structural brick; glu-lam beams; steel columns.		
COMPONENT:	Exterior Closure	RATING: 1 x WEIGHT: 8 =	SCORE: 8
Weatherproof, tight, well-maintained exterior walls, doors, windows/finishes			
COMMENTS:	Brick; aluminum fascia & mechanical screen panels		
COMPONENT:	Roofing	RATING: 2 x WEIGHT: 10 =	SCORE: 20
Majority of roofing and flashing appear sound, but a small portion of roofing shows deterioration where maintenance or minor repair needed			
COMMENTS:	Built-up w/ gravel ballast

Secondary Systems			
COMPONENT:	Floor Finishes	RATING: 2 x WEIGHT: 6 = SCORE: 12	
	Some wear is evident on finish; maintenance needed		
COMMENTS:	Carpet; concrete; ceramic tile; vinyl tile		
COMPONENT:	Wall Finishes	RATING: 1 x WEIGHT: 6 = SCORE: 6	
	Maintainable surfaces in good condition		
COMMENTS:	Gypsum board; brick; concrete; ceramic tile		
COMPONENT:	Ceiling Finishes	RATING: 1 x WEIGHT: 6 = SCORE: 6	
	Maintainable surfaces in good condition; good alignment and appearance		
COMMENTS:	Lay-in and direct-adhered tile; gypsum board; exposed wood beams; vent wood		
COMPONENT:	Doors & Hardware	RATING: 3 x WEIGHT: 6 = SCORE: 18	
	Functional, but dated; some maintenance required		
COMMENTS:	Interior wood doors w HM frames; exterior wood doors w HM frames and HM doors/frames; coiling door

Service Systems			
COMPONENT:	Elevators	RATING: 2 x WEIGHT: 6 = SCORE: 12	
	Aged elevators functional, but deterioration or abuse of finishes is evident		
COMMENTS:	3 stop		
COMPONENT:	Plumbing	RATING: 1 x WEIGHT: 8 = SCORE: 8	
	Fixtures and piping appear to be in good condition; no evidence of leaks		
COMMENTS:	Copper, cast iron, black steel and PVC piping; porcelain fixtures		
COMPONENT:	HVAC	RATING: 2 x WEIGHT: 8 = SCORE: 16	
	Equipment in fair condition; minor deterioration; controls require troubleshooting; most areas have A/C; hazardous areas are ventilated		
COMMENTS:	Built-up AHU w fan powered VAVs; air-cooled chiller 2021; 2 HW boilers		
COMPONENT:	Electrical	RATING: 1 x WEIGHT: 8 = SCORE: 8	
	Adequate service and distribution capacity for current/future needs		
COMMENTS:	1600amp, 408/277v; 100 KW emergency generator		
COMPONENT:	Lights/Power	RATING: 1 x WEIGHT: 8 = SCORE: 8	
	Contemporary lighting with good work area illumination; ample outlets

Safety Systems			
COMPONENT:	Life/Safety	RATING: 1 x WEIGHT: 10 = SCORE: 10	
	Appears to meet current codes		
COMMENTS:			
COMPONENT:	Fire Safety	RATING: 1 x WEIGHT: 10 = SCORE: 10	
	Locally monitored detection; alarm and strobes present; sprinklers in high hazard areas		
COMMENTS:			
COMPONENT:	Modifications	RATING: 1 x WEIGHT: 7 = SCORE: 7	
	Modifications appear to be in compliance with codes and sound construction practices; HVAC/electrical service properly provided		
COMMENTS:	Renovations completed 2002 & 2016 appears to be in compliance with codes & well-constructed

Quality Standards			
COMPONENT:	Maintenance	RATING: 1 x WEIGHT: 7 = SCORE: 7	
	Facility appears well maintained		
COMMENTS:			
COMPONENT:	Remaining Life	RATING: 1 x WEIGHT: 6 = SCORE: 6	
	Life expectancy is >20 years; minor system deterioration		
COMMENTS:			
COMPONENT:	Appearance	RATING: 1 x WEIGHT: 6 = SCORE: 6	
	Well-constructed building; generally attractive interior and exterior		
COMMENTS:

TOTAL SCORE = 206 PREVIOUS BIENNIUM SCORE = 202
CONDITION: Adequate

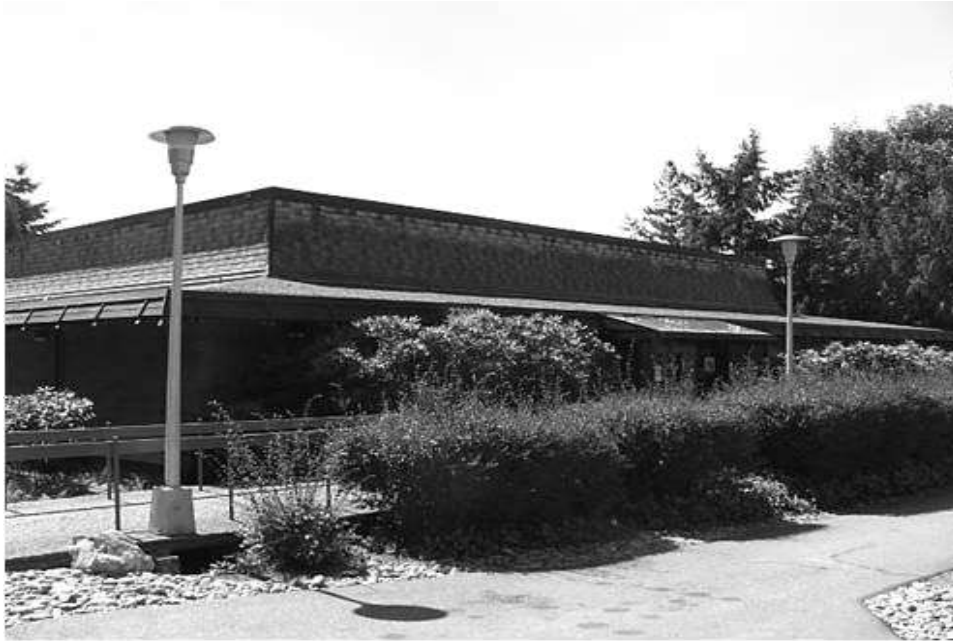
Nursed (070-23) STATE UFI: A07524 Main Campus (070A)
AREA: 17,589 SF BUILT: 1971 REMODELED: No PREDOMINANT USE: General Classroom
CONSTRUCTION TYPE: Medium CRV/SF: \$376 REPLACEMENT VALUE: \$6,613,464

Primary Systems			
COMPONENT:	Structure	RATING: 3 x WEIGHT: 8 =	SCORE: 24
Some cracking evident but does not likely affect structural integrity; Visible defects apparent but are non-structural			
COMMENTS:	Concrete; structural brick; glu-lam beams; steel columns		
COMPONENT:	Exterior Closure	RATING: 3 x WEIGHT: 8 =	SCORE: 24
Sound and weatherproof but with some physical deterioration evident			
COMMENTS:	Brick; aluminum fascia & soffits; exposed wood beams; asbestos tiles on mechanical screens		
COMPONENT:	Roofing	RATING: 4 x WEIGHT: 10 =	SCORE: 40
General deterioration and some leaks are evident; reconditioning or partial repair is needed			
COMMENTS:	Built-up roof w/ aggregate ballast

Secondary Systems			
COMPONENT:	Floor Finishes	RATING: 3 x WEIGHT: 6 = SCORE: 18	
	Some physical wear and minor imperfections are evident; beginning deterioration		
COMMENTS:	Carpet; VAT; concrete; ceramic tile; sheet vinyl		
COMPONENT:	Wall Finishes	RATING: 2 x WEIGHT: 6 = SCORE: 12	
	Maintainable surfaces, minor maintenance is required in some areas		
COMMENTS:	Gypsum board; brick; concrete; ceramic tile; wood strip; vinyl wall covering		
COMPONENT:	Ceiling Finishes	RATING: 2 x WEIGHT: 6 = SCORE: 12	
	Aging surfaces in fair condition and good alignment		
COMMENTS:	Lay-in and direct-adhered tile; exposed glu-lam beams; vent wood panels; gypsum board		
COMPONENT:	Doors & Hardware	RATING: 3 x WEIGHT: 6 = SCORE: 18	
	Functional, but dated; some maintenance required		
COMMENTS:	Interior and exterior wood doors w HM frames-general surface wear

Service Systems			
COMPONENT:	Elevators	RATING: 5 x WEIGHT: 6 = SCORE: 30	
	No elevator access for upper floors		
COMMENTS:	1 story (2-story in part; Nursing Skills Lab in basement; no elevator		
COMPONENT:	Plumbing	RATING: 3 x WEIGHT: 8 = SCORE: 24	
	Fixtures are functional but dated; some leaks; maintenance required		
COMMENTS:	Copper, galvanized, cast iron and steel piping; porcelain fixtures		
COMPONENT:	HVAC	RATING: 3 x WEIGHT: 8 = SCORE: 24	
	System generally adequate; some deterioration; needs balancing; some areas have A/C; hazardous areas are ventilated		
COMMENTS:	3 HW boilers; AHUs; no A/C		
COMPONENT:	Electrical	RATING: 3 x WEIGHT: 8 = SCORE: 24	
	Service capacity meets current needs but inadequate for future		
COMMENTS:	300amp 480/277v		
COMPONENT:	Lights/Power	RATING: 3 x WEIGHT: 8 = SCORE: 24	
	Adequate work area illumination; adequate outlets for current use; maintenance required		
COMMENTS:	Lay-in, wall mount, recessed can and hanging strip fluorescent fixtures

Quality Standards			
COMPONENT:	Maintenance	RATING: 3 x WEIGHT: 7 = SCORE: 21	
	Routine maintenance is required; deferred maintenance is evident; impact is minor to moderate		
COMMENTS:			
COMPONENT:	Remaining Life	RATING: 5 x WEIGHT: 6 = SCORE: 30	
	Life expectancy is <5 years; significant system deterioration		
COMMENTS:	Building either needs a major renovation of interior w new roof and HVAC or should be replaced		
COMPONENT:	Appearance	RATING: 3 x WEIGHT: 6 = SCORE: 18	
	Average construction; average interior and exterior appearance		
COMMENTS:	Exterior is very utilitarian

TOTAL SCORE = 458 PREVIOUS BIENNIUM SCORE = 458
CONDITION: Needs Improvement/Renovation

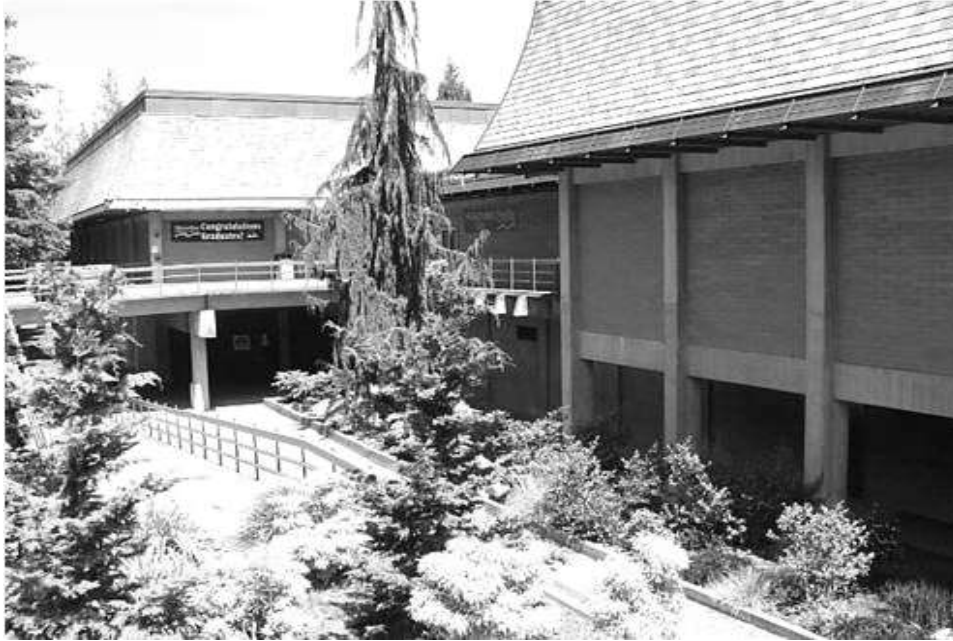
Physed (070-30) STATE UFI: A05877 Main Campus (070A)
 AREA: 46,656 SF BUILT: 1972 REMODELED: No PREDOMINANT USE: Gymnasium
 CONSTRUCTION TYPE: Heavy CRV/SF: \$349 REPLACEMENT VALUE: \$16,282,944

Primary Systems			
COMPONENT:	Structure	RATING: 2 x WEIGHT: 8 =	SCORE: 16
Minor cracks evident in a small portion of the structure			
COMMENTS:	Concrete frame; steel trusses		
COMPONENT:	Exterior Closure	RATING: 1 x WEIGHT: 8 =	SCORE: 8
Weatherproof, tight, well-maintained exterior walls, doors, windows/finishes			
COMMENTS:	Brick; metal fascia		
COMPONENT:	Roofing	RATING: 3 x WEIGHT: 10 =	SCORE: 30
Some deterioration is evident in membrane and flashings; maintenance or minor repair is needed			
COMMENTS:	Built-up roof w/aggregate ballast-needs maintenance; PVC single ply; metal mansards 2018

Secondary Systems			
COMPONENT:	Floor Finishes	RATING: 2 x WEIGHT: 6 =	SCORE: 12
Some wear is evident on finish; maintenance needed			
COMMENTS:	Hardwood; vinyl tile; worn carpet; rubber floor; concrete; ceramic tile-cracking		
COMPONENT:	Wall Finishes	RATING: 2 x WEIGHT: 6 =	SCORE: 12
Maintainable surfaces, minor maintenance is required in some areas			
COMMENTS:	Gypsum board; concrete; hardboard & tectum panels; ceramic tile; vinyl wall covering		
COMPONENT:	Ceiling Finishes	RATING: 3 x WEIGHT: 6 =	SCORE: 18
Some wear and tear; Minor damage, staining or deterioration			
COMMENTS:	Direct-adhered and lay-in tile; exposed structure; gypsum board		
COMPONENT:	Doors & Hardware	RATING: 3 x WEIGHT: 6 =	SCORE: 18
Functional, but dated; some maintenance required			
COMMENTS:	Exterior & interior wood and HM doors w HM frames

Service Systems			
COMPONENT:	Elevators	RATING: 5 x WEIGHT: 6 =	SCORE: 30
No elevator access for upper floors			
COMMENTS:	2 story		
COMPONENT:	Plumbing	RATING: 3 x WEIGHT: 8 =	SCORE: 24
Fixtures are functional but dated; some leaks; maintenance required			
COMMENTS:	Galvanized, steel, cast iron and copper piping; porcelain fixtures		
COMPONENT:	HVAC	RATING: 3 x WEIGHT: 8 =	SCORE: 24
System generally adequate; some deterioration; needs balancing; some areas have A/C; hazardous areas are ventilated			
COMMENTS:	AHUs and HW boilers w hydronic radiators; replacement funded in 07		
COMPONENT:	Electrical	RATING: 3 x WEIGHT: 8 =	SCORE: 24
Service capacity meets current needs but inadequate for future			
COMMENTS:	600amp 480/277v		
COMPONENT:	Lights/Power	RATING: 2 x WEIGHT: 8 =	SCORE: 16
Contemporary lighting with good work area illumination; adequate number of outlets; some finishes appear aged			
COMMENTS:	Ceiling mount, wall mount and lay-in fluorescent fixtures; high-bay in gym

Quality Standards			
COMPONENT:	Maintenance	RATING: 2 x WEIGHT: 7 = SCORE: 14	
	Routine maintenance is required; impact is minor		
COMMENTS:			
COMPONENT:	Remaining Life	RATING: 3 x WEIGHT: 6 = SCORE: 18	
	Life expectancy is roughly 10-15 years; moderate system deterioration		
COMMENTS:	Interior needs comprehensive renovation to extend useful life		
COMPONENT:	Appearance	RATING: 4 x WEIGHT: 6 = SCORE: 24	
	Average construction; some unattractive exterior and interior spaces		
COMMENTS:

CONDITION: Needs Improvement/Renovation

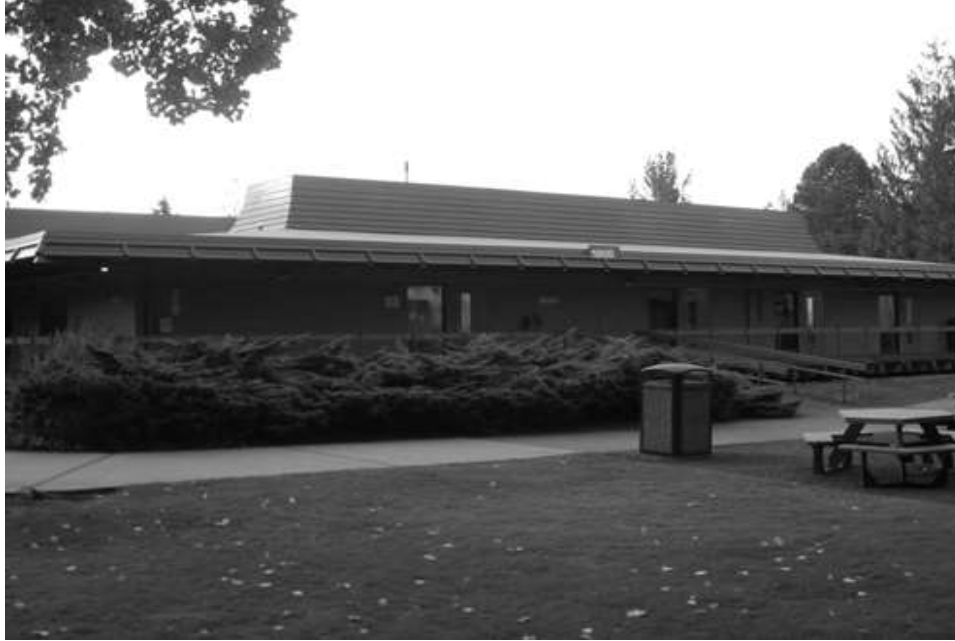
Regla (070-18) STATE UFI: A08307 Main Campus (070A)
 AREA: 6,500 SF BUILT: 1966 REMODELED: No PREDOMINANT USE: General Classroom
 CONSTRUCTION TYPE: Medium CRV/SF: \$376 REPLACEMENT VALUE: \$2,444,000

Primary Systems			
COMPONENT:	Structure	RATING: 1 x WEIGHT: 8.3 = SCORE: 8.3	
No signs of settlement or cracking, no abrupt vertical changes Columns, bearing walls and roof structure appears sound/free of defects			
COMMENTS:	Concrete, structural brick, glu-lam beams, steel columns		
COMPONENT:	Exterior Closure	RATING: 1 x WEIGHT: 8.3 = SCORE: 8.3	
Weatherproof, tight, well-maintained exterior walls, doors, windows/finishes			
COMMENTS:	Brick; aluminum fascia; exposed wood beams; aluminum panels on mechanical screens		
COMPONENT:	Roofing	RATING: 1 x WEIGHT: 10.4 = SCORE: 10.4	
Flashing and penetrations appear sound and membrane appears water- tight; drainage is positive and there are overflow scuppers			
COMMENTS:	New 2009

Secondary Systems			
COMPONENT:	Floor Finishes	RATING: 1 x WEIGHT: 6.3 =	SCORE: 6.3
Nice appearance, smooth transitions, level subfloors, no cracks/separating			
COMMENTS:	Carpet tile		
COMPONENT:	Wall Finishes	RATING: 2 x WEIGHT: 6.3 =	SCORE: 12.5
Maintainable surfaces, minor maintenance is required in some areas			
COMMENTS:	Gypsum board; brick; concrete		
COMPONENT:	Ceiling Finishes	RATING: 2 x WEIGHT: 6.3 =	SCORE: 12.5
Aging surfaces in fair condition and good alignment			
COMMENTS:	Lay-in tile; gypsum board		
COMPONENT:	Doors & Hardware	RATING: 2 x WEIGHT: 6.3 =	SCORE: 12.5
Fairly modern door surfaces and hardware with minor deterioration; good working order			
COMMENTS:	Exterior HM doors/frames

Service Systems			
COMPONENT:	Elevators	RATING: 0 x WEIGHT: 0 =	SCORE: 0
No data			
COMMENTS:			
COMPONENT:	Plumbing	RATING: 1 x WEIGHT: 8.3 =	SCORE: 8.3
Fixtures and piping appear to be in good condition; no evidence of leaks			
COMMENTS:	Copper, cast iron, steel and PVC piping; porcelain fixtures		
COMPONENT:	HVAC	RATING: 1 x WEIGHT: 8.3 =	SCORE: 8.3
Equipment in good condition; easily controlled; serves all required spaces; All necessary spaces are adequately ventilated; A/C provided throughout			
COMMENTS:	Rooftop packaged HVAC units w gas packs		
COMPONENT:	Electrical	RATING: 1 x WEIGHT: 8.3 =	SCORE: 8.3
Adequate service and distribution capacity for current/future needs			
COMMENTS:	400amp 208/120v		
COMPONENT:	Lights/Power	RATING: 1 x WEIGHT: 8.3 =	SCORE: 8.3
Contemporary lighting with good work area illumination; ample outlets			
COMMENTS:	Lay-in, ceiling-mount and recessed can fluorescent fixtures

Safety Systems			
COMPONENT:	Life/Safety	RATING: 3 x WEIGHT: 10.4 =	SCORE: 31.3
Generally meets codes for vintage of construction			
COMMENTS:			
COMPONENT:	Fire Safety	RATING: 1 x WEIGHT: 10.4 =	SCORE: 10.4
Locally monitored detection; alarm and strobes present; sprinklers in high hazard areas			
COMMENTS:			
COMPONENT:	Modifications	RATING: 1 x WEIGHT: 7.3 =	SCORE: 7.3
Modifications appear to be in compliance with codes and sound construction practices; HVAC/electrical service properly provided			
COMMENTS: Comprehensive interior remodel in 2009

Quality Standards			
COMPONENT:	Maintenance	RATING: 1 x WEIGHT: 7.3 =	SCORE: 7.3
Facility appears well maintained			
COMMENTS:			
COMPONENT:	Remaining Life	RATING: 1 x WEIGHT: 6.3 =	SCORE: 6.3
Life expectancy is >20 years; minor system deterioration			
COMMENTS: Major interior renovation and new roof and HVAC in 2009			
COMPONENT:	Appearance	RATING: 3 x WEIGHT: 6.3 =	SCORE: 18.8
Average construction; average interior and exterior appearance			
COMMENTS: Very utilitarian exterior

CONDITION: Adequate

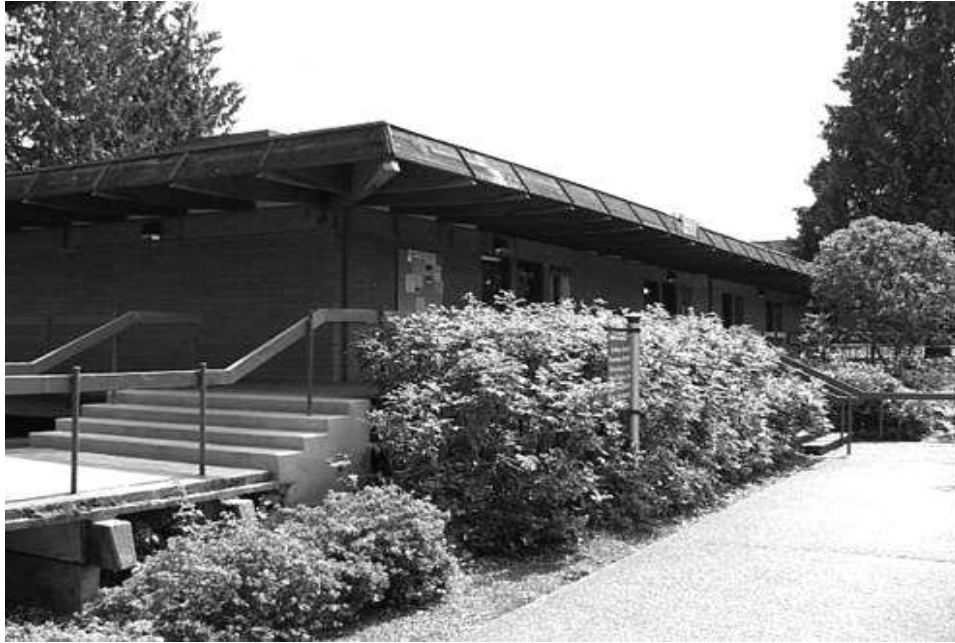
Regcla (070-22)	STATE UFI: A07428	Main Campus (070A)
AREA: 6,270 SF	BUILT: 1966	REMODELED: No
CONSTRUCTION TYPE: Medium	CRV/SF: \$376	REPLACEMENT VALUE: \$2,357,520

Primary Systems			
COMPONENT:	Structure	RATING: 1 x WEIGHT: 8 =	SCORE: 8
No signs of settlement or cracking, no abrupt vertical changes Columns, bearing walls and roof structure appears sound/free of defects			
COMMENTS:	Concrete; structural brick; glu-lam beams; steel columns.		
COMPONENT:	Exterior Closure	RATING: 2 x WEIGHT: 8 =	SCORE: 16
Weatherproof exterior, but finish appears poorly maintained			
COMMENTS:	Brick; Hardie-board fascia; exposed wood beams; concrete asbestos tiles on mechanical screens		
COMPONENT:	Roofing	RATING: 3 x WEIGHT: 10 =	SCORE: 30
Some deterioration is evident in membrane and flashings; maintenance or minor repair is needed			
COMMENTS:	Built-up roof w/gravel ballast

Secondary Systems			
COMPONENT:	Floor Finishes	RATING: 3 x WEIGHT: 6 = SCORE: 18	
	Some physical wear and minor imperfections are evident; beginning deterioration		
COMMENTS:	Vinyl tile; carpet; carpet tile		
COMPONENT:	Wall Finishes	RATING: 1 x WEIGHT: 6 = SCORE: 6	
	Maintainable surfaces in good condition		
COMMENTS:	Gypsum board; 1x4 horizontal cedar siding; brick		
COMPONENT:	Ceiling Finishes	RATING: 3 x WEIGHT: 6 = SCORE: 18	
	Some wear and tear; Minor damage, staining or deterioration		
COMMENTS:	Direct-adhered tile; exposed glu-lam beams; gypsum board		
COMPONENT:	Doors & Hardware	RATING: 3 x WEIGHT: 6 = SCORE: 18	
	Functional, but dated; some maintenance required		
COMMENTS:	Interior wood doors w HM frames-surface wear; exterior wood doors/HM frames

Service Systems			
COMPONENT:	Elevators	RATING: 5 x WEIGHT: 6 = SCORE: 30	
	No elevator access for upper floors		
COMMENTS:	Some classrooms have multi-levels		
COMPONENT:	Plumbing	RATING: 3 x WEIGHT: 8 = SCORE: 24	
	Fixtures are functional but dated; some leaks; maintenance required		
COMMENTS:	Copper and cast iron piping; no restrooms		
COMPONENT:	HVAC	RATING: 3 x WEIGHT: 8 = SCORE: 24	
	System generally adequate; some deterioration; needs balancing; some areas have A/C; hazardous areas are ventilated		
COMMENTS:	Rooftop heating and ventilating w dual-duct mixing boxes; no A/C		
COMPONENT:	Electrical	RATING: 3 x WEIGHT: 8 = SCORE: 24	
	Service capacity meets current needs but inadequate for future		
COMMENTS:	150 amp 208/120v; 100amp 208/120v; fed from transformer vault		
COMPONENT:	Lights/Power	RATING: 3 x WEIGHT: 8 = SCORE: 24	
	Adequate work area illumination; adequate outlets for current use; maintenance required

Quality Standards			
COMPONENT:	Maintenance	RATING: 1 x WEIGHT: 7 = SCORE: 7	
	Facility appears well maintained		
COMMENTS:			
COMPONENT:	Remaining Life	RATING: 5 x WEIGHT: 6 = SCORE: 30	
	Life expectancy is <5 years; significant system deterioration		
COMMENTS:	Building either needs a major renovation of interior w new roof and HVAC or should be replaced		
COMPONENT:	Appearance	RATING: 4 x WEIGHT: 6 = SCORE: 24	
	Average construction; some unattractive exterior and interior spaces		
COMMENTS:

CONDITION: Needs Improvement/Renovation

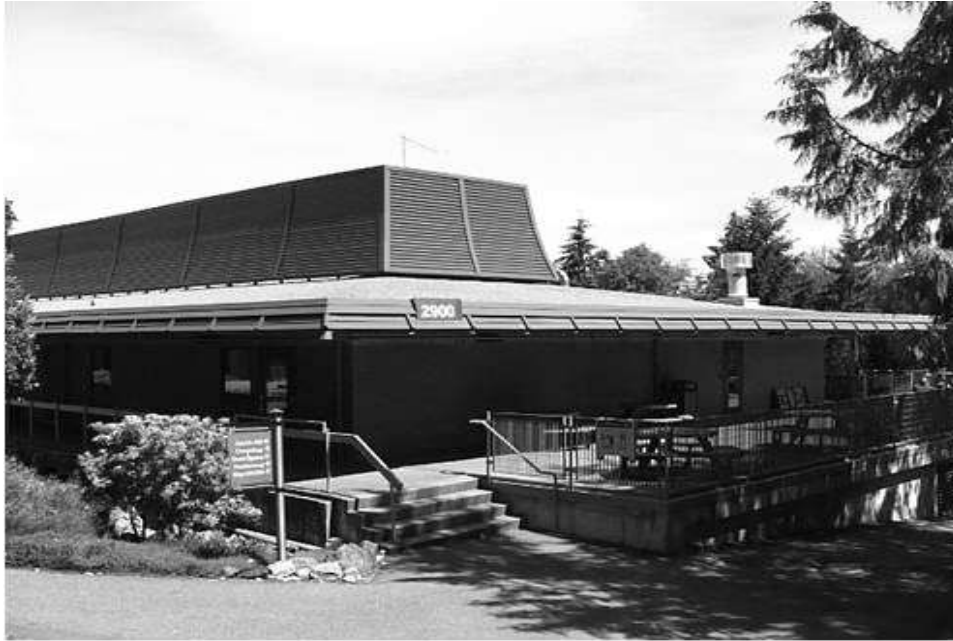
Schlab (070-29) STATE UFI: A04022 Main Campus (070A)
AREA: 36,084 SF BUILT: 1965 REMODELED: No PREDOMINANT USE: Science Lab.
CONSTRUCTION TYPE: Medium CRV/SF: \$489 REPLACEMENT VALUE: \$17,645,076

Primary Systems			
COMPONENT:	Structure	RATING: 3 x WEIGHT: 8 =	SCORE: 24
Some cracking evident but does not likely affect structural integrity; Visible defects apparent but are non-structural			
COMMENTS:	Concrete; structural brick; glu-lam beams; steel columns		
COMPONENT:	Exterior Closure	RATING: 1 x WEIGHT: 8 =	SCORE: 8
Weatherproof, tight, well-maintained exterior walls, doors, windows/finishes			
COMMENTS:	Brick; aluminum fascia; aluminum mechanical screens		
COMPONENT:	Roofing	RATING: 3 x WEIGHT: 10 =	SCORE: 30
Some deterioration is evident in membrane and flashings; maintenance or minor repair is needed			
COMMENTS:	BUR w/gravel ballast-2004; glass skylights

Secondary Systems			
COMPONENT:	Floor Finishes	RATING: 1 x WEIGHT: 6 = SCORE: 6	
	Nice appearance, smooth transitions, level subfloors, no cracks/separating		
COMMENTS:	Carpet; vinyl tile; concrete; sheet vinyl; ceramic tile; VAT		
COMPONENT:	Wall Finishes	RATING: 2 x WEIGHT: 6 = SCORE: 12	
	Maintainable surfaces, minor maintenance is required in some areas		
COMMENTS:	Gypsum board; brick; concrete; CMU; ceramic tile; corrugated metal panels		
COMPONENT:	Ceiling Finishes	RATING: 1 x WEIGHT: 6 = SCORE: 6	
	Maintainable surfaces in good condition; good alignment and appearance		
COMMENTS:	Gypsum board; suspended tile; exposed glu-lam beams; direct-adhered tile; exposed wood deck		
COMPONENT:	Doors & Hardware	RATING: 1 x WEIGHT: 6 = SCORE: 6	
	Appropriate hardware, closers, panic devices; in good working order		
COMMENTS:	Interior wood doors w HM frames; exterior HM doors/frames; OH coiling door

Service Systems			
COMPONENT:	Elevators	RATING: 1 x WEIGHT: 6 = SCORE: 6	
	Appropriate and functional for occupancy and use		
COMMENTS:	Exterior elevator tower		
COMPONENT:	Plumbing	RATING: 1 x WEIGHT: 8 = SCORE: 8	
	Fixtures and piping appear to be in good condition; no evidence of leaks		
COMMENTS:	Copper, cast iron and steel piping; porcelain fixtures		
COMPONENT:	HVAC	RATING: 2 x WEIGHT: 8 = SCORE: 16	
	Equipment in fair condition; minor deterioration; controls require troubleshooting; most areas have A/C; hazardous areas are ventilated		
COMMENTS:	Rooftop HVAC units w fan powered VAVs; air-cooled chiller and AHU; 2 HW boilers; unit heater		
COMPONENT:	Electrical	RATING: 1 x WEIGHT: 8 = SCORE: 8	
	Adequate service and distribution capacity for current/future needs		
COMMENTS:	2000amp 408277v; 50 kW generator set; photovoltaic panels		
COMPONENT:	Lights/Power	RATING: 1 x WEIGHT: 8 = SCORE: 8	
	Contemporary lighting with good work area illumination; ample outlets

Safety Systems			
COMPONENT:	Life/Safety	RATING: 3 x WEIGHT: 10 = SCORE: 30	
	Generally meets codes for vintage of construction		
COMMENTS:			
COMPONENT:	Fire Safety	RATING: 1 x WEIGHT: 10 = SCORE: 10	
	Locally monitored detection; alarm and strobes present; sprinklers in high hazard areas		
COMMENTS:			
COMPONENT:	Modifications	RATING: 1 x WEIGHT: 7 = SCORE: 7	
	Modifications appear to be in compliance with codes and sound construction practices; HVAC/electrical service properly provided		
COMMENTS:	Renovation completed 2004 appears to be in compliance with codes & well-constructed

Quality Standards			
COMPONENT:	Maintenance	RATING: 1 x WEIGHT: 7 = SCORE: 7	
	Facility appears well maintained		
COMMENTS:			
COMPONENT:	Remaining Life	RATING: 1 x WEIGHT: 6 = SCORE: 6	
	Life expectancy is >20 years; minor system deterioration		
COMMENTS:	Extensive renovation in 2004; RUL >15 years		
COMPONENT:	Appearance	RATING: 3 x WEIGHT: 6 = SCORE: 18	
	Average construction; average interior and exterior appearance		
COMMENTS:	Exterior is very utilitarian

CONDITION: Adequate
