2023 FACILITY CONDITION SURVEY

Shoreline Community College

SURVEY CONDUCTED BY:
Steve Lewandowski
State Board for Community
and Technical Colleges

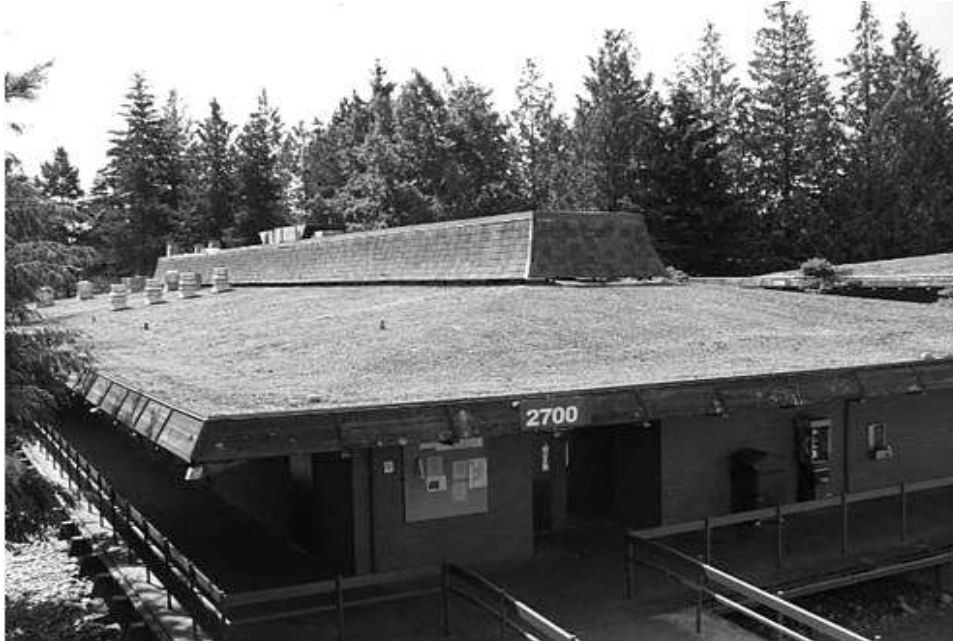
Scilab (070-27) STATE UFI: A09157 Main Campus (070A)
 AREA: 9,400 SF BUILT: 1965 REMODELED: No PREDOMINANT USE: Science Lab.
 CONSTRUCTION TYPE: Medium CRV/SF: \$489 REPLACEMENT VALUE: \$4,596,600

Primary Systems			
COMPONENT:	Structure	RATING: 3 x WEIGHT: 8.3 =	SCORE: 25
Some cracking evident but does not likely affect structural integrity; Visible defects apparent but are non-structural			
COMMENTS:	Concrete; structural brick; glu-lam beams; steel columns		
COMPONENT:	Exterior Closure	RATING: 3 x WEIGHT: 8.3 =	SCORE: 25
Sound and weatherproof but with some physical deterioration evident			
COMMENTS:	Brick; Hardie-board fascia; exposed wood beams; concrete asbestos tiles on mechanical screens		
COMPONENT:	Roofing	RATING: 3 x WEIGHT: 10.4 =	SCORE: 31.3
Some deterioration is evident in membrane and flashings; maintenance or minor repair is needed			
COMMENTS:	Gravel ballasted built-up roof membrane

Secondary Systems			
COMPONENT:	Floor Finishes	RATING: 3 x WEIGHT: 6.3 =	SCORE: 18.8
Some physical wear and minor imperfections are evident; beginning deterioration			
COMMENTS:	Vinyl asbestos tile; ceramic tile; carpet; carpet tile		
COMPONENT:	Wall Finishes	RATING: 2 x WEIGHT: 6.3 =	SCORE: 12.5
Maintainable surfaces, minor maintenance is required in some areas			
COMMENTS:	Gypsum board; brick		
COMPONENT:	Ceiling Finishes	RATING: 4 x WEIGHT: 6.3 =	SCORE: 25
General deterioration and moderate amount of staining or damage apparent			
COMMENTS:	Direct-adhered tile; gypsum board; exposed wood beams		
COMPONENT:	Doors & Hardware	RATING: 3 x WEIGHT: 6.3 =	SCORE: 18.8
Functional, but dated; some maintenance required			
COMMENTS:	Interior wood doors/frames-surface wear; exterior HM doors/frames

Service Systems			
COMPONENT:	Elevators	RATING: 0 x WEIGHT: 0 =	SCORE: 0
No data			
COMMENTS:			
COMPONENT:	Plumbing	RATING: 3 x WEIGHT: 8.3 =	SCORE: 25
Fixtures are functional but dated; some leaks; maintenance required			
COMMENTS:	Galvanized, copper, steel, cast iron and glass piping; porcelain fixtures		
COMPONENT:	HVAC	RATING: 3 x WEIGHT: 8.3 =	SCORE: 25
System generally adequate; some deterioration; needs balancing; some areas have A/C; hazardous areas are ventilated			
COMMENTS:	Rooftop AHUs; hot water heating from 2400A; no A/C		
COMPONENT:	Electrical	RATING: 3 x WEIGHT: 8.3 =	SCORE: 25
Service capacity meets current needs but inadequate for future			
COMMENTS:	125amp 208/120v		
COMPONENT:	Lights/Power	RATING: 3 x WEIGHT: 8.3 =	SCORE: 25
Adequate work area illumination; adequate outlets for current use; maintenance required			
COMMENTS:	Surface mount and hanging fluorescent fixtures

Quality Standards			
COMPONENT:	Maintenance	RATING: 3 x WEIGHT: 7.3 =	SCORE: 21.9
Routine maintenance is required; deferred maintenance is evident; impact is minor to moderate			
COMMENTS:			
COMPONENT:	Remaining Life	RATING: 5 x WEIGHT: 6.3 =	SCORE: 31.3
Life expectancy is <5 years; significant system deterioration			
COMMENTS: Building should either receive a comprehensive interior renovation and new roof and HVAC, or be replaced			
COMPONENT:	Appearance	RATING: 5 x WEIGHT: 6.3 =	SCORE: 31.3
Poor to average construction; very unattractive exterior and interior spaces			
COMMENTS:

CONDITION: Replace or Renovate

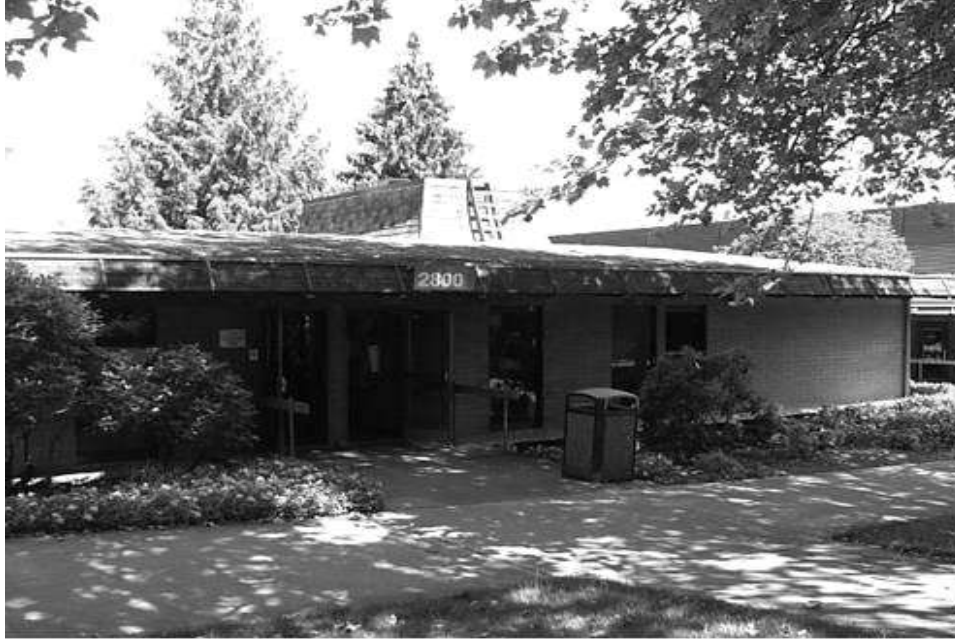
Scioff (070-28) STATE UFI: A01606 Main Campus (070A)
 AREA: 4,180 SF BUILT: 1966 REMODELED: No PREDOMINANT USE: Administration
 CONSTRUCTION TYPE: Medium CRV/SF: \$336 REPLACEMENT VALUE: \$1,404,480

Primary Systems			
COMPONENT:	Structure	RATING: 3 x WEIGHT: 8.3 =	SCORE: 25
Some cracking evident but does not likely affect structural integrity; Visible defects apparent but are non-structural			
COMMENTS:	Concrete; structural brick; glu-lam beams; steel columns		
COMPONENT:	Exterior Closure	RATING: 3 x WEIGHT: 8.3 =	SCORE: 25
Sound and weatherproof but with some physical deterioration evident			
COMMENTS:	Brick; Hardie-board fascia; exposed wood beams; concrete asbestos tiles on mechanical screens		
COMPONENT:	Roofing	RATING: 3 x WEIGHT: 10.4 =	SCORE: 31.3
Some deterioration is evident in membrane and flashings; maintenance or minor repair is needed			
COMMENTS:	Ballasted built-up roof membrane

Secondary Systems			
COMPONENT:	Floor Finishes	RATING: 2 x WEIGHT: 6.3 = SCORE: 12.5	
	Some wear is evident on finish; maintenance needed		
COMMENTS:	Concrete; carpet; vinyl tile; sheet vinyl		
COMPONENT:	Wall Finishes	RATING: 4 x WEIGHT: 6.3 = SCORE: 25	
	Aging surfaces generally require maintenance; some areas require repair		
COMMENTS:	Brick; gypsum board; vinyl wall covering; wood strip; generally good		
COMPONENT:	Ceiling Finishes	RATING: 3 x WEIGHT: 6.3 = SCORE: 18.8	
	Some wear and tear; Minor damage, staining or deterioration		
COMMENTS:	Direct-adhered tile; exposed glu-lam beams; good condition		
COMPONENT:	Doors & Hardware	RATING: 4 x WEIGHT: 6.3 = SCORE: 25	
	General deterioration evident in both door and hardware; some doors with significant deterioration		
COMMENTS:	Interior wood glazed doors w wood frames-surface wear; exterior wood doors w HM frames

Service Systems			
COMPONENT:	Elevators	RATING: 0 x WEIGHT: 0 = SCORE: 0	
	No data		
COMMENTS:			
COMPONENT:	Plumbing	RATING: 3 x WEIGHT: 8.3 = SCORE: 25	
	Fixtures are functional but dated; some leaks; maintenance required		
COMMENTS:	Copper, cast iron and galvanized piping; porcelain fixtures		
COMPONENT:	HVAC	RATING: 3 x WEIGHT: 8.3 = SCORE: 25	
	System generally adequate; some deterioration; needs balancing; some areas have A/C; hazardous areas are ventilated		
COMMENTS:	Rooftop AHU w/mixing boxes; hot water heat from 2400A		
COMPONENT:	Electrical	RATING: 1 x WEIGHT: 8.3 = SCORE: 8.3	
	Adequate service and distribution capacity for current/future needs		
COMMENTS:	200amp 208/120v		
COMPONENT:	Lights/Power	RATING: 3 x WEIGHT: 8.3 = SCORE: 25	
	Adequate work area illumination; adequate outlets for current use; maintenance required		
COMMENTS:	Hanging circular and strip incandescent and fluorescent fixtures

Quality Standards			
COMPONENT:	Maintenance	RATING: 3 x WEIGHT: 7.3 = SCORE: 21.9	
Routine maintenance is required; deferred maintenance is evident; impact is minor to moderate			
COMMENTS:			
COMPONENT:	Remaining Life	RATING: 5 x WEIGHT: 6.3 = SCORE: 31.3	
Life expectancy is <5 years; significant system deterioration			
COMMENTS: Building should either receive a comprehensive interior renovation and new roof and HVAC, or be replaced			
COMPONENT:	Appearance	RATING: 5 x WEIGHT: 6.3 = SCORE: 31.3	
Poor to average construction; very unattractive exterior and interior spaces			
COMMENTS:

CONDITION: Needs Improvement/Renovation

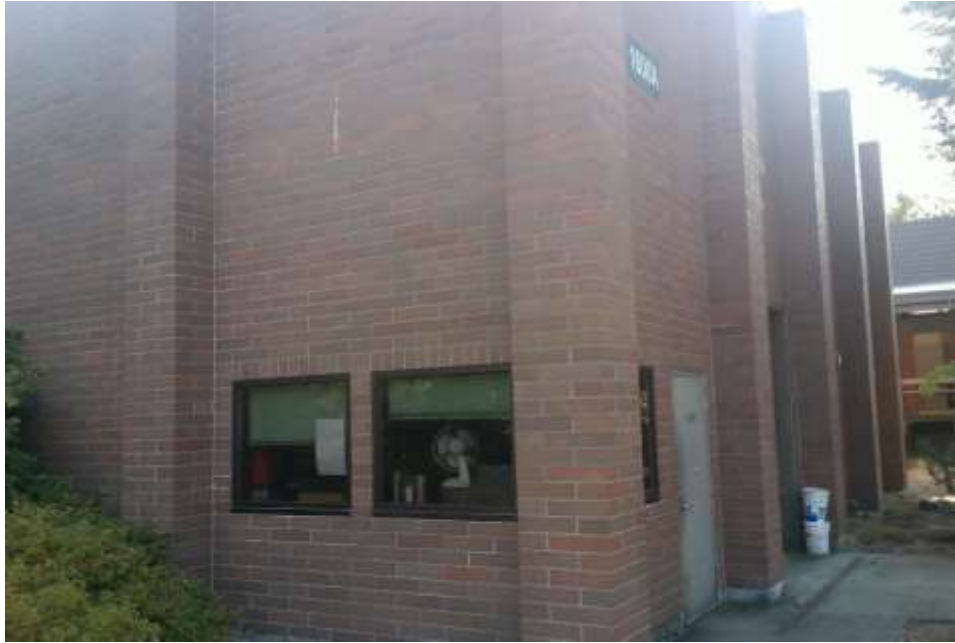
Theater Workshop (070-16A) STATE UFI: A10480 Main Campus (070A)
AREA: 2,864 SF BUILT: 1992 REMODELED: No PREDOMINANT USE: Shop
CONSTRUCTION TYPE: No data CRV/SF: \$188 REPLACEMENT VALUE: \$538,432

Primary Systems			
COMPONENT:	Structure	RATING: 1 x WEIGHT: 9.2 =	SCORE: 9.2
No signs of settlement or cracking, no abrupt vertical changes Columns, bearing walls and roof structure appears sound/free of defects			
COMMENTS:	No data		
COMPONENT:	Exterior Closure	RATING: 2 x WEIGHT: 9.2 =	SCORE: 18.4
Weatherproof exterior, but finish appears poorly maintained			
COMMENTS:	No data		
COMPONENT:	Roofing	RATING: 3 x WEIGHT: 11.5 =	SCORE: 34.5
Some deterioration is evident in membrane and flashings; maintenance or minor repair is needed			
COMMENTS:	No data

Secondary Systems			
COMPONENT:	Floor Finishes	RATING: 2 x WEIGHT: 6.9 =	SCORE: 13.8
Some wear is evident on finish; maintenance needed			
COMMENTS:	Exposed wood and concrete		
COMPONENT:	Wall Finishes	RATING: 3 x WEIGHT: 6.9 =	SCORE: 20.7
Aging surfaces, but sound; some maintenance is required			
COMMENTS:	GWB at office		
COMPONENT:	Ceiling Finishes	RATING: 1 x WEIGHT: 6.9 =	SCORE: 6.9
Maintainable surfaces in good condition; good alignment and appearance			
COMMENTS:	GWB		
COMPONENT:	Doors & Hardware	RATING: 3 x WEIGHT: 6.9 =	SCORE: 20.7
Functional, but dated; some maintenance required			
COMMENTS:	No data

Service Systems			
COMPONENT:	Elevators	RATING: 0 x WEIGHT: 0 =	SCORE: 0
No data			
COMMENTS:	No data		
COMPONENT:	Plumbing	RATING: 3 x WEIGHT: 9.2 =	SCORE: 27.6
Fixtures are functional but dated; some leaks; maintenance required			
COMMENTS:	No data		
COMPONENT:	HVAC	RATING: 3 x WEIGHT: 9.2 =	SCORE: 27.6
System generally adequate; some deterioration; needs balancing; some areas have A/C; hazardous areas are ventilated			
COMMENTS:	No data		
COMPONENT:	Electrical	RATING: 1 x WEIGHT: 9.2 =	SCORE: 9.2
Adequate service and distribution capacity for current/future needs			
COMMENTS:	125Amp		
COMPONENT:	Lights/Power	RATING: 3 x WEIGHT: 9.2 =	SCORE: 27.6
Adequate work area illumination; adequate outlets for current use; maintenance required			
COMMENTS:	No data

TOTAL SCORE = 341 PREVIOUS BIENNIUM SCORE = 341
CONDITION: Needs Improvement/Additional Maintenance

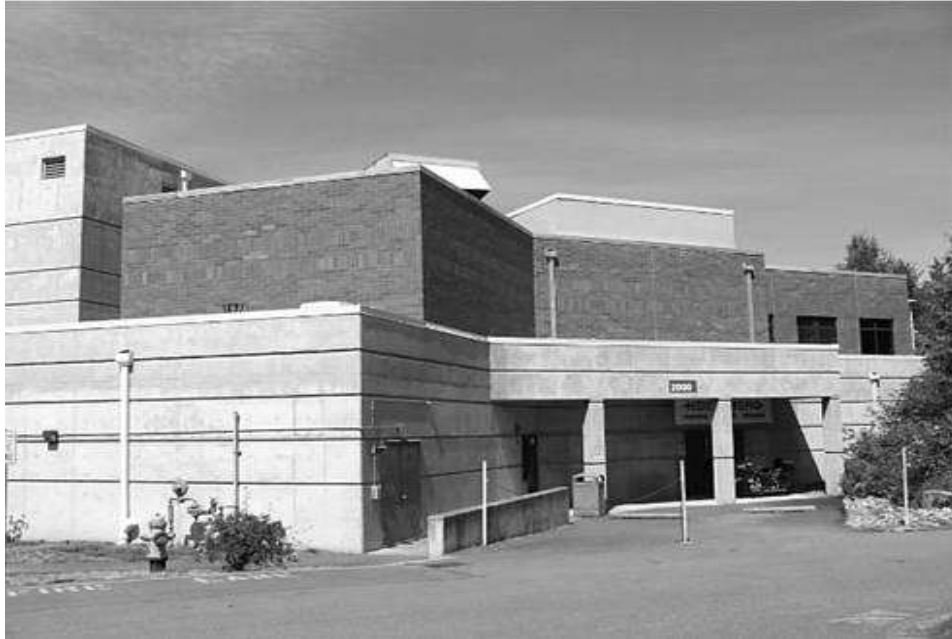
Vocational Arts Facility (070-20) STATE UFI: A03730 Main Campus (070A)
AREA: 23,454 SF BUILT: 1995 REMODELED: No PREDOMINANT USE: Visual Arts
CONSTRUCTION TYPE: Heavy CRV/SF: \$421 REPLACEMENT VALUE: \$9,874,134

Primary Systems			
COMPONENT:	Structure	RATING: 1 x WEIGHT: 8 =	SCORE: 8
No signs of settlement or cracking, no abrupt vertical changes Columns, bearing walls and roof structure appears sound/free of defects			
COMMENTS:	Concrete		
COMPONENT:	Exterior Closure	RATING: 1 x WEIGHT: 8 =	SCORE: 8
Weatherproof, tight, well-maintained exterior walls, doors, windows/finishes			
COMMENTS:	Brick; concrete; stucco		
COMPONENT:	Roofing	RATING: 3 x WEIGHT: 10 =	SCORE: 30
Some deterioration is evident in membrane and flashings; maintenance or minor repair is needed			
COMMENTS:	BUR w mineral-surfaced cap sheet; Kalwall skylight; corrugated metal at outdoor kiln area, repairs funded 2021

Secondary Systems			
COMPONENT:	Floor Finishes	RATING: 2 x WEIGHT: 6 = SCORE: 12	
	Some wear is evident on finish; maintenance needed		
COMMENTS:	Vinyl tiles; concrete; carpet; sheet vinyl-general wear		
COMPONENT:	Wall Finishes	RATING: 2 x WEIGHT: 6 = SCORE: 12	
	Maintainable surfaces, minor maintenance is required in some areas		
COMMENTS:	Gypsum board; CMU; concrete		
COMPONENT:	Ceiling Finishes	RATING: 1 x WEIGHT: 6 = SCORE: 6	
	Maintainable surfaces in good condition; good alignment and appearance		
COMMENTS:	Gypsum board; lay-in tile; exposed wood deck; wood beams; metal deck pan		
COMPONENT:	Doors & Hardware	RATING: 3 x WEIGHT: 6 = SCORE: 18	
	Functional, but dated; some maintenance required		
COMMENTS:	Interior wood doors-surface wear, w HM frames; HM doors/frames; exterior HM doors/frames

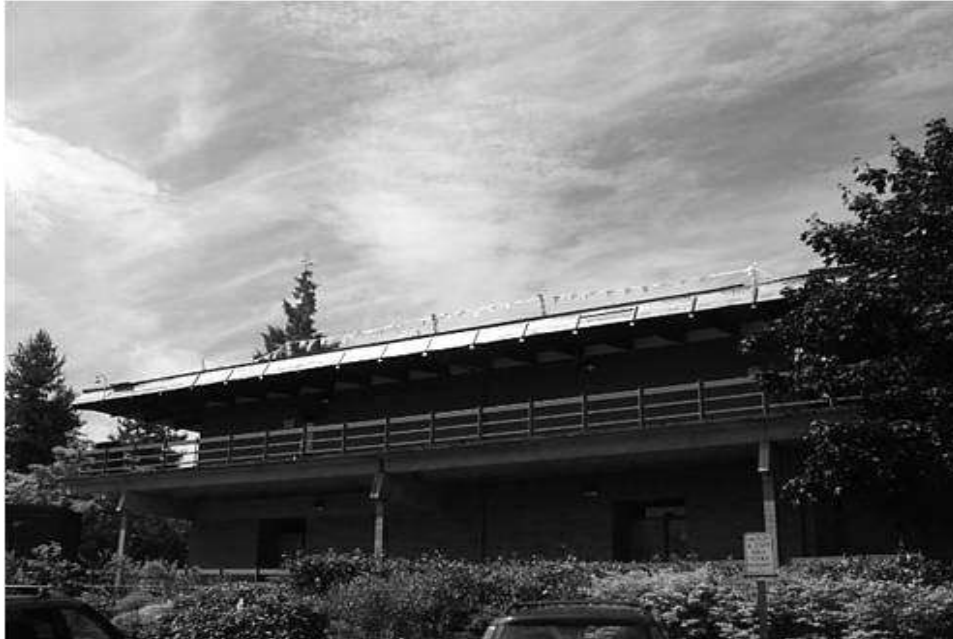
Voctec (070-25) STATE UFI: A06611 Main Campus (070A)
 AREA: 25,952 SF BUILT: 1972 REMODELED: No PREDOMINANT USE: Vocational Arts
 CONSTRUCTION TYPE: Medium CRV/SF: \$395 REPLACEMENT VALUE: \$10,251,040

Primary Systems			
COMPONENT:	Structure	RATING: 3 x WEIGHT: 8 =	SCORE: 24
Some cracking evident but does not likely affect structural integrity; Visible defects apparent but are non-structural			
COMMENTS:	Concrete; structural brick; glu-lam beams; steel columns		
COMPONENT:	Exterior Closure	RATING: 3 x WEIGHT: 8 =	SCORE: 24
Sound and weatherproof but with some physical deterioration evident			
COMMENTS:	Brick; cedar fascia; exposed wood beams; concrete asbestos tiles on mechanical screens		
COMPONENT:	Roofing	RATING: 1 x WEIGHT: 10 =	SCORE: 10
Flashing and penetrations appear sound and membrane appears water- tight; drainage is positive and there are overflow scuppers			
COMMENTS:	PVC single-ply membrane-2007

Secondary Systems			
COMPONENT:	Floor Finishes	RATING: 3 x WEIGHT: 6 = SCORE: 18	
	Some physical wear and minor imperfections are evident; beginning deterioration		
COMMENTS:	Carpet; sheet vinyl; concrete; vinyl tile; ceramic tile		
COMPONENT:	Wall Finishes	RATING: 1 x WEIGHT: 6 = SCORE: 6	
	Maintainable surfaces in good condition		
COMMENTS:	Brick; gypsum board; ceramic tile		
COMPONENT:	Ceiling Finishes	RATING: 5 x WEIGHT: 6 = SCORE: 30	
	Deteriorated, significant number of stained or sagging areas; inappropriate for occupancy		
COMMENTS:	Lay-in tile,, exposed concrete structure; concealed spline tile		
COMPONENT:	Doors & Hardware	RATING: 3 x WEIGHT: 6 = SCORE: 18	
	Functional, but dated; some maintenance required		
COMMENTS:	Interior and exterior wood doors w HM frames-surface wear; OH metal doors

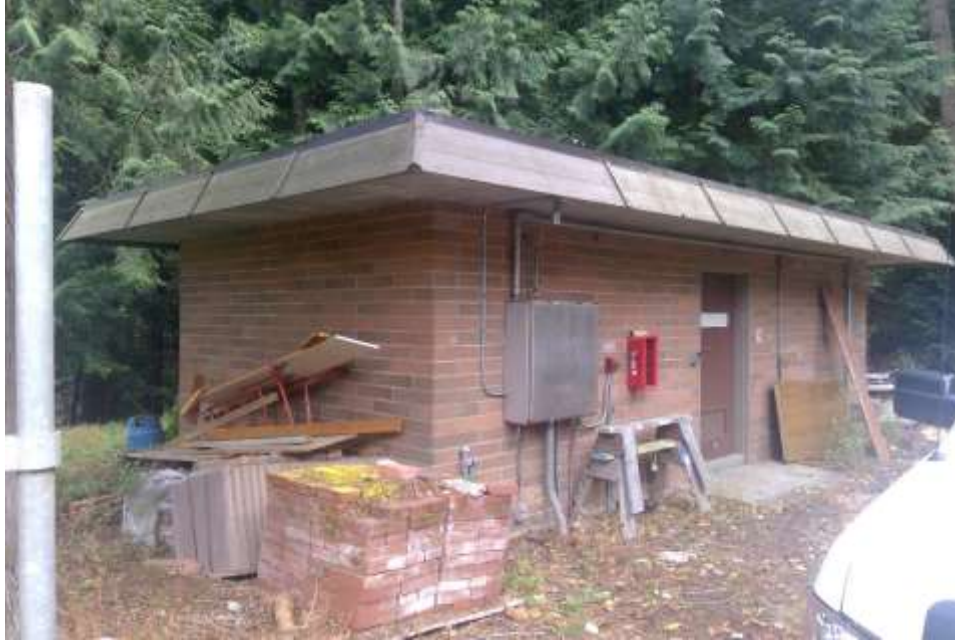
Fuel (070-F) STATE UFI: A25235 Main Campus (070A)
 AREA: 288 SF BUILT: 0 REMODELED: No PREDOMINANT USE: Classroom
 CONSTRUCTION TYPE: No data CRV/SF: \$356 REPLACEMENT VALUE: \$102,528

Primary Systems			
COMPONENT:	Structure	RATING: 1 x WEIGHT: 11.6 =	SCORE: 11.6
No signs of settlement or cracking, no abrupt vertical changes Columns, bearing walls and roof structure appears sound/free of defects			
COMMENTS:	No data		
COMPONENT:	Exterior Closure	RATING: 2 x WEIGHT: 11.6 =	SCORE: 23.1
Weatherproof exterior, but finish appears poorly maintained			
COMMENTS:	No data		
COMPONENT:	Roofing	RATING: 2 x WEIGHT: 14.5 =	SCORE: 28.9
Majority of roofing and flashing appear sound, but a small portion of roofing shows deterioration where maintenance or minor repair needed			
COMMENTS:	No data

Secondary Systems			
COMPONENT:	Floor Finishes	RATING: 0 x WEIGHT: 0 =	SCORE: 0
No data			
COMMENTS:	No Comments		
COMPONENT:	Wall Finishes	RATING: 0 x WEIGHT: 0 =	SCORE: 0
No data			
COMMENTS:	No data		
COMPONENT:	Ceiling Finishes	RATING: 0 x WEIGHT: 0 =	SCORE: 0
No data			
COMMENTS:	No data		
COMPONENT:	Doors & Hardware	RATING: 3 x WEIGHT: 8.7 =	SCORE: 26
Functional, but dated; some maintenance required			
COMMENTS:	No data

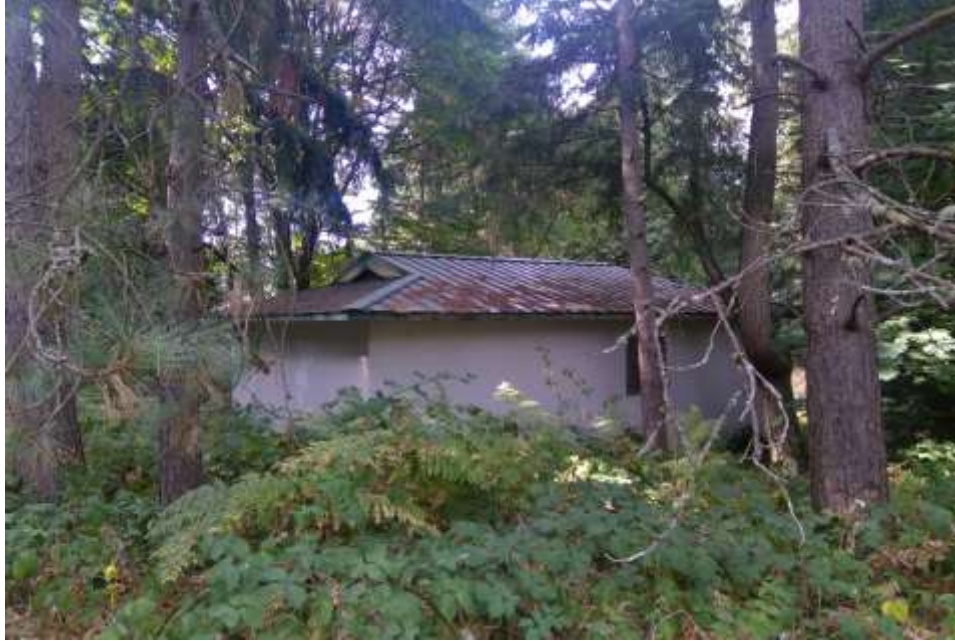
Pump House (070-P) STATE UFI: A25236 Main Campus (070A)
AREA: 594 SF BUILT: 0 REMODELED: No PREDOMINANT USE: Utilities
CONSTRUCTION TYPE: No data CRV/SF: \$231 REPLACEMENT VALUE: \$137,214

Primary Systems			
COMPONENT:	Structure	RATING: 1 x WEIGHT: 10.2 =	SCORE: 10.2
No signs of settlement or cracking, no abrupt vertical changes Columns, bearing walls and roof structure appears sound/free of defects			
COMMENTS:	No data		
COMPONENT:	Exterior Closure	RATING: 2 x WEIGHT: 10.2 =	SCORE: 20.5
Weatherproof exterior, but finish appears poorly maintained			
COMMENTS:	No data		
COMPONENT:	Roofing	RATING: 3 x WEIGHT: 12.8 =	SCORE: 38.4
Some deterioration is evident in membrane and flashings; maintenance or minor repair is needed			
COMMENTS:	No data

Secondary Systems			
COMPONENT:	Floor Finishes	RATING: 0 x WEIGHT: 0 =	SCORE: 0
No data			
COMMENTS:	No data		
COMPONENT:	Wall Finishes	RATING: 0 x WEIGHT: 0 =	SCORE: 0
No data			
COMMENTS:	No data		
COMPONENT:	Ceiling Finishes	RATING: 2 x WEIGHT: 7.7 =	SCORE: 15.4
Aging surfaces in fair condition and good alignment			
COMMENTS:	No data		
COMPONENT:	Doors & Hardware	RATING: 2 x WEIGHT: 7.7 =	SCORE: 15.4
Fairly modern door surfaces and hardware with minor deterioration; good working order			
COMMENTS:	No data

Service Systems			
COMPONENT:	Elevators	RATING: 0 x WEIGHT: 0 =	SCORE: 0
No data			
COMMENTS:	No data		
COMPONENT:	Plumbing	RATING: 0 x WEIGHT: 0 =	SCORE: 0
No data			
COMMENTS:	No data		
COMPONENT:	HVAC	RATING: 4 x WEIGHT: 10.2 =	SCORE: 41
System partially adequate; many areas served by equipment needing repair; areas with A/C very limited, but hazardous areas are ventilated			
COMMENTS:	No data		
COMPONENT:	Electrical	RATING: 1 x WEIGHT: 10.2 =	SCORE: 10.2
Adequate service and distribution capacity for current/future needs			
COMMENTS:	No data		
COMPONENT:	Lights/Power	RATING: 2 x WEIGHT: 10.2 =	SCORE: 20.5
Contemporary lighting with good work area illumination; adequate number of outlets; some finishes appear aged			
COMMENTS:	No data

Safety Systems			
COMPONENT:	Life/Safety	RATING: 3 x WEIGHT: 12.8 =	SCORE: 38.4
Generally meets codes for vintage of construction			
COMMENTS:	No data		
COMPONENT:	Fire Safety	RATING: 2 x WEIGHT: 12.8 =	SCORE: 25.6
Locally monitored detection; alarm present, but missing visual component or sprinklers			
COMMENTS:	No data		
COMPONENT:	Modifications	RATING: 1 x WEIGHT: 9 =	SCORE: 9
Modifications appear to be in compliance with codes and sound construction practices; HVAC/electrical service properly provided			
COMMENTS:	No data

Quality Standards			
COMPONENT:	Maintenance	RATING: 2 x WEIGHT: 9 =	SCORE: 17.9
Routine maintenance is required; impact is minor			
COMMENTS:	No data		
COMPONENT:	Remaining Life	RATING: 1 x WEIGHT: 7.7 =	SCORE: 7.7
Life expectancy is >20 years; minor system deterioration			
COMMENTS:	No data		
COMPONENT:	Appearance	RATING: 3 x WEIGHT: 7.7 =	SCORE: 23.1
Average construction; average interior and exterior appearance			
COMMENTS:	No data

Heat Loss			
COMPONENT:	Insulation	RATING: 4 x WEIGHT: 7.7 =	SCORE: 30.7
Insulation present in some areas or systems, but missing in other areas or systems			
COMMENTS:	No data		
COMPONENT:	Glazing	RATING: 0 x WEIGHT: 0 =	SCORE: 0
No data			
COMMENTS:	No data

CONDITION: Needs Improvement/Additional Maintenance
