2023 FACILITY CONDITION SURVEY

Skagit Valley College

SURVEY CONDUCTED BY:
Steve Lewandowski
State Board for Community
and Technical Colleges

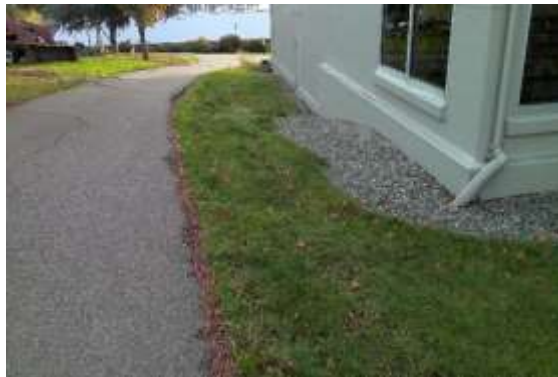
Carryover from prior survey : No
Location : Whidbey Campus (040C)
Building name : Whidbey Hayes Hall (040-18)
Unique Facility Identifier (UFI) : A09219
Funding category in capital budget : Minor Works Facility appropriation
Unifomat category : B20-Exterior Enclosure
Assessment : Asset should be repaired to extend its useful life
Quantity : 50
Unit of measurement : LF
Component : Concrete joints
Location within building or site : East wall
Issue clarity : Adequate information was provided to assess deficiency
Main cause of asset degradation or failure : Age/Wear
Detailed description : The east wall of the library has an exterior concrete retaining wall that allows water to infiltrate the wall near the base. The lower portion of the wall materials become saturated during rain events. The footing drain and exterior waterproofing no longer maintain a water-tight condition. The east wall waterproofing membrane and footing drain should be replaced to maintain a water-tight condition

Recommended funding schedule : Immediate (scoring weight=4)
Estimated remaining life (years) : 3
Estimated average life expectancy (years) : 30
Scoring priority category 1 : High Repair/Repl. Cost (scoring weight=12)
Category 1 percentage : 70 %
Scoring priority category 2 : System Use (scoring weight=15)
Category 2 percentage : 30 %
Project construction estimate (MACC): \$50,000
Total project estimate (including soft costs): \$70,000
Additional points based on building condition: 1
Deficiency score : $4 \times ((12 \times 70\%) + (15 \times 30\%)) + 1 = 52.6$

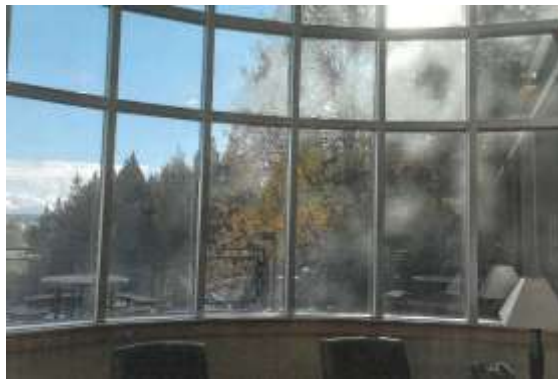
Deficiency F16

Carryover from prior survey : No
Location : San Juan Center (040H)
Building name : San Juan Center (040-89)
Unique Facility Identifier (UFI) : A04979
Funding category in capital budget : Minor Works Facility appropriation
Uniformat category : B20-Exterior Enclosure
Assessment : Asset should be repaired to extend its useful life
Quantity : 1
Unit of measurement : LS
Component : Storefront system
Location within building or site : 2nd floor
Issue clarity : Adequate information was provided to assess deficiency
Main cause of asset degradation or failure : Weather
Detailed description : The storefront system in the building lobby has failed. Several glazing panels have also failed. The water intrusion has caused damage to the interior walls. The storefront system and related interior damage should be repaired. The failed glazing panels should also be replaced.
Recommended funding schedule : Immediate (scoring weight=4)

Estimated remaining life (years) : 3
Estimated average life expectancy (years) : 30
Scoring priority category 1 : System Use (scoring weight=15)
Category 1 percentage : 60 %
Scoring priority category 2 : High Repair/Repl. Cost (scoring weight=12)
Category 2 percentage : 40 %
Project construction estimate (MACC): \$72,000
Total project estimate (including soft costs): \$100,000
Additional points based on building condition: 1
Deficiency score : $4 \times ((15 \times 60\%) + (12 \times 40\%)) + 1 = 56.2$

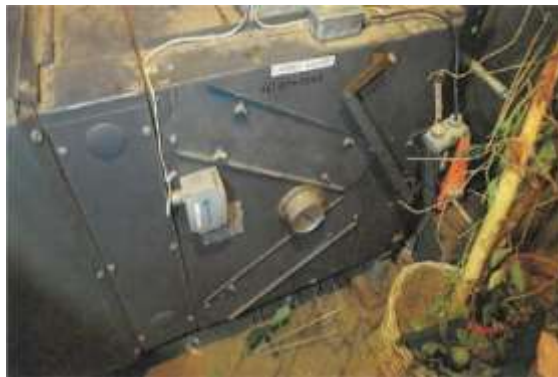
Deficiency F17

Carryover from prior survey : No
Location : Main Campus (040A)
Building name : Hodson Hall (040-40)
Unique Facility Identifier (UFI) : A09436
Funding category in capital budget : Minor Works Facility appropriation
Unifomat category : D30-HVAC
Assessment : Asset is near or at the end of its useful life and should be replaced
Quantity : 1
Unit of measurement : EA
Component : HVAC unit
Location within building or site : Attic
Issue clarity : Adequate information was provided to assess deficiency
Main cause of asset degradation or failure : Age/Wear
Detailed description : The college is concerned about the HVAC unit serving the theater space. It has exceeded its expected life, but still functions as designed and is still maintainable. The unit was not replaced during the theater remodel in 2008 (minor works program project). The unit should be replaced.
Recommended funding schedule : Fund in Next Biennium (scoring weight=2.5)

Estimated remaining life (years) : 5
Estimated average life expectancy (years) : 25
Scoring priority category 1 : High Repair/Repl. Cost (scoring weight=12)
Category 1 percentage : 60 %
Scoring priority category 2 : System Use (scoring weight=15)
Category 2 percentage : 40 %
Project construction estimate (MACC): \$384,000
Total project estimate (including soft costs): \$538,000
Additional points based on building condition: 1
Deficiency score : $2.5 \times ((12 \times 60\%) + (15 \times 40\%)) + 1 = 34$

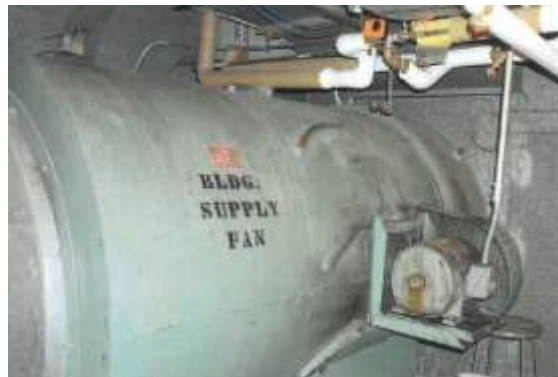
Deficiency F18

Carryover from prior survey : No
Location : Main Campus (040A)
Building name : Roberts Hall (040-80)
Unique Facility Identifier (UFI) : A09398
Funding category in capital budget : Minor Works Facility appropriation
Unifomat category : D30-HVAC
Assessment : Asset is near or at the end of its useful life and should be replaced
Quantity : 1
Unit of measurement : EA
Component : Air handler
Location within building or site : Attic
Issue clarity : Adequate information was provided to assess deficiency
Main cause of asset degradation or failure : Age/Wear
Detailed description : The college is concerned about the age of the air handler unit serving classroom spaces. The unit has required maintenance and minor repairs to remain functional. It is not known at the time of the survey if the system could be re-conditioned to extend its useful life or if the system would require complete replacement (which has significant cost). A consultant evaluation of the system indicated that the equipment has reached the end of its expected life, but can continue to be useful with additional maintenance. The air handler should continue to be maintained and be replaced in the future.

Recommended funding schedule : Fund in Next Biennium (scoring weight=2.5)
Estimated remaining life (years) : 5
Estimated average life expectancy (years) : 40
Scoring priority category 1 : System Use (scoring weight=15)
Category 1 percentage : 60 %
Scoring priority category 2 : High Repair/Repl. Cost (scoring weight=12)
Category 2 percentage : 40 %
Project construction estimate (MACC): \$783,000
Total project estimate (including soft costs): \$1,098,000
Additional points based on building condition: 2
Deficiency score : $2.5 \times ((15 \times 60\%) + (12 \times 40\%)) + 2 = 36.5$

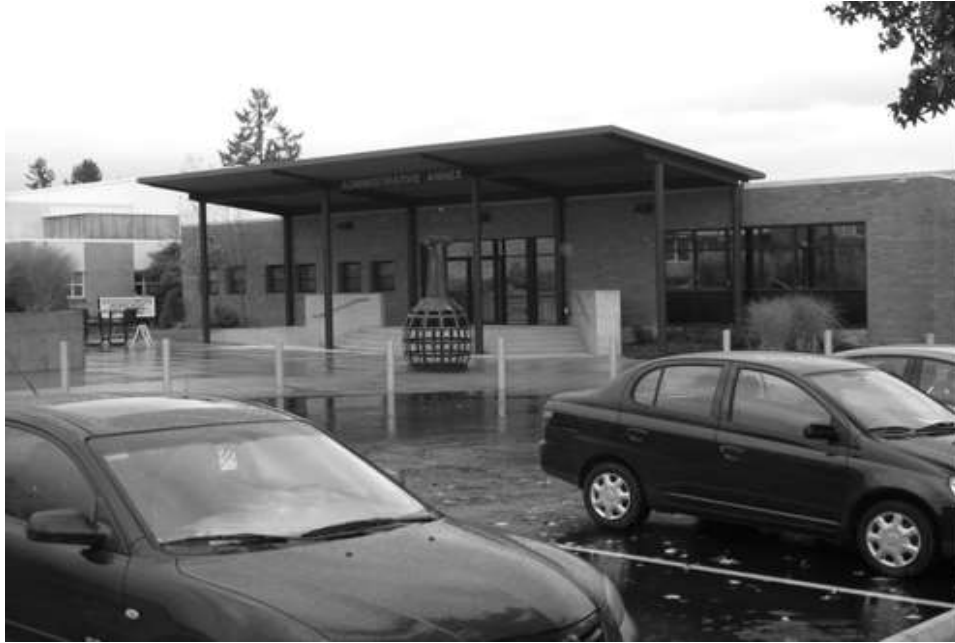
Administrative Annex (040-37) STATE UFI: A00766 Main Campus (040A)
 AREA: 10,224 SF BUILT: 1986 REMODELED: 2008 PREDOMINANT USE: Administration
 CONSTRUCTION TYPE: Medium CRV/SF: \$336 REPLACEMENT VALUE: \$3,435,264

Primary Systems			
COMPONENT:	Structure	RATING: 1 x WEIGHT: 8.3 =	SCORE: 8.3
No signs of settlement or cracking, no abrupt vertical changes Columns, bearing walls and roof structure appears sound/free of defects			
COMMENTS:	Wood frame & trusses; glu-lam beams		
COMPONENT:	Exterior Closure	RATING: 2 x WEIGHT: 8.3 =	SCORE: 16.7
Weatherproof exterior, but finish appears poorly maintained			
COMMENTS:	Brick veneer; EIFS; stucco; corrugated metal panels; concrete		
COMPONENT:	Roofing	RATING: 1 x WEIGHT: 10.4 =	SCORE: 10.4
Flashing and penetrations appear sound and membrane appears water- tight; drainage is positive and there are overflow scuppers			
COMMENTS:	TPO single-ply membrane; replaced in 2013

Secondary Systems			
COMPONENT:	Floor Finishes	RATING: 1 x WEIGHT: 6.3 =	SCORE: 6.3
Nice appearance, smooth transitions, level subfloors, no cracks/separating			
COMMENTS:	Vinyl tile; carpet; ceramic tile		
COMPONENT:	Wall Finishes	RATING: 1 x WEIGHT: 6.3 =	SCORE: 6.3
Maintainable surfaces in good condition			
COMMENTS:	Brick; gypsum board; ceramic tile		
COMPONENT:	Ceiling Finishes	RATING: 1 x WEIGHT: 6.3 =	SCORE: 6.3
Maintainable surfaces in good condition; good alignment and appearance			
COMMENTS:	Lay-in tile; gypsum board; wood decking		
COMPONENT:	Doors & Hardware	RATING: 2 x WEIGHT: 6.3 =	SCORE: 12.5
Fairly modern door surfaces and hardware with minor deterioration; good working order			
COMMENTS:	Interior wood doors/frames; Exterior aluminum doors/frames; HM doors/frames

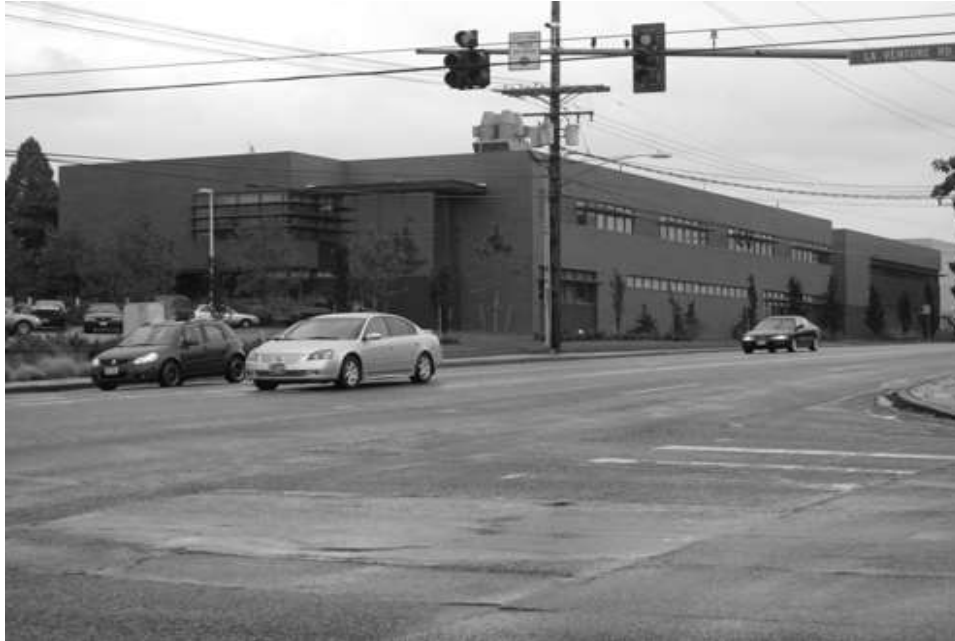
Angst Hall (040-55) STATE UFI: A06053 Main Campus (040A)
 AREA: 67,942 SF BUILT: 2009 REMODELED: No PREDOMINANT USE: Science Lab.
 CONSTRUCTION TYPE: Heavy CRV/SF: \$489 REPLACEMENT VALUE: \$33,223,638

Primary Systems			
COMPONENT:	Structure	RATING: 1 x WEIGHT: 8 =	SCORE: 8
No signs of settlement or cracking, no abrupt vertical changes Columns, bearing walls and roof structure appears sound/free of defects			
COMMENTS:	Structural steel; concrete; brick		
COMPONENT:	Exterior Closure	RATING: 1 x WEIGHT: 8 =	SCORE: 8
Weatherproof, tight, well-maintained exterior walls, doors, windows/finishes			
COMMENTS:	Brick; steel sun shades; aluminum window walls; plexiglass panels		
COMPONENT:	Roofing	RATING: 1 x WEIGHT: 10 =	SCORE: 10
Flashing and penetrations appear sound and membrane appears water- tight; drainage is positive and there are overflow scuppers			
COMMENTS:	Single-ply TPO membrane; skylights

Secondary Systems			
COMPONENT:	Floor Finishes	RATING: 2 x WEIGHT: 6 =	SCORE: 12
Some wear is evident on finish; maintenance needed			
COMMENTS:	Terrazzo; Marmoleum tiles; carpet tile; ceramic tile; sheet vinyl		
COMPONENT:	Wall Finishes	RATING: 1 x WEIGHT: 6 =	SCORE: 6
Maintainable surfaces in good condition			
COMMENTS:	Gypsum board; brick; glass window walls; ceramic tile		
COMPONENT:	Ceiling Finishes	RATING: 1 x WEIGHT: 6 =	SCORE: 6
Maintainable surfaces in good condition; good alignment and appearance			
COMMENTS:	Lay-in tile; gypsum board		
COMPONENT:	Doors & Hardware	RATING: 1 x WEIGHT: 6 =	SCORE: 6
Appropriate hardware, closers, panic devices; in good working order			
COMMENTS:	Interior wood doors w HM frames and HM doors/frames; exterior HM doors/frames and aluminum doors/frames

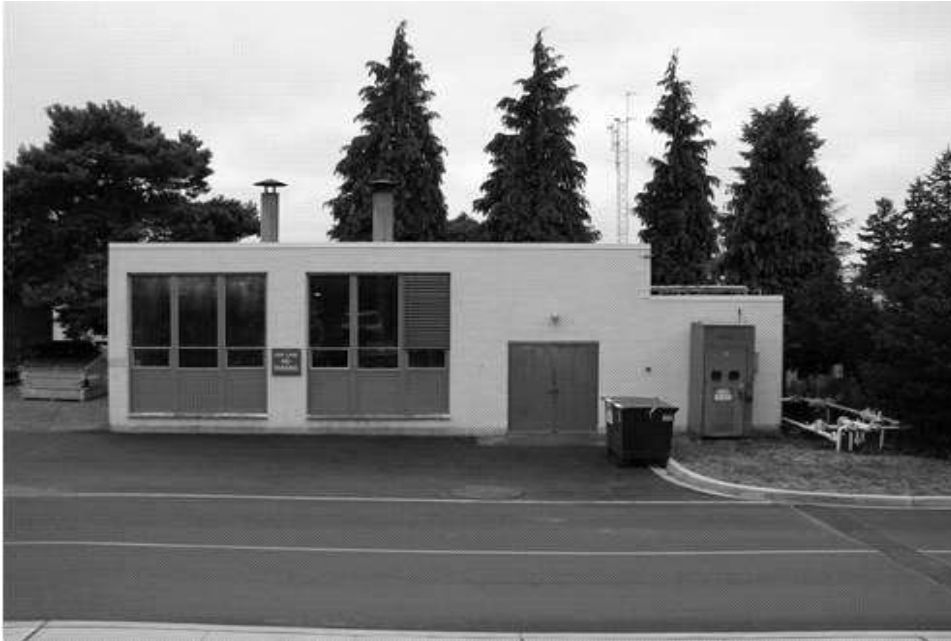
Boiler (040-20) STATE UFI: A01655 Main Campus (040A)
 AREA: 1,443 SF BUILT: 1959 REMODELED: 2004 PREDOMINANT USE: Utility
 CONSTRUCTION TYPE: Heavy CRV/SF: \$330 REPLACEMENT VALUE: \$476,190

Primary Systems			
COMPONENT:	Structure	RATING: 1 x WEIGHT: 9.1 =	SCORE: 9.1
No signs of settlement or cracking, no abrupt vertical changes Columns, bearing walls and roof structure appears sound/free of defects			
COMMENTS:	CMU walls, concrete roof		
COMPONENT:	Exterior Closure	RATING: 2 x WEIGHT: 9.1 =	SCORE: 18.3
Weatherproof exterior, but finish appears poorly maintained			
COMMENTS:	CMU		
COMPONENT:	Roofing	RATING: 3 x WEIGHT: 11.4 =	SCORE: 34.2
Some deterioration is evident in membrane and flashings; maintenance or minor repair is needed			
COMMENTS:	Single ply Hypalon membrane, late 1990s

Secondary Systems			
COMPONENT:	Floor Finishes	RATING: 1 x WEIGHT: 6.8 =	SCORE: 6.8
Nice appearance, smooth transitions, level subfloors, no cracks/separating			
COMMENTS:	Concrete		
COMPONENT:	Wall Finishes	RATING: 2 x WEIGHT: 6.8 =	SCORE: 13.7
Maintainable surfaces, minor maintenance is required in some areas			
COMMENTS:	CMU		
COMPONENT:	Ceiling Finishes	RATING: 0 x WEIGHT: 0 =	SCORE: 0
No data			
COMMENTS:	Concrete		
COMPONENT:	Doors & Hardware	RATING: 3 x WEIGHT: 6.8 =	SCORE: 20.5
Functional, but dated; some maintenance required			
COMMENTS:	Interior wood door w HM frame; exterior HM doors/frames

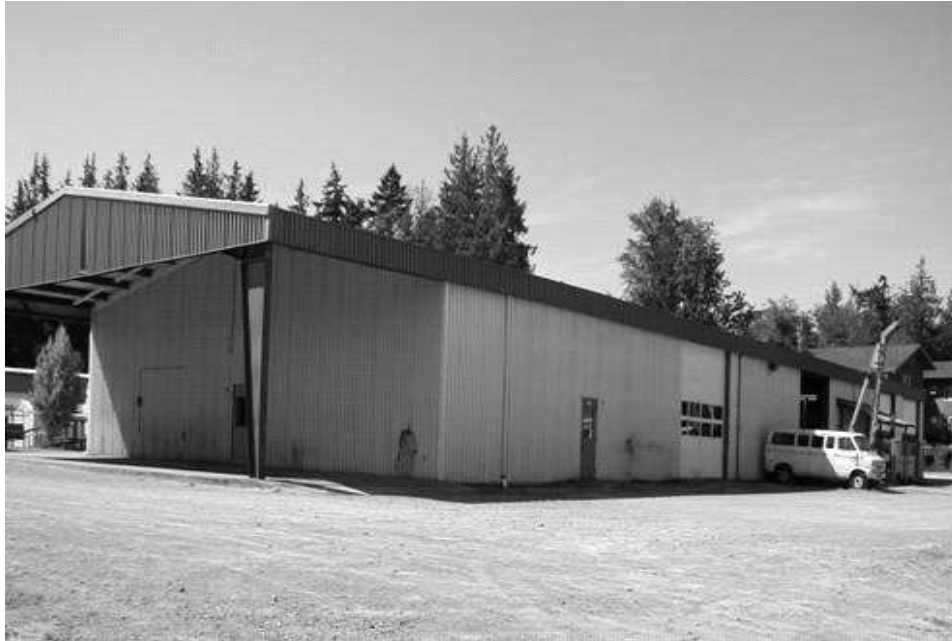
Diesel Building (040-86) STATE UFI: A08595 Main Campus (040A)
 AREA: 10,900 SF BUILT: 1982 REMODELED: No PREDOMINANT USE: Vocational Arts
 CONSTRUCTION TYPE: Heavy CRV/SF: \$3949 REPLACEMENT VALUE: \$43,044,100

Primary Systems			
COMPONENT:	Structure	RATING: 1 x WEIGHT: 8.8 =	SCORE: 8.8
No signs of settlement or cracking, no abrupt vertical changes Columns, bearing walls and roof structure appears sound/free of defects			
COMMENTS:	Steel frame		
COMPONENT:	Exterior Closure	RATING: 3 x WEIGHT: 8.8 =	SCORE: 26.3
Sound and weatherproof but with some physical deterioration evident			
COMMENTS:	Metal corrugated panels		
COMPONENT:	Roofing	RATING: 1 x WEIGHT: 11 =	SCORE: 11
Flashing and penetrations appear sound and membrane appears water- tight; drainage is positive and there are overflow scuppers			
COMMENTS:	Metal roof-2008

Secondary Systems			
COMPONENT:	Floor Finishes	RATING: 1 x WEIGHT: 6.6 = SCORE: 6.6	
	Nice appearance, smooth transitions, level subfloors, no cracks/separating		
COMMENTS:	Concrete; epoxy		
COMPONENT:	Wall Finishes	RATING: 3 x WEIGHT: 6.6 = SCORE: 19.8	
	Aging surfaces, but sound; some maintenance is required		
COMMENTS:	Exposed structure and encapsulated insulation-random damage; gypsum board		
COMPONENT:	Ceiling Finishes	RATING: 3 x WEIGHT: 6.6 = SCORE: 19.8	
	Some wear and tear; Minor damage, staining or deterioration		
COMMENTS:	Exposed structure and encapsulated insulation-random damage; gypsum board		
COMPONENT:	Doors & Hardware	RATING: 2 x WEIGHT: 6.6 = SCORE: 13.2	
	Fairly modern door surfaces and hardware with minor deterioration; good working order		
COMMENTS:	Interior wood doors w HM frames; exterior HM doors/frames and OH metal doors

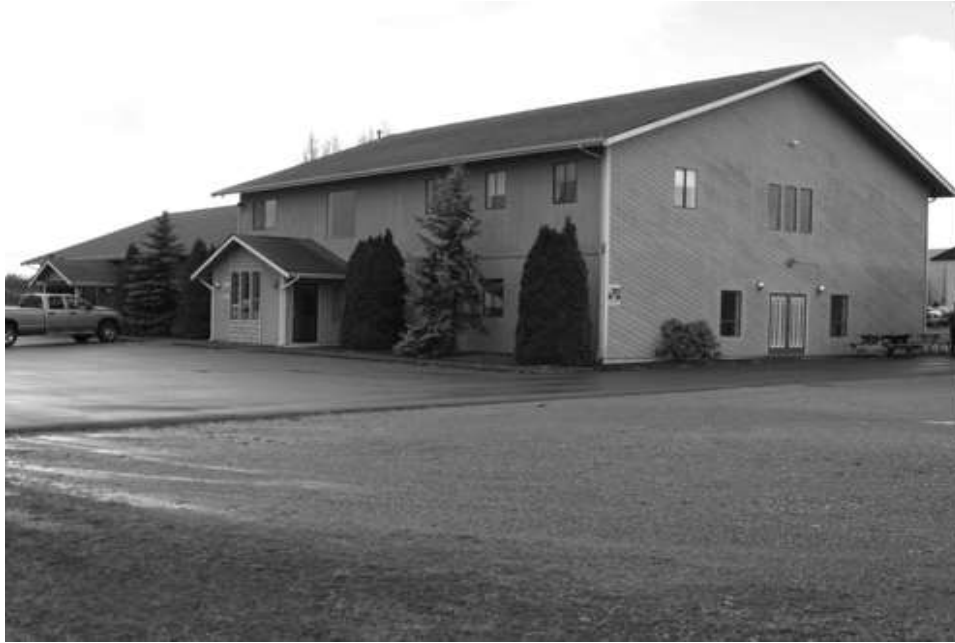
East Campus Building (040-92) STATE UFI: A06954 Main Campus (040A)
AREA: 10,250 SF BUILT: 1984 REMODELED: No PREDOMINANT USE: Vacant
CONSTRUCTION TYPE: Light CRV/SF: \$231 REPLACEMENT VALUE: \$2,367,750

Primary Systems			
COMPONENT:	Structure	RATING: 1 x WEIGHT: 8 =	SCORE: 8
No signs of settlement or cracking, no abrupt vertical changes Columns, bearing walls and roof structure appears sound/free of defects			
COMMENTS:	Wood frame		
COMPONENT:	Exterior Closure	RATING: 2 x WEIGHT: 8 =	SCORE: 16
Weatherproof exterior, but finish appears poorly maintained			
COMMENTS:	Vertical wood siding; cedar shingles		
COMPONENT:	Roofing	RATING: 1 x WEIGHT: 10 =	SCORE: 10
Flashing and penetrations appear sound and membrane appears water- tight; drainage is positive and there are overflow scuppers			
COMMENTS:	New composition asphalt shingle roof 2011-13

Secondary Systems			
COMPONENT:	Floor Finishes	RATING: 2 x WEIGHT: 6 = SCORE: 12	
	Some wear is evident on finish; maintenance needed		
COMMENTS:	Carpet; vinyl tile		
COMPONENT:	Wall Finishes	RATING: 1 x WEIGHT: 6 = SCORE: 6	
	Maintainable surfaces in good condition		
COMMENTS:	Gypsum board		
COMPONENT:	Ceiling Finishes	RATING: 1 x WEIGHT: 6 = SCORE: 6	
	Maintainable surfaces in good condition; good alignment and appearance		
COMMENTS:	Gypsum board; lay-in tile		
COMPONENT:	Doors & Hardware	RATING: 3 x WEIGHT: 6 = SCORE: 18	
	Functional, but dated; some maintenance required		
COMMENTS:	Interior wood doors/frames; exterior wood doors/frames and aluminum doors/frames

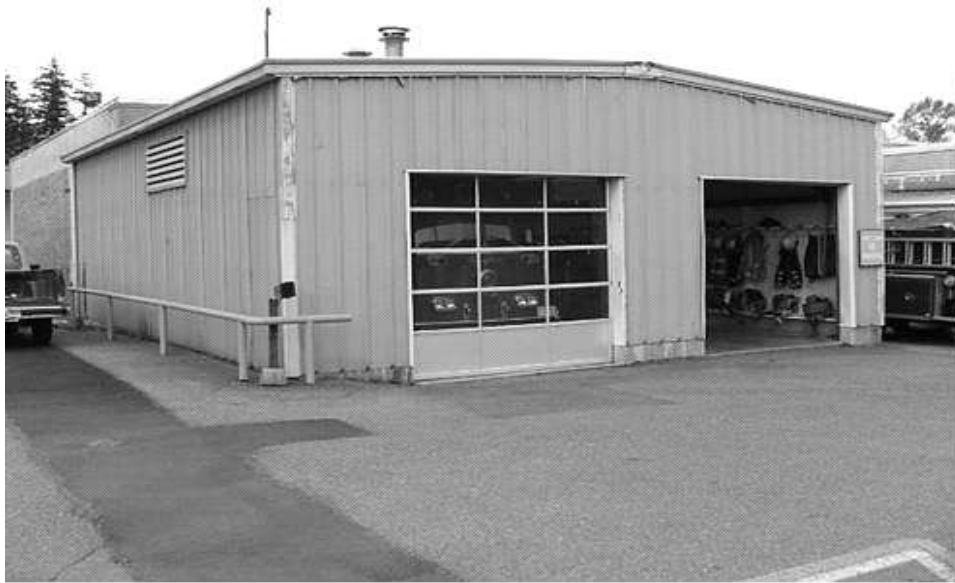
Fire Station (040-81) STATE UFI: A03657 Main Campus (040A)
AREA: 2,400 SF BUILT: 1973 REMODELED: No PREDOMINANT USE: Storage
CONSTRUCTION TYPE: Light CRV/SF: \$198 REPLACEMENT VALUE: \$475,200

Primary Systems			
COMPONENT:	Structure	RATING: 2 x WEIGHT: 9.1 = SCORE: 18.3	
Minor cracks evident in a small portion of the structure			
COMMENTS:	Steel frame		
COMPONENT:	Exterior Closure	RATING: 2 x WEIGHT: 9.1 = SCORE: 18.3	
Weatherproof exterior, but finish appears poorly maintained			
COMMENTS:	Metal corrugated panels		
COMPONENT:	Roofing	RATING: 1 x WEIGHT: 11.4 = SCORE: 11.4	
Flashing and penetrations appear sound and membrane appears water- tight; drainage is positive and there are overflow scuppers			
COMMENTS:	Metal corrugated panels; replacement funded 2023-25

Secondary Systems			
COMPONENT:	Floor Finishes	RATING: 1 x WEIGHT: 6.8 =	SCORE: 6.8
Nice appearance, smooth transitions, level subfloors, no cracks/separating			
COMMENTS:	Concrete		
COMPONENT:	Wall Finishes	RATING: 0 x WEIGHT: 0 =	SCORE: 0
No data			
COMMENTS:	Exposed structure and encapsulated insulation		
COMPONENT:	Ceiling Finishes	RATING: 0 x WEIGHT: 0 =	SCORE: 0
No data			
COMMENTS:	Exposed structure and encapsulated insulation		
COMPONENT:	Doors & Hardware	RATING: 3 x WEIGHT: 6.8 =	SCORE: 20.5
Functional, but dated; some maintenance required			
COMMENTS:	Interior/exterior HM doors/frames; metal glazed OH doors

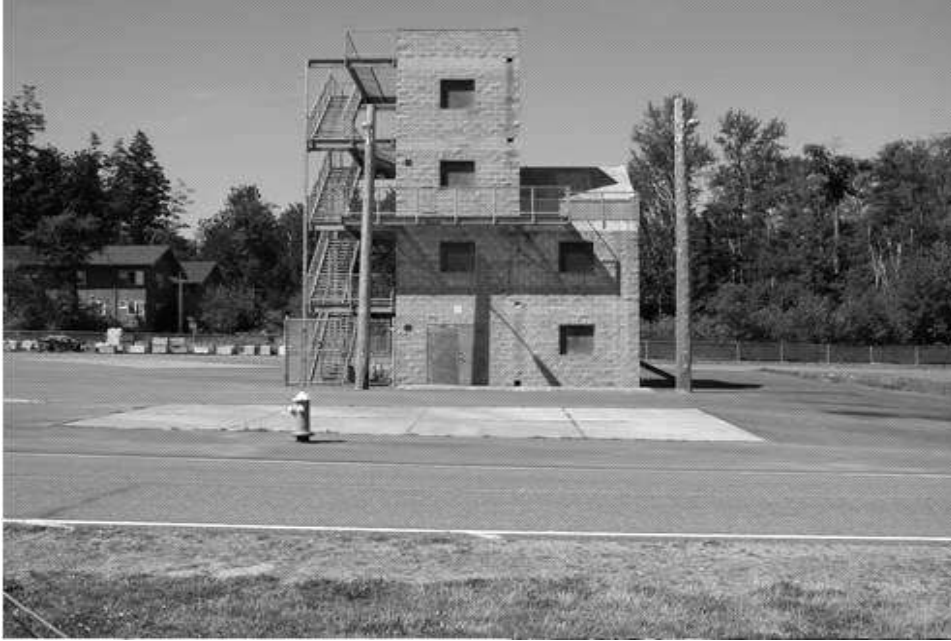
Fire Training Tower (040-71) STATE UFI: A08310 Main Campus (040A)
 AREA: 5,100 SF BUILT: 1998 REMODELED: No PREDOMINANT USE: Training
 CONSTRUCTION TYPE: Medium CRV/SF: \$198 REPLACEMENT VALUE: \$1,009,800

Primary Systems			
COMPONENT:	Structure	RATING: 1 x WEIGHT: 16.5 = SCORE: 16.5	
No signs of settlement or cracking, no abrupt vertical changes Columns, bearing walls and roof structure appears sound/free of defects			
COMMENTS:	CMU, concrete; steel exterior staircase		
COMPONENT:	Exterior Closure	RATING: 3 x WEIGHT: 16.5 = SCORE: 49.4	
Sound and weatherproof but with some physical deterioration evident			
COMMENTS:	CMU		
COMPONENT:	Roofing	RATING: 4 x WEIGHT: 20.6 = SCORE: 82.3	
General deterioration and some leaks are evident; reconditioning or partial repair is needed			
COMMENTS:	Concrete; plywood for training area

Secondary Systems			
COMPONENT:	Floor Finishes	RATING: 0 x WEIGHT: 0 = SCORE: 0	
No data			
COMMENTS:	Concrete		
COMPONENT:	Wall Finishes	RATING: 0 x WEIGHT: 0 = SCORE: 0	
No data			
COMMENTS:	CMU		
COMPONENT:	Ceiling Finishes	RATING: 0 x WEIGHT: 0 = SCORE: 0	
No data			
COMMENTS:	Concrete		
COMPONENT:	Doors & Hardware	RATING: 3 x WEIGHT: 12.3 = SCORE: 37	
Functional, but dated; some maintenance required			
COMMENTS:	Exterior HM door/frame

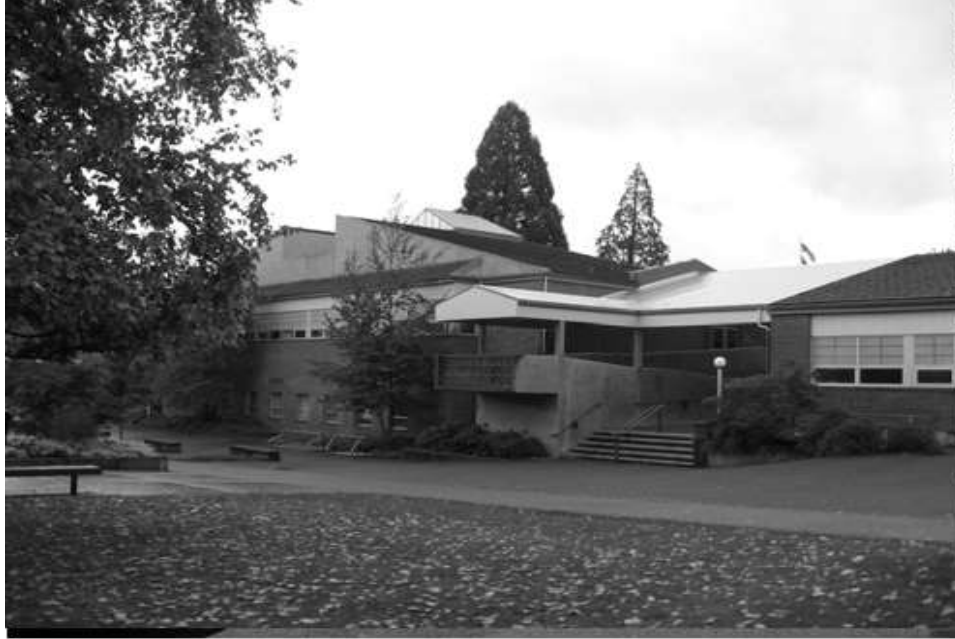
Ford Hall (040-54) STATE UF1: A05075 Main Campus (040A)
 AREA: 23,600 SF BUILT: 1988 REMODELED: No PREDOMINANT USE: Computer Lab.
 CONSTRUCTION TYPE: Medium CRV/SF: \$376 REPLACEMENT VALUE: \$8,873,600

Primary Systems			
COMPONENT:	Structure	RATING: 1 x WEIGHT: 8.4 =	SCORE: 8.4
No signs of settlement or cracking, no abrupt vertical changes Columns, bearing walls and roof structure appears sound/free of defects			
COMMENTS:	Wood frame and trusses; concrete; glu-lam framed breezeway between buildings		
COMPONENT:	Exterior Closure	RATING: 1 x WEIGHT: 8.4 =	SCORE: 8.4
Weatherproof, tight, well-maintained exterior walls, doors, windows/finishes			
COMMENTS:	Brick veneer; stucco		
COMPONENT:	Roofing	RATING: 3 x WEIGHT: 10.5 =	SCORE: 31.5
Some deterioration is evident in membrane and flashings; maintenance or minor repair is needed			
COMMENTS:	Cement tile; corrugated Lexan panels; skylight over light well/atrium

Secondary Systems			
COMPONENT:	Floor Finishes	RATING: 3 x WEIGHT: 6.3 = SCORE: 18.9	
	Some physical wear and minor imperfections are evident; beginning deterioration		
COMMENTS:	Vinyl tile-older and worn; carpet; ceramic tile; rubber; raised floor in server room. New floor 2nd floor 2014		
COMPONENT:	Wall Finishes	RATING: 1 x WEIGHT: 6.3 = SCORE: 6.3	
	Maintainable surfaces in good condition		
COMMENTS:	Gypsum board and ceramic tile		
COMPONENT:	Ceiling Finishes	RATING: 3 x WEIGHT: 6.3 = SCORE: 18.9	
	Some wear and tear; Minor damage, staining or deterioration		
COMMENTS:	Lay-in tiles; gypsum board		
COMPONENT:	Doors & Hardware	RATING: 3 x WEIGHT: 6.3 = SCORE: 18.9	
	Functional, but dated; some maintenance required		
COMMENTS:	Exterior & interior wood doors w HM frames-general wear

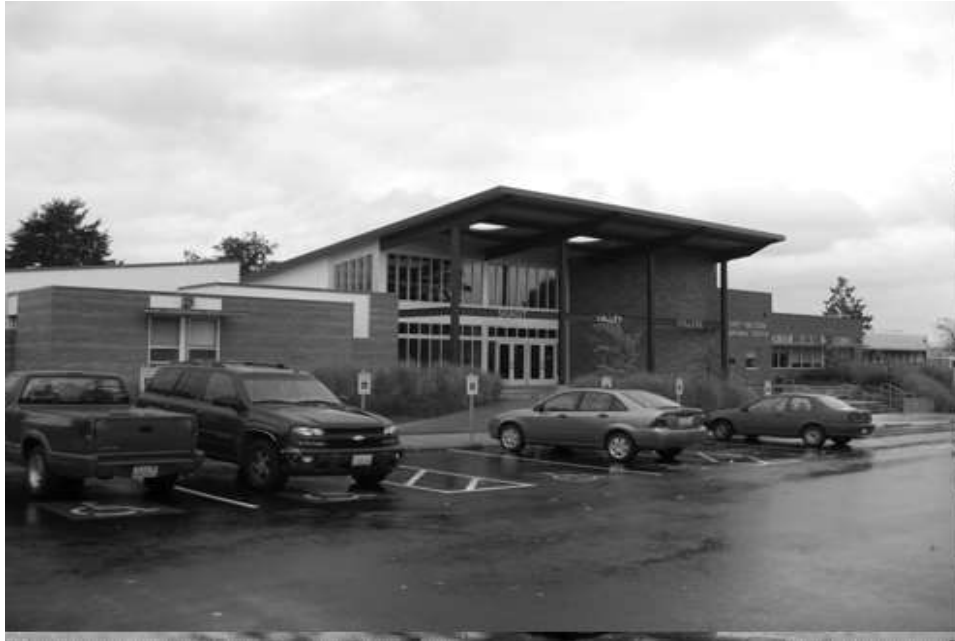
Gary Knutzen Cardinal Center (040-30) STATE UFI: A09143 Main Campus (040A)
AREA: 27,558 SF BUILT: 1959 REMODELED: 2005 PREDOMINANT USE: Student Center
CONSTRUCTION TYPE: Medium CRV/SF: \$391 REPLACEMENT VALUE: \$10,775,178

Primary Systems			
COMPONENT:	Structure	RATING: 1 x WEIGHT: 8.3 =	SCORE: 8.3
No signs of settlement or cracking, no abrupt vertical changes Columns, bearing walls and roof structure appears sound/free of defects			
COMMENTS:	Steel; wood framing		
COMPONENT:	Exterior Closure	RATING: 1 x WEIGHT: 8.3 =	SCORE: 8.3
Weatherproof, tight, well-maintained exterior walls, doors, windows/finishes			
COMMENTS:	Brick; stucco; concrete		
COMPONENT:	Roofing	RATING: 2 x WEIGHT: 10.4 =	SCORE: 20.9
Majority of roofing and flashing appear sound, but a small portion of roofing shows deterioration where maintenance or minor repair needed			
COMMENTS:	Main roof single-ply 2005

Secondary Systems			
COMPONENT:	Floor Finishes	RATING: 1 x WEIGHT: 6.3 =	SCORE: 6.3
Nice appearance, smooth transitions, level subfloors, no cracks/separating			
COMMENTS:	Carpet; vinyl asbestos and composition tile; concrete; ceramic tile; sheet vinyl-some wear		
COMPONENT:	Wall Finishes	RATING: 1 x WEIGHT: 6.3 =	SCORE: 6.3
Maintainable surfaces in good condition			
COMMENTS:	Gypsum board, brick, ceramic tile; moveable partition walls		
COMPONENT:	Ceiling Finishes	RATING: 2 x WEIGHT: 6.3 =	SCORE: 12.5
Aging surfaces in fair condition and good alignment			
COMMENTS:	Gypsum board; lay-in tile; wood decking; metal deck pan		
COMPONENT:	Doors & Hardware	RATING: 2 x WEIGHT: 6.3 =	SCORE: 12.5
Fairly modern door surfaces and hardware with minor deterioration; good working order			
COMMENTS:	Interior wood doors w HM frames-significant surface wear; exterior HM doors/frames; aluminum doors/frames; window wall

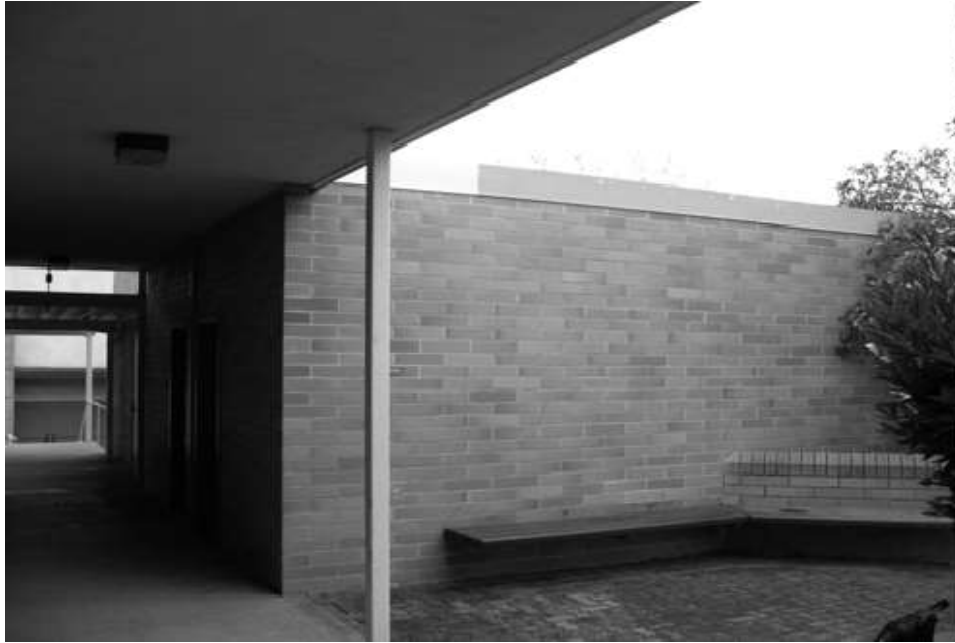
Hodson Exterior Restroom (040-41) STATE UFI: A03904 Main Campus (040A)
AREA: 473 SF BUILT: 1980 REMODELED: No PREDOMINANT USE: Rest Room
CONSTRUCTION TYPE: Medium CRV/SF: \$198 REPLACEMENT VALUE: \$93,654

Primary Systems			
COMPONENT:	Structure	RATING: 1 x WEIGHT: 8.7 =	SCORE: 8.7
No signs of settlement or cracking, no abrupt vertical changes Columns, bearing walls and roof structure appears sound/free of defects			
COMMENTS:	Brick w wood roof framing		
COMPONENT:	Exterior Closure	RATING: 4 x WEIGHT: 8.7 =	SCORE: 34.9
General deterioration detected, one or more minor leaks apparent			
COMMENTS:	Brick		
COMPONENT:	Roofing	RATING: 4 x WEIGHT: 10.9 =	SCORE: 43.6
General deterioration and some leaks are evident; reconditioning or partial repair is needed			
COMMENTS:	PVC single-ply roof

Secondary Systems			
COMPONENT:	Floor Finishes	RATING: 1 x WEIGHT: 6.5 = SCORE: 6.5	
	Nice appearance, smooth transitions, level subfloors, no cracks/separating		
COMMENTS:	Concrete floor w epoxy coating		
COMPONENT:	Wall Finishes	RATING: 1 x WEIGHT: 6.5 = SCORE: 6.5	
	Maintainable surfaces in good condition		
COMMENTS:	Brick and tile		
COMPONENT:	Ceiling Finishes	RATING: 5 x WEIGHT: 6.5 = SCORE: 32.7	
	Deteriorated, significant number of stained or sagging areas; inappropriate for occupancy		
COMMENTS:	Lay-in tile		
COMPONENT:	Doors & Hardware	RATING: 3 x WEIGHT: 6.5 = SCORE: 19.6	
	Functional, but dated; some maintenance required		
COMMENTS:	Wood doors and frames

Service Systems			
COMPONENT:	Elevators	RATING: 0 x WEIGHT: 0 = SCORE: 0	
	No data		
COMMENTS:			
COMPONENT:	Plumbing	RATING: 2 x WEIGHT: 8.7 = SCORE: 17.4	
	Fixtures and piping are functional; finishes require maintenance		
COMMENTS:	Copper, cast iron and ABS piping; porcelain fixtures		
COMPONENT:	HVAC	RATING: 3 x WEIGHT: 8.7 = SCORE: 26.1	
	System generally adequate; some deterioration; needs balancing; some areas have A/C; hazardous areas are ventilated		
COMMENTS:	Baseboard electric heat; exhaust fans		
COMPONENT:	Electrical	RATING: 1 x WEIGHT: 8.7 = SCORE: 8.7	
	Adequate service and distribution capacity for current/future needs		
COMMENTS:	200amp 480/277v		
COMPONENT:	Lights/Power	RATING: 3 x WEIGHT: 8.7 = SCORE: 26.1	
	Adequate work area illumination; adequate outlets for current use; maintenance required		
COMMENTS:	Lay-in fluorescent lights

Safety Systems			
COMPONENT:	Life/Safety	RATING: 3 x WEIGHT: 10.9 = SCORE: 32.7	
	Generally meets codes for vintage of construction		
COMMENTS:			
COMPONENT:	Fire Safety	RATING: 5 x WEIGHT: 10.9 = SCORE: 54.5	
	Life safety or accessibility violations exist; Missing exit signs or extinguishers throughout; No alarm or sprinklers		
COMMENTS:			
COMPONENT:	Modifications	RATING: 1 x WEIGHT: 7.6 = SCORE: 7.6	
	Modifications appear to be in compliance with codes and sound construction practices; HVAC/electrical service properly provided		
COMMENTS:	Adjacent electrical distribution room

Quality Standards			
COMPONENT:	Maintenance	RATING: 3 x WEIGHT: 7.6 = SCORE: 22.9	
	Routine maintenance is required; deferred maintenance is evident; impact is minor to moderate		
COMMENTS:			
COMPONENT:	Remaining Life	RATING: 3 x WEIGHT: 6.5 = SCORE: 19.6	
	Life expectancy is roughly 10-15 years; moderate system deterioration		
COMMENTS:	Should have 10 to 15 year life left. Renovation occurring 2017.		
COMPONENT:	Appearance	RATING: 5 x WEIGHT: 6.5 = SCORE: 32.7	
	Poor to average construction; very unattractive exterior and interior spaces		
COMMENTS:

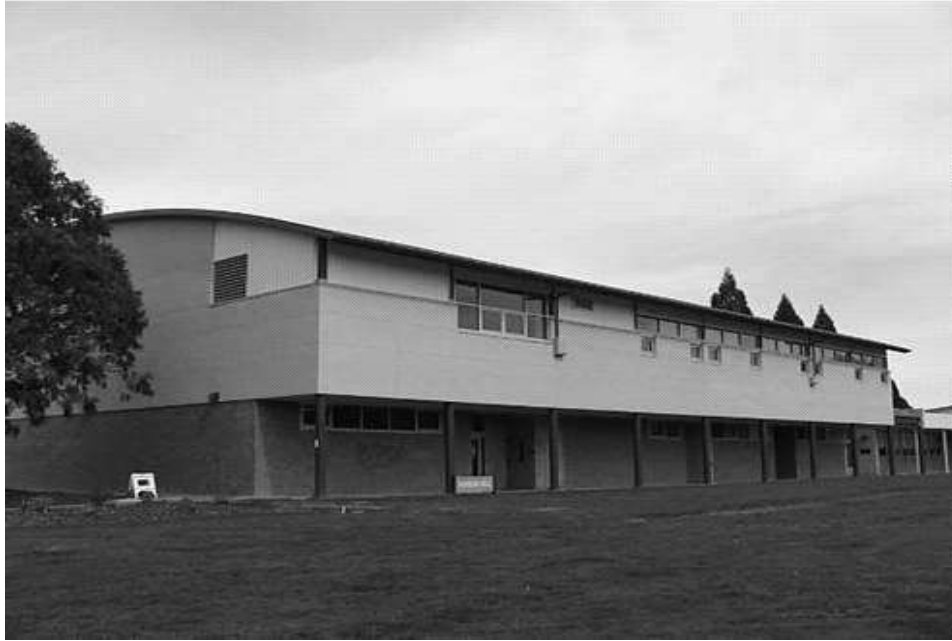
Hodson Hall (040-40) STATE UFI: A09436 Main Campus (040A)
AREA: 31,312 SF BUILT: 1959 REMODELED: 2009 PREDOMINANT USE: Visual Arts
CONSTRUCTION TYPE: Medium CRV/SF: \$421 REPLACEMENT VALUE: \$13,182,352

Primary Systems			
COMPONENT:	Structure	RATING: 2 x WEIGHT: 8 =	SCORE: 16
Minor cracks evident in a small portion of the structure			
COMMENTS: Steel framed original building and second story addition; steel columns; wood framing			
COMPONENT:	Exterior Closure	RATING: 1 x WEIGHT: 8 =	SCORE: 8
Weatherproof, tight, well-maintained exterior walls, doors, windows/finishes			
COMMENTS: Brick; stucco; metal fascia; corrugated metal siding - good condition			
COMPONENT:	Roofing	RATING: 3 x WEIGHT: 10 =	SCORE: 30
Some deterioration is evident in membrane and flashings; maintenance or minor repair is needed			
COMMENTS: Metal standing seam roof; Hypalon single-ply roof

Secondary Systems			
COMPONENT:	Floor Finishes	RATING: 3 x WEIGHT: 6 = SCORE: 18	
Some physical wear and minor imperfections are evident; beginning deterioration			
COMMENTS:	Vinyl tile; carpet; concrete; ceramic tile		
COMPONENT:	Wall Finishes	RATING: 2 x WEIGHT: 6 = SCORE: 12	
Maintainable surfaces, minor maintenance is required in some areas			
COMMENTS:	Gypsum board; concrete; ceramic tile		
COMPONENT:	Ceiling Finishes	RATING: 2 x WEIGHT: 6 = SCORE: 12	
Aging surfaces in fair condition and good alignment			
COMMENTS:	Lay-in tiles; wood slat accents; metal deck pan		
COMPONENT:	Doors & Hardware	RATING: 1 x WEIGHT: 6 = SCORE: 6	
Appropriate hardware, closers, panic devices; in good working order			
COMMENTS:	Interior wood doors w HM frames; exterior HM doors/frames; aluminum doors/frames

Service Systems			
COMPONENT:	Elevators	RATING: 1 x WEIGHT: 6 = SCORE: 6	
Appropriate and functional for occupancy and use			
COMMENTS:	2 stop		
COMPONENT:	Plumbing	RATING: 1 x WEIGHT: 8 = SCORE: 8	
Fixtures and piping appear to be in good condition; no evidence of leaks			
COMMENTS:	Copper, cast iron, steel and PVC piping; porcelain fixtures		
COMPONENT:	HVAC	RATING: 3 x WEIGHT: 8 = SCORE: 24	
System generally adequate; some deterioration; needs balancing; some areas have A/C; hazardous areas are ventilated			
COMMENTS:	4-pipe fan coil units; air-cooled chiller; hydronic heat from central plant; DX cooling; unit heaters; original AHU in theater		
COMPONENT:	Electrical	RATING: 1 x WEIGHT: 8 = SCORE: 8	
Adequate service and distribution capacity for current/future needs			
COMMENTS:	600amp 480/277v		
COMPONENT:	Lights/Power	RATING: 1 x WEIGHT: 8 = SCORE: 8	
Contemporary lighting with good work area illumination; ample outlets

Safety Systems			
COMPONENT:	Life/Safety	RATING: 1 x WEIGHT: 10 = SCORE: 10	
	Appears to meet current codes		
COMMENTS:			
COMPONENT:	Fire Safety	RATING: 1 x WEIGHT: 10 = SCORE: 10	
	Locally monitored detection; alarm and strobes present; sprinklers in high hazard areas		
COMMENTS:			
COMPONENT:	Modifications	RATING: 1 x WEIGHT: 7 = SCORE: 7	
	Modifications appear to be in compliance with codes and sound construction practices; HVAC/electrical service properly provided		
COMMENTS:	2005 and 2009 theater wing remodels and modifications are well constructed and good quality

Quality Standards			
COMPONENT:	Maintenance	RATING: 1 x WEIGHT: 7 = SCORE: 7	
	Facility appears well maintained		
COMMENTS:			
COMPONENT:	Remaining Life	RATING: 1 x WEIGHT: 6 = SCORE: 6	
	Life expectancy is >20 years; minor system deterioration		
COMMENTS:	Soundly constructed building; second story addition in 2005		
COMPONENT:	Appearance	RATING: 2 x WEIGHT: 6 = SCORE: 12	
	Well-constructed building; average interior and exterior appearance		
COMMENTS:

Heat Loss			
COMPONENT:	Insulation	RATING: 3 x WEIGHT: 6 = SCORE: 18	
	Insulation present, but not to current standards (installed prior to 2010)		
COMMENTS:			
COMPONENT:	Glazing	RATING: 4 x WEIGHT: 6 = SCORE: 24	
	Mix of double and single glazed windows		
COMMENTS:	Some single-glazed windows in small area-being replaced in 2011

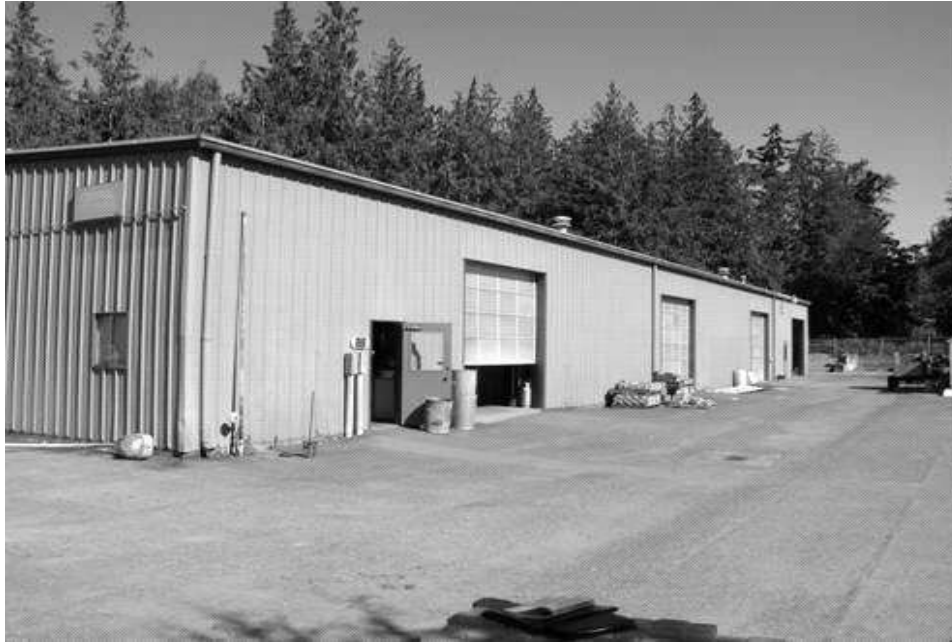
Maintenance Bldg (040-21) STATE UFI: A07870 Main Campus (040A)
AREA: 4,800 SF BUILT: 1976 REMODELED: No PREDOMINANT USE: Maintenance
CONSTRUCTION TYPE: Medium CRV/SF: \$264 REPLACEMENT VALUE: \$1,267,200

Primary Systems			
COMPONENT:	Structure	RATING: 1 x WEIGHT: 8.3 =	SCORE: 8.3
No signs of settlement or cracking, no abrupt vertical changes Columns, bearing walls and roof structure appears sound/free of defects			
COMMENTS:	Steel frame		
COMPONENT:	Exterior Closure	RATING: 3 x WEIGHT: 8.3 =	SCORE: 25
Sound and weatherproof but with some physical deterioration evident			
COMMENTS:	Metal panels-random damage		
COMPONENT:	Roofing	RATING: 2 x WEIGHT: 10.4 =	SCORE: 20.9
Majority of roofing and flashing appear sound, but a small portion of roofing shows deterioration where maintenance or minor repair needed			
COMMENTS:	Deteriorating metal roof and gutters; new roof funded in 2007; will not be done

Secondary Systems			
COMPONENT:	Floor Finishes	RATING: 3 x WEIGHT: 6.3 =	SCORE: 18.8
Some physical wear and minor imperfections are evident; beginning deterioration			
COMMENTS:	Concrete; carpet		
COMPONENT:	Wall Finishes	RATING: 3 x WEIGHT: 6.3 =	SCORE: 18.8
Aging surfaces, but sound; some maintenance is required			
COMMENTS:	Exposed structure and encapsulated insulation; gypsum board		
COMPONENT:	Ceiling Finishes	RATING: 3 x WEIGHT: 6.3 =	SCORE: 18.8
Some wear and tear; Minor damage, staining or deterioration			
COMMENTS:	Exposed structure and encapsulated insulation; gypsum board		
COMPONENT:	Doors & Hardware	RATING: 3 x WEIGHT: 6.3 =	SCORE: 18.8
Functional, but dated; some maintenance required			
COMMENTS:	Interior/exterior HM doors/frames; OH metal doors-random dents

Service Systems			
COMPONENT:	Elevators	RATING: 0 x WEIGHT: 0 =	SCORE: 0
No data			
COMMENTS:			
COMPONENT:	Plumbing	RATING: 2 x WEIGHT: 8.3 =	SCORE: 16.7
Fixtures and piping are functional; finishes require maintenance			
COMMENTS:	Copper and cast iron piping; porcelain fixtures		
COMPONENT:	HVAC	RATING: 3 x WEIGHT: 8.3 =	SCORE: 25
System generally adequate; some deterioration; needs balancing; some areas have A/C; hazardous areas are ventilated			
COMMENTS:	No ventilation; unit heaters only; no shop dust collection; window A/C		
COMPONENT:	Electrical	RATING: 3 x WEIGHT: 8.3 =	SCORE: 25
Service capacity meets current needs but inadequate for future			
COMMENTS:	200amp 208/120v		
COMPONENT:	Lights/Power	RATING: 3 x WEIGHT: 8.3 =	SCORE: 25
Adequate work area illumination; adequate outlets for current use; maintenance required			
COMMENTS:	Hanging and ceiling-mount fluorescent and high bay mercury vapor lighting;

Safety Systems			
COMPONENT:	Life/Safety	RATING: 3 x WEIGHT: 10.4 = SCORE: 31.3	
Generally meets codes for vintage of construction			
COMMENTS:			
COMPONENT:	Fire Safety	RATING: 5 x WEIGHT: 10.4 = SCORE: 52.1	
Life safety or accessibility violations exist; Missing exit signs or extinguishers throughout; No alarm or sprinklers			
COMMENTS:			
COMPONENT:	Modifications	RATING: 3 x WEIGHT: 7.3 = SCORE: 21.9	
Some modifications lack code compliance; HVAC service not fully considered during renovation			
COMMENTS: Many small interior modifications; generally haphazard

Quality Standards			
COMPONENT:	Maintenance	RATING: 3 x WEIGHT: 7.3 = SCORE: 21.9	
Routine maintenance is required; deferred maintenance is evident; impact is minor to moderate			
COMMENTS:			
COMPONENT:	Remaining Life	RATING: 3 x WEIGHT: 6.3 = SCORE: 18.8	
Life expectancy is roughly 10-15 years; moderate system deterioration			
COMMENTS: Building and site may be taken over by a local school consortium in 3 to 5 years			
COMPONENT:	Appearance	RATING: 4 x WEIGHT: 6.3 = SCORE: 25	
Average construction; some unattractive exterior and interior spaces			
COMMENTS:

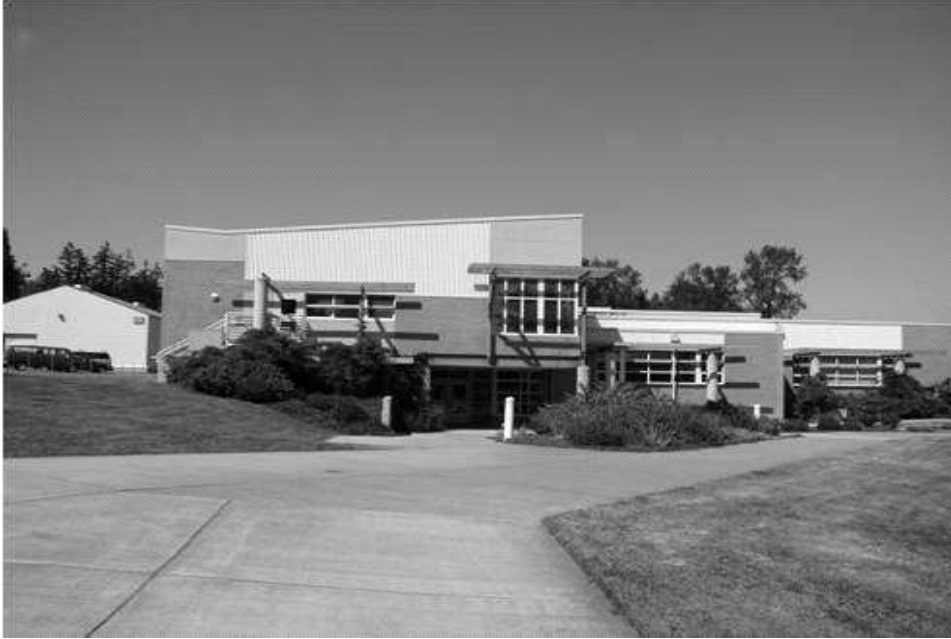
Nelson Hall (040-82) STATE UFI: A07932 Main Campus (040A)
AREA: 13,055 SF BUILT: 1996 REMODELED: No PREDOMINANT USE: General Classroom
CONSTRUCTION TYPE: Medium CRV/SF: \$376 REPLACEMENT VALUE: \$4,908,680

Primary Systems			
COMPONENT:	Structure	RATING: 2 x WEIGHT: 8.4 =	SCORE: 16.8
Minor cracks evident in a small portion of the structure			
COMMENTS:	Wood frame and concrete		
COMPONENT:	Exterior Closure	RATING: 1 x WEIGHT: 8.4 =	SCORE: 8.4
Weatherproof, tight, well-maintained exterior walls, doors, windows/finishes			
COMMENTS:	Brick veneer; corrugated metal siding; stucco		
COMPONENT:	Roofing	RATING: 3 x WEIGHT: 10.5 =	SCORE: 31.5
Some deterioration is evident in membrane and flashings; maintenance or minor repair is needed			
COMMENTS:	Hypalon single ply membrane

Secondary Systems			
COMPONENT:	Floor Finishes	RATING: 2 x WEIGHT: 6.3 =	SCORE: 12.6
Some wear is evident on finish; maintenance needed			
COMMENTS:	Ceramic tile; rubber; carpet-random wear; vinyl tile		
COMPONENT:	Wall Finishes	RATING: 1 x WEIGHT: 6.3 =	SCORE: 6.3
Maintainable surfaces in good condition			
COMMENTS:	Gypsum board; concrete; ceramic tile		
COMPONENT:	Ceiling Finishes	RATING: 1 x WEIGHT: 6.3 =	SCORE: 6.3
Maintainable surfaces in good condition; good alignment and appearance			
COMMENTS:	Gypsum board; lay-in tile		
COMPONENT:	Doors & Hardware	RATING: 3 x WEIGHT: 6.3 =	SCORE: 18.9
Functional, but dated; some maintenance required			
COMMENTS:	Interior wood doors w HM frames; exterior HM doors/frames-worn

Service Systems			
COMPONENT:	Elevators	RATING: 2 x WEIGHT: 6.3 =	SCORE: 12.6
Aged elevators functional, but deterioration or abuse of finishes is evident			
COMMENTS:	3 stop (2 story split level building)		
COMPONENT:	Plumbing	RATING: 1 x WEIGHT: 8.4 =	SCORE: 8.4
Fixtures and piping appear to be in good condition; no evidence of leaks			
COMMENTS:	Copper, cast iron, steel and ABS piping; porcelain fixtures		
COMPONENT:	HVAC	RATING: 3 x WEIGHT: 8.4 =	SCORE: 25.2
System generally adequate; some deterioration; needs balancing; some areas have A/C; hazardous areas are ventilated			
COMMENTS:	AHUs w VAVs; DX cooling (AC units funded 2021, but not completed); hydronic and steam heat from central plant		
COMPONENT:	Electrical	RATING: 1 x WEIGHT: 8.4 =	SCORE: 8.4
Adequate service and distribution capacity for current/future needs			
COMMENTS:	400amp 480/277v		
COMPONENT:	Lights/Power	RATING: 1 x WEIGHT: 8.4 =	SCORE: 8.4

Quality Standards			
COMPONENT:	Maintenance	RATING: 1 x WEIGHT: 7.4 =	SCORE: 7.4
Facility appears well maintained			
COMMENTS:			
COMPONENT:	Remaining Life	RATING: 1 x WEIGHT: 6.3 =	SCORE: 6.3
Life expectancy is >20 years; minor system deterioration			
COMMENTS: Relatively new facility			
COMPONENT:	Appearance	RATING: 1 x WEIGHT: 6.3 =	SCORE: 6.3
Well-constructed building; generally attractive interior and exterior			
COMMENTS:

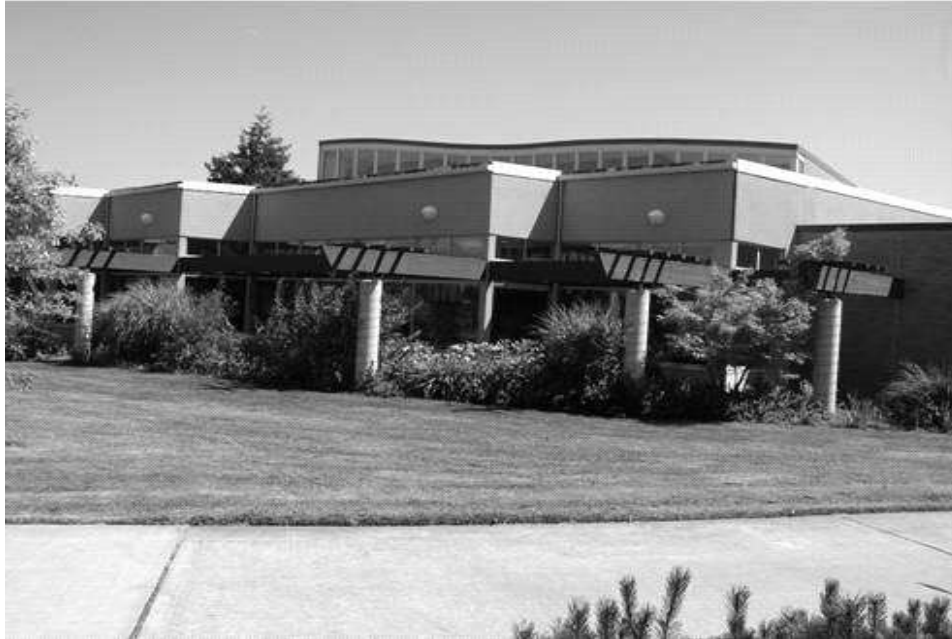
Norwood Cole Library (040-70) STATE UFI: A05680 Main Campus (040A)
AREA: 26,730 SF BUILT: 1963 REMODELED: 1995 PREDOMINANT USE: Library
CONSTRUCTION TYPE: Medium CRV/SF: \$376 REPLACEMENT VALUE: \$10,050,480

Primary Systems			
COMPONENT:	Structure	RATING: 3 x WEIGHT: 8.3 =	SCORE: 25
Some cracking evident but does not likely affect structural integrity; Visible defects apparent but are non-structural			
COMMENTS:	Steel columns and joists; concrete columns; steel beams; exterior wood trellis		
COMPONENT:	Exterior Closure	RATING: 1 x WEIGHT: 8.3 =	SCORE: 8.3
Weatherproof, tight, well-maintained exterior walls, doors, windows/finishes			
COMMENTS:	Brick veneer; stucco; concrete; brick cracks in multiple areas; stucco deterioration at some corners		
COMPONENT:	Roofing	RATING: 3 x WEIGHT: 10.4 =	SCORE: 31.3
Some deterioration is evident in membrane and flashings; maintenance or minor repair is needed			
COMMENTS:	TPO single-ply membrane; cap sheet BUR-edges at gutters need sealing; standing seam metal cap

Secondary Systems			
COMPONENT:	Floor Finishes	RATING: 3 x WEIGHT: 6.3 = SCORE: 18.8	
	Some physical wear and minor imperfections are evident; beginning deterioration		
COMMENTS:	Vinyl tile; carpet; ceramic tile		
COMPONENT:	Wall Finishes	RATING: 1 x WEIGHT: 6.3 = SCORE: 6.3	
	Maintainable surfaces in good condition		
COMMENTS:	Gypsum board; concrete; ceramic tile		
COMPONENT:	Ceiling Finishes	RATING: 3 x WEIGHT: 6.3 = SCORE: 18.8	
	Some wear and tear; Minor damage, staining or deterioration		
COMMENTS:	Gypsum board; lay-in tile; vent wood; direct-adhered tile		
COMPONENT:	Doors & Hardware	RATING: 1 x WEIGHT: 6.3 = SCORE: 6.3	
	Appropriate hardware, closers, panic devices; in good working order		
COMMENTS:	Interior wood doors w HM frames; exterior HM and aluminum doors/frames

Service Systems			
COMPONENT:	Elevators	RATING: 0 x WEIGHT: 0 = SCORE: 0	
	No data		
COMMENTS:			
COMPONENT:	Plumbing	RATING: 3 x WEIGHT: 8.3 = SCORE: 25	
	Fixtures are functional but dated; some leaks; maintenance required		
COMMENTS:	Copper, cast iron, steel and ABS piping; porcelain fixtures		
COMPONENT:	HVAC	RATING: 3 x WEIGHT: 8.3 = SCORE: 25	
	System generally adequate; some deterioration; needs balancing; some areas have A/C; hazardous areas are ventilated		
COMMENTS:	AHUs-steam from central plant (exchanger); air cooled chiller; rooftop packaged A/C units; no A/C in central stack area		
COMPONENT:	Electrical	RATING: 1 x WEIGHT: 8.3 = SCORE: 8.3	
	Adequate service and distribution capacity for current/future needs		
COMMENTS:	450amp 208/120v; 400amp 408/277v		
COMPONENT:	Lights/Power	RATING: 1 x WEIGHT: 8.3 = SCORE: 8.3	
	Contemporary lighting with good work area illumination; ample outlets		
COMMENTS:	Lay-in, recessed can and hanging circular fluorescent lighting

Safety Systems			
COMPONENT:	Life/Safety	RATING: 1 x WEIGHT: 10.4 =	SCORE: 10.4
Appears to meet current codes			
COMMENTS:			
COMPONENT:	Fire Safety	RATING: 1 x WEIGHT: 10.4 =	SCORE: 10.4
Locally monitored detection; alarm and strobes present; sprinklers in high hazard areas			
COMMENTS:			
COMPONENT:	Modifications	RATING: 3 x WEIGHT: 7.3 =	SCORE: 21.9
Some modifications lack code compliance; HVAC service not fully considered during renovation			
COMMENTS: A/C upgrade not provided during last remodel

Quality Standards			
COMPONENT:	Maintenance	RATING: 2 x WEIGHT: 7.3 =	SCORE: 14.6
Routine maintenance is required; impact is minor			
COMMENTS:			
COMPONENT:	Remaining Life	RATING: 3 x WEIGHT: 6.3 =	SCORE: 18.8
Life expectancy is roughly 10-15 years; moderate system deterioration			
COMMENTS: Building construction is average			
COMPONENT:	Appearance	RATING: 2 x WEIGHT: 6.3 =	SCORE: 12.5
Well-constructed building; average interior and exterior appearance			
COMMENTS: Exterior is very average

Heat Loss			
COMPONENT:	Insulation	RATING: 2 x WEIGHT: 6.3 =	SCORE: 12.5
Some insulation meets current standards (2010 or newer), but other insulated areas or systems do not			
COMMENTS:			
COMPONENT:	Glazing	RATING: 3 x WEIGHT: 6.3 =	SCORE: 18.8
Double glazing with aluminum/metal window frames that conduct heat			
COMMENTS: Leaks at north windows

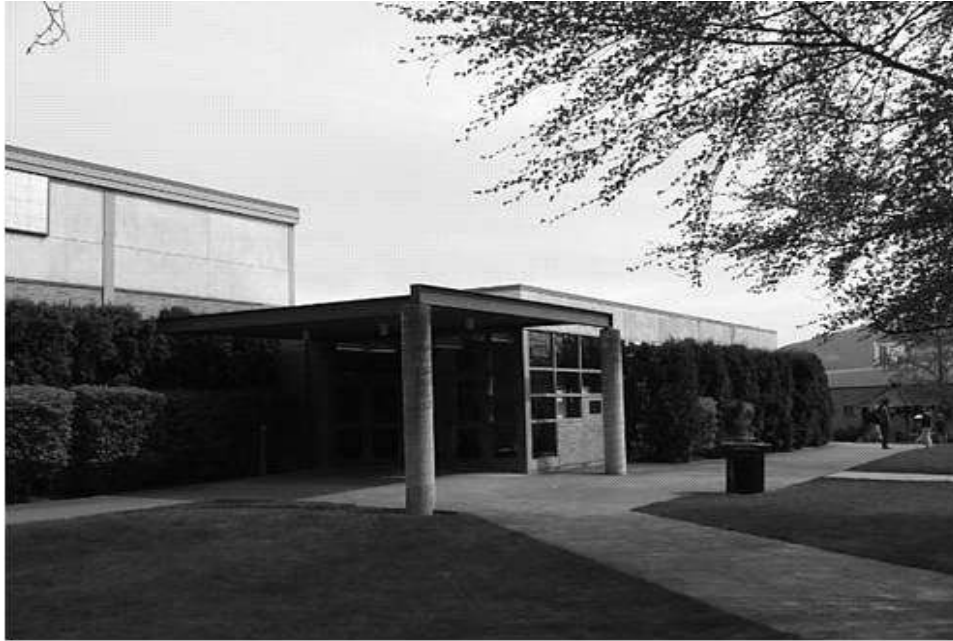
Pavilion (040-50) STATE UFI: A08558 Main Campus (040A)
 AREA: 27,252 SF BUILT: 1956 REMODELED: 2001 PREDOMINANT USE: Gymnasium
 CONSTRUCTION TYPE: Heavy CRV/SF: \$349 REPLACEMENT VALUE: \$9,510,948

Primary Systems			
COMPONENT:	Structure	RATING: 1 x WEIGHT: 8 =	SCORE: 8
No signs of settlement or cracking, no abrupt vertical changes Columns, bearing walls and roof structure appears sound/free of defects			
COMMENTS:	Steel-frame; brick; concrete; glu-lam beams		
COMPONENT:	Exterior Closure	RATING: 3 x WEIGHT: 8 =	SCORE: 24
Sound and weatherproof but with some physical deterioration evident			
COMMENTS:	Brick, stucco; west wall stucco cracked and water damage		
COMPONENT:	Roofing	RATING: 1 x WEIGHT: 10 =	SCORE: 10
Flashing and penetrations appear sound and membrane appears water- tight; drainage is positive and there are overflow scuppers			
COMMENTS:	Single ply PVC membrane

Secondary Systems			
COMPONENT:	Floor Finishes	RATING: 2 x WEIGHT: 6 = SCORE: 12	
	Some wear is evident on finish; maintenance needed		
COMMENTS:	Hardwood; carpet; concrete; epoxy; linoleum; ceramic tile		
COMPONENT:	Wall Finishes	RATING: 1 x WEIGHT: 6 = SCORE: 6	
	Maintainable surfaces in good condition		
COMMENTS:	Ceramic tile; wood panels; gypsum board; brick; CMU; carpet		
COMPONENT:	Ceiling Finishes	RATING: 2 x WEIGHT: 6 = SCORE: 12	
	Aging surfaces in fair condition and good alignment		
COMMENTS:	Gypsum board; exposed concrete structure; metal deck pan; direct-adhered tile		
COMPONENT:	Doors & Hardware	RATING: 3 x WEIGHT: 6 = SCORE: 18	
	Functional, but dated; some maintenance required		
COMMENTS:	Interior wood doors w HM frames; exterior HM doors/frames-extensive surface wear; some dents

Service Systems			
COMPONENT:	Elevators	RATING: 5 x WEIGHT: 6 = SCORE: 30	
	No elevator access for upper floors		
COMMENTS:	1 story w/ gym mezzanine		
COMPONENT:	Plumbing	RATING: 3 x WEIGHT: 8 = SCORE: 24	
	Fixtures are functional but dated; some leaks; maintenance required		
COMMENTS:	Galvanized, cast iron, steel, copper and PVC pipe; porcelain fixtures		
COMPONENT:	HVAC	RATING: 1 x WEIGHT: 8 = SCORE: 8	
	Equipment in good condition; easily controlled; serves all required spaces; All necessary spaces are adequately ventilated; A/C provided throughout		
COMMENTS:	Steam/hot water heat w fan coil units and steam radiators- fed from central plant; DX cooling; rooftop gas packs		
COMPONENT:	Electrical	RATING: 3 x WEIGHT: 8 = SCORE: 24	
	Service capacity meets current needs but inadequate for future		
COMMENTS:	800amp 480/277v		
COMPONENT:	Lights/Power	RATING: 1 x WEIGHT: 8 = SCORE: 8	
	Contemporary lighting with good work area illumination; ample outlets

COMMENTS:	Hanging, ceiling-mount and recessed can fluorescent fixtures; 2013 ESCO replacement

Quality Standards			
COMPONENT:	Maintenance	RATING: 1 x WEIGHT: 7 = SCORE: 7	
	Facility appears well maintained		
COMMENTS:			
COMPONENT:	Remaining Life	RATING: 3 x WEIGHT: 6 = SCORE: 18	
	Life expectancy is roughly 10-15 years; moderate system deterioration		
COMMENTS:	Reasonably well-constructed building; should have 20+ yr. life		
COMPONENT:	Appearance	RATING: 3 x WEIGHT: 6 = SCORE: 18	
	Average construction; average interior and exterior appearance		
COMMENTS:
