2023 FACILITY CONDITION SURVEY

Skagit Valley College

SURVEY CONDUCTED BY:
Steve Lewandowski
State Board for Community
and Technical Colleges

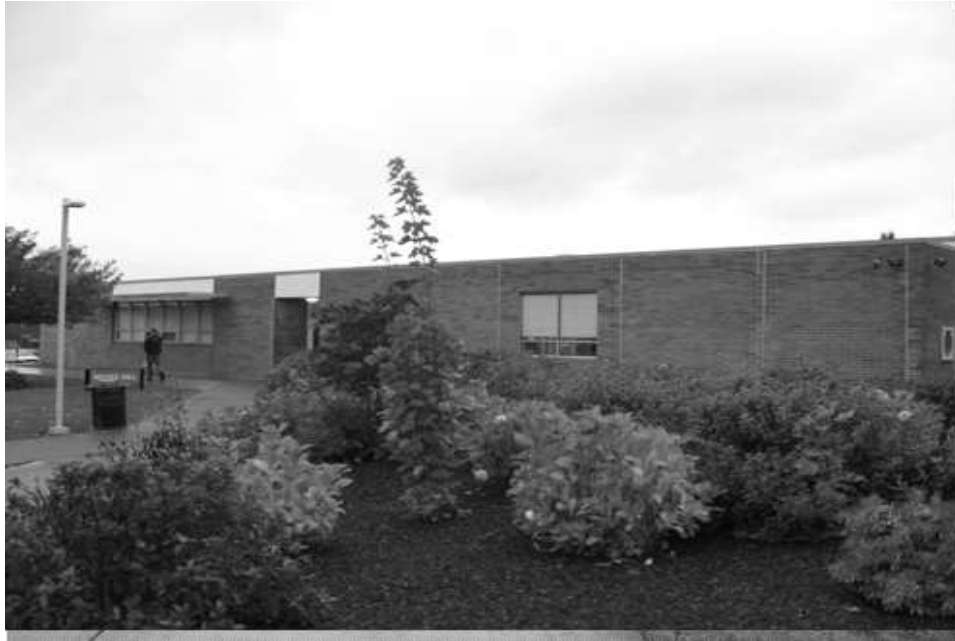
Reeves Hall (040-85) STATE UFI: A05238 Main Campus (040A)
AREA: 21,970 SF BUILT: 1959 REMODELED: 2013 PREDOMINANT USE: General Classroom
CONSTRUCTION TYPE: Medium CRV/SF: \$376 REPLACEMENT VALUE: \$8,260,720

Primary Systems			
COMPONENT:	Structure	RATING: 1 x WEIGHT: 8.3 = SCORE: 8.3	
No signs of settlement or cracking, no abrupt vertical changes Columns, bearing walls and roof structure appears sound/free of defects			
COMMENTS:	Steel columns & roof trusses; CMU		
COMPONENT:	Exterior Closure	RATING: 1 x WEIGHT: 8.3 = SCORE: 8.3	
Weatherproof, tight, well-maintained exterior walls, doors, windows/finishes			
COMMENTS:	Brick veneer; stucco; CMU; fiberglass; metal panels; funded in 2011 for brick tuck-point		
COMPONENT:	Roofing	RATING: 1 x WEIGHT: 10.4 = SCORE: 10.4	
Flashing and penetrations appear sound and membrane appears water- tight; drainage is positive and there are overflow scuppers			
COMMENTS:	Single-ply 2013

Secondary Systems			
COMPONENT:	Floor Finishes	RATING: 4 x WEIGHT: 6.3 =	SCORE: 25
General deterioration evident; one-third to one-half of flooring exhibits extensive deterioration			
COMMENTS:	Vinyl asbestos tile, carpet, concrete; ceramic tile		
COMPONENT:	Wall Finishes	RATING: 3 x WEIGHT: 6.3 =	SCORE: 18.8
Aging surfaces, but sound; some maintenance is required			
COMMENTS:	Gypsum board; plaster; tectum panels; CMU; plywood; ceramic tile; brick		
COMPONENT:	Ceiling Finishes	RATING: 4 x WEIGHT: 6.3 =	SCORE: 25
General deterioration and moderate amount of staining or damage apparent			
COMMENTS:	Lay-in tile; gypsum board; metal deck pan		
COMPONENT:	Doors & Hardware	RATING: 4 x WEIGHT: 6.3 =	SCORE: 25
General deterioration evident in both door and hardware; some doors with significant deterioration			
COMMENTS:	Interior wood doors w HM frames; exterior HM doors/frames; OH metal doors

Service Systems			
COMPONENT:	Elevators	RATING: 0 x WEIGHT: 0 =	SCORE: 0
No data			
COMMENTS:			
COMPONENT:	Plumbing	RATING: 3 x WEIGHT: 8.3 =	SCORE: 25
Fixtures are functional but dated; some leaks; maintenance required			
COMMENTS:	Galvanized, cast iron and steel piping; porcelain fixtures		
COMPONENT:	HVAC	RATING: 5 x WEIGHT: 8.3 =	SCORE: 41.7
Inadequate capacity, zoning and distribution; equipment deteriorating; areas with A/C extremely limited; no ventilation in hazardous areas			
COMMENTS:	HW unit ventilators-fed from central plant, make-up air unit; unit heaters		
COMPONENT:	Electrical	RATING: 4 x WEIGHT: 8.3 =	SCORE: 33.4
Service capacity generally meets current need, but electrical load in some areas exceeds circuit or panel capacity			
COMMENTS:	600amp 480/277v		
COMPONENT:	Lights/Power	RATING: 3 x WEIGHT: 8.3 =	SCORE: 25
Adequate work area illumination; adequate outlets for current use; maintenance required

Safety Systems			
COMPONENT:	Life/Safety	RATING: 3 x WEIGHT: 10.4 = SCORE: 31.3	
Generally meets codes for vintage of construction			
COMMENTS:			
COMPONENT:	Fire Safety	RATING: 2 x WEIGHT: 10.4 = SCORE: 20.9	
Locally monitored detection; alarm present, but missing visual component or sprinklers			
COMMENTS:			
COMPONENT:	Modifications	RATING: 1 x WEIGHT: 7.3 = SCORE: 7.3	
Modifications appear to be in compliance with codes and sound construction practices; HVAC/electrical service properly provided			
COMMENTS: Few modifications to present

Quality Standards			
COMPONENT:	Maintenance	RATING: 3 x WEIGHT: 7.3 = SCORE: 21.9	
Routine maintenance is required; deferred maintenance is evident; impact is minor to moderate			
COMMENTS:			
COMPONENT:	Remaining Life	RATING: 3 x WEIGHT: 6.3 = SCORE: 18.8	
Life expectancy is roughly 10-15 years; moderate system deterioration			
COMMENTS: Many system upgrades in 2011-13			
COMPONENT:	Appearance	RATING: 3 x WEIGHT: 6.3 = SCORE: 18.8	
Average construction; average interior and exterior appearance			
COMMENTS:

Heat Loss			
COMPONENT:	Insulation	RATING: 3 x WEIGHT: 6.3 = SCORE: 18.8	
Insulation present, but not to current standards (installed prior to 2010)			
COMMENTS:			
COMPONENT:	Glazing	RATING: 3 x WEIGHT: 6.3 = SCORE: 18.8	
Double glazing with aluminum/metal window frames that conduct heat			
COMMENTS: Most windows replaced in 2011-13

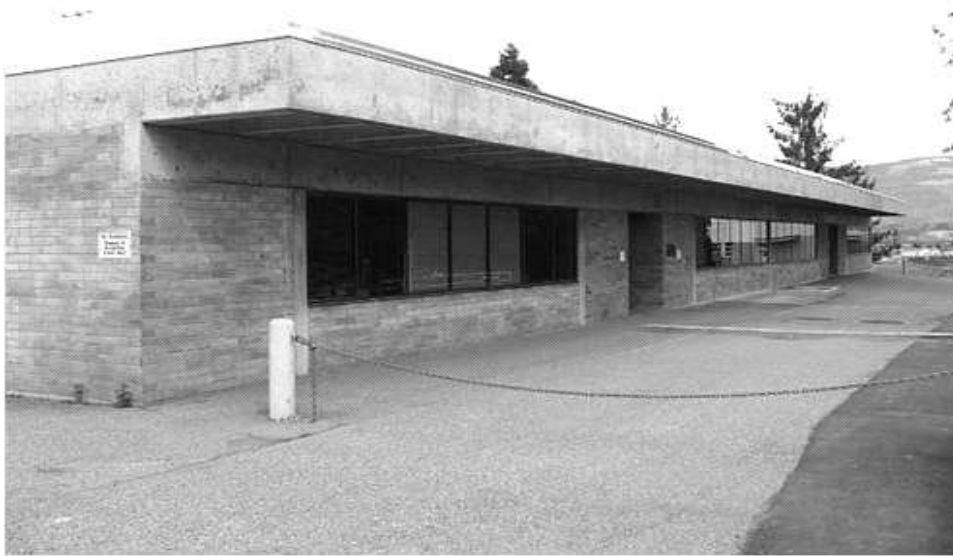
Roberts Hall (040-80) STATE UFI: A09398 Main Campus (040A)
AREA: 33,281 SF BUILT: 1971 REMODELED: No PREDOMINANT USE: Vocational Arts
CONSTRUCTION TYPE: Heavy CRV/SF: \$395 REPLACEMENT VALUE: \$13,145,995

Primary Systems			
COMPONENT:	Structure	RATING: 2 x WEIGHT: 8.3 =	SCORE: 16.7
Minor cracks evident in a small portion of the structure			
COMMENTS:	Structural brick; concrete		
COMPONENT:	Exterior Closure	RATING: 1 x WEIGHT: 8.3 =	SCORE: 8.3
Weatherproof, tight, well-maintained exterior walls, doors, windows/finishes			
COMMENTS:	Brick; concrete		
COMPONENT:	Roofing	RATING: 3 x WEIGHT: 10.4 =	SCORE: 31.3
Some deterioration is evident in membrane and flashings; maintenance or minor repair is needed			
COMMENTS:	Ballasted PVC single-ply membrane-2003

Secondary Systems			
COMPONENT:	Floor Finishes	RATING: 3 x WEIGHT: 6.3 =	SCORE: 18.8
Some physical wear and minor imperfections are evident; beginning deterioration			
COMMENTS:	Concrete; sheet vinyl; carpet; epoxy flooring		
COMPONENT:	Wall Finishes	RATING: 3 x WEIGHT: 6.3 =	SCORE: 18.8
Aging surfaces, but sound; some maintenance is required			
COMMENTS:	Exposed brick walls; gypsum board; ceramic tile		
COMPONENT:	Ceiling Finishes	RATING: 3 x WEIGHT: 6.3 =	SCORE: 18.8
Some wear and tear; Minor damage, staining or deterioration			
COMMENTS:	Concrete; lay-in tile; direct-adhered tile		
COMPONENT:	Doors & Hardware	RATING: 3 x WEIGHT: 6.3 =	SCORE: 18.8
Functional, but dated; some maintenance required			
COMMENTS:	Interior HM doors/frames; exterior HM doors/frames; glazed metal OH doors

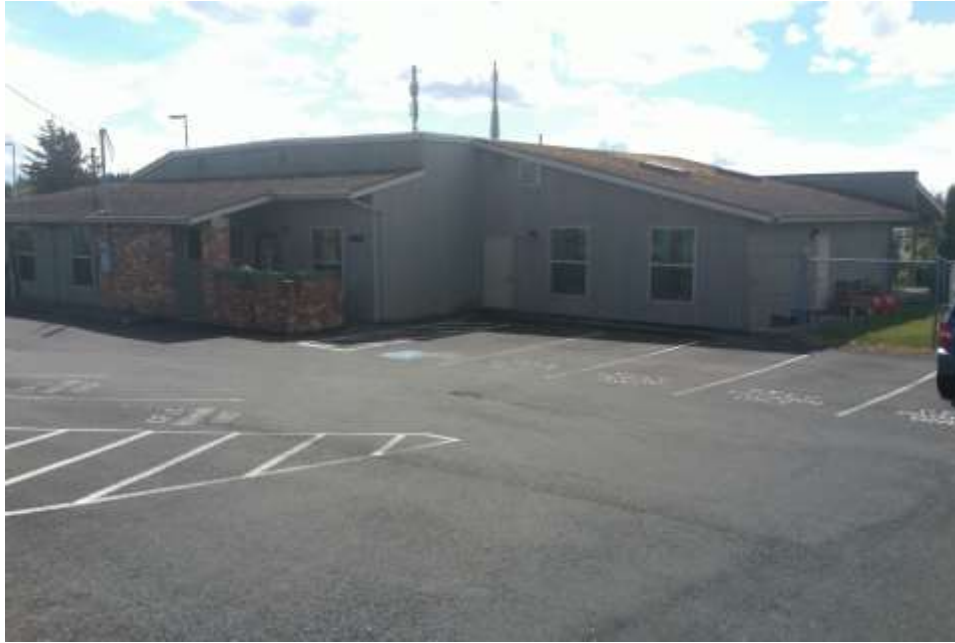
Child & Family Learning Center (040-42) STATE UFI: A03753 Main Campus (040A)
AREA: 4,792 SF BUILT: 1986 REMODELED: No PREDOMINANT USE: Child Care Education
CONSTRUCTION TYPE: No data CRV/SF: \$231 REPLACEMENT VALUE: \$1,106,952

Primary Systems			
COMPONENT:	Structure	RATING: 2 x WEIGHT: 8.3 = SCORE: 16.7	
	Minor cracks evident in a small portion of the structure		
COMMENTS:	No data		
COMPONENT:	Exterior Closure	RATING: 3 x WEIGHT: 8.3 = SCORE: 25	
	Sound and weatherproof but with some physical deterioration evident		
COMMENTS:	No data		
COMPONENT:	Roofing	RATING: 2 x WEIGHT: 10.4 = SCORE: 20.9	
	Majority of roofing and flashing appear sound, but a small portion of roofing shows deterioration where maintenance or minor repair needed		
COMMENTS:	comp shingles 2001

Secondary Systems			
COMPONENT:	Floor Finishes	RATING: 3 x WEIGHT: 6.3 =	SCORE: 18.8
Some physical wear and minor imperfections are evident; beginning deterioration			
COMMENTS:	No data		
COMPONENT:	Wall Finishes	RATING: 3 x WEIGHT: 6.3 =	SCORE: 18.8
Aging surfaces, but sound; some maintenance is required			
COMMENTS:	No data		
COMPONENT:	Ceiling Finishes	RATING: 3 x WEIGHT: 6.3 =	SCORE: 18.8
Some wear and tear; Minor damage, staining or deterioration			
COMMENTS:	No data		
COMPONENT:	Doors & Hardware	RATING: 2 x WEIGHT: 6.3 =	SCORE: 12.5
Fairly modern door surfaces and hardware with minor deterioration; good working order			
COMMENTS:	No data

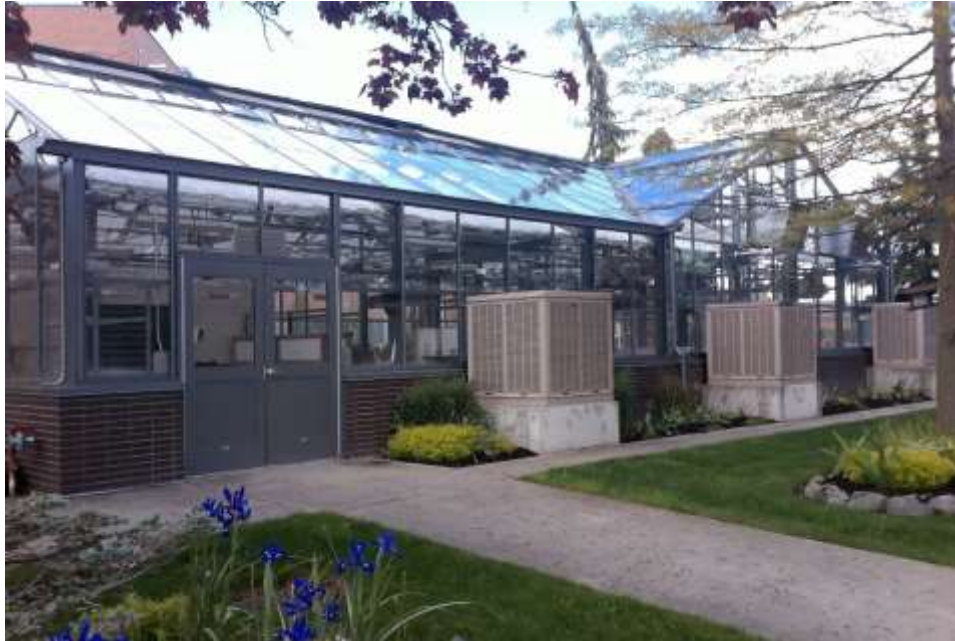
Greenhouse (040-99) STATE UFI: A10392 Main Campus (040A)
 AREA: 2,628 SF BUILT: 2010 REMODELED: No PREDOMINANT USE: Greenhouse
 CONSTRUCTION TYPE: Light CRV/SF: \$198 REPLACEMENT VALUE: \$520,344

Primary Systems			
COMPONENT:	Structure	RATING: 1 x WEIGHT: 9.7 = SCORE: 9.7	
No signs of settlement or cracking, no abrupt vertical changes Columns, bearing walls and roof structure appears sound/free of defects			
COMMENTS:	Steel framing		
COMPONENT:	Exterior Closure	RATING: 1 x WEIGHT: 9.7 = SCORE: 9.7	
Weatherproof, tight, well-maintained exterior walls, doors, windows/finishes			
COMMENTS:	Glass; brick		
COMPONENT:	Roofing	RATING: 1 x WEIGHT: 12.1 = SCORE: 12.1	
Flashing and penetrations appear sound and membrane appears water- tight; drainage is positive and there are overflow scuppers			
COMMENTS:	Glass

Secondary Systems			
COMPONENT:	Floor Finishes	RATING: 1 x WEIGHT: 7.2 =	SCORE: 7.2
	Nice appearance, smooth transitions, level subfloors, no cracks/separating		
COMMENTS:	Concrete		
COMPONENT:	Wall Finishes	RATING: 1 x WEIGHT: 7.2 =	SCORE: 7.2
	Maintainable surfaces in good condition		
COMMENTS:	Glass; vinyl panels; CMU; corrugated metal panels		
COMPONENT:	Ceiling Finishes	RATING: 0 x WEIGHT: 0 =	SCORE: 0
	No data		
COMMENTS:	Glass; plywood deck		
COMPONENT:	Doors & Hardware	RATING: 1 x WEIGHT: 7.2 =	SCORE: 7.2
	Appropriate hardware, closers, panic devices; in good working order		
COMMENTS:	Interior/exterior HM doors/frames

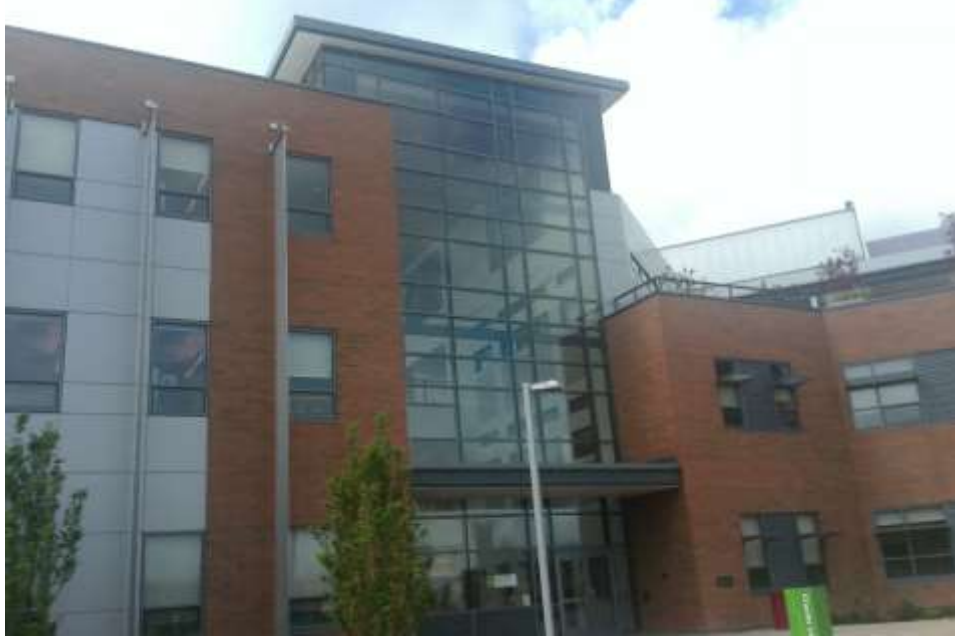
Lewis Hall (040-59) STATE UFI: A21241 Main Campus (040A)
AREA: 72,858 SF BUILT: 2014 REMODELED: No PREDOMINANT USE: Classroom
CONSTRUCTION TYPE: No data CRV/SF: \$356 REPLACEMENT VALUE: \$25,937,448

Primary Systems			
COMPONENT:	Structure	RATING: 1 x WEIGHT: 8.4 =	SCORE: 8.4
No signs of settlement or cracking, no abrupt vertical changes Columns, bearing walls and roof structure appears sound/free of defects			
COMMENTS:	No data		
COMPONENT:	Exterior Closure	RATING: 1 x WEIGHT: 8.4 =	SCORE: 8.4
Weatherproof, tight, well-maintained exterior walls, doors, windows/finishes			
COMMENTS:	Metal siding		
COMPONENT:	Roofing	RATING: 1 x WEIGHT: 10.5 =	SCORE: 10.5
Flashing and penetrations appear sound and membrane appears water- tight; drainage is positive and there are overflow scuppers			
COMMENTS:	Single -ply

Secondary Systems			
COMPONENT:	Floor Finishes	RATING: 1 x WEIGHT: 6.3 =	SCORE: 6.3
Nice appearance, smooth transitions, level subfloors, no cracks/separating			
COMMENTS:	No data		
COMPONENT:	Wall Finishes	RATING: 1 x WEIGHT: 6.3 =	SCORE: 6.3
Maintainable surfaces in good condition			
COMMENTS:	No data		
COMPONENT:	Ceiling Finishes	RATING: 1 x WEIGHT: 6.3 =	SCORE: 6.3
Maintainable surfaces in good condition; good alignment and appearance			
COMMENTS:	No data		
COMPONENT:	Doors & Hardware	RATING: 1 x WEIGHT: 6.3 =	SCORE: 6.3
Appropriate hardware, closers, panic devices; in good working order			
COMMENTS:	No data

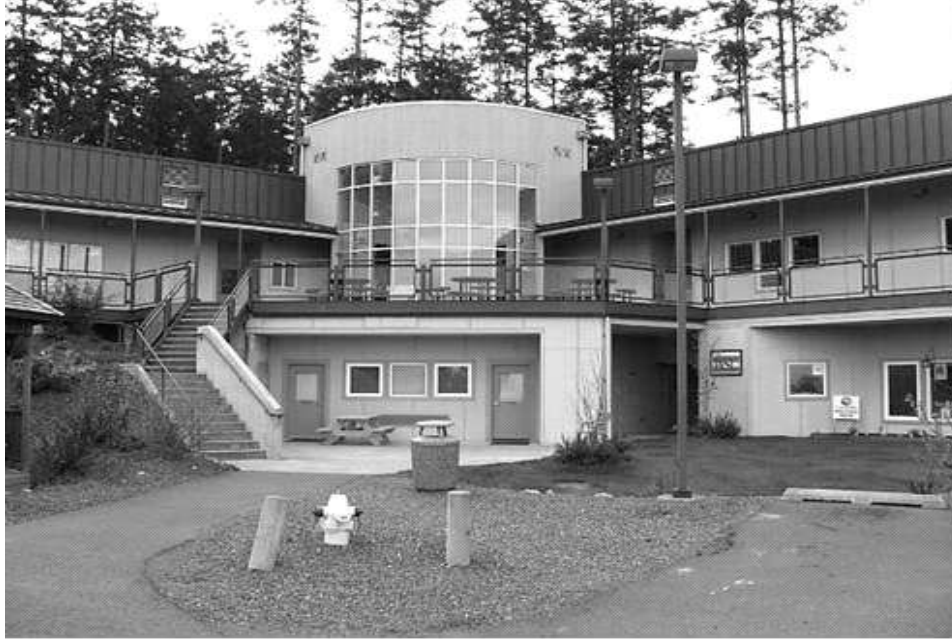
San Juan Center (040-89) STATE UFI: A04979 San Juan Center (040H)
 AREA: 7,710 SF BUILT: 1996 REMODELED: No PREDOMINANT USE: General Classroom
 CONSTRUCTION TYPE: Light CRV/SF: \$369 REPLACEMENT VALUE: \$2,844,990

Primary Systems			
COMPONENT:	Structure	RATING: 2 x WEIGHT: 8 =	SCORE: 16
Minor cracks evident in a small portion of the structure			
COMMENTS:	Stepped foundation; Wood frame		
COMPONENT:	Exterior Closure	RATING: 1 x WEIGHT: 8 =	SCORE: 8
Weatherproof, tight, well-maintained exterior walls, doors, windows/finishes			
COMMENTS:	Wood panels & battens; vertical cedar siding; standing seam metal panels; concrete		
COMPONENT:	Roofing	RATING: 1 x WEIGHT: 10 =	SCORE: 10
Flashing and penetrations appear sound and membrane appears water- tight; drainage is positive and there are overflow scuppers			
COMMENTS:	Standing seam metal panels; Hypalon single ply- 2015

Secondary Systems			
COMPONENT:	Floor Finishes	RATING: 2 x WEIGHT: 6 = SCORE: 12	
	Some wear is evident on finish; maintenance needed		
COMMENTS:	Carpet-surface wear; vinyl tile		
COMPONENT:	Wall Finishes	RATING: 1 x WEIGHT: 6 = SCORE: 6	
	Maintainable surfaces in good condition		
COMMENTS:	Gypsum board		
COMPONENT:	Ceiling Finishes	RATING: 1 x WEIGHT: 6 = SCORE: 6	
	Maintainable surfaces in good condition; good alignment and appearance		
COMMENTS:	Lay-in tile; gypsum board		
COMPONENT:	Doors & Hardware	RATING: 2 x WEIGHT: 6 = SCORE: 12	
	Fairly modern door surfaces and hardware with minor deterioration; good working order		
COMMENTS:	Interior wood doors w HM frames-surface wear; exterior HM doors/frames

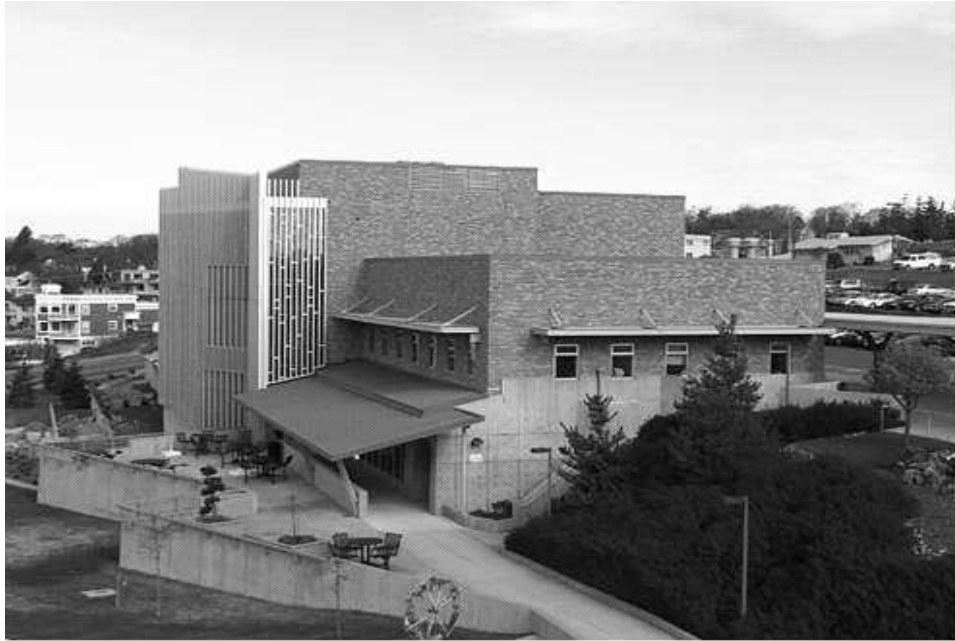
Oak Hall (040-16) STATE UFI: A03072 Whidbey Campus (040C)
AREA: 40,725 SF BUILT: 2001 REMODELED: No PREDOMINANT USE: Multi-use
CONSTRUCTION TYPE: Heavy CRV/SF: \$395 REPLACEMENT VALUE: \$16,086,375

Primary Systems			
COMPONENT:	Structure	RATING: 1 x WEIGHT: 8.4 =	SCORE: 8.4
No signs of settlement or cracking, no abrupt vertical changes Columns, bearing walls and roof structure appears sound/free of defects			
COMMENTS:	Concrete; steel frame		
COMPONENT:	Exterior Closure	RATING: 1 x WEIGHT: 8.4 =	SCORE: 8.4
Weatherproof, tight, well-maintained exterior walls, doors, windows/finishes			
COMMENTS:	Concrete; brick veneer; aluminum curtain wall		
COMPONENT:	Roofing	RATING: 2 x WEIGHT: 10.5 =	SCORE: 21
Majority of roofing and flashing appear sound, but a small portion of roofing shows deterioration where maintenance or minor repair needed			
COMMENTS:	Standing seam metal; EPDM at mechanical wells

Secondary Systems			
COMPONENT:	Floor Finishes	RATING: 2 x WEIGHT: 6.3 =	SCORE: 12.6
Some wear is evident on finish; maintenance needed			
COMMENTS:	Concrete; carpet; ceramic tile; slate; rubber mats		
COMPONENT:	Wall Finishes	RATING: 1 x WEIGHT: 6.3 =	SCORE: 6.3
Maintainable surfaces in good condition			
COMMENTS:	Concrete; gypsum board; plaster veneer; ceramic tile; vent wood		
COMPONENT:	Ceiling Finishes	RATING: 1 x WEIGHT: 6.3 =	SCORE: 6.3
Maintainable surfaces in good condition; good alignment and appearance			
COMMENTS:	Gypsum board; lay-in tile; vent wood		
COMPONENT:	Doors & Hardware	RATING: 2 x WEIGHT: 6.3 =	SCORE: 12.6
Fairly modern door surfaces and hardware with minor deterioration; good working order			
COMMENTS:	Interior wood doors w HM frames; exterior HM doors/frames

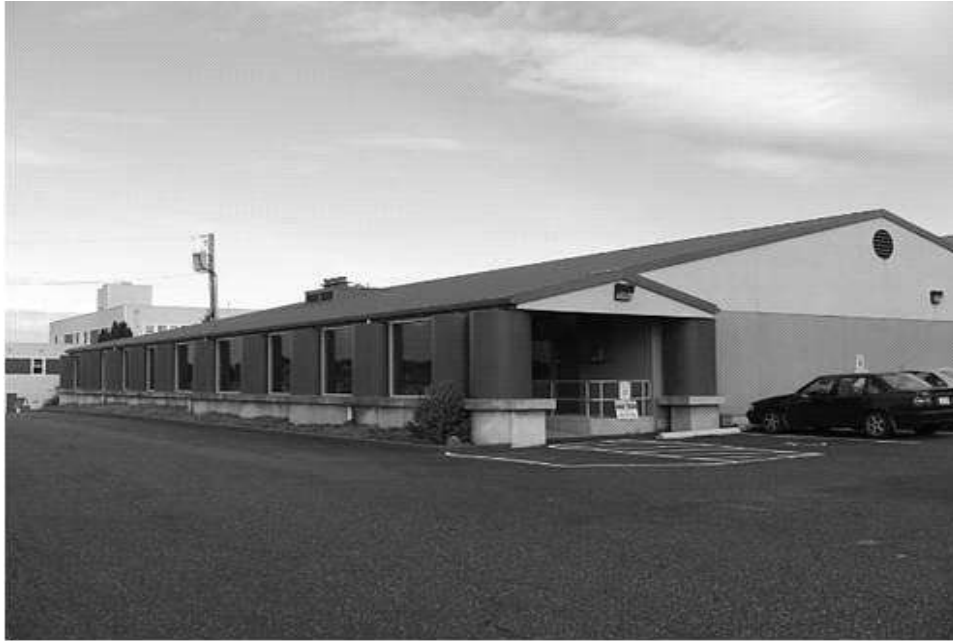
Sprague Hall (040-15) STATE UFI: A01220 Whidbey Campus (040C)
AREA: 6,048 SF BUILT: 1967 REMODELED: No PREDOMINANT USE: General Classroom
CONSTRUCTION TYPE: Temporary CRV/SF: \$376 REPLACEMENT VALUE: \$2,274,048

Primary Systems			
COMPONENT:	Structure	RATING: 3 x WEIGHT: 8.3 =	SCORE: 25
Some cracking evident but does not likely affect structural integrity; Visible defects apparent but are non-structural			
COMMENTS:	Wood framed roof structure over six portables originally from Boeing		
COMPONENT:	Exterior Closure	RATING: 3 x WEIGHT: 8.3 =	SCORE: 25
Sound and weatherproof but with some physical deterioration evident			
COMMENTS:	EIFS; portable metal cladding; large sheet metal columns and aluminum window wall on south		
COMPONENT:	Roofing	RATING: 3 x WEIGHT: 10.4 =	SCORE: 31.3
Some deterioration is evident in membrane and flashings; maintenance or minor repair is needed			
COMMENTS:	Standing seam metal

Secondary Systems			
COMPONENT:	Floor Finishes	RATING: 2 x WEIGHT: 6.3 = SCORE: 12.5	
	Some wear is evident on finish; maintenance needed		
COMMENTS:	Vinyl tile; carpet-general surface wear		
COMPONENT:	Wall Finishes	RATING: 3 x WEIGHT: 6.3 = SCORE: 18.8	
	Aging surfaces, but sound; some maintenance is required		
COMMENTS:	Gypsum board-marred/dinged; vinyl panels		
COMPONENT:	Ceiling Finishes	RATING: 5 x WEIGHT: 6.3 = SCORE: 31.3	
	Deteriorated, significant number of stained or sagging areas; inappropriate for occupancy		
COMMENTS:	Lay-in tiles - warped due to moisture above because of no roof insulation		
COMPONENT:	Doors & Hardware	RATING: 3 x WEIGHT: 6.3 = SCORE: 18.8	
	Functional, but dated; some maintenance required		
COMMENTS:	Interior wood doors/frames; exterior HM doors/frames; general surface wear

Service Systems			
COMPONENT:	Elevators	RATING: 0 x WEIGHT: 0 = SCORE: 0	
	No data		
COMMENTS:			
COMPONENT:	Plumbing	RATING: 3 x WEIGHT: 8.3 = SCORE: 25	
	Fixtures are functional but dated; some leaks; maintenance required		
COMMENTS:	Copper, steel and ABS piping; porcelain fixtures		
COMPONENT:	HVAC	RATING: 4 x WEIGHT: 8.3 = SCORE: 33.4	
	System partially adequate; many areas served by equipment needing repair; areas with A/C very limited, but hazardous areas are ventilated		
COMMENTS:	Ceiling-mount electric furnaces 2015		
COMPONENT:	Electrical	RATING: 3 x WEIGHT: 8.3 = SCORE: 25	
	Service capacity meets current needs but inadequate for future		
COMMENTS:	800amp 208/120v		
COMPONENT:	Lights/Power	RATING: 3 x WEIGHT: 8.3 = SCORE: 25	
	Adequate work area illumination; adequate outlets for current use; maintenance required		
COMMENTS:	Lay-in fluorescent lighting

Safety Systems			
COMPONENT:	Life/Safety	RATING: 3 x WEIGHT: 10.4 = SCORE: 31.3	
Generally meets codes for vintage of construction			
COMMENTS:			
COMPONENT:	Fire Safety	RATING: 2 x WEIGHT: 10.4 = SCORE: 20.9	
Locally monitored detection; alarm present, but missing visual component or sprinklers			
COMMENTS:			
COMPONENT:	Modifications	RATING: 5 x WEIGHT: 7.3 = SCORE: 36.5	
Modifications not well thought out or constructed; inadequate HVAC and electrical service provided			
COMMENTS: No real coherence to spaces

Quality Standards			
COMPONENT:	Maintenance	RATING: 3 x WEIGHT: 7.3 = SCORE: 21.9	
Routine maintenance is required; deferred maintenance is evident; impact is minor to moderate			
COMMENTS:			
COMPONENT:	Remaining Life	RATING: 5 x WEIGHT: 6.3 = SCORE: 31.3	
Life expectancy is <5 years; significant system deterioration			
COMMENTS: Structure is basically constructed of modular units; not cost-effective to maintain long-term			
COMPONENT:	Appearance	RATING: 3 x WEIGHT: 6.3 = SCORE: 18.8	
Average construction; average interior and exterior appearance			
COMMENTS:

Heat Loss			
COMPONENT:	Insulation	RATING: 4 x WEIGHT: 6.3 = SCORE: 25	
Insulation present in some areas or systems, but missing in other areas or systems			
COMMENTS: No roof insulation			
COMPONENT:	Glazing	RATING: 4 x WEIGHT: 6.3 = SCORE: 25	
Mix of double and single glazed windows			
COMMENTS:

CONDITION: Replace or Renovate

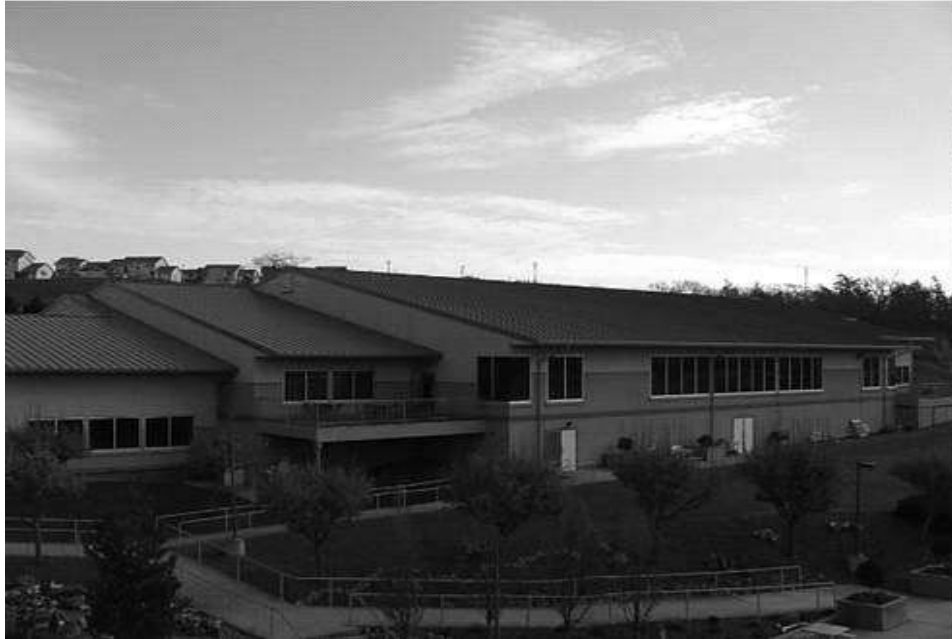
Whidbey Hayes Hall (040-18) STATE UFI: A09219 Whidbey Campus (040C)
 AREA: 15,562 SF BUILT: 1993 REMODELED: No PREDOMINANT USE: Multi-Use
 CONSTRUCTION TYPE: Medium CRV/SF: \$395 REPLACEMENT VALUE: \$6,146,990

Primary Systems			
COMPONENT:	Structure	RATING: 1 x WEIGHT: 8.8 = SCORE: 8.8	
No signs of settlement or cracking, no abrupt vertical changes Columns, bearing walls and roof structure appears sound/free of defects			
COMMENTS:	Wood frame, roof trusses		
COMPONENT:	Exterior Closure	RATING: 1 x WEIGHT: 8.8 = SCORE: 8.8	
Weatherproof, tight, well-maintained exterior walls, doors, windows/finishes			
COMMENTS:	EIFS		
COMPONENT:	Roofing	RATING: 3 x WEIGHT: 11 = SCORE: 32.9	
Some deterioration is evident in membrane and flashings; maintenance or minor repair is needed			
COMMENTS:	Standing seam metal

Secondary Systems			
COMPONENT:	Floor Finishes	RATING: 2 x WEIGHT: 6.6 =	SCORE: 13.2
Some wear is evident on finish; maintenance needed			
COMMENTS:	Strip vinyl; carpet-surface wear; ceramic tile		
COMPONENT:	Wall Finishes	RATING: 2 x WEIGHT: 6.6 =	SCORE: 13.2
Maintainable surfaces, minor maintenance is required in some areas			
COMMENTS:	Gypsum board, ceramic tile		
COMPONENT:	Ceiling Finishes	RATING: 1 x WEIGHT: 6.6 =	SCORE: 6.6
Maintainable surfaces in good condition; good alignment and appearance			
COMMENTS:	Gypsum board; lay-in tile		
COMPONENT:	Doors & Hardware	RATING: 3 x WEIGHT: 6.6 =	SCORE: 19.8
Functional, but dated; some maintenance required			
COMMENTS:	Interior wood doors/frames-surface wear; exterior aluminum/wood entry doors/frames

Service Systems			
COMPONENT:	Elevators	RATING: 0 x WEIGHT: 0 =	SCORE: 0
No data			
COMMENTS:			
COMPONENT:	Plumbing	RATING: 1 x WEIGHT: 8.8 =	SCORE: 8.8
Fixtures and piping appear to be in good condition; no evidence of leaks			
COMMENTS:	Copper, cast iron and steel piping, porcelain fixtures		
COMPONENT:	HVAC	RATING: 3 x WEIGHT: 8.8 =	SCORE: 26.3
System generally adequate; some deterioration; needs balancing; some areas have A/C; hazardous areas are ventilated			
COMMENTS:	Rooftop packaged HVAC units		
COMPONENT:	Electrical	RATING: 1 x WEIGHT: 8.8 =	SCORE: 8.8
Adequate service and distribution capacity for current/future needs			
COMMENTS:	1200amp 480/277v		
COMPONENT:	Lights/Power	RATING: 1 x WEIGHT: 8.8 =	SCORE: 8.8
Contemporary lighting with good work area illumination; ample outlets			
COMMENTS:	Surface mount, pendant and recessed can fluorescent fixtures

Safety Systems			
COMPONENT:	Life/Safety	RATING: 1 x WEIGHT: 11 = SCORE: 11	
	Appears to meet current codes		
COMMENTS:			
COMPONENT:	Fire Safety	RATING: 1 x WEIGHT: 11 = SCORE: 11	
	Locally monitored detection; alarm and strobes present; sprinklers in high hazard areas		
COMMENTS:			
COMPONENT:	Modifications	RATING: 0 x WEIGHT: 0 = SCORE: 0	
	No data		
COMMENTS:	None apparent

Quality Standards			
COMPONENT:	Maintenance	RATING: 1 x WEIGHT: 7.7 = SCORE: 7.7	
	Facility appears well maintained		
COMMENTS:			
COMPONENT:	Remaining Life	RATING: 1 x WEIGHT: 6.6 = SCORE: 6.6	
	Life expectancy is >20 years; minor system deterioration		
COMMENTS:			
COMPONENT:	Appearance	RATING: 1 x WEIGHT: 6.6 = SCORE: 6.6	
	Well-constructed building; generally attractive interior and exterior		
COMMENTS:	Attractive interior spaces

CONDITION: Adequate

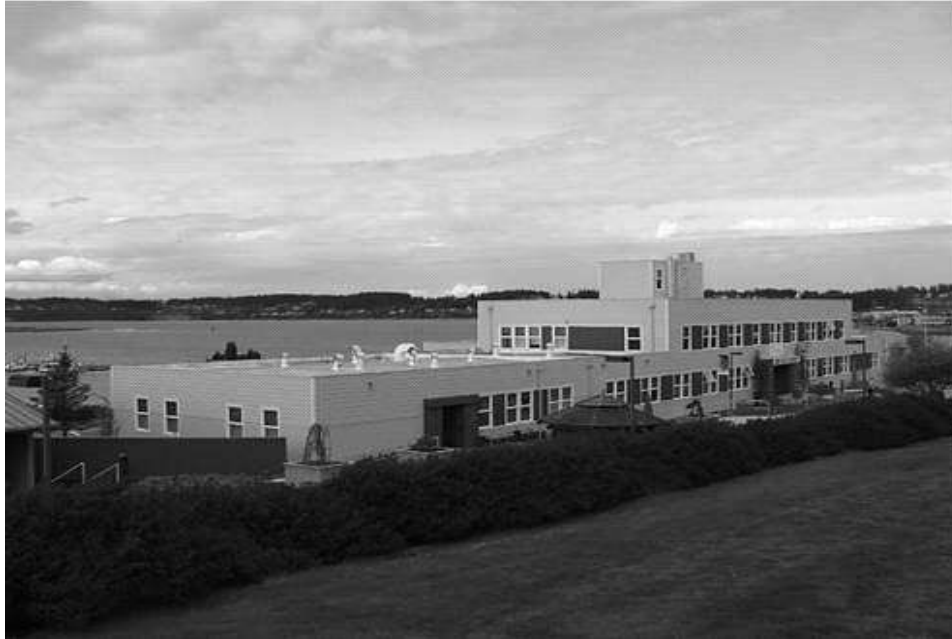
Whidbey Old Main (040-11) STATE UFI: A06127 Whidbey Campus (040C)
AREA: 27,342 SF BUILT: 1941 REMODELED: 2005 PREDOMINANT USE: Administration
CONSTRUCTION TYPE: Medium CRV/SF: \$376 REPLACEMENT VALUE: \$10,280,592

Primary Systems			
COMPONENT:	Structure	RATING: 3 x WEIGHT: 8 =	SCORE: 24
Some cracking evident but does not likely affect structural integrity; Visible defects apparent but are non-structural			
COMMENTS:	Wood frame, CMU boiler house; possible seismic issues		
COMPONENT:	Exterior Closure	RATING: 3 x WEIGHT: 8 =	SCORE: 24
Sound and weatherproof but with some physical deterioration evident			
COMMENTS:	Hardboard beveled siding-2003		
COMPONENT:	Roofing	RATING: 1 x WEIGHT: 10 =	SCORE: 10
Flashing and penetrations appear sound and membrane appears water- tight; drainage is positive and there are overflow scuppers			
COMMENTS:	Hypalon single-ply 2017-2019

Secondary Systems			
COMPONENT:	Floor Finishes	RATING: 3 x WEIGHT: 6 = SCORE: 18	
	Some physical wear and minor imperfections are evident; beginning deterioration		
COMMENTS:	Vinyl composition and vinyl asbestos tile; carpet-surface wear; Ceramic tile		
COMPONENT:	Wall Finishes	RATING: 2 x WEIGHT: 6 = SCORE: 12	
	Maintainable surfaces, minor maintenance is required in some areas		
COMMENTS:	Gypsum board and ceramic tile		
COMPONENT:	Ceiling Finishes	RATING: 2 x WEIGHT: 6 = SCORE: 12	
	Aging surfaces in fair condition and good alignment		
COMMENTS:	Lay-in tile and painted plywood		
COMPONENT:	Doors & Hardware	RATING: 2 x WEIGHT: 6 = SCORE: 12	
	Fairly modern door surfaces and hardware with minor deterioration; good working order		
COMMENTS:	Interior wood doors/frames; exterior wood/aluminum doors/frames-surface wear

Service Systems			
COMPONENT:	Elevators	RATING: 1 x WEIGHT: 6 = SCORE: 6	
	Appropriate and functional for occupancy and use		
COMMENTS:	3 stop-2005		
COMPONENT:	Plumbing	RATING: 3 x WEIGHT: 8 = SCORE: 24	
	Fixtures are functional but dated; some leaks; maintenance required		
COMMENTS:	Cast iron, galvanized, steel, copper and ABS piping; porcelain fixtures		
COMPONENT:	HVAC	RATING: 3 x WEIGHT: 8 = SCORE: 24	
	System generally adequate; some deterioration; needs balancing; some areas have A/C; hazardous areas are ventilated		
COMMENTS:	HW boiler and radiators (40% replaced 2019; remaining in 2023-25); electric baseboard heat; no A/C		
COMPONENT:	Electrical	RATING: 1 x WEIGHT: 8 = SCORE: 8	
	Adequate service and distribution capacity for current/future needs		
COMMENTS:	800amp 208/120v-2003 ; new service and distribution in 2003		
COMPONENT:	Lights/Power	RATING: 3 x WEIGHT: 8 = SCORE: 24	
	Adequate work area illumination; adequate outlets for current use; maintenance required

Safety Systems			
COMPONENT:	Life/Safety	RATING: 3 x WEIGHT: 10 = SCORE: 30	
	Generally meets codes for vintage of construction		
COMMENTS:			
COMPONENT:	Fire Safety	RATING: 1 x WEIGHT: 10 = SCORE: 10	
	Locally monitored detection; alarm and strobes present; sprinklers in high hazard areas		
COMMENTS:	Dry sprinkler system		
COMPONENT:	Modifications	RATING: 3 x WEIGHT: 7 = SCORE: 21	
	Some modifications lack code compliance; HVAC service not fully considered during renovation		
COMMENTS:	Average modification of original spaces

Quality Standards			
COMPONENT:	Maintenance	RATING: 3 x WEIGHT: 7 = SCORE: 21	
	Routine maintenance is required; deferred maintenance is evident; impact is minor to moderate		
COMMENTS:	High maintenance heating system		
COMPONENT:	Remaining Life	RATING: 4 x WEIGHT: 6 = SCORE: 24	
	Life expectancy is 5-10 years; moderate to significant system deterioration		
COMMENTS:	Building is 70 years old; not cost-effective to maintain long-term		
COMPONENT:	Appearance	RATING: 3 x WEIGHT: 6 = SCORE: 18	
	Average construction; average interior and exterior appearance		
COMMENTS:	Exterior is average; interior has some areas not very bright or attractive

Heat Loss			
COMPONENT:	Insulation	RATING: 5 x WEIGHT: 6 = SCORE: 30	
	No insulation		
COMMENTS:			
COMPONENT:	Glazing	RATING: 3 x WEIGHT: 6 = SCORE: 18	
	Double glazing with aluminum/metal window frames that conduct heat		
COMMENTS:	Operable units; minor glazing seal failures

CONDITION: Needs Improvement/Renovation
