# **2023** FACILITY CONDITION SURVEY

Spokane Community College

SURVEY CONDUCTED BY:  
Steve Lewandowski  
State Board for Community  
and Technical Colleges

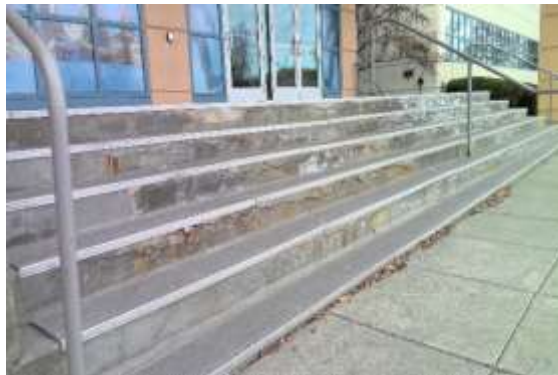
Carryover from prior survey : No
Location : Main Campus (171A)
Building name : Site (171A)
Unique Facility Identifier (UFI) : 171A
Funding category in capital budget : Minor Works Site appropriation
Uniformat category : G20-Site Improvements
Assessment : Asset is near or at the end of its useful life and should be replaced
Quantity : 1
Unit of measurement : LS
Component : Stairs
Location within building or site : East Main Entrance
Issue clarity : Adequate information was provided to assess deficiency
Main cause of asset degradation or failure : Age/Wear
Detailed description : The concrete steps have deteriorated due to age and weathering. They are causing a safety issue and are difficult to repair for long term. The steps should be replaced. (Estimate from Vendor).
Recommended funding schedule : Immediate (scoring weight=4)
Estimated remaining life (years) : 7
Estimated average life expectancy (years) : 20

Scoring priority category 1 : System Use (scoring weight=15)
Category 1 percentage : 80 %
Scoring priority category 2 : High Repair/Repl. Cost (scoring weight=12)
Category 2 percentage : 20 %
Project construction estimate (MACC): \$100,000
Total project estimate (including soft costs): \$139,000
Additional points based on building condition: 0
Deficiency score : $4 \times ((15 \times 80\%) + (12 \times 20\%)) + 0 = 57.6$

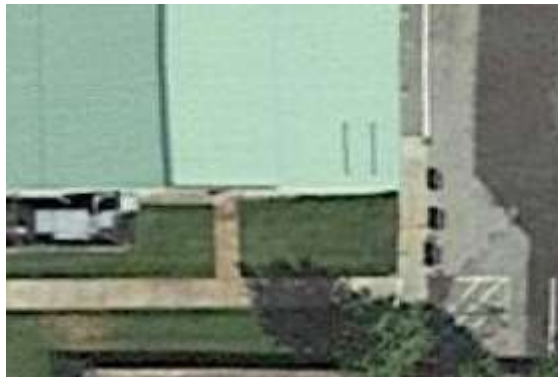
**Deficiency S02**

Carryover from prior survey : No
Location : Colville Center (171D)
Building name : Site (171D)
Unique Facility Identifier (UFI) : 171D
Funding category in capital budget : Minor Works Site appropriation
Uniformat category : G20-Site Improvements
Assessment : Asset is near or at the end of its useful life and should be replaced
Quantity : 1
Unit of measurement : LS
Component : Stairs
Location within building or site : Exterior Entrances
Issue clarity : Adequate information was provided to assess deficiency
Main cause of asset degradation or failure : Age/Wear
Detailed description : A section of concrete appears to heave and settle with the freeze/ thaw cycles. The concrete has not degraded, but can restrict the operation of the entrance door. Replacing the concrete would not fix the issue, since it has not even failed. The portion of concrete near the doors should be replaced so that it does not affect the door operation.

Recommended funding schedule : Immediate (scoring weight=4)
Estimated remaining life (years) : 3
Estimated average life expectancy (years) : 30
Scoring priority category 1 : High Repair/Repl. Cost (scoring weight=12)
Category 1 percentage : 70 %
Scoring priority category 2 : Facility Use/ Civil Rights Violation (scoring weight=20)
Category 2 percentage : 30 %
Project construction estimate (MACC): \$20,000
Total project estimate (including soft costs): \$27,000
Additional points based on building condition: 0
Deficiency score : $4 \times ((12 \times 70\%) + (20 \times 30\%)) + 0 = 57.6$

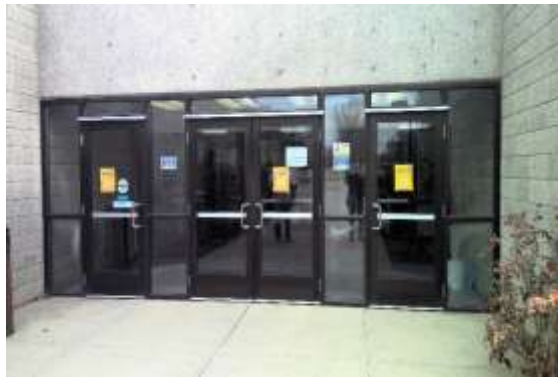
**Deficiency F14**

Carryover from prior survey : No
Location : Main Campus (171A)
Building name : Health Science (171-9)
Unique Facility Identifier (UFI) : A08699
Funding category in capital budget : Minor Works Facility appropriation
Uniformat category : B20-Exterior Enclosure
Assessment : Asset should be repaired to extend its useful life
Quantity : 1
Unit of measurement : LS
Component : Entrance storefront system
Location within building or site : South Entrance
Issue clarity : Adequate information was provided to assess deficiency
Main cause of asset degradation or failure : Age/Wear
Detailed description : The steel storefront framing at the south side of the building has deteriorated and become difficult to repair. The storefront doors are no longer able to be adjusted. The doors should be replaced.
Recommended funding schedule : Fund in Next Biennium (scoring weight=2.5)
Estimated remaining life (years) : 5
Estimated average life expectancy (years) : 30

Scoring priority category 1 : High Repair/Repl. Cost (scoring weight=12)
Category 1 percentage : 70 %
Scoring priority category 2 : High Operating Cost (scoring weight=10)
Category 2 percentage : 30 %
Project construction estimate (MACC): \$30,000
Total project estimate (including soft costs): \$41,000
Additional points based on building condition: 1
Deficiency score : $2.5 \times ((12 \times 70\%) + (10 \times 30\%)) + 1 = 29.5$

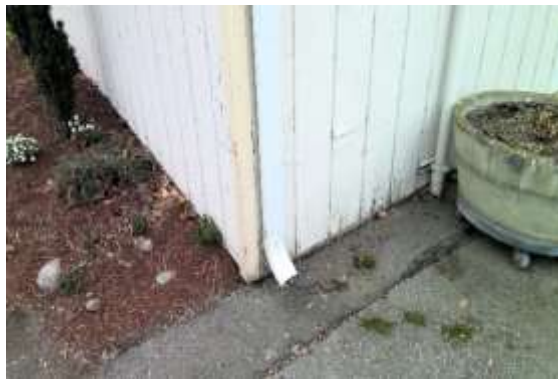
**Deficiency F15**

Carryover from prior survey : No
Location : Main Campus (171A)
Building name : Greenhouse (171-10)
Unique Facility Identifier (UFI) : A09082
Funding category in capital budget : Minor Works Facility appropriation
Uniformat category : B20-Exterior Enclosure
Assessment : Asset is near or at the end of its useful life and should be replaced
Quantity : 3880
Unit of measurement : SF
Component : Board and batten siding
Location within building or site : Exterior
Issue clarity : Adequate information was provided to assess deficiency
Main cause of asset degradation or failure : Age/Wear
Detailed description : The siding has deteriorated due to the degraded paint finish. The siding still protects the building envelope, but should be properly maintained to extend the life of the system. The siding should be replaced in the future when it no longer protects the building envelope and can no longer be maintained.
Recommended funding schedule : Fund in Next Biennium (scoring weight=2.5)

Estimated remaining life (years) : 5
Estimated average life expectancy (years) : 30
Scoring priority category 1 : High Repair/Repl. Cost (scoring weight=12)
Category 1 percentage : 60 %
Scoring priority category 2 : High Operating Cost (scoring weight=10)
Category 2 percentage : 40 %
Project construction estimate (MACC): \$95,000
Total project estimate (including soft costs): \$132,000
Additional points based on building condition: 5
Deficiency score : $2.5 \times ((12 \times 60\%) + (10 \times 40\%)) + 5 = 33$

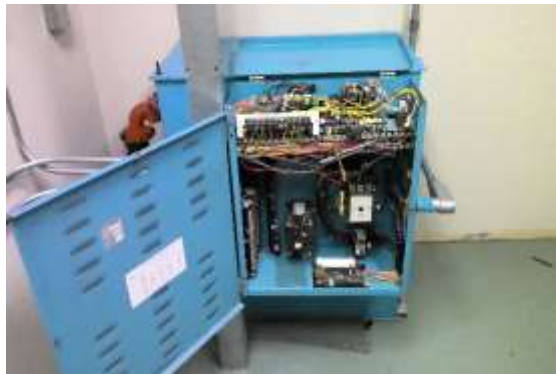
**Deficiency F16**

Carryover from prior survey : No
Location : Main Campus (171A)
Building name : Learning Resources Center (171-16)
Unique Facility Identifier (UFI) : A07767
Funding category in capital budget : Minor Works Facility appropriation
Unifomat category : D10-Conveying
Assessment : Asset is near or at the end of its useful life and should be replaced
Quantity : 1
Unit of measurement : LS
Component : Elevator equipment
Location within building or site : Elevator Car 1
Issue clarity : Adequate information was provided to assess deficiency
Main cause of asset degradation or failure : Age/Wear
Detailed description : The college is concerned about the age of the elevator controls (roughly 33 years old). Parts are more difficult to find, however, the controls can still be maintained. System elevator controls commonly have a life of 40 or more years if they are maintainable, even when parts are difficult to obtain. If the controls are no longer maintainable (even if it is difficult), then confirmation must be made by the elevator maintenance contractor to support the replacement at this time. The controls should continue to be maintained and be monitored for future replacement.

Recommended funding schedule : Fund in Next Biennium (scoring weight=2.5)
Estimated remaining life (years) : 5
Estimated average life expectancy (years) : 40
Scoring priority category 1 : System Use (scoring weight=15)
Category 1 percentage : 80 %
Scoring priority category 2 : Facility Use/ Civil Rights Violation (scoring weight=20)
Category 2 percentage : 20 %
Project construction estimate (MACC): \$220,000
Total project estimate (including soft costs): \$305,000
Additional points based on building condition: 1
Deficiency score : $2.5 \times ((15 \times 80\%) + (20 \times 20\%)) + 1 = 41$

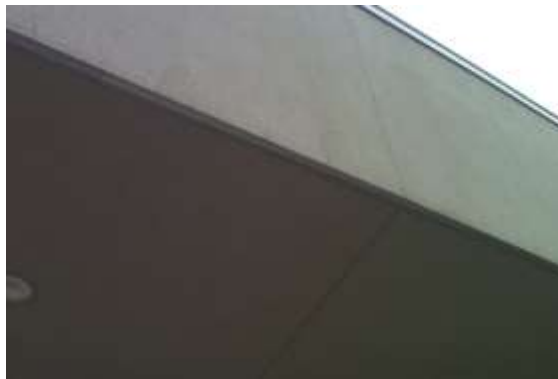
**Deficiency F17**

Carryover from prior survey : No
Location : Main Campus (171A)
Building name : Learning Resources Center (171-16)
Unique Facility Identifier (UFI) : A07767
Funding category in capital budget : Minor Works Facility appropriation
Uniformat category : B20-Exterior Enclosure
Assessment : Asset should be repaired to extend its useful life
Unit of measurement : #REF!
Component : Siding - stucco
Location within building or site : Exterior
Issue clarity : Adequate information was provided to assess deficiency
Main cause of asset degradation or failure : Age/Wear
Detailed description : The Dryvit finish on the building facia has begun to exhibit cracking in some areas. The facia needs to be properly maintained (with sealant) to ensure water does not freeze within the surface and cause more significant damage to the stucco. The system should continue to be monitored for repairs.
Recommended funding schedule : Deferred Backlog (scoring weight=1)

Estimated remaining life (years) : 5
Estimated average life expectancy (years) : 25
Scoring priority category 1 : High Repair/Repl. Cost (scoring weight=12)
Category 1 percentage : 60 %
Scoring priority category 2 : System Use (scoring weight=15)
Category 2 percentage : 40 %
Project construction estimate (MACC): \$180,000
Total project estimate (including soft costs): \$250,000
Additional points based on building condition: 1
Deficiency score : $1 \times ((12 \times 60\%) + (15 \times 40\%)) + 1 = 14.2$

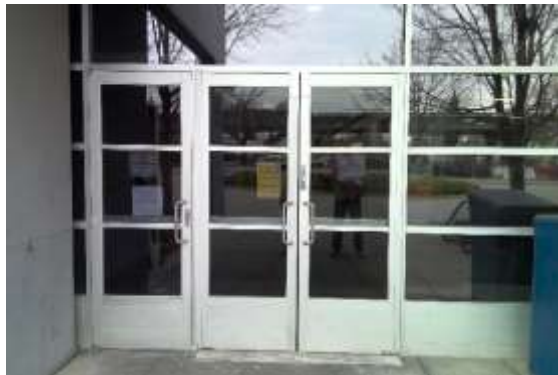
**Deficiency F18**

Carryover from prior survey : No
Location : Main Campus (171A)
Building name : Learning Resources Center (171-16)
Unique Facility Identifier (UFI) : A07767
Funding category in capital budget : Minor Works Facility appropriation
Uniformat category : B20-Exterior Enclosure
Assessment : Asset is near or at the end of its useful life and should be replaced
Quantity : 1
Unit of measurement : LS
Component : Entrance storefront system
Location within building or site : West & East Main Entrances
Issue clarity : Adequate information was provided to assess deficiency
Main cause of asset degradation or failure : Age/Wear
Detailed description : Both the east and west entrance storefronts have deteriorated. The doors still function, however, they have become less secure. The doors should continue to be monitored for replacement.
Recommended funding schedule : Fund in Next Biennium (scoring weight=2.5)
Estimated remaining life (years) : 5

Estimated average life expectancy (years) : 20
Scoring priority category 1 : High Repair/Repl. Cost (scoring weight=12)
Category 1 percentage : 50 %
Scoring priority category 2 : System Use (scoring weight=15)
Category 2 percentage : 50 %
Project construction estimate (MACC): \$60,000
Total project estimate (including soft costs): \$83,000
Additional points based on building condition: 1
Deficiency score : $2.5 \times ((12 \times 50\%) + (15 \times 50\%)) + 1 = 34.8$

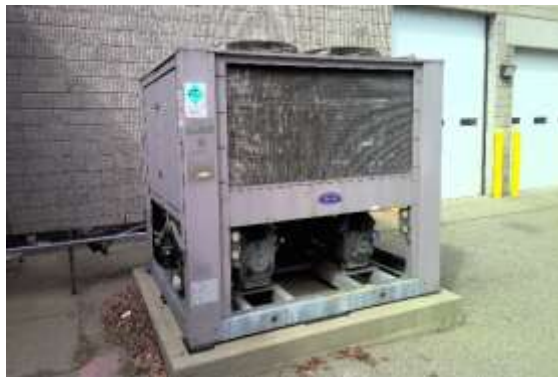
**Deficiency F19**

Carryover from prior survey : No
Location : Main Campus (171A)
Building name : Automotive (171-18)
Unique Facility Identifier (UFI) : A07575
Funding category in capital budget : Minor Works Facility appropriation
Unifomat category : D30-HVAC
Assessment : Asset is near or at the end of its useful life and should be replaced
Quantity : 1
Unit of measurement : LS
Component : Direct expansion chiller
Location within building or site : North Main Entrance
Issue clarity : Adequate information was provided to assess deficiency
Main cause of asset degradation or failure : Age/Wear
Detailed description : The chiller on the north end of the building is near the end of its useful life. The unit still functions, but has required an increased level of maintenance to keep it functioning properly. The unit should continue to be monitored for replacement.
Recommended funding schedule : Immediate (scoring weight=4)
Estimated remaining life (years) : 3

Estimated average life expectancy (years) : 20
Scoring priority category 1 : System Use (scoring weight=15)
Category 1 percentage : 70 %
Scoring priority category 2 : High Repair/Repl. Cost (scoring weight=12)
Category 2 percentage : 30 %
Project construction estimate (MACC): \$111,000
Total project estimate (including soft costs): \$154,000
Additional points based on building condition: 5
Deficiency score : $4 \times ((15 \times 70\%) + (12 \times 30\%)) + 5 = 61.4$

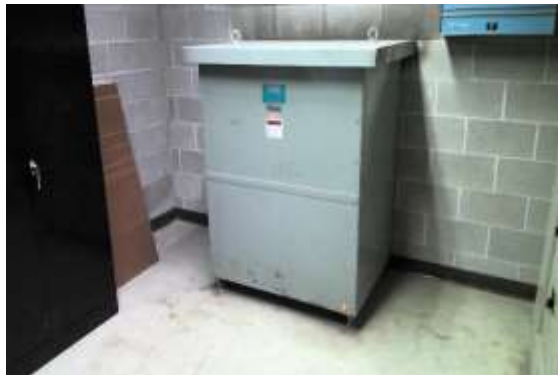
**Deficiency F20**

Carryover from prior survey : No
Location : Main Campus (171A)
Building name : Automotive (171-18)
Unique Facility Identifier (UFI) : A07575
Funding category in capital budget : Minor Works Facility appropriation
Unifomat category : D50-Electrical
Assessment : Asset is near or at the end of its useful life and should be replaced
Quantity : 1
Unit of measurement : LS
Component : Transformer
Location within building or site : Room 148
Issue clarity : Adequate information was provided to assess deficiency
Main cause of asset degradation or failure : Age/Wear
Detailed description : The college is concerned about the age of the interior building transformer in Room 148. The unit is at the end of its expected life and should be replaced to avoid system disruptions.
Recommended funding schedule : Immediate (scoring weight=4)
Estimated remaining life (years) : 3
Estimated average life expectancy (years) : 40
Scoring priority category 1 : System Use (scoring weight=15)

Category 1 percentage : 70 %
Scoring priority category 2 : Facility Use/ Civil Rights Violation (scoring weight=20)
Category 2 percentage : 30 %
Project construction estimate (MACC): \$25,000
Total project estimate (including soft costs): \$34,000
Additional points based on building condition: 5
Deficiency score : $4 \times ((15 \times 70\%) + (20 \times 30\%)) + 5 = 71$

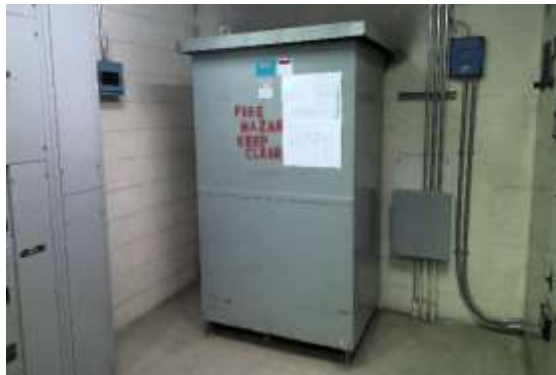
**Deficiency F21**

Carryover from prior survey : No
Location : Main Campus (171A)
Building name : Automotive (171-18)
Unique Facility Identifier (UFI) : A07575
Funding category in capital budget : Minor Works Facility appropriation
Unifomat category : D50-Electrical
Assessment : Asset is near or at the end of its useful life and should be replaced
Quantity : 1
Unit of measurement : LS
Component : Transformer
Location within building or site : Room 126
Issue clarity : Adequate information was provided to assess deficiency
Main cause of asset degradation or failure : Age/Wear
Detailed description : The college is concerned about the age of the interior building transformer in Room 126. The unit is at the end of its expected life and should be replaced to avoid system disruptions.
Recommended funding schedule : Immediate (scoring weight=4)
Estimated remaining life (years) : 3
Estimated average life expectancy (years) : 40
Scoring priority category 1 : System Use (scoring weight=15)

Category 1 percentage : 70 %
Scoring priority category 2 : Facility Use/ Civil Rights Violation (scoring weight=20)
Category 2 percentage : 30 %
Project construction estimate (MACC): \$30,000
Total project estimate (including soft costs): \$41,000
Additional points based on building condition: 5
Deficiency score : $4 \times ((15 \times 70\%) + (20 \times 30\%)) + 5 = 71$

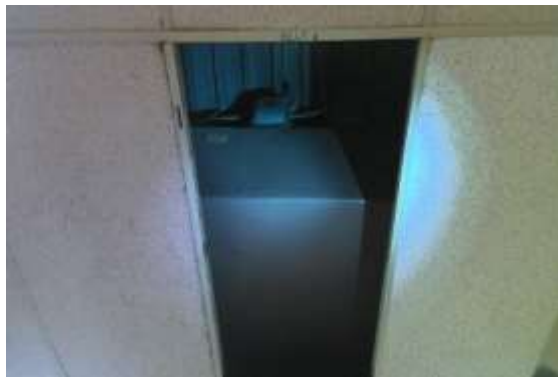
**Deficiency F22**

Carryover from prior survey : No
Location : Main Campus (171A)
Building name : Heavy Equipment / Maintenance (171-19)
Unique Facility Identifier (UFI) : A02485
Funding category in capital budget : Minor Works Facility appropriation
Unifomat category : D30-HVAC
Assessment : Asset is near or at the end of its useful life and should be replaced
Quantity : 20
Unit of measurement : EA
Component : HVAC unit
Location within building or site : Multiple
Issue clarity : Adequate information was provided to assess deficiency
Main cause of asset degradation or failure : Age/Wear
Detailed description : The college is concerned about the reliability of the many fan coils throughout the building. There are approximately twenty coils that require more frequent maintenance to maintain full system function. Ten of the coils in the worst condition should be replaced.
Recommended funding schedule : Immediate (scoring weight=4)

Estimated remaining life (years) : 3
Estimated average life expectancy (years) : 25
Scoring priority category 1 : System Use (scoring weight=15)
Category 1 percentage : 70 %
Scoring priority category 2 : High Repair/Repl. Cost (scoring weight=12)
Category 2 percentage : 30 %
Project construction estimate (MACC): \$200,000
Total project estimate (including soft costs): \$278,000
Additional points based on building condition: 2
Deficiency score : $4 \times ((15 \times 70\%) + (12 \times 30\%)) + 2 = 58.4$

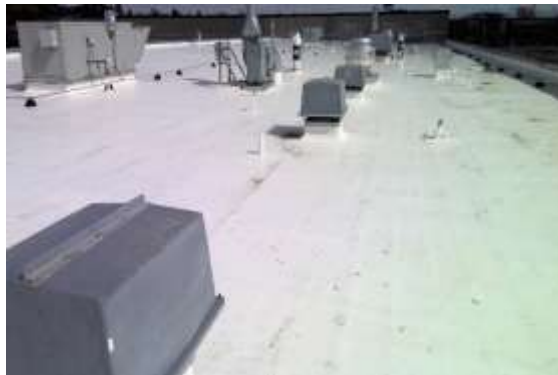
**Deficiency F23**

Carryover from prior survey : No
Location : Main Campus (171A)
Building name : Heavy Equipment / Maintenance (171-19)
Unique Facility Identifier (UFI) : A02485
Funding category in capital budget : Minor Works Facility appropriation
Unifomat category : D30-HVAC
Assessment : Asset is near or at the end of its useful life and should be replaced
Quantity : 12
Unit of measurement : EA
Component : Exhaust system
Location within building or site : Roof
Issue clarity : Adequate information was provided to assess deficiency
Main cause of asset degradation or failure : Age/Wear
Detailed description : The shop and restroom exhaust fans are beyond their expected life, but still function. The units are still functional but should be monitored and considered for future replacement.
Recommended funding schedule : Fund in Next Biennium (scoring weight=2.5)
Estimated remaining life (years) : 5
Estimated average life expectancy (years) : 20

Scoring priority category 1 : High Repair/Repl. Cost (scoring weight=12)
Category 1 percentage : 100 %
Scoring priority category 2 : None
Category 2 percentage : 0 %
Project construction estimate (MACC): \$120,000
Total project estimate (including soft costs): \$166,000
Additional points based on building condition: 2
Deficiency score : $2.5 \times (12 \times 100\%) + 2 = 32$

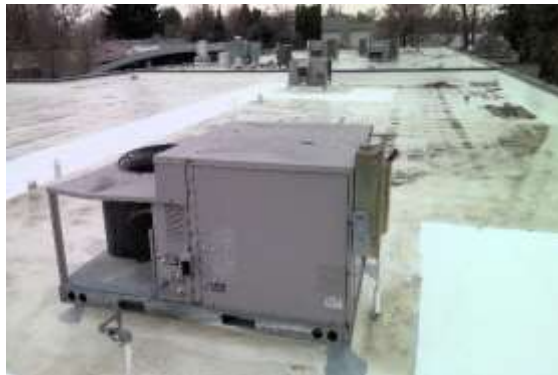
**Deficiency F24**

Carryover from prior survey : No
Location : Main Campus (171A)
Building name : Bigfoot Head Start Child Care (171-20)
Unique Facility Identifier (UFI) : A00521
Funding category in capital budget : Minor Works Facility appropriation
Unifomat category : D30-HVAC
Assessment : Asset is near or at the end of its useful life and should be replaced
Quantity : 6
Unit of measurement : EA
Component : HVAC unit
Location within building or site : Roof
Issue clarity : Adequate information was provided to assess deficiency
Main cause of asset degradation or failure : Age/Wear
Detailed description : The college is concerned about the age and reliability of six rooftop HVAC units. The units are still functioning but have become more difficult to repair. The units should continue to be monitored for replacement.
Recommended funding schedule : Fund in Next Biennium (scoring weight=2.5)
Estimated remaining life (years) : 5

Estimated average life expectancy (years) : 25
Scoring priority category 1 : System Use (scoring weight=15)
Category 1 percentage : 80 %
Scoring priority category 2 : High Operating Cost (scoring weight=10)
Category 2 percentage : 20 %
Project construction estimate (MACC): \$540,000
Total project estimate (including soft costs): \$750,000
Additional points based on building condition: 1
Deficiency score : $2.5 \times ((15 \times 80\%) + (10 \times 20\%)) + 1 = 36$

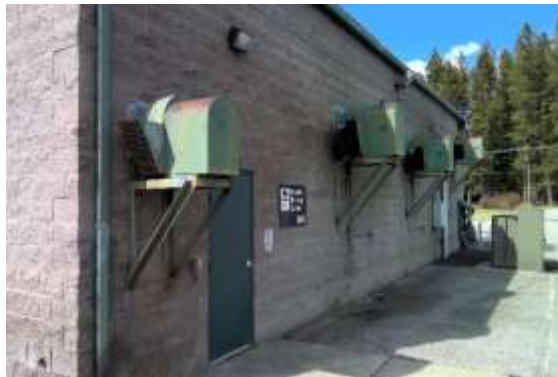
**Deficiency F25**

Carryover from prior survey : No
Location : Colville Center (171D)
Building name : Industrial Training Ctr (171-608)
Unique Facility Identifier (UFI) : A00002
Funding category in capital budget : Minor Works Facility appropriation
Unifomat category : D30-HVAC
Assessment : Asset is near or at the end of its useful life and should be replaced
Quantity : 4
Unit of measurement : EA
Component : Exhaust system
Location within building or site : Exterior Wall
Issue clarity : Adequate information was provided to assess deficiency
Main cause of asset degradation or failure : Age/Wear
Detailed description : The exhaust fans in the welding area have degraded and are less reliable. These units should be replaced.
Recommended funding schedule : Immediate (scoring weight=4)
Estimated remaining life (years) : 3
Estimated average life expectancy (years) : 25
Scoring priority category 1 : High Repair/Repl. Cost (scoring weight=12)

Category 1 percentage : 50 %
Scoring priority category 2 : System Use (scoring weight=15)
Category 2 percentage : 50 %
Project construction estimate (MACC): \$60,000
Total project estimate (including soft costs): \$83,000
Additional points based on building condition: 1
Deficiency score : $4 \times ((12 \times 50\%) + (15 \times 50\%)) + 1 = 55$

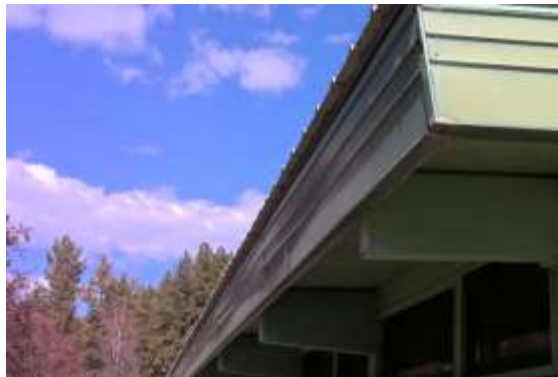
**Deficiency F26**

Carryover from prior survey : No
Location : Colville Center (171D)
Building name : Colville Center, Owned (171-617)
Unique Facility Identifier (UFI) : A06470
Funding category in capital budget : Minor Works Facility appropriation
Uniformat category : B20-Exterior Enclosure
Assessment : Asset is near or at the end of its useful life and should be replaced
Quantity : 1
Unit of measurement : LS
Component : Exterior Insulation and finish
Location within building or site : Exterior Wall
Issue clarity : Adequate information was provided to assess deficiency
Main cause of asset degradation or failure : Age/Wear
Detailed description : Several sections of exterior metal siding have degraded. These areas do not allow water to penetrate the building envelope, but should be repaired or replaced.
Recommended funding schedule : Fund in Next Biennium (scoring weight=2.5)
Estimated remaining life (years) : 5
Estimated average life expectancy (years) : 30

Scoring priority category 1 : High Repair/Repl. Cost (scoring weight=12)
Category 1 percentage : 100 %
Scoring priority category 2 : None
Category 2 percentage : 0 %
Project construction estimate (MACC): \$30,000
Total project estimate (including soft costs): \$41,000
Additional points based on building condition: 2
Deficiency score : $2.5 \times (12 \times 100\%) + 2 = 32$

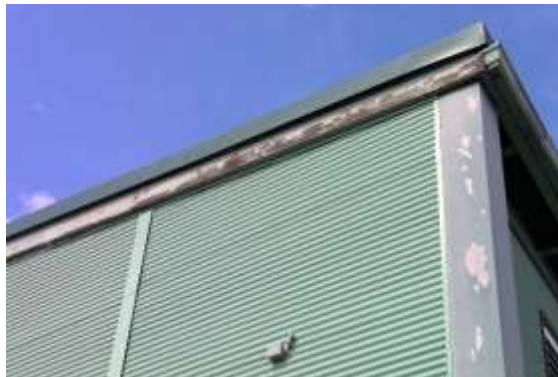
**Deficiency F27**

Carryover from prior survey : No
Location : Colville Center (171D)
Building name : Colville Center, Owned (171-617)
Unique Facility Identifier (UFI) : A06470
Funding category in capital budget : Minor Works Facility appropriation
Uniformat category : B20-Exterior Enclosure
Assessment : Asset is near or at the end of its useful life and should be replaced
Quantity : 1
Unit of measurement : LS
Component : Facia
Location within building or site : Exterior
Issue clarity : Adequate information was provided to assess deficiency
Main cause of asset degradation or failure : Age/Wear
Detailed description : The wood facia boards finish has degraded. The boards now exhibit some signs of possible rot. The boards should be replaced or re-finished to ensure a water-tight envelope.
Recommended funding schedule : Fund in Next Biennium (scoring weight=2.5)
Estimated remaining life (years) : 5
Estimated average life expectancy (years) : 40

Scoring priority category 1 : High Repair/Repl. Cost (scoring weight=12)
Category 1 percentage : 100 %
Scoring priority category 2 : None
Category 2 percentage : 0 %
Project construction estimate (MACC): \$40,000
Total project estimate (including soft costs): \$55,000
Additional points based on building condition: 2
Deficiency score : $2.5 \times (12 \times 100\%) + 2 = 32$

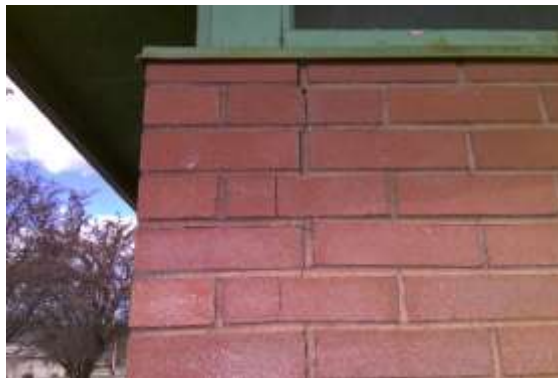
**Deficiency F28**

Carryover from prior survey : No
Location : Colville Center (171D)
Building name : Colville Center, Owned (171-617)
Unique Facility Identifier (UFI) : A06470
Funding category in capital budget : Minor Works Facility appropriation
Uniformat category : B20-Exterior Enclosure
Assessment : Asset should be repaired to extend its useful life
Quantity : 1
Unit of measurement : LS
Component : Siding - masonry
Location within building or site : Exterior
Issue clarity : Adequate information was provided to assess deficiency
Main cause of asset degradation or failure : Age/Wear
Detailed description : There a small section of brick that exhibits some cracking. This section should be repaired.
Recommended funding schedule : Immediate (scoring weight=4)
Estimated remaining life (years) : 3
Estimated average life expectancy (years) : 50
Scoring priority category 1 : High Repair/Repl. Cost (scoring weight=12)
Category 1 percentage : 60 %

Scoring priority category 2 : System Use (scoring weight=15)
Category 2 percentage : 40 %
Project construction estimate (MACC): \$20,000
Total project estimate (including soft costs): \$27,000
Additional points based on building condition: 2
Deficiency score : $4 \times ((12 \times 60\%) + (15 \times 40\%)) + 2 = 54.8$

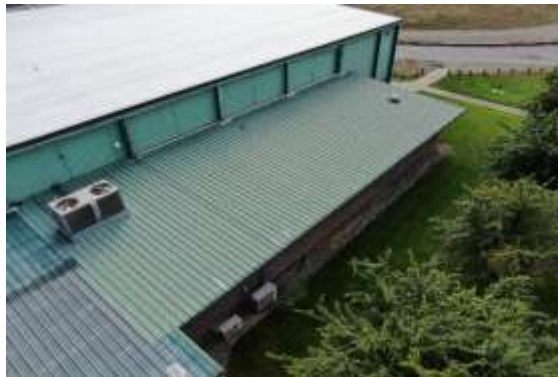
**Deficiency F29**

Carryover from prior survey : No
Location : Colville Center (171D)
Building name : Colville Center, Owned (171-617)
Unique Facility Identifier (UFI) : A06470
Funding category in capital budget : Minor Works Facility appropriation
Uniformat category : B20-Exterior Enclosure
Assessment : Asset should be repaired to extend its useful life
Quantity : 1
Unit of measurement : LS
Component : Soffits
Location within building or site : Exterior
Issue clarity : Adequate information was provided to assess deficiency
Main cause of asset degradation or failure : Age/Wear
Detailed description : The college was concerned about prior roof leaks, however, the leaks appeared to have been addressed. The roof should continue to be monitored for repairs.
Recommended funding schedule : Deferred Backlog (scoring weight=1)
Estimated remaining life (years) : 7
Estimated average life expectancy (years) : 25
Scoring priority category 1 : System Use (scoring weight=15)

Category 1 percentage : 70 %
Scoring priority category 2 : High Repair/Repl. Cost (scoring weight=12)
Category 2 percentage : 30 %
Project construction estimate (MACC): \$72,000
Total project estimate (including soft costs): \$100,000
Additional points based on building condition: 2
Deficiency score : $1 \times ((15 \times 70\%) + (12 \times 30\%)) + 2 = 16.1$

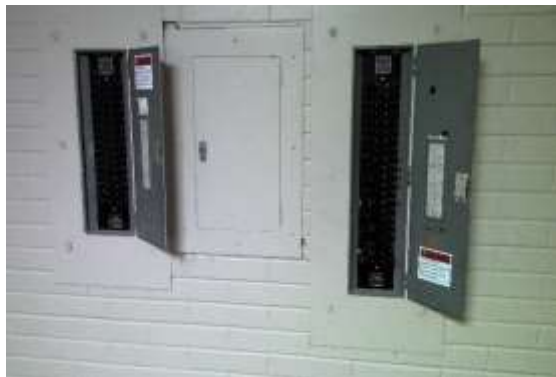
**Deficiency F30**

Carryover from prior survey : No
Location : Colville Center (171D)
Building name : Colville Center, Owned (171-617)
Unique Facility Identifier (UFI) : A06470
Funding category in capital budget : Minor Works Facility appropriation
Unifomat category : D50-Electrical
Assessment : Asset is near or at the end of its useful life and should be replaced
Quantity : 1
Unit of measurement : LS
Component : Electrical panel
Location within building or site : Multiple
Issue clarity : Adequate information was provided to assess deficiency
Main cause of asset degradation or failure : Age/Wear
Detailed description : The Federal Pacific electrical distribution panels are past their expected life. The panels present a substantial fire risk due to defective circuitry. A recent arc flash event in one of the panels has occurred and panel had to be replaced. These panels should be replaced.
Recommended funding schedule : Immediate (scoring weight=4)

Estimated remaining life (years) : 3
Estimated average life expectancy (years) : 40
Scoring priority category 1 : Health/Safety (scoring weight=25)
Category 1 percentage : 50 %
Scoring priority category 2 : System Use (scoring weight=15)
Category 2 percentage : 50 %
Project construction estimate (MACC): \$60,000
Total project estimate (including soft costs): \$83,000
Additional points based on building condition: 2
Deficiency score : $4 \times ((25 \times 50\%) + (15 \times 50\%)) + 2 = 82$

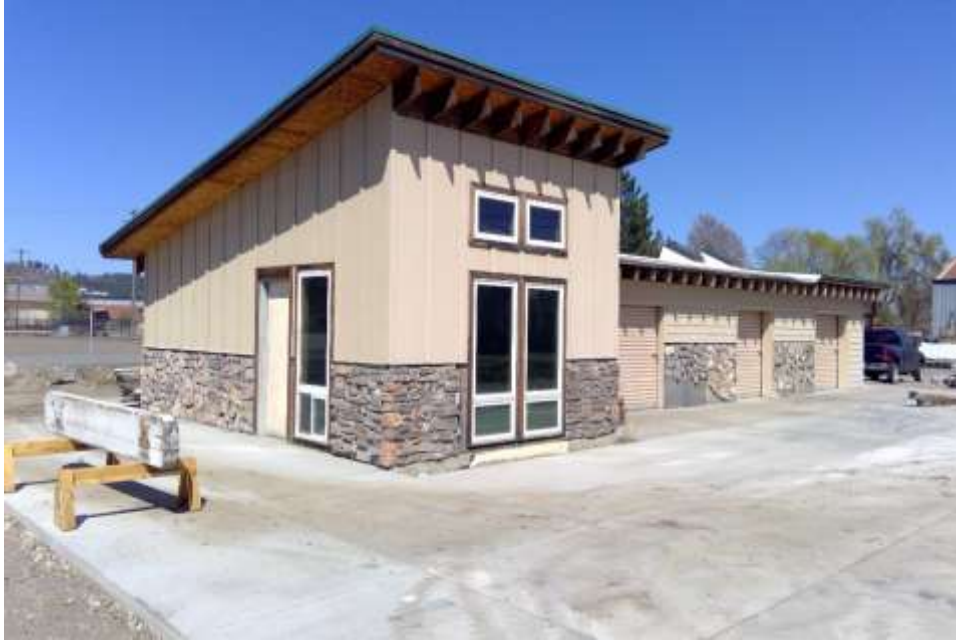
Apprenticeship Training Modules (171-605)      STATE UFI: A21469      Apprenticeship Trng Site (171C)  
AREA: 1,505 SF      BUILT: 2004      REMODELED: No      PREDOMINANT USE: Storage  
CONSTRUCTION TYPE: No data      CRV/SF: \$231      REPLACEMENT VALUE: \$347,655

Primary Systems			
COMPONENT:	Structure	RATING: 1 x WEIGHT: 9.3 =	SCORE: 9.3
No signs of settlement or cracking, no abrupt vertical changes Columns, bearing walls and roof structure appears sound/free of defects			
COMMENTS:	Slab on grade		
COMPONENT:	Exterior Closure	RATING: 2 x WEIGHT: 9.3 =	SCORE: 18.7
Weatherproof exterior, but finish appears poorly maintained			
COMMENTS:	Hardiplank, stone		
COMPONENT:	Roofing	RATING: 2 x WEIGHT: 11.7 =	SCORE: 23.4
Majority of roofing and flashing appear sound, but a small portion of roofing shows deterioration where maintenance or minor repair needed			
COMMENTS:	Single-ply

Secondary Systems			
COMPONENT:	Floor Finishes	RATING: 2 x WEIGHT: 7 =	SCORE: 14
Some wear is evident on finish; maintenance needed			
COMMENTS:	No data		
COMPONENT:	Wall Finishes	RATING: 1 x WEIGHT: 7 =	SCORE: 7
Maintainable surfaces in good condition			
COMMENTS:	No data		
COMPONENT:	Ceiling Finishes	RATING: 2 x WEIGHT: 7 =	SCORE: 14
Aging surfaces in fair condition and good alignment			
COMMENTS:	No data		
COMPONENT:	Doors & Hardware	RATING: 1 x WEIGHT: 7 =	SCORE: 7
Appropriate hardware, closers, panic devices; in good working order			
COMMENTS:	No data

Service Systems			
COMPONENT:	Elevators	RATING: 0 x WEIGHT: 0 =	SCORE: 0
No data			
COMMENTS:	One story		
COMPONENT:	Plumbing	RATING: 0 x WEIGHT: 0 =	SCORE: 0
No data			
COMMENTS:	No data		
COMPONENT:	HVAC	RATING: 1 x WEIGHT: 9.3 =	SCORE: 9.3
Equipment in good condition; easily controlled; serves all required spaces; All necessary spaces are adequately ventilated; A/C provided throughout			
COMMENTS:	No data		
COMPONENT:	Electrical	RATING: 1 x WEIGHT: 9.3 =	SCORE: 9.3
Adequate service and distribution capacity for current/future needs			
COMMENTS:	No data		
COMPONENT:	Lights/Power	RATING: 1 x WEIGHT: 9.3 =	SCORE: 9.3
Contemporary lighting with good work area illumination; ample outlets			
COMMENTS:	No data

Quality Standards			
COMPONENT:	Maintenance	RATING: 2 x WEIGHT: 8.2 =	SCORE: 16.4
	Routine maintenance is required; impact is minor		
COMMENTS:	No data		
COMPONENT:	Remaining Life	RATING: 1 x WEIGHT: 7 =	SCORE: 7
	Life expectancy is >20 years; minor system deterioration		
COMMENTS:	No data		
COMPONENT:	Appearance	RATING: 3 x WEIGHT: 7 =	SCORE: 21
	Average construction; average interior and exterior appearance		
COMMENTS:	No data

CONDITION: Adequate

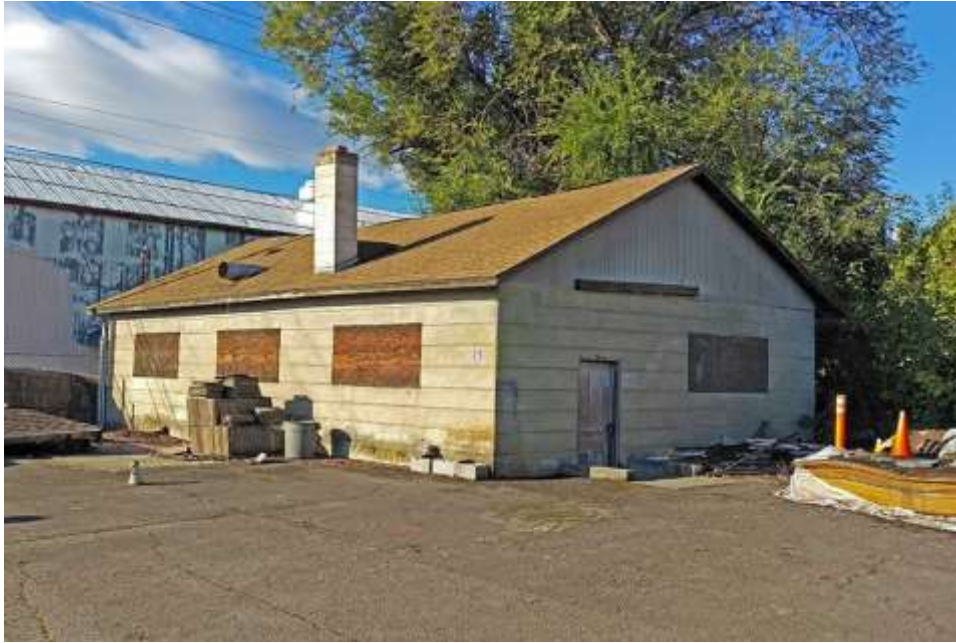
Apprenticeship Training, Storage (171-645)      STATE UFI: A25178      Apprenticeship Trng Site (171C)  
AREA: 1,500 SF      BUILT: 0      REMODELED: No      PREDOMINANT USE: Storage  
CONSTRUCTION TYPE: No data      CRV/SF: \$231      REPLACEMENT VALUE: \$346,500

Primary Systems			
COMPONENT:	Structure	RATING: 2 x WEIGHT: 10.3 =	SCORE: 20.7
Minor cracks evident in a small portion of the structure			
COMMENTS:	Concrete footing, wood structure		
COMPONENT:	Exterior Closure	RATING: 4 x WEIGHT: 10.3 =	SCORE: 41.3
General deterioration detected, one or more minor leaks apparent			
COMMENTS:	Wood, metal siding		
COMPONENT:	Roofing	RATING: 3 x WEIGHT: 12.9 =	SCORE: 38.8
Some deterioration is evident in membrane and flashings; maintenance or minor repair is needed			
COMMENTS:	Composition shingles

Secondary Systems			
COMPONENT:	Floor Finishes	RATING: 4 x WEIGHT: 7.8 =	SCORE: 31
General deterioration evident; one-third to one-half of flooring exhibits extensive deterioration			
COMMENTS:	Plywood		
COMPONENT:	Wall Finishes	RATING: 4 x WEIGHT: 7.8 =	SCORE: 31
Aging surfaces generally require maintenance; some areas require repair			
COMMENTS:	Plywood		
COMPONENT:	Ceiling Finishes	RATING: 0 x WEIGHT: 0 =	SCORE: 0
No data			
COMMENTS:	Exposed structure		
COMPONENT:	Doors & Hardware	RATING: 4 x WEIGHT: 7.8 =	SCORE: 31
General deterioration evident in both door and hardware; some doors with significant deterioration			
COMMENTS:	wood doors

Service Systems			
COMPONENT:	Elevators	RATING: 0 x WEIGHT: 0 =	SCORE: 0
No data			
COMMENTS:	One story		
COMPONENT:	Plumbing	RATING: 0 x WEIGHT: 0 =	SCORE: 0
No data			
COMMENTS:	None		
COMPONENT:	HVAC	RATING: 4 x WEIGHT: 10.3 =	SCORE: 41.3
System partially adequate; many areas served by equipment needing repair; areas with A/C very limited, but hazardous areas are ventilated			
COMMENTS:	No data		
COMPONENT:	Electrical	RATING: 1 x WEIGHT: 10.3 =	SCORE: 10.3
Adequate service and distribution capacity for current/future needs			
COMMENTS:	No data		
COMPONENT:	Lights/Power	RATING: 3 x WEIGHT: 10.3 =	SCORE: 31
Adequate work area illumination; adequate outlets for current use; maintenance required			
COMMENTS:	No data

Safety Systems			
COMPONENT:	Life/Safety	RATING: 3 x WEIGHT: 12.9 =	SCORE: 38.8
Generally meets codes for vintage of construction			
COMMENTS:	No data		
COMPONENT:	Fire Safety	RATING: 5 x WEIGHT: 12.9 =	SCORE: 64.6
Life safety or accessibility violations exist; Missing exit signs or extinguishers throughout; No alarm or sprinklers			
COMMENTS:	No data		
COMPONENT:	Modifications	RATING: 0 x WEIGHT: 0 =	SCORE: 0
No data			
COMMENTS:	No data

Quality Standards			
COMPONENT:	Maintenance	RATING: 5 x WEIGHT: 9 =	SCORE: 45.2
General deterioration is evident; lack of adequate maintenance is evident; impact is moderate to severe			
COMMENTS:	No data		
COMPONENT:	Remaining Life	RATING: 5 x WEIGHT: 7.8 =	SCORE: 38.8
Life expectancy is <5 years; significant system deterioration			
COMMENTS:	No data		
COMPONENT:	Appearance	RATING: 4 x WEIGHT: 7.8 =	SCORE: 31
Average construction; some unattractive exterior and interior spaces			
COMMENTS:	No data

CONDITION: Replace or Renovate

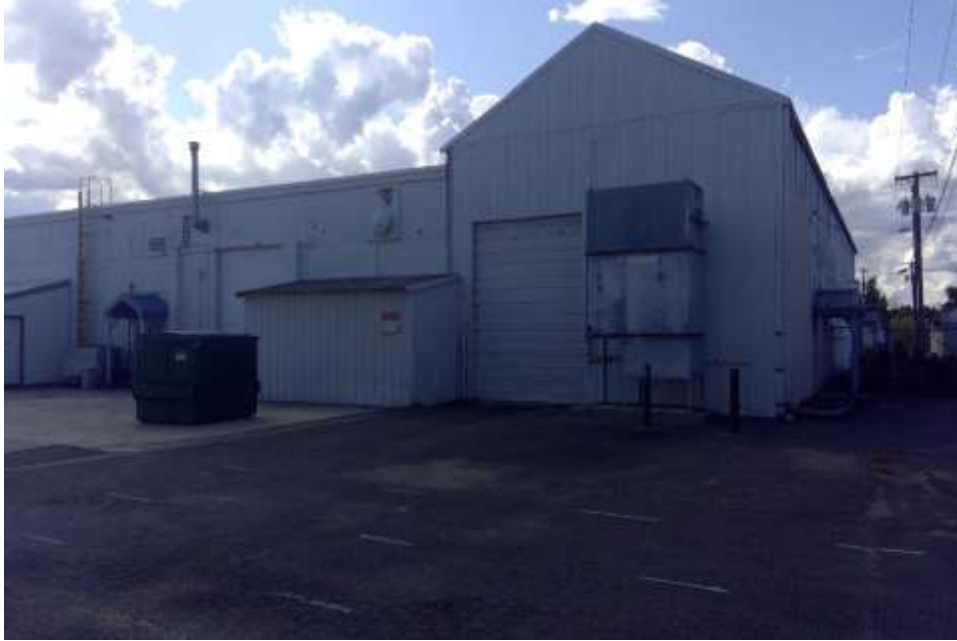
Apprenticeship West (171-602)	STATE UFI: A00226	Apprenticeship Trng Site (171C)
AREA: 19,497 SF	BUILT: 1960	REMODELED: No
CONSTRUCTION TYPE: Medium	CRV/SF: \$395	REPLACEMENT VALUE: \$7,701,315

Primary Systems			
COMPONENT:	Structure	RATING: 1 x WEIGHT: 8 =	SCORE: 8
No signs of settlement or cracking, no abrupt vertical changes Columns, bearing walls and roof structure appears sound/free of defects			
COMMENTS:	Steel frame; CMU and concrete		
COMPONENT:	Exterior Closure	RATING: 3 x WEIGHT: 8 =	SCORE: 24
Sound and weatherproof but with some physical deterioration evident			
COMMENTS:	CMU walls; metal walls-badly dented		
COMPONENT:	Roofing	RATING: 5 x WEIGHT: 10 =	SCORE: 50
Leaking and deterioration is to point where new roof is required			
COMMENTS:	Gravel coated built-up-needs replacement; metal on one portion

Secondary Systems			
COMPONENT:	Floor Finishes	RATING: 3 x WEIGHT: 6 =	SCORE: 18
	Some physical wear and minor imperfections are evident; beginning deterioration		
COMMENTS:	Carpet; concrete; ceramic tile; vinyl tile-cracking and minor splits throughout		
COMPONENT:	Wall Finishes	RATING: 2 x WEIGHT: 6 =	SCORE: 12
	Maintainable surfaces, minor maintenance is required in some areas		
COMMENTS:	CMU; Gypsum board; metal; ceramic tile; wood paneling		
COMPONENT:	Ceiling Finishes	RATING: 3 x WEIGHT: 6 =	SCORE: 18
	Some wear and tear; Minor damage, staining or deterioration		
COMMENTS:	Gypsum board, lay-in tile, roof deck and direct-adhered tile		
COMPONENT:	Doors & Hardware	RATING: 3 x WEIGHT: 6 =	SCORE: 18
	Functional, but dated; some maintenance required		
COMMENTS:	Interior wood doors/frames; exterior metal doors/frames; metal OH door

Service Systems			
COMPONENT:	Elevators	RATING: 5 x WEIGHT: 6 =	SCORE: 30
	No elevator access for upper floors		
COMMENTS:	2nd story with stair access only to offices		
COMPONENT:	Plumbing	RATING: 3 x WEIGHT: 8 =	SCORE: 24
	Fixtures are functional but dated; some leaks; maintenance required		
COMMENTS:	Copper; steel, galvanized piping; porcelain fixtures		
COMPONENT:	HVAC	RATING: 3 x WEIGHT: 8 =	SCORE: 24
	System generally adequate; some deterioration; needs balancing; some areas have A/C; hazardous areas are ventilated		
COMMENTS:	2 new packaged rooftop HVAC units installed in 2010; hot water boilers; unit heaters; split system HVAC		
COMPONENT:	Electrical	RATING: 3 x WEIGHT: 8 =	SCORE: 24
	Service capacity meets current needs but inadequate for future		
COMMENTS:	200amp 204/120v		
COMPONENT:	Lights/Power	RATING: 3 x WEIGHT: 8 =	SCORE: 24
	Adequate work area illumination; adequate outlets for current use; maintenance required

Safety Systems			
COMPONENT:	Life/Safety	RATING: 3 x WEIGHT: 10 =	SCORE: 30
Generally meets codes for vintage of construction			
COMMENTS:	Some code violations upstairs		
COMPONENT:	Fire Safety	RATING: 3 x WEIGHT: 10 =	SCORE: 30
Extinguishers and signed egress; no alarm or sprinklers			
COMMENTS:			
COMPONENT:	Modifications	RATING: 5 x WEIGHT: 7 =	SCORE: 35
Modifications not well thought out or constructed; inadequate HVAC and electrical service provided			
COMMENTS:

Quality Standards			
COMPONENT:	Maintenance	RATING: 5 x WEIGHT: 7 =	SCORE: 35
General deterioration is evident; lack of adequate maintenance is evident; impact is moderate to severe			
COMMENTS:	Especially roof maintenance		
COMPONENT:	Remaining Life	RATING: 1 x WEIGHT: 6 =	SCORE: 6
Life expectancy is >20 years; minor system deterioration			
COMMENTS:	Suitable for long term use for construction type programs		
COMPONENT:	Appearance	RATING: 5 x WEIGHT: 6 =	SCORE: 30
Poor to average construction; very unattractive exterior and interior spaces			
COMMENTS:

CONDITION: Replace or Renovate

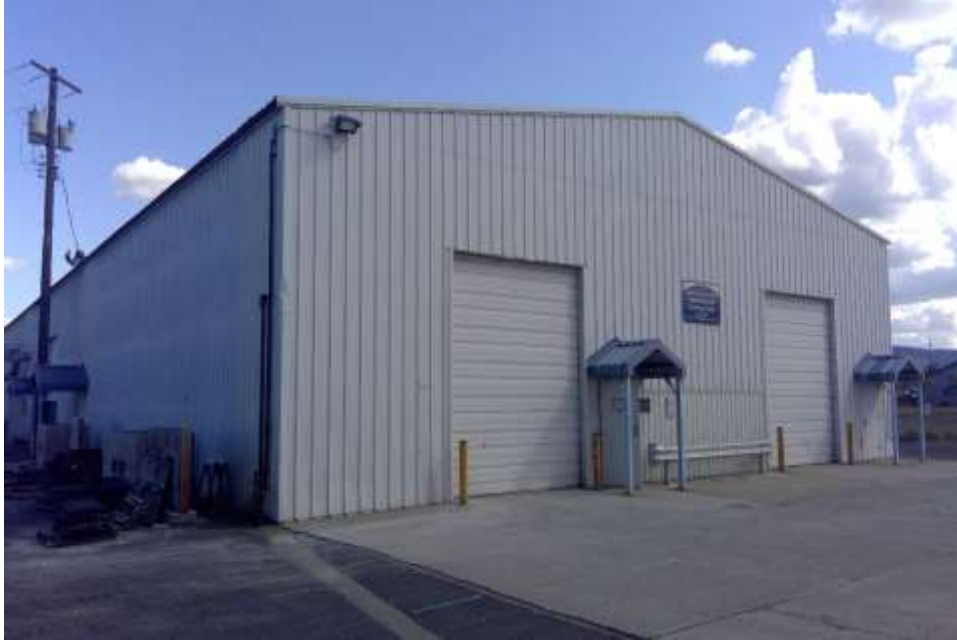
Apprenticeship East (171-603)      STATE UFI: A10412      Apprenticeship Trng Site (171C)  
AREA: 24,063 SF      BUILT: 1960      REMODELED: No      PREDOMINANT USE: Vocational Arts  
CONSTRUCTION TYPE: Medium      CRV/SF: \$395      REPLACEMENT VALUE: \$9,504,885

Primary Systems			
COMPONENT:	Structure	RATING: 3 x WEIGHT: 8 =	SCORE: 24
Some cracking evident but does not likely affect structural integrity; Visible defects apparent but are non-structural			
COMMENTS:	Steel framing; concrete slab		
COMPONENT:	Exterior Closure	RATING: 3 x WEIGHT: 8 =	SCORE: 24
Sound and weatherproof but with some physical deterioration evident			
COMMENTS:	Metal walls		
COMPONENT:	Roofing	RATING: 3 x WEIGHT: 10 =	SCORE: 30
Some deterioration is evident in membrane and flashings; maintenance or minor repair is needed			
COMMENTS:	Metal roof with elastomeric coating

Secondary Systems			
COMPONENT:	Floor Finishes	RATING: 3 x WEIGHT: 6 = SCORE: 18	
	Some physical wear and minor imperfections are evident; beginning deterioration		
COMMENTS:	Concrete on main floor; carpet/tile upstairs; ceramic tile in rest rooms		
COMPONENT:	Wall Finishes	RATING: 3 x WEIGHT: 6 = SCORE: 18	
	Aging surfaces, but sound; some maintenance is required		
COMMENTS:	CMU, ceramic tile and plywood; Gypsum board-some damage		
COMPONENT:	Ceiling Finishes	RATING: 3 x WEIGHT: 6 = SCORE: 18	
	Some wear and tear; Minor damage, staining or deterioration		
COMMENTS:	No ceiling except in classrooms (Gypsum board)		
COMPONENT:	Doors & Hardware	RATING: 3 x WEIGHT: 6 = SCORE: 18	
	Functional, but dated; some maintenance required		
COMMENTS:	Interior wood doors/frames and metal doors/frames; exterior metal doors/frames; OH metal doors

Service Systems			
COMPONENT:	Elevators	RATING: 5 x WEIGHT: 6 = SCORE: 30	
	No elevator access for upper floors		
COMMENTS:	Only stair access to 2nd floor office		
COMPONENT:	Plumbing	RATING: 3 x WEIGHT: 8 = SCORE: 24	
	Fixtures are functional but dated; some leaks; maintenance required		
COMMENTS:	Galvanized, cast iron and PVC piping; older porcelain fixtures		
COMPONENT:	HVAC	RATING: 1 x WEIGHT: 8 = SCORE: 8	
	Equipment in good condition; easily controlled; serves all required spaces; All necessary spaces are adequately ventilated; A/C provided throughout		
COMMENTS:	New radiant ceiling heating system installed in 2007; gas unit heaters; A\C in office		
COMPONENT:	Electrical	RATING: 3 x WEIGHT: 8 = SCORE: 24	
	Service capacity meets current needs but inadequate for future		
COMMENTS:	1200amp 480/208v		
COMPONENT:	Lights/Power	RATING: 3 x WEIGHT: 8 = SCORE: 24	
	Adequate work area illumination; adequate outlets for current use; maintenance required

Safety Systems			
COMPONENT:	Life/Safety	RATING: 3 x WEIGHT: 10 = SCORE: 30	
	Generally meets codes for vintage of construction		
COMMENTS:	Some structural code concerns concerning office area		
COMPONENT:	Fire Safety	RATING: 5 x WEIGHT: 10 = SCORE: 50	
	Life safety or accessibility violations exist; Missing exit signs or extinguishers throughout; No alarm or sprinklers		
COMMENTS:			
COMPONENT:	Modifications	RATING: 5 x WEIGHT: 7 = SCORE: 35	
	Modifications not well thought out or constructed; inadequate HVAC and electrical service provided		
COMMENTS:	Upper level modifications are poorly laid out

Quality Standards			
COMPONENT:	Maintenance	RATING: 3 x WEIGHT: 7 = SCORE: 21	
	Routine maintenance is required; deferred maintenance is evident; impact is minor to moderate		
COMMENTS:			
COMPONENT:	Remaining Life	RATING: 3 x WEIGHT: 6 = SCORE: 18	
	Life expectancy is roughly 10-15 years; moderate system deterioration		
COMMENTS:	Adequate for long term use for construction vocational programs		
COMPONENT:	Appearance	RATING: 5 x WEIGHT: 6 = SCORE: 30	
	Poor to average construction; very unattractive exterior and interior spaces		
COMMENTS:

CONDITION: Replace or Renovate

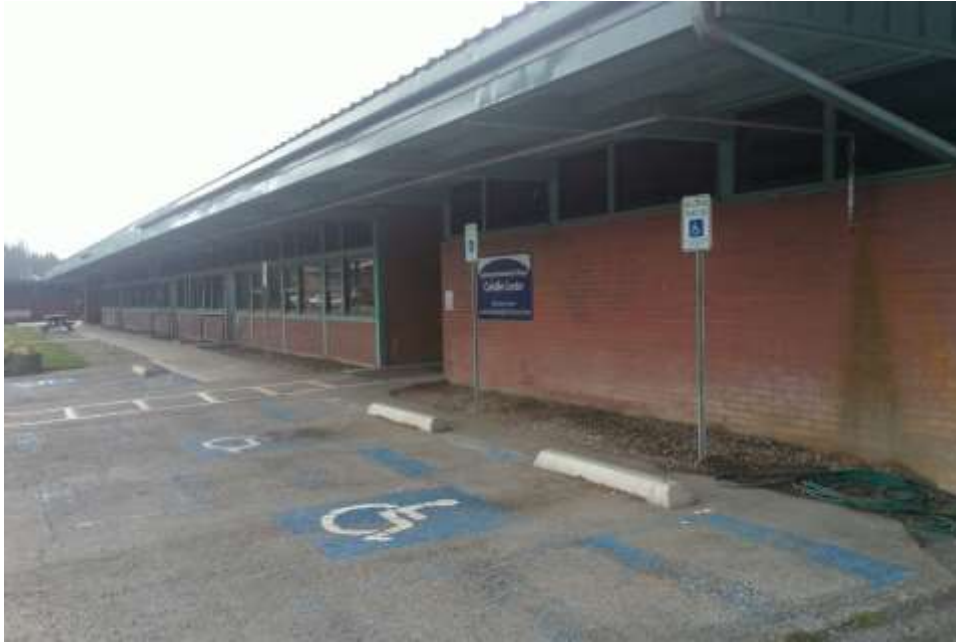
Colville Center, Owned (171-617)      STATE UFI: A06470      Colville Center (171D)  
AREA: 48,965 SF      BUILT: 1954      REMODELED: 2010      PREDOMINANT USE: Multi-Use  
CONSTRUCTION TYPE: Medium      CRV/SF: \$395      REPLACEMENT VALUE: \$19,341,175

Primary Systems			
COMPONENT:	Structure	RATING: 2 x WEIGHT: 8.3 =	SCORE: 16.7
Minor cracks evident in a small portion of the structure			
COMMENTS: Concrete slab; wood and metal framing; may have seismic integrity issues			
COMPONENT:	Exterior Closure	RATING: 2 x WEIGHT: 8.3 =	SCORE: 16.7
Weatherproof exterior, but finish appears poorly maintained			
COMMENTS: Brick; window walls; metal panel siding; some damage to underside of overhangs			
COMPONENT:	Roofing	RATING: 2 x WEIGHT: 10.4 =	SCORE: 20.9
Majority of roofing and flashing appear sound, but a small portion of roofing shows deterioration where maintenance or minor repair needed			
COMMENTS: Built-up roof over gym is badly deteriorated; metal roof and cap sheet membrane OK

Secondary Systems			
COMPONENT:	Floor Finishes	RATING: 1 x WEIGHT: 6.3 =	SCORE: 6.3
	Nice appearance, smooth transitions, level subfloors, no cracks/separating		
COMMENTS:	Carpet and vinyl tile; carpet deterioration throughout		
COMPONENT:	Wall Finishes	RATING: 1 x WEIGHT: 6.3 =	SCORE: 6.3
	Maintainable surfaces in good condition		
COMMENTS:	Brick and gypsum board		
COMPONENT:	Ceiling Finishes	RATING: 2 x WEIGHT: 6.3 =	SCORE: 12.5
	Aging surfaces in fair condition and good alignment		
COMMENTS:	Lay-in ceiling tiles throughout		
COMPONENT:	Doors & Hardware	RATING: 3 x WEIGHT: 6.3 =	SCORE: 18.8
	Functional, but dated; some maintenance required		
COMMENTS:	Interior wood doors w HM frames; exterior metal doors w HM frames

Service Systems			
COMPONENT:	Elevators	RATING: 0 x WEIGHT: 0 =	SCORE: 0
	No data		
COMMENTS:			
COMPONENT:	Plumbing	RATING: 3 x WEIGHT: 8.3 =	SCORE: 25
	Fixtures are functional but dated; some leaks; maintenance required		
COMMENTS:	Galvanized, copper and cast iron piping; older porcelain fixtures		
COMPONENT:	HVAC	RATING: 1 x WEIGHT: 8.3 =	SCORE: 8.3
	Equipment in good condition; easily controlled; serves all required spaces; All necessary spaces are adequately ventilated; A/C provided throughout		
COMMENTS:	New boilers and portion of HVAC; design issues with HVAC system		
COMPONENT:	Electrical	RATING: 1 x WEIGHT: 8.3 =	SCORE: 8.3
	Adequate service and distribution capacity for current/future needs		
COMMENTS:	800amp 208/120v		
COMPONENT:	Lights/Power	RATING: 2 x WEIGHT: 8.3 =	SCORE: 16.7
	Contemporary lighting with good work area illumination; adequate number of outlets; some finishes appear aged		
COMMENTS:	Recessed ceiling fluorescent lights, mixed vintage

Safety Systems			
COMPONENT:	Life/Safety	RATING: 2 x WEIGHT: 10.4 = SCORE: 20.9	
Most areas meet current codes; some areas meet codes for prior construction phases			
COMMENTS:			
COMPONENT:	Fire Safety	RATING: 1 x WEIGHT: 10.4 = SCORE: 10.4	
Locally monitored detection; alarm and strobes present; sprinklers in high hazard areas			
COMMENTS:			
COMPONENT:	Modifications	RATING: 1 x WEIGHT: 7.3 = SCORE: 7.3	
Modifications appear to be in compliance with codes and sound construction practices; HVAC/electrical service properly provided			
COMMENTS: Overall modifications appear to be well constructed

Quality Standards			
COMPONENT:	Maintenance	RATING: 2 x WEIGHT: 7.3 = SCORE: 14.6	
Routine maintenance is required; impact is minor			
COMMENTS:			
COMPONENT:	Remaining Life	RATING: 3 x WEIGHT: 6.3 = SCORE: 18.8	
Life expectancy is roughly 10-15 years; moderate system deterioration			
COMMENTS: Renovation may not be cost-effective			
COMPONENT:	Appearance	RATING: 3 x WEIGHT: 6.3 = SCORE: 18.8	
Average construction; average interior and exterior appearance			
COMMENTS:

CONDITION: Needs Improvement/Additional Maintenance

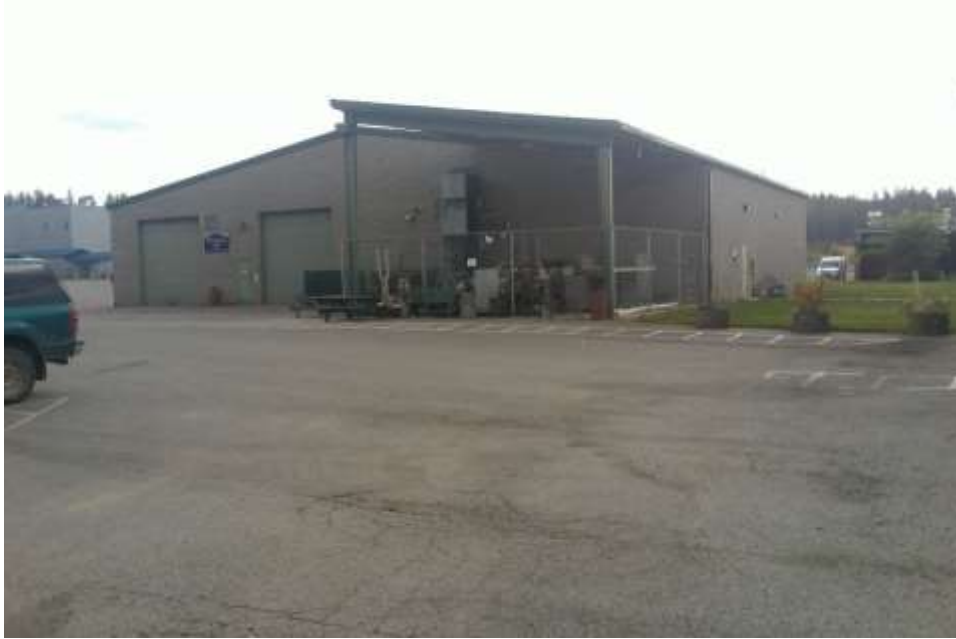
Industrial Training Ctr (171-608)      STATE UFI: A00002      Colville Center (171D)  
AREA: 7,370 SF      BUILT: 1994      REMODELED: No      PREDOMINANT USE: Vocational Arts  
CONSTRUCTION TYPE: Heavy      CRV/SF: \$395      REPLACEMENT VALUE: \$2,911,150

Primary Systems			
COMPONENT:	Structure	RATING: 1 x WEIGHT: 8.7 =	SCORE: 8.7
No signs of settlement or cracking, no abrupt vertical changes Columns, bearing walls and roof structure appears sound/free of defects			
COMMENTS:	Concrete slab; steel frame		
COMPONENT:	Exterior Closure	RATING: 1 x WEIGHT: 8.7 =	SCORE: 8.7
Weatherproof, tight, well-maintained exterior walls, doors, windows/finishes			
COMMENTS:	CMU construction		
COMPONENT:	Roofing	RATING: 1 x WEIGHT: 10.9 =	SCORE: 10.9
Flashing and penetrations appear sound and membrane appears water- tight; drainage is positive and there are overflow scuppers			
COMMENTS:	Standing seam metal roof

Secondary Systems			
COMPONENT:	Floor Finishes	RATING: 2 x WEIGHT: 6.5 =	SCORE: 13.1
Some wear is evident on finish; maintenance needed			
COMMENTS:	Vinyl tile in small office area is deteriorating		
COMPONENT:	Wall Finishes	RATING: 1 x WEIGHT: 6.5 =	SCORE: 6.5
Maintainable surfaces in good condition			
COMMENTS:	CMU and Gypsum board		
COMPONENT:	Ceiling Finishes	RATING: 1 x WEIGHT: 6.5 =	SCORE: 6.5
Maintainable surfaces in good condition; good alignment and appearance			
COMMENTS:	Drop ceiling in office		
COMPONENT:	Doors & Hardware	RATING: 3 x WEIGHT: 6.5 =	SCORE: 19.6
Functional, but dated; some maintenance required			
COMMENTS:	Interior and exterior HM doors/frames; OH metal door-poor quality door hardware

Service Systems			
COMPONENT:	Elevators	RATING: 0 x WEIGHT: 0 =	SCORE: 0
No data			
COMMENTS:			
COMPONENT:	Plumbing	RATING: 1 x WEIGHT: 8.7 =	SCORE: 8.7
Fixtures and piping appear to be in good condition; no evidence of leaks			
COMMENTS:	Copper, steel, cast iron; PVC; porcelain fixtures		
COMPONENT:	HVAC	RATING: 3 x WEIGHT: 8.7 =	SCORE: 26.1
System generally adequate; some deterioration; needs balancing; some areas have A/C; hazardous areas are ventilated			
COMMENTS:	Radiant ceiling heat		
COMPONENT:	Electrical	RATING: 1 x WEIGHT: 8.7 =	SCORE: 8.7
Adequate service and distribution capacity for current/future needs			
COMMENTS:	1000amp 480/208v		
COMPONENT:	Lights/Power	RATING: 1 x WEIGHT: 8.7 =	SCORE: 8.7
Contemporary lighting with good work area illumination; ample outlets			
COMMENTS:	Metal halide ceiling lights

Safety Systems			
COMPONENT:	Life/Safety	RATING: 1 x WEIGHT: 10.9 = SCORE: 10.9	
	Appears to meet current codes		
COMMENTS:			
COMPONENT:	Fire Safety	RATING: 1 x WEIGHT: 10.9 = SCORE: 10.9	
	Locally monitored detection; alarm and strobes present; sprinklers in high hazard areas		
COMMENTS:			
COMPONENT:	Modifications	RATING: 3 x WEIGHT: 7.6 = SCORE: 22.9	
	Some modifications lack code compliance; HVAC service not fully considered during renovation		
COMMENTS:	Small office area has no ventilation

Quality Standards			
COMPONENT:	Maintenance	RATING: 1 x WEIGHT: 7.6 = SCORE: 7.6	
	Facility appears well maintained		
COMMENTS:			
COMPONENT:	Remaining Life	RATING: 1 x WEIGHT: 6.5 = SCORE: 6.5	
	Life expectancy is >20 years; minor system deterioration		
COMMENTS:	Newer building to support vocational training		
COMPONENT:	Appearance	RATING: 3 x WEIGHT: 6.5 = SCORE: 19.6	
	Average construction; average interior and exterior appearance		
COMMENTS:

CONDITION: Adequate
