# **2023** FACILITY CONDITION SURVEY

Spokane Community College

SURVEY CONDUCTED BY:  
Steve Lewandowski  
State Board for Community  
and Technical Colleges

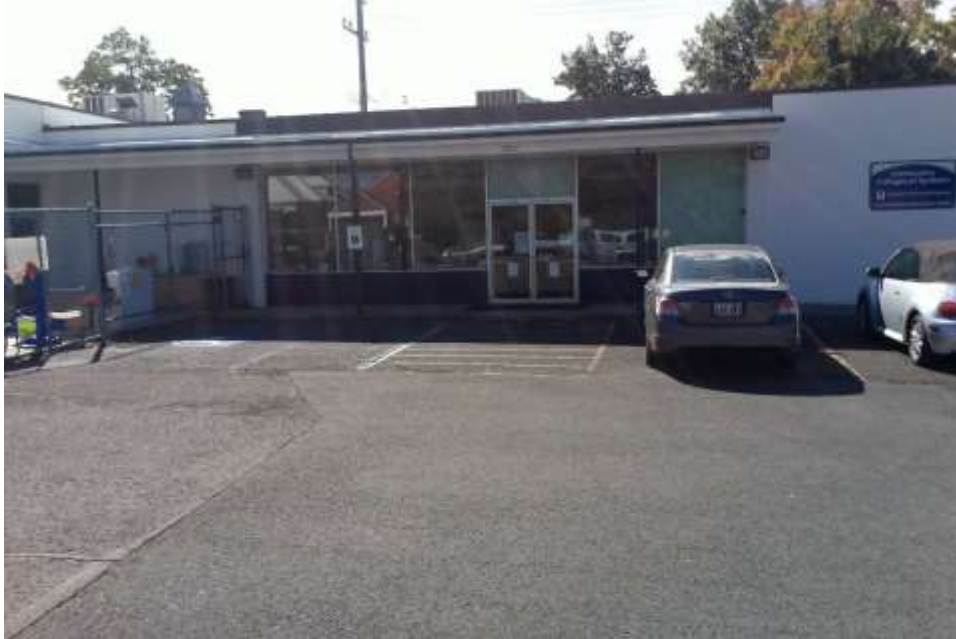
Early Head Start (171-625)      STATE UFI: A09841      Early Head Start (171F)  
 AREA: 4,900 SF      BUILT: 1970      REMODELED: No      PREDOMINANT USE: Multi-Use  
 CONSTRUCTION TYPE: Medium      CRV/SF: \$395      REPLACEMENT VALUE: \$1,935,500

Primary Systems			
COMPONENT:	Structure	RATING: 1 x WEIGHT: 8.3 =	SCORE: 8.3
No signs of settlement or cracking, no abrupt vertical changes Columns, bearing walls and roof structure appears sound/free of defects			
COMMENTS:	CMU w concrete slab		
COMPONENT:	Exterior Closure	RATING: 2 x WEIGHT: 8.3 =	SCORE: 16.7
Weatherproof exterior, but finish appears poorly maintained			
COMMENTS:	CMU		
COMPONENT:	Roofing	RATING: 1 x WEIGHT: 10.4 =	SCORE: 10.4
Flashing and penetrations appear sound and membrane appears water- tight; drainage is positive and there are overflow scuppers			
COMMENTS:	BUR - 2014

Secondary Systems			
COMPONENT:	Floor Finishes	RATING: 3 x WEIGHT: 6.3 =	SCORE: 18.8
Some physical wear and minor imperfections are evident; beginning deterioration			
COMMENTS:	Carpet; vinyl tile; ceramic tile; sheet vinyl		
COMPONENT:	Wall Finishes	RATING: 1 x WEIGHT: 6.3 =	SCORE: 6.3
Maintainable surfaces in good condition			
COMMENTS:	CMU; gypsum board; ceramic tile		
COMPONENT:	Ceiling Finishes	RATING: 3 x WEIGHT: 6.3 =	SCORE: 18.8
Some wear and tear; Minor damage, staining or deterioration			
COMMENTS:	Lay-in and spline ceiling tiles		
COMPONENT:	Doors & Hardware	RATING: 3 x WEIGHT: 6.3 =	SCORE: 18.8
Functional, but dated; some maintenance required			
COMMENTS:	Wood doors w HM frames; HM and aluminum exterior doors

CONDITION: Needs Improvement/Renovation

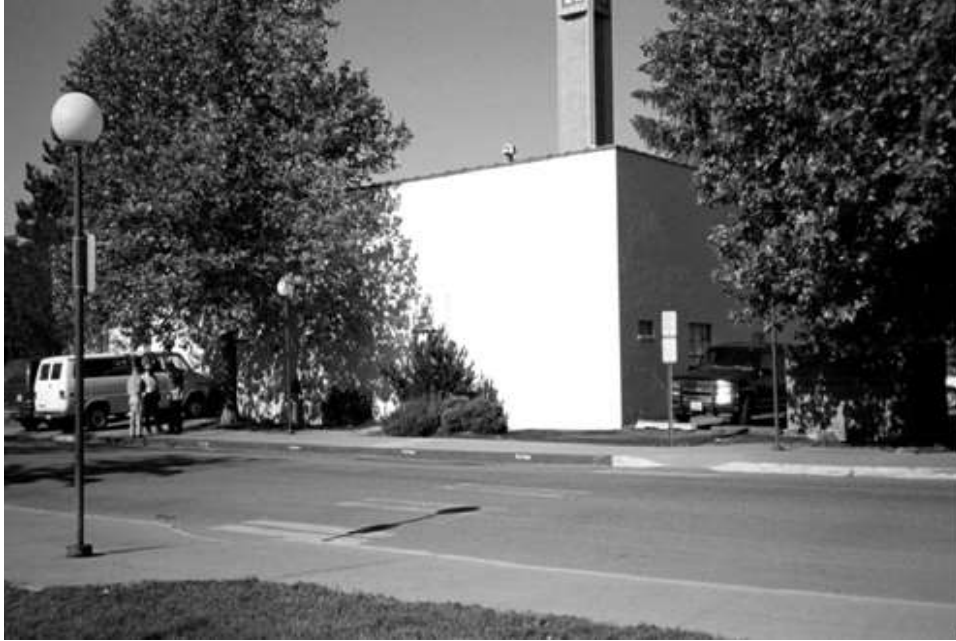
Environmental Sci. Annex (171-111)      STATE UFI: A09497      Main Campus (171A)  
AREA: 5,416 SF      BUILT: 1955      REMODELED: No      PREDOMINANT USE: General Classroom  
CONSTRUCTION TYPE: Heavy      CRV/SF: \$376      REPLACEMENT VALUE: \$2,036,416

Primary Systems			
COMPONENT:	Structure	RATING: 1 x WEIGHT: 8.3 =	SCORE: 8.3
No signs of settlement or cracking, no abrupt vertical changes Columns, bearing walls and roof structure appears sound/free of defects			
COMMENTS:	CMU and concrete		
COMPONENT:	Exterior Closure	RATING: 3 x WEIGHT: 8.3 =	SCORE: 25
Sound and weatherproof but with some physical deterioration evident			
COMMENTS:	CMU; needs joint caulking and crack sealing		
COMPONENT:	Roofing	RATING: 5 x WEIGHT: 10.4 =	SCORE: 52.1
Leaking and deterioration is to point where new roof is required			
COMMENTS:	Built-up w/ UV coat; deteriorating membrane

Secondary Systems			
COMPONENT:	Floor Finishes	RATING: 3 x WEIGHT: 6.3 =	SCORE: 18.8
Some physical wear and minor imperfections are evident; beginning deterioration			
COMMENTS:	Concrete; ceramic tile; vinyl tile		
COMPONENT:	Wall Finishes	RATING: 1 x WEIGHT: 6.3 =	SCORE: 6.3
Maintainable surfaces in good condition			
COMMENTS:	CMU and Gypsum board		
COMPONENT:	Ceiling Finishes	RATING: 3 x WEIGHT: 6.3 =	SCORE: 18.8
Some wear and tear; Minor damage, staining or deterioration			
COMMENTS:			
COMPONENT:	Doors & Hardware	RATING: 3 x WEIGHT: 6.3 =	SCORE: 18.8
Functional, but dated; some maintenance required			
COMMENTS:	Mix of older/newer doors and hardware

CONDITION: Needs Improvement/Renovation

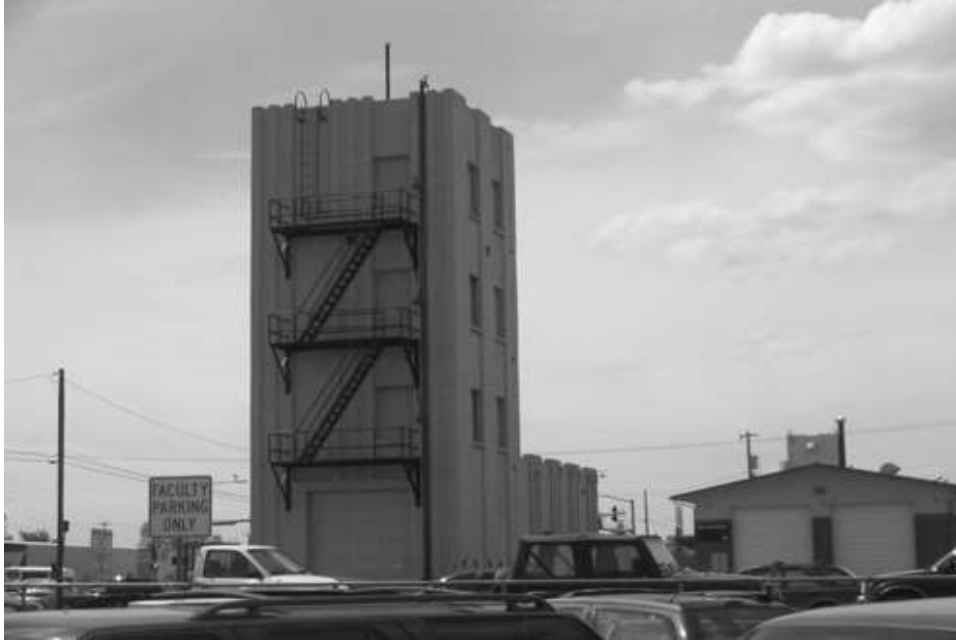
Fire Drill Tower (171-24)      STATE UFI: A07122      Main Campus (171A)  
AREA: 2,800 SF      BUILT: 1958      REMODELED: No      PREDOMINANT USE: Storage  
CONSTRUCTION TYPE: Heavy      CRV/SF: \$198      REPLACEMENT VALUE: \$554,400

Primary Systems			
COMPONENT:	Structure	RATING: 3 x WEIGHT: 8.8 =	SCORE: 26.5
Some cracking evident but does not likely affect structural integrity; Visible defects apparent but are non-structural			
COMMENTS:	Cast concrete		
COMPONENT:	Exterior Closure	RATING: 3 x WEIGHT: 8.8 =	SCORE: 26.5
Sound and weatherproof but with some physical deterioration evident			
COMMENTS:	Concrete		
COMPONENT:	Roofing	RATING: 3 x WEIGHT: 11.1 =	SCORE: 33.2
Some deterioration is evident in membrane and flashings; maintenance or minor repair is needed			
COMMENTS:	Not accessible-BUR?

Secondary Systems			
COMPONENT:	Floor Finishes	RATING: 3 x WEIGHT: 6.6 =	SCORE: 19.9
Some physical wear and minor imperfections are evident; beginning deterioration			
COMMENTS:	Concrete		
COMPONENT:	Wall Finishes	RATING: 3 x WEIGHT: 6.6 =	SCORE: 19.9
Aging surfaces, but sound; some maintenance is required			
COMMENTS:	Concrete; CMU		
COMPONENT:	Ceiling Finishes	RATING: 3 x WEIGHT: 6.6 =	SCORE: 19.9
Some wear and tear; Minor damage, staining or deterioration			
COMMENTS:	Concrete		
COMPONENT:	Doors & Hardware	RATING: 3 x WEIGHT: 6.6 =	SCORE: 19.9
Functional, but dated; some maintenance required			
COMMENTS:	Wood and steel doors w steel frames

CONDITION: Needs Improvement/Renovation

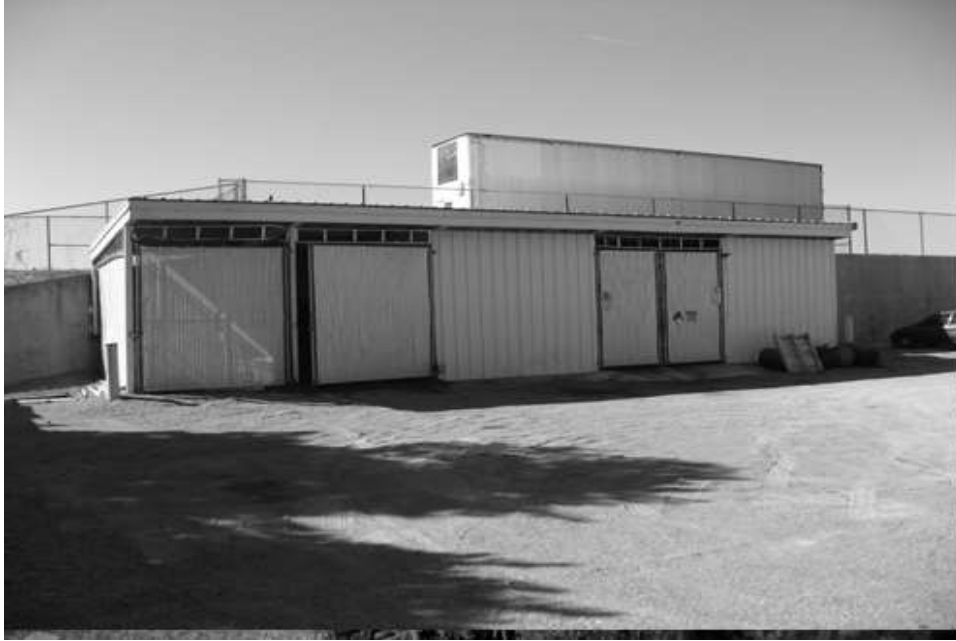
Hazardous Material Stor. (171-22)      STATE UFI: A02286      Main Campus (171A)  
AREA: 928 SF      BUILT: 1990      REMODELED: No      PREDOMINANT USE: Storage  
CONSTRUCTION TYPE: Light      CRV/SF: \$198      REPLACEMENT VALUE: \$183,744

Primary Systems			
COMPONENT:	Structure	RATING: 1 x WEIGHT: 11.1 =	SCORE: 11.1
No signs of settlement or cracking, no abrupt vertical changes Columns, bearing walls and roof structure appears sound/free of defects			
COMMENTS:	Metal framing; concrete slab		
COMPONENT:	Exterior Closure	RATING: 3 x WEIGHT: 11.1 =	SCORE: 33.4
Sound and weatherproof but with some physical deterioration evident			
COMMENTS:	Metal wall panels; concrete wall		
COMPONENT:	Roofing	RATING: 1 x WEIGHT: 13.9 =	SCORE: 13.9
Flashing and penetrations appear sound and membrane appears water- tight; drainage is positive and there are overflow scuppers			
COMMENTS:	Metal roof panels

Secondary Systems			
COMPONENT:	Floor Finishes	RATING: 3 x WEIGHT: 8.3 =	SCORE: 25
Some physical wear and minor imperfections are evident; beginning deterioration			
COMMENTS:	Concrete		
COMPONENT:	Wall Finishes	RATING: 1 x WEIGHT: 8.3 =	SCORE: 8.3
Maintainable surfaces in good condition			
COMMENTS:	Metal panels; concrete		
COMPONENT:	Ceiling Finishes	RATING: 0 x WEIGHT: 0 =	SCORE: 0
No data			
COMMENTS:	None		
COMPONENT:	Doors & Hardware	RATING: 1 x WEIGHT: 8.3 =	SCORE: 8.3
Appropriate hardware, closers, panic devices; in good working order			
COMMENTS:	Chain link fence gates

Quality Standards			
COMPONENT:	Maintenance	RATING: 1 x WEIGHT: 9.7 = SCORE: 9.7	
	Facility appears well maintained		
COMMENTS:			
COMPONENT:	Remaining Life	RATING: 1 x WEIGHT: 8.3 = SCORE: 8.3	
	Life expectancy is >20 years; minor system deterioration		
COMMENTS:			
COMPONENT:	Appearance	RATING: 1 x WEIGHT: 8.3 = SCORE: 8.3	
	Well-constructed building; generally attractive interior and exterior		
COMMENTS:

CONDITION: Adequate

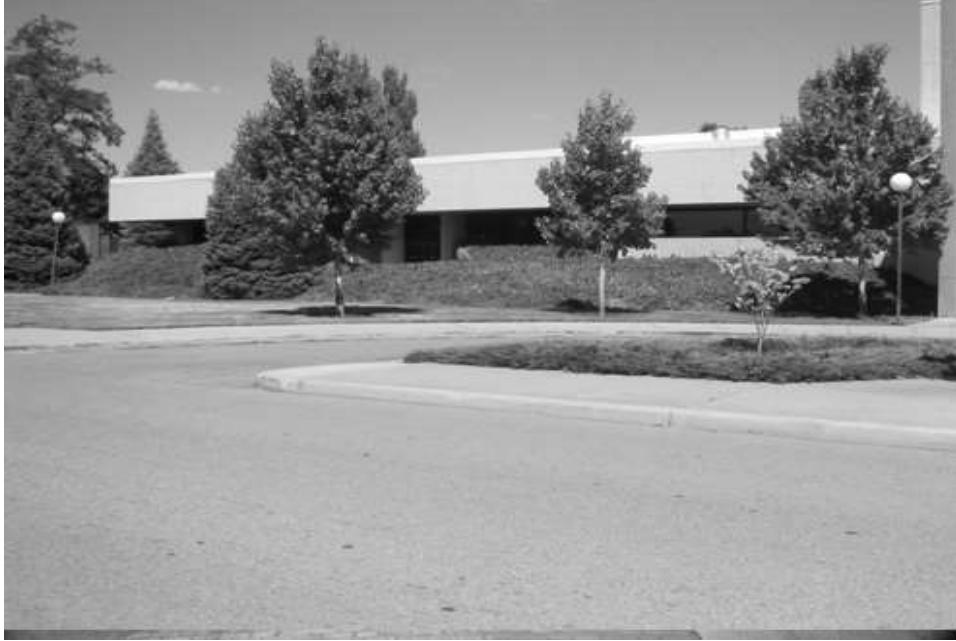
Learning Resources Center (171-16)      STATE UFI: A07767      Main Campus (171A)  
AREA: 58,198 SF      BUILT: 1976      REMODELED: 1992      PREDOMINANT USE: Library  
CONSTRUCTION TYPE: Heavy      CRV/SF: \$376      REPLACEMENT VALUE: \$21,882,448

Primary Systems			
COMPONENT:	Structure	RATING: 1 x WEIGHT: 8 =	SCORE: 8
No signs of settlement or cracking, no abrupt vertical changes Columns, bearing walls and roof structure appears sound/free of defects			
COMMENTS:	concrete; steel		
COMPONENT:	Exterior Closure	RATING: 1 x WEIGHT: 8 =	SCORE: 8
Weatherproof, tight, well-maintained exterior walls, doors, windows/finishes			
COMMENTS:	Concrete/stucco		
COMPONENT:	Roofing	RATING: 3 x WEIGHT: 10 =	SCORE: 30
Some deterioration is evident in membrane and flashings; maintenance or minor repair is needed			
COMMENTS:	BUR with UV coating upper portion; single ply lower portion 2011

Secondary Systems			
COMPONENT:	Floor Finishes	RATING: 1 x WEIGHT: 6 =	SCORE: 6
	Nice appearance, smooth transitions, level subfloors, no cracks/separating		
COMMENTS:	Carpet; quarry tile; vinyl tile; some carpet deterioration evident; ceramic tile		
COMPONENT:	Wall Finishes	RATING: 1 x WEIGHT: 6 =	SCORE: 6
	Maintainable surfaces in good condition		
COMMENTS:	Gypsum board; concrete; vinyl wall covering; interior aluminum window walls; T&G wood		
COMPONENT:	Ceiling Finishes	RATING: 2 x WEIGHT: 6 =	SCORE: 12
	Aging surfaces in fair condition and good alignment		
COMMENTS:	Lay-in tile throughout		
COMPONENT:	Doors & Hardware	RATING: 1 x WEIGHT: 6 =	SCORE: 6
	Appropriate hardware, closers, panic devices; in good working order		
COMMENTS:	Interior wood doors and HM frames; aluminum exterior doors

Service Systems			
COMPONENT:	Elevators	RATING: 1 x WEIGHT: 6 =	SCORE: 6
	Appropriate and functional for occupancy and use		
COMMENTS:			
COMPONENT:	Plumbing	RATING: 1 x WEIGHT: 8 =	SCORE: 8
	Fixtures and piping appear to be in good condition; no evidence of leaks		
COMMENTS:	Galvanized, steel, and cast iron piping; porcelain fixtures		
COMPONENT:	HVAC	RATING: 3 x WEIGHT: 8 =	SCORE: 24
	System generally adequate; some deterioration; needs balancing; some areas have A/C; hazardous areas are ventilated		
COMMENTS:	Mix of older and newer equipment in generally good condition		
COMPONENT:	Electrical	RATING: 1 x WEIGHT: 8 =	SCORE: 8
	Adequate service and distribution capacity for current/future needs		
COMMENTS:	Adequate for current and future use		
COMPONENT:	Lights/Power	RATING: 1 x WEIGHT: 8 =	SCORE: 8
	Contemporary lighting with good work area illumination; ample outlets		
COMMENTS:	Lay-in and recessed can fluorescent lighting

Safety Systems			
COMPONENT:	Life/Safety	RATING: 1 x WEIGHT: 10 = SCORE: 10	
	Appears to meet current codes		
COMMENTS:			
COMPONENT:	Fire Safety	RATING: 1 x WEIGHT: 10 = SCORE: 10	
	Locally monitored detection; alarm and strobes present; sprinklers in high hazard areas		
COMMENTS:	Sprinklers in stack area		
COMPONENT:	Modifications	RATING: 1 x WEIGHT: 7 = SCORE: 7	
	Modifications appear to be in compliance with codes and sound construction practices; HVAC/electrical service properly provided		
COMMENTS:	Modifications appear adequately constructed

Quality Standards			
COMPONENT:	Maintenance	RATING: 1 x WEIGHT: 7 = SCORE: 7	
	Facility appears well maintained		
COMMENTS:			
COMPONENT:	Remaining Life	RATING: 1 x WEIGHT: 6 = SCORE: 6	
	Life expectancy is >20 years; minor system deterioration		
COMMENTS:	Well constructed and renovated; should have 20+ years of remaining life		
COMPONENT:	Appearance	RATING: 1 x WEIGHT: 6 = SCORE: 6	
	Well-constructed building; generally attractive interior and exterior		
COMMENTS:

CONDITION: Adequate

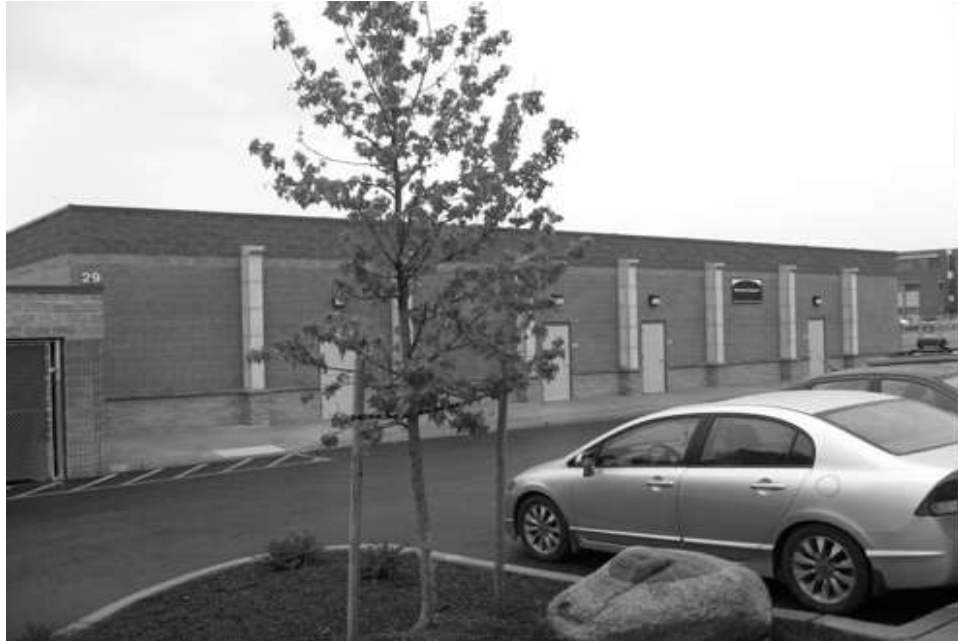
Permanent Support (171-29)      STATE UFI: A10691      Main Campus (171A)  
AREA: 3,104 SF      BUILT: 2010      REMODELED: No      PREDOMINANT USE: Storage  
CONSTRUCTION TYPE: Medium      CRV/SF: \$231      REPLACEMENT VALUE: \$717,024

Primary Systems			
COMPONENT:	Structure	RATING: 1 x WEIGHT: 8.7 =	SCORE: 8.7
No signs of settlement or cracking, no abrupt vertical changes Columns, bearing walls and roof structure appears sound/free of defects			
COMMENTS:	CMU; concrete; metal trusses		
COMPONENT:	Exterior Closure	RATING: 1 x WEIGHT: 8.7 =	SCORE: 8.7
Weatherproof, tight, well-maintained exterior walls, doors, windows/finishes			
COMMENTS:	CMU		
COMPONENT:	Roofing	RATING: 1 x WEIGHT: 10.9 =	SCORE: 10.9
Flashing and penetrations appear sound and membrane appears water- tight; drainage is positive and there are overflow scuppers			
COMMENTS:	Single-ply TPO membrane; sonotube skylights

Secondary Systems			
COMPONENT:	Floor Finishes	RATING: 1 x WEIGHT: 6.5 =	SCORE: 6.5
	Nice appearance, smooth transitions, level subfloors, no cracks/separating		
COMMENTS:	Concrete		
COMPONENT:	Wall Finishes	RATING: 1 x WEIGHT: 6.5 =	SCORE: 6.5
	Maintainable surfaces in good condition		
COMMENTS:	CMU		
COMPONENT:	Ceiling Finishes	RATING: 1 x WEIGHT: 6.5 =	SCORE: 6.5
	Maintainable surfaces in good condition; good alignment and appearance		
COMMENTS:	Metal deck pan		
COMPONENT:	Doors & Hardware	RATING: 1 x WEIGHT: 6.5 =	SCORE: 6.5
	Appropriate hardware, closers, panic devices; in good working order		
COMMENTS:	Metal doors/HM frames; insulated metal OH doors

Service Systems			
COMPONENT:	Elevators	RATING: 0 x WEIGHT: 0 =	SCORE: 0
	No data		
COMMENTS:	One story		
COMPONENT:	Plumbing	RATING: 1 x WEIGHT: 8.7 =	SCORE: 8.7
	Fixtures and piping appear to be in good condition; no evidence of leaks		
COMMENTS:	PVC; no fixtures		
COMPONENT:	HVAC	RATING: 1 x WEIGHT: 8.7 =	SCORE: 8.7
	Equipment in good condition; easily controlled; serves all required spaces; All necessary spaces are adequately ventilated; A/C provided throughout		
COMMENTS:	Electric ceiling-mount unit heaters		
COMPONENT:	Electrical	RATING: 1 x WEIGHT: 8.7 =	SCORE: 8.7
	Adequate service and distribution capacity for current/future needs		
COMMENTS:	225amp 240v		
COMPONENT:	Lights/Power	RATING: 1 x WEIGHT: 8.7 =	SCORE: 8.7
	Contemporary lighting with good work area illumination; ample outlets		
COMMENTS:	Ceiling hung fluorescent

Safety Systems			
COMPONENT:	Life/Safety	RATING: 1 x WEIGHT: 10.9 = SCORE: 10.9	
	Appears to meet current codes		
COMMENTS:			
COMPONENT:	Fire Safety	RATING: 1 x WEIGHT: 10.9 = SCORE: 10.9	
	Locally monitored detection; alarm and strobes present; sprinklers in high hazard areas		
COMMENTS:	Fire extinguishers only required		
COMPONENT:	Modifications	RATING: 1 x WEIGHT: 7.6 = SCORE: 7.6	
	Modifications appear to be in compliance with codes and sound construction practices; HVAC/electrical service properly provided		
COMMENTS:	None

Quality Standards			
COMPONENT:	Maintenance	RATING: 1 x WEIGHT: 7.6 = SCORE: 7.6	
	Facility appears well maintained		
COMMENTS:			
COMPONENT:	Remaining Life	RATING: 1 x WEIGHT: 6.5 = SCORE: 6.5	
	Life expectancy is >20 years; minor system deterioration		
COMMENTS:	Brand new building		
COMPONENT:	Appearance	RATING: 1 x WEIGHT: 6.5 = SCORE: 6.5	
	Well-constructed building; generally attractive interior and exterior		
COMMENTS:

CONDITION: Superior

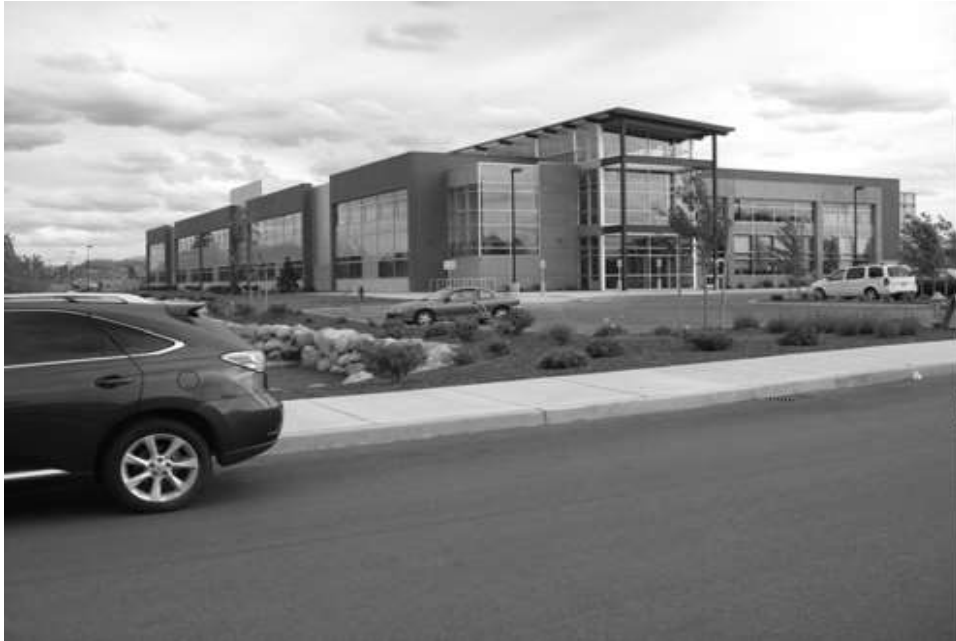
Stannard Technical Education (171-28)      STATE UFI: A10892      Main Campus (171A)  
AREA: 73,275 SF      BUILT: 2011      REMODELED: No      PREDOMINANT USE: Vocational Arts  
CONSTRUCTION TYPE: Heavy      CRV/SF: \$395      REPLACEMENT VALUE: \$28,943,625

Primary Systems			
COMPONENT:	Structure	RATING: 1 x WEIGHT: 8 =	SCORE: 8
No signs of settlement or cracking, no abrupt vertical changes Columns, bearing walls and roof structure appears sound/free of defects			
COMMENTS:	Structural steel; concrete		
COMPONENT:	Exterior Closure	RATING: 1 x WEIGHT: 8 =	SCORE: 8
Weatherproof, tight, well-maintained exterior walls, doors, windows/finishes			
COMMENTS:	Brick, concrete; metal solar thermal panels		
COMPONENT:	Roofing	RATING: 1 x WEIGHT: 10 =	SCORE: 10
Flashing and penetrations appear sound and membrane appears water- tight; drainage is positive and there are overflow scuppers			
COMMENTS:	Single-ply TPO membrane

Secondary Systems			
COMPONENT:	Floor Finishes	RATING: 1 x WEIGHT: 6 = SCORE: 6	
	Nice appearance, smooth transitions, level subfloors, no cracks/separating		
COMMENTS:	Concrete; quarry tile; carpet		
COMPONENT:	Wall Finishes	RATING: 1 x WEIGHT: 6 = SCORE: 6	
	Maintainable surfaces in good condition		
COMMENTS:	Gypsum board, ceramic tile and fiberboard scuff protection panels		
COMPONENT:	Ceiling Finishes	RATING: 1 x WEIGHT: 6 = SCORE: 6	
	Maintainable surfaces in good condition; good alignment and appearance		
COMMENTS:	Metal pan deck; lay-in tile		
COMPONENT:	Doors & Hardware	RATING: 1 x WEIGHT: 6 = SCORE: 6	
	Appropriate hardware, closers, panic devices; in good working order		
COMMENTS:	Interior wood and metal doors w HM frames, some glazing and sidelites; ext. aluminum doors/frames

Service Systems			
COMPONENT:	Elevators	RATING: 1 x WEIGHT: 6 = SCORE: 6	
	Appropriate and functional for occupancy and use		
COMMENTS:	2 stop		
COMPONENT:	Plumbing	RATING: 1 x WEIGHT: 8 = SCORE: 8	
	Fixtures and piping appear to be in good condition; no evidence of leaks		
COMMENTS:	Copper, steel and PVC piping; porcelain fixtures		
COMPONENT:	HVAC	RATING: 1 x WEIGHT: 8 = SCORE: 8	
	Equipment in good condition; easily controlled; serves all required spaces; All necessary spaces are adequately ventilated; A/C provided throughout		
COMMENTS:	3 hot water boilers; chiller; AHUs w VAV and heat recovery; in-floor radiant heat; gas unit heaters		
COMPONENT:	Electrical	RATING: 1 x WEIGHT: 8 = SCORE: 8	
	Adequate service and distribution capacity for current/future needs		
COMMENTS:	2500amp 408/277 and 4000amp 208/120; emergency generator		
COMPONENT:	Lights/Power	RATING: 1 x WEIGHT: 8 = SCORE: 8	
	Contemporary lighting with good work area illumination; ample outlets

Safety Systems			
COMPONENT:	Life/Safety	RATING: 1 x WEIGHT: 10 =	SCORE: 10
Appears to meet current codes			
COMMENTS:			
COMPONENT:	Fire Safety	RATING: 1 x WEIGHT: 10 =	SCORE: 10
Locally monitored detection; alarm and strobes present; sprinklers in high hazard areas			
COMMENTS:			
COMPONENT:	Modifications	RATING: 1 x WEIGHT: 7 =	SCORE: 7
Modifications appear to be in compliance with codes and sound construction practices; HVAC/electrical service properly provided			
COMMENTS: Brand new building

Quality Standards			
COMPONENT:	Maintenance	RATING: 1 x WEIGHT: 7 =	SCORE: 7
Facility appears well maintained			
COMMENTS: Future maintenance resources may be inadequate			
COMPONENT:	Remaining Life	RATING: 1 x WEIGHT: 6 =	SCORE: 6
Life expectancy is >20 years; minor system deterioration			
COMMENTS: Should have 50 year life			
COMPONENT:	Appearance	RATING: 1 x WEIGHT: 6 =	SCORE: 6
Well-constructed building; generally attractive interior and exterior			
COMMENTS:

CONDITION: Superior

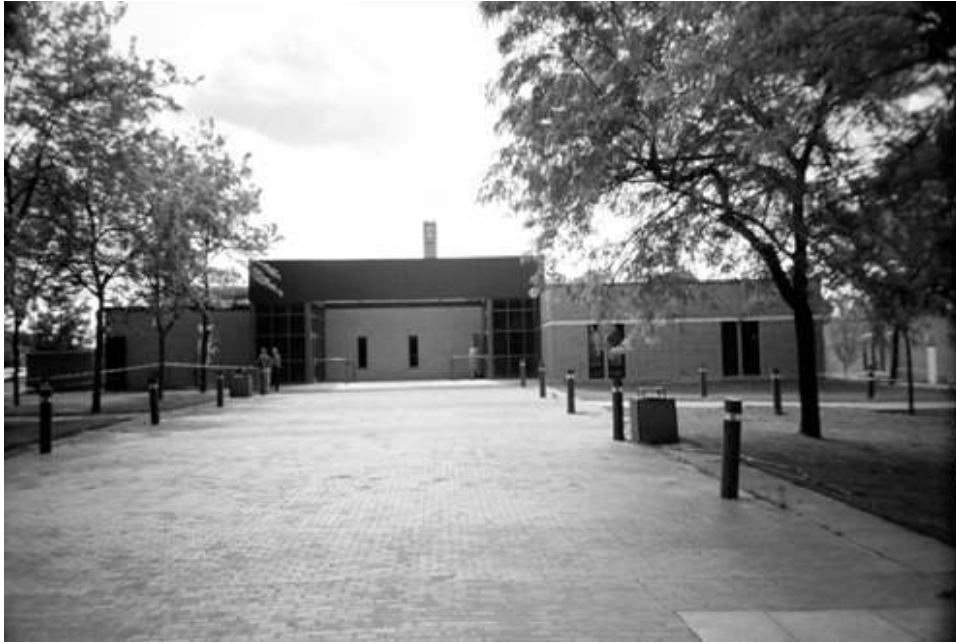
Student Services (171-15)      STATE UFI: A08828      Main Campus (171A)  
AREA: 48,993 SF      BUILT: 1976      REMODELED: 2013      PREDOMINANT USE: Administration  
CONSTRUCTION TYPE: Medium      CRV/SF: \$336      REPLACEMENT VALUE: \$16,461,648

Primary Systems			
COMPONENT:	Structure	RATING: 1 x WEIGHT: 8 =	SCORE: 8
No signs of settlement or cracking, no abrupt vertical changes Columns, bearing walls and roof structure appears sound/free of defects			
COMMENTS:	Split-face CMU and concrete		
COMPONENT:	Exterior Closure	RATING: 2 x WEIGHT: 8 =	SCORE: 16
Weatherproof exterior, but finish appears poorly maintained			
COMMENTS:	CMU walls; deterioration of siding on clerestory walls		
COMPONENT:	Roofing	RATING: 2 x WEIGHT: 10 =	SCORE: 20
Majority of roofing and flashing appear sound, but a small portion of roofing shows deterioration where maintenance or minor repair needed			
COMMENTS:	BUR reconditioned in 2013. Single-ply on newer section

Secondary Systems			
COMPONENT:	Floor Finishes	RATING: 2 x WEIGHT: 6 =	SCORE: 12
	Some wear is evident on finish; maintenance needed		
COMMENTS:	New carpet throughout in 2006		
COMPONENT:	Wall Finishes	RATING: 1 x WEIGHT: 6 =	SCORE: 6
	Maintainable surfaces in good condition		
COMMENTS:	Gypsum board and ceramic tile		
COMPONENT:	Ceiling Finishes	RATING: 2 x WEIGHT: 6 =	SCORE: 12
	Aging surfaces in fair condition and good alignment		
COMMENTS:	New lay-in tile installed in 2006		
COMPONENT:	Doors & Hardware	RATING: 2 x WEIGHT: 6 =	SCORE: 12
	Fairly modern door surfaces and hardware with minor deterioration; good working order		
COMMENTS:	Interior wood doors w HM frames; exterior aluminum doors/frames

Service Systems			
COMPONENT:	Elevators	RATING: 1 x WEIGHT: 6 =	SCORE: 6
	Appropriate and functional for occupancy and use		
COMMENTS:	Two stories on west addition		
COMPONENT:	Plumbing	RATING: 1 x WEIGHT: 8 =	SCORE: 8
	Fixtures and piping appear to be in good condition; no evidence of leaks		
COMMENTS:	Copper, steel, cast iron, galvanized and PVC piping; porcelain fixtures		
COMPONENT:	HVAC	RATING: 2 x WEIGHT: 8 =	SCORE: 16
	Equipment in fair condition; minor deterioration; controls require troubleshooting; most areas have A/C; hazardous areas are ventilated		
COMMENTS:	All new equipment in 2002; rooftop packaged units; 2 hot water boilers and chiller		
COMPONENT:	Electrical	RATING: 1 x WEIGHT: 8 =	SCORE: 8
	Adequate service and distribution capacity for current/future needs		
COMMENTS:	600amp 480/277v		
COMPONENT:	Lights/Power	RATING: 1 x WEIGHT: 8 =	SCORE: 8
	Contemporary lighting with good work area illumination; ample outlets

Safety Systems			
COMPONENT:	Life/Safety	RATING: 1 x WEIGHT: 10 = SCORE: 10	
	Appears to meet current codes		
COMMENTS:			
COMPONENT:	Fire Safety	RATING: 1 x WEIGHT: 10 = SCORE: 10	
	Locally monitored detection; alarm and strobes present; sprinklers in high hazard areas		
COMMENTS:	Fire alarm; sprinklers on west addition		
COMPONENT:	Modifications	RATING: 1 x WEIGHT: 7 = SCORE: 7	
	Modifications appear to be in compliance with codes and sound construction practices; HVAC/electrical service properly provided		
COMMENTS:	Small addition constructed in 2002; larger addition in 2013; appears to be good quality

Quality Standards			
COMPONENT:	Maintenance	RATING: 1 x WEIGHT: 7 = SCORE: 7	
	Facility appears well maintained		
COMMENTS:	Exterior maintenance required		
COMPONENT:	Remaining Life	RATING: 1 x WEIGHT: 6 = SCORE: 6	
	Life expectancy is >20 years; minor system deterioration		
COMMENTS:	Good construction enhances life expectancy; interior remodeled in 2006		
COMPONENT:	Appearance	RATING: 2 x WEIGHT: 6 = SCORE: 12	
	Well-constructed building; average interior and exterior appearance		
COMMENTS:	Average exterior

CONDITION: Adequate

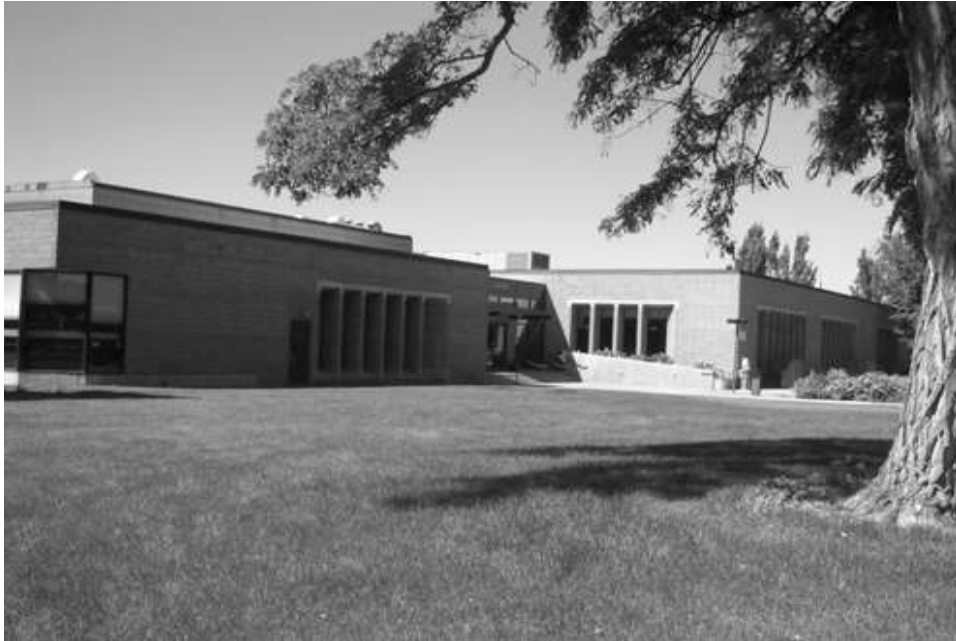
Student Center (171-6)      STATE UFI: A06460      Main Campus (171A)  
AREA: 98,151 SF      BUILT: 1972      REMODELED: 2011      PREDOMINANT USE: Student Center  
CONSTRUCTION TYPE: Heavy      CRV/SF: \$391      REPLACEMENT VALUE: \$38,377,041

Primary Systems			
COMPONENT:	Structure	RATING: 1 x WEIGHT: 8 =	SCORE: 8
No signs of settlement or cracking, no abrupt vertical changes Columns, bearing walls and roof structure appears sound/free of defects			
COMMENTS:	Split-face CMU; concrete; steel		
COMPONENT:	Exterior Closure	RATING: 1 x WEIGHT: 8 =	SCORE: 8
Weatherproof, tight, well-maintained exterior walls, doors, windows/finishes			
COMMENTS:	Split-face CMU exterior walls		
COMPONENT:	Roofing	RATING: 2 x WEIGHT: 10 =	SCORE: 20
Majority of roofing and flashing appear sound, but a small portion of roofing shows deterioration where maintenance or minor repair needed			
COMMENTS:	Built-up w/ UV coat and hypalon; two areas of BUR are older w some deterioration

Secondary Systems			
COMPONENT:	Floor Finishes	RATING: 2 x WEIGHT: 6 =	SCORE: 12
Some wear is evident on finish; maintenance needed			
COMMENTS:	Terrazzo; quarry tile; carpet; ceramic tile; concrete		
COMPONENT:	Wall Finishes	RATING: 2 x WEIGHT: 6 =	SCORE: 12
Maintainable surfaces, minor maintenance is required in some areas			
COMMENTS:	CMU; gypsum board; ceramic tile		
COMPONENT:	Ceiling Finishes	RATING: 2 x WEIGHT: 6 =	SCORE: 12
Aging surfaces in fair condition and good alignment			
COMMENTS:	Lay-in ceiling tile; Gypsum board		
COMPONENT:	Doors & Hardware	RATING: 2 x WEIGHT: 6 =	SCORE: 12
Fairly modern door surfaces and hardware with minor deterioration; good working order			
COMMENTS:	Wood laminate interior doors & HM frames; aluminum exterior doors/frames

Service Systems			
COMPONENT:	Elevators	RATING: 1 x WEIGHT: 6 =	SCORE: 6
Appropriate and functional for occupancy and use			
COMMENTS:	3-stop		
COMPONENT:	Plumbing	RATING: 3 x WEIGHT: 8 =	SCORE: 24
Fixtures are functional but dated; some leaks; maintenance required			
COMMENTS:	Copper, galvanized and cast iron piping; porcelain fixtures		
COMPONENT:	HVAC	RATING: 2 x WEIGHT: 8 =	SCORE: 16
Equipment in fair condition; minor deterioration; controls require troubleshooting; most areas have A/C; hazardous areas are ventilated			
COMMENTS:	Split-system heat pumps; 2 newer hot water boilers and AHUs		
COMPONENT:	Electrical	RATING: 1 x WEIGHT: 8 =	SCORE: 8
Adequate service and distribution capacity for current/future needs			
COMMENTS:	3000amp 208/120v		
COMPONENT:	Lights/Power	RATING: 1 x WEIGHT: 8 =	SCORE: 8
Contemporary lighting with good work area illumination; ample outlets			
COMMENTS:	Lay-in fluorescent and recessed can lights; wall mount and ceiling-mount fluorescent lights

Safety Systems			
COMPONENT:	Life/Safety	RATING: 2 x WEIGHT: 10 = SCORE: 20	
	Most areas meet current codes; some areas meet codes for prior construction phases		
COMMENTS:			
COMPONENT:	Fire Safety	RATING: 1 x WEIGHT: 10 = SCORE: 10	
	Locally monitored detection; alarm and strobes present; sprinklers in high hazard areas		
COMMENTS:			
COMPONENT:	Modifications	RATING: 1 x WEIGHT: 7 = SCORE: 7	
	Modifications appear to be in compliance with codes and sound construction practices; HVAC/electrical service properly provided		
COMMENTS:	All modifications appear to be properly constructed

Quality Standards			
COMPONENT:	Maintenance	RATING: 1 x WEIGHT: 7 = SCORE: 7	
	Facility appears well maintained		
COMMENTS:			
COMPONENT:	Remaining Life	RATING: 1 x WEIGHT: 6 = SCORE: 6	
	Life expectancy is >20 years; minor system deterioration		
COMMENTS:	Older but well-constructed		
COMPONENT:	Appearance	RATING: 3 x WEIGHT: 6 = SCORE: 18	
	Average construction; average interior and exterior appearance		
COMMENTS:

CONDITION: Adequate

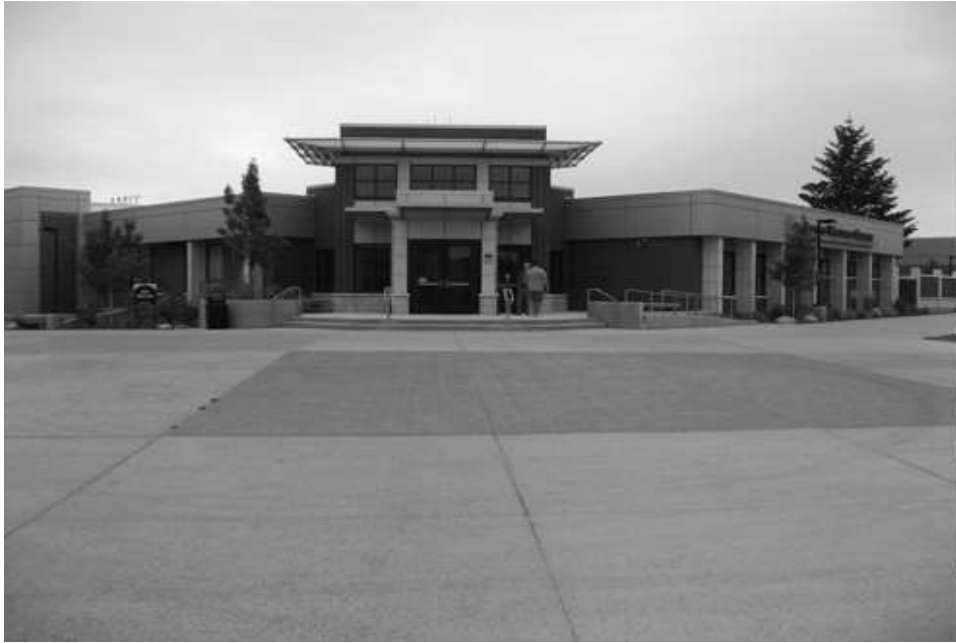
Jenkins Wellness Center (171-7)      STATE UFI: A06777      Main Campus (171A)  
AREA: 35,661 SF      BUILT: 1972      REMODELED: 2010      PREDOMINANT USE: Student Support  
CONSTRUCTION TYPE: Medium      CRV/SF: \$489      REPLACEMENT VALUE: \$17,438,229

Primary Systems			
COMPONENT:	Structure	RATING: 1 x WEIGHT: 8.3 = SCORE: 8.3	
No signs of settlement or cracking, no abrupt vertical changes Columns, bearing walls and roof structure appears sound/free of defects			
COMMENTS:	Concrete and CMU-good condition		
COMPONENT:	Exterior Closure	RATING: 1 x WEIGHT: 8.3 = SCORE: 8.3	
Weatherproof, tight, well-maintained exterior walls, doors, windows/finishes			
COMMENTS:	Brick; metal panels; cement block		
COMPONENT:	Roofing	RATING: 2 x WEIGHT: 10.4 = SCORE: 20.9	
Majority of roofing and flashing appear sound, but a small portion of roofing shows deterioration where maintenance or minor repair needed			
COMMENTS:	Single-ply TPO membrane; Sonotube and curb mount skylights

Secondary Systems			
COMPONENT:	Floor Finishes	RATING: 2 x WEIGHT: 6.3 =	SCORE: 12.5
Some wear is evident on finish; maintenance needed			
COMMENTS:	Carpet, solid vinyl tile, sheet vinyl		
COMPONENT:	Wall Finishes	RATING: 2 x WEIGHT: 6.3 =	SCORE: 12.5
Maintainable surfaces, minor maintenance is required in some areas			
COMMENTS:	Gypsum board; CMU; quarry tile; vinyl wall covering		
COMPONENT:	Ceiling Finishes	RATING: 1 x WEIGHT: 6.3 =	SCORE: 6.3
Maintainable surfaces in good condition; good alignment and appearance			
COMMENTS:	Lay-in tile; gypsum board		
COMPONENT:	Doors & Hardware	RATING: 1 x WEIGHT: 6.3 =	SCORE: 6.3
Appropriate hardware, closers, panic devices; in good working order			
COMMENTS:	Wood interior doors w HM frames; aluminum exterior doors

Service Systems			
COMPONENT:	Elevators	RATING: 0 x WEIGHT: 0 =	SCORE: 0
No data			
COMMENTS:			
COMPONENT:	Plumbing	RATING: 1 x WEIGHT: 8.3 =	SCORE: 8.3
Fixtures and piping appear to be in good condition; no evidence of leaks			
COMMENTS:	Copper, steel, cast iron and PVC piping; porcelain fixtures		
COMPONENT:	HVAC	RATING: 1 x WEIGHT: 8.3 =	SCORE: 8.3
Equipment in good condition; easily controlled; serves all required spaces; All necessary spaces are adequately ventilated; A/C provided throughout			
COMMENTS:	Hot water condensing boilers; chiller; AHU w VAV		
COMPONENT:	Electrical	RATING: 1 x WEIGHT: 8.3 =	SCORE: 8.3
Adequate service and distribution capacity for current/future needs			
COMMENTS:	2000 amp 208/120v and 1600 amp 480/277v; emergency generator		
COMPONENT:	Lights/Power	RATING: 1 x WEIGHT: 8.3 =	SCORE: 8.3
Contemporary lighting with good work area illumination; ample outlets			
COMMENTS:	Lay-in and recessed can fluorescent lights

Safety Systems			
COMPONENT:	Life/Safety	RATING: 1 x WEIGHT: 10.4 =	SCORE: 10.4
Appears to meet current codes			
COMMENTS:			
COMPONENT:	Fire Safety	RATING: 1 x WEIGHT: 10.4 =	SCORE: 10.4
Locally monitored detection; alarm and strobes present; sprinklers in high hazard areas			
COMMENTS:			
COMPONENT:	Modifications	RATING: 1 x WEIGHT: 7.3 =	SCORE: 7.3
Modifications appear to be in compliance with codes and sound construction practices; HVAC/electrical service properly provided			
COMMENTS: 2010 complete interior renovation; well-constructed

Quality Standards			
COMPONENT:	Maintenance	RATING: 1 x WEIGHT: 7.3 =	SCORE: 7.3
Facility appears well maintained			
COMMENTS:			
COMPONENT:	Remaining Life	RATING: 1 x WEIGHT: 6.3 =	SCORE: 6.3
Life expectancy is >20 years; minor system deterioration			
COMMENTS: Well constructed renovation; 30+ year life expectancy			
COMPONENT:	Appearance	RATING: 1 x WEIGHT: 6.3 =	SCORE: 6.3
Well-constructed building; generally attractive interior and exterior			
COMMENTS:

CONDITION: Superior

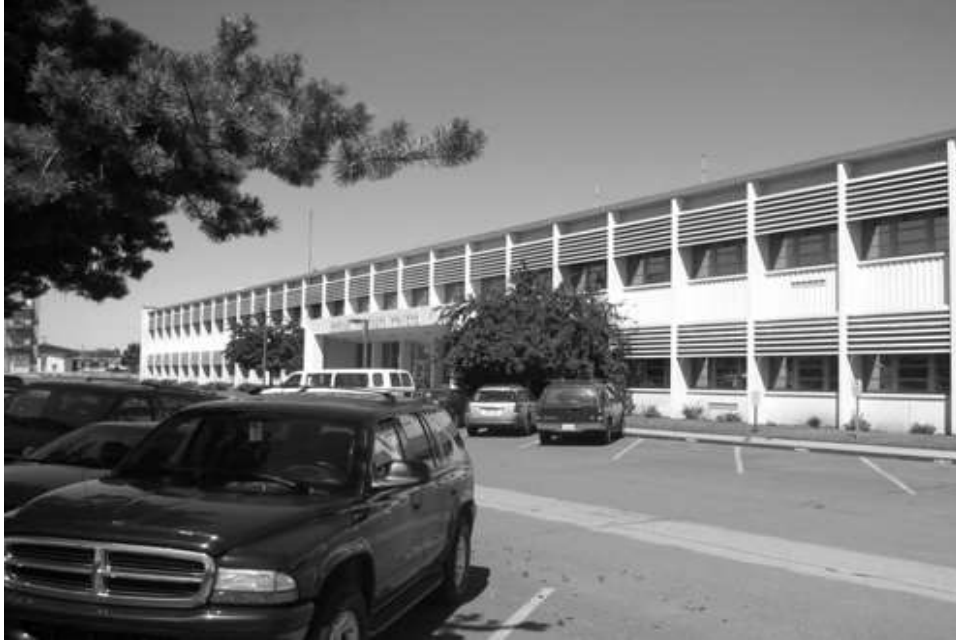
Main (171-1)      STATE UFI: A08547      Main Campus (171A)  
AREA: 257,124 SF      BUILT: 1956      REMODELED: 2020      PREDOMINANT USE: Multi-Purpose  
CONSTRUCTION TYPE: Heavy      CRV/SF: \$395      REPLACEMENT VALUE: \$10,156,398

Primary Systems			
COMPONENT:	Structure	RATING: 2 x WEIGHT: 8 =	SCORE: 16
Minor cracks evident in a small portion of the structure			
COMMENTS:	Concrete; steel; some code concerns		
COMPONENT:	Exterior Closure	RATING: 1 x WEIGHT: 8 =	SCORE: 8
Weatherproof, tight, well-maintained exterior walls, doors, windows/finishes			
COMMENTS:	Concrete; CMU;		
COMPONENT:	Roofing	RATING: 3 x WEIGHT: 10 =	SCORE: 30
Some deterioration is evident in membrane and flashings; maintenance or minor repair is needed			
COMMENTS:	Built-up roof w/ UV coating-most areas need recoating

Secondary Systems			
COMPONENT:	Floor Finishes	RATING: 2 x WEIGHT: 6 = SCORE: 12	
	Some wear is evident on finish; maintenance needed		
COMMENTS:	Carpet; quarry tile; vinyl tile		
COMPONENT:	Wall Finishes	RATING: 2 x WEIGHT: 6 = SCORE: 12	
	Maintainable surfaces, minor maintenance is required in some areas		
COMMENTS:	Gypsum board; CMU; ceramic tile		
COMPONENT:	Ceiling Finishes	RATING: 2 x WEIGHT: 6 = SCORE: 12	
	Aging surfaces in fair condition and good alignment		
COMMENTS:	Lay-in ceiling tile; Gypsum board; significant staining throughout		
COMPONENT:	Doors & Hardware	RATING: 2 x WEIGHT: 6 = SCORE: 12	
	Fairly modern door surfaces and hardware with minor deterioration; good working order		
COMMENTS:	Newer interior wood doors w HM frames; metal exterior doors-general deterioration

Service Systems			
COMPONENT:	Elevators	RATING: 2 x WEIGHT: 6 = SCORE: 12	
	Aged elevators functional, but deterioration or abuse of finishes is evident		
COMMENTS:	Renovated 2013, 2 stop		
COMPONENT:	Plumbing	RATING: 3 x WEIGHT: 8 = SCORE: 24	
	Fixtures are functional but dated; some leaks; maintenance required		
COMMENTS:	Copper, galvanized, cast iron and steel piping; old porcelain fixtures		
COMPONENT:	HVAC	RATING: 3 x WEIGHT: 8 = SCORE: 24	
	System generally adequate; some deterioration; needs balancing; some areas have A/C; hazardous areas are ventilated		
COMMENTS:	Hot water boilers 2015, chillers, AHUs; mix of equipment vintages		
COMPONENT:	Electrical	RATING: 3 x WEIGHT: 8 = SCORE: 24	
	Service capacity meets current needs but inadequate for future		
COMMENTS:	2000amp 208/120v original; distribution panels at capacity		
COMPONENT:	Lights/Power	RATING: 2 x WEIGHT: 8 = SCORE: 16	
	Contemporary lighting with good work area illumination; adequate number of outlets; some finishes appear aged

Safety Systems			
COMPONENT:	Life/Safety	RATING: 2 x WEIGHT: 10 = SCORE: 20	
	Most areas meet current codes; some areas meet codes for prior construction phases		
COMMENTS:	Some code deficiencies; minimal exit and emergency lighting		
COMPONENT:	Fire Safety	RATING: 1 x WEIGHT: 10 = SCORE: 10	
	Locally monitored detection; alarm and strobes present; sprinklers in high hazard areas		
COMMENTS:			
COMPONENT:	Modifications	RATING: 2 x WEIGHT: 7 = SCORE: 14	
	Modifications appear to be in compliance with codes and sound construction practices, however, HVAC/electrical service was not properly reconfigured		
COMMENTS:	Mix of good and marginal modifications

Quality Standards			
COMPONENT:	Maintenance	RATING: 1 x WEIGHT: 7 = SCORE: 7	
	Facility appears well maintained		
COMMENTS:			
COMPONENT:	Remaining Life	RATING: 1 x WEIGHT: 6 = SCORE: 6	
	Life expectancy is >20 years; minor system deterioration		
COMMENTS:	Programmatically inadequate; replace with separate building		
COMPONENT:	Appearance	RATING: 2 x WEIGHT: 6 = SCORE: 12	
	Well-constructed building; average interior and exterior appearance		
COMMENTS:	Interior and exterior are very dated

CONDITION: Needs Improvement/Additional Maintenance

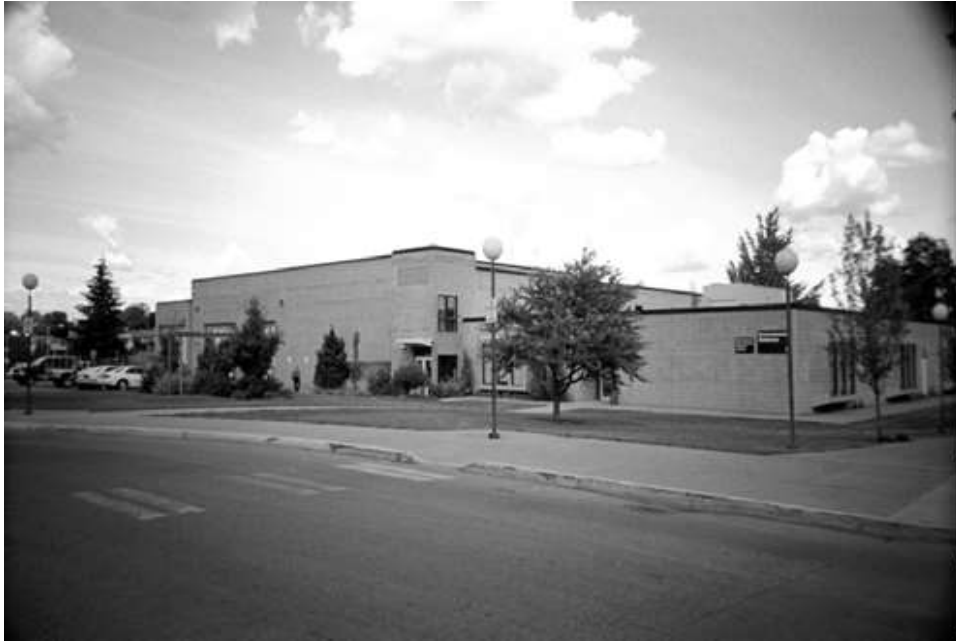
Environmental Sciences (171-8)      STATE UFI: A09615      Main Campus (171A)  
AREA: 35,668 SF      BUILT: 1973      REMODELED: No      PREDOMINANT USE: General Classroom  
CONSTRUCTION TYPE: Heavy      CRV/SF: \$376      REPLACEMENT VALUE: \$13,411,168

Primary Systems			
COMPONENT:	Structure	RATING: 1 x WEIGHT: 8 =	SCORE: 8
No signs of settlement or cracking, no abrupt vertical changes Columns, bearing walls and roof structure appears sound/free of defects			
COMMENTS: Split-face CMU and concrete; seismic concerns			
COMPONENT:	Exterior Closure	RATING: 2 x WEIGHT: 8 =	SCORE: 16
Weatherproof exterior, but finish appears poorly maintained			
COMMENTS: CMU walls; window frame caulking needs replacement			
COMPONENT:	Roofing	RATING: 2 x WEIGHT: 10 =	SCORE: 20
Majority of roofing and flashing appear sound, but a small portion of roofing shows deterioration where maintenance or minor repair needed			
COMMENTS: No scuppers; built-up roof new coating installed in 04, but aging membrane

Secondary Systems			
COMPONENT:	Floor Finishes	RATING: 1 x WEIGHT: 6 = SCORE: 6	
	Nice appearance, smooth transitions, level subfloors, no cracks/separating		
COMMENTS:	Concrete, brick, newer carpet tile, ceramic tile; 9"x9" tile		
COMPONENT:	Wall Finishes	RATING: 1 x WEIGHT: 6 = SCORE: 6	
	Maintainable surfaces in good condition		
COMMENTS:	CMU and some Gypsum board		
COMPONENT:	Ceiling Finishes	RATING: 1 x WEIGHT: 6 = SCORE: 6	
	Maintainable surfaces in good condition; good alignment and appearance		
COMMENTS:	Lay-in ceiling panels		
COMPONENT:	Doors & Hardware	RATING: 1 x WEIGHT: 6 = SCORE: 6	
	Appropriate hardware, closers, panic devices; in good working order		
COMMENTS:	Interior wood doors w HM frames; exterior metal doors and frames-deteriorating; OH roll-up doors

Service Systems			
COMPONENT:	Elevators	RATING: 2 x WEIGHT: 6 = SCORE: 12	
	Aged elevators functional, but deterioration or abuse of finishes is evident		
COMMENTS:	1 stop		
COMPONENT:	Plumbing	RATING: 3 x WEIGHT: 8 = SCORE: 24	
	Fixtures are functional but dated; some leaks; maintenance required		
COMMENTS:	Copper, galvanized, steel and cast iron piping; porcelain fixtures		
COMPONENT:	HVAC	RATING: 3 x WEIGHT: 8 = SCORE: 24	
	System generally adequate; some deterioration; needs balancing; some areas have A/C; hazardous areas are ventilated		
COMMENTS:	Rooftop multi-zone units; some new in 04		
COMPONENT:	Electrical	RATING: 3 x WEIGHT: 8 = SCORE: 24	
	Service capacity meets current needs but inadequate for future		
COMMENTS:	Old multi-switch main panel; no ratings		
COMPONENT:	Lights/Power	RATING: 1 x WEIGHT: 8 = SCORE: 8	
	Contemporary lighting with good work area illumination; ample outlets		
COMMENTS:	Lay-in, ceiling-mount and hanging fluorescent lights; insufficient illumination in some areas

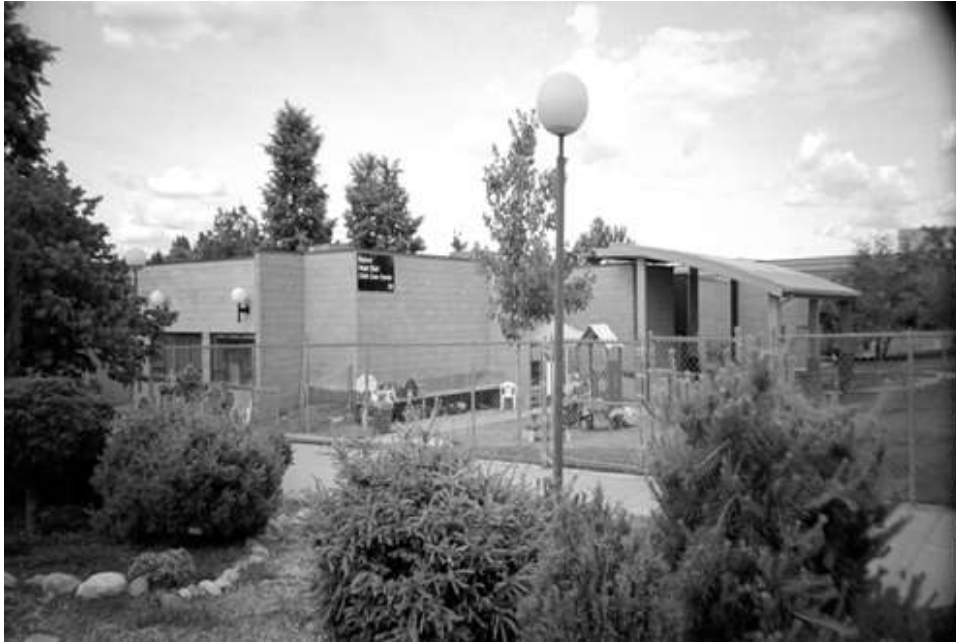
Bigfoot Head Start Child Care (171-20)      STATE UFI: A00521      Main Campus (171A)  
 AREA: 8,795 SF      BUILT: 1984      REMODELED: No      PREDOMINANT USE: Child Care  
 CONSTRUCTION TYPE: Medium      CRV/SF: \$349      REPLACEMENT VALUE: \$3,069,455

Primary Systems			
COMPONENT:	Structure	RATING: 1 x WEIGHT: 8.8 =	SCORE: 8.8
No signs of settlement or cracking, no abrupt vertical changes Columns, bearing walls and roof structure appears sound/free of defects			
COMMENTS:	Concrete and split-face CMU		
COMPONENT:	Exterior Closure	RATING: 1 x WEIGHT: 8.8 =	SCORE: 8.8
Weatherproof, tight, well-maintained exterior walls, doors, windows/finishes			
COMMENTS:	CMU		
COMPONENT:	Roofing	RATING: 2 x WEIGHT: 11 =	SCORE: 22
Majority of roofing and flashing appear sound, but a small portion of roofing shows deterioration where maintenance or minor repair needed			
COMMENTS:	BUR; new roof in 2002; UV coat deteriorated on south half

Secondary Systems			
COMPONENT:	Floor Finishes	RATING: 2 x WEIGHT: 6.6 =	SCORE: 13.2
Some wear is evident on finish; maintenance needed			
COMMENTS:	Carpet and sheet vinyl; ceramic tile; vinyl tile		
COMPONENT:	Wall Finishes	RATING: 2 x WEIGHT: 6.6 =	SCORE: 13.2
Maintainable surfaces, minor maintenance is required in some areas			
COMMENTS:	Gypsum board; plastic wall panels; ceramic tile		
COMPONENT:	Ceiling Finishes	RATING: 3 x WEIGHT: 6.6 =	SCORE: 19.8
Some wear and tear; Minor damage, staining or deterioration			
COMMENTS:	Lay-in ceiling tile; random deterioration due to water damage		
COMPONENT:	Doors & Hardware	RATING: 1 x WEIGHT: 6.6 =	SCORE: 6.6
Appropriate hardware, closers, panic devices; in good working order			
COMMENTS:	Interior laminate doors w HM frames; exterior aluminum doors/frames

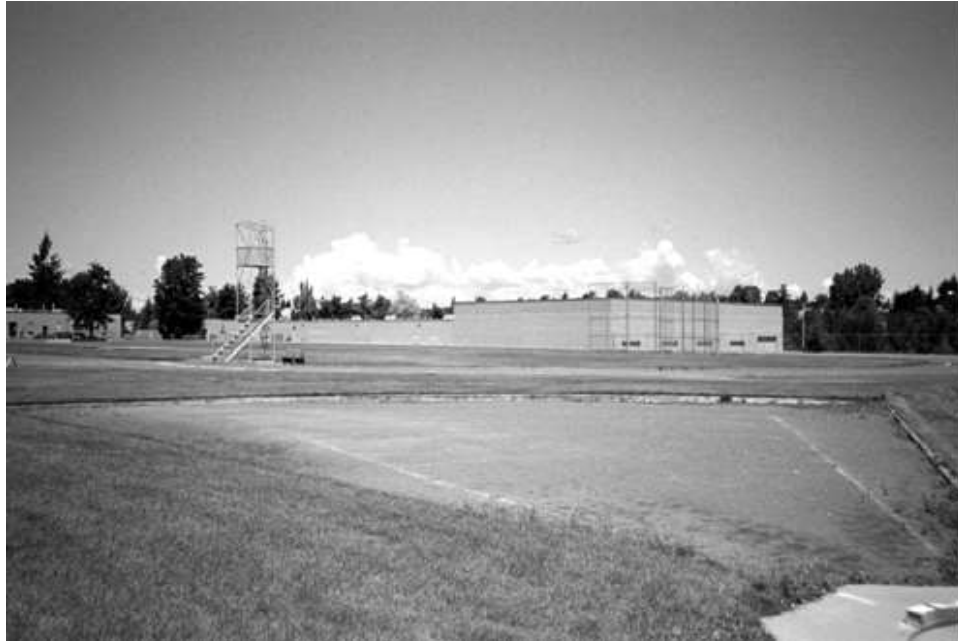
Heavy Equipment / Maintenance (171-19)      STATE UFI: A02485      Main Campus (171A)  
AREA: 51,579 SF      BUILT: 1976      REMODELED: 2013      PREDOMINANT USE: Vocational Arts  
CONSTRUCTION TYPE: Heavy      CRV/SF: \$395      REPLACEMENT VALUE: \$20,373,705

Primary Systems			
COMPONENT:	Structure	RATING: 1 x WEIGHT: 8.3 =	SCORE: 8.3
No signs of settlement or cracking, no abrupt vertical changes Columns, bearing walls and roof structure appears sound/free of defects			
COMMENTS:	Concrete and split-face CMU; steel trusses		
COMPONENT:	Exterior Closure	RATING: 2 x WEIGHT: 8.3 =	SCORE: 16.7
Weatherproof exterior, but finish appears poorly maintained			
COMMENTS:	CMU walls		
COMPONENT:	Roofing	RATING: 2 x WEIGHT: 10.4 =	SCORE: 20.9
Majority of roofing and flashing appear sound, but a small portion of roofing shows deterioration where maintenance or minor repair needed			
COMMENTS:	BUR; portion of roof UV coating and parapet cap flashings are deteriorated; funded in 2011

Secondary Systems			
COMPONENT:	Floor Finishes	RATING: 1 x WEIGHT: 6.3 =	SCORE: 6.3
Nice appearance, smooth transitions, level subfloors, no cracks/separating			
COMMENTS:	Terrazzo; concrete-random cracks in one shop; vinyl tile; brick; ceramic tile		
COMPONENT:	Wall Finishes	RATING: 2 x WEIGHT: 6.3 =	SCORE: 12.5
Maintainable surfaces, minor maintenance is required in some areas			
COMMENTS:	CMU and gypsum board; ceramic tile		
COMPONENT:	Ceiling Finishes	RATING: 1 x WEIGHT: 6.3 =	SCORE: 6.3
Maintainable surfaces in good condition; good alignment and appearance			
COMMENTS:	Concrete; Gypsum board; drop ceilings; some areas of staining and dirt		
COMPONENT:	Doors & Hardware	RATING: 3 x WEIGHT: 6.3 =	SCORE: 18.8
Functional, but dated; some maintenance required			
COMMENTS:	Primarily metal interior doors and frames; ceiling roll-up doors

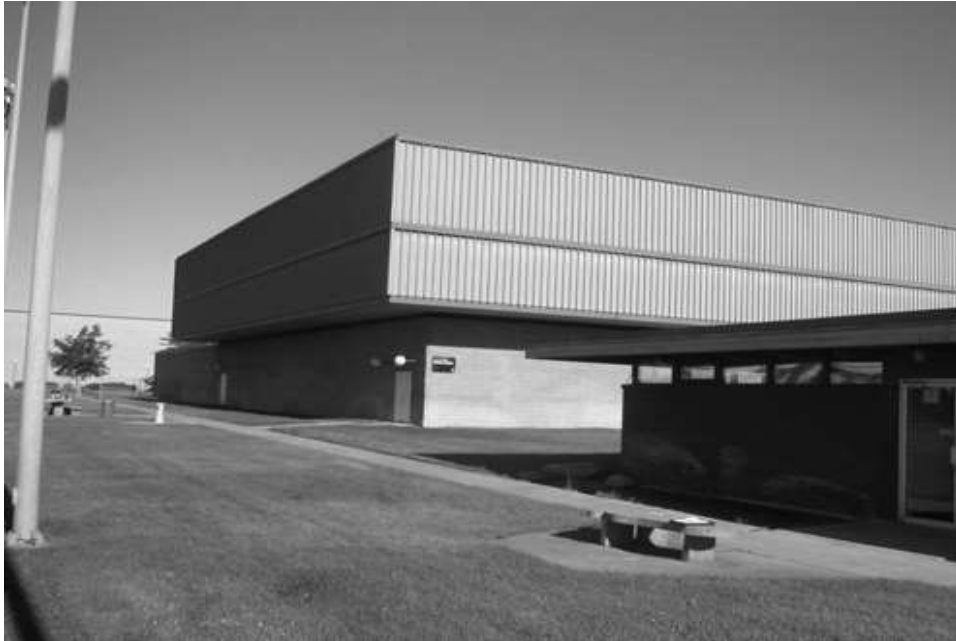
Johnson Sports Center (171-5)      STATE UFI: A03206      Main Campus (171A)  
AREA: 65,484 SF      BUILT: 1972      REMODELED: No      PREDOMINANT USE: Gymnasium  
CONSTRUCTION TYPE: Heavy      CRV/SF: \$349      REPLACEMENT VALUE: \$22,853,916

Primary Systems			
COMPONENT:	Structure	RATING: 1 x WEIGHT: 8.3 =	SCORE: 8.3
No signs of settlement or cracking, no abrupt vertical changes Columns, bearing walls and roof structure appears sound/free of defects			
COMMENTS:	Split-face CMU; steel; concrete slab		
COMPONENT:	Exterior Closure	RATING: 1 x WEIGHT: 8.3 =	SCORE: 8.3
Weatherproof, tight, well-maintained exterior walls, doors, windows/finishes			
COMMENTS:	CMU walls; metal wall panels		
COMPONENT:	Roofing	RATING: 2 x WEIGHT: 10.4 =	SCORE: 20.9
Majority of roofing and flashing appear sound, but a small portion of roofing shows deterioration where maintenance or minor repair needed			
COMMENTS:	Hypalon membrane on lower roof; adequate condition; upper BUR deteriorated; funded in 2011

Secondary Systems			
COMPONENT:	Floor Finishes	RATING: 2 x WEIGHT: 6.3 =	SCORE: 12.5
Some wear is evident on finish; maintenance needed			
COMMENTS:	Carpet; vinyl tile; ceramic tile; maple wood floor; some tile/carpet deterioration		
COMPONENT:	Wall Finishes	RATING: 2 x WEIGHT: 6.3 =	SCORE: 12.5
Maintainable surfaces, minor maintenance is required in some areas			
COMMENTS:	CMU walls; some Gypsum board; ceramic tile		
COMPONENT:	Ceiling Finishes	RATING: 3 x WEIGHT: 6.3 =	SCORE: 18.8
Some wear and tear; Minor damage, staining or deterioration			
COMMENTS:	Direct adhered and lay-in tile-dirty tiles; Gypsum board		
COMPONENT:	Doors & Hardware	RATING: 2 x WEIGHT: 6.3 =	SCORE: 12.5
Fairly modern door surfaces and hardware with minor deterioration; good working order			
COMMENTS:	Wood interior doors w HM frames; HM ext. doors/frames; some deterioration

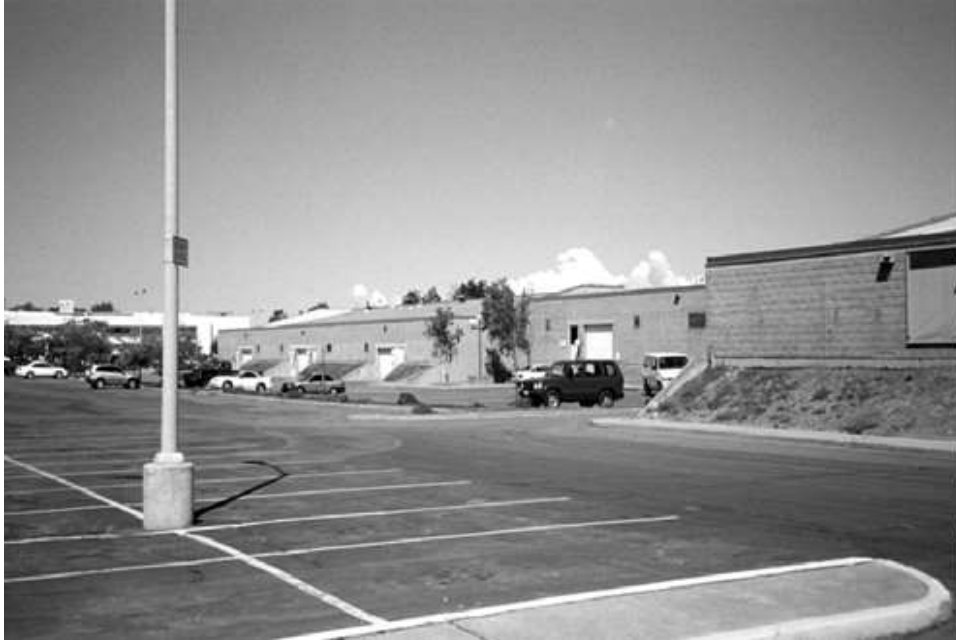
Automotive (171-18)      STATE UFI: A07575      Main Campus (171A)  
AREA: 92,319 SF      BUILT: 1976      REMODELED: No      PREDOMINANT USE: Vocational Arts  
CONSTRUCTION TYPE: Heavy      CRV/SF: \$395      REPLACEMENT VALUE: \$36,466,005

Primary Systems			
COMPONENT:	Structure	RATING: 1 x WEIGHT: 8.8 =	SCORE: 8.8
No signs of settlement or cracking, no abrupt vertical changes Columns, bearing walls and roof structure appears sound/free of defects			
COMMENTS:	Split-face CMU and concrete		
COMPONENT:	Exterior Closure	RATING: 1 x WEIGHT: 8.8 =	SCORE: 8.8
Weatherproof, tight, well-maintained exterior walls, doors, windows/finishes			
COMMENTS:	CMU block; some joint caulking required		
COMPONENT:	Roofing	RATING: 3 x WEIGHT: 11 =	SCORE: 32.9
Some deterioration is evident in membrane and flashings; maintenance or minor repair is needed			
COMMENTS:	BUR with UV coating

Secondary Systems			
COMPONENT:	Floor Finishes	RATING: 2 x WEIGHT: 6.6 =	SCORE: 13.2
Some wear is evident on finish; maintenance needed			
COMMENTS:	Terrazzo; concrete w random cracking in shops; vinyl tile-random wear; brick; ceramic tile		
COMPONENT:	Wall Finishes	RATING: 2 x WEIGHT: 6.6 =	SCORE: 13.2
Maintainable surfaces, minor maintenance is required in some areas			
COMMENTS:	CMU and some Gypsum board; ceramic tile		
COMPONENT:	Ceiling Finishes	RATING: 3 x WEIGHT: 6.6 =	SCORE: 19.8
Some wear and tear; Minor damage, staining or deterioration			
COMMENTS:	Lay-in tile and concrete; stained ceiling tiles--random throughout		
COMPONENT:	Doors & Hardware	RATING: 3 x WEIGHT: 6.6 =	SCORE: 19.8
Functional, but dated; some maintenance required			
COMMENTS:	Interior metal doors and frames with older hardware; roll-up doors need to be rebuilt; OH doors
