# **2023** FACILITY CONDITION SURVEY

Spokane Community College

SURVEY CONDUCTED BY:  
Steve Lewandowski  
State Board for Community  
and Technical Colleges

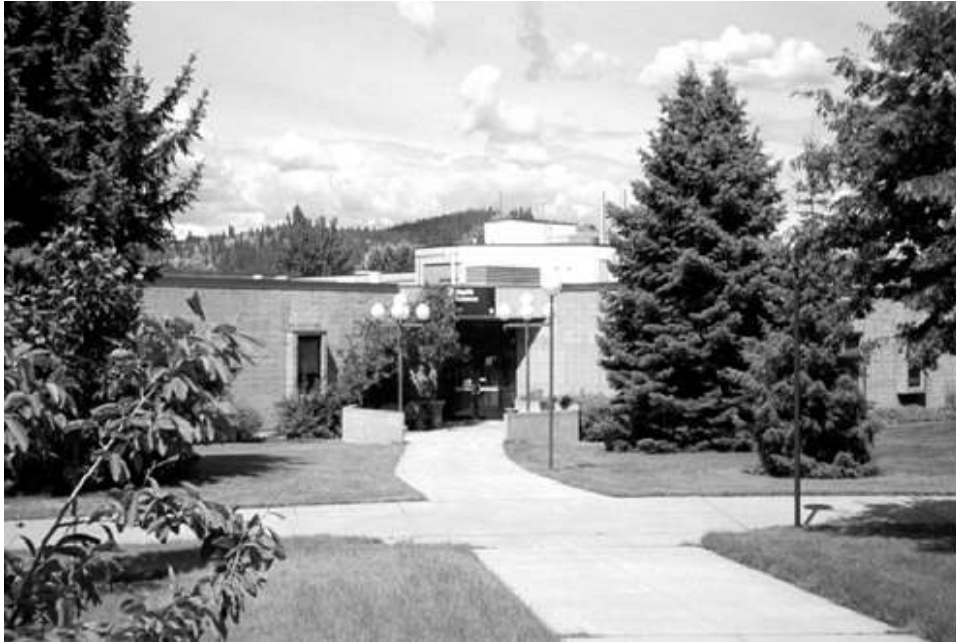
Health Science (171-9)      STATE UFI: A08699      Main Campus (171A)  
 AREA: 70,970 SF      BUILT: 1974      REMODELED: No      PREDOMINANT USE: General Classroom  
 CONSTRUCTION TYPE: Heavy      CRV/SF: \$376      REPLACEMENT VALUE: \$26,684,720

Primary Systems			
COMPONENT:	Structure	RATING: 1 x WEIGHT: 8 =	SCORE: 8
No signs of settlement or cracking, no abrupt vertical changes Columns, bearing walls and roof structure appears sound/free of defects			
COMMENTS:	CUM; concrete; steel		
COMPONENT:	Exterior Closure	RATING: 1 x WEIGHT: 8 =	SCORE: 8
Weatherproof, tight, well-maintained exterior walls, doors, windows/finishes			
COMMENTS:	CMU and concrete; some window frames need re-caulking		
COMPONENT:	Roofing	RATING: 2 x WEIGHT: 10 =	SCORE: 20
Majority of roofing and flashing appear sound, but a small portion of roofing shows deterioration where maintenance or minor repair needed			
COMMENTS:	BUR w/ UV coating; new coating applied in 04; random peeling in small areas

Secondary Systems			
COMPONENT:	Floor Finishes	RATING: 2 x WEIGHT: 6 =	SCORE: 12
Some wear is evident on finish; maintenance needed			
COMMENTS:	Terrazzo; vinyl tile; sheet vinyl; carpet		
COMPONENT:	Wall Finishes	RATING: 1 x WEIGHT: 6 =	SCORE: 6
Maintainable surfaces in good condition			
COMMENTS:	CMU and Gypsum board; vinyl wall covering; ceramic tile		
COMPONENT:	Ceiling Finishes	RATING: 1 x WEIGHT: 6 =	SCORE: 6
Maintainable surfaces in good condition; good alignment and appearance			
COMMENTS:	New lay-in ceiling tile		
COMPONENT:	Doors & Hardware	RATING: 3 x WEIGHT: 6 =	SCORE: 18
Functional, but dated; some maintenance required			
COMMENTS:	Laminate interior doors w HM frames; some deterioration; aluminum exterior doors

Service Systems			
COMPONENT:	Elevators	RATING: 1 x WEIGHT: 6 =	SCORE: 6
Appropriate and functional for occupancy and use			
COMMENTS:			
COMPONENT:	Plumbing	RATING: 1 x WEIGHT: 8 =	SCORE: 8
Fixtures and piping appear to be in good condition; no evidence of leaks			
COMMENTS:	Newer copper, galvanized, steel and PVC piping; porcelain fixtures		
COMPONENT:	HVAC	RATING: 3 x WEIGHT: 8 =	SCORE: 24
System generally adequate; some deterioration; needs balancing; some areas have A/C; hazardous areas are ventilated			
COMMENTS:	DX split system cooling-deteriorating; hot water boiler; AHU		
COMPONENT:	Electrical	RATING: 1 x WEIGHT: 8 =	SCORE: 8
Adequate service and distribution capacity for current/future needs			
COMMENTS:	1200 amp 208/120v		
COMPONENT:	Lights/Power	RATING: 1 x WEIGHT: 8 =	SCORE: 8
Contemporary lighting with good work area illumination; ample outlets			
COMMENTS:	Lay-in fluorescent lighting; new in 02

Safety Systems			
COMPONENT:	Life/Safety	RATING: 1 x WEIGHT: 10 = SCORE: 10	
	Appears to meet current codes		
COMMENTS:	Generally meets codes		
COMPONENT:	Fire Safety	RATING: 1 x WEIGHT: 10 = SCORE: 10	
	Locally monitored detection; alarm and strobes present; sprinklers in high hazard areas		
COMMENTS:	Fire alarm; no sprinklers		
COMPONENT:	Modifications	RATING: 1 x WEIGHT: 7 = SCORE: 7	
	Modifications appear to be in compliance with codes and sound construction practices; HVAC/electrical service properly provided		
COMMENTS:	2002 renovation appears well done; good quality

Quality Standards			
COMPONENT:	Maintenance	RATING: 1 x WEIGHT: 7 = SCORE: 7	
	Facility appears well maintained		
COMMENTS:			
COMPONENT:	Remaining Life	RATING: 1 x WEIGHT: 6 = SCORE: 6	
	Life expectancy is >20 years; minor system deterioration		
COMMENTS:	Renovated in 2002; should have 25 yr. Remaining life		
COMPONENT:	Appearance	RATING: 1 x WEIGHT: 6 = SCORE: 6	
	Well-constructed building; generally attractive interior and exterior		
COMMENTS:

CONDITION: Adequate

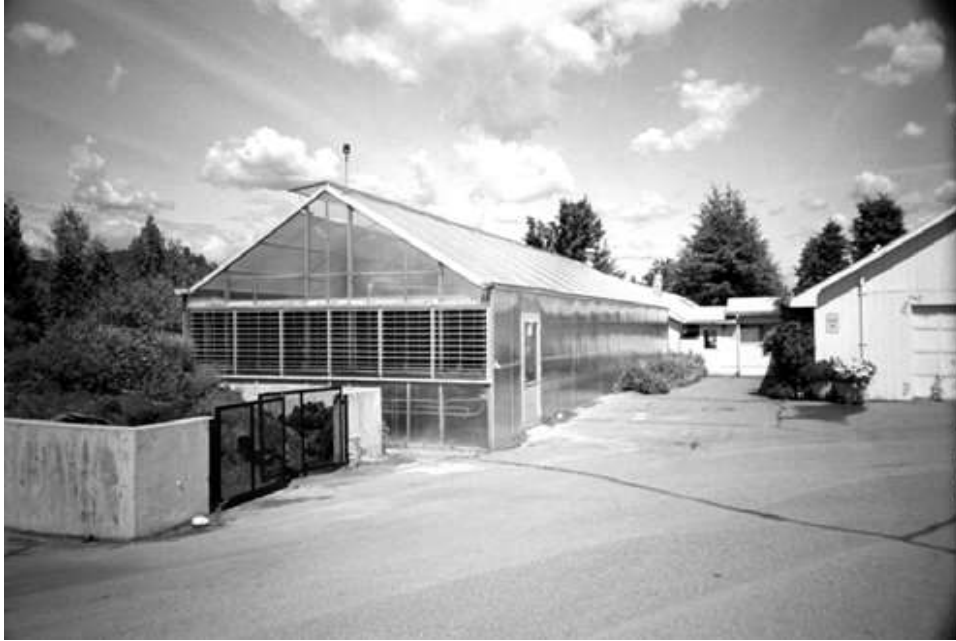
Greenhouse (171-10)      STATE UFI: A09082      Main Campus (171A)  
AREA: 9,846 SF      BUILT: 1973      REMODELED: 2012      PREDOMINANT USE: Greenhouse  
CONSTRUCTION TYPE: Light      CRV/SF: \$231      REPLACEMENT VALUE: \$2,274,426

Primary Systems			
COMPONENT:	Structure	RATING: 2 x WEIGHT: 8.3 =	SCORE: 16.7
Minor cracks evident in a small portion of the structure			
COMMENTS:	Wood framing; concrete slab		
COMPONENT:	Exterior Closure	RATING: 3 x WEIGHT: 8.3 =	SCORE: 25
Sound and weatherproof but with some physical deterioration evident			
COMMENTS:	T1-11 plywood; fiberglass and acrylic panels; New acrylic panels in 2002		
COMPONENT:	Roofing	RATING: 3 x WEIGHT: 10.4 =	SCORE: 31.3
Some deterioration is evident in membrane and flashings; maintenance or minor repair is needed			
COMMENTS:	3-tab asphalt shingles-new in 2006; new fiberglass and acrylic panels in 2002. Repairs funded 2023-25

Secondary Systems			
COMPONENT:	Floor Finishes	RATING: 3 x WEIGHT: 6.3 =	SCORE: 18.8
Some physical wear and minor imperfections are evident; beginning deterioration			
COMMENTS:	Concrete and vinyl tile; quarry tile		
COMPONENT:	Wall Finishes	RATING: 1 x WEIGHT: 6.3 =	SCORE: 6.3
Maintainable surfaces in good condition			
COMMENTS:	Gypsum board; fiberglass and acrylic panels; T1-11; ceramic tile		
COMPONENT:	Ceiling Finishes	RATING: 2 x WEIGHT: 6.3 =	SCORE: 12.5
Aging surfaces in fair condition and good alignment			
COMMENTS:	Gypsum board and drop ceilings; acrylic panels		
COMPONENT:	Doors & Hardware	RATING: 3 x WEIGHT: 6.3 =	SCORE: 18.8
Functional, but dated; some maintenance required			
COMMENTS:	Wood doors and HM frames

Service Systems			
COMPONENT:	Elevators	RATING: 0 x WEIGHT: 0 =	SCORE: 0
No data			
COMMENTS:			
COMPONENT:	Plumbing	RATING: 3 x WEIGHT: 8.3 =	SCORE: 25
Fixtures are functional but dated; some leaks; maintenance required			
COMMENTS:	Copper and PVC piping; porcelain fixtures		
COMPONENT:	HVAC	RATING: 1 x WEIGHT: 8.3 =	SCORE: 8.3
Equipment in good condition; easily controlled; serves all required spaces; All necessary spaces are adequately ventilated; A/C provided throughout			
COMMENTS:	Electric and gas unit heaters; evaporative coolers		
COMPONENT:	Electrical	RATING: 3 x WEIGHT: 8.3 =	SCORE: 25
Service capacity meets current needs but inadequate for future			
COMMENTS:	200amp 208/120v		
COMPONENT:	Lights/Power	RATING: 3 x WEIGHT: 8.3 =	SCORE: 25
Adequate work area illumination; adequate outlets for current use; maintenance required			
COMMENTS:	Ceiling-mount and truss mount fluorescent and incandescent lights

Safety Systems			
COMPONENT:	Life/Safety	RATING: 3 x WEIGHT: 10.4 =	SCORE: 31.3
Generally meets codes for vintage of construction			
COMMENTS:			
COMPONENT:	Fire Safety	RATING: 2 x WEIGHT: 10.4 =	SCORE: 20.9
Locally monitored detection; alarm present, but missing visual component or sprinklers			
COMMENTS:			
COMPONENT:	Modifications	RATING: 1 x WEIGHT: 7.3 =	SCORE: 7.3
Modifications appear to be in compliance with codes and sound construction practices; HVAC/electrical service properly provided			
COMMENTS: All modifications are properly constructed

Quality Standards			
COMPONENT:	Maintenance	RATING: 3 x WEIGHT: 7.3 =	SCORE: 21.9
Routine maintenance is required; deferred maintenance is evident; impact is minor to moderate			
COMMENTS:			
COMPONENT:	Remaining Life	RATING: 3 x WEIGHT: 6.3 =	SCORE: 18.8
Life expectancy is roughly 10-15 years; moderate system deterioration			
COMMENTS: Greenhouses are newer; older instructional bldg. Should be replaced in next 10 yrs.			
COMPONENT:	Appearance	RATING: 3 x WEIGHT: 6.3 =	SCORE: 18.8
Average construction; average interior and exterior appearance			
COMMENTS:

CONDITION: Needs Improvement/Renovation

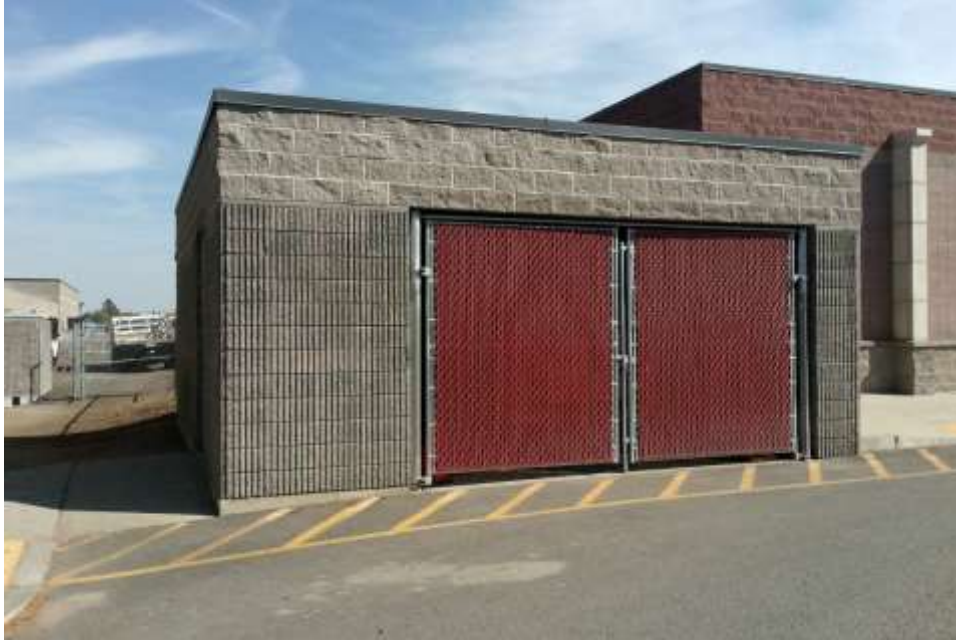
Dumpster Enclosure (171-41)      STATE UFI: A10269      Main Campus (171A)  
AREA: 572 SF      BUILT: 2010      REMODELED: No      PREDOMINANT USE: Storage  
CONSTRUCTION TYPE: No data      CRV/SF: \$94      REPLACEMENT VALUE: \$53,768

Primary Systems			
COMPONENT:	Structure	RATING: 1 x WEIGHT: 12.6 =	SCORE: 12.6
No signs of settlement or cracking, no abrupt vertical changes Columns, bearing walls and roof structure appears sound/free of defects			
COMMENTS:	No data		
COMPONENT:	Exterior Closure	RATING: 1 x WEIGHT: 12.6 =	SCORE: 12.6
Weatherproof, tight, well-maintained exterior walls, doors, windows/finishes			
COMMENTS:	No data		
COMPONENT:	Roofing	RATING: 1 x WEIGHT: 15.7 =	SCORE: 15.7
Flashing and penetrations appear sound and membrane appears water- tight; drainage is positive and there are overflow scuppers			
COMMENTS:	No data

Secondary Systems			
COMPONENT:	Floor Finishes	RATING: 1 x WEIGHT: 9.4 =	SCORE: 9.4
	Nice appearance, smooth transitions, level subfloors, no cracks/separating		
COMMENTS:	No data		
COMPONENT:	Wall Finishes	RATING: 0 x WEIGHT: 0 =	SCORE: 0
	No data		
COMMENTS:	No data		
COMPONENT:	Ceiling Finishes	RATING: 0 x WEIGHT: 0 =	SCORE: 0
	No data		
COMMENTS:	No data		
COMPONENT:	Doors & Hardware	RATING: 1 x WEIGHT: 9.4 =	SCORE: 9.4
	Appropriate hardware, closers, panic devices; in good working order		
COMMENTS:	No data

Quality Standards			
COMPONENT:	Maintenance	RATING: 1 x WEIGHT: 11 =	SCORE: 11
	Facility appears well maintained		
COMMENTS:	No data		
COMPONENT:	Remaining Life	RATING: 1 x WEIGHT: 9.4 =	SCORE: 9.4
	Life expectancy is >20 years; minor system deterioration		
COMMENTS:	No data		
COMPONENT:	Appearance	RATING: 3 x WEIGHT: 9.4 =	SCORE: 28.3
	Average construction; average interior and exterior appearance		
COMMENTS:	No data

CONDITION: Adequate
