2023 FACILITY CONDITION SURVEY

Walla Walla Community
College

SURVEY CONDUCTED BY:
Steve Lewandowski
State Board for Community
and Technical Colleges

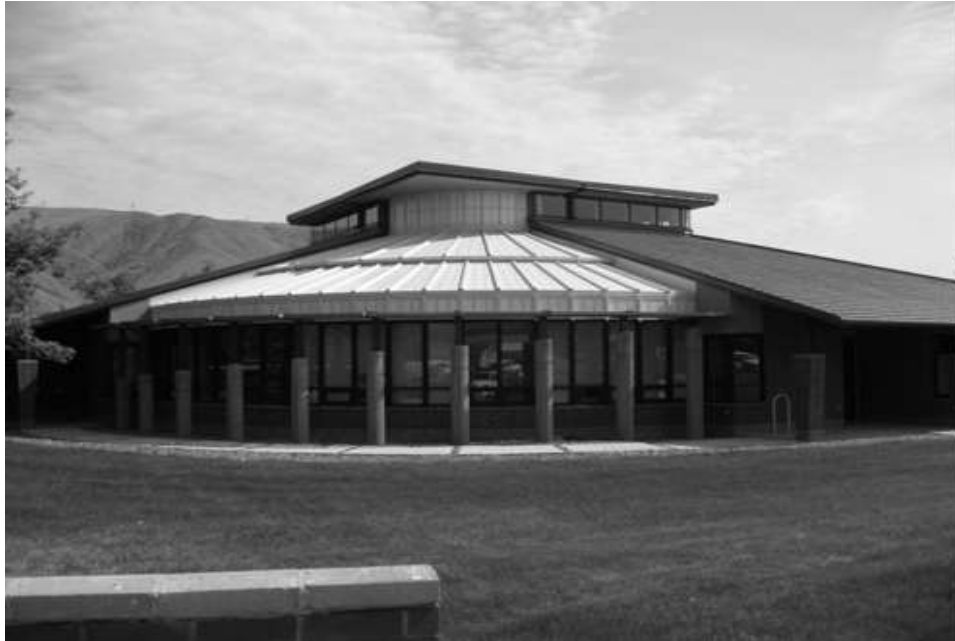
Clarkston Health Science (200-CHS) STATE UFI: A01930 Clarkston Campus (200B)
 AREA: 8,900 SF BUILT: 2007 REMODELED: No PREDOMINANT USE: General Classroom
 CONSTRUCTION TYPE: Medium CRV/SF: \$376 REPLACEMENT VALUE: \$3,346,400

Primary Systems			
COMPONENT:	Structure	RATING: 1 x WEIGHT: 8.3 =	SCORE: 8.3
No signs of settlement or cracking, no abrupt vertical changes Columns, bearing walls and roof structure appears sound/free of defects			
COMMENTS:	Wood and steel framing		
COMPONENT:	Exterior Closure	RATING: 1 x WEIGHT: 8.3 =	SCORE: 8.3
Weatherproof, tight, well-maintained exterior walls, doors, windows/finishes			
COMMENTS:	Brick; split face CMU; Kalwall panels		
COMPONENT:	Roofing	RATING: 1 x WEIGHT: 10.4 =	SCORE: 10.4
Flashing and penetrations appear sound and membrane appears water- tight; drainage is positive and there are overflow scuppers			
COMMENTS:	Cement shingles; Kalwall skylights (leaks - repairs funded 21-23); stucco soffits

Secondary Systems			
COMPONENT:	Floor Finishes	RATING: 1 x WEIGHT: 6.3 = SCORE: 6.3	
	Nice appearance, smooth transitions, level subfloors, no cracks/separating		
COMMENTS:	Carpet; vinyl tile; ceramic tile		
COMPONENT:	Wall Finishes	RATING: 1 x WEIGHT: 6.3 = SCORE: 6.3	
	Maintainable surfaces in good condition		
COMMENTS:	Gypsum board; ceramic tile		
COMPONENT:	Ceiling Finishes	RATING: 1 x WEIGHT: 6.3 = SCORE: 6.3	
	Maintainable surfaces in good condition; good alignment and appearance		
COMMENTS:	Lay-in tile; gypsum board		
COMPONENT:	Doors & Hardware	RATING: 1 x WEIGHT: 6.3 = SCORE: 6.3	
	Appropriate hardware, closers, panic devices; in good working order		
COMMENTS:	Exterior aluminum doors/frames; interior wood doors/HM frames; lever hardware

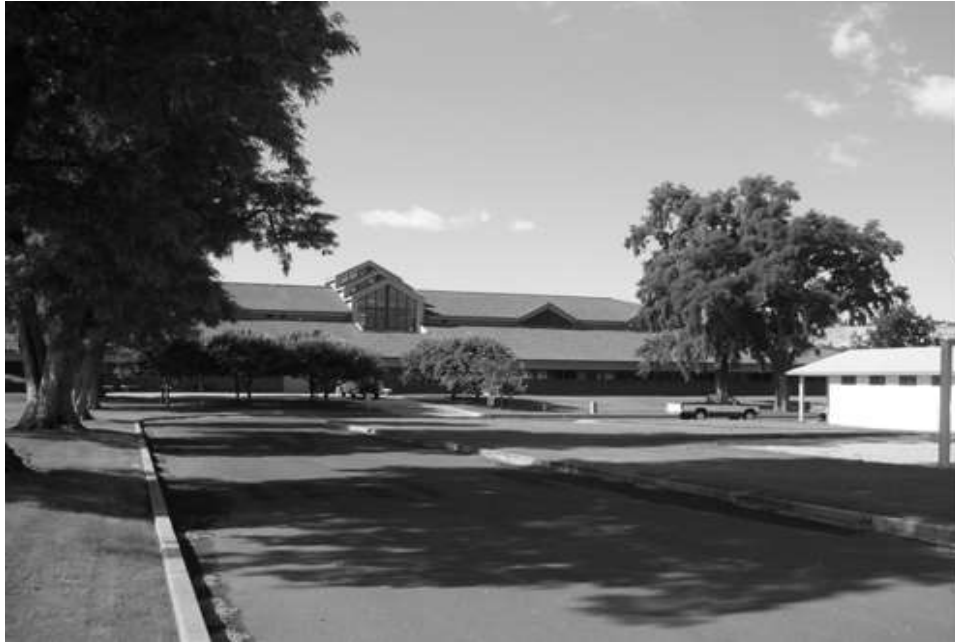
Clarkston Main Building (200-CLK) STATE UFI: A06271 Clarkston Campus (200B)
AREA: 44,896 SF BUILT: 1988 REMODELED: 2015 PREDOMINANT USE: General Classroom
CONSTRUCTION TYPE: Medium CRV/SF: \$376 REPLACEMENT VALUE: \$16,880,896

Primary Systems			
COMPONENT:	Structure	RATING: 1 x WEIGHT: 8 =	SCORE: 8
No signs of settlement or cracking, no abrupt vertical changes Columns, bearing walls and roof structure appears sound/free of defects			
COMMENTS:	Brick; concrete; no problems		
COMPONENT:	Exterior Closure	RATING: 1 x WEIGHT: 8 =	SCORE: 8
Weatherproof, tight, well-maintained exterior walls, doors, windows/finishes			
COMMENTS:	Brick; EIFS		
COMPONENT:	Roofing	RATING: 1 x WEIGHT: 10 =	SCORE: 10
Flashing and penetrations appear sound and membrane appears water- tight; drainage is positive and there are overflow scuppers			
COMMENTS:	Cement tile-tile/flashing repairs in 2010

Secondary Systems			
COMPONENT:	Floor Finishes	RATING: 2 x WEIGHT: 6 = SCORE: 12	
	Some wear is evident on finish; maintenance needed		
COMMENTS:	Carpet and vinyl tile; ceramic tile; sheet vinyl		
COMPONENT:	Wall Finishes	RATING: 2 x WEIGHT: 6 = SCORE: 12	
	Maintainable surfaces, minor maintenance is required in some areas		
COMMENTS:	Gypsum board; brick; vinyl wall panels; ceramic tile		
COMPONENT:	Ceiling Finishes	RATING: 2 x WEIGHT: 6 = SCORE: 12	
	Aging surfaces in fair condition and good alignment		
COMMENTS:	Gypsum board; lay-in tile-random water stains		
COMPONENT:	Doors & Hardware	RATING: 2 x WEIGHT: 6 = SCORE: 12	
	Fairly modern door surfaces and hardware with minor deterioration; good working order		
COMMENTS:	Interior wood doors w HM frames; exterior aluminum doors/frames and HM doors/frames

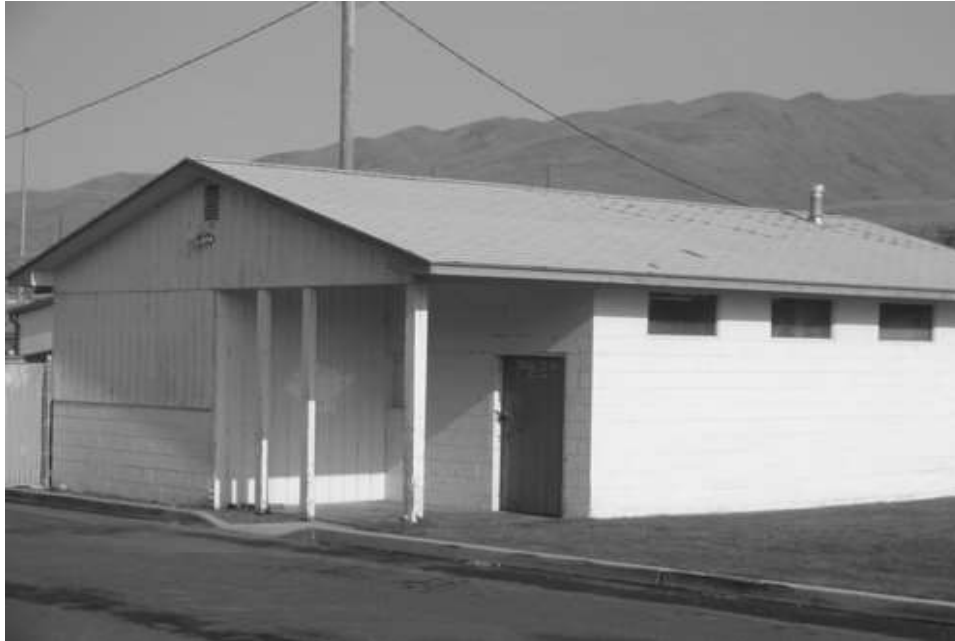
Clarkston Maintenance Shop (200-CMS) STATE UFI: A03114 Clarkston Campus (200B)
AREA: 785 SF BUILT: 1955 REMODELED: No PREDOMINANT USE: Maintenance
CONSTRUCTION TYPE: Medium CRV/SF: \$264 REPLACEMENT VALUE: \$207,240

Primary Systems			
COMPONENT:	Structure	RATING: 3 x WEIGHT: 8.8 =	SCORE: 26.5
Some cracking evident but does not likely affect structural integrity; Visible defects apparent but are non-structural			
COMMENTS:	CMU and concrete		
COMPONENT:	Exterior Closure	RATING: 4 x WEIGHT: 8.8 =	SCORE: 35.4
General deterioration detected, one or more minor leaks apparent			
COMMENTS:	CMU; T&G wood siding; plywood		
COMPONENT:	Roofing	RATING: 1 x WEIGHT: 11.1 =	SCORE: 11.1
Flashing and penetrations appear sound and membrane appears water- tight; drainage is positive and there are overflow scuppers			
COMMENTS:	3-tab asphalt shingles-replaced in 2010

Secondary Systems			
COMPONENT:	Floor Finishes	RATING: 3 x WEIGHT: 6.6 = SCORE: 19.9	
	Some physical wear and minor imperfections are evident; beginning deterioration		
COMMENTS:	Concrete		
COMPONENT:	Wall Finishes	RATING: 4 x WEIGHT: 6.6 = SCORE: 26.5	
	Aging surfaces generally require maintenance; some areas require repair		
COMMENTS:	CMU - some efflorescence throughout		
COMPONENT:	Ceiling Finishes	RATING: 3 x WEIGHT: 6.6 = SCORE: 19.9	
	Some wear and tear; Minor damage, staining or deterioration		
COMMENTS:	Plywood		
COMPONENT:	Doors & Hardware	RATING: 5 x WEIGHT: 6.6 = SCORE: 33.2	
	Inoperable, deteriorating and outdated; non-secure		
COMMENTS:	Wood doors and frames

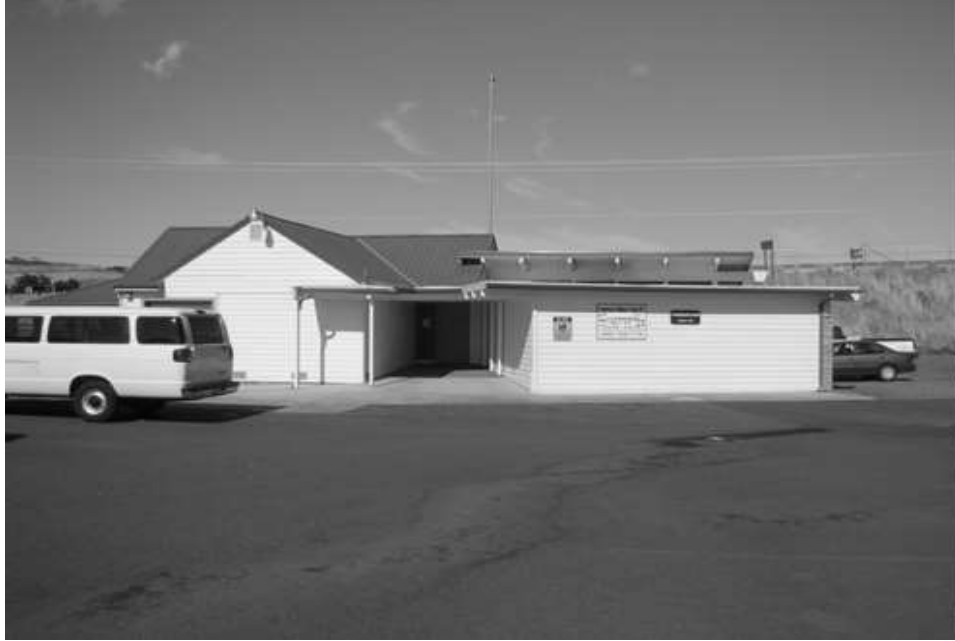
Clk Child Care Center (200-PCC) STATE UFI: A04676 Clarkston Campus (200B)
 AREA: 3,376 SF BUILT: 1975 REMODELED: No PREDOMINANT USE: Child Care
 CONSTRUCTION TYPE: Light CRV/SF: \$264 REPLACEMENT VALUE: \$891,264

Primary Systems			
COMPONENT:	Structure	RATING: 3 x WEIGHT: 8.3 =	SCORE: 25
Some cracking evident but does not likely affect structural integrity; Visible defects apparent but are non-structural			
COMMENTS:	Wood framing; concrete foundation; drainage problem in crawl space		
COMPONENT:	Exterior Closure	RATING: 3 x WEIGHT: 8.3 =	SCORE: 25
Sound and weatherproof but with some physical deterioration evident			
COMMENTS:	Horizontal vinyl siding; split brick; Masonite siding		
COMPONENT:	Roofing	RATING: 1 x WEIGHT: 10.4 =	SCORE: 10.4
Flashing and penetrations appear sound and membrane appears water- tight; drainage is positive and there are overflow scuppers			
COMMENTS:	Metal 2019; TPO membrane on flat roof in 2010

Secondary Systems			
COMPONENT:	Floor Finishes	RATING: 3 x WEIGHT: 6.3 = SCORE: 18.8	
	Some physical wear and minor imperfections are evident; beginning deterioration		
COMMENTS:	Carpet and vinyl sheet flooring		
COMPONENT:	Wall Finishes	RATING: 3 x WEIGHT: 6.3 = SCORE: 18.8	
	Aging surfaces, but sound; some maintenance is required		
COMMENTS:	Older gypsum board		
COMPONENT:	Ceiling Finishes	RATING: 3 x WEIGHT: 6.3 = SCORE: 18.8	
	Some wear and tear; Minor damage, staining or deterioration		
COMMENTS:	Older gypsum board and T&G wood		
COMPONENT:	Doors & Hardware	RATING: 3 x WEIGHT: 6.3 = SCORE: 18.8	
	Functional, but dated; some maintenance required		
COMMENTS:	Interior/exterior wood doors/frames

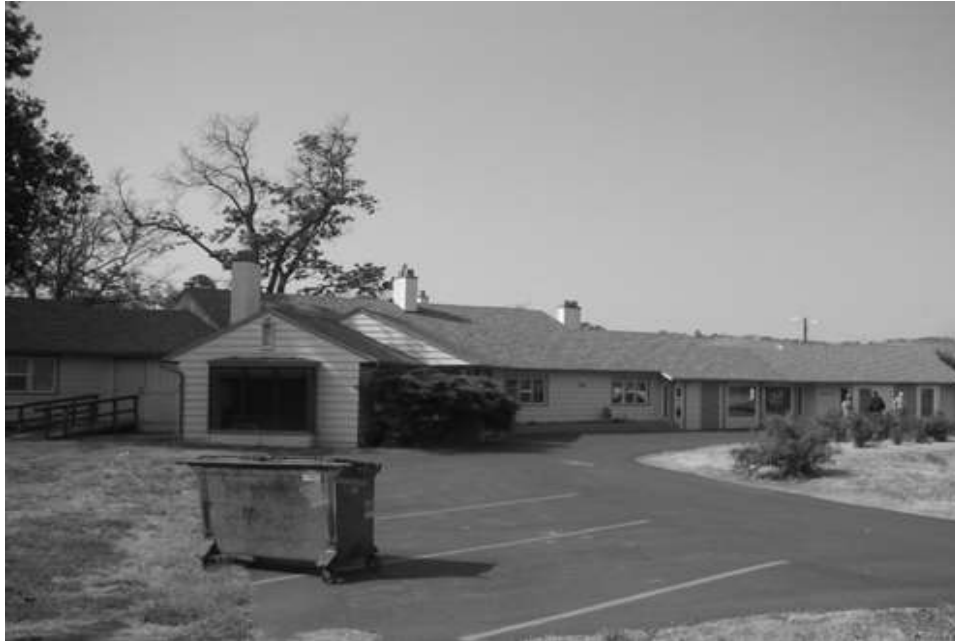
Fair Street House (200-FSH) STATE UFI: A06736 Clarkston Campus (200B)
AREA: 4,400 SF BUILT: 1957 REMODELED: No PREDOMINANT USE: Child Care
CONSTRUCTION TYPE: Light CRV/SF: \$264 REPLACEMENT VALUE: \$1,161,600

Primary Systems			
COMPONENT:	Structure	RATING: 4 x WEIGHT: 8.3 =	SCORE: 33.4
Some structural flaws potentially exist and should be evaluated by a structural engineer			
COMMENTS:	Wood frame; concrete slab; partial concrete basement		
COMPONENT:	Exterior Closure	RATING: 3 x WEIGHT: 8.3 =	SCORE: 25
Sound and weatherproof but with some physical deterioration evident			
COMMENTS:	Horizontal beveled siding - may be asbestos		
COMPONENT:	Roofing	RATING: 1 x WEIGHT: 10.4 =	SCORE: 10.4
Flashing and penetrations appear sound and membrane appears water- tight; drainage is positive and there are overflow scuppers			
COMMENTS:	Metal roofing 2019

Secondary Systems			
COMPONENT:	Floor Finishes	RATING: 3 x WEIGHT: 6.3 =	SCORE: 18.8
Some physical wear and minor imperfections are evident; beginning deterioration			
COMMENTS:	Carpet and sheet vinyl - new in 1998		
COMPONENT:	Wall Finishes	RATING: 2 x WEIGHT: 6.3 =	SCORE: 12.5
Maintainable surfaces, minor maintenance is required in some areas			
COMMENTS:	Painted Gypsum board		
COMPONENT:	Ceiling Finishes	RATING: 1 x WEIGHT: 6.3 =	SCORE: 6.3
Maintainable surfaces in good condition; good alignment and appearance			
COMMENTS:	Painted Gypsum board		
COMPONENT:	Doors & Hardware	RATING: 1 x WEIGHT: 6.3 =	SCORE: 6.3
Appropriate hardware, closers, panic devices; in good working order			
COMMENTS:	Interior HM doors/frames and wood frames; exterior HM doors/frames

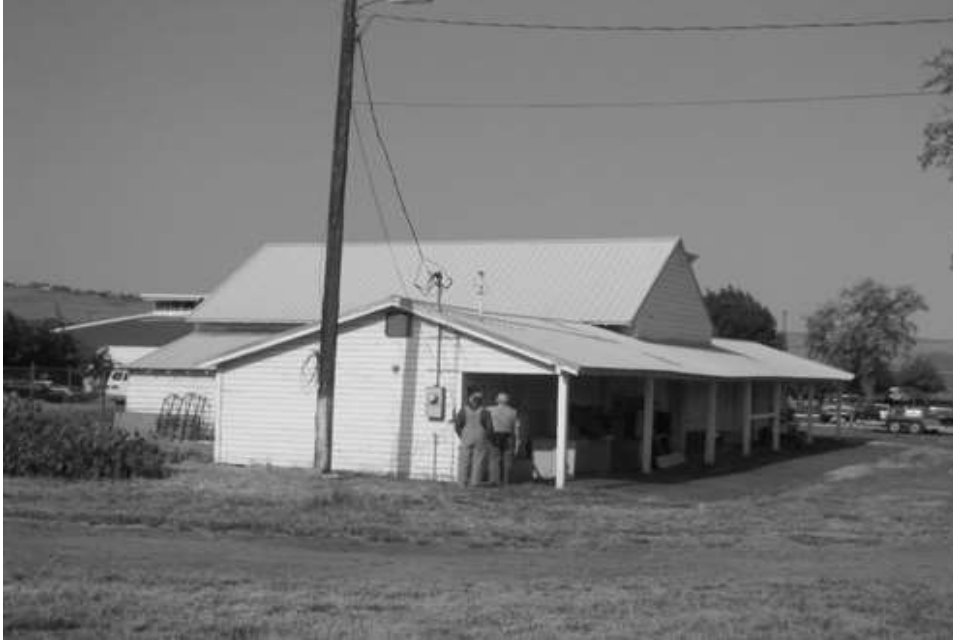
Stable Storage Bldg (200-CST) STATE UFI: A00950 Clarkston Campus (2008)
AREA: 1,500 SF BUILT: 1955 REMODELED: No PREDOMINANT USE: Storage
CONSTRUCTION TYPE: Light CRV/SF: \$198 REPLACEMENT VALUE: \$297,000

Primary Systems			
COMPONENT:	Structure	RATING: 5 x WEIGHT: 12.7 =	SCORE: 63.5
Visible settlement and potential structural failure; potential safety hazard Structural defects apparent in superstructure			
COMMENTS:	Wood frame; concrete slab; structural concerns		
COMPONENT:	Exterior Closure	RATING: 5 x WEIGHT: 12.7 =	SCORE: 63.5
Significant deterioration, leaking and air infiltration apparent			
COMMENTS:	T&G horizontal wood siding		
COMPONENT:	Roofing	RATING: 3 x WEIGHT: 15.9 =	SCORE: 47.6
Some deterioration is evident in membrane and flashings; maintenance or minor repair is needed			
COMMENTS:	Metal roof panels

Secondary Systems			
COMPONENT:	Floor Finishes	RATING: 0 x WEIGHT: 0 =	SCORE: 0
No data			
COMMENTS:	Concrete		
COMPONENT:	Wall Finishes	RATING: 5 x WEIGHT: 9.5 =	SCORE: 47.6
Surfaces are deteriorated and require resurfacing or rebuilding			
COMMENTS:	Plywood		
COMPONENT:	Ceiling Finishes	RATING: 0 x WEIGHT: 0 =	SCORE: 0
No data			
COMMENTS:	underside of envelope		
COMPONENT:	Doors & Hardware	RATING: 5 x WEIGHT: 9.5 =	SCORE: 47.6
Inoperable, deteriorating and outdated; non-secure			
COMMENTS:	Wood doors and frames

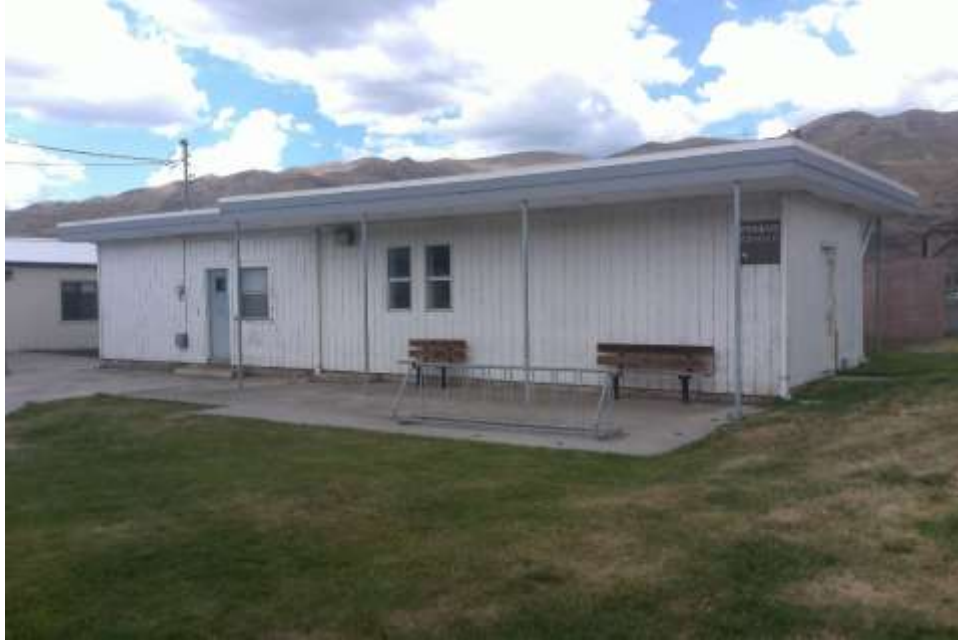
Clarkston Fitness Center (200-CFC) STATE UFI: A03395 Clarkston Campus (200B)
AREA: 1,800 SF BUILT: 1955 REMODELED: No PREDOMINANT USE: General Classroom
CONSTRUCTION TYPE: Medium CRV/SF: \$376 REPLACEMENT VALUE: \$676,800

Primary Systems			
COMPONENT:	Structure	RATING: 3 x WEIGHT: 8.3 =	SCORE: 25
Some cracking evident but does not likely affect structural integrity; Visible defects apparent but are non-structural			
COMMENTS:	No data		
COMPONENT:	Exterior Closure	RATING: 4 x WEIGHT: 8.3 =	SCORE: 33.4
General deterioration detected, one or more minor leaks apparent			
COMMENTS:	EIFS applied over brick exterior in 1989		
COMPONENT:	Roofing	RATING: 3 x WEIGHT: 10.4 =	SCORE: 31.3
Some deterioration is evident in membrane and flashings; maintenance or minor repair is needed			
COMMENTS:	Built-up roof w UV coating applied in 1985-coating beginning to deteriorate

Secondary Systems			
COMPONENT:	Floor Finishes	RATING: 3 x WEIGHT: 6.3 =	SCORE: 18.8
Some physical wear and minor imperfections are evident; beginning deterioration			
COMMENTS:	Sheet vinyl; vinyl-tile; ceramic tile; carpet		
COMPONENT:	Wall Finishes	RATING: 2 x WEIGHT: 6.3 =	SCORE: 12.5
Maintainable surfaces, minor maintenance is required in some areas			
COMMENTS:	Gypsum board; ceramic tile		
COMPONENT:	Ceiling Finishes	RATING: 2 x WEIGHT: 6.3 =	SCORE: 12.5
Aging surfaces in fair condition and good alignment			
COMMENTS:	Lay-in tile		
COMPONENT:	Doors & Hardware	RATING: 3 x WEIGHT: 6.3 =	SCORE: 18.8
Functional, but dated; some maintenance required			
COMMENTS:	Interior wood doors/frames; exterior aluminum doors/frames; OH coiling door

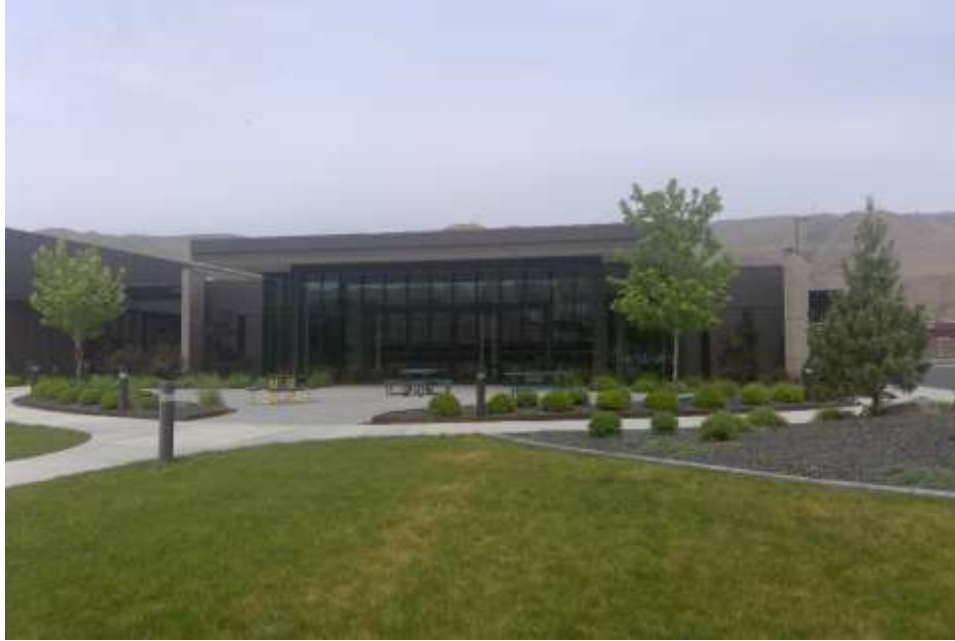
Clk Workforce & Bus Dev (200-CWB) STATE UFI: A25253 Clarkston Campus (200B)
AREA: 16,013 SF BUILT: 2017 REMODELED: No PREDOMINANT USE: Classroom
CONSTRUCTION TYPE: No data CRV/SF: \$356 REPLACEMENT VALUE: \$5,700,628

Primary Systems			
COMPONENT:	Structure	RATING: 1 x WEIGHT: 8.8 = SCORE: 8.8	
No signs of settlement or cracking, no abrupt vertical changes Columns, bearing walls and roof structure appears sound/free of defects			
COMMENTS:	No data		
COMPONENT:	Exterior Closure	RATING: 1 x WEIGHT: 8.8 = SCORE: 8.8	
Weatherproof, tight, well-maintained exterior walls, doors, windows/finishes			
COMMENTS:	No data		
COMPONENT:	Roofing	RATING: 1 x WEIGHT: 11 = SCORE: 11	
Flashing and penetrations appear sound and membrane appears water- tight; drainage is positive and there are overflow scuppers			
COMMENTS:	No data

Secondary Systems			
COMPONENT:	Floor Finishes	RATING: 1 x WEIGHT: 6.6 =	SCORE: 6.6
Nice appearance, smooth transitions, level subfloors, no cracks/separating			
COMMENTS:	No data		
COMPONENT:	Wall Finishes	RATING: 1 x WEIGHT: 6.6 =	SCORE: 6.6
Maintainable surfaces in good condition			
COMMENTS:	No data		
COMPONENT:	Ceiling Finishes	RATING: 1 x WEIGHT: 6.6 =	SCORE: 6.6
Maintainable surfaces in good condition; good alignment and appearance			
COMMENTS:	No data		
COMPONENT:	Doors & Hardware	RATING: 1 x WEIGHT: 6.6 =	SCORE: 6.6
Appropriate hardware, closers, panic devices; in good working order			
COMMENTS:	No data

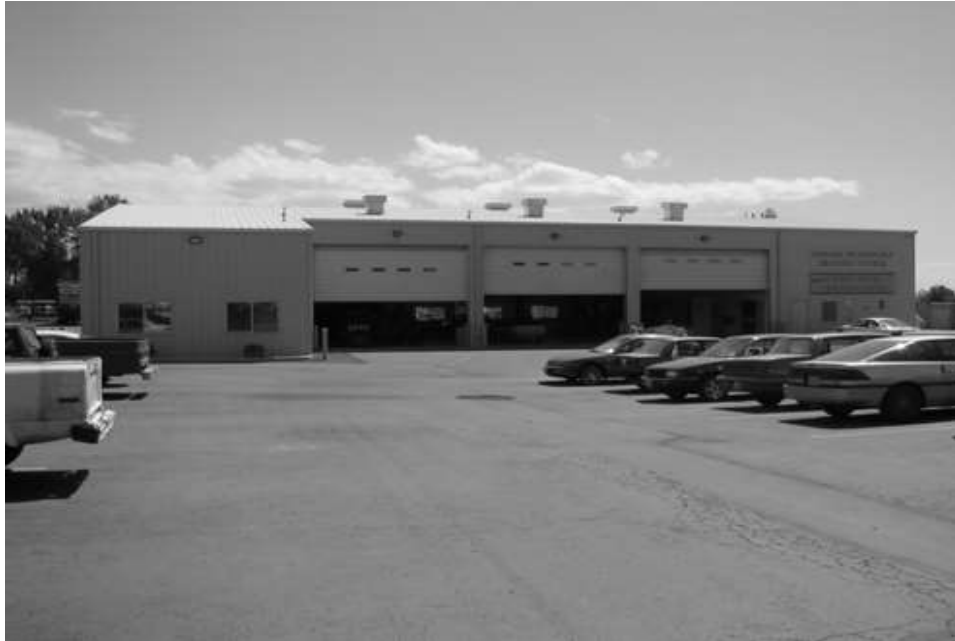
Applied Tech Training Cnt (200-P) STATE UFI: A04806 Main Campus (200A)
AREA: 10,802 SF BUILT: 1996 REMODELED: 2002 PREDOMINANT USE: Vocational Arts
CONSTRUCTION TYPE: Light CRV/SF: \$395 REPLACEMENT VALUE: \$4,266,790

Primary Systems			
COMPONENT:	Structure	RATING: 1 x WEIGHT: 8 =	SCORE: 8
No signs of settlement or cracking, no abrupt vertical changes Columns, bearing walls and roof structure appears sound/free of defects			
COMMENTS:	Steel frame; concrete slab		
COMPONENT:	Exterior Closure	RATING: 1 x WEIGHT: 8 =	SCORE: 8
Weatherproof, tight, well-maintained exterior walls, doors, windows/finishes			
COMMENTS:	Metal wall panels		
COMPONENT:	Roofing	RATING: 2 x WEIGHT: 10 =	SCORE: 20
Majority of roofing and flashing appear sound, but a small portion of roofing shows deterioration where maintenance or minor repair needed			
COMMENTS:	Metal roof

Secondary Systems			
COMPONENT:	Floor Finishes	RATING: 1 x WEIGHT: 6 = SCORE: 6	
	Nice appearance, smooth transitions, level subfloors, no cracks/separating		
COMMENTS:	Concrete; vinyl tile; carpet		
COMPONENT:	Wall Finishes	RATING: 1 x WEIGHT: 6 = SCORE: 6	
	Maintainable surfaces in good condition		
COMMENTS:	Gypsum board and vinyl-faced insulation		
COMPONENT:	Ceiling Finishes	RATING: 1 x WEIGHT: 6 = SCORE: 6	
	Maintainable surfaces in good condition; good alignment and appearance		
COMMENTS:	Lay-in tile; gypsum board; metal ceiling deck		
COMPONENT:	Doors & Hardware	RATING: 1 x WEIGHT: 6 = SCORE: 6	
	Appropriate hardware, closers, panic devices; in good working order		
COMMENTS:	Interior wood doors w HM frames; exterior HM doors/frames; OH metal doors

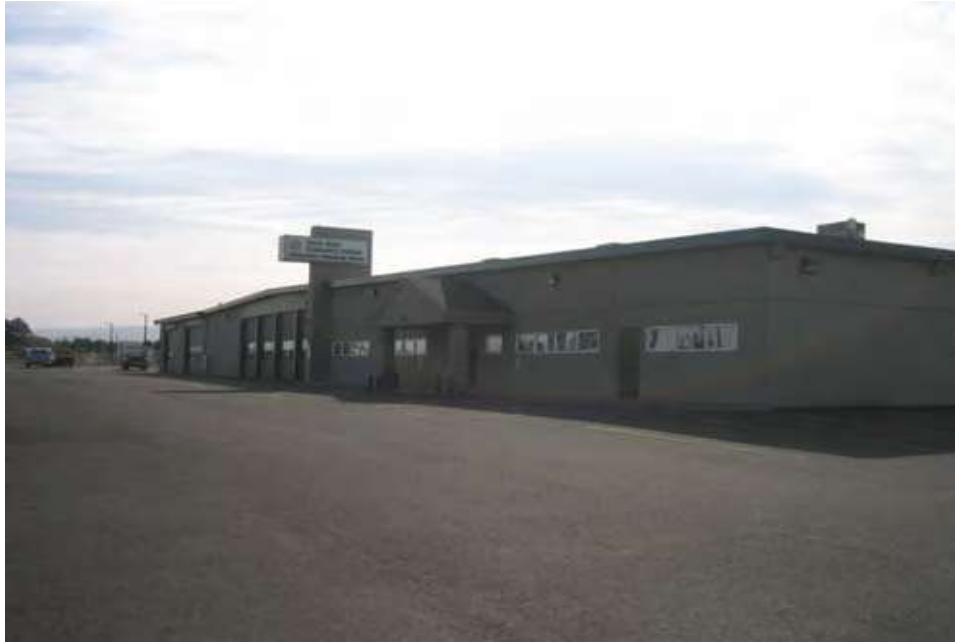
Auto Training Center (200-U) STATE UFI: A09856 Main Campus (200A)
AREA: 22,760 SF BUILT: 1958 REMODELED: No PREDOMINANT USE: Vocational Arts
CONSTRUCTION TYPE: Light CRV/SF: \$264 REPLACEMENT VALUE: \$6,008,640

Primary Systems			
COMPONENT:	Structure	RATING: 3 x WEIGHT: 8 =	SCORE: 24
Some cracking evident but does not likely affect structural integrity; Visible defects apparent but are non-structural			
COMMENTS:	Steel and wood framing; CMU; concrete slab; slab cracking throughout		
COMPONENT:	Exterior Closure	RATING: 2 x WEIGHT: 8 =	SCORE: 16
Weatherproof exterior, but finish appears poorly maintained			
COMMENTS:	CMU and metal panels		
COMPONENT:	Roofing	RATING: 3 x WEIGHT: 10 =	SCORE: 30
Some deterioration is evident in membrane and flashings; maintenance or minor repair is needed			
COMMENTS:	Metal roof with failing fasteners. North section single ply 2021.

Secondary Systems			
COMPONENT:	Floor Finishes	RATING: 3 x WEIGHT: 6 = SCORE: 18	
	Some physical wear and minor imperfections are evident; beginning deterioration		
COMMENTS:	Concrete; vinyl tile; sheet vinyl; concrete is cracked throughout		
COMPONENT:	Wall Finishes	RATING: 1 x WEIGHT: 6 = SCORE: 6	
	Maintainable surfaces in good condition		
COMMENTS:	Gypsum board; CMU; metal panels; plywood		
COMPONENT:	Ceiling Finishes	RATING: 1 x WEIGHT: 6 = SCORE: 6	
	Maintainable surfaces in good condition; good alignment and appearance		
COMMENTS:	Lay-in ceiling tile; acoustical tile; plywood; gypsum board		
COMPONENT:	Doors & Hardware	RATING: 1 x WEIGHT: 6 = SCORE: 6	
	Appropriate hardware, closers, panic devices; in good working order		
COMMENTS:	Interior wood and HM doors w HM frames; exterior aluminum and HM doors/frames; OH metal doors

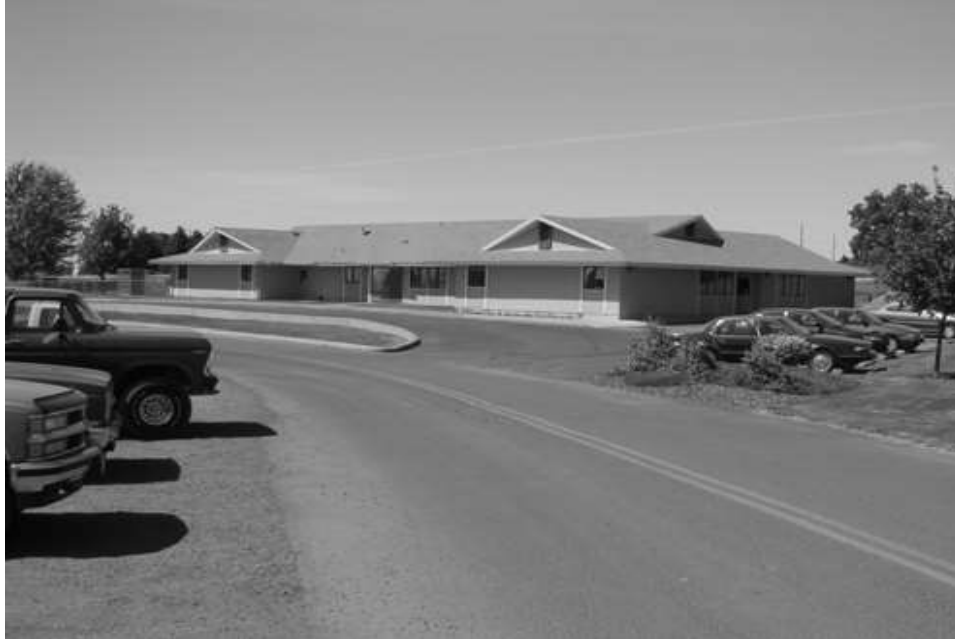
Child Care Center (200-K) STATE UFI: A03943 Main Campus (200A)
AREA: 3,295 SF BUILT: 1989 REMODELED: No PREDOMINANT USE: Child Care
CONSTRUCTION TYPE: Light CRV/SF: \$264 REPLACEMENT VALUE: \$869,880

Primary Systems			
COMPONENT:	Structure	RATING: 1 x WEIGHT: 8.3 =	SCORE: 8.3
No signs of settlement or cracking, no abrupt vertical changes Columns, bearing walls and roof structure appears sound/free of defects			
COMMENTS:	Wood framing; concrete slab		
COMPONENT:	Exterior Closure	RATING: 2 x WEIGHT: 8.3 =	SCORE: 16.7
Weatherproof exterior, but finish appears poorly maintained			
COMMENTS:	EIFS and wood siding-some wood deterioration		
COMPONENT:	Roofing	RATING: 2 x WEIGHT: 10.4 =	SCORE: 20.9
Majority of roofing and flashing appear sound, but a small portion of roofing shows deterioration where maintenance or minor repair needed			
COMMENTS:	New 3-tab asphalt shingles and gutters in 04

Secondary Systems			
COMPONENT:	Floor Finishes	RATING: 2 x WEIGHT: 6.3 = SCORE: 12.5	
	Some wear is evident on finish; maintenance needed		
COMMENTS:	Carpet-wearing; vinyl tile; sheet vinyl		
COMPONENT:	Wall Finishes	RATING: 2 x WEIGHT: 6.3 = SCORE: 12.5	
	Maintainable surfaces, minor maintenance is required in some areas		
COMMENTS:	Gypsum board; plastic wall panels		
COMPONENT:	Ceiling Finishes	RATING: 1 x WEIGHT: 6.3 = SCORE: 6.3	
	Maintainable surfaces in good condition; good alignment and appearance		
COMMENTS:	Gypsum board		
COMPONENT:	Doors & Hardware	RATING: 2 x WEIGHT: 6.3 = SCORE: 12.5	
	Fairly modern door surfaces and hardware with minor deterioration; good working order		
COMMENTS:	Interior wood doors w HM frames; exterior HM doors/frames

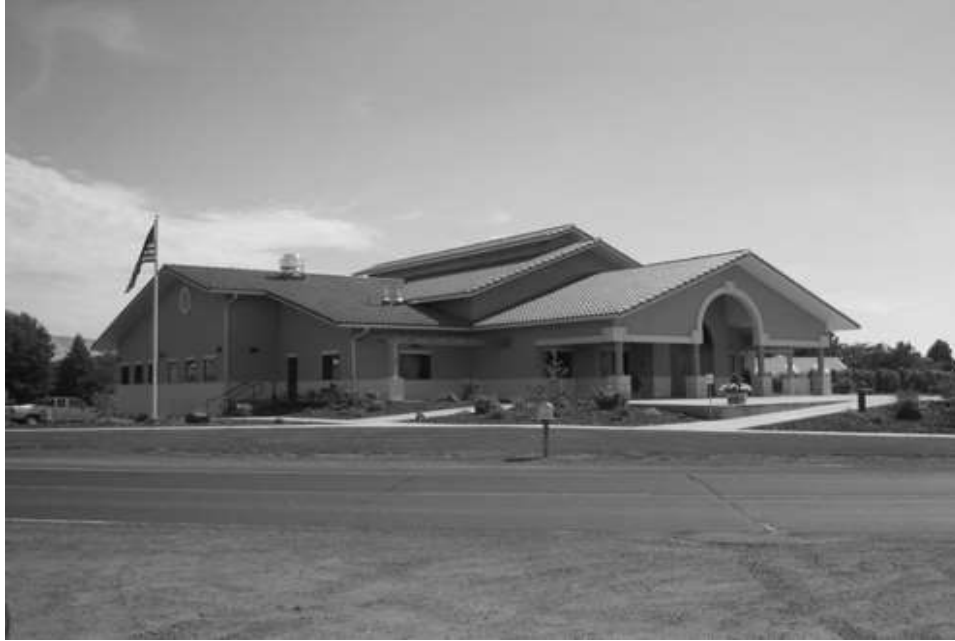
Cntr For Enology & Vitclt (200-T) STATE UFI: A09609 Main Campus (200A)
AREA: 15,000 SF BUILT: 2003 REMODELED: No PREDOMINANT USE: Special Program
CONSTRUCTION TYPE: Light CRV/SF: \$369 REPLACEMENT VALUE: \$5,535,000

Primary Systems			
COMPONENT:	Structure	RATING: 1 x WEIGHT: 8 =	SCORE: 8
No signs of settlement or cracking, no abrupt vertical changes Columns, bearing walls and roof structure appears sound/free of defects			
COMMENTS:	Wood framing w concrete slab		
COMPONENT:	Exterior Closure	RATING: 1 x WEIGHT: 8 =	SCORE: 8
Weatherproof, tight, well-maintained exterior walls, doors, windows/finishes			
COMMENTS:	EIFS		
COMPONENT:	Roofing	RATING: 1 x WEIGHT: 10 =	SCORE: 10
Flashing and penetrations appear sound and membrane appears water- tight; drainage is positive and there are overflow scuppers			
COMMENTS:	Clay tile

Secondary Systems			
COMPONENT:	Floor Finishes	RATING: 1 x WEIGHT: 6 = SCORE: 6	
	Nice appearance, smooth transitions, level subfloors, no cracks/separating		
COMMENTS:	Concrete; sheet vinyl; carpet; ceramic tile		
COMPONENT:	Wall Finishes	RATING: 1 x WEIGHT: 6 = SCORE: 6	
	Maintainable surfaces in good condition		
COMMENTS:	Concrete; Gypsum board; vinyl wall covering; ceramic tile		
COMPONENT:	Ceiling Finishes	RATING: 1 x WEIGHT: 6 = SCORE: 6	
	Maintainable surfaces in good condition; good alignment and appearance		
COMMENTS:	Concrete; Gypsum board; lay-in ceiling tiles; metal floor pan deck		
COMPONENT:	Doors & Hardware	RATING: 1 x WEIGHT: 6 = SCORE: 6	
	Appropriate hardware, closers, panic devices; in good working order		
COMMENTS:	Interior and exterior wood doors w HM frames and HM doors/frames

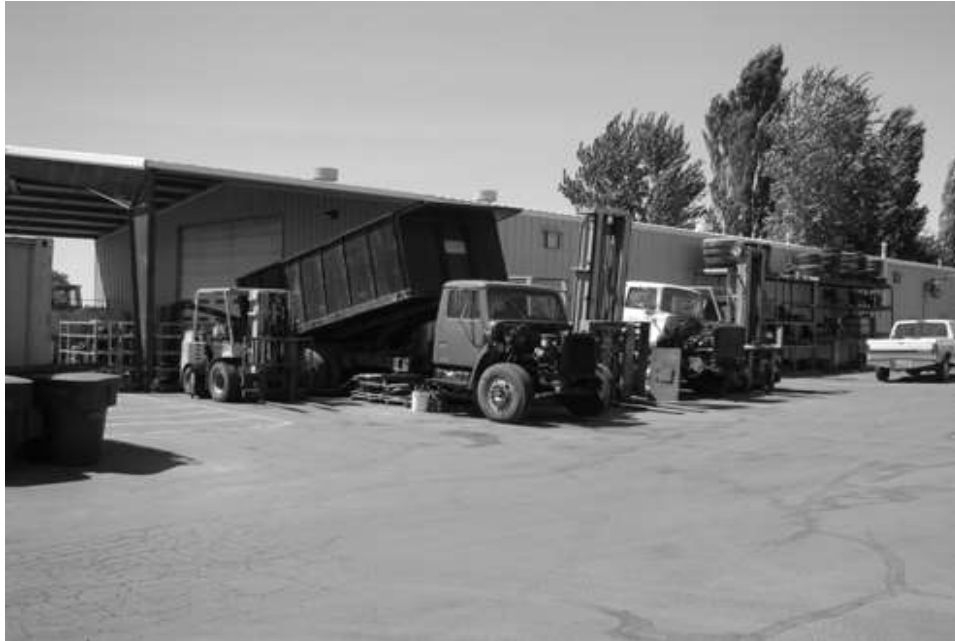
Diesel Mechanics 1 (200-L) STATE UFI: A01639 Main Campus (200A)
AREA: 10,080 SF BUILT: 1974 REMODELED: No PREDOMINANT USE: Vocational Arts
CONSTRUCTION TYPE: Light CRV/SF: \$395 REPLACEMENT VALUE: \$3,981,600

Primary Systems			
COMPONENT:	Structure	RATING: 1 x WEIGHT: 8.4 =	SCORE: 8.4
No signs of settlement or cracking, no abrupt vertical changes Columns, bearing walls and roof structure appears sound/free of defects			
COMMENTS:	No data		
COMPONENT:	Exterior Closure	RATING: 2 x WEIGHT: 8.4 =	SCORE: 16.8
Weatherproof exterior, but finish appears poorly maintained			
COMMENTS:	Metal walls		
COMPONENT:	Roofing	RATING: 1 x WEIGHT: 10.5 =	SCORE: 10.5
Flashing and penetrations appear sound and membrane appears water- tight; drainage is positive and there are overflow scuppers			
COMMENTS:	New metal roof 2011

Secondary Systems			
COMPONENT:	Floor Finishes	RATING: 2 x WEIGHT: 6.3 =	SCORE: 12.6
Some wear is evident on finish; maintenance needed			
COMMENTS:	Concrete and vinyl tile		
COMPONENT:	Wall Finishes	RATING: 2 x WEIGHT: 6.3 =	SCORE: 12.6
Maintainable surfaces, minor maintenance is required in some areas			
COMMENTS:	Gypsum board and CMU		
COMPONENT:	Ceiling Finishes	RATING: 2 x WEIGHT: 6.3 =	SCORE: 12.6
Aging surfaces in fair condition and good alignment			
COMMENTS:	Acoustical adhered and lay-in ceiling tile		
COMPONENT:	Doors & Hardware	RATING: 1 x WEIGHT: 6.3 =	SCORE: 6.3
Appropriate hardware, closers, panic devices; in good working order			
COMMENTS:	New OH doors 2013

Service Systems			
COMPONENT:	Elevators	RATING: 5 x WEIGHT: 6.3 =	SCORE: 31.5
No elevator access for upper floors			
COMMENTS:	second floor storage and office		
COMPONENT:	Plumbing	RATING: 3 x WEIGHT: 8.4 =	SCORE: 25.2
Fixtures are functional but dated; some leaks; maintenance required			
COMMENTS:	Galvanized, cast iron and steel piping; porcelain fixtures		
COMPONENT:	HVAC	RATING: 2 x WEIGHT: 8.4 =	SCORE: 16.8
Equipment in fair condition; minor deterioration; controls require troubleshooting; most areas have A/C; hazardous areas are ventilated			
COMMENTS:	Ceiling radiant heat-new in 2007; 2 FAG furnaces w A/C		
COMPONENT:	Electrical	RATING: 1 x WEIGHT: 8.4 =	SCORE: 8.4
Adequate service and distribution capacity for current/future needs			
COMMENTS:	600amp 208/120v		
COMPONENT:	Lights/Power	RATING: 1 x WEIGHT: 8.4 =	SCORE: 8.4
Contemporary lighting with good work area illumination; ample outlets			
COMMENTS:	Ceiling mount and hanging fluorescent lighting

Safety Systems			
COMPONENT:	Life/Safety	RATING: 3 x WEIGHT: 10.5 =	SCORE: 31.5
Generally meets codes for vintage of construction			
COMMENTS:			
COMPONENT:	Fire Safety	RATING: 2 x WEIGHT: 10.5 =	SCORE: 21
Locally monitored detection; alarm present, but missing visual component or sprinklers			
COMMENTS:	Partial sprinklers		
COMPONENT:	Modifications	RATING: 0 x WEIGHT: 0 =	SCORE: 0
No data			
COMMENTS:	None evident

Quality Standards			
COMPONENT:	Maintenance	RATING: 1 x WEIGHT: 7.4 =	SCORE: 7.4
Facility appears well maintained			
COMMENTS:			
COMPONENT:	Remaining Life	RATING: 1 x WEIGHT: 6.3 =	SCORE: 6.3
Life expectancy is >20 years; minor system deterioration			
COMMENTS:	Sound structure; should have 20-25 years of remaining life		
COMPONENT:	Appearance	RATING: 1 x WEIGHT: 6.3 =	SCORE: 6.3
Well-constructed building; generally attractive interior and exterior			
COMMENTS:

TOTAL SCORE = 293 PREVIOUS BIENNIUM SCORE = 301
CONDITION: Needs Improvement/Additional Maintenance

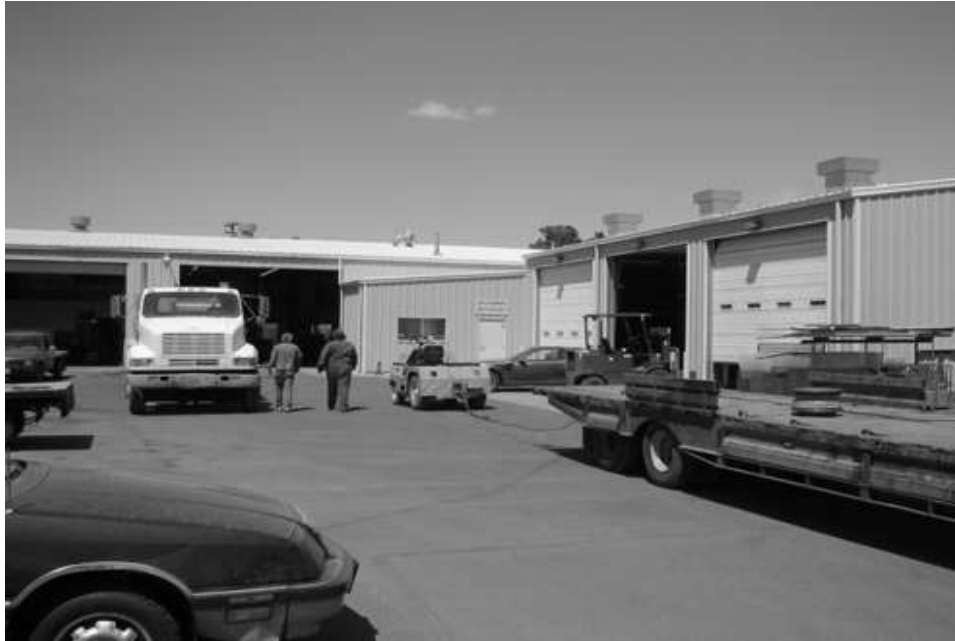
Diesel Mechanics 2 (200-M) STATE UFI: A04151 Main Campus (200A)
AREA: 13,172 SF BUILT: 1979 REMODELED: No PREDOMINANT USE: Vocational Arts
CONSTRUCTION TYPE: Light CRV/SF: \$395 REPLACEMENT VALUE: \$5,202,940

Primary Systems			
COMPONENT:	Structure	RATING: 1 x WEIGHT: 9.2 =	SCORE: 9.2
No signs of settlement or cracking, no abrupt vertical changes Columns, bearing walls and roof structure appears sound/free of defects			
COMMENTS:	Steel framing; concrete slab		
COMPONENT:	Exterior Closure	RATING: 1 x WEIGHT: 9.2 =	SCORE: 9.2
Weatherproof, tight, well-maintained exterior walls, doors, windows/finishes			
COMMENTS:	Metal walls		
COMPONENT:	Roofing	RATING: 1 x WEIGHT: 11.5 =	SCORE: 11.5
Flashing and penetrations appear sound and membrane appears water- tight; drainage is positive and there are overflow scuppers			
COMMENTS:	Metal roof 2011

Secondary Systems			
COMPONENT:	Floor Finishes	RATING: 2 x WEIGHT: 6.9 =	SCORE: 13.8
Some wear is evident on finish; maintenance needed			
COMMENTS:	Concrete and vinyl tile		
COMPONENT:	Wall Finishes	RATING: 3 x WEIGHT: 6.9 =	SCORE: 20.7
Aging surfaces, but sound; some maintenance is required			
COMMENTS:	Gypsum board and CMU		
COMPONENT:	Ceiling Finishes	RATING: 0 x WEIGHT: 0 =	SCORE: 0
No data			
COMMENTS:	Metal roof deck		
COMPONENT:	Doors & Hardware	RATING: 1 x WEIGHT: 6.9 =	SCORE: 6.9
Appropriate hardware, closers, panic devices; in good working order			
COMMENTS:	Interior/exterior HM doors/frames; OH doors 2012

Service Systems			
COMPONENT:	Elevators	RATING: 0 x WEIGHT: 0 =	SCORE: 0
No data			
COMMENTS:			
COMPONENT:	Plumbing	RATING: 2 x WEIGHT: 9.2 =	SCORE: 18.4
Fixtures and piping are functional; finishes require maintenance			
COMMENTS:	Copper, steel, cast iron and galvanized piping; new rest rooms in 04; new supply piping		
COMPONENT:	HVAC	RATING: 3 x WEIGHT: 9.2 =	SCORE: 27.6
System generally adequate; some deterioration; needs balancing; some areas have A/C; hazardous areas are ventilated			
COMMENTS:	Hanging unit heaters; ceiling radiant heat; paddle fans; new ventilation/exhaust system in 04		
COMPONENT:	Electrical	RATING: 2 x WEIGHT: 9.2 =	SCORE: 18.4
Adequate service and distribution capacity for current/future needs; some deterioration evident			
COMMENTS:	1000amp 208/120v		
COMPONENT:	Lights/Power	RATING: 3 x WEIGHT: 9.2 =	SCORE: 27.6
Adequate work area illumination; adequate outlets for current use; maintenance required

Quality Standards			
COMPONENT:	Maintenance	RATING: 1 x WEIGHT: 8 =	SCORE: 8
Facility appears well maintained			
COMMENTS:			
COMPONENT:	Remaining Life	RATING: 2 x WEIGHT: 6.9 =	SCORE: 13.8
Life expectancy is 15-20 years; minor to moderate system deterioration			
COMMENTS: Should have 20-25 years of remaining life; addition on east end built in 2001			
COMPONENT:	Appearance	RATING: 3 x WEIGHT: 6.9 =	SCORE: 20.7
Average construction; average interior and exterior appearance			
COMMENTS:

TOTAL SCORE = 316 PREVIOUS BIENNIUM SCORE = 316
CONDITION: Needs Improvement/Additional Maintenance

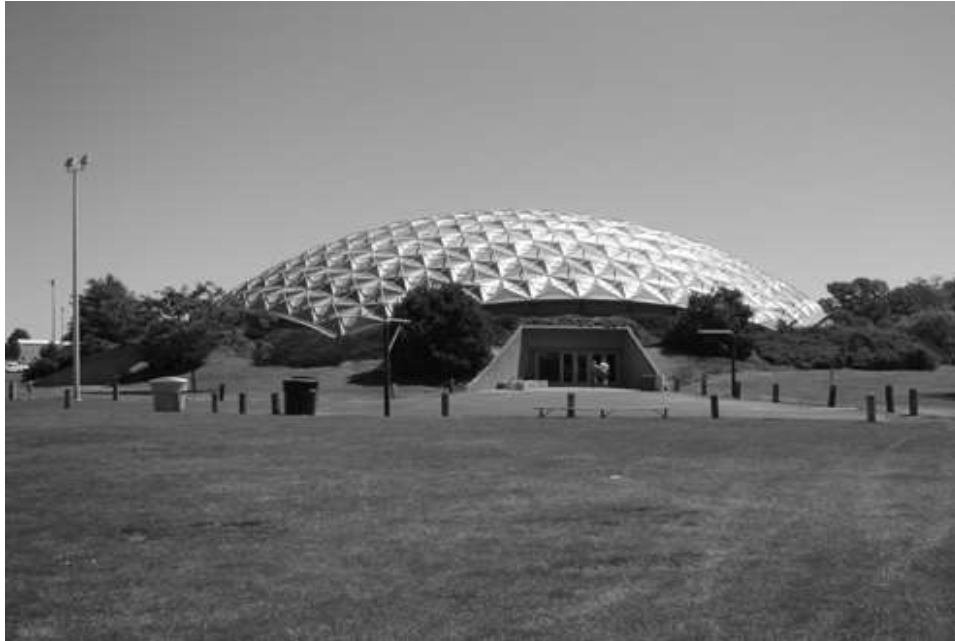
Dietrich Activity Center (200-A) STATE UFI: A00144 Main Campus (200A)
AREA: 38,500 SF BUILT: 1977 REMODELED: No PREDOMINANT USE: Gymnasium
CONSTRUCTION TYPE: Medium CRV/SF: \$349 REPLACEMENT VALUE: \$13,436,500

Primary Systems			
COMPONENT:	Structure	RATING: 1 x WEIGHT: 8 =	SCORE: 8
No signs of settlement or cracking, no abrupt vertical changes Columns, bearing walls and roof structure appears sound/free of defects			
COMMENTS:	Concrete; CMU; metal framing		
COMPONENT:	Exterior Closure	RATING: 1 x WEIGHT: 8 =	SCORE: 8
Weatherproof, tight, well-maintained exterior walls, doors, windows/finishes			
COMMENTS:	Concrete and CMU		
COMPONENT:	Roofing	RATING: 2 x WEIGHT: 10 =	SCORE: 20
Majority of roofing and flashing appear sound, but a small portion of roofing shows deterioration where maintenance or minor repair needed			
COMMENTS:	Aluminum roof panels-but high maintenance; panels re-caulked in 2008; connection bolt-packs funded 21-23

Secondary Systems			
COMPONENT:	Floor Finishes	RATING: 1 x WEIGHT: 6 =	SCORE: 6
Nice appearance, smooth transitions, level subfloors, no cracks/separating			
COMMENTS:	Concrete; wood; carpet; quarry tile		
COMPONENT:	Wall Finishes	RATING: 1 x WEIGHT: 6 =	SCORE: 6
Maintainable surfaces in good condition			
COMMENTS:	Concrete and CMU; ceramic tile		
COMPONENT:	Ceiling Finishes	RATING: 1 x WEIGHT: 6 =	SCORE: 6
Maintainable surfaces in good condition; good alignment and appearance			
COMMENTS:	Concrete and vinyl		
COMPONENT:	Doors & Hardware	RATING: 3 x WEIGHT: 6 =	SCORE: 18
Functional, but dated; some maintenance required			
COMMENTS:	Interior HM doors/frames; exterior glazed metal doors/frames-extensive wear

Service Systems			
COMPONENT:	Elevators	RATING: 3 x WEIGHT: 6 =	SCORE: 18
Elevators provided but functionality is inadequate; Unreliable operation			
COMMENTS:	2 stop		
COMPONENT:	Plumbing	RATING: 3 x WEIGHT: 8 =	SCORE: 24
Fixtures are functional but dated; some leaks; maintenance required			
COMMENTS:	Copper, steel, cast iron and galvanized piping-partially replaced in 2010; porcelain fixtures		
COMPONENT:	HVAC	RATING: 1 x WEIGHT: 8 =	SCORE: 8
Equipment in good condition; easily controlled; serves all required spaces; All necessary spaces are adequately ventilated; A/C provided throughout			
COMMENTS:	6 new AHUs connected to chiller in D building; 3 HW boilers; DX cooling; through ESCO contract in 2011		
COMPONENT:	Electrical	RATING: 1 x WEIGHT: 8 =	SCORE: 8
Adequate service and distribution capacity for current/future needs			
COMMENTS:	1600amp 480/277v; 1200amp 480/277v		
COMPONENT:	Lights/Power	RATING: 1 x WEIGHT: 8 =	SCORE: 8

Quality Standards			
COMPONENT:	Maintenance	RATING: 1 x WEIGHT: 7 = SCORE: 7	
	Facility appears well maintained		
COMMENTS:			
COMPONENT:	Remaining Life	RATING: 1 x WEIGHT: 6 = SCORE: 6	
	Life expectancy is >20 years; minor system deterioration		
COMMENTS:	Should have medium to long term life expectancy if properly maintained		
COMPONENT:	Appearance	RATING: 1 x WEIGHT: 6 = SCORE: 6	
	Well-constructed building; generally attractive interior and exterior		
COMMENTS:	Interesting exterior design

CONDITION: Adequate

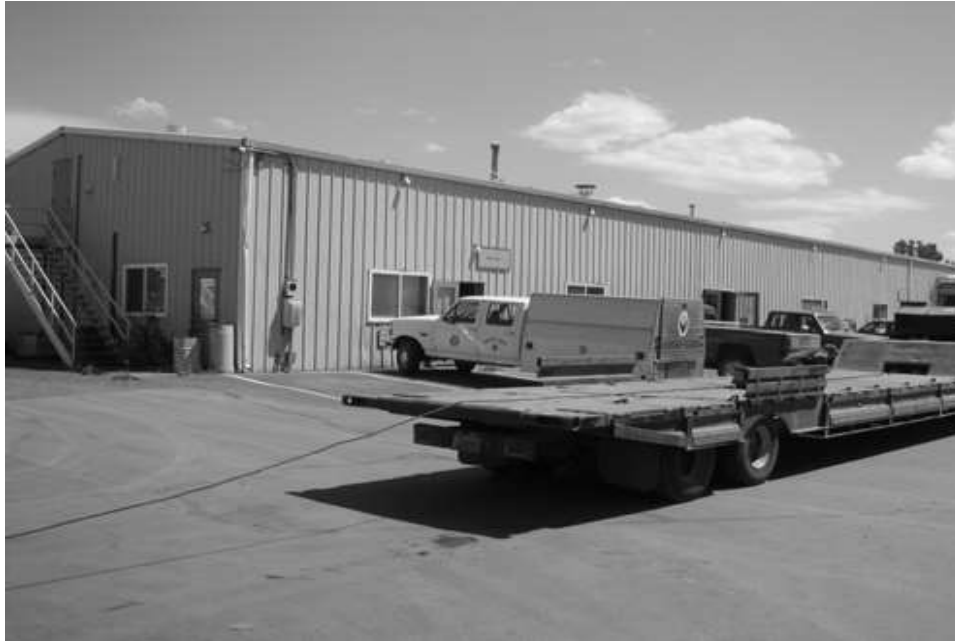
Farrier (200-N) STATE UFI: A00588 Main Campus (200A)
 AREA: 8,475 SF BUILT: 1975 REMODELED: No PREDOMINANT USE: Vocational Arts
 CONSTRUCTION TYPE: Light CRV/SF: \$369 REPLACEMENT VALUE: \$3,127,275

Primary Systems			
COMPONENT:	Structure	RATING: 1 x WEIGHT: 8.8 =	SCORE: 8.8
No signs of settlement or cracking, no abrupt vertical changes Columns, bearing walls and roof structure appears sound/free of defects			
COMMENTS:	Metal framing; concrete slab		
COMPONENT:	Exterior Closure	RATING: 3 x WEIGHT: 8.8 =	SCORE: 26.3
Sound and weatherproof but with some physical deterioration evident			
COMMENTS:	Metal walls-some random dents and rust		
COMPONENT:	Roofing	RATING: 3 x WEIGHT: 11 =	SCORE: 32.9
Some deterioration is evident in membrane and flashings; maintenance or minor repair is needed			
COMMENTS:	Metal roof has had rubberized coating applied

Secondary Systems			
COMPONENT:	Floor Finishes	RATING: 3 x WEIGHT: 6.6 = SCORE: 19.8	
	Some physical wear and minor imperfections are evident; beginning deterioration		
COMMENTS:	Concrete floors; vinyl tile; sheet vinyl;		
COMPONENT:	Wall Finishes	RATING: 1 x WEIGHT: 6.6 = SCORE: 6.6	
	Maintainable surfaces in good condition		
COMMENTS:	Gypsum board; plastic wall panels		
COMPONENT:	Ceiling Finishes	RATING: 1 x WEIGHT: 6.6 = SCORE: 6.6	
	Maintainable surfaces in good condition; good alignment and appearance		
COMMENTS:	Metal panels; gypsum board		
COMPONENT:	Doors & Hardware	RATING: 2 x WEIGHT: 6.6 = SCORE: 13.2	
	Fairly modern door surfaces and hardware with minor deterioration; good working order		
COMMENTS:	Interior/exterior HM doors/frames-some new in 04; OH metal doors

Service Systems			
COMPONENT:	Elevators	RATING: 0 x WEIGHT: 0 = SCORE: 0	
	No data		
COMMENTS:	2nd floor storage only		
COMPONENT:	Plumbing	RATING: 1 x WEIGHT: 8.8 = SCORE: 8.8	
	Fixtures and piping appear to be in good condition; no evidence of leaks		
COMMENTS:	New copper piping and fixtures in 04; cast iron, steel		
COMPONENT:	HVAC	RATING: 3 x WEIGHT: 8.8 = SCORE: 26.3	
	System generally adequate; some deterioration; needs balancing; some areas have A/C; hazardous areas are ventilated		
COMMENTS:	Gas fired unit heaters; 2 FAG furnaces w A/C; electric baseboard heat		
COMPONENT:	Electrical	RATING: 1 x WEIGHT: 8.8 = SCORE: 8.8	
	Adequate service and distribution capacity for current/future needs		
COMMENTS:	2 ea 250amp 208/120-new in 04; 600amp 208/120v main		
COMPONENT:	Lights/Power	RATING: 2 x WEIGHT: 8.8 = SCORE: 17.6	
	Contemporary lighting with good work area illumination; adequate number of outlets; some finishes appear aged

Quality Standards			
COMPONENT:	Maintenance	RATING: 1 x WEIGHT: 7.7 = SCORE: 7.7	
	Facility appears well maintained		
COMMENTS:			
COMPONENT:	Remaining Life	RATING: 1 x WEIGHT: 6.6 = SCORE: 6.6	
	Life expectancy is >20 years; minor system deterioration		
COMMENTS:	Sound structure; should have 20-25 years of remaining life		
COMPONENT:	Appearance	RATING: 3 x WEIGHT: 6.6 = SCORE: 19.8	
	Average construction; average interior and exterior appearance		
COMMENTS:	Upgraded interior

TOTAL SCORE = 315 PREVIOUS BIENNIUM SCORE = 324
CONDITION: Needs Improvement/Additional Maintenance

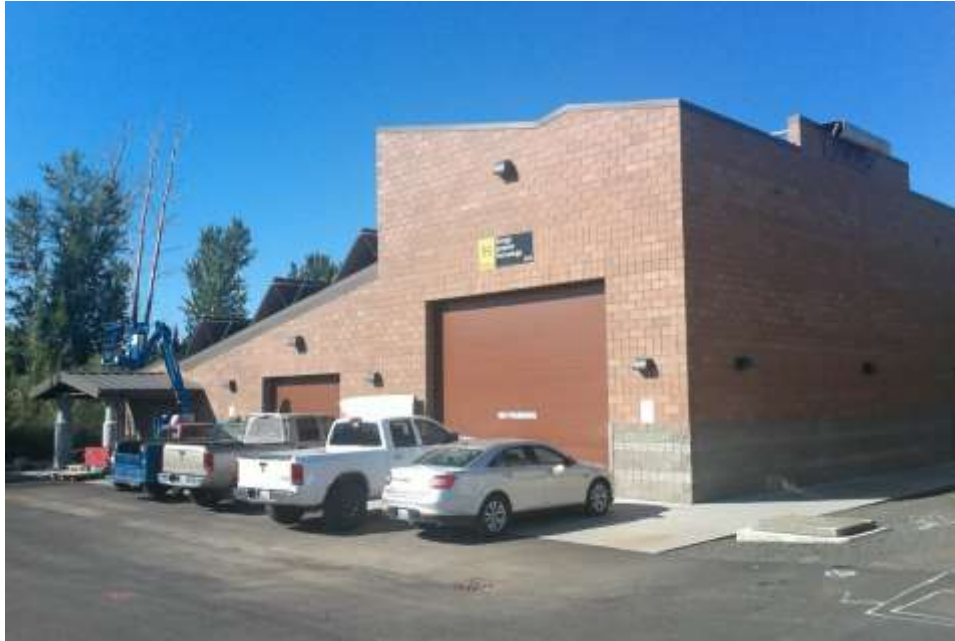
Health Ed Bldg. (200-H) STATE UFI: A01752 Main Campus (200A)
 AREA: 15,530 SF BUILT: 1977 REMODELED: 2012 PREDOMINANT USE: Classroom
 CONSTRUCTION TYPE: No data CRV/SF: \$356 REPLACEMENT VALUE: \$5,528,680

Primary Systems			
COMPONENT:	Structure	RATING: 1 x WEIGHT: 8.3 =	SCORE: 8.3
No signs of settlement or cracking, no abrupt vertical changes Columns, bearing walls and roof structure appears sound/free of defects			
COMMENTS:	No data		
COMPONENT:	Exterior Closure	RATING: 2 x WEIGHT: 8.3 =	SCORE: 16.7
Weatherproof exterior, but finish appears poorly maintained			
COMMENTS:	No data		
COMPONENT:	Roofing	RATING: 2 x WEIGHT: 10.4 =	SCORE: 20.9
Majority of roofing and flashing appear sound, but a small portion of roofing shows deterioration where maintenance or minor repair needed			
COMMENTS:	single-ply with insulation and solar panels

Secondary Systems			
COMPONENT:	Floor Finishes	RATING: 2 x WEIGHT: 6.3 =	SCORE: 12.5
Some wear is evident on finish; maintenance needed			
COMMENTS:	No data		
COMPONENT:	Wall Finishes	RATING: 2 x WEIGHT: 6.3 =	SCORE: 12.5
Maintainable surfaces, minor maintenance is required in some areas			
COMMENTS:	No data		
COMPONENT:	Ceiling Finishes	RATING: 1 x WEIGHT: 6.3 =	SCORE: 6.3
Maintainable surfaces in good condition; good alignment and appearance			
COMMENTS:	No data		
COMPONENT:	Doors & Hardware	RATING: 3 x WEIGHT: 6.3 =	SCORE: 18.8
Functional, but dated; some maintenance required			
COMMENTS:	No data

Service Systems			
COMPONENT:	Elevators	RATING: 0 x WEIGHT: 0 =	SCORE: 0
No data			
COMMENTS:	No data		
COMPONENT:	Plumbing	RATING: 1 x WEIGHT: 8.3 =	SCORE: 8.3
Fixtures and piping appear to be in good condition; no evidence of leaks			
COMMENTS:	No data		
COMPONENT:	HVAC	RATING: 2 x WEIGHT: 8.3 =	SCORE: 16.7
Equipment in fair condition; minor deterioration; controls require troubleshooting; most areas have A/C; hazardous areas are ventilated			
COMMENTS:	Condensing unit (failing) - funded 21-23		
COMPONENT:	Electrical	RATING: 1 x WEIGHT: 8.3 =	SCORE: 8.3
Adequate service and distribution capacity for current/future needs			
COMMENTS:	400Amp		
COMPONENT:	Lights/Power	RATING: 3 x WEIGHT: 8.3 =	SCORE: 25
Adequate work area illumination; adequate outlets for current use; maintenance required			
COMMENTS:	No data

Safety Systems			
COMPONENT:	Life/Safety	RATING: 3 x WEIGHT: 10.4 = SCORE: 31.3	
	Generally meets codes for vintage of construction		
COMMENTS:	No data		
COMPONENT:	Fire Safety	RATING: 2 x WEIGHT: 10.4 = SCORE: 20.9	
	Locally monitored detection; alarm present, but missing visual component or sprinklers		
COMMENTS:	No data		
COMPONENT:	Modifications	RATING: 1 x WEIGHT: 7.3 = SCORE: 7.3	
	Modifications appear to be in compliance with codes and sound construction practices; HVAC/electrical service properly provided		
COMMENTS:	East shop well done

Quality Standards			
COMPONENT:	Maintenance	RATING: 3 x WEIGHT: 7.3 = SCORE: 21.9	
	Routine maintenance is required; deferred maintenance is evident; impact is minor to moderate		
COMMENTS:	No data		
COMPONENT:	Remaining Life	RATING: 3 x WEIGHT: 6.3 = SCORE: 18.8	
	Life expectancy is roughly 10-15 years; moderate system deterioration		
COMMENTS:	No data		
COMPONENT:	Appearance	RATING: 3 x WEIGHT: 6.3 = SCORE: 18.8	
	Average construction; average interior and exterior appearance		
COMMENTS:	No data

CONDITION: Needs Improvement/Additional Maintenance

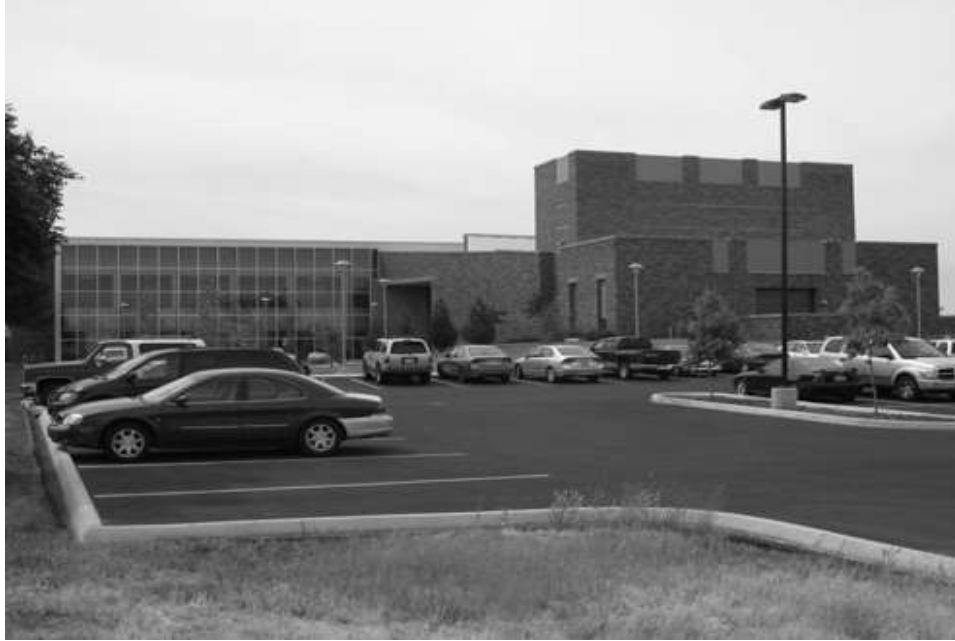
Health Sci/Performing Art (200-E) STATE UFI: A09551 Main Campus (200A)
AREA: 36,164 SF BUILT: 2007 REMODELED: No PREDOMINANT USE: Vocational Arts
CONSTRUCTION TYPE: Heavy CRV/SF: \$395 REPLACEMENT VALUE: \$14,284,780

Primary Systems			
COMPONENT:	Structure	RATING: 1 x WEIGHT: 8 =	SCORE: 8
No signs of settlement or cracking, no abrupt vertical changes Columns, bearing walls and roof structure appears sound/free of defects			
COMMENTS:	Steel frame; CMU; brick		
COMPONENT:	Exterior Closure	RATING: 1 x WEIGHT: 8 =	SCORE: 8
Weatherproof, tight, well-maintained exterior walls, doors, windows/finishes			
COMMENTS:	Brick; concrete; aluminum window walls		
COMPONENT:	Roofing	RATING: 1 x WEIGHT: 10 =	SCORE: 10
Flashing and penetrations appear sound and membrane appears water- tight; drainage is positive and there are overflow scuppers			
COMMENTS:	Single ply membrane-coated

Secondary Systems			
COMPONENT:	Floor Finishes	RATING: 1 x WEIGHT: 6 = SCORE: 6	
	Nice appearance, smooth transitions, level subfloors, no cracks/separating		
COMMENTS:	Vinyl tile; ceramic tile; concrete; carpet; hardwood stage floor		
COMPONENT:	Wall Finishes	RATING: 1 x WEIGHT: 6 = SCORE: 6	
	Maintainable surfaces in good condition		
COMMENTS:	Gypsum board; Masonite panels; concrete; brick; wood panels		
COMPONENT:	Ceiling Finishes	RATING: 1 x WEIGHT: 6 = SCORE: 6	
	Maintainable surfaces in good condition; good alignment and appearance		
COMMENTS:	Lay-in tiles; gypsum board		
COMPONENT:	Doors & Hardware	RATING: 1 x WEIGHT: 6 = SCORE: 6	
	Appropriate hardware, closers, panic devices; in good working order		
COMMENTS:	Interior wood doors w HM frames and sidelites; exterior aluminum doors/frames

Service Systems			
COMPONENT:	Elevators	RATING: 1 x WEIGHT: 6 = SCORE: 6	
	Appropriate and functional for occupancy and use		
COMMENTS:	2 stop		
COMPONENT:	Plumbing	RATING: 1 x WEIGHT: 8 = SCORE: 8	
	Fixtures and piping appear to be in good condition; no evidence of leaks		
COMMENTS:	Copper, cast iron, galvanized and steel piping ; porcelain fixtures		
COMPONENT:	HVAC	RATING: 1 x WEIGHT: 8 = SCORE: 8	
	Equipment in good condition; easily controlled; serves all required spaces; All necessary spaces are adequately ventilated; A/C provided throughout		
COMMENTS:	DX refrigeration w air cooled condensers; AHUs w VAVs; hot water boilers		
COMPONENT:	Electrical	RATING: 1 x WEIGHT: 8 = SCORE: 8	
	Adequate service and distribution capacity for current/future needs		
COMMENTS:	2000amp 120/208 v; 15 KW emergency generator		
COMPONENT:	Lights/Power	RATING: 1 x WEIGHT: 8 = SCORE: 8	
	Contemporary lighting with good work area illumination; ample outlets

Safety Systems			
COMPONENT:	Life/Safety	RATING: 1 x WEIGHT: 10 = SCORE: 10	
	Appears to meet current codes		
COMMENTS:			
COMPONENT:	Fire Safety	RATING: 1 x WEIGHT: 10 = SCORE: 10	
	Locally monitored detection; alarm and strobes present; sprinklers in high hazard areas		
COMMENTS:			
COMPONENT:	Modifications	RATING: 1 x WEIGHT: 7 = SCORE: 7	
	Modifications appear to be in compliance with codes and sound construction practices; HVAC/electrical service properly provided		
COMMENTS:	New building; none evident

Quality Standards			
COMPONENT:	Maintenance	RATING: 1 x WEIGHT: 7 = SCORE: 7	
	Facility appears well maintained		
COMMENTS:			
COMPONENT:	Remaining Life	RATING: 1 x WEIGHT: 6 = SCORE: 6	
	Life expectancy is >20 years; minor system deterioration		
COMMENTS:	Well-constructed building; RUL >30 yrs.		
COMPONENT:	Appearance	RATING: 3 x WEIGHT: 6 = SCORE: 18	
	Average construction; average interior and exterior appearance		
COMMENTS:	Very bright interior spaces; good use of light; exterior is somewhat bland

CONDITION: Superior
