2023 FACILITY CONDITION SURVEY

Walla Walla Community
College

SURVEY CONDUCTED BY:
Steve Lewandowski
State Board for Community
and Technical Colleges

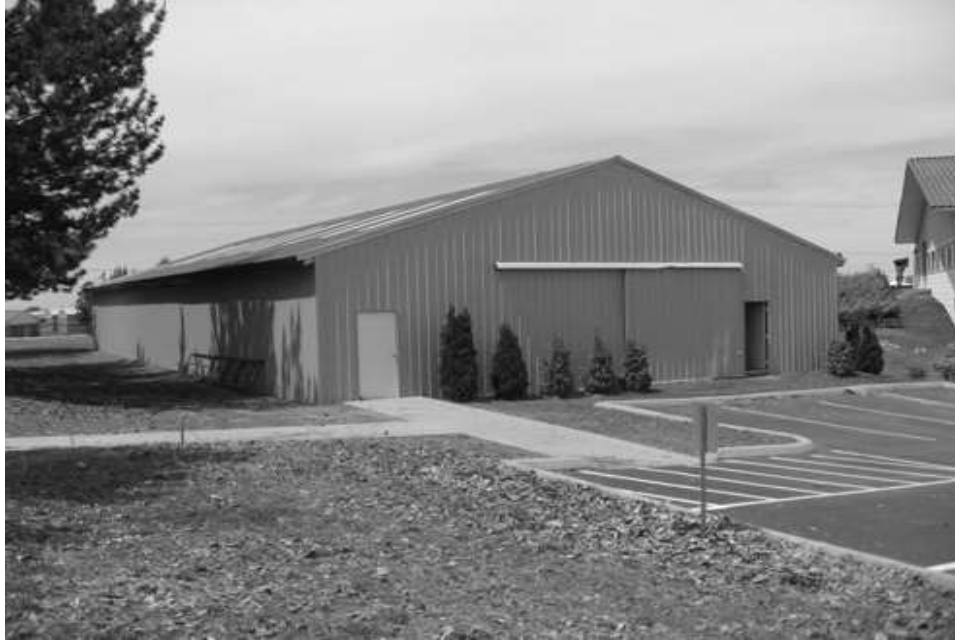
Hper Annex Hitting Fac (200-PEX) STATE UFI: A08489 Main Campus (200A)
 AREA: 5,500 SF BUILT: 1992 REMODELED: No PREDOMINANT USE: Baseball Practice
 CONSTRUCTION TYPE: Light CRV/SF: \$198 REPLACEMENT VALUE: \$1,089,000

Primary Systems			
COMPONENT:	Structure	RATING: 2 x WEIGHT: 9.3 =	SCORE: 18.5
Minor cracks evident in a small portion of the structure			
COMMENTS:	Wood frame; lots of water stained trusses		
COMPONENT:	Exterior Closure	RATING: 1 x WEIGHT: 9.3 =	SCORE: 9.3
Weatherproof, tight, well-maintained exterior walls, doors, windows/finishes			
COMMENTS:	Metal panels		
COMPONENT:	Roofing	RATING: 1 x WEIGHT: 11.6 =	SCORE: 11.6
Flashing and penetrations appear sound and membrane appears water- tight; drainage is positive and there are overflow scuppers			
COMMENTS:	Metal panels

Secondary Systems			
COMPONENT:	Floor Finishes	RATING: 3 x WEIGHT: 7 = SCORE: 20.9	
	Some physical wear and minor imperfections are evident; beginning deterioration		
COMMENTS:	Concrete		
COMPONENT:	Wall Finishes	RATING: 3 x WEIGHT: 7 = SCORE: 20.9	
	Aging surfaces, but sound; some maintenance is required		
COMMENTS:	Plywood; well-worn from use		
COMPONENT:	Ceiling Finishes	RATING: 0 x WEIGHT: 0 = SCORE: 0	
	No data		
COMMENTS:	Metal panels		
COMPONENT:	Doors & Hardware	RATING: 3 x WEIGHT: 7 = SCORE: 20.9	
	Functional, but dated; some maintenance required		
COMMENTS:	Exterior wood doors w HM frames

Service Systems			
COMPONENT:	Elevators	RATING: 0 x WEIGHT: 0 = SCORE: 0	
	No data		
COMMENTS:			
COMPONENT:	Plumbing	RATING: 0 x WEIGHT: 0 = SCORE: 0	
	No data		
COMMENTS:			
COMPONENT:	HVAC	RATING: 3 x WEIGHT: 9.3 = SCORE: 27.8	
	System generally adequate; some deterioration; needs balancing; some areas have A/C; hazardous areas are ventilated		
COMMENTS:	electric infra-red heaters; gas unit heater		
COMPONENT:	Electrical	RATING: 1 x WEIGHT: 9.3 = SCORE: 9.3	
	Adequate service and distribution capacity for current/future needs		
COMMENTS:	200amp 208/120v		
COMPONENT:	Lights/Power	RATING: 3 x WEIGHT: 9.3 = SCORE: 27.8	
	Adequate work area illumination; adequate outlets for current use; maintenance required		
COMMENTS:	Ceiling mount HPS lights

Safety Systems			
COMPONENT:	Life/Safety	RATING: 3 x WEIGHT: 11.6 =	SCORE: 34.8
Generally meets codes for vintage of construction			
COMMENTS:			
COMPONENT:	Fire Safety	RATING: 5 x WEIGHT: 11.6 =	SCORE: 57.9
Life safety or accessibility violations exist; Missing exit signs or extinguishers throughout; No alarm or sprinklers			
COMMENTS:			
COMPONENT:	Modifications	RATING: 3 x WEIGHT: 8.1 =	SCORE: 24.3
Some modifications lack code compliance; HVAC service not fully considered during renovation			
COMMENTS: None evident

Quality Standards			
COMPONENT:	Maintenance	RATING: 5 x WEIGHT: 8.1 =	SCORE: 40.6
General deterioration is evident; lack of adequate maintenance is evident; impact is moderate to severe			
COMMENTS:			
COMPONENT:	Remaining Life	RATING: 3 x WEIGHT: 7 =	SCORE: 20.9
Life expectancy is roughly 10-15 years; moderate system deterioration			
COMMENTS: May have 10 yr. life as current use or for storage			
COMPONENT:	Appearance	RATING: 3 x WEIGHT: 7 =	SCORE: 20.9
Average construction; average interior and exterior appearance			
COMMENTS:

CONDITION: Needs Improvement/Renovation

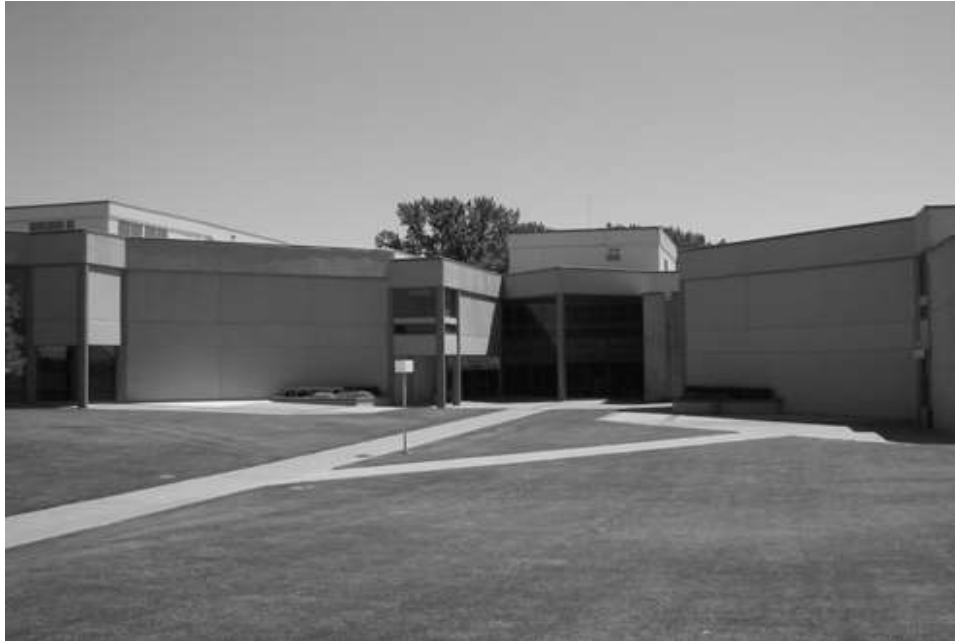
Main Building (200-D) STATE UFI: A02150 Main Campus (200A)
AREA: 226,348 SF BUILT: 1974 REMODELED: 2010 PREDOMINANT USE: Multi-Use
CONSTRUCTION TYPE: Heavy CRV/SF: \$395 REPLACEMENT VALUE: \$89,407,460

Primary Systems			
COMPONENT:	Structure	RATING: 2 x WEIGHT: 8 =	SCORE: 16
Minor cracks evident in a small portion of the structure			
COMMENTS:	Concrete column and beam; steel; CMU		
COMPONENT:	Exterior Closure	RATING: 1 x WEIGHT: 8 =	SCORE: 8
Weatherproof, tight, well-maintained exterior walls, doors, windows/finishes			
COMMENTS:	EIFS wall system; concrete		
COMPONENT:	Roofing	RATING: 2 x WEIGHT: 10 =	SCORE: 20
Majority of roofing and flashing appear sound, but a small portion of roofing shows deterioration where maintenance or minor repair needed			
COMMENTS:	TPO single-ply (50% of area 2015); EPDM; BUR w UV coating- ply

Secondary Systems			
COMPONENT:	Floor Finishes	RATING: 2 x WEIGHT: 6 = SCORE: 12	
	Some wear is evident on finish; maintenance needed		
COMMENTS:	Carpet; concrete; vinyl tile-random carpet wear throughout		
COMPONENT:	Wall Finishes	RATING: 1 x WEIGHT: 6 = SCORE: 6	
	Maintainable surfaces in good condition		
COMMENTS:	Concrete; gypsum board; CMU		
COMPONENT:	Ceiling Finishes	RATING: 3 x WEIGHT: 6 = SCORE: 18	
	Some wear and tear; Minor damage, staining or deterioration		
COMMENTS:	Lay-in ceiling tile; concrete; metal roof pan		
COMPONENT:	Doors & Hardware	RATING: 2 x WEIGHT: 6 = SCORE: 12	
	Fairly modern door surfaces and hardware with minor deterioration; good working order		
COMMENTS:	Interior wood veneer, laminate and HM metal doors w HM frames; exterior aluminum doors/frames and HM doors/frames

Service Systems			
COMPONENT:	Elevators	RATING: 2 x WEIGHT: 6 = SCORE: 12	
	Aged elevators functional, but deterioration or abuse of finishes is evident		
COMMENTS:	3 elevators-two 3 stop and one 2 stop		
COMPONENT:	Plumbing	RATING: 3 x WEIGHT: 8 = SCORE: 24	
	Fixtures are functional but dated; some leaks; maintenance required		
COMMENTS:	Copper, galvanized, cast iron, steel and PVC piping; porcelain fixtures		
COMPONENT:	HVAC	RATING: 2 x WEIGHT: 8 = SCORE: 16	
	Equipment in fair condition; minor deterioration; controls require troubleshooting; most areas have A/C; hazardous areas are ventilated		
COMMENTS:	2 HW boilers; 2 chillers-new in 2007; air handlers; rooftop packaged HVAC units; penthouse louver problems		
COMPONENT:	Electrical	RATING: 1 x WEIGHT: 8 = SCORE: 8	
	Adequate service and distribution capacity for current/future needs		
COMMENTS:	1600amp 480/277; 1800amp 208/120		
COMPONENT:	Lights/Power	RATING: 2 x WEIGHT: 8 = SCORE: 16

Safety Systems			
COMPONENT:	Life/Safety	RATING: 3 x WEIGHT: 10 =	SCORE: 30
Generally meets codes for vintage of construction			
COMMENTS:	Generally meets codes for vintage of construction		
COMPONENT:	Fire Safety	RATING: 1 x WEIGHT: 10 =	SCORE: 10
Locally monitored detection; alarm and strobes present; sprinklers in high hazard areas			
COMMENTS:	Building is partially sprinklered		
COMPONENT:	Modifications	RATING: 1 x WEIGHT: 7 =	SCORE: 7
Modifications appear to be in compliance with codes and sound construction practices; HVAC/electrical service properly provided			
COMMENTS:	Five major additions since 1974; modifications are adequate; minor renovations funded 21-23

Quality Standards			
COMPONENT:	Maintenance	RATING: 1 x WEIGHT: 7 =	SCORE: 7
Facility appears well maintained			
COMMENTS:			
COMPONENT:	Remaining Life	RATING: 1 x WEIGHT: 6 =	SCORE: 6
Life expectancy is >20 years; minor system deterioration			
COMMENTS:	Building is structurally very sound; medium to long term life expectancy		
COMPONENT:	Appearance	RATING: 3 x WEIGHT: 6 =	SCORE: 18
Average construction; average interior and exterior appearance			
COMMENTS:	Exterior is very average and nondescript

CONDITION: Needs Improvement/Additional Maintenance

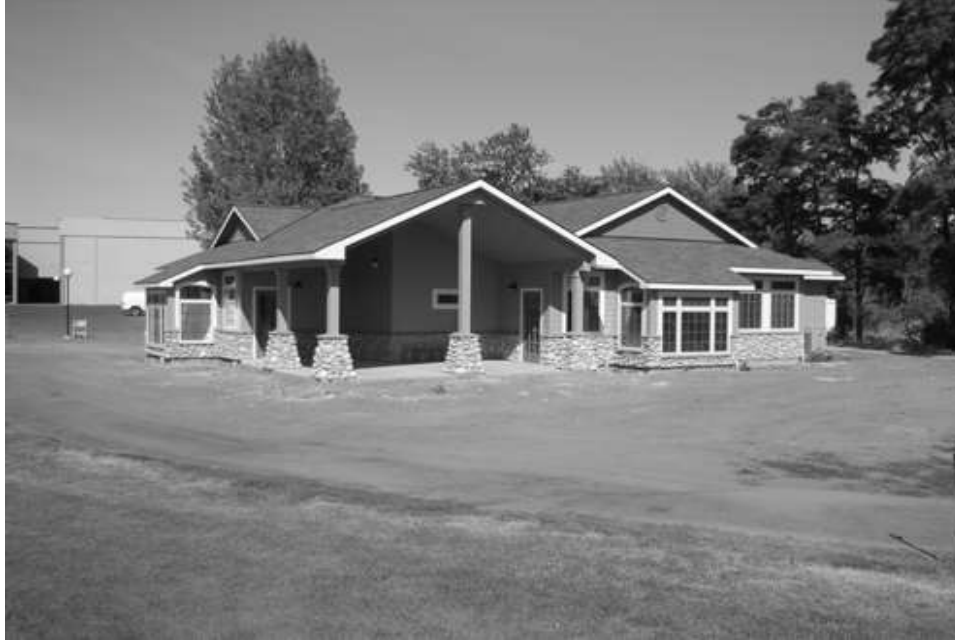
New Parent Child Center (200-B) STATE UFI: A00283 Main Campus (200A)
AREA: 2,500 SF BUILT: 2003 REMODELED: No PREDOMINANT USE: Parent Instruction
CONSTRUCTION TYPE: Light CRV/SF: \$264 REPLACEMENT VALUE: \$660,000

Primary Systems			
COMPONENT:	Structure	RATING: 1 x WEIGHT: 8.3 =	SCORE: 8.3
No signs of settlement or cracking, no abrupt vertical changes Columns, bearing walls and roof structure appears sound/free of defects			
COMMENTS:	Wood framing/Concrete footings/Raised foundation		
COMPONENT:	Exterior Closure	RATING: 1 x WEIGHT: 8.3 =	SCORE: 8.3
Weatherproof, tight, well-maintained exterior walls, doors, windows/finishes			
COMMENTS:	Hardie-Plank horizontal lap siding/river rock		
COMPONENT:	Roofing	RATING: 1 x WEIGHT: 10.4 =	SCORE: 10.4
Flashing and penetrations appear sound and membrane appears water- tight; drainage is positive and there are overflow scuppers			
COMMENTS:	3-tab architectural asphalt shingles

Secondary Systems			
COMPONENT:	Floor Finishes	RATING: 1 x WEIGHT: 6.3 = SCORE: 6.3	
	Nice appearance, smooth transitions, level subfloors, no cracks/separating		
COMMENTS:	Sheet vinyl/carpet/quarry tile		
COMPONENT:	Wall Finishes	RATING: 1 x WEIGHT: 6.3 = SCORE: 6.3	
	Maintainable surfaces in good condition		
COMMENTS:	Painted Gypsum board		
COMPONENT:	Ceiling Finishes	RATING: 1 x WEIGHT: 6.3 = SCORE: 6.3	
	Maintainable surfaces in good condition; good alignment and appearance		
COMMENTS:	Painted Gypsum board		
COMPONENT:	Doors & Hardware	RATING: 1 x WEIGHT: 6.3 = SCORE: 6.3	
	Appropriate hardware, closers, panic devices; in good working order		
COMMENTS:	Six panel fir and glazed fir interior doors w wood frames; glazed wood exterior doors

Service Systems			
COMPONENT:	Elevators	RATING: 0 x WEIGHT: 0 = SCORE: 0	
	No data		
COMMENTS:			
COMPONENT:	Plumbing	RATING: 1 x WEIGHT: 8.3 = SCORE: 8.3	
	Fixtures and piping appear to be in good condition; no evidence of leaks		
COMMENTS:	Copper steel, cast iron and PVC piping; porcelain fixtures		
COMPONENT:	HVAC	RATING: 2 x WEIGHT: 8.3 = SCORE: 16.7	
	Equipment in fair condition; minor deterioration; controls require troubleshooting; most areas have A/C; hazardous areas are ventilated		
COMMENTS:	High efficiency split system gas furnaces with A/C		
COMPONENT:	Electrical	RATING: 1 x WEIGHT: 8.3 = SCORE: 8.3	
	Adequate service and distribution capacity for current/future needs		
COMMENTS:	200amp 480/240v; 200amp 208/120v		
COMPONENT:	Lights/Power	RATING: 1 x WEIGHT: 8.3 = SCORE: 8.3	
	Contemporary lighting with good work area illumination; ample outlets		
COMMENTS:	Hanging, recessed can and ceiling-mount fluorescent lighting; Craftsman wall/hanging fixtures

CONDITION: Superior

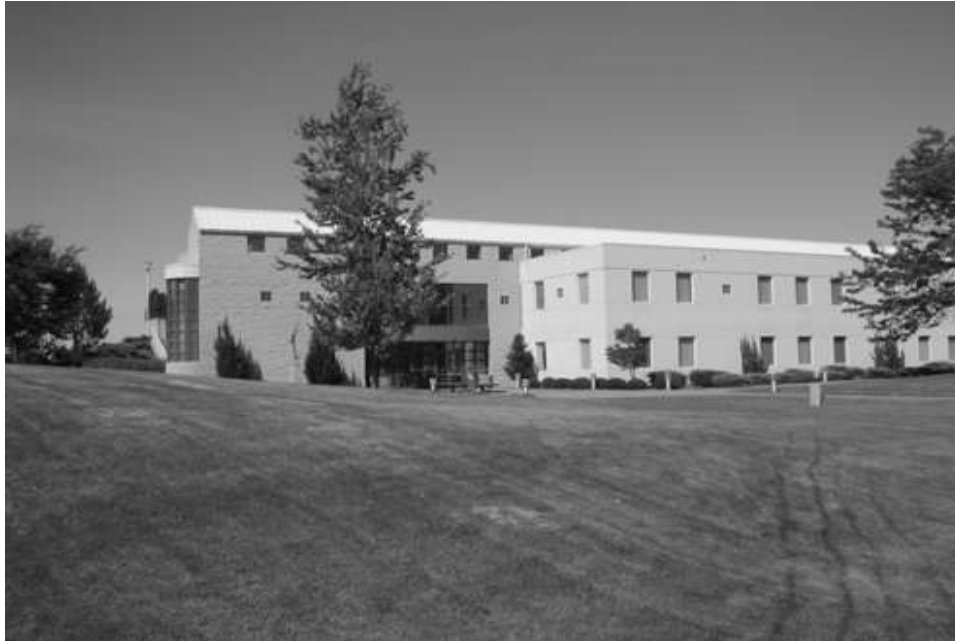
Technology Center (200-F) STATE UFI: A07510 Main Campus (200A)
AREA: 26,085 SF BUILT: 1991 REMODELED: No PREDOMINANT USE: General Classroom
CONSTRUCTION TYPE: Medium CRV/SF: \$376 REPLACEMENT VALUE: \$9,807,960

Primary Systems			
COMPONENT:	Structure	RATING: 1 x WEIGHT: 8.4 =	SCORE: 8.4
No signs of settlement or cracking, no abrupt vertical changes Columns, bearing walls and roof structure appears sound/free of defects			
COMMENTS:	Steel frame and CMU; concrete		
COMPONENT:	Exterior Closure	RATING: 2 x WEIGHT: 8.4 =	SCORE: 16.8
Weatherproof exterior, but finish appears poorly maintained			
COMMENTS:	CMU and EIFS		
COMPONENT:	Roofing	RATING: 1 x WEIGHT: 10.5 =	SCORE: 10.5
Flashing and penetrations appear sound and membrane appears water- tight; drainage is positive and there are overflow scuppers			
COMMENTS:	Metal roof; Hypalon roof

Secondary Systems			
COMPONENT:	Floor Finishes	RATING: 2 x WEIGHT: 6.3 = SCORE: 12.6	
	Some wear is evident on finish; maintenance needed		
COMMENTS:	Carpet-general wear; vinyl tile; ceramic tile; concrete		
COMPONENT:	Wall Finishes	RATING: 1 x WEIGHT: 6.3 = SCORE: 6.3	
	Maintainable surfaces in good condition		
COMMENTS:	CMU and painted Gypsum board; ceramic tile		
COMPONENT:	Ceiling Finishes	RATING: 2 x WEIGHT: 6.3 = SCORE: 12.6	
	Aging surfaces in fair condition and good alignment		
COMMENTS:	Lay-in ceiling tile and painted Gypsum board; metal deck pan		
COMPONENT:	Doors & Hardware	RATING: 2 x WEIGHT: 6.3 = SCORE: 12.6	
	Fairly modern door surfaces and hardware with minor deterioration; good working order		
COMMENTS:	Interior wood doors w HM frames; exterior aluminum doors/frames

CONDITION: Adequate

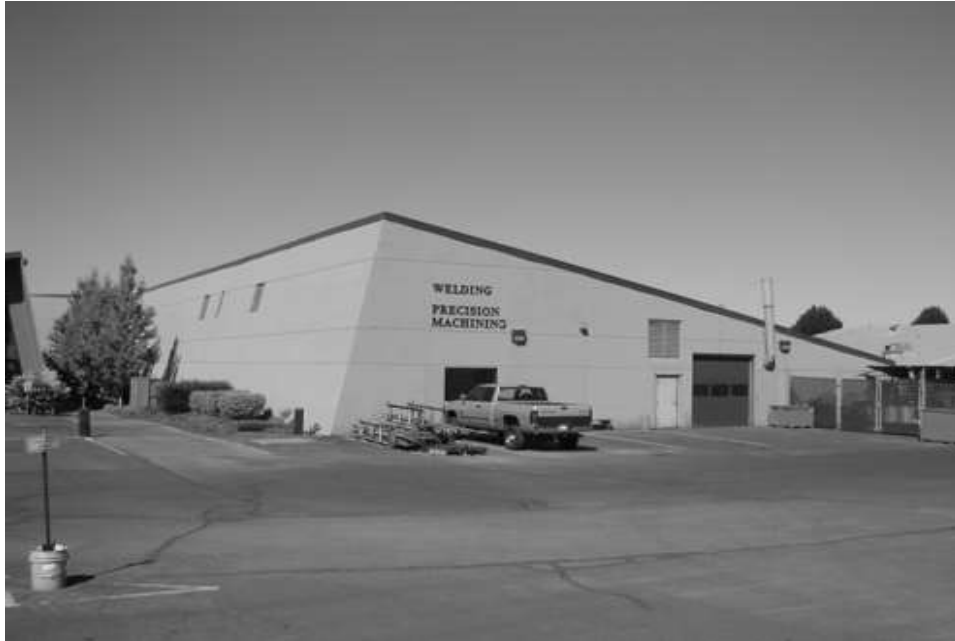
Vocational Technical (200-J) STATE UFI: A05479 Main Campus (200A)
 AREA: 55,819 SF BUILT: 1976 REMODELED: 2003 PREDOMINANT USE: Vocational Arts
 CONSTRUCTION TYPE: Medium CRV/SF: \$395 REPLACEMENT VALUE: \$22,048,505

Primary Systems			
COMPONENT:	Structure	RATING: 1 x WEIGHT: 8.3 =	SCORE: 8.3
No signs of settlement or cracking, no abrupt vertical changes Columns, bearing walls and roof structure appears sound/free of defects			
COMMENTS:	Tilt-up concrete; steel trusses; steel beams		
COMPONENT:	Exterior Closure	RATING: 2 x WEIGHT: 8.3 =	SCORE: 16.7
Weatherproof exterior, but finish appears poorly maintained			
COMMENTS:	Tilt-up concrete; CMU; EIFS-random cracking		
COMPONENT:	Roofing	RATING: 1 x WEIGHT: 10.4 =	SCORE: 10.4
Flashing and penetrations appear sound and membrane appears water- tight; drainage is positive and there are overflow scuppers			
COMMENTS:	BUR on Auto covered w PVC membrane in 09; Welding area new 2012

Secondary Systems			
COMPONENT:	Floor Finishes	RATING: 3 x WEIGHT: 6.3 =	SCORE: 18.8
Some physical wear and minor imperfections are evident; beginning deterioration			
COMMENTS:	Concrete; vinyl tile; carpet-random carpet deterioration		
COMPONENT:	Wall Finishes	RATING: 2 x WEIGHT: 6.3 =	SCORE: 12.5
Maintainable surfaces, minor maintenance is required in some areas			
COMMENTS:	Concrete and gypsum board		
COMPONENT:	Ceiling Finishes	RATING: 1 x WEIGHT: 6.3 =	SCORE: 6.3
Maintainable surfaces in good condition; good alignment and appearance			
COMMENTS:	Concrete and lay-in ceiling tile		
COMPONENT:	Doors & Hardware	RATING: 3 x WEIGHT: 6.3 =	SCORE: 18.8
Functional, but dated; some maintenance required			
COMMENTS:	Interior HM doors/frames; exterior aluminum doors/frames; metal OH doors

CONDITION: Needs Improvement/Additional Maintenance

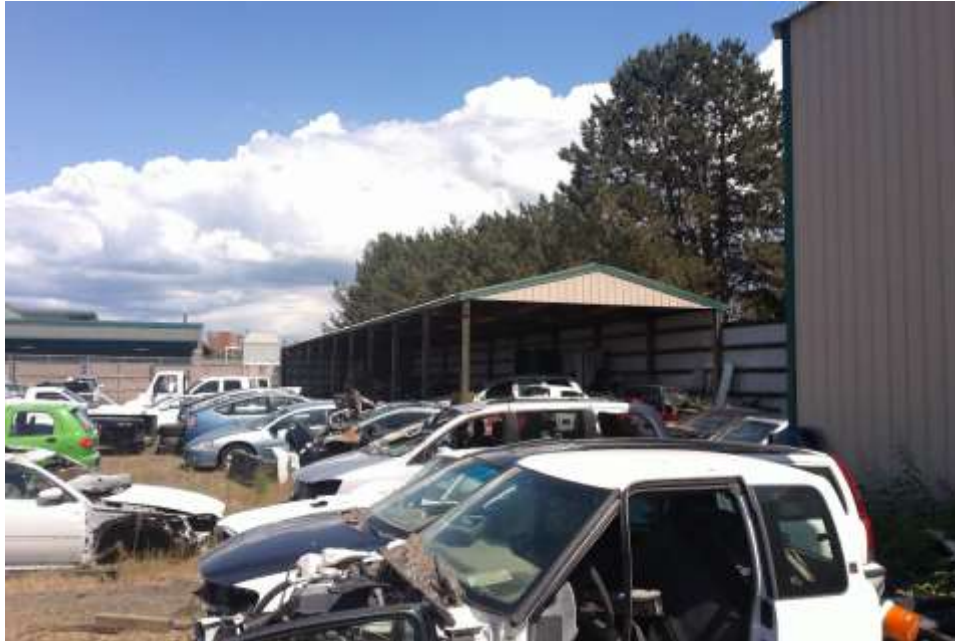
3 Wall Storage Shed (200-0) STATE UFI: A10311 Main Campus (200A)
AREA: 2,880 SF BUILT: 2001 REMODELED: No PREDOMINANT USE: Storage
CONSTRUCTION TYPE: No data CRV/SF: \$94 REPLACEMENT VALUE: \$270,720

Primary Systems			
COMPONENT:	Structure	RATING: 3 x WEIGHT: 19.1 =	SCORE: 57.4
Some cracking evident but does not likely affect structural integrity; Visible defects apparent but are non-structural			
COMMENTS:	No data		
COMPONENT:	Exterior Closure	RATING: 1 x WEIGHT: 19.1 =	SCORE: 19.1
Weatherproof, tight, well-maintained exterior walls, doors, windows/finishes			
COMMENTS:	No data		
COMPONENT:	Roofing	RATING: 2 x WEIGHT: 23.9 =	SCORE: 47.9
Majority of roofing and flashing appear sound, but a small portion of roofing shows deterioration where maintenance or minor repair needed			
COMMENTS:	No data

Secondary Systems			
COMPONENT:	Floor Finishes	RATING: 3 x WEIGHT: 14.4 =	SCORE: 43.1
Some physical wear and minor imperfections are evident; beginning deterioration			
COMMENTS:	No data		
COMPONENT:	Wall Finishes	RATING: 0 x WEIGHT: 0 =	SCORE: 0
No data			
COMMENTS:	No data		
COMPONENT:	Ceiling Finishes	RATING: 0 x WEIGHT: 0 =	SCORE: 0
No data			
COMMENTS:	No data		
COMPONENT:	Doors & Hardware	RATING: 0 x WEIGHT: 0 =	SCORE: 0
No data			
COMMENTS:	No data

CONDITION: Needs Improvement/Renovation

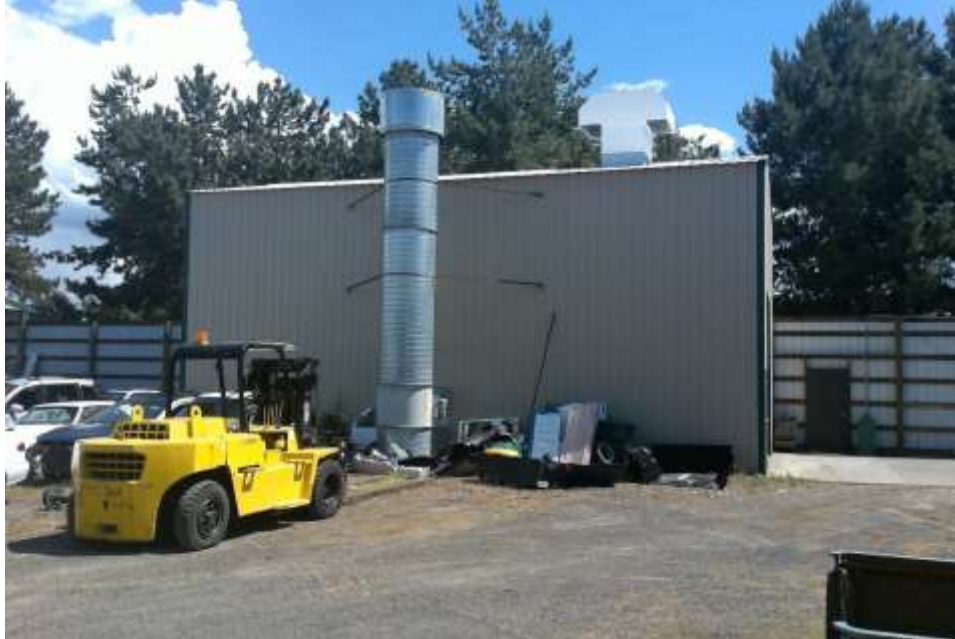
Auto Paint Booth (200-0) STATE UFI: A10958 Main Campus (200A)
AREA: 1,080 SF BUILT: 1999 REMODELED: No PREDOMINANT USE: Vocational
CONSTRUCTION TYPE: No data CRV/SF: \$419 REPLACEMENT VALUE: \$452,520

Primary Systems			
COMPONENT:	Structure	RATING: 1 x WEIGHT: 9.8 = SCORE: 9.8	
No signs of settlement or cracking, no abrupt vertical changes Columns, bearing walls and roof structure appears sound/free of defects			
COMMENTS:	No data		
COMPONENT:	Exterior Closure	RATING: 1 x WEIGHT: 9.8 = SCORE: 9.8	
Weatherproof, tight, well-maintained exterior walls, doors, windows/finishes			
COMMENTS:	No data		
COMPONENT:	Roofing	RATING: 3 x WEIGHT: 12.3 = SCORE: 36.8	
Some deterioration is evident in membrane and flashings; maintenance or minor repair is needed			
COMMENTS:	No data

Secondary Systems			
COMPONENT:	Floor Finishes	RATING: 3 x WEIGHT: 7.4 =	SCORE: 22.1
Some physical wear and minor imperfections are evident; beginning deterioration			
COMMENTS:	No data		
COMPONENT:	Wall Finishes	RATING: 3 x WEIGHT: 7.4 =	SCORE: 22.1
Aging surfaces, but sound; some maintenance is required			
COMMENTS:	No data		
COMPONENT:	Ceiling Finishes	RATING: 3 x WEIGHT: 7.4 =	SCORE: 22.1
Some wear and tear; Minor damage, staining or deterioration			
COMMENTS:	No data		
COMPONENT:	Doors & Hardware	RATING: 3 x WEIGHT: 7.4 =	SCORE: 22.1
Functional, but dated; some maintenance required			
COMMENTS:	No data
