2023 FACILITY CONDITION SURVEY

Wenatchee Valley College

SURVEY CONDUCTED BY:
Steve Lewandowski
State Board for Community
and Technical Colleges

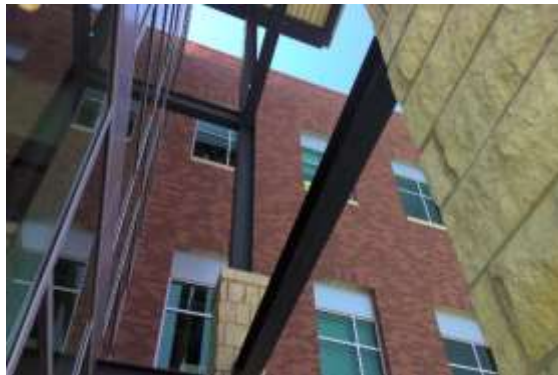
Deficiency F18

Carryover from prior survey : No
Location : Main Campus (150A)
Building name : Wenatchi Hall (150-Wti)
Unique Facility Identifier (UFI) : A06617
Funding category in capital budget : Minor Works Facility appropriation
Uniformat category : B20-Exterior Enclosure
Assessment : Asset should be repaired to extend its useful life
Quantity : 1
Unit of measurement : EA
Component : Siding
Location within building or site : Multiple
Issue clarity : Adequate information was provided to assess deficiency
Main cause of asset degradation or failure : Age/Wear
Detailed description : Several areas have degraded due to weather exposure. These areas require maintenance. The system should continue to be monitored for repair.
Recommended funding schedule : Fund in Next Biennium (scoring weight=2.5)
Estimated remaining life (years) : 5
Estimated average life expectancy (years) : 20
Scoring priority category 1 : High Repair/Repl. Cost (scoring weight=12)

Category 1 percentage : 70 %
Scoring priority category 2 : Quality of Use (scoring weight=5)
Category 2 percentage : 30 %
Project construction estimate (MACC): \$20,000
Total project estimate (including soft costs): \$28,000
Additional points based on building condition: 0
Deficiency score : $2.5 \times ((12 \times 70\%) + (5 \times 30\%)) + 0 = 24.8$

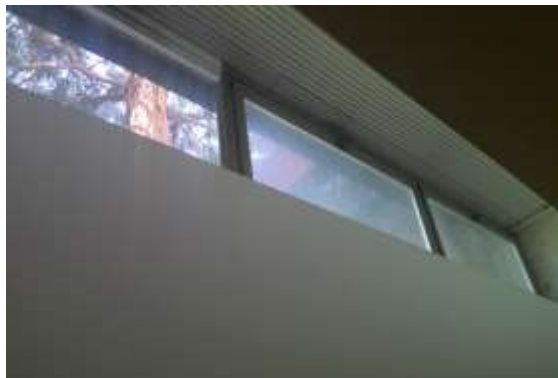
Deficiency F19

Carryover from prior survey : No
Location : Main Campus (150A)
Building name : Multiple (150A)
Unique Facility Identifier (UFI) : 150A
Funding category in capital budget : Minor Works Facility appropriation
Uniformat category : B20-Exterior Enclosure
Assessment : Asset is near or at the end of its useful life and should be replaced
Quantity : 13
Unit of measurement : EA
Component : Glazing
Location within building or site : Perimeter
Issue clarity : Adequate information was provided to assess deficiency
Main cause of asset degradation or failure : Age/Wear
Detailed description : There are several doors and window systems that have failed and should be replaced.
Recommended funding schedule : Immediate (scoring weight=4)
Estimated remaining life (years) : 3
Estimated average life expectancy (years) : 30
Scoring priority category 1 : System Use (scoring weight=15)
Category 1 percentage : 60 %
Scoring priority category 2 : High Repair/Repl. Cost (scoring weight=12)

Category 2 percentage : 40 %
Project construction estimate (MACC): \$50,000
Total project estimate (including soft costs): \$70,000
Additional points based on building condition: 0
Deficiency score : $4 \times ((15 \times 60\%) + (12 \times 40\%)) + 0 = 55.2$

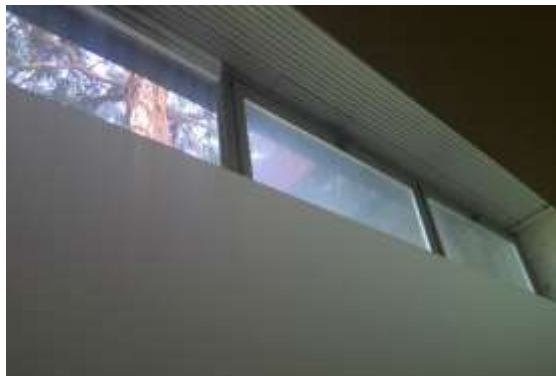
Deficiency F20

Carryover from prior survey : No
Location : Main Campus (150A)
Building name : Van Tassell (150-Vtc)
Unique Facility Identifier (UFI) : A00894
Funding category in capital budget : Minor Works Facility appropriation
Uniformat category : B20-Exterior Enclosure
Assessment : Asset is near or at the end of its useful life and should be replaced
Quantity : 16
Unit of measurement : EA
Component : Glazing
Location within building or site : Perimeter
Issue clarity : Adequate information was provided to assess deficiency
Main cause of asset degradation or failure : Age/Wear
Detailed description : Several windows have failed and should be replaced.
Recommended funding schedule : Immediate (scoring weight=4)
Estimated remaining life (years) : 3
Estimated average life expectancy (years) : 20
Scoring priority category 1 : System Use (scoring weight=15)
Category 1 percentage : 70 %
Scoring priority category 2 : High Repair/Repl. Cost (scoring weight=12)

Category 2 percentage : 30 %
Project construction estimate (MACC): \$30,000
Total project estimate (including soft costs): \$42,000
Additional points based on building condition: 1
Deficiency score : $4 \times ((15 \times 70\%) + (12 \times 30\%)) + 1 = 57.4$

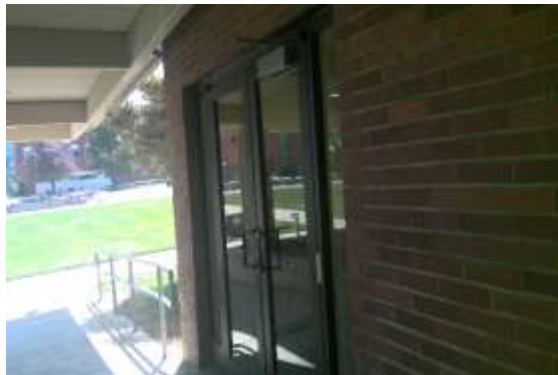
Deficiency F21

Carryover from prior survey : No
Location : Main Campus (150A)
Building name : Multiple (150A)
Unique Facility Identifier (UFI) : 150A
Funding category in capital budget : Minor Works Facility appropriation
Uniformat category : B20-Exterior Enclosure
Assessment : Asset is near or at the end of its useful life and should be replaced
Quantity : 14
Unit of measurement : EA
Component : Doors
Location within building or site : Perimeter
Issue clarity : Adequate information was provided to assess deficiency
Main cause of asset degradation or failure : Age/Wear
Detailed description : Doors and hinges on Eller Fox, Van Tassle, and Brown Library are failing due to age. These failing doors should be replaced.
Recommended funding schedule : Immediate (scoring weight=4)
Estimated remaining life (years) : 3
Estimated average life expectancy (years) : 25
Scoring priority category 1 : High Repair/Repl. Cost (scoring weight=12)

Category 1 percentage : 80 %
Scoring priority category 2 : High Operating Cost (scoring weight=10)
Category 2 percentage : 20 %
Project construction estimate (MACC): \$50,000
Total project estimate (including soft costs): \$70,000
Additional points based on building condition: 0
Deficiency score : $4 \times ((12 \times 80\%) + (10 \times 20\%)) + 0 = 46.4$

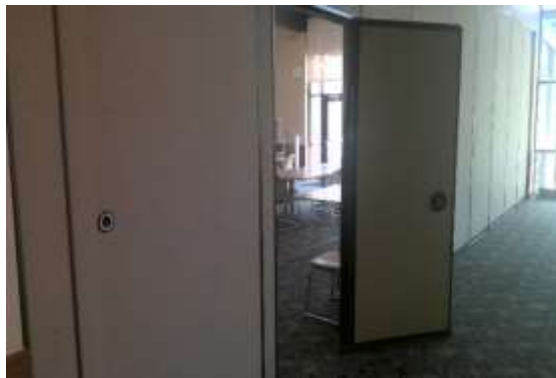
Deficiency F22

Carryover from prior survey : No
Location : Main Campus (150A)
Building name : Van Tassell (150-Vtc)
Unique Facility Identifier (UFI) : A00894
Funding category in capital budget : Minor Works Facility appropriation
Uniformat category : C30-Interior Finishes
Assessment : Asset is near or at the end of its useful life and should be replaced
Quantity : 1
Unit of measurement : EA
Component : Partition wall system
Location within building or site : 1st floor
Issue clarity : Adequate information was provided to assess deficiency
Main cause of asset degradation or failure : Age/Wear
Detailed description : The partition wall has degraded and no longer closes. The system should be replaced.
Recommended funding schedule : Immediate (scoring weight=4)
Estimated remaining life (years) : 3
Estimated average life expectancy (years) : 20
Scoring priority category 1 : System Use (scoring weight=15)
Category 1 percentage : 80 %

Scoring priority category 2 : High Repair/Repl. Cost (scoring weight=12)
Category 2 percentage : 20 %
Project construction estimate (MACC): \$40,000
Total project estimate (including soft costs): \$56,000
Additional points based on building condition: 1
Deficiency score : $4 \times ((15 \times 80\%) + (12 \times 20\%)) + 1 = 58.6$

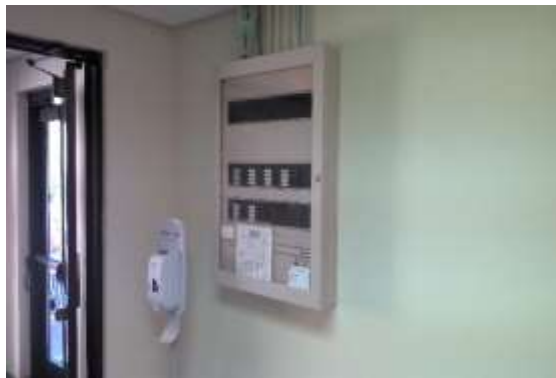
Deficiency F23

Carryover from prior survey : No
Location : North Campus (150B)
Building name : Wendall George Hall (150-Wgh)
Unique Facility Identifier (UFI) : A01911
Funding category in capital budget : Minor Works Facility appropriation
Uniformat category : D40-Fire Protection
Assessment : Asset is near or at the end of its useful life and should be replaced
Quantity : 1
Unit of measurement : EA
Component : Fire alarm control panel
Location within building or site : 1st floor
Issue clarity : Adequate information was provided to assess deficiency
Main cause of asset degradation or failure : Age/Wear
Detailed description : The fire alarm panel is beyond its expected life and should be replaced.
Recommended funding schedule : Immediate (scoring weight=4)
Estimated remaining life (years) : 3
Estimated average life expectancy (years) : 15
Scoring priority category 1 : System Use (scoring weight=15)
Category 1 percentage : 70 %

Scoring priority category 2 : Health/Safety (scoring weight=25)
Category 2 percentage : 30 %
Project construction estimate (MACC): \$30,000
Total project estimate (including soft costs): \$42,000
Additional points based on building condition: 1
Deficiency score : $4 \times ((15 \times 70\%) + (25 \times 30\%)) + 1 = 73$

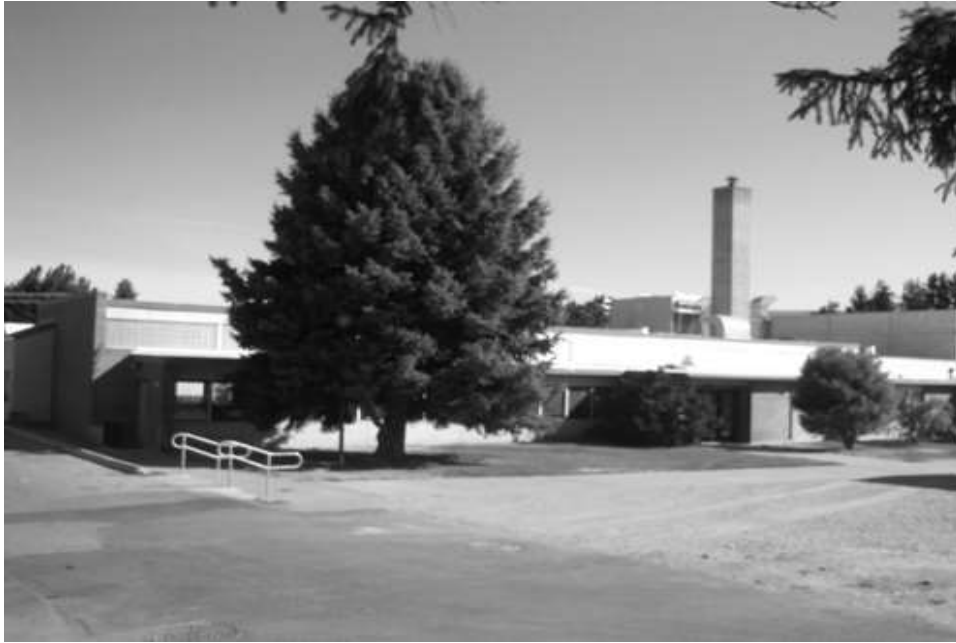
Batjer (150-BTJ) STATE UFI: A04052 Main Campus (150A)
AREA: 40,784 SF BUILT: 1950 REMODELED: No PREDOMINANT USE: Multi-Use
CONSTRUCTION TYPE: Medium CRV/SF: \$395 REPLACEMENT VALUE: \$16,109,680

Primary Systems			
COMPONENT:	Structure	RATING: 3 x WEIGHT: 8 =	SCORE: 24
Some cracking evident but does not likely affect structural integrity; Visible defects apparent but are non-structural			
COMMENTS:	Concrete; steel framing; concrete slab		
COMPONENT:	Exterior Closure	RATING: 3 x WEIGHT: 8 =	SCORE: 24
Sound and weatherproof but with some physical deterioration evident			
COMMENTS:	Concrete; brick		
COMPONENT:	Roofing	RATING: 3 x WEIGHT: 10 =	SCORE: 30
Some deterioration is evident in membrane and flashings; maintenance or minor repair is needed			
COMMENTS:	Hypalon single-ply/cap sheet; concrete parapet replacement in 08

Secondary Systems			
COMPONENT:	Floor Finishes	RATING: 4 x WEIGHT: 6 =	SCORE: 24
General deterioration evident; one-third to one-half of flooring exhibits extensive deterioration			
COMMENTS:	Vinyl tile; concrete; carpet		
COMPONENT:	Wall Finishes	RATING: 3 x WEIGHT: 6 =	SCORE: 18
Aging surfaces, but sound; some maintenance is required			
COMMENTS:	CMU; gypsum board; ceramic tile; concrete		
COMPONENT:	Ceiling Finishes	RATING: 3 x WEIGHT: 6 =	SCORE: 18
Some wear and tear; Minor damage, staining or deterioration			
COMMENTS:	Lay-in tile; direct-adhered tile; gypsum board; metal roof deck		
COMPONENT:	Doors & Hardware	RATING: 4 x WEIGHT: 6 =	SCORE: 24
General deterioration evident in both door and hardware; some doors with significant deterioration			
COMMENTS:	Interior wood/HM doors/HM frames; exterior metal frame glazed doors; metal OH doors

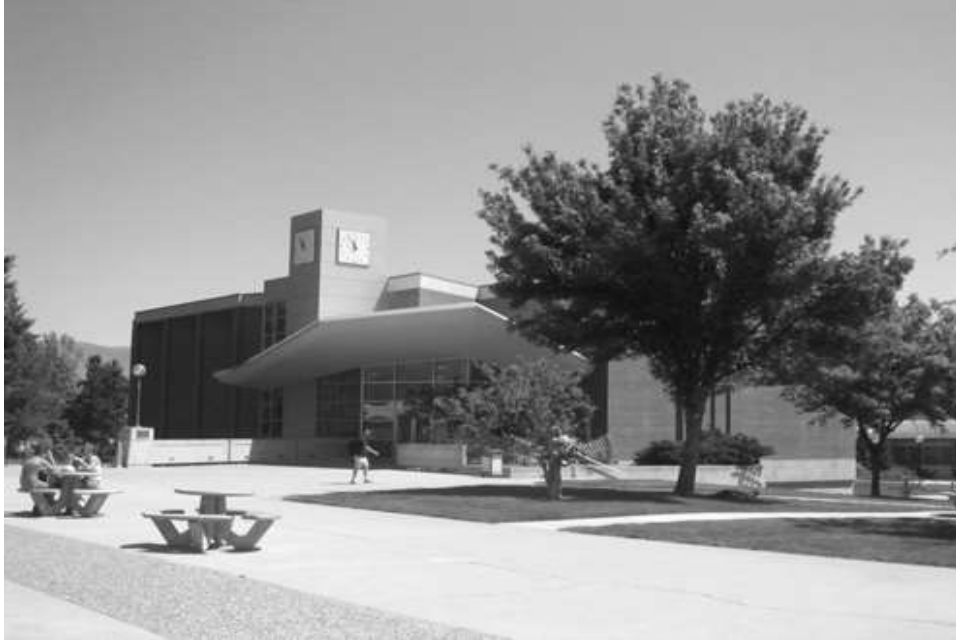
Brown Library (150-BLM) STATE UFI: A02712 Main Campus (150A)
AREA: 33,756 SF BUILT: 1972 REMODELED: 2010 PREDOMINANT USE: Library
CONSTRUCTION TYPE: Heavy CRV/SF: \$376 REPLACEMENT VALUE: \$12,692,256

Primary Systems			
COMPONENT:	Structure	RATING: 2 x WEIGHT: 8 =	SCORE: 16
Minor cracks evident in a small portion of the structure			
COMMENTS: Poured concrete; brick; steel; concrete columns			
COMPONENT:	Exterior Closure	RATING: 2 x WEIGHT: 8 =	SCORE: 16
Weatherproof exterior, but finish appears poorly maintained			
COMMENTS: Brick; concrete; aluminum window walls			
COMPONENT:	Roofing	RATING: 1 x WEIGHT: 10 =	SCORE: 10
Flashing and penetrations appear sound and membrane appears water- tight; drainage is positive and there are overflow scuppers			
COMMENTS: New TPO single-ply membrane installed in 2011

Secondary Systems			
COMPONENT:	Floor Finishes	RATING: 2 x WEIGHT: 6 =	SCORE: 12
Some wear is evident on finish; maintenance needed			
COMMENTS:	Carpet tile; concrete; vinyl tile; sheet vinyl		
COMPONENT:	Wall Finishes	RATING: 2 x WEIGHT: 6 =	SCORE: 12
Maintainable surfaces, minor maintenance is required in some areas			
COMMENTS:	Brick and gypsum board		
COMPONENT:	Ceiling Finishes	RATING: 1 x WEIGHT: 6 =	SCORE: 6
Maintainable surfaces in good condition; good alignment and appearance			
COMMENTS:	Gypsum board; lay-in tile		
COMPONENT:	Doors & Hardware	RATING: 1 x WEIGHT: 6 =	SCORE: 6
Appropriate hardware, closers, panic devices; in good working order			
COMMENTS:	Interior laminate\wood doors w HM\wood frames; exterior aluminum doors/frames

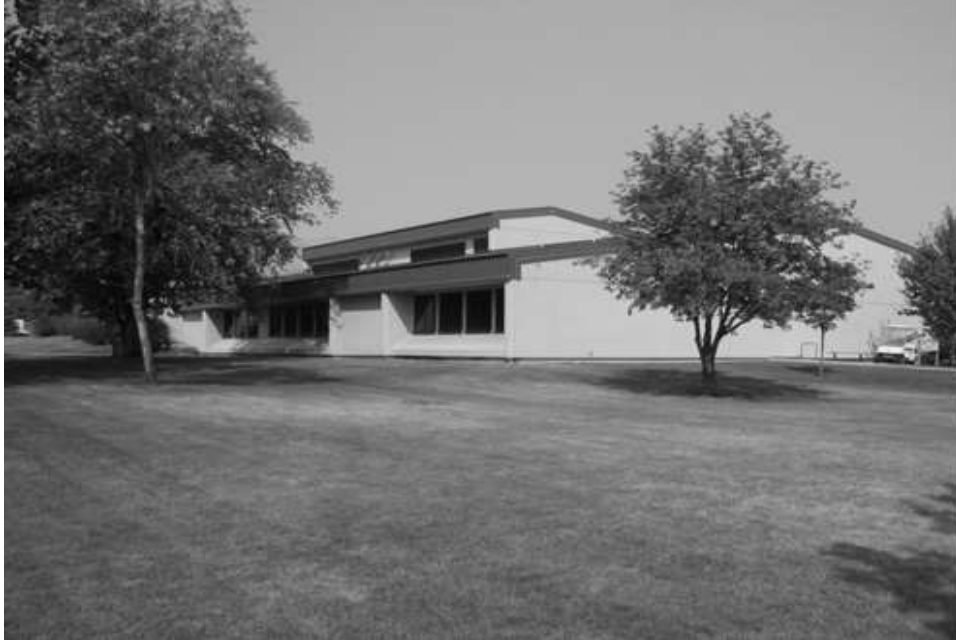
Eller/Fox (150-EFS) STATE UFI: A00748 Main Campus (150A)
 AREA: 16,200 SF BUILT: 1988 REMODELED: No PREDOMINANT USE: Science Lab.
 CONSTRUCTION TYPE: Medium CRV/SF: \$489 REPLACEMENT VALUE: \$7,921,800

Primary Systems			
COMPONENT:	Structure	RATING: 1 x WEIGHT: 8.3 =	SCORE: 8.3
No signs of settlement or cracking, no abrupt vertical changes Columns, bearing walls and roof structure appears sound/free of defects			
COMMENTS:	CMU; concrete		
COMPONENT:	Exterior Closure	RATING: 2 x WEIGHT: 8.3 =	SCORE: 16.7
Weatherproof exterior, but finish appears poorly maintained			
COMMENTS:	CMU; EIFS; metal panels		
COMPONENT:	Roofing	RATING: 1 x WEIGHT: 10.4 =	SCORE: 10.4
Flashing and penetrations appear sound and membrane appears water- tight; drainage is positive and there are overflow scuppers			
COMMENTS:	Standing seam metal roof

Secondary Systems			
COMPONENT:	Floor Finishes	RATING: 3 x WEIGHT: 6.3 = SCORE: 18.8	
	Some physical wear and minor imperfections are evident; beginning deterioration		
COMMENTS:	Carpet-random deterioration; vinyl tile; sheet vinyl; concrete; ceramic tile		
COMPONENT:	Wall Finishes	RATING: 1 x WEIGHT: 6.3 = SCORE: 6.3	
	Maintainable surfaces in good condition		
COMMENTS:	CMU; gypsum board; ceramic tile		
COMPONENT:	Ceiling Finishes	RATING: 3 x WEIGHT: 6.3 = SCORE: 18.8	
	Some wear and tear; Minor damage, staining or deterioration		
COMMENTS:	Lay-in tile throughout		
COMPONENT:	Doors & Hardware	RATING: 3 x WEIGHT: 6.3 = SCORE: 18.8	
	Functional, but dated; some maintenance required		
COMMENTS:	Interior laminate doors w HM frames; exterior HM doors/frames

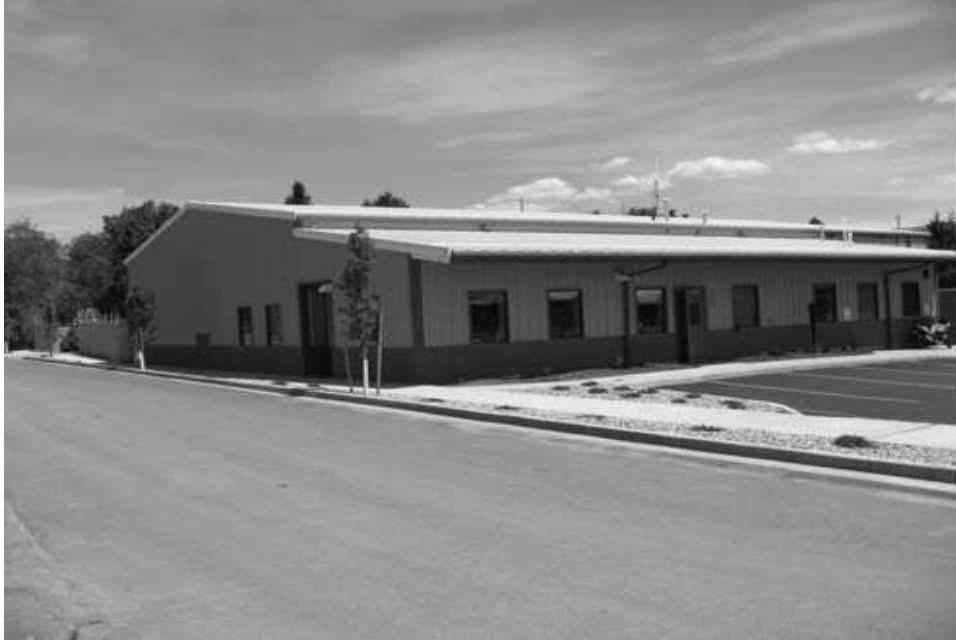
Facilities (150-FAC) STATE UFI: A08925 Main Campus (150A)
AREA: 7,339 SF BUILT: 2009 REMODELED: No PREDOMINANT USE: Maintenance
CONSTRUCTION TYPE: Medium CRV/SF: \$264 REPLACEMENT VALUE: \$1,937,496

Primary Systems			
COMPONENT:	Structure	RATING: 1 x WEIGHT: 8.3 =	SCORE: 8.3
No signs of settlement or cracking, no abrupt vertical changes Columns, bearing walls and roof structure appears sound/free of defects			
COMMENTS:	Steel frame; CMU		
COMPONENT:	Exterior Closure	RATING: 1 x WEIGHT: 8.3 =	SCORE: 8.3
Weatherproof, tight, well-maintained exterior walls, doors, windows/finishes			
COMMENTS:	Metal panel; CMU		
COMPONENT:	Roofing	RATING: 1 x WEIGHT: 10.4 =	SCORE: 10.4
Flashing and penetrations appear sound and membrane appears water- tight; drainage is positive and there are overflow scuppers			
COMMENTS:	Metal panel

Secondary Systems			
COMPONENT:	Floor Finishes	RATING: 2 x WEIGHT: 6.3 =	SCORE: 12.5
Some wear is evident on finish; maintenance needed			
COMMENTS:	Vinyl tile; concrete; sheet vinyl		
COMPONENT:	Wall Finishes	RATING: 1 x WEIGHT: 6.3 =	SCORE: 6.3
Maintainable surfaces in good condition			
COMMENTS:	Gypsum board		
COMPONENT:	Ceiling Finishes	RATING: 1 x WEIGHT: 6.3 =	SCORE: 6.3
Maintainable surfaces in good condition; good alignment and appearance			
COMMENTS:	Lay-in tile		
COMPONENT:	Doors & Hardware	RATING: 1 x WEIGHT: 6.3 =	SCORE: 6.3
Appropriate hardware, closers, panic devices; in good working order			
COMMENTS:	Exterior/interior HM doors/frames; OH sectional metal doors

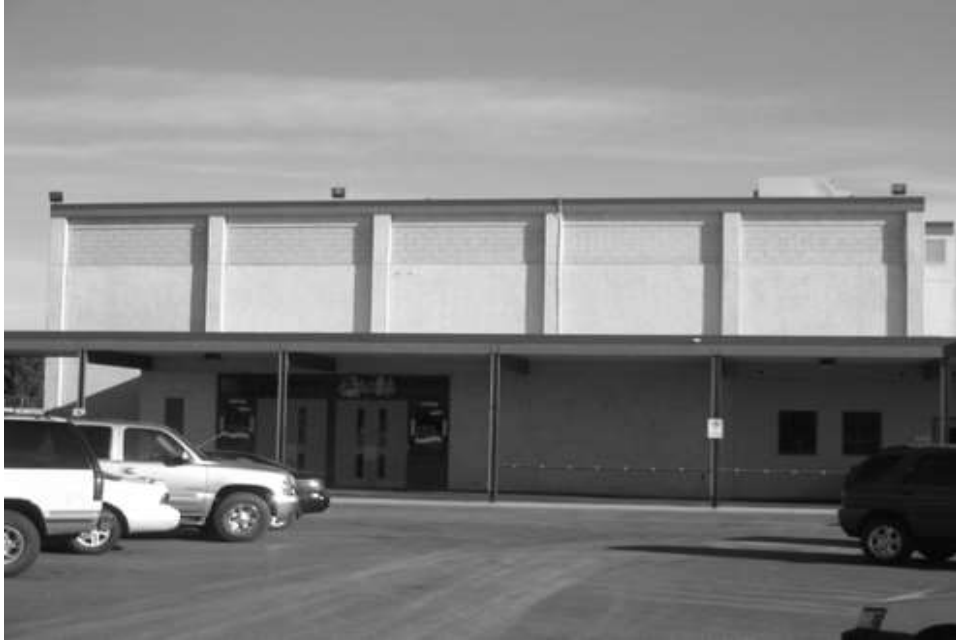
Gym (150-GYM) STATE UFI: A05684 Main Campus (150A)
AREA: 25,901 SF BUILT: 1962 REMODELED: No PREDOMINANT USE: Gymnasium
CONSTRUCTION TYPE: Medium CRV/SF: \$349 REPLACEMENT VALUE: \$9,039,449

Primary Systems			
COMPONENT:	Structure	RATING: 3 x WEIGHT: 8 =	SCORE: 24
Some cracking evident but does not likely affect structural integrity; Visible defects apparent but are non-structural			
COMMENTS:	Steel; concrete; CMU; wood beams; some seismic concerns		
COMPONENT:	Exterior Closure	RATING: 3 x WEIGHT: 8 =	SCORE: 24
Sound and weatherproof but with some physical deterioration evident			
COMMENTS:	CMU; concrete wall panels-minor cracking		
COMPONENT:	Roofing	RATING: 2 x WEIGHT: 10 =	SCORE: 20
Majority of roofing and flashing appear sound, but a small portion of roofing shows deterioration where maintenance or minor repair needed			
COMMENTS:	Single-ply hypalon roof membrane-new in 2004

Secondary Systems			
COMPONENT:	Floor Finishes	RATING: 3 x WEIGHT: 6 = SCORE: 18	
	Some physical wear and minor imperfections are evident; beginning deterioration		
COMMENTS:	Hardwood; carpet; vinyl tile; ceramic tile; concrete		
COMPONENT:	Wall Finishes	RATING: 2 x WEIGHT: 6 = SCORE: 12	
	Maintainable surfaces, minor maintenance is required in some areas		
COMMENTS:	CMU; gypsum board; ceramic tile; Dryvit panels		
COMPONENT:	Ceiling Finishes	RATING: 3 x WEIGHT: 6 = SCORE: 18	
	Some wear and tear; Minor damage, staining or deterioration		
COMMENTS:	Tectum panels; gypsum board; lay-in tile; wood roof deck		
COMPONENT:	Doors & Hardware	RATING: 3 x WEIGHT: 6 = SCORE: 18	
	Functional, but dated; some maintenance required		
COMMENTS:	Interior HM/laminate/wood doors w wood/HM frames; exterior HM doors/frames

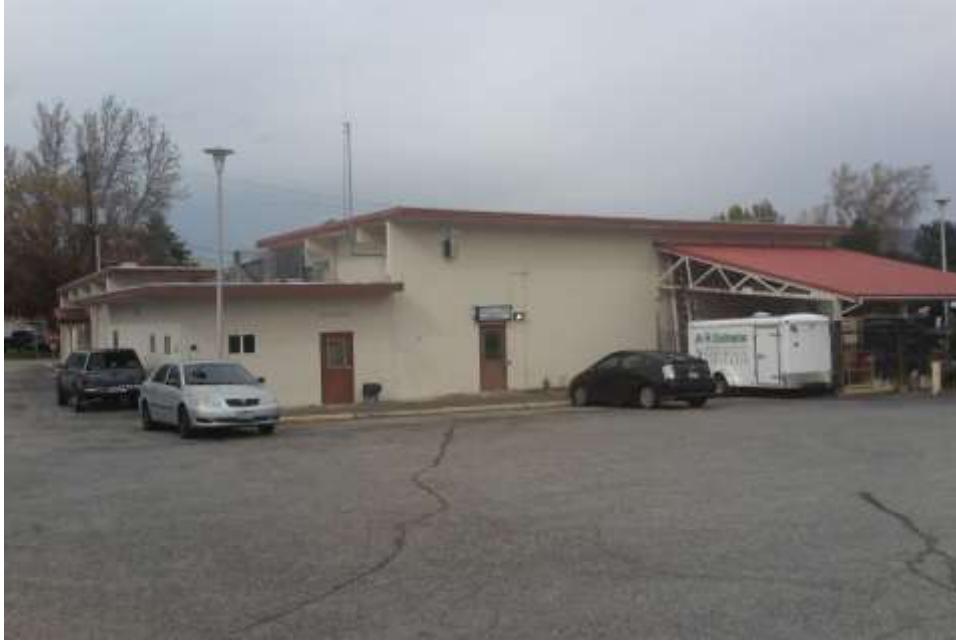
Industrial Technology (150-INT) STATE UFI: A00152 Main Campus (150A)
AREA: 8,428 SF BUILT: 1970 REMODELED: 2010 PREDOMINANT USE: Vocational Arts
CONSTRUCTION TYPE: Medium CRV/SF: \$395 REPLACEMENT VALUE: \$3,329,060

Primary Systems			
COMPONENT:	Structure	RATING: 3 x WEIGHT: 8.3 =	SCORE: 25
Some cracking evident but does not likely affect structural integrity; Visible defects apparent but are non-structural			
COMMENTS:	CMU; concrete; wood beam; seismic concerns		
COMPONENT:	Exterior Closure	RATING: 3 x WEIGHT: 8.3 =	SCORE: 25
Sound and weatherproof but with some physical deterioration evident			
COMMENTS:	CMU		
COMPONENT:	Roofing	RATING: 1 x WEIGHT: 10.4 =	SCORE: 10.4
Flashing and penetrations appear sound and membrane appears water- tight; drainage is positive and there are overflow scuppers			
COMMENTS:	Single-ply 2016

Secondary Systems			
COMPONENT:	Floor Finishes	RATING: 3 x WEIGHT: 6.3 =	SCORE: 18.8
Some physical wear and minor imperfections are evident; beginning deterioration			
COMMENTS:	Carpet; concrete		
COMPONENT:	Wall Finishes	RATING: 3 x WEIGHT: 6.3 =	SCORE: 18.8
Aging surfaces, but sound; some maintenance is required			
COMMENTS:	CMU and Gypsum board		
COMPONENT:	Ceiling Finishes	RATING: 3 x WEIGHT: 6.3 =	SCORE: 18.8
Some wear and tear; Minor damage, staining or deterioration			
COMMENTS:	Lay-in tile; wood roof deck; gypsum board		
COMPONENT:	Doors & Hardware	RATING: 3 x WEIGHT: 6.3 =	SCORE: 18.8
Functional, but dated; some maintenance required			
COMMENTS:	Interior/exterior HM doors/frames; metal OH doors

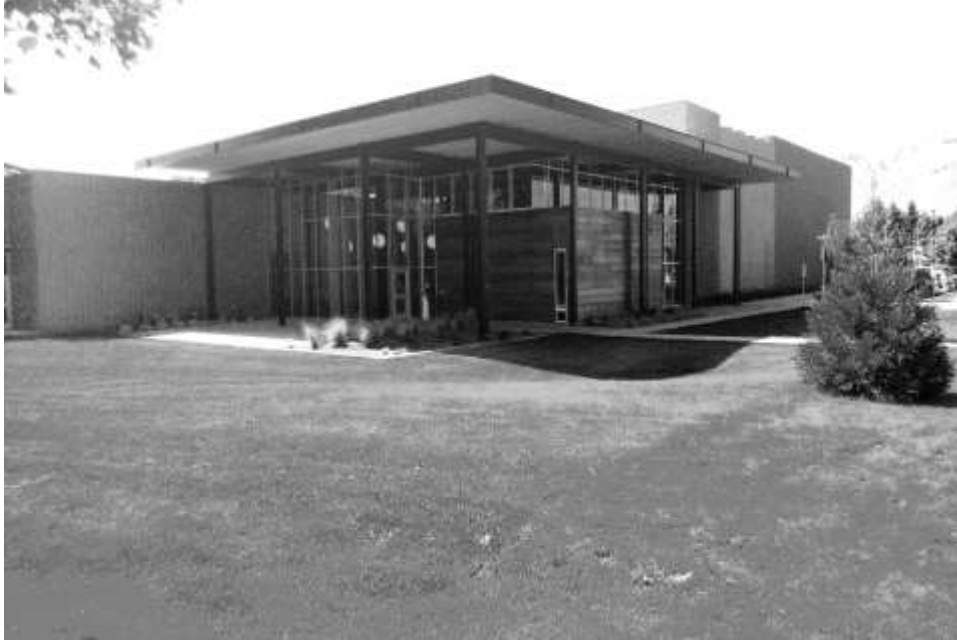
Music And Art Center (150-MAC) STATE UFI: A11095 Main Campus (150A)
AREA: 27,656 SF BUILT: 2012 REMODELED: No PREDOMINANT USE: Classroom
CONSTRUCTION TYPE: Heavy CRV/SF: \$461 REPLACEMENT VALUE: \$12,749,416

Primary Systems			
COMPONENT:	Structure	RATING: 1 x WEIGHT: 8.3 =	SCORE: 8.3
No signs of settlement or cracking, no abrupt vertical changes Columns, bearing walls and roof structure appears sound/free of defects			
COMMENTS:	Steel frame; brick		
COMPONENT:	Exterior Closure	RATING: 1 x WEIGHT: 8.3 =	SCORE: 8.3
Weatherproof, tight, well-maintained exterior walls, doors, windows/finishes			
COMMENTS:	Brick; aluminum window walls; aluminum panels		
COMPONENT:	Roofing	RATING: 1 x WEIGHT: 10.4 =	SCORE: 10.4
Flashing and penetrations appear sound and membrane appears water- tight; drainage is positive and there are overflow scuppers			
COMMENTS:	TPO single-ply membrane

Secondary Systems			
COMPONENT:	Floor Finishes	RATING: 1 x WEIGHT: 6.3 =	SCORE: 6.3
Nice appearance, smooth transitions, level subfloors, no cracks/separating			
COMMENTS:			
COMPONENT:	Wall Finishes	RATING: 1 x WEIGHT: 6.3 =	SCORE: 6.3
Maintainable surfaces in good condition			
COMMENTS:			
COMPONENT:	Ceiling Finishes	RATING: 1 x WEIGHT: 6.3 =	SCORE: 6.3
Maintainable surfaces in good condition; good alignment and appearance			
COMMENTS:			
COMPONENT:	Doors & Hardware	RATING: 1 x WEIGHT: 6.3 =	SCORE: 6.3
Appropriate hardware, closers, panic devices; in good working order			
COMMENTS:

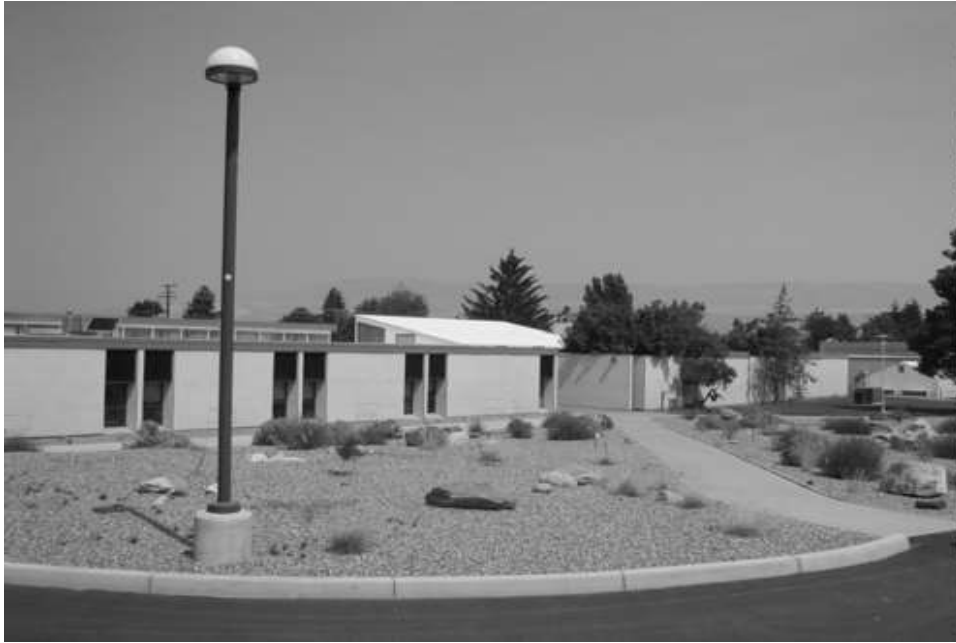
Sexton (150-SXT) STATE UFI: A06871 Main Campus (150A)
 AREA: 26,631 SF BUILT: 1967 REMODELED: No PREDOMINANT USE: Computer Lab.
 CONSTRUCTION TYPE: Medium CRV/SF: \$376 REPLACEMENT VALUE: \$10,013,256

Primary Systems			
COMPONENT:	Structure	RATING: 1 x WEIGHT: 8.3 =	SCORE: 8.3
No signs of settlement or cracking, no abrupt vertical changes Columns, bearing walls and roof structure appears sound/free of defects			
COMMENTS:	CMU and concrete; wood roof deck; laminated wood beams		
COMPONENT:	Exterior Closure	RATING: 3 x WEIGHT: 8.3 =	SCORE: 25
Sound and weatherproof but with some physical deterioration evident			
COMMENTS:	CMU with Dryvit overlay-random exterior cracking		
COMPONENT:	Roofing	RATING: 2 x WEIGHT: 10.4 =	SCORE: 20.9
Majority of roofing and flashing appear sound, but a small portion of roofing shows deterioration where maintenance or minor repair needed			
COMMENTS:	Single-ply hypalon roof-new in 2004

Secondary Systems			
COMPONENT:	Floor Finishes	RATING: 2 x WEIGHT: 6.3 =	SCORE: 12.5
Some wear is evident on finish; maintenance needed			
COMMENTS:	Carpet; vinyl tile; ceramic tile		
COMPONENT:	Wall Finishes	RATING: 2 x WEIGHT: 6.3 =	SCORE: 12.5
Maintainable surfaces, minor maintenance is required in some areas			
COMMENTS:	CMU and Gypsum board		
COMPONENT:	Ceiling Finishes	RATING: 3 x WEIGHT: 6.3 =	SCORE: 18.8
Some wear and tear; Minor damage, staining or deterioration			
COMMENTS:	Lay-in and direct adhered tile; new ceilings in 80% of building in 99; drywall		
COMPONENT:	Doors & Hardware	RATING: 3 x WEIGHT: 6.3 =	SCORE: 18.8
Functional, but dated; some maintenance required			
COMMENTS:	Interior wood doors w HM frames; exterior aluminum doors/frames

Service Systems			
COMPONENT:	Elevators	RATING: 0 x WEIGHT: 0 =	SCORE: 0
No data			
COMMENTS:			
COMPONENT:	Plumbing	RATING: 1 x WEIGHT: 8.3 =	SCORE: 8.3
Fixtures and piping appear to be in good condition; no evidence of leaks			
COMMENTS:	Copper, galvanized, steel and cast iron piping' porcelain fixtures		
COMPONENT:	HVAC	RATING: 2 x WEIGHT: 8.3 =	SCORE: 16.7
Equipment in fair condition; minor deterioration; controls require troubleshooting; most areas have A/C; hazardous areas are ventilated			
COMMENTS:	4 new air handlers in 1999; hot water boiler and chiller in central plant		
COMPONENT:	Electrical	RATING: 1 x WEIGHT: 8.3 =	SCORE: 8.3
Adequate service and distribution capacity for current/future needs			
COMMENTS:	600amp 277/480v		
COMPONENT:	Lights/Power	RATING: 1 x WEIGHT: 8.3 =	SCORE: 8.3
Contemporary lighting with good work area illumination; ample outlets			
COMMENTS:	Lay-in and ceiling-mount fluorescent lighting; halogen spotlights

Quality Standards			
COMPONENT:	Maintenance	RATING: 2 x WEIGHT: 7.3 = SCORE: 14.6	
	Routine maintenance is required; impact is minor		
COMMENTS:			
COMPONENT:	Remaining Life	RATING: 3 x WEIGHT: 6.3 = SCORE: 18.8	
	Life expectancy is roughly 10-15 years; moderate system deterioration		
COMMENTS:	Interior remodel in 1999; may not be cost-effective for long-term use		
COMPONENT:	Appearance	RATING: 3 x WEIGHT: 6.3 = SCORE: 18.8	
	Average construction; average interior and exterior appearance		
COMMENTS:

CONDITION: Needs Improvement/Additional Maintenance

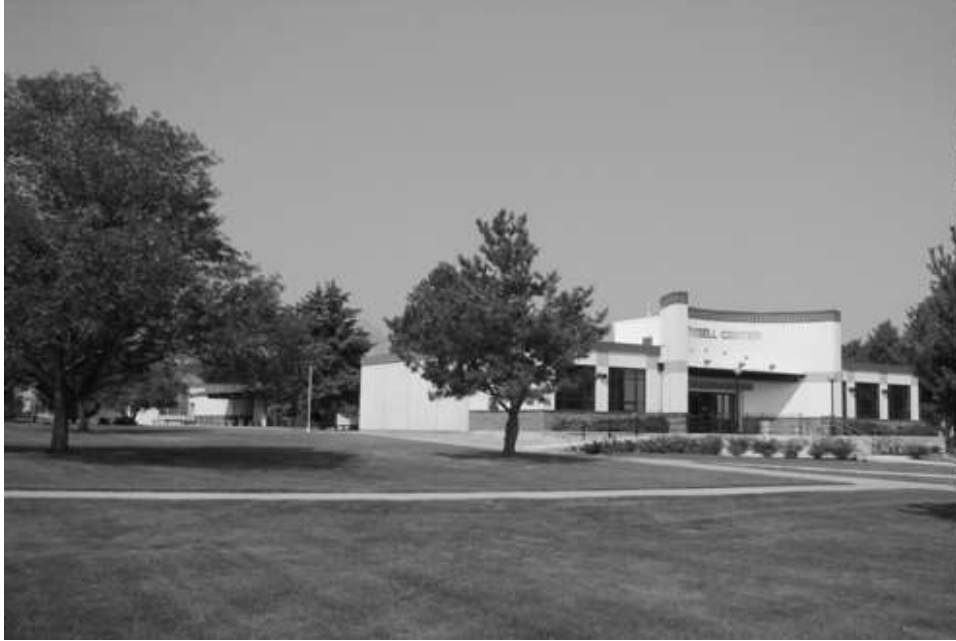
Van Tassell (150-VTC) STATE UFI: A00894 Main Campus (150A)
AREA: 24,640 SF BUILT: 1962 REMODELED: No PREDOMINANT USE: Student Center
CONSTRUCTION TYPE: Medium CRV/SF: \$391 REPLACEMENT VALUE: \$9,634,240

Primary Systems			
COMPONENT:	Structure	RATING: 1 x WEIGHT: 8.3 =	SCORE: 8.3
No signs of settlement or cracking, no abrupt vertical changes Columns, bearing walls and roof structure appears sound/free of defects			
COMMENTS:	CMU; concrete; wood roof deck; wood beams		
COMPONENT:	Exterior Closure	RATING: 3 x WEIGHT: 8.3 =	SCORE: 25
Sound and weatherproof but with some physical deterioration evident			
COMMENTS:	CMU and cement masonry panels-random cracking; aluminum glazed window walls		
COMPONENT:	Roofing	RATING: 2 x WEIGHT: 10.4 =	SCORE: 20.9
Majority of roofing and flashing appear sound, but a small portion of roofing shows deterioration where maintenance or minor repair needed			
COMMENTS:	New single-ply hypalon roof in 2003

Secondary Systems			
COMPONENT:	Floor Finishes	RATING: 2 x WEIGHT: 6.3 =	SCORE: 12.5
Some wear is evident on finish; maintenance needed			
COMMENTS:	Carpet; vinyl tile; ceramic tile; quarry tile		
COMPONENT:	Wall Finishes	RATING: 1 x WEIGHT: 6.3 =	SCORE: 6.3
Maintainable surfaces in good condition			
COMMENTS:	CMU and gypsum board; ceramic tile		
COMPONENT:	Ceiling Finishes	RATING: 2 x WEIGHT: 6.3 =	SCORE: 12.5
Aging surfaces in fair condition and good alignment			
COMMENTS:	Lay-in tile; acoustical tile; wood roof deck; gypsum board		
COMPONENT:	Doors & Hardware	RATING: 2 x WEIGHT: 6.3 =	SCORE: 12.5
Fairly modern door surfaces and hardware with minor deterioration; good working order			
COMMENTS:	Newer interior p-lam and wood doors/frames; exterior aluminum doors/frames

Service Systems			
COMPONENT:	Elevators	RATING: 0 x WEIGHT: 0 =	SCORE: 0
No data			
COMMENTS:			
COMPONENT:	Plumbing	RATING: 3 x WEIGHT: 8.3 =	SCORE: 25
Fixtures are functional but dated; some leaks; maintenance required			
COMMENTS:	Copper, cast iron, steel and galvanized piping; porcelain fixtures		
COMPONENT:	HVAC	RATING: 1 x WEIGHT: 8.3 =	SCORE: 8.3
Equipment in good condition; easily controlled; serves all required spaces; All necessary spaces are adequately ventilated; A/C provided throughout			
COMMENTS:	Rooftop packaged HVAC units-new in 98 and 04; window units; wall radiators		
COMPONENT:	Electrical	RATING: 1 x WEIGHT: 8.3 =	SCORE: 8.3
Adequate service and distribution capacity for current/future needs			
COMMENTS:	1000amp 277/480v		
COMPONENT:	Lights/Power	RATING: 1 x WEIGHT: 8.3 =	SCORE: 8.3
Contemporary lighting with good work area illumination; ample outlets			
COMMENTS:	Ceiling mount, lay-in and hanging circular fluorescent lighting

Safety Systems			
COMPONENT:	Life/Safety	RATING: 1 x WEIGHT: 10.4 =	SCORE: 10.4
Appears to meet current codes			
COMMENTS:			
COMPONENT:	Fire Safety	RATING: 1 x WEIGHT: 10.4 =	SCORE: 10.4
Locally monitored detection; alarm and strobes present; sprinklers in high hazard areas			
COMMENTS:			
COMPONENT:	Modifications	RATING: 1 x WEIGHT: 7.3 =	SCORE: 7.3
Modifications appear to be in compliance with codes and sound construction practices; HVAC/electrical service properly provided			
COMMENTS: 1998 remodel was well constructed; 04 kitchen/dining remodel very nice

Quality Standards			
COMPONENT:	Maintenance	RATING: 1 x WEIGHT: 7.3 =	SCORE: 7.3
Facility appears well maintained			
COMMENTS:			
COMPONENT:	Remaining Life	RATING: 1 x WEIGHT: 6.3 =	SCORE: 6.3
Life expectancy is >20 years; minor system deterioration			
COMMENTS: Interior was extensively remodeled in 1998 and 2004			
COMPONENT:	Appearance	RATING: 3 x WEIGHT: 6.3 =	SCORE: 18.8
Average construction; average interior and exterior appearance			
COMMENTS: Very average and utilitarian exterior

CONDITION: Adequate

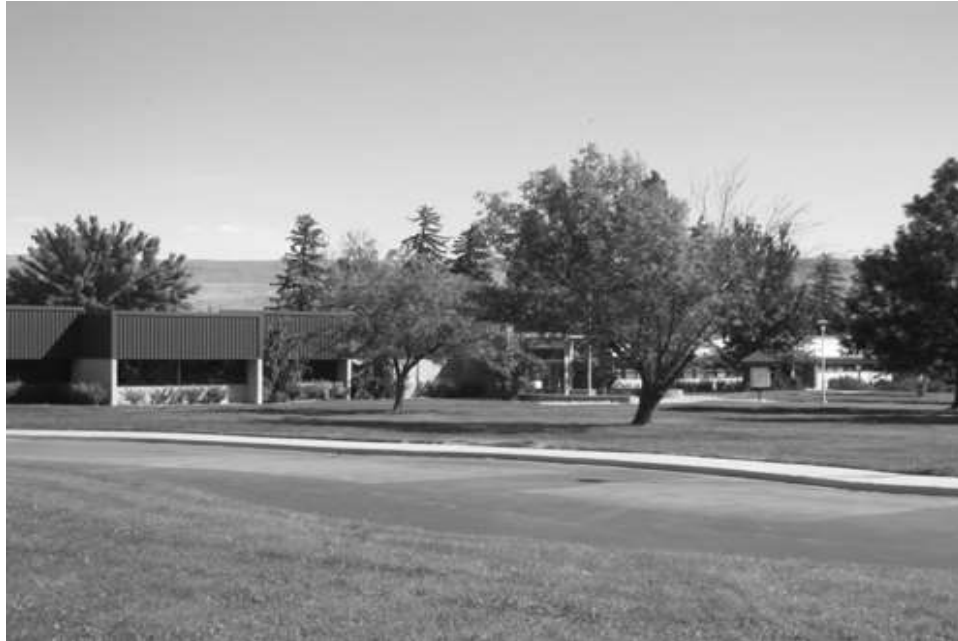
Wells (150-WEL) STATE UFI: A04977 Main Campus (150A)
 AREA: 40,523 SF BUILT: 1952 REMODELED: No PREDOMINANT USE: Mixed Use
 CONSTRUCTION TYPE: Medium CRV/SF: \$395 REPLACEMENT VALUE: \$16,006,585

Primary Systems			
COMPONENT:	Structure	RATING: 1 x WEIGHT: 8.3 = SCORE: 8.3	
No signs of settlement or cracking, no abrupt vertical changes Columns, bearing walls and roof structure appears sound/free of defects			
COMMENTS:	Concrete; brick; wood framing; some seismic concerns		
COMPONENT:	Exterior Closure	RATING: 1 x WEIGHT: 8.3 = SCORE: 8.3	
Weatherproof, tight, well-maintained exterior walls, doors, windows/finishes			
COMMENTS:	Concrete and brick-exterior deterioration in a number of areas on all wings		
COMPONENT:	Roofing	RATING: 1 x WEIGHT: 10.4 = SCORE: 10.4	
Flashing and penetrations appear sound and membrane appears water- tight; drainage is positive and there are overflow scuppers			
COMMENTS:	Hypalon single-ply roof 2014 on the upper roof. Single-ply on other sections.

Secondary Systems			
COMPONENT:	Floor Finishes	RATING: 2 x WEIGHT: 6.3 =	SCORE: 12.5
Some wear is evident on finish; maintenance needed			
COMMENTS:	Vinyl tile; ceramic tile; carpet		
COMPONENT:	Wall Finishes	RATING: 2 x WEIGHT: 6.3 =	SCORE: 12.5
Maintainable surfaces, minor maintenance is required in some areas			
COMMENTS:	CMU; brick; gypsum board; ceramic tile		
COMPONENT:	Ceiling Finishes	RATING: 2 x WEIGHT: 6.3 =	SCORE: 12.5
Aging surfaces in fair condition and good alignment			
COMMENTS:	Lay-in tile; direct adhered tile; gypsum board		
COMPONENT:	Doors & Hardware	RATING: 2 x WEIGHT: 6.3 =	SCORE: 12.5
Fairly modern door surfaces and hardware with minor deterioration; good working order			
COMMENTS:	Interior wood doors w HM frames; exterior metal doors/frames and aluminum doors/frames

Service Systems			
COMPONENT:	Elevators	RATING: 0 x WEIGHT: 0 =	SCORE: 0
No data			
COMMENTS:			
COMPONENT:	Plumbing	RATING: 3 x WEIGHT: 8.3 =	SCORE: 25
Fixtures are functional but dated; some leaks; maintenance required			
COMMENTS:	Galvanized, steel and cast iron piping; some copper; porcelain fixtures		
COMPONENT:	HVAC	RATING: 2 x WEIGHT: 8.3 =	SCORE: 16.7
Equipment in fair condition; minor deterioration; controls require troubleshooting; most areas have A/C; hazardous areas are ventilated			
COMMENTS:	Chiller in Batjer; hot water boilers; rooftop packaged A/C units; some replaced in 1996		
COMPONENT:	Electrical	RATING: 1 x WEIGHT: 8.3 =	SCORE: 8.3
Adequate service and distribution capacity for current/future needs			
COMMENTS:	1200amp 208/120v new equipment 2021 for replacement area		
COMPONENT:	Lights/Power	RATING: 3 x WEIGHT: 8.3 =	SCORE: 25
Adequate work area illumination; adequate outlets for current use; maintenance required

COMMENTS:	Ceiling mount, hanging and lay-in fluorescent lighting; some inadequate lighting

Safety Systems			
COMPONENT:	Life/Safety	RATING: 2 x WEIGHT: 10.4 = SCORE: 20.9	
Most areas meet current codes; some areas meet codes for prior construction phases			
COMMENTS:			
COMPONENT:	Fire Safety	RATING: 2 x WEIGHT: 10.4 = SCORE: 20.9	
Locally monitored detection; alarm present, but missing visual component or sprinklers			
COMMENTS:			
COMPONENT:	Modifications	RATING: 1 x WEIGHT: 7.3 = SCORE: 7.3	
Modifications appear to be in compliance with codes and sound construction practices; HVAC/electrical service properly provided			
COMMENTS: Modifications in replacement area appear well done, but still under construction

Quality Standards			
COMPONENT:	Maintenance	RATING: 2 x WEIGHT: 7.3 = SCORE: 14.6	
Routine maintenance is required; impact is minor			
COMMENTS:			
COMPONENT:	Remaining Life	RATING: 1 x WEIGHT: 6.3 = SCORE: 6.3	
Life expectancy is >20 years; minor system deterioration			
COMMENTS: Three wings partially remodeled in recent years, but building is almost 60 years old			
COMPONENT:	Appearance	RATING: 3 x WEIGHT: 6.3 = SCORE: 18.8	
Average construction; average interior and exterior appearance			
COMMENTS:

CONDITION: Adequate

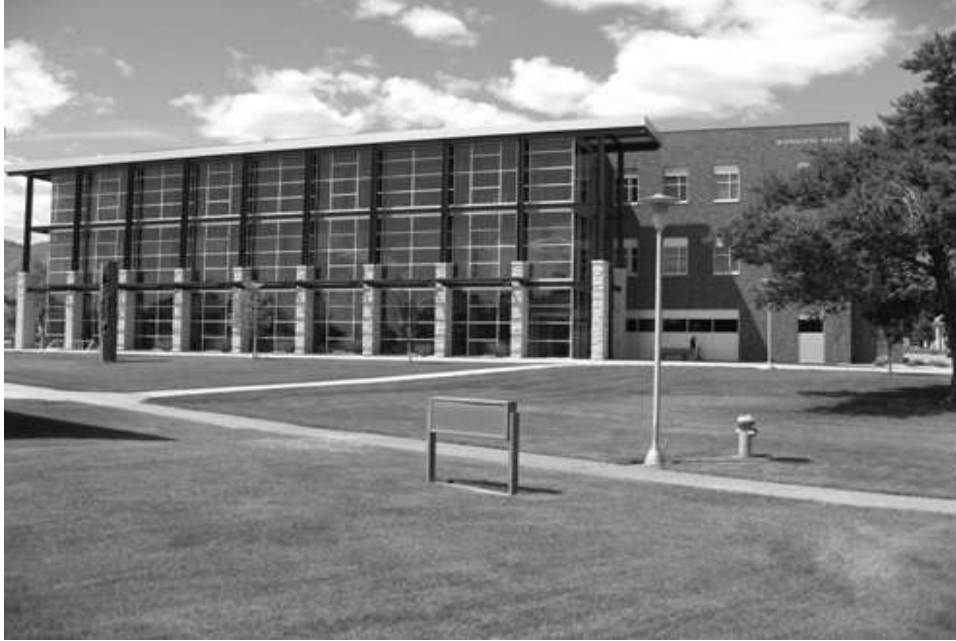
Wenatchi Hall (150-WTI) STATE UFI: A06617 Main Campus (150A)
 AREA: 82,000 SF BUILT: 2007 REMODELED: No PREDOMINANT USE: Multi-Use
 CONSTRUCTION TYPE: Heavy CRV/SF: \$461 REPLACEMENT VALUE: \$37,802,000

Primary Systems			
COMPONENT:	Structure	RATING: 1 x WEIGHT: 8.4 = SCORE: 8.4	
No signs of settlement or cracking, no abrupt vertical changes Columns, bearing walls and roof structure appears sound/free of defects			
COMMENTS:	Steel frame; brick; concrete columns		
COMPONENT:	Exterior Closure	RATING: 1 x WEIGHT: 8.4 = SCORE: 8.4	
Weatherproof, tight, well-maintained exterior walls, doors, windows/finishes			
COMMENTS:	Brick; aluminum window walls; aluminum panels; sandstone block		
COMPONENT:	Roofing	RATING: 3 x WEIGHT: 10.5 = SCORE: 31.5	
Some deterioration is evident in membrane and flashings; maintenance or minor repair is needed			
COMMENTS:	TPO single-ply membrane; skylight

Secondary Systems			
COMPONENT:	Floor Finishes	RATING: 1 x WEIGHT: 6.3 = SCORE: 6.3	
	Nice appearance, smooth transitions, level subfloors, no cracks/separating		
COMMENTS:	Carpet; vinyl tile; ceramic tile		
COMPONENT:	Wall Finishes	RATING: 1 x WEIGHT: 6.3 = SCORE: 6.3	
	Maintainable surfaces in good condition		
COMMENTS:	Sandstone block; gypsum board; ceramic tile; Masonite wainscot; concrete columns		
COMPONENT:	Ceiling Finishes	RATING: 1 x WEIGHT: 6.3 = SCORE: 6.3	
	Maintainable surfaces in good condition; good alignment and appearance		
COMMENTS:	Lay-in tile; gypsum board; perforated wood tiles		
COMPONENT:	Doors & Hardware	RATING: 1 x WEIGHT: 6.3 = SCORE: 6.3	
	Appropriate hardware, closers, panic devices; in good working order		
COMMENTS:	Interior wood doors w HM frames; exterior aluminum doors/frames

Service Systems			
COMPONENT:	Elevators	RATING: 1 x WEIGHT: 6.3 = SCORE: 6.3	
	Appropriate and functional for occupancy and use		
COMMENTS:	4 stop - 2 elevators		
COMPONENT:	Plumbing	RATING: 1 x WEIGHT: 8.4 = SCORE: 8.4	
	Fixtures and piping appear to be in good condition; no evidence of leaks		
COMMENTS:	Copper, cast iron, steel and ABS piping; porcelain fixtures-water saving		
COMPONENT:	HVAC	RATING: 1 x WEIGHT: 8.4 = SCORE: 8.4	
	Equipment in good condition; easily controlled; serves all required spaces; All necessary spaces are adequately ventilated; A/C provided throughout		
COMMENTS:	Chillers; AHUs w electric duct heaters and VAVs; small DX units		
COMPONENT:	Electrical	RATING: 1 x WEIGHT: 8.4 = SCORE: 8.4	
	Adequate service and distribution capacity for current/future needs		
COMMENTS:	1600amp 208/120v; 4000amp 480/277v; 275 kva generator		
COMPONENT:	Lights/Power	RATING: 1 x WEIGHT: 8.4 = SCORE: 8.4

Safety Systems			
COMPONENT:	Life/Safety	RATING: 1 x WEIGHT: 10.5 =	SCORE: 10.5
Appears to meet current codes			
COMMENTS:			
COMPONENT:	Fire Safety	RATING: 1 x WEIGHT: 10.5 =	SCORE: 10.5
Locally monitored detection; alarm and strobes present; sprinklers in high hazard areas			
COMMENTS:			
COMPONENT:	Modifications	RATING: 0 x WEIGHT: 0 =	SCORE: 0
No data			
COMMENTS: New building

Quality Standards			
COMPONENT:	Maintenance	RATING: 1 x WEIGHT: 7.4 =	SCORE: 7.4
Facility appears well maintained			
COMMENTS:			
COMPONENT:	Remaining Life	RATING: 1 x WEIGHT: 6.3 =	SCORE: 6.3
Life expectancy is >20 years; minor system deterioration			
COMMENTS: Very well constructed building; quality materials; RUL >45 yrs.			
COMPONENT:	Appearance	RATING: 1 x WEIGHT: 6.3 =	SCORE: 6.3
Well-constructed building; generally attractive interior and exterior			
COMMENTS:

CONDITION: Superior

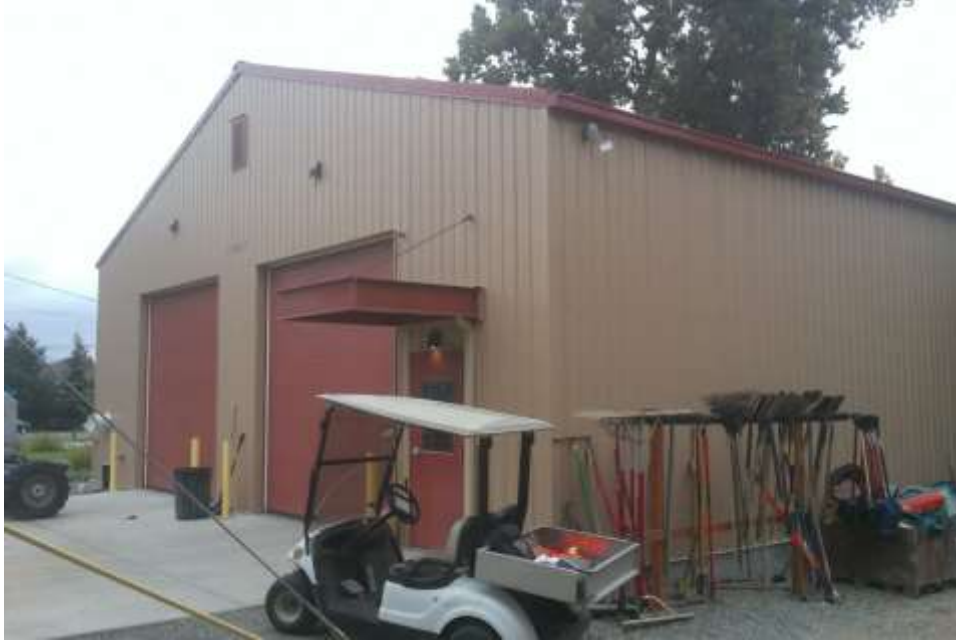
Facilities Storage Building (150-FSB) STATE UFI: A21470 Main Campus (150A)
AREA: 4,992 SF BUILT: 2016 REMODELED: No PREDOMINANT USE: Storage
CONSTRUCTION TYPE: No data CRV/SF: \$231 REPLACEMENT VALUE: \$1,153,152

Primary Systems			
COMPONENT:	Structure	RATING: 1 x WEIGHT: 9.3 = SCORE: 9.3	
No signs of settlement or cracking, no abrupt vertical changes Columns, bearing walls and roof structure appears sound/free of defects			
COMMENTS:	No data		
COMPONENT:	Exterior Closure	RATING: 1 x WEIGHT: 9.3 = SCORE: 9.3	
Weatherproof, tight, well-maintained exterior walls, doors, windows/finishes			
COMMENTS:	No data		
COMPONENT:	Roofing	RATING: No data	
No data			
COMMENTS:	No data

Secondary Systems			
COMPONENT:	Floor Finishes	RATING: 1 x WEIGHT: 7 =	SCORE: 7
	Nice appearance, smooth transitions, level subfloors, no cracks/separating		
COMMENTS:	No data		
COMPONENT:	Wall Finishes	RATING: No data	
	No data		
COMMENTS:	No data		
COMPONENT:	Ceiling Finishes	RATING: 1 x WEIGHT: 7 =	SCORE: 7
	Maintainable surfaces in good condition; good alignment and appearance		
COMMENTS:	No data		
COMPONENT:	Doors & Hardware	RATING: 1 x WEIGHT: 7 =	SCORE: 7
	Appropriate hardware, closers, panic devices; in good working order		
COMMENTS:	No data

Service Systems			
COMPONENT:	Elevators	RATING: 0 x WEIGHT: 0 =	SCORE: 0
	No data		
COMMENTS:	No data		
COMPONENT:	Plumbing	RATING: 0 x WEIGHT: 0 =	SCORE: 0
	No data		
COMMENTS:	No data		
COMPONENT:	HVAC	RATING: 1 x WEIGHT: 9.3 =	SCORE: 9.3
	Equipment in good condition; easily controlled; serves all required spaces; All necessary spaces are adequately ventilated; A/C provided throughout		
COMMENTS:	No data		
COMPONENT:	Electrical	RATING: 1 x WEIGHT: 9.3 =	SCORE: 9.3
	Adequate service and distribution capacity for current/future needs		
COMMENTS:	No data		
COMPONENT:	Lights/Power	RATING: 1 x WEIGHT: 9.3 =	SCORE: 9.3
	Contemporary lighting with good work area illumination; ample outlets		
COMMENTS:	No data

Safety Systems			
COMPONENT:	Life/Safety	RATING: 1 x WEIGHT: 11.7 =	SCORE: 11.7
	Appears to meet current codes		
COMMENTS:	No data		
COMPONENT:	Fire Safety	RATING: 1 x WEIGHT: 11.7 =	SCORE: 11.7
	Locally monitored detection; alarm and strobes present; sprinklers in high hazard areas		
COMMENTS:	No data		
COMPONENT:	Modifications	RATING: 0 x WEIGHT: 0 =	SCORE: 0
	No data		
COMMENTS:	No data

Quality Standards			
COMPONENT:	Maintenance	RATING: 1 x WEIGHT: 8.2 =	SCORE: 8.2
	Facility appears well maintained		
COMMENTS:	No data		
COMPONENT:	Remaining Life	RATING: 1 x WEIGHT: 7 =	SCORE: 7
	Life expectancy is >20 years; minor system deterioration		
COMMENTS:	No data		
COMPONENT:	Appearance	RATING: 1 x WEIGHT: 7 =	SCORE: 7
	Well-constructed building; generally attractive interior and exterior		
COMMENTS:	No data

CONDITION: Superior

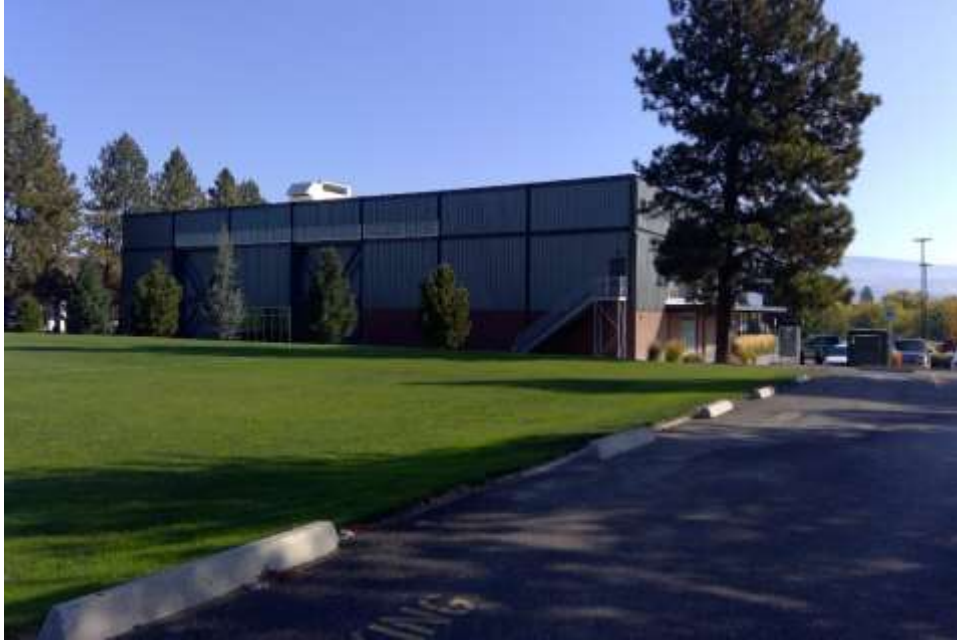
New Student Recreation Center (150-SRC) STATE UFI: A25176 Main Campus (150A)
AREA: 17,500 SF BUILT: 2017 REMODELED: No PREDOMINANT USE: Gymnasium
CONSTRUCTION TYPE: No data CRV/SF: \$349 REPLACEMENT VALUE: \$6,107,500

Primary Systems			
COMPONENT:	Structure	RATING: 1 x WEIGHT: 8.4 =	SCORE: 8.4
No signs of settlement or cracking, no abrupt vertical changes Columns, bearing walls and roof structure appears sound/free of defects			
COMMENTS:	No data		
COMPONENT:	Exterior Closure	RATING: 1 x WEIGHT: 8.4 =	SCORE: 8.4
Weatherproof, tight, well-maintained exterior walls, doors, windows/finishes			
COMMENTS:	No data		
COMPONENT:	Roofing	RATING: 1 x WEIGHT: 10.5 =	SCORE: 10.5
Flashing and penetrations appear sound and membrane appears water- tight; drainage is positive and there are overflow scuppers			
COMMENTS:	No data

Secondary Systems			
COMPONENT:	Floor Finishes	RATING: 1 x WEIGHT: 6.3 =	SCORE: 6.3
	Nice appearance, smooth transitions, level subfloors, no cracks/separating		
COMMENTS:	No data		
COMPONENT:	Wall Finishes	RATING: 1 x WEIGHT: 6.3 =	SCORE: 6.3
	Maintainable surfaces in good condition		
COMMENTS:	No data		
COMPONENT:	Ceiling Finishes	RATING: 1 x WEIGHT: 6.3 =	SCORE: 6.3
	Maintainable surfaces in good condition; good alignment and appearance		
COMMENTS:	No data		
COMPONENT:	Doors & Hardware	RATING: 1 x WEIGHT: 6.3 =	SCORE: 6.3
	Appropriate hardware, closers, panic devices; in good working order		
COMMENTS:	No data

Service Systems			
COMPONENT:	Elevators	RATING: 1 x WEIGHT: 6.3 =	SCORE: 6.3
	Appropriate and functional for occupancy and use		
COMMENTS:	No data		
COMPONENT:	Plumbing	RATING: 1 x WEIGHT: 8.4 =	SCORE: 8.4
	Fixtures and piping appear to be in good condition; no evidence of leaks		
COMMENTS:	No data		
COMPONENT:	HVAC	RATING: 1 x WEIGHT: 8.4 =	SCORE: 8.4
	Equipment in good condition; easily controlled; serves all required spaces; All necessary spaces are adequately ventilated; A/C provided throughout		
COMMENTS:	No data		
COMPONENT:	Electrical	RATING: 1 x WEIGHT: 8.4 =	SCORE: 8.4
	Adequate service and distribution capacity for current/future needs		
COMMENTS:	No data		
COMPONENT:	Lights/Power	RATING: 1 x WEIGHT: 8.4 =	SCORE: 8.4
	Contemporary lighting with good work area illumination; ample outlets		
COMMENTS:	No data

Safety Systems			
COMPONENT:	Life/Safety	RATING: 1 x WEIGHT: 10.5 =	SCORE: 10.5
	Appears to meet current codes		
COMMENTS:	No data		
COMPONENT:	Fire Safety	RATING: 1 x WEIGHT: 10.5 =	SCORE: 10.5
	Locally monitored detection; alarm and strobes present; sprinklers in high hazard areas		
COMMENTS:	No data		
COMPONENT:	Modifications	RATING: 0 x WEIGHT: 0 =	SCORE: 0
	No data		
COMMENTS:	No data

Quality Standards			
COMPONENT:	Maintenance	RATING: 1 x WEIGHT: 7.4 =	SCORE: 7.4
	Facility appears well maintained		
COMMENTS:	No data		
COMPONENT:	Remaining Life	RATING: 1 x WEIGHT: 6.3 =	SCORE: 6.3
	Life expectancy is >20 years; minor system deterioration		
COMMENTS:	No data		
COMPONENT:	Appearance	RATING: 1 x WEIGHT: 6.3 =	SCORE: 6.3
	Well-constructed building; generally attractive interior and exterior		
COMMENTS:	No data

CONDITION: Superior

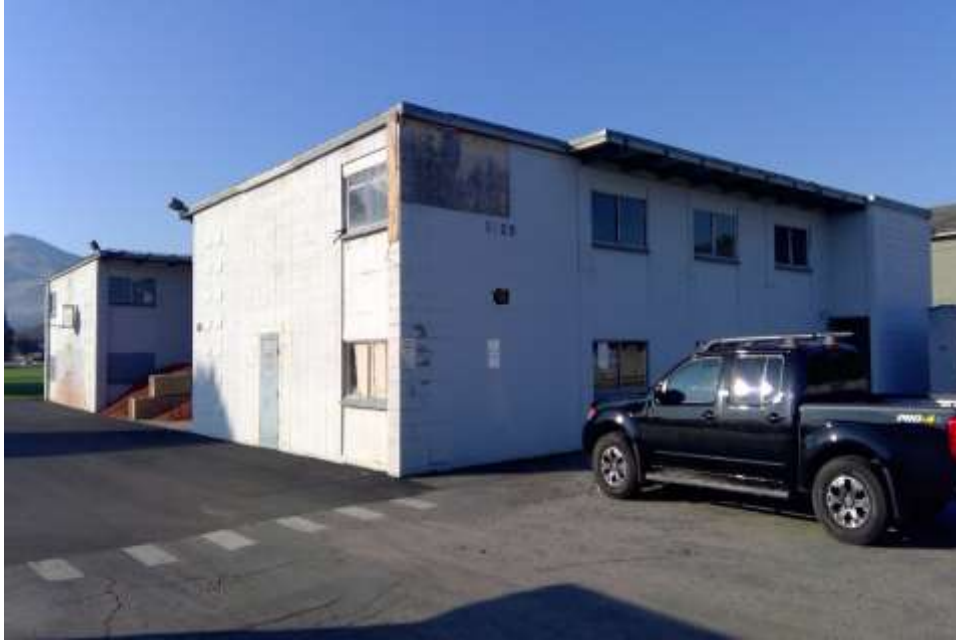
Old West Side Hs Ah2 (150-AH2) STATE UFI: A25187 Main Campus (150A)
AREA: 14,760 SF BUILT: 0 REMODELED: No PREDOMINANT USE: Classroom
CONSTRUCTION TYPE: No data CRV/SF: \$356 REPLACEMENT VALUE: \$5,254,560

Primary Systems			
COMPONENT:	Structure	RATING: 2 x WEIGHT: 8 =	SCORE: 16
Minor cracks evident in a small portion of the structure			
COMMENTS:	No data		
COMPONENT:	Exterior Closure	RATING: 3 x WEIGHT: 8 =	SCORE: 24
Sound and weatherproof but with some physical deterioration evident			
COMMENTS:	No data		
COMPONENT:	Roofing	RATING: 4 x WEIGHT: 10 =	SCORE: 40
General deterioration and some leaks are evident; reconditioning or partial repair is needed			
COMMENTS:	No data

Secondary Systems			
COMPONENT:	Floor Finishes	RATING: 3 x WEIGHT: 6 = SCORE: 18	
	Some physical wear and minor imperfections are evident; beginning deterioration		
COMMENTS:	No data		
COMPONENT:	Wall Finishes	RATING: 2 x WEIGHT: 6 = SCORE: 12	
	Maintainable surfaces, minor maintenance is required in some areas		
COMMENTS:	No data		
COMPONENT:	Ceiling Finishes	RATING: 3 x WEIGHT: 6 = SCORE: 18	
	Some wear and tear; Minor damage, staining or deterioration		
COMMENTS:	No data		
COMPONENT:	Doors & Hardware	RATING: 3 x WEIGHT: 6 = SCORE: 18	
	Functional, but dated; some maintenance required		
COMMENTS:	No data

Service Systems			
COMPONENT:	Elevators	RATING: 5 x WEIGHT: 6 = SCORE: 30	
	No elevator access for upper floors		
COMMENTS:	No data		
COMPONENT:	Plumbing	RATING: 3 x WEIGHT: 8 = SCORE: 24	
	Fixtures are functional but dated; some leaks; maintenance required		
COMMENTS:	No data		
COMPONENT:	HVAC	RATING: 4 x WEIGHT: 8 = SCORE: 32	
	System partially adequate; many areas served by equipment needing repair; areas with A/C very limited, but hazardous areas are ventilated		
COMMENTS:	No data		
COMPONENT:	Electrical	RATING: 3 x WEIGHT: 8 = SCORE: 24	
	Service capacity meets current needs but inadequate for future		
COMMENTS:	No data		
COMPONENT:	Lights/Power	RATING: 3 x WEIGHT: 8 = SCORE: 24	
	Adequate work area illumination; adequate outlets for current use; maintenance required		
COMMENTS:	No data

Safety Systems			
COMPONENT:	Life/Safety	RATING: 4 x WEIGHT: 10 = SCORE: 40	
	Generally meets codes for vintage of construction; minor health or accessibility violations exist		
COMMENTS:	No data		
COMPONENT:	Fire Safety	RATING: 3 x WEIGHT: 10 = SCORE: 30	
	Extinguishers and signed egress; no alarm or sprinklers		
COMMENTS:	No data		
COMPONENT:	Modifications	RATING: 3 x WEIGHT: 7 = SCORE: 21	
	Some modifications lack code compliance; HVAC service not fully considered during renovation		
COMMENTS:	No data

Quality Standards			
COMPONENT:	Maintenance	RATING: 5 x WEIGHT: 7 = SCORE: 35	
	General deterioration is evident; lack of adequate maintenance is evident; impact is moderate to severe		
COMMENTS:	No data		
COMPONENT:	Remaining Life	RATING: 5 x WEIGHT: 6 = SCORE: 30	
	Life expectancy is <5 years; significant system deterioration		
COMMENTS:	No data		
COMPONENT:	Appearance	RATING: 4 x WEIGHT: 6 = SCORE: 24	
	Average construction; some unattractive exterior and interior spaces		
COMMENTS:	No data

Heat Loss			
COMPONENT:	Insulation	RATING: 4 x WEIGHT: 6 = SCORE: 24	
	Insulation present in some areas or systems, but missing in other areas or systems		
COMMENTS:	No data		
COMPONENT:	Glazing	RATING: 5 x WEIGHT: 6 = SCORE: 30	
	Single glazing		
COMMENTS:	No data

CONDITION: Replace or Renovate
