2023 FACILITY CONDITION SURVEY

Wenatchee Valley College

SURVEY CONDUCTED BY:
Steve Lewandowski
State Board for Community
and Technical Colleges

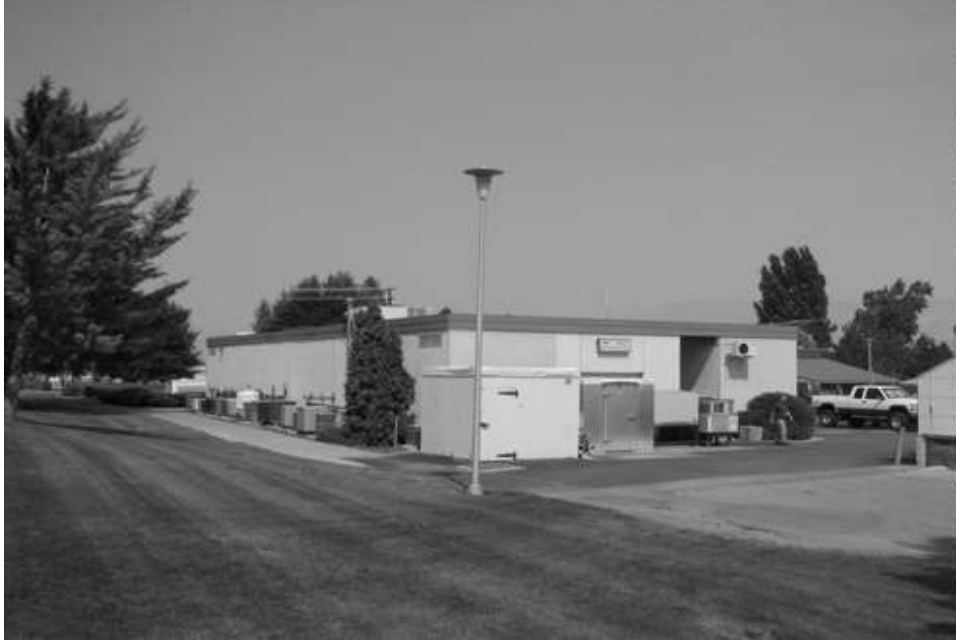
Refrigeration (150-RFG) STATE UFI: A05917 Main Campus (150A)
AREA: 4,384 SF BUILT: 1967 REMODELED: No PREDOMINANT USE: Vocational Arts
CONSTRUCTION TYPE: Medium CRV/SF: \$395 REPLACEMENT VALUE: \$1,731,680

Primary Systems			
COMPONENT:	Structure	RATING: 3 x WEIGHT: 8.7 =	SCORE: 26.1
Some cracking evident but does not likely affect structural integrity; Visible defects apparent but are non-structural			
COMMENTS:	CMU; wood beams; seismic concerns		
COMPONENT:	Exterior Closure	RATING: 3 x WEIGHT: 8.7 =	SCORE: 26.1
Sound and weatherproof but with some physical deterioration evident			
COMMENTS:	Dryvit panels-larger cracks in several panels		
COMPONENT:	Roofing	RATING: 1 x WEIGHT: 10.9 =	SCORE: 10.9
Flashing and penetrations appear sound and membrane appears water- tight; drainage is positive and there are overflow scuppers			
COMMENTS:	Single-ply membrane 2015

Secondary Systems			
COMPONENT:	Floor Finishes	RATING: 1 x WEIGHT: 6.5 =	SCORE: 6.5
	Nice appearance, smooth transitions, level subfloors, no cracks/separating		
COMMENTS:	Concrete floor throughout		
COMPONENT:	Wall Finishes	RATING: 1 x WEIGHT: 6.5 =	SCORE: 6.5
	Maintainable surfaces in good condition		
COMMENTS:	Unfinished CMU walls		
COMPONENT:	Ceiling Finishes	RATING: 1 x WEIGHT: 6.5 =	SCORE: 6.5
	Maintainable surfaces in good condition; good alignment and appearance		
COMMENTS:	T&G wood ceiling-underside of roof deck		
COMPONENT:	Doors & Hardware	RATING: 3 x WEIGHT: 6.5 =	SCORE: 19.6
	Functional, but dated; some maintenance required		
COMMENTS:	Exterior/interior HM doors/frames; metal OH door

Service Systems			
COMPONENT:	Elevators	RATING: 0 x WEIGHT: 0 =	SCORE: 0
	No data		
COMMENTS:			
COMPONENT:	Plumbing	RATING: 3 x WEIGHT: 8.7 =	SCORE: 26.1
	Fixtures are functional but dated; some leaks; maintenance required		
COMMENTS:	Galvanized, copper and cast iron piping; porcelain fixtures		
COMPONENT:	HVAC	RATING: 4 x WEIGHT: 8.7 =	SCORE: 34.9
	System partially adequate; many areas served by equipment needing repair; areas with A/C very limited, but hazardous areas are ventilated		
COMMENTS:	Rooftop packaged A/C units		
COMPONENT:	Electrical	RATING: 1 x WEIGHT: 8.7 =	SCORE: 8.7
	Adequate service and distribution capacity for current/future needs		
COMMENTS:	400amp 208/120v		
COMPONENT:	Lights/Power	RATING: 3 x WEIGHT: 8.7 =	SCORE: 26.1
	Adequate work area illumination; adequate outlets for current use; maintenance required		
COMMENTS:	Ceiling-mount fluorescent fixtures; inadequate lighting in some areas

Quality Standards			
COMPONENT:	Maintenance	RATING: 3 x WEIGHT: 7.6 =	SCORE: 22.9
Routine maintenance is required; deferred maintenance is evident; impact is minor to moderate			
COMMENTS:			
COMPONENT:	Remaining Life	RATING: 5 x WEIGHT: 6.5 =	SCORE: 32.7
Life expectancy is <5 years; significant system deterioration			
COMMENTS:	Older building that is inadequate in size and poor design for instructional use		
COMPONENT:	Appearance	RATING: 5 x WEIGHT: 6.5 =	SCORE: 32.7
Poor to average construction; very unattractive exterior and interior spaces			
COMMENTS:

CONDITION: Needs Improvement/Renovation

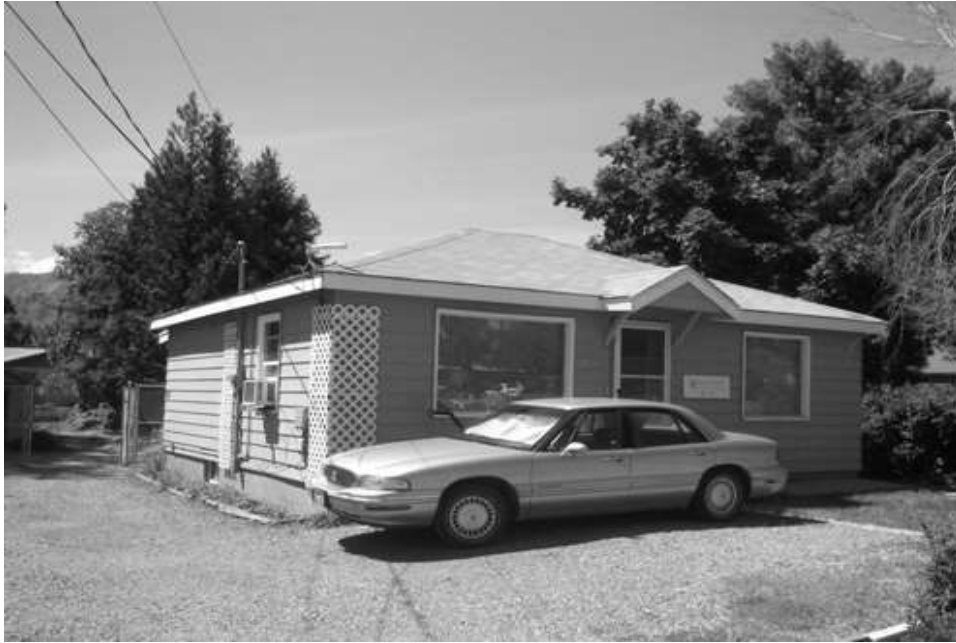
Grants House (150-HS1) STATE UFI: A07871 Main Campus (150A)
AREA: 1,658 SF BUILT: 1930 REMODELED: No PREDOMINANT USE: Faculty Office
CONSTRUCTION TYPE: Light CRV/SF: \$231 REPLACEMENT VALUE: \$382,998

Primary Systems			
COMPONENT:	Structure	RATING: 3 x WEIGHT: 8 =	SCORE: 24
Some cracking evident but does not likely affect structural integrity; Visible defects apparent but are non-structural			
COMMENTS:	Wood frame; CMU and concrete foundation		
COMPONENT:	Exterior Closure	RATING: 3 x WEIGHT: 8 =	SCORE: 24
Sound and weatherproof but with some physical deterioration evident			
COMMENTS:	Aluminum siding and T1-11 wood		
COMPONENT:	Roofing	RATING: 2 x WEIGHT: 10 =	SCORE: 20
Majority of roofing and flashing appear sound, but a small portion of roofing shows deterioration where maintenance or minor repair needed			
COMMENTS:	3-tab asphalt shingle roof

Secondary Systems			
COMPONENT:	Floor Finishes	RATING: 2 x WEIGHT: 6 =	SCORE: 12
Some wear is evident on finish; maintenance needed			
COMMENTS:	Carpet over wood strip flooring - carpet is stained; ceramic tile		
COMPONENT:	Wall Finishes	RATING: 2 x WEIGHT: 6 =	SCORE: 12
Maintainable surfaces, minor maintenance is required in some areas			
COMMENTS:	Plaster		
COMPONENT:	Ceiling Finishes	RATING: 2 x WEIGHT: 6 =	SCORE: 12
Aging surfaces in fair condition and good alignment			
COMMENTS:	Plaster		
COMPONENT:	Doors & Hardware	RATING: 3 x WEIGHT: 6 =	SCORE: 18
Functional, but dated; some maintenance required			
COMMENTS:	Interior/exterior wood panel doors/frames

CONDITION: Needs Improvement/Renovation

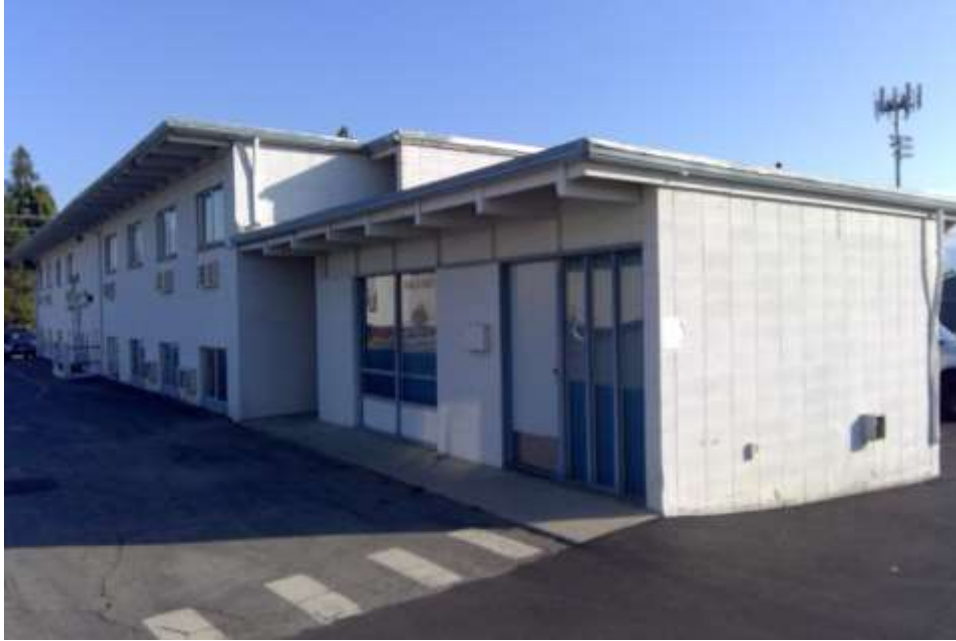
Knights Hall A (150-KHA) STATE UFI: A25186 Main Campus (150A)
AREA: 15,385 SF BUILT: 0 REMODELED: No PREDOMINANT USE: Classroom
CONSTRUCTION TYPE: No data CRV/SF: \$356 REPLACEMENT VALUE: \$5,477,060

Primary Systems			
COMPONENT:	Structure	RATING: 2 x WEIGHT: 8 =	SCORE: 16
Minor cracks evident in a small portion of the structure			
COMMENTS:	No data		
COMPONENT:	Exterior Closure	RATING: 3 x WEIGHT: 8 =	SCORE: 24
Sound and weatherproof but with some physical deterioration evident			
COMMENTS:	No data		
COMPONENT:	Roofing	RATING: 2 x WEIGHT: 10 =	SCORE: 20
Majority of roofing and flashing appear sound, but a small portion of roofing shows deterioration where maintenance or minor repair needed			
COMMENTS:	No data

Secondary Systems			
COMPONENT:	Floor Finishes	RATING: 3 x WEIGHT: 6 =	SCORE: 18
	Some physical wear and minor imperfections are evident; beginning deterioration		
COMMENTS:	No data		
COMPONENT:	Wall Finishes	RATING: 2 x WEIGHT: 6 =	SCORE: 12
	Maintainable surfaces, minor maintenance is required in some areas		
COMMENTS:	No data		
COMPONENT:	Ceiling Finishes	RATING: 3 x WEIGHT: 6 =	SCORE: 18
	Some wear and tear; Minor damage, staining or deterioration		
COMMENTS:	No data		
COMPONENT:	Doors & Hardware	RATING: 2 x WEIGHT: 6 =	SCORE: 12
	Fairly modern door surfaces and hardware with minor deterioration; good working order		
COMMENTS:	No data

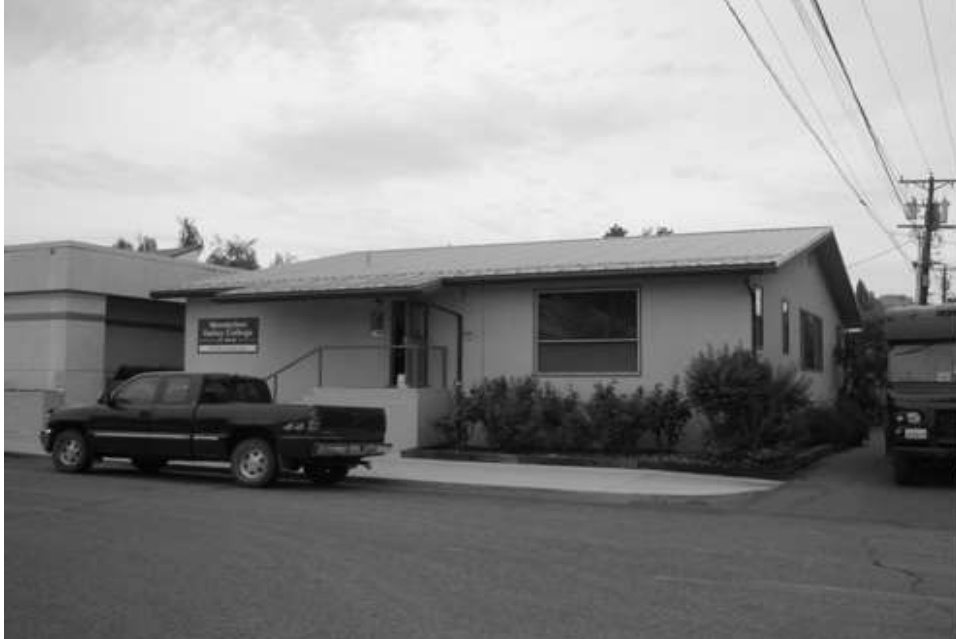
North Administration Bldg (150-NAD) STATE UFI: A08937 North Campus (150B)
AREA: 5,600 SF BUILT: 1975 REMODELED: No PREDOMINANT USE: Student Services
CONSTRUCTION TYPE: Light CRV/SF: \$231 REPLACEMENT VALUE: \$1,293,600

Primary Systems			
COMPONENT:	Structure	RATING: 1 x WEIGHT: 8 =	SCORE: 8
No signs of settlement or cracking, no abrupt vertical changes Columns, bearing walls and roof structure appears sound/free of defects			
COMMENTS:	Wood frame; concrete foundation		
COMPONENT:	Exterior Closure	RATING: 2 x WEIGHT: 8 =	SCORE: 16
Weatherproof exterior, but finish appears poorly maintained			
COMMENTS:	Plaster exterior walls		
COMPONENT:	Roofing	RATING: 1 x WEIGHT: 10 =	SCORE: 10
Flashing and penetrations appear sound and membrane appears water- tight; drainage is positive and there are overflow scuppers			
COMMENTS:	Metal roof-new in 1996

Secondary Systems			
COMPONENT:	Floor Finishes	RATING: 3 x WEIGHT: 6 =	SCORE: 18
Some physical wear and minor imperfections are evident; beginning deterioration			
COMMENTS:	Carpet-some wear; sheet vinyl; vinyl tile		
COMPONENT:	Wall Finishes	RATING: 1 x WEIGHT: 6 =	SCORE: 6
Maintainable surfaces in good condition			
COMMENTS:	Gypsum board; carpet wainscot; wood paneling		
COMPONENT:	Ceiling Finishes	RATING: 1 x WEIGHT: 6 =	SCORE: 6
Maintainable surfaces in good condition; good alignment and appearance			
COMMENTS:	Gypsum board; lay-in tile; direct-adhered tile		
COMPONENT:	Doors & Hardware	RATING: 1 x WEIGHT: 6 =	SCORE: 6
Appropriate hardware, closers, panic devices; in good working order			
COMMENTS:	Interior wood doors/frames; exterior wood/HM doors and wood frames-some wear

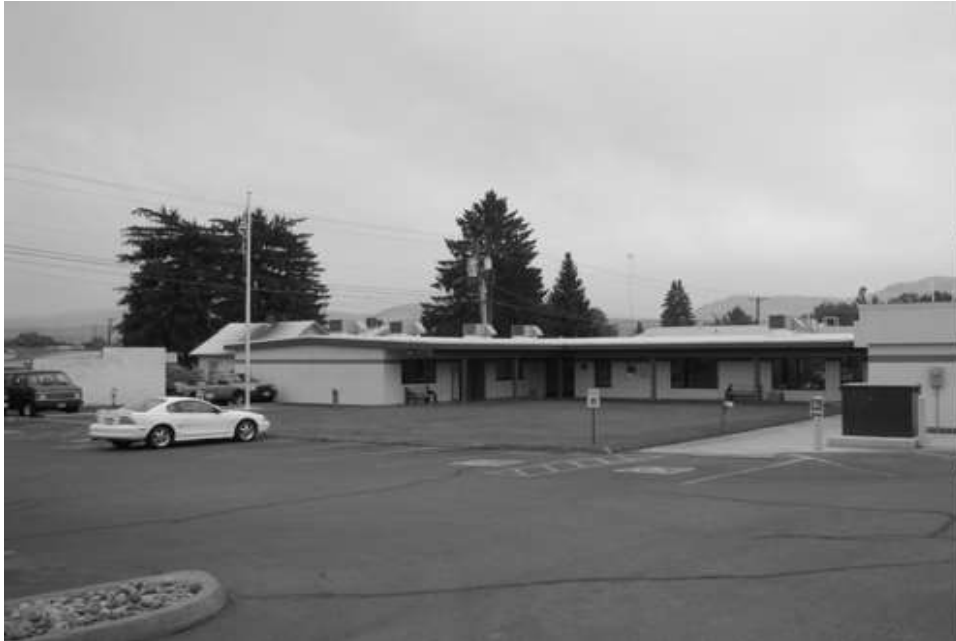
Wendall George Hall (150-WGH) STATE UFI: A01911 North Campus (150B)
AREA: 8,848 SF BUILT: 0 REMODELED: No PREDOMINANT USE: Mixed Use
CONSTRUCTION TYPE: Light CRV/SF: \$395 REPLACEMENT VALUE: \$3,494,960

Primary Systems			
COMPONENT:	Structure	RATING: 1 x WEIGHT: 8.3 =	SCORE: 8.3
No signs of settlement or cracking, no abrupt vertical changes Columns, bearing walls and roof structure appears sound/free of defects			
COMMENTS:	Concrete; wood framing		
COMPONENT:	Exterior Closure	RATING: 1 x WEIGHT: 8.3 =	SCORE: 8.3
Weatherproof, tight, well-maintained exterior walls, doors, windows/finishes			
COMMENTS:	New EIFS exterior in 2000; wood soffits		
COMPONENT:	Roofing	RATING: 1 x WEIGHT: 10.4 =	SCORE: 10.4
Flashing and penetrations appear sound and membrane appears water- tight; drainage is positive and there are overflow scuppers			
COMMENTS:	New TPO membrane installed in 2011 to overlay defective membrane installed in 2011; warranty work

Secondary Systems			
COMPONENT:	Floor Finishes	RATING: 2 x WEIGHT: 6.3 =	SCORE: 12.5
Some wear is evident on finish; maintenance needed			
COMMENTS:	Carpet; epoxy flooring; vinyl tile; ceramic tile		
COMPONENT:	Wall Finishes	RATING: 1 x WEIGHT: 6.3 =	SCORE: 6.3
Maintainable surfaces in good condition			
COMMENTS:	Gypsum board; ceramic tile		
COMPONENT:	Ceiling Finishes	RATING: 3 x WEIGHT: 6.3 =	SCORE: 18.8
Some wear and tear; Minor damage, staining or deterioration			
COMMENTS:	Lay-in tiles-staining on many tiles from roof leaks		
COMPONENT:	Doors & Hardware	RATING: 2 x WEIGHT: 6.3 =	SCORE: 12.5
Fairly modern door surfaces and hardware with minor deterioration; good working order			
COMMENTS:	Interior wood doors w HM frames; exterior aluminum and HM doors w aluminum/HM frames

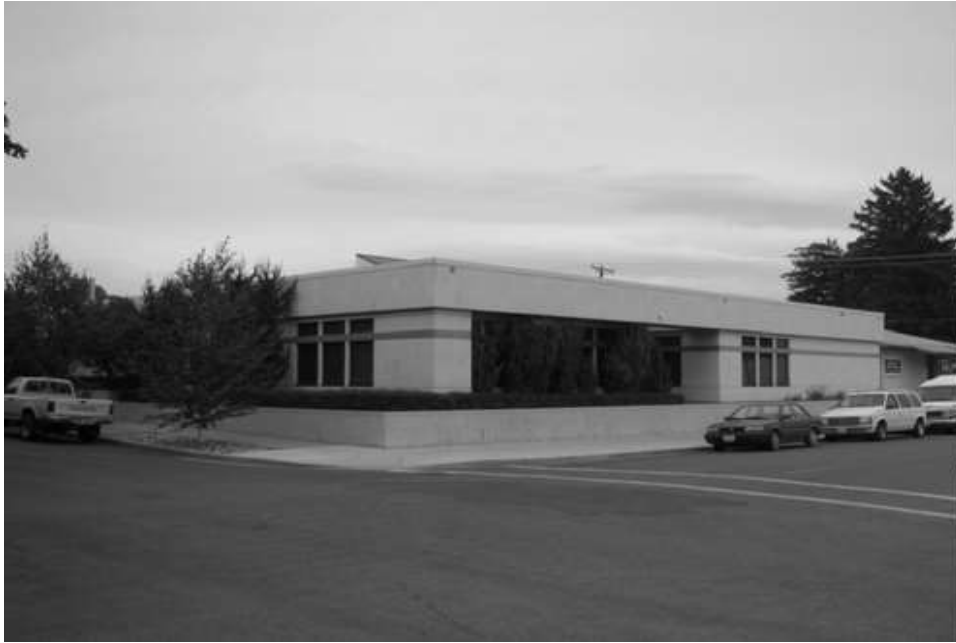
North Friendship Hall (150-NFH) STATE UFI: A07184 North Campus (150B)
AREA: 7,131 SF BUILT: 1985 REMODELED: No PREDOMINANT USE: General Classroom
CONSTRUCTION TYPE: Medium CRV/SF: \$376 REPLACEMENT VALUE: \$2,681,256

Primary Systems			
COMPONENT:	Structure	RATING: 1 x WEIGHT: 8.3 =	SCORE: 8.3
No signs of settlement or cracking, no abrupt vertical changes Columns, bearing walls and roof structure appears sound/free of defects			
COMMENTS:	CMU; wood framing		
COMPONENT:	Exterior Closure	RATING: 2 x WEIGHT: 8.3 =	SCORE: 16.7
Weatherproof exterior, but finish appears poorly maintained			
COMMENTS:	Stucco (dryvit)-some minor cracks need patching; wood soffits		
COMPONENT:	Roofing	RATING: 1 x WEIGHT: 10.4 =	SCORE: 10.4
Flashing and penetrations appear sound and membrane appears water- tight; drainage is positive and there are overflow scuppers			
COMMENTS:	New TPO membrane installed in 2011 to overlay defective membrane installed in 2011; warranty work

Secondary Systems			
COMPONENT:	Floor Finishes	RATING: 2 x WEIGHT: 6.3 =	SCORE: 12.5
Some wear is evident on finish; maintenance needed			
COMMENTS:	Carpet-some wear; vinyl tile; exposed aggregate concrete; ceramic tile		
COMPONENT:	Wall Finishes	RATING: 1 x WEIGHT: 6.3 =	SCORE: 6.3
Maintainable surfaces in good condition			
COMMENTS:	Gypsum board throughout; good condition		
COMPONENT:	Ceiling Finishes	RATING: 3 x WEIGHT: 6.3 =	SCORE: 18.8
Some wear and tear; Minor damage, staining or deterioration			
COMMENTS:	Lay-in tile; gypsum board-some stains from roof leaks; wood		
COMPONENT:	Doors & Hardware	RATING: 2 x WEIGHT: 6.3 =	SCORE: 12.5
Fairly modern door surfaces and hardware with minor deterioration; good working order			
COMMENTS:	Interior wood doors w HM frames; exterior aluminum/wood doors and aluminum/HM frames

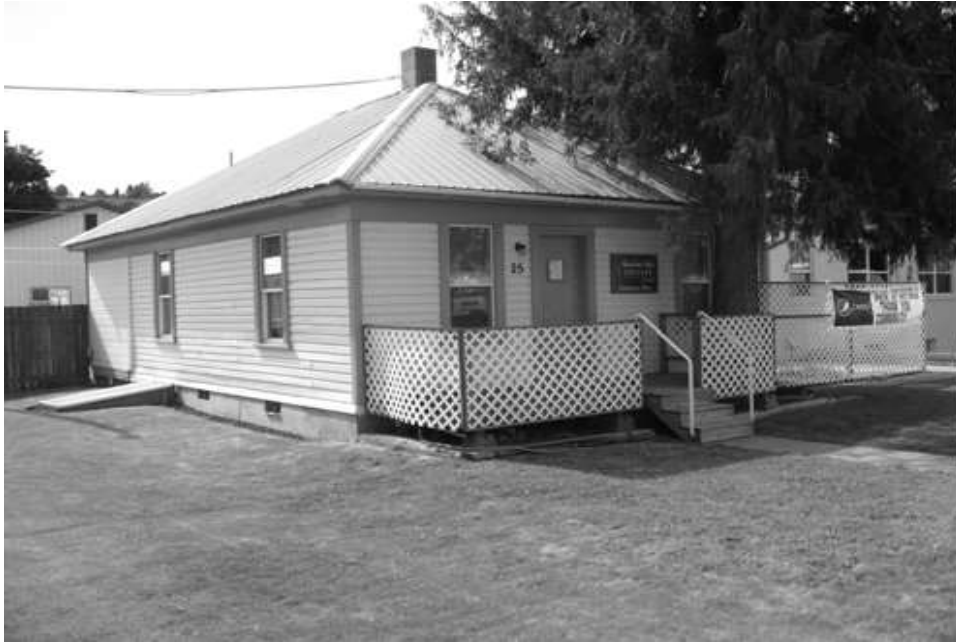
Omak Foundation Office (150-NC7) STATE UFI: A20418 North Campus (150B)
AREA: 839 SF BUILT: 2005 REMODELED: No PREDOMINANT USE: Administration
CONSTRUCTION TYPE: Light CRV/SF: \$231 REPLACEMENT VALUE: \$193,809

Primary Systems			
COMPONENT:	Structure	RATING: 4 x WEIGHT: 8.3 =	SCORE: 33.4
Some structural flaws potentially exist and should be evaluated by a structural engineer			
COMMENTS:	Wood frame; concrete foundation		
COMPONENT:	Exterior Closure	RATING: 3 x WEIGHT: 8.3 =	SCORE: 25
Sound and weatherproof but with some physical deterioration evident			
COMMENTS:	Horizontal wood siding; older and checked		
COMPONENT:	Roofing	RATING: 2 x WEIGHT: 10.4 =	SCORE: 20.9
Majority of roofing and flashing appear sound, but a small portion of roofing shows deterioration where maintenance or minor repair needed			
COMMENTS:	Metal roof panels over asphalt shingles

Secondary Systems			
COMPONENT:	Floor Finishes	RATING: 3 x WEIGHT: 6.3 =	SCORE: 18.8
Some physical wear and minor imperfections are evident; beginning deterioration			
COMMENTS:	Carpet; sheet vinyl		
COMPONENT:	Wall Finishes	RATING: 2 x WEIGHT: 6.3 =	SCORE: 12.5
Maintainable surfaces, minor maintenance is required in some areas			
COMMENTS:	Gypsum board		
COMPONENT:	Ceiling Finishes	RATING: 3 x WEIGHT: 6.3 =	SCORE: 18.8
Some wear and tear; Minor damage, staining or deterioration			
COMMENTS:	Gypsum board		
COMPONENT:	Doors & Hardware	RATING: 3 x WEIGHT: 6.3 =	SCORE: 18.8
Functional, but dated; some maintenance required			
COMMENTS:	Interior wood doors/frames; exterior wood/HM doors/wood frames

Service Systems			
COMPONENT:	Elevators	RATING: 0 x WEIGHT: 0 =	SCORE: 0
No data			
COMMENTS:	1 story w partial basement. No elevator.		
COMPONENT:	Plumbing	RATING: 3 x WEIGHT: 8.3 =	SCORE: 25
Fixtures are functional but dated; some leaks; maintenance required			
COMMENTS:	Galvanized and cast iron piping; porcelain fixtures		
COMPONENT:	HVAC	RATING: 3 x WEIGHT: 8.3 =	SCORE: 25
System generally adequate; some deterioration; needs balancing; some areas have A/C; hazardous areas are ventilated			
COMMENTS:	Electric wall heaters w fans		
COMPONENT:	Electrical	RATING: 3 x WEIGHT: 8.3 =	SCORE: 25
Service capacity meets current needs but inadequate for future			
COMMENTS:	100amp 208/120v		
COMPONENT:	Lights/Power	RATING: 3 x WEIGHT: 8.3 =	SCORE: 25
Adequate work area illumination; adequate outlets for current use; maintenance required			
COMMENTS:	Ceiling mount fluorescent lights; inadequate

Safety Systems			
COMPONENT:	Life/Safety	RATING: 5 x WEIGHT: 10.4 =	SCORE: 52.1
Does not meet minimum health/safety requirements or not accessible			
COMMENTS:			
COMPONENT:	Fire Safety	RATING: 5 x WEIGHT: 10.4 =	SCORE: 52.1
Life safety or accessibility violations exist; Missing exit signs or extinguishers throughout; No alarm or sprinklers			
COMMENTS:			
COMPONENT:	Modifications	RATING: 5 x WEIGHT: 7.3 =	SCORE: 36.5
Modifications not well thought out or constructed; inadequate HVAC and electrical service provided			
COMMENTS: Interior poorly modified by previous owners

Quality Standards			
COMPONENT:	Maintenance	RATING: 5 x WEIGHT: 7.3 =	SCORE: 36.5
General deterioration is evident; lack of adequate maintenance is evident; impact is moderate to severe			
COMMENTS:			
COMPONENT:	Remaining Life	RATING: 5 x WEIGHT: 6.3 =	SCORE: 31.3
Life expectancy is <5 years; significant system deterioration			
COMMENTS: Most systems are older; not cost-effective to renovate; RUL <10 yrs.			
COMPONENT:	Appearance	RATING: 5 x WEIGHT: 6.3 =	SCORE: 31.3
Poor to average construction; very unattractive exterior and interior spaces			
COMMENTS:

CONDITION: Replace or Renovate

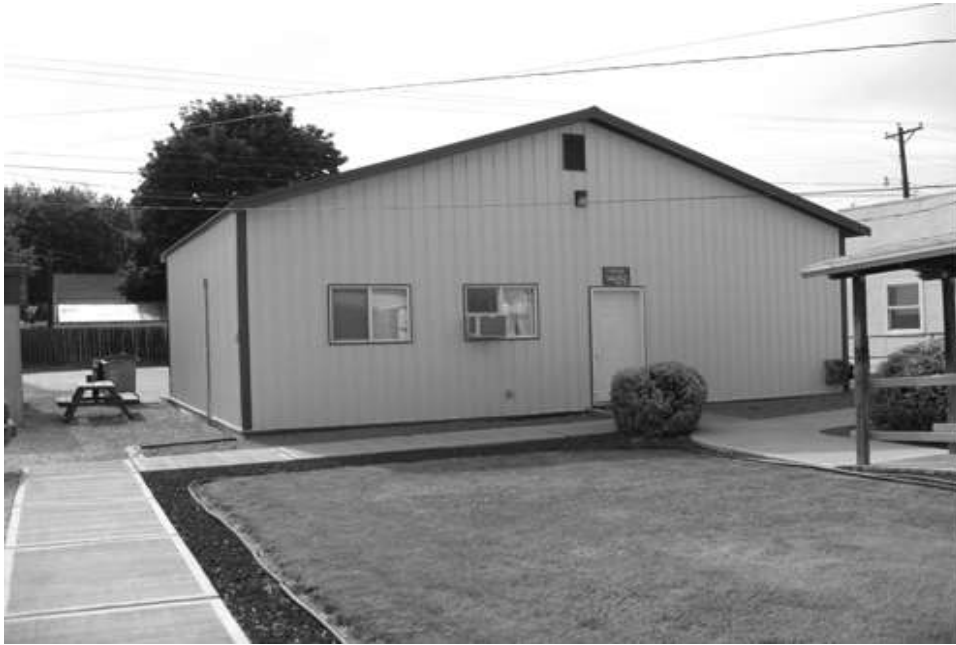
Omak Facilities Building (150-NC6) STATE UFI: A20475 North Campus (150B)
AREA: 1,034 SF BUILT: 2005 REMODELED: No PREDOMINANT USE: Maintenance
CONSTRUCTION TYPE: Light CRV/SF: \$244 REPLACEMENT VALUE: \$252,296

Primary Systems			
COMPONENT:	Structure	RATING: 1 x WEIGHT: 8.3 =	SCORE: 8.3
No signs of settlement or cracking, no abrupt vertical changes Columns, bearing walls and roof structure appears sound/free of defects			
COMMENTS:	Wood frame; concrete slab		
COMPONENT:	Exterior Closure	RATING: 2 x WEIGHT: 8.3 =	SCORE: 16.7
Weatherproof exterior, but finish appears poorly maintained			
COMMENTS:	Metal siding		
COMPONENT:	Roofing	RATING: 1 x WEIGHT: 10.4 =	SCORE: 10.4
Flashing and penetrations appear sound and membrane appears water- tight; drainage is positive and there are overflow scuppers			
COMMENTS:	Metal roof

Secondary Systems			
COMPONENT:	Floor Finishes	RATING: 2 x WEIGHT: 6.3 =	SCORE: 12.5
Some wear is evident on finish; maintenance needed			
COMMENTS:	Concrete; carpet; sheet vinyl		
COMPONENT:	Wall Finishes	RATING: 1 x WEIGHT: 6.3 =	SCORE: 6.3
Maintainable surfaces in good condition			
COMMENTS:	Gypsum board		
COMPONENT:	Ceiling Finishes	RATING: 1 x WEIGHT: 6.3 =	SCORE: 6.3
Maintainable surfaces in good condition; good alignment and appearance			
COMMENTS:	Gypsum board		
COMPONENT:	Doors & Hardware	RATING: 1 x WEIGHT: 6.3 =	SCORE: 6.3
Appropriate hardware, closers, panic devices; in good working order			
COMMENTS:	Interior/exterior HM doors/wood frames

Service Systems			
COMPONENT:	Elevators	RATING: 0 x WEIGHT: 0 =	SCORE: 0
No data			
COMMENTS:			
COMPONENT:	Plumbing	RATING: 1 x WEIGHT: 8.3 =	SCORE: 8.3
Fixtures and piping appear to be in good condition; no evidence of leaks			
COMMENTS:	Copper, steel, cast iron and ABS piping; porcelain fixtures		
COMPONENT:	HVAC	RATING: 1 x WEIGHT: 8.3 =	SCORE: 8.3
Equipment in good condition; easily controlled; serves all required spaces; All necessary spaces are adequately ventilated; A/C provided throughout			
COMMENTS:	Electric wall furnace and window A/C		
COMPONENT:	Electrical	RATING: 1 x WEIGHT: 8.3 =	SCORE: 8.3
Adequate service and distribution capacity for current/future needs			
COMMENTS:	200amp 120/208v		
COMPONENT:	Lights/Power	RATING: 1 x WEIGHT: 8.3 =	SCORE: 8.3
Contemporary lighting with good work area illumination; ample outlets			
COMMENTS:	Ceiling mount fluorescent lighting

Safety Systems			
COMPONENT:	Life/Safety	RATING: 3 x WEIGHT: 10.4 = SCORE: 31.3	
	Generally meets codes for vintage of construction		
COMMENTS:			
COMPONENT:	Fire Safety	RATING: 5 x WEIGHT: 10.4 = SCORE: 52.1	
	Life safety or accessibility violations exist; Missing exit signs or extinguishers throughout; No alarm or sprinklers		
COMMENTS:			
COMPONENT:	Modifications	RATING: 3 x WEIGHT: 7.3 = SCORE: 21.9	
	Some modifications lack code compliance; HVAC service not fully considered during renovation		
COMMENTS:	Minor modifications; average workmanship

Quality Standards			
COMPONENT:	Maintenance	RATING: 3 x WEIGHT: 7.3 = SCORE: 21.9	
	Routine maintenance is required; deferred maintenance is evident; impact is minor to moderate		
COMMENTS:			
COMPONENT:	Remaining Life	RATING: 1 x WEIGHT: 6.3 = SCORE: 6.3	
	Life expectancy is >20 years; minor system deterioration		
COMMENTS:	Newer metal building; should have RUL of 20 yrs.		
COMPONENT:	Appearance	RATING: 3 x WEIGHT: 6.3 = SCORE: 18.8	
	Average construction; average interior and exterior appearance		
COMMENTS:	Average looking interior and exterior

TOTAL SCORE = 290 PREVIOUS BIENNIUM SCORE = 290
CONDITION: Needs Improvement/Additional Maintenance

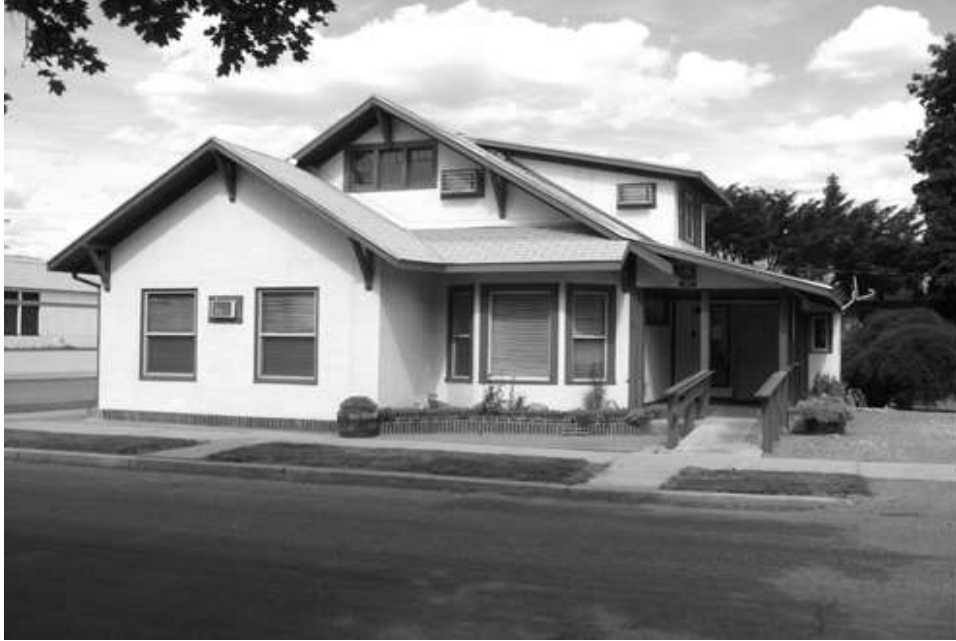
Distance Learning Center (150-DLC) STATE UFI: A20883 North Campus (150B)
AREA: 3,194 SF BUILT: 1975 REMODELED: No PREDOMINANT USE: Classroom
CONSTRUCTION TYPE: Light CRV/SF: \$231 REPLACEMENT VALUE: \$737,814

Primary Systems			
COMPONENT:	Structure	RATING: 4 x WEIGHT: 8 =	SCORE: 32
Some structural flaws potentially exist and should be evaluated by a structural engineer			
COMMENTS:	Wood frame; enclosed porch is sagging; possible structural issues		
COMPONENT:	Exterior Closure	RATING: 5 x WEIGHT: 8 =	SCORE: 40
Significant deterioration, leaking and air infiltration apparent			
COMMENTS:	Wood siding		
COMPONENT:	Roofing	RATING: 3 x WEIGHT: 10 =	SCORE: 30
Some deterioration is evident in membrane and flashings; maintenance or minor repair is needed			
COMMENTS:	Asphalt shingles

Secondary Systems			
COMPONENT:	Floor Finishes	RATING: 4 x WEIGHT: 6 =	SCORE: 24
General deterioration evident; one-third to one-half of flooring exhibits extensive deterioration			
COMMENTS:	Carpet; sheet vinyl		
COMPONENT:	Wall Finishes	RATING: 3 x WEIGHT: 6 =	SCORE: 18
Aging surfaces, but sound; some maintenance is required			
COMMENTS:	Gypsum board		
COMPONENT:	Ceiling Finishes	RATING: 3 x WEIGHT: 6 =	SCORE: 18
Some wear and tear; Minor damage, staining or deterioration			
COMMENTS:	Gypsum board; direct-adhered tile		
COMPONENT:	Doors & Hardware	RATING: 3 x WEIGHT: 6 =	SCORE: 18
Functional, but dated; some maintenance required			
COMMENTS:	Interior wood doors/frames; exterior HM/wood doors/wood frames

Service Systems			
COMPONENT:	Elevators	RATING: 5 x WEIGHT: 6 =	SCORE: 30
No elevator access for upper floors			
COMMENTS:	2 story w basement; no elevator		
COMPONENT:	Plumbing	RATING: 3 x WEIGHT: 8 =	SCORE: 24
Fixtures are functional but dated; some leaks; maintenance required			
COMMENTS:	Copper; cast iron and ABS piping		
COMPONENT:	HVAC	RATING: 3 x WEIGHT: 8 =	SCORE: 24
System generally adequate; some deterioration; needs balancing; some areas have A/C; hazardous areas are ventilated			
COMMENTS:	Electric baseboards; window A/C; electric force air furnace w cooling coil		
COMPONENT:	Electrical	RATING: 1 x WEIGHT: 8 =	SCORE: 8
Adequate service and distribution capacity for current/future needs			
COMMENTS:	200amp 208/120v		
COMPONENT:	Lights/Power	RATING: 3 x WEIGHT: 8 =	SCORE: 24
Adequate work area illumination; adequate outlets for current use; maintenance required			
COMMENTS:	Ceiling mount fluorescent lights; inadequate

Safety Systems			
COMPONENT:	Life/Safety	RATING: 5 x WEIGHT: 10 =	SCORE: 50
Does not meet minimum health/safety requirements or not accessible			
COMMENTS:			
COMPONENT:	Fire Safety	RATING: 3 x WEIGHT: 10 =	SCORE: 30
Extinguishers and signed egress; no alarm or sprinklers			
COMMENTS:			
COMPONENT:	Modifications	RATING: 5 x WEIGHT: 7 =	SCORE: 35
Modifications not well thought out or constructed; inadequate HVAC and electrical service provided			
COMMENTS: Interior poorly modified by previous owners

Quality Standards			
COMPONENT:	Maintenance	RATING: 4 x WEIGHT: 7 =	SCORE: 28
Lack of maintenance in some areas is evident; impact is moderate			
COMMENTS: Average maintenance			
COMPONENT:	Remaining Life	RATING: 5 x WEIGHT: 6 =	SCORE: 30
Life expectancy is <5 years; significant system deterioration			
COMMENTS: Most systems are older; not cost-effective to renovate; RUL <10 yrs.			
COMPONENT:	Appearance	RATING: 5 x WEIGHT: 6 =	SCORE: 30
Poor to average construction; very unattractive exterior and interior spaces			
COMMENTS:

CONDITION: Replace or Renovate

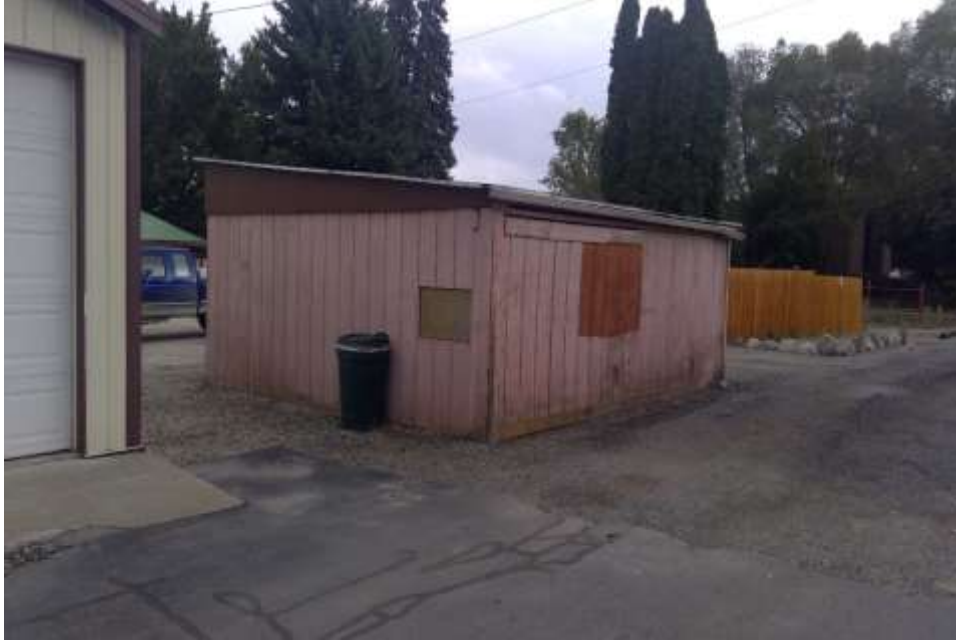
North Storage Building (150-NSB) STATE UFI: A21453 North Campus (150B)
AREA: 440 SF BUILT: 1970 REMODELED: No PREDOMINANT USE: Storage
CONSTRUCTION TYPE: No data CRV/SF: \$231 REPLACEMENT VALUE: \$101,640

Primary Systems			
COMPONENT:	Structure	RATING: 3 x WEIGHT: 11.8 =	SCORE: 35.4
Some cracking evident but does not likely affect structural integrity; Visible defects apparent but are non-structural			
COMMENTS:	No data		
COMPONENT:	Exterior Closure	RATING: 4 x WEIGHT: 11.8 =	SCORE: 47.2
General deterioration detected, one or more minor leaks apparent			
COMMENTS:	No data		
COMPONENT:	Roofing	RATING: 2 x WEIGHT: 14.7 =	SCORE: 29.5
Majority of roofing and flashing appear sound, but a small portion of roofing shows deterioration where maintenance or minor repair needed			
COMMENTS:	No data

Secondary Systems			
COMPONENT:	Floor Finishes	RATING: 1 x WEIGHT: 8.8 =	SCORE: 8.8
	Nice appearance, smooth transitions, level subfloors, no cracks/separating		
COMMENTS:	No data		
COMPONENT:	Wall Finishes	RATING: 0 x WEIGHT: 0 =	SCORE: 0
	No data		
COMMENTS:	No data		
COMPONENT:	Ceiling Finishes	RATING: 0 x WEIGHT: 0 =	SCORE: 0
	No data		
COMMENTS:	No data		
COMPONENT:	Doors & Hardware	RATING: 3 x WEIGHT: 8.8 =	SCORE: 26.5
	Functional, but dated; some maintenance required		
COMMENTS:	No data

Service Systems			
COMPONENT:	Elevators	RATING: 0 x WEIGHT: 0 =	SCORE: 0
	No data		
COMMENTS:	No data		
COMPONENT:	Plumbing	RATING: 0 x WEIGHT: 0 =	SCORE: 0
	No data		
COMMENTS:	No data		
COMPONENT:	HVAC	RATING: 0 x WEIGHT: 0 =	SCORE: 0
	No data		
COMMENTS:	No data		
COMPONENT:	Electrical	RATING: 3 x WEIGHT: 11.8 =	SCORE: 35.4
	Service capacity meets current needs but inadequate for future		
COMMENTS:	No data		
COMPONENT:	Lights/Power	RATING: 3 x WEIGHT: 11.8 =	SCORE: 35.4
	Adequate work area illumination; adequate outlets for current use; maintenance required		
COMMENTS:	No data

Safety Systems			
COMPONENT:	Life/Safety	RATING: 3 x WEIGHT: 14.7 =	SCORE: 44.2
	Generally meets codes for vintage of construction		
COMMENTS:	No data		
COMPONENT:	Fire Safety	RATING: 5 x WEIGHT: 14.7 =	SCORE: 73.7
	Life safety or accessibility violations exist; Missing exit signs or extinguishers throughout; No alarm or sprinklers		
COMMENTS:	No data		
COMPONENT:	Modifications	RATING: 0 x WEIGHT: 0 =	SCORE: 0
	No data		
COMMENTS:	No data

Quality Standards			
COMPONENT:	Maintenance	RATING: 5 x WEIGHT: 10.3 =	SCORE: 51.6
	General deterioration is evident; lack of adequate maintenance is evident; impact is moderate to severe		
COMMENTS:	No data		
COMPONENT:	Remaining Life	RATING: 4 x WEIGHT: 8.8 =	SCORE: 35.4
	Life expectancy is 5-10 years; moderate to significant system deterioration		
COMMENTS:	No data		
COMPONENT:	Appearance	RATING: 5 x WEIGHT: 8.8 =	SCORE: 44.2
	Poor to average construction; very unattractive exterior and interior spaces		
COMMENTS:	No data

CONDITION: Replace or Renovate
